**SMOKE CAME OUT OF THE DADO PANEL IN
REAR CABIN DURING PASSENGERS
DISEMBARKING**

**EVA AIRWAYS FLIGHT BR67
BOEING 747-400, B-16410
BANGKOK SUVARNABHUMI INTERNATIONAL
AIRPORT FEBRUARY 23, 2008**

Final Report

Report Number: ASC-AFR-09-05-002

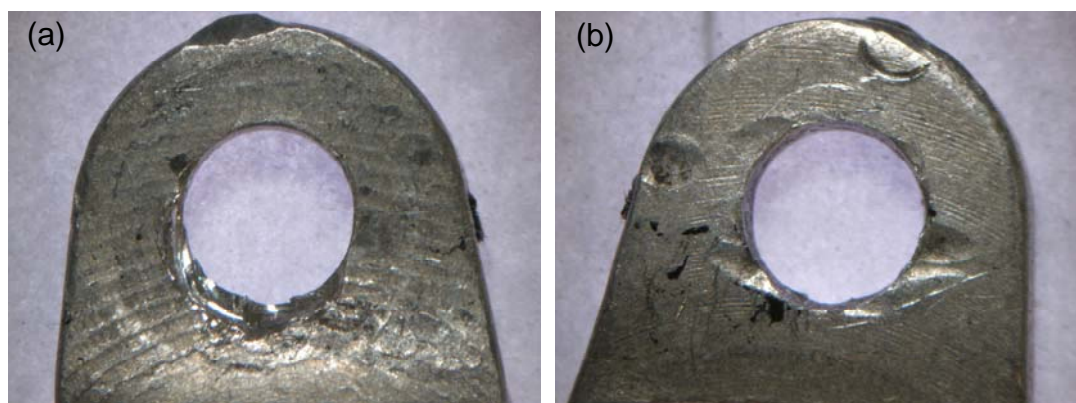
ear (surface B, near the wall), there are some clear pressing marks as shown in figure 1.16-3(b). The thickness measurement results of the straight part and ear part of the standoff are corresponding with the requirement.

Fig. 1.16-3 Macro observation of the upper ear

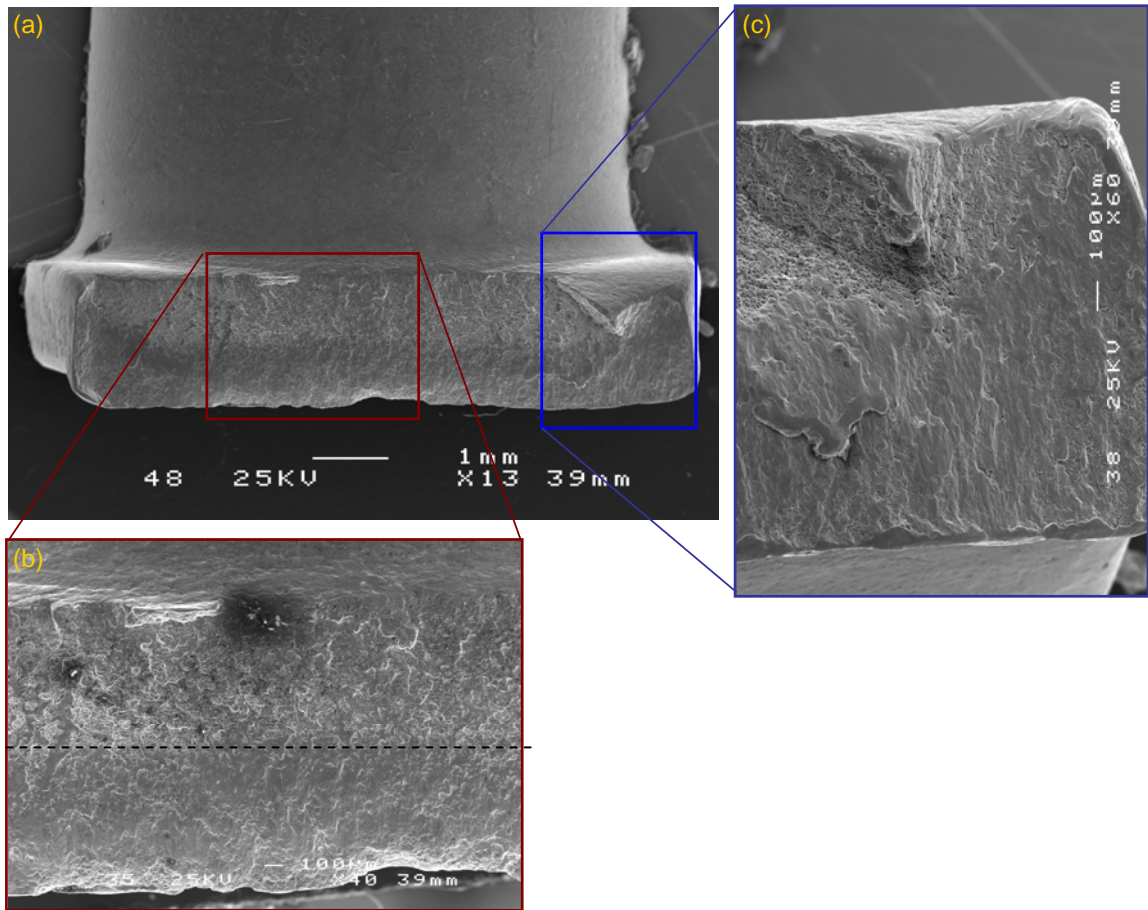
The fracture surface examined by Scanning Electron Microscope (SEM) was shown in figure 1.16-4. Figure 1.16-4(b) showed enlarged morphology of the red line framed region in figure 1.16-4, fracture surface near the upper part (near surface A) was quite rough, but fracture surface near the lower part (near surface B) was flat. The SEM photographs at higher magnification showed worn heavily. Figure 1.16-4(c) showed enlarged morphology of the blue line framed region in figure 1.16-4, local ductile dimple-fracture region were found, and the region was supposed to be the final overload fracture.

Fig. 1.16-4 Fracture surface examined by SEM

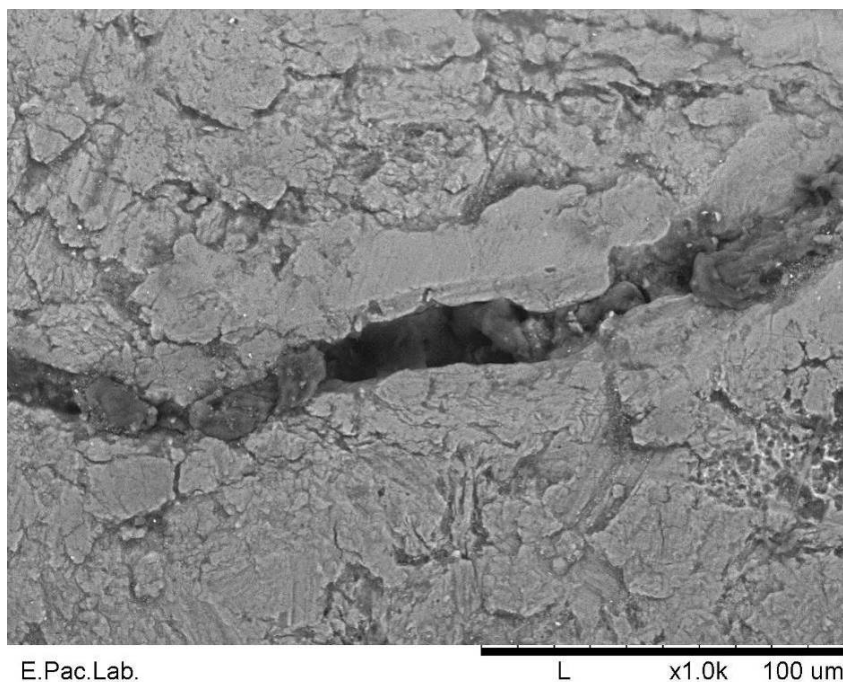
Fig. 1.16-6 Micro-defect on the back of the upper ear

According to chapter 1.16.1, some micro-defects are found on the surface B of the upper ear, shown in figure 1.16-6. The boundary condition of FEA simulation is modified, such as the blind rivet at the upper side is loose slightly, some cracks are added on the surface B, and then compute again. The result of FEA simulation shows that the initial fracture happened near surface B, shown in Fig 2.1-4, and is similar to the conclusion of Chung-Shan Institute of Science and Technology (CSIST).

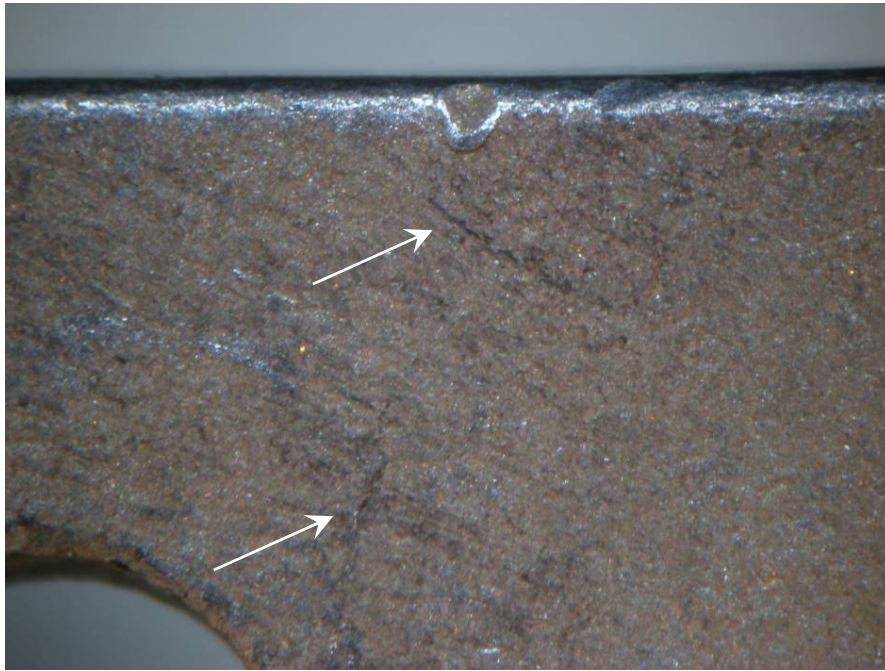
In order to confirm the fatigue striation characteristics, fracture surface examined by SEM was conducted at by Graduate Institute of Materials Science and Technology, National Taiwan University of Science and Technology (NTUST). It showed that the back of the upper ear (surface B) was quite rough, and some micro-defects are found, shown in figure 1.16-6. More spares were inspected, and the some micro-defects were found in the ear part (surface B), shown in figure 1.16-7.

Fig. 1.16-7 Micro-defect on the back of ear part of the spare

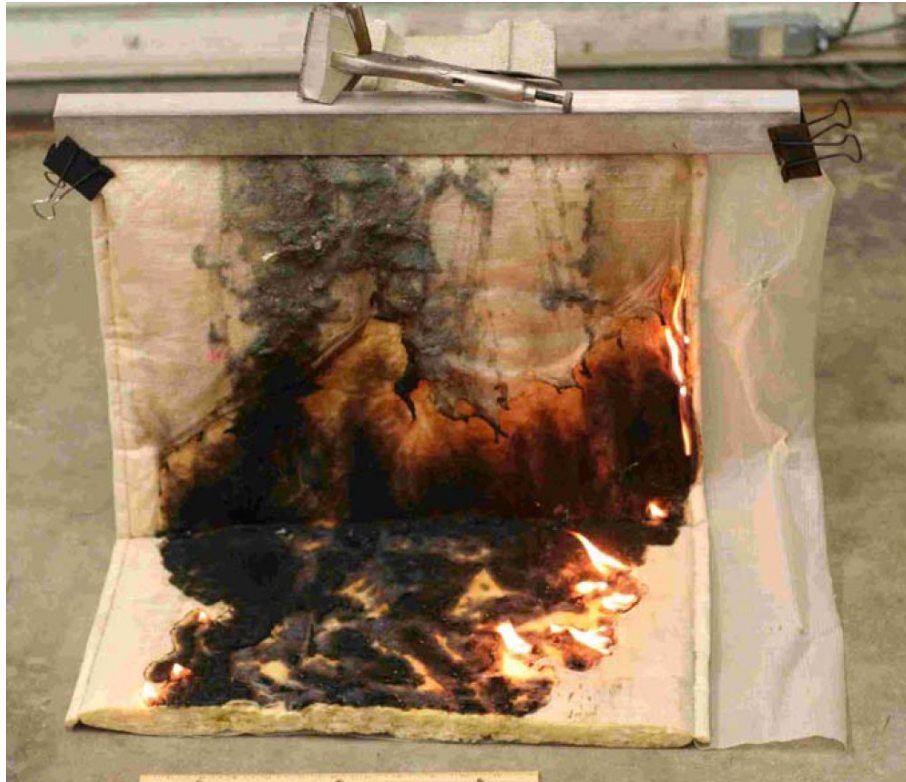
Fig. 1.16-7 Burn Test of Insulation Blanket

Test report concluded that the insulation blanket conformed to the required specifications, but the contaminated insulation blanket failed the cotton swab burn test.

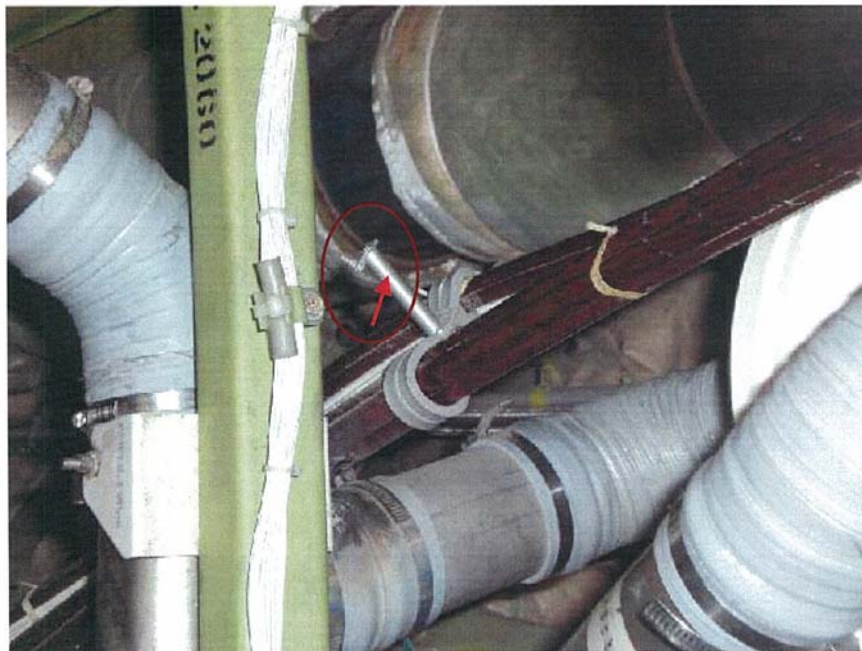
照片一、斷裂之電纜線支撐架（圈示處）的周圍環境及斷裂狀況

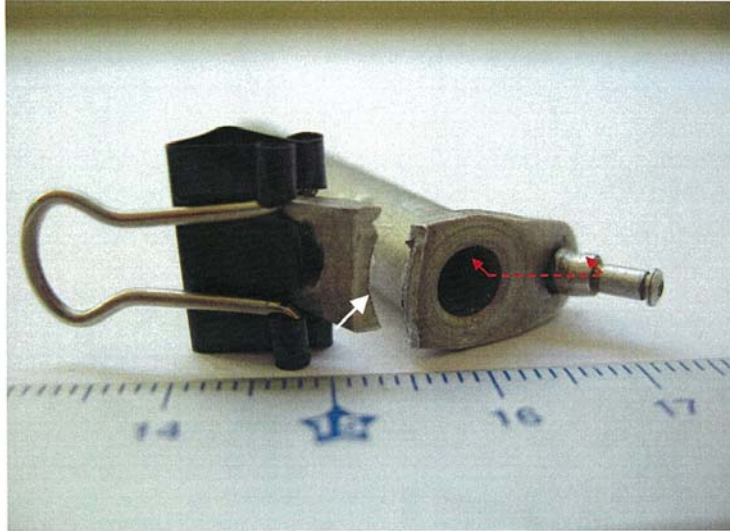
照片二、電纜線支撐架試樣的斷裂情形，白色箭頭處有剪唇。取虛線處的縱截面作金相觀察

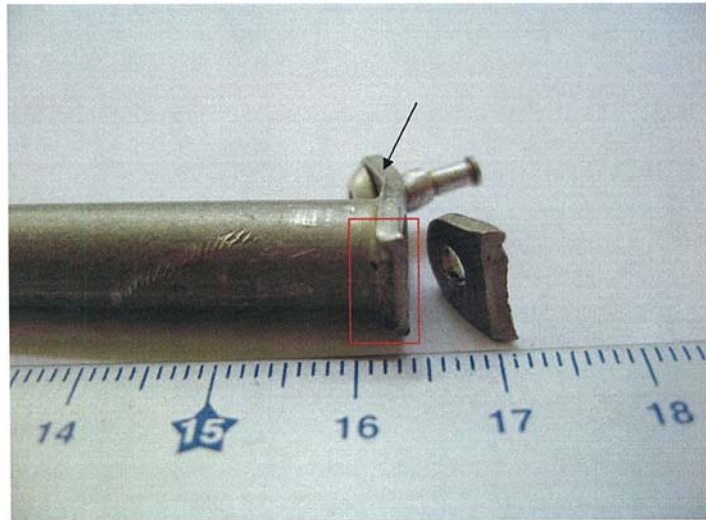
照片三、由另一角度觀察的電纜線支撐架試樣的斷裂情形，箭頭處顯示試樣彎曲

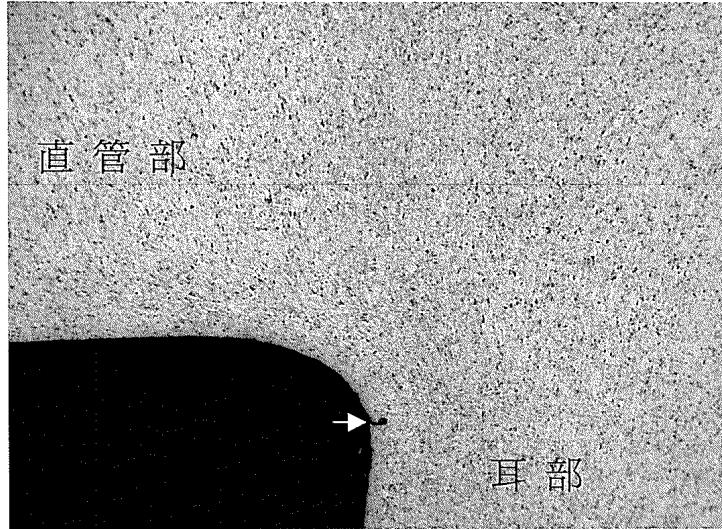
照片四、支撐架試樣轉角處的縱向金相，可知為鍛造成形，箭頭處有微裂 (Kroll's reagent, x 50)

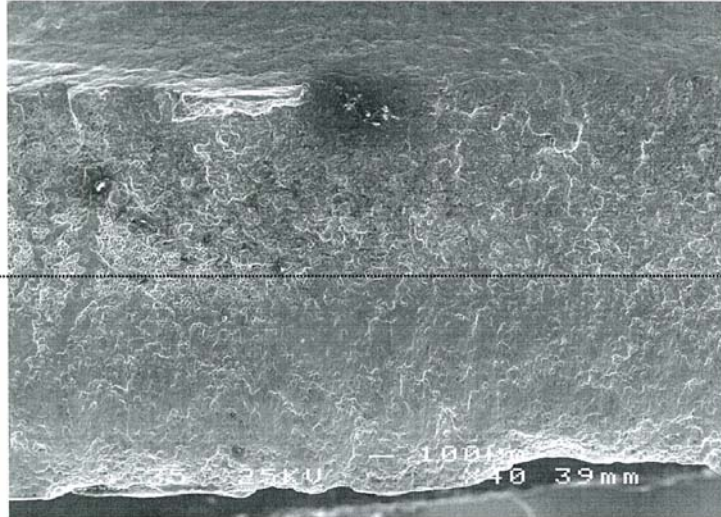
照片八、為照片七之紅框內破斷面的形態，虛線下方破斷面區域較平坦 (SEM, x 40)

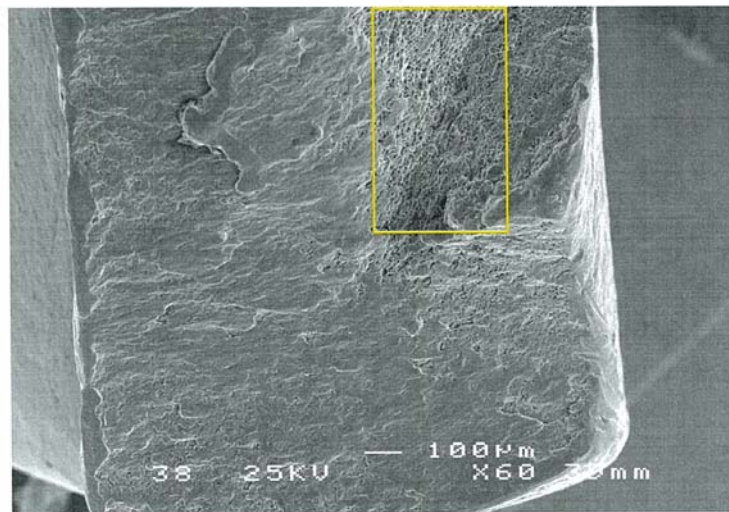
照片九、為照片七之藍框內破斷面旋轉 90 度後的放大形態，方框區域呈凹窩形態 (SEM, x 60)

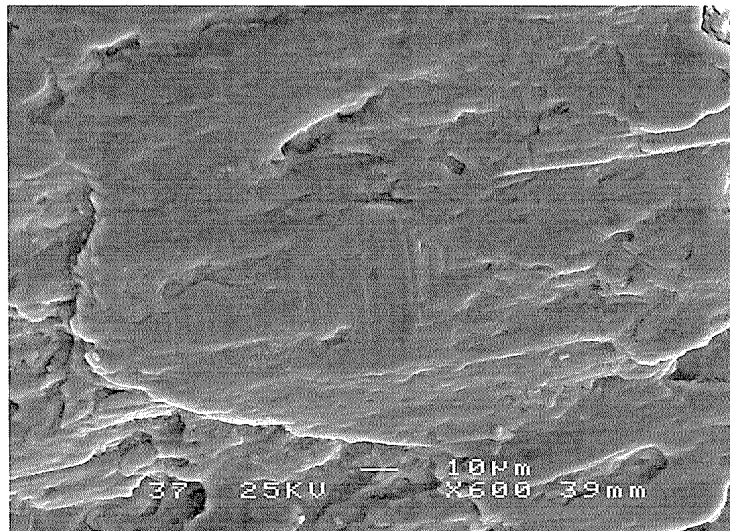
照片十一、為照片七之破斷面下半部的局部形態 (SEM, x 600)

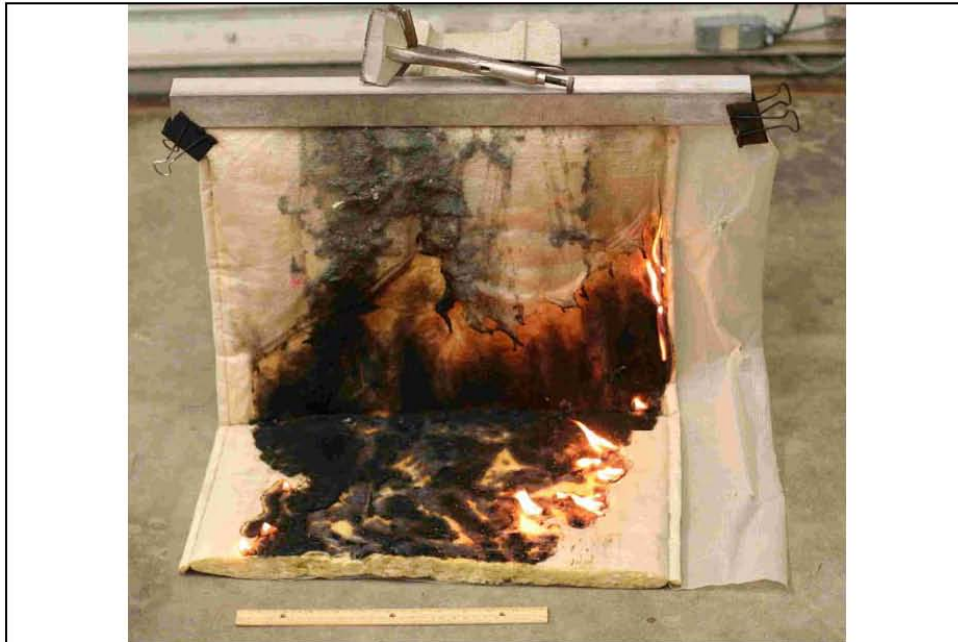
Figure 1. An initial alcohol-soaked cotton swab was dropped in the center of the flat area and the flame extinguished. When the flame went out, a small circular hole in the surface film existed in the center of the lower flat area shown. This photo shows a second test, in which a burning alcohol-soaked cotton swab was dropped near the left end of the fold. The visible creeping flame burned around and past where the initial flame stopped when this photo was taken.
