Aircraft Occurrence Investigation Report

ASC-AOR-05-08-001

TRANSASIA AIRWAYS FLIGHT GE006

NUMBER ONE ENGINE FIRE AFTER LANDING

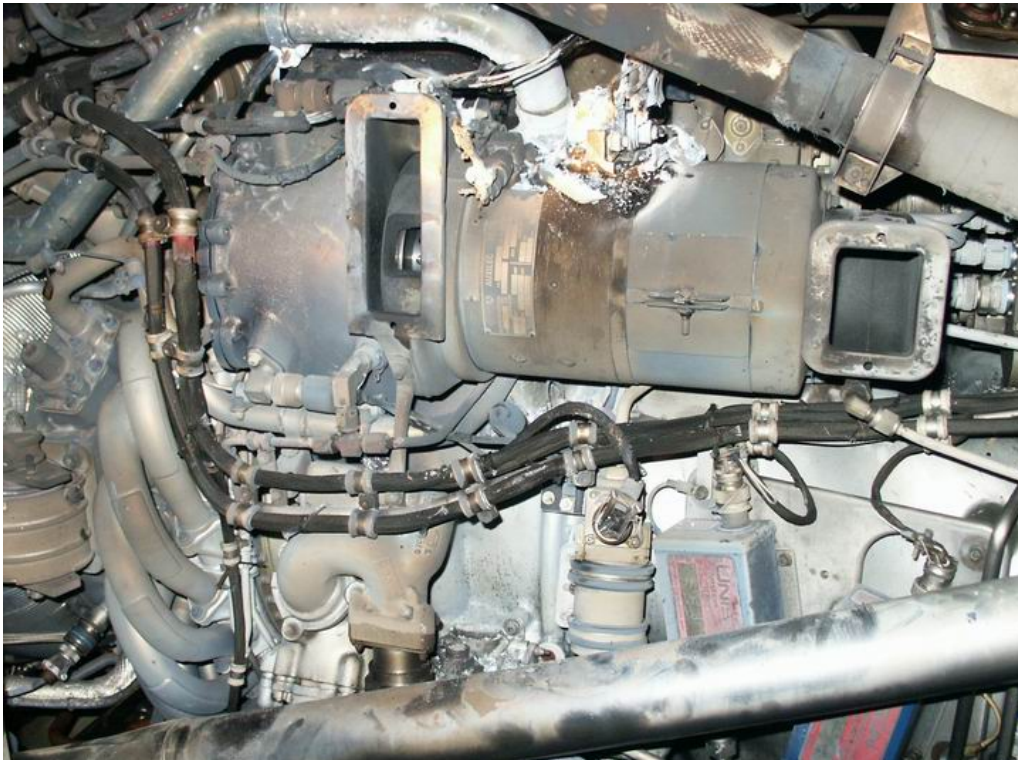
Figure 1.2-1 DC starter generator wire protection cover

No aircraft structural damage was found. During inspection to number one engine, TNA maintenance crew found an over heat condition on the inner side of the forward inboard cowling; some fire damage to the DC starter generator wire protection cover (Figure 1.2-1); some fire damaged to the propeller signal/control system wire bundle; some soot on the fire loop over top of the engine; a perforation on the top right side of the top of rear inlet case (Figure 1.2-2).

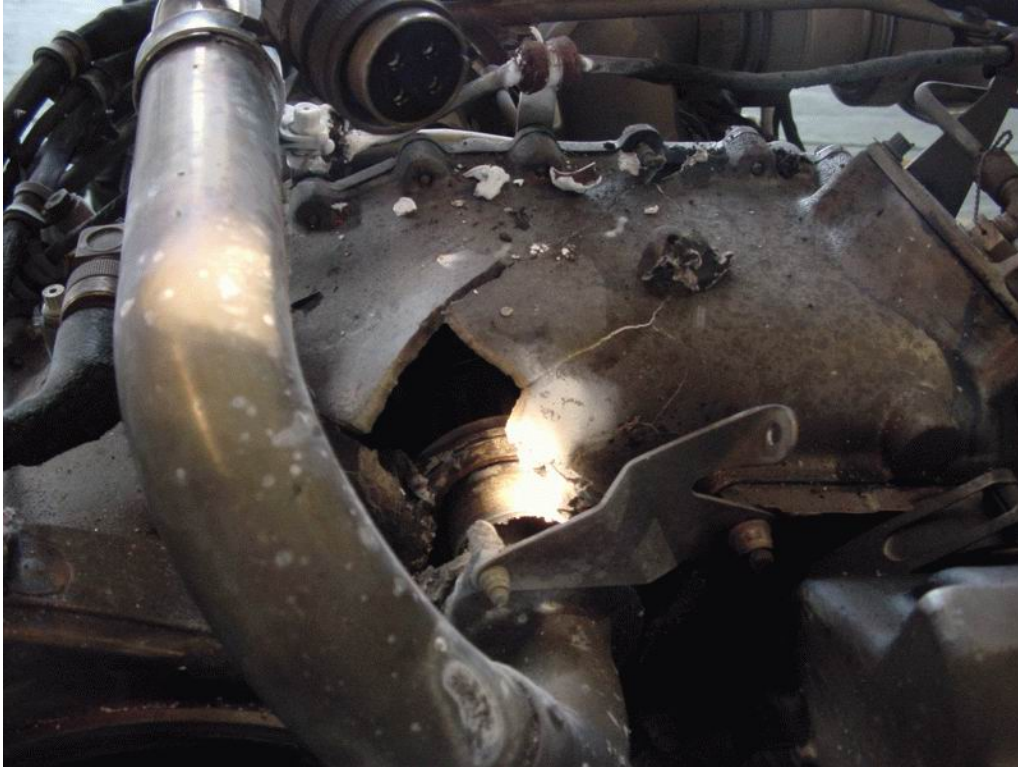
Figure 1.2-2 Perforation on the top right side of the rear inlet case

During an after landing inspection of the number-1 engine, a perforation was observed on the top right side of the rear inlet case. There was fire soot around the rear inlet case and fire damage to electrical wires nearby.

Released impeller debris caused the puncture of the rear inlet case.

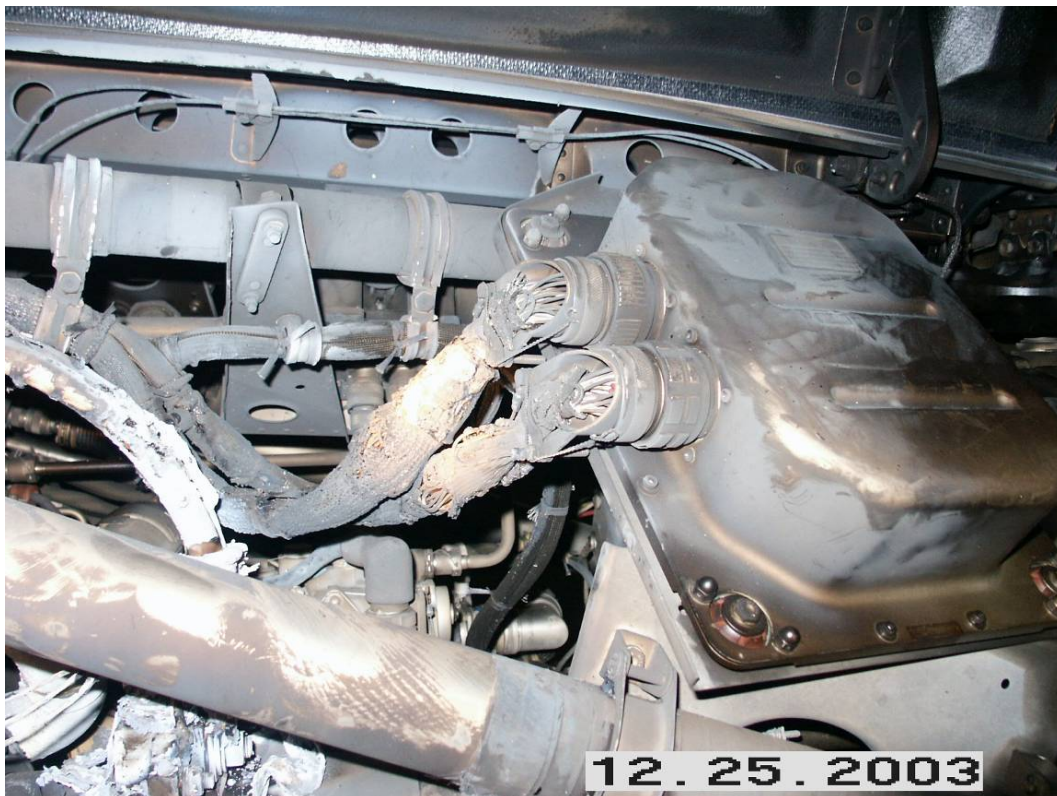
Figure 1.7-1 Part of the fire damaged wiring

number one T-Handle. After parking, the maintenance inspectors found fire damage and indications of overheat around the upper right region of the rear inlet case (See Figure 1.2-1.) Part of the fire damaged wiring is also presented in Figure 1.7-1.

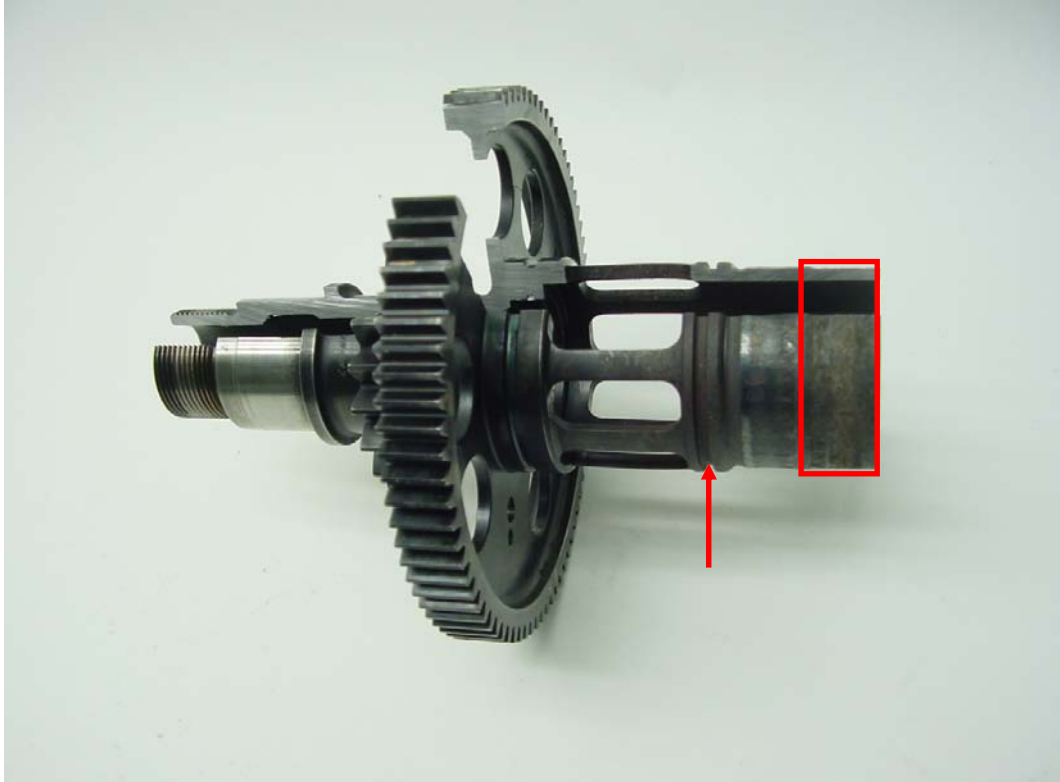
Figure 1.8-1 Location of the rubber seal (indicated by the red arrow) and the carbon seal (indicated by the red box).

One possibility was that the impeller sustained an excessive load of unknown origin that led to disintegration during normal operation. The other possibility was that the impeller rubber seal (as indicated by Figure 1.8-1) was missing during installation. That may have resulted in long-term impeller vibration and metal contact between the impeller and impeller shaft which led to the disintegration of the impeller. Appendix 2 and Appendix 3 contain the technical examination reports prepared by the ASC and SECA respectively.

The engine distress was most likely initiated by a fire in the region of the breather impeller carbon seal (as indicated by Figure 1.8-1). The fire most probably migrated inside the breather gear, caused a raise in temperature and resulted in the sudden increase of the breather impeller locating diameter. This resulted in the fracture of the breather impeller in overload.

The initiating cause for the fire is most probably resulting from the oil in the carbon seal region having reached the temperature of auto ignition. The reason of the oil having reached such level of temperature could not be ascertained.

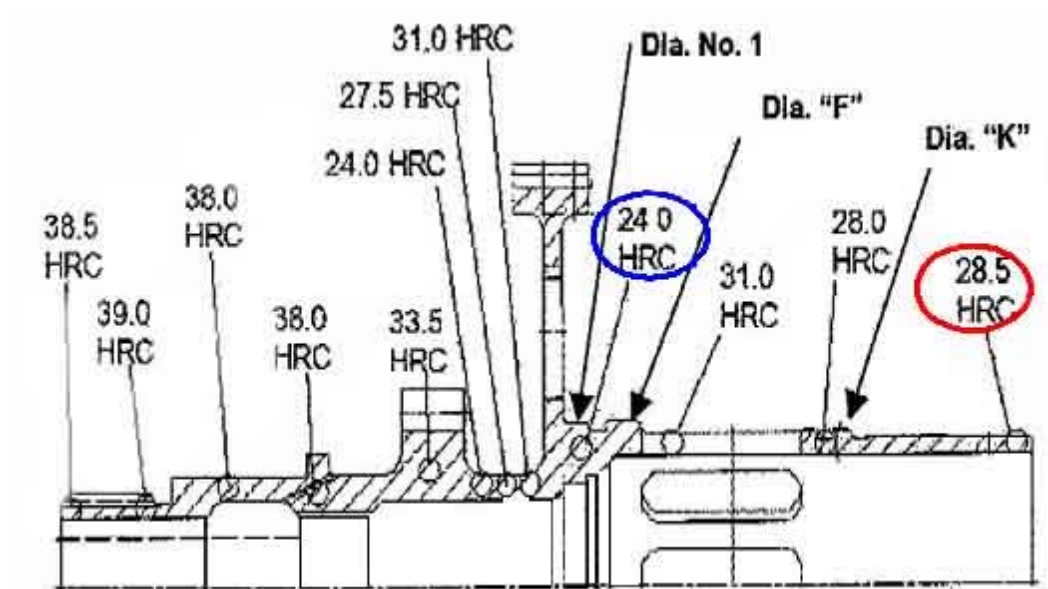
The examination of the hardness of the breather shaft at carbon seal region was 28.5 HRC⁴ (See Figure 2.3-1) which was softer than the drawing requirement of 35~41HRC in the original design. Severe wear with dark brown coloration on the external diameter of the impeller shaft was also observed, which revealed that there had been a high temperature caused by severe friction. The stains of white ashes around the fractured area of the rear inlet case indicated that there had been a fire. (See Figure 2.3-2) The tempered appearance was assumed to be the result of the aforesaid cause.

Figure 2.3-1 The hardness of the breather gear shaft (red circle) measured 28.5 HRC, higher than the other end of the shaft (blue circle), 24.0 HRC.

As Figure 2.3-1 has shown, the most severe tempered place was located at the other end of the carbon seal region of the shaft (24.0 HRC). It was in a position to be burnt most severely because it was closest to the fire source epicenter. Such findings are not entirely consistent with the finding of PWC's report, which asserted that the fire epicenter was in the region of the impeller breather carbon seal. If the fire started from the carbon seal region, it should have the highest temperature because it was very close to the heat epicenter and exposed to the heat for longer time. But the most severe tempered area was found to be at the other side of the impeller. PWC's findings that the heat epicenter was likely in the region of the carbon seal area were not consistent with the evidence. Overall, the evidence indicated that there had been a very high temperature with a subsequent fire in this part of the engine.

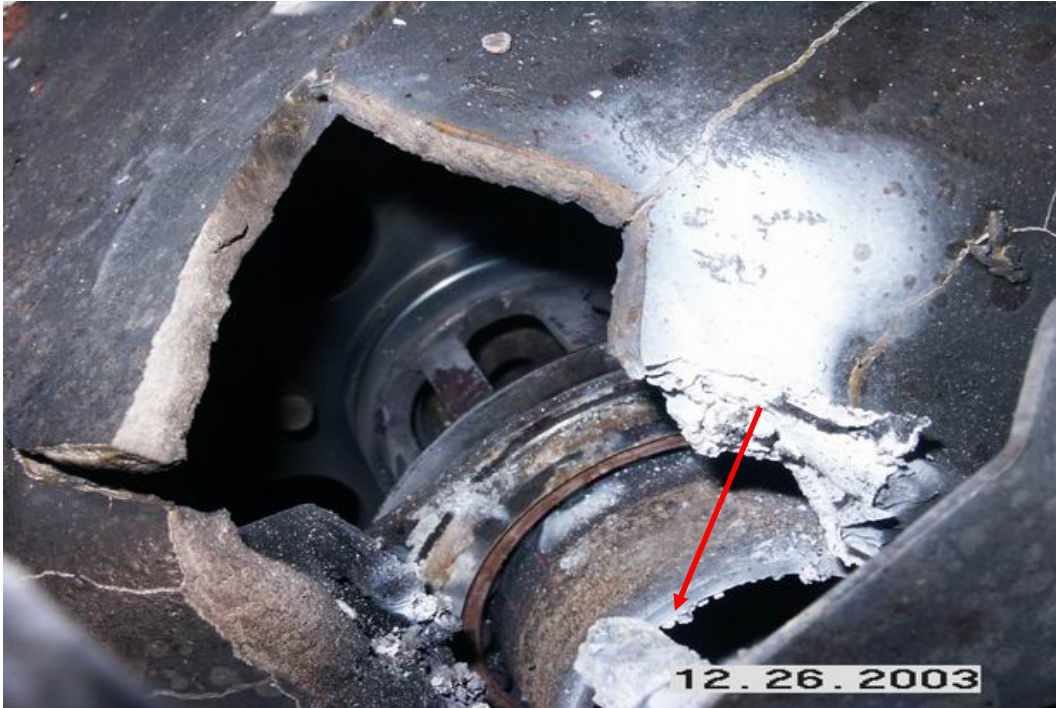
Figure 2.3-2 Severe wear in brown coloration on the outer diameter of impeller shaft (red arrow); stains of white ashes around the fractured area of rear inlet case.

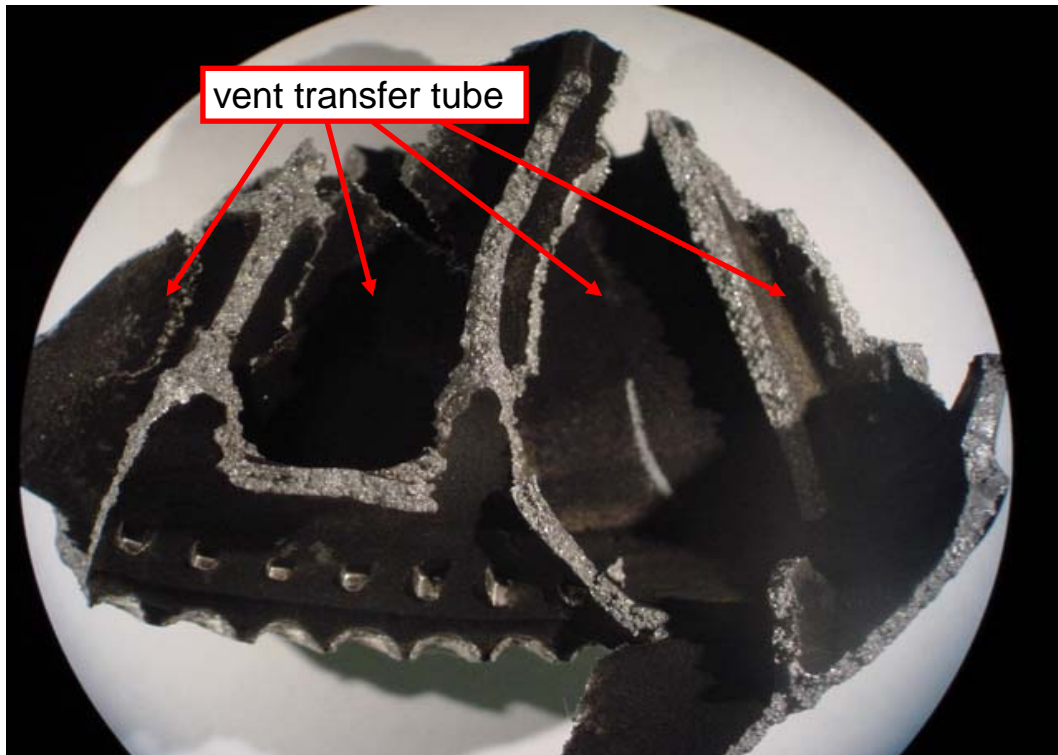
The middle section of the impeller shaft, enwrapped by the impeller, also had been tempered and exhibited reduced hardness of 31.0 HRC. It revealed that the middle section was exposed to a higher temperature. The vent transfer tube inside the impeller contained black carbon deposits (see Figure 2.3-3). This indicated that that the impeller had

been operating in a very high temperature environment and directing the burning smoke into the vent transfer tube which built up a layer of black carbon deposits.

Figure 2.3-3 Black carbon deposits were found in the vent transfer tube inside the impeller

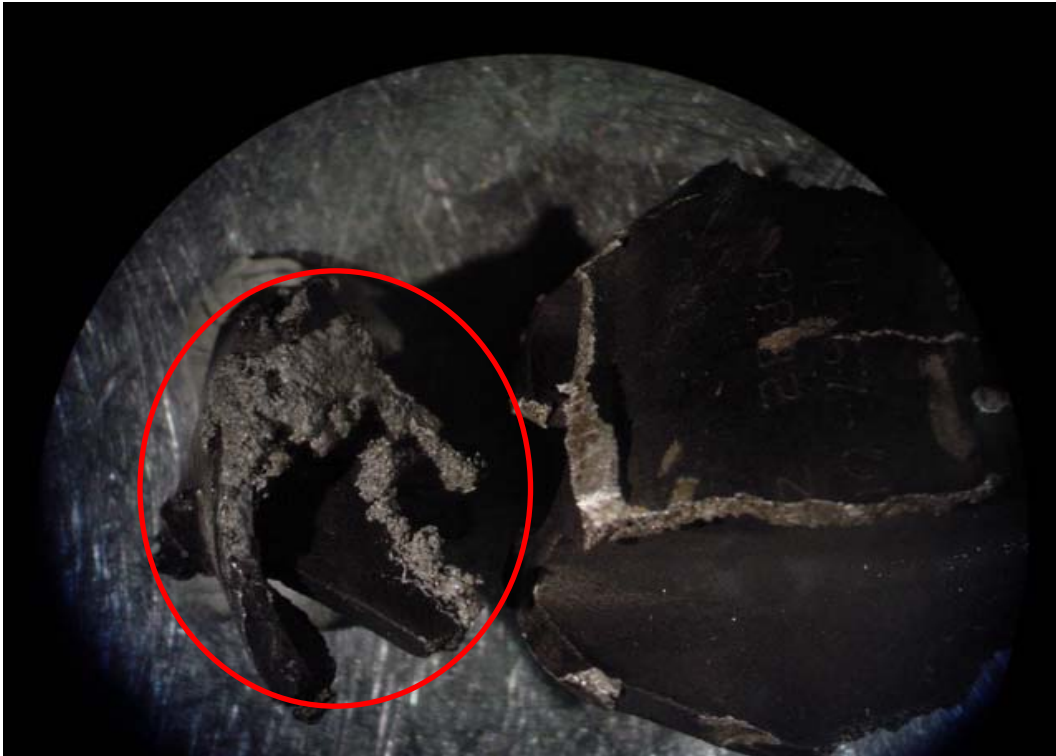
The melted aluminum and magnesium alloy particles adhered to the inner wall of rear inlet case indicated that the impeller breather was exposed to a high temperature during revolving. The metal particles of the impeller had (see Figure 2.3-4) precipitated, displaced and adhered to the inner wall of rear inlet case by the strong centrifugal force (see Figure 2.3-5,-6) during high speed rotation. A large amount of precipitated metal particles coupled with the deterioration of impeller structural strength due to overheating had caused the impeller to disintegrate.

Figure 2.3-4 The precipitation and displacement of metal particles of impeller (red line) .

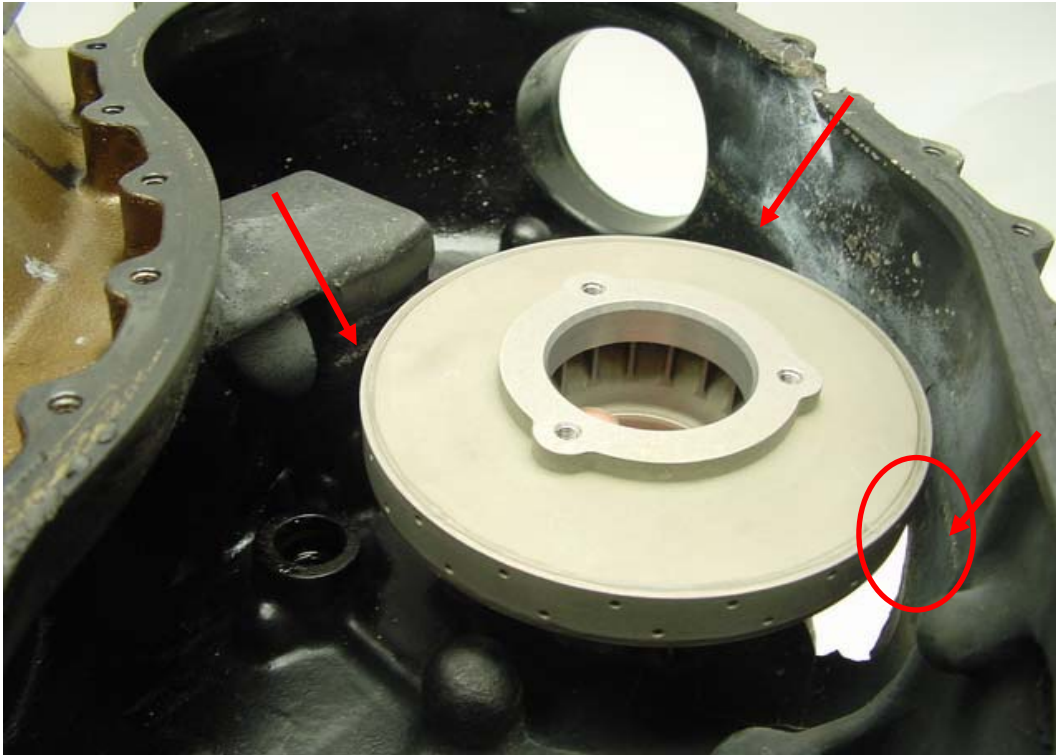
Figure 2.3-5 The melted magnesium alloy particles (red arrow) adhered to the inner wall of rear inlet case. See Figure 2.3-6 for enlargement of the area circled by red line.

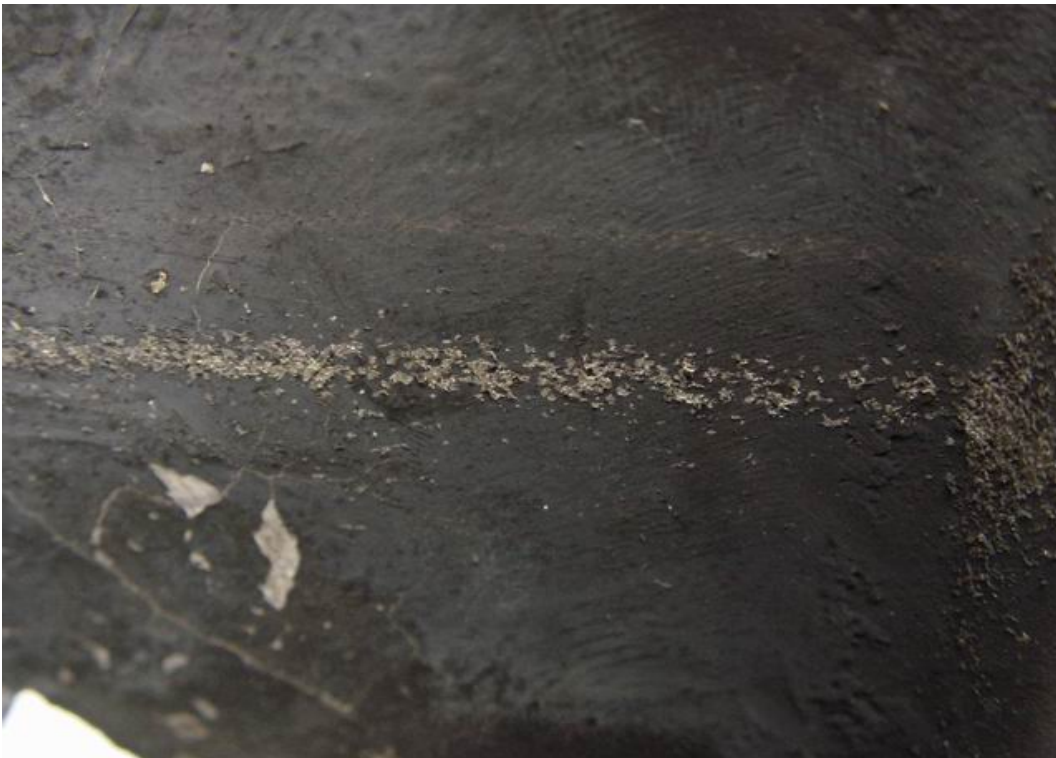
Figure 2.3-6 The melted metal of the impeller was flung outward by centrifugal force and adhered to the inner wall of the rear inlet case
