Aviation Safety Council

Aircraft Incident Report

Number: ASC/AIR-2000/01

Occurrence: Runway excursion after landing

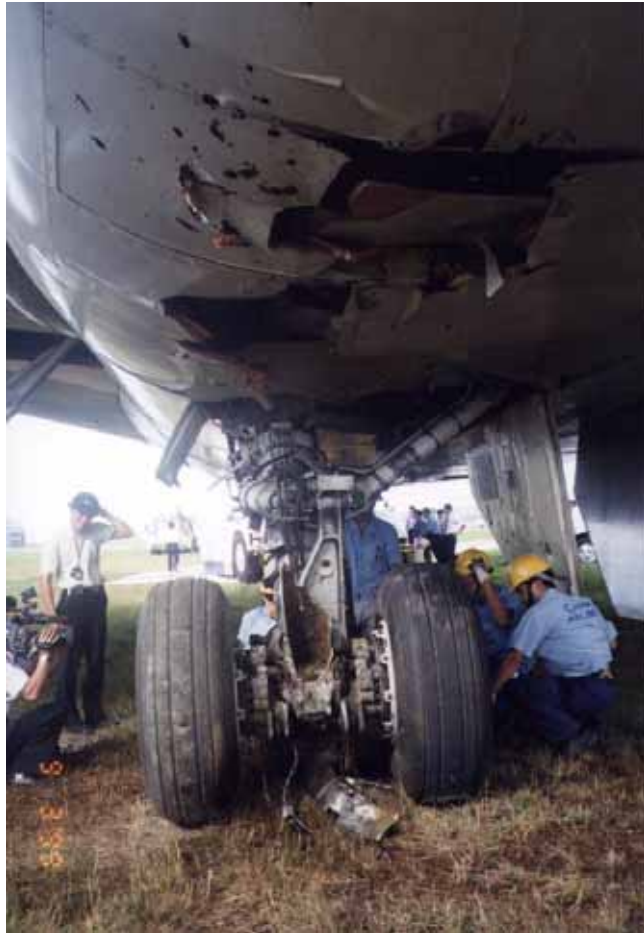
Fig. 1-1 Damage to Fuselage

A 26ft x 10ft lower fuselage skin immediately adjacent to the left body gear, including the hydraulic lines, were damaged (Fig. 1-1). Some parts of the nose gear assembly and both nose tires were damaged (Fig. 1-2). The axles of the front and rear trucks of the left body gear were snapped (Fig. 1-3 & 1-4). Scrubbed marks were found at the bottom of #1 engine cowling. Please refer to Fig. 1-5 & 1-6 for the outlook of the aircraft and gear locations.

1. Bulkhead at left lower fuselage STA 1480 was torn or deformed;
2. Fairing panel support at lower fuselage STA 1480 was cracked and deformed;
3. Skin between #38 and #41 frames at left fuselage from STA 1480 to STA 1740 was cracked, wrinkled or dented in varying sizes, while the frames and stringers were also snapped, dented and deformed in varying degrees;

4. Skin between #42 and #45 frames at left fuselage from STA 1740 to STA 1800 was cracked, wrinkled or dented in varying sizes, while the frames and stringers were also snapped, dented or deformed in varying degrees;

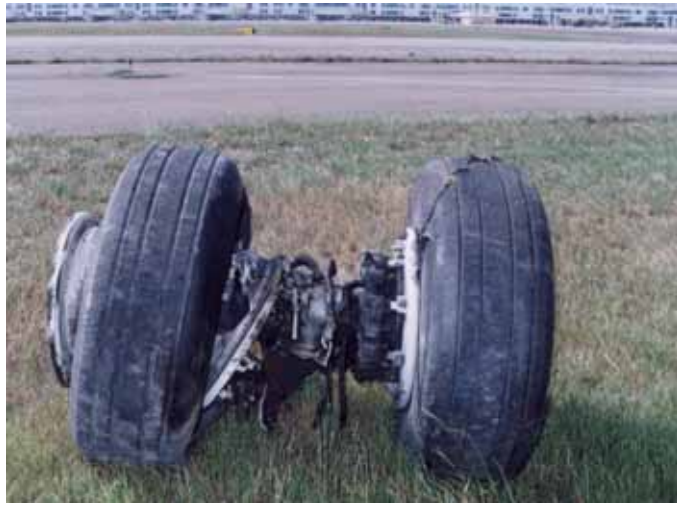
Fig. 1-3 Damage to Front Truck of Left Body Gear

1. Front truck: The front truck was separated from the gear, and found 5 meters to the left of the manhole. The axle snapped at a 45° angle, severing the cables and hydraulic lines (Fig. 1-22).
- Left front wheel (#5) : The flange was separated from the hub, and the brakes were squeezed as a result. The inner tire bead was broken and blow off from it's seat, while the outer tire bead was push off it's seat and shifted inward. A 45° gash was found to run across the tread, from the inner sidewall to outer sidewall, causing the tire to deflate.
 - Right front wheel (#6) : The inner hub was slightly deformed. The brakes appeared to be normal. Cut at a oblique angle, the tire was deflated.

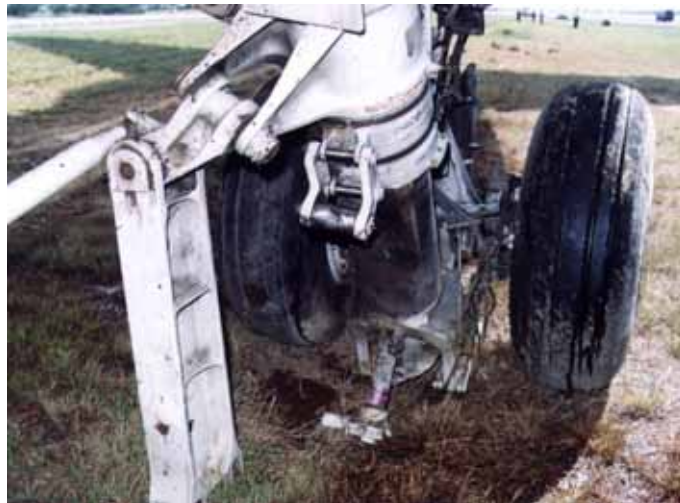
Fig. 1-4 Damage to Rear Truck of Left Body Gear

- Rear truck: The axle snapped at a 45° angle (Fig. 1-23).

The hub, brakes and tire of #7 and #8 wheels appeared to be intact.

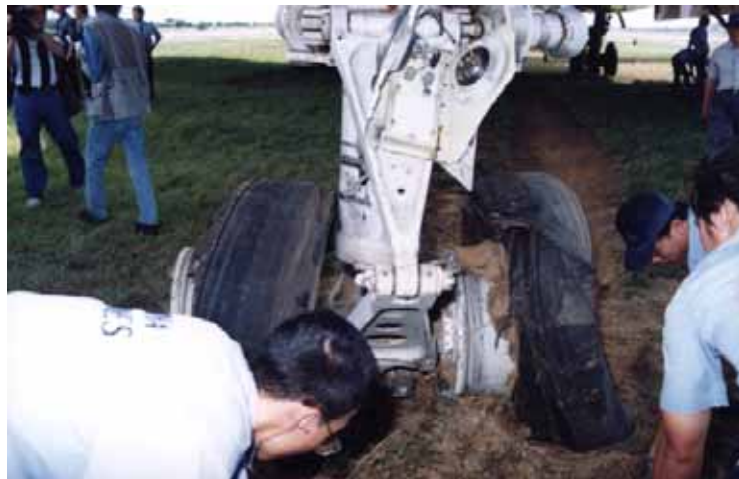
Fig. 1-7 Landing Light Separated

1. Nose gear: No visible damage to the structure and shock strut. The landing light was separated, while the squat switch was deformed and displaced (Fig. 1-7).

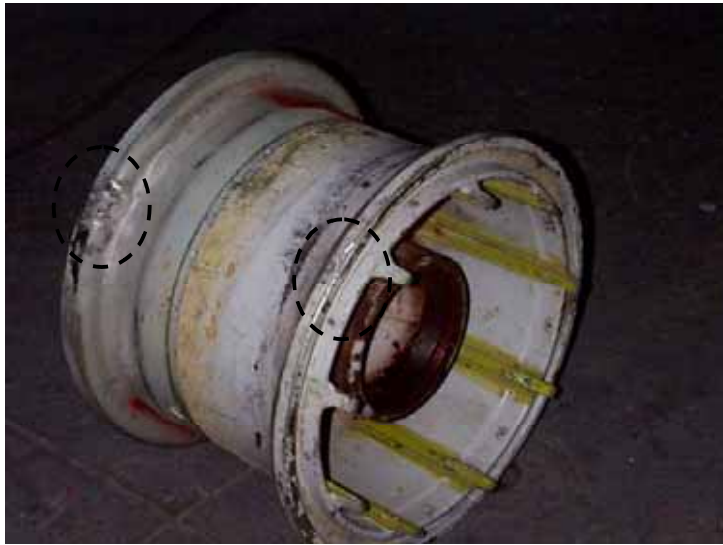
2. Left nose wheel hub: Spot-like abrasion marks were found on both left and right flanges at about the same height (Fig. 1-8). Spots where both flanges (Fig. 1-9 & Fig. 1-10) were impacted were dented and deformed. The right side of the hub was covered with mud (Fig. 1-11).

Fig. 1-8 Spot-like Abrasion Marks (circled areas)

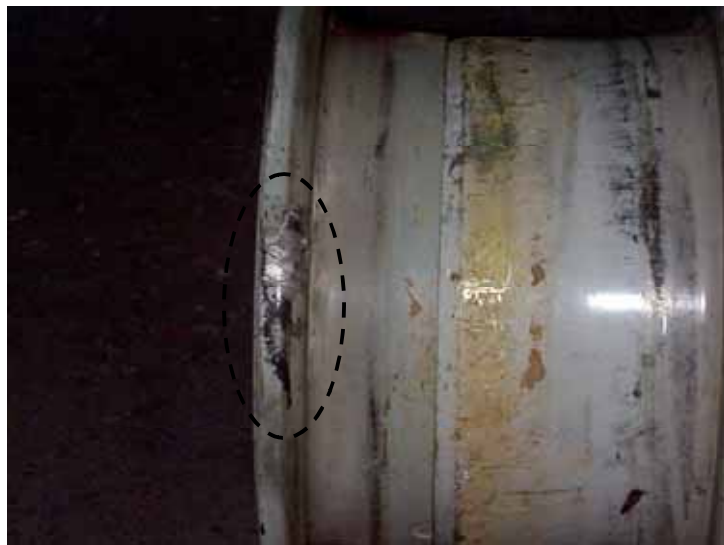
Fig. 1-9 Left Flange Dented and Deformed (circled area)

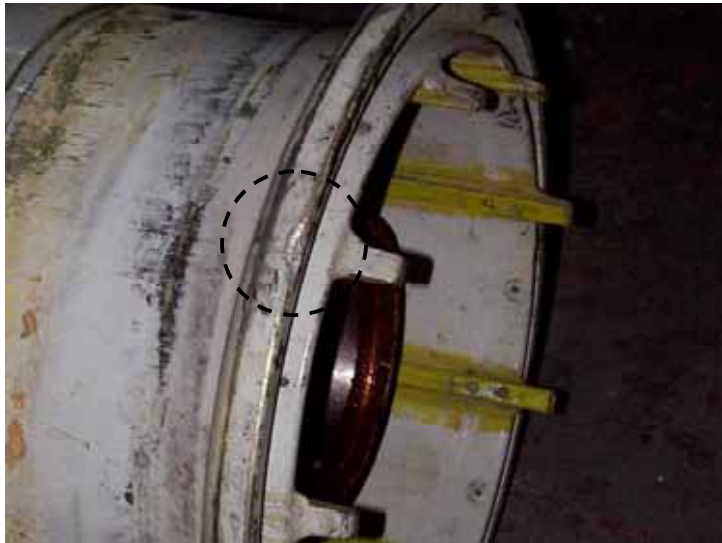
Fig. 1-10 Right Flange Dented and Deformed (circled area)

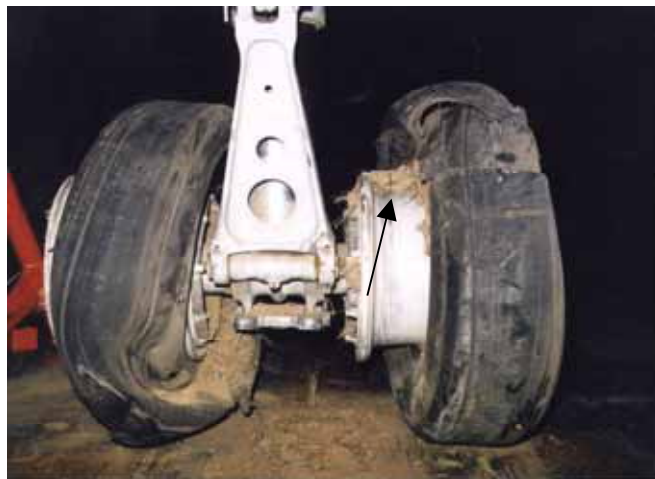
Fig. 1-11 Left Wheel Hub Covered with Mud (pointed area)

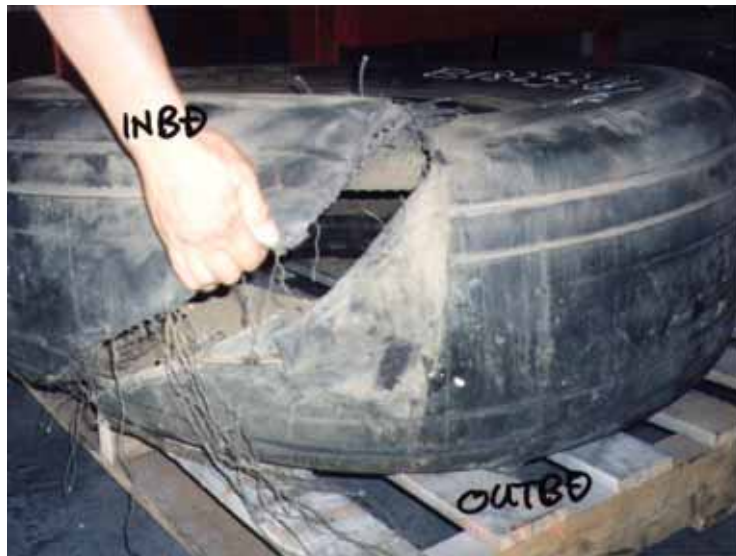
3. Left nose tire: Cracks on the right sidewall was straightly parallel with the cords. A 45° cut by foreign objects inclined from the sidewall to the entire tread, forming a 32" scratch. The dismounted right sidewall slipped to the left, and the tire is deflated (Fig. 1-12). A ring of white marks were observed on the left sidewall near the rim line (Fig. 1-13), while the entire tread was covered with abrasion marks vertical to the grooves (Fig. 1-14). A ring of

Fig. 1-12 Left Tire Damage and Tread Abrasion

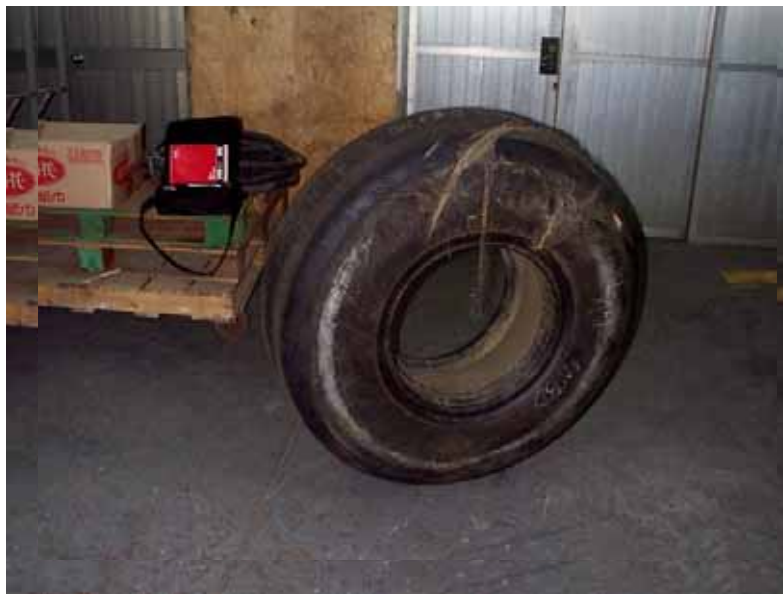
Fig. 1-13 White Marks on Left Sidewall

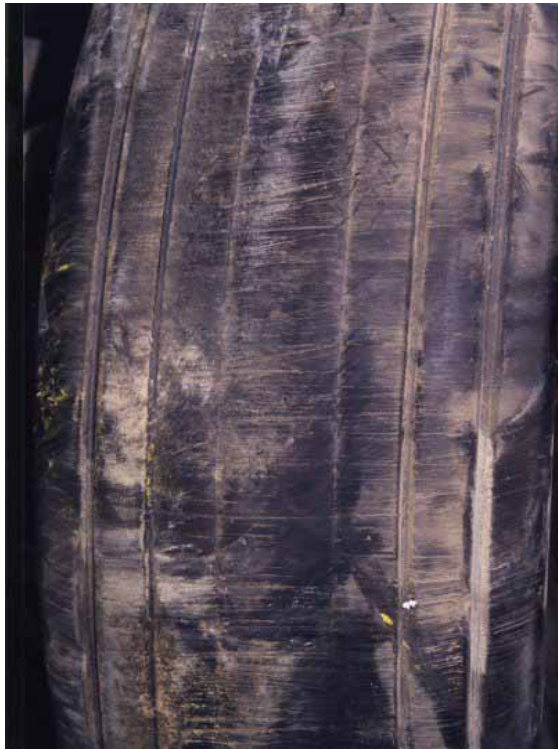
Fig. 1-14 Tread Covered with Abrasion Vertical to Grooves

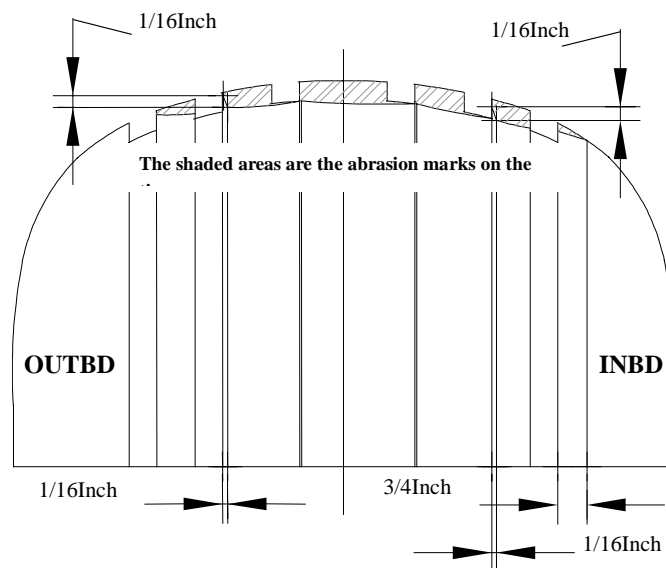
abrasion marks $\frac{3}{4}$ " in width were also observed on the right tread shoulder. The 2nd and 5th grooves from the outer shoulder were approximately $\frac{1}{8}$ " in depth, and tread rubber to the right of both grooves rose approximately $\frac{1}{16}$ " for the entire circumference, while the 3rd and 4th grooves were completely worn out. (Fig. 1-15).

Fig. 1-15 Wear on Left Tire Tread

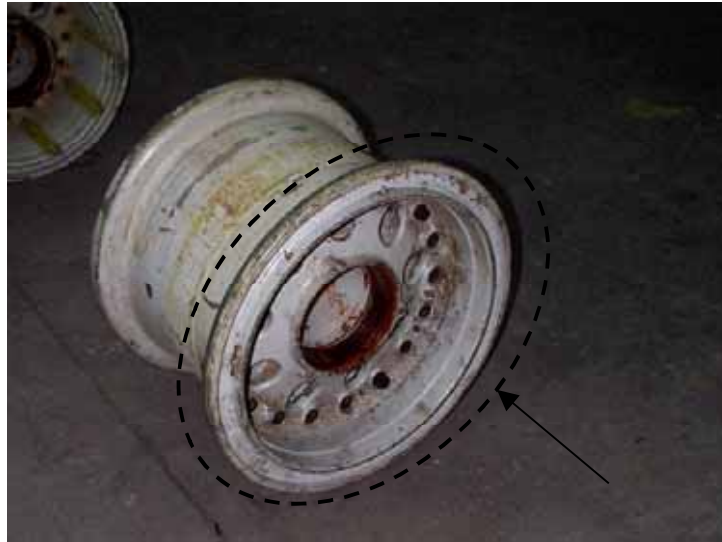
4. Right nose wheel hub: Scratch marks were found on the deformed right flange (Fig. 1-16). The hub was covered with mud (Fig. 1-17).

Fig. 1-16 Deformed Flange

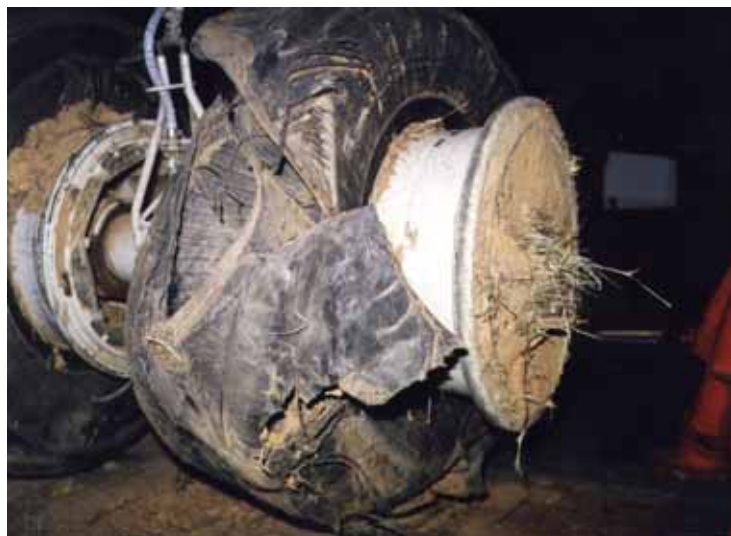
Fig. 1-17 Hub's Right Side Covered with Mud

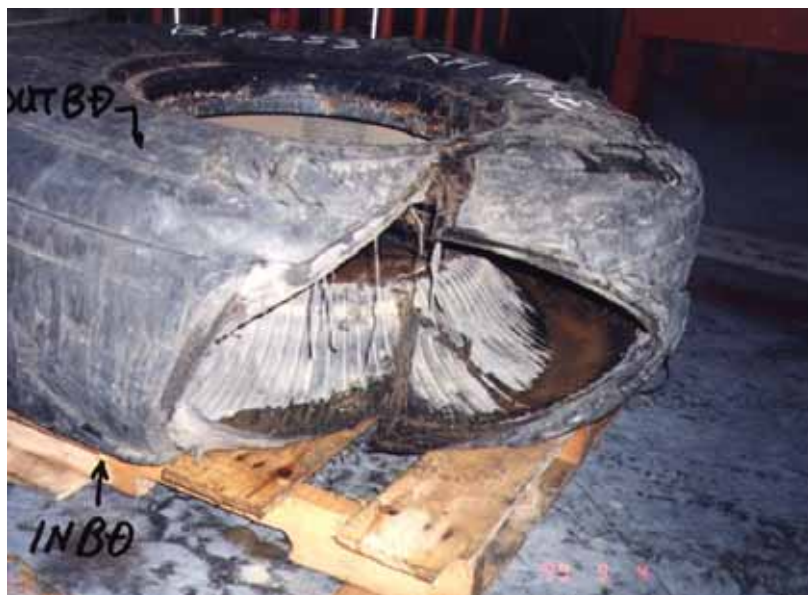
5. Right nose tire: Bulged, delaminated tire surface and 6" to 12" cuts caused by foreign objects were found on the right sidewall which slipped off the nose gear hub to the left. Abrasion marks covered the entire right tread shoulder, and extended to the right sidewall. A 24" kite-shaped tread was ripped off the tire, creating an 18" hole (Fig. 1-18) where white marks were found on the right-hand side edge. Immediately in front of the hole on the tread was a fan-shaped abrasion mark, the depth of which decreased as it extended from right to left (Fig. 1-19). Similar to those seen on the right wheel, abrasion marks vertical to the grooves covered the ripped off tire casing (Fig. 1-20), which was found between the manhole and where the aircraft came to stop. The 2nd groove from the outer shoulder was approximately 1/8" in depth, and part of the tread rubber to the right of the groove rose approximately 3/16", while the 3rd and 4th grooves were completely worn out. (Fig. 1-21).

Fig. 1-18 Damaged Right Tire and Tread Abrasion

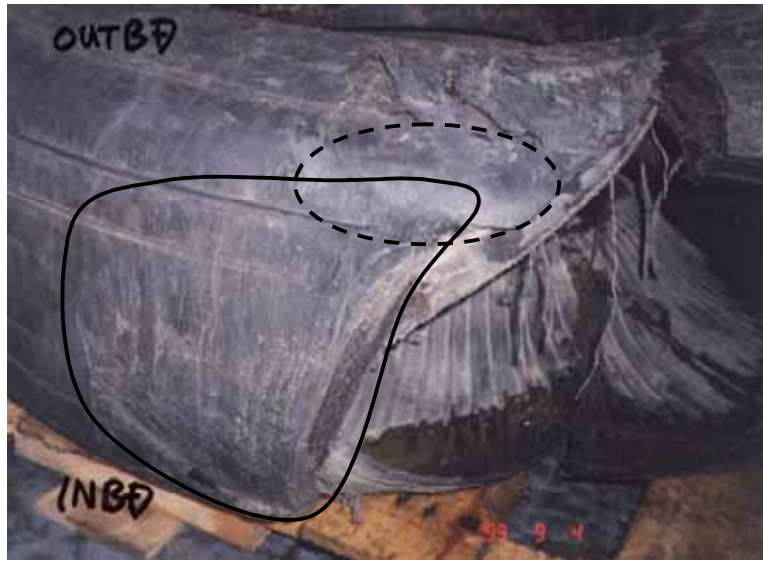
Fig. 1-19 Fan-shaped Abrasion and White Marks

(abrasion is enclosed by full line; marks are enclosed by dotted line)

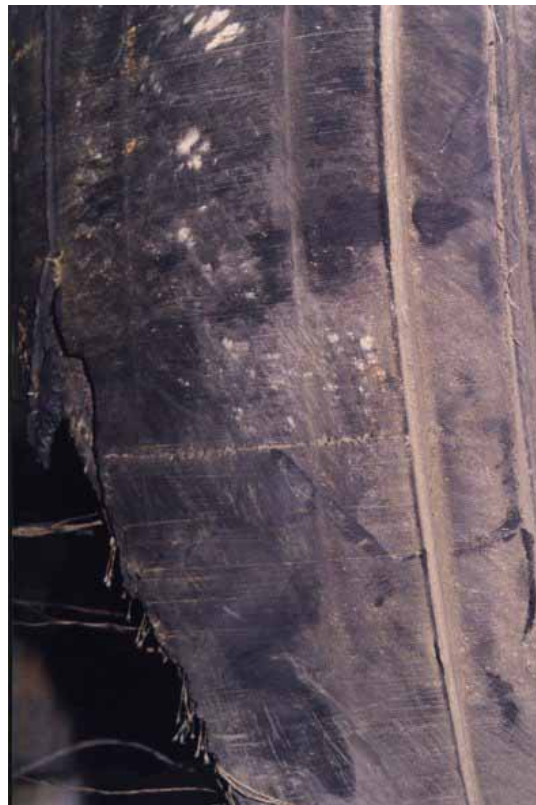
Fig. 1-20 Abrasion Vertical to Grooves

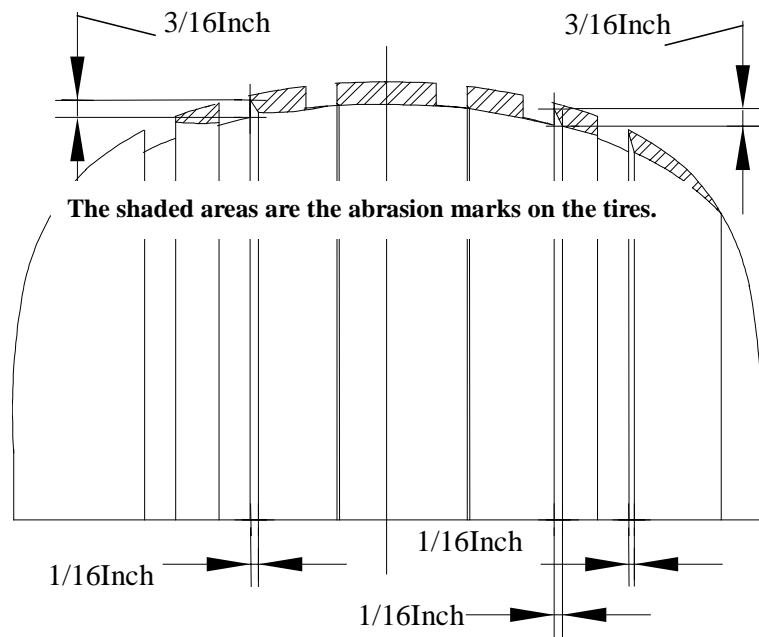
Fig. 1-21 Abrasion on Right Sidewall

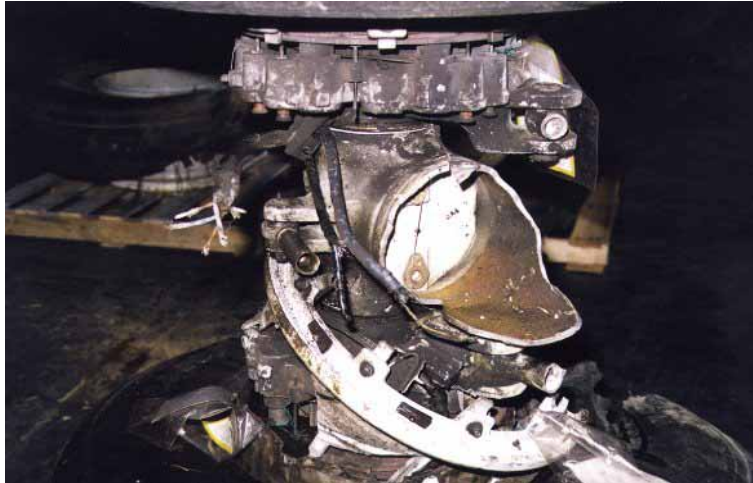
Fig. 1-22 Damage to Front Body Gear Truck

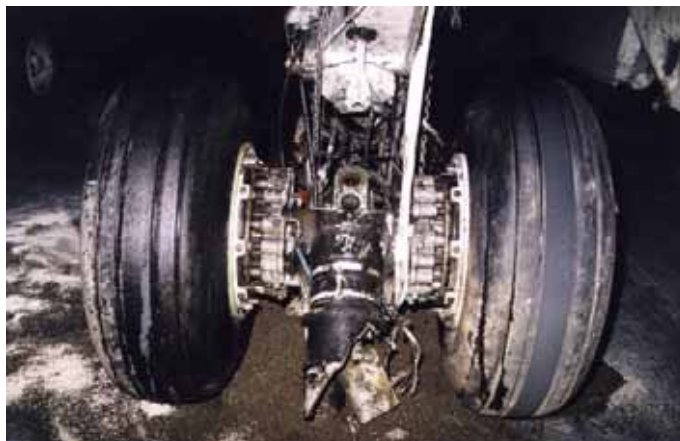
Fig. 1-23 Rear Truck Snapped at 45° Angle

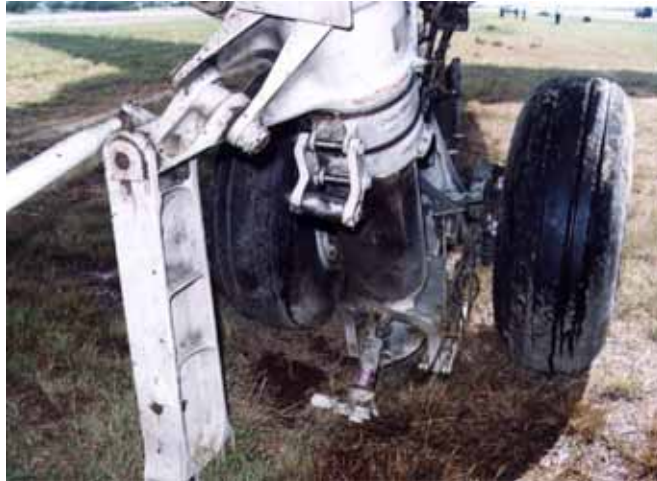
Tire pressure was normal (Fig. 1-24) .

Fig. 1-24 Damage to Rear Body Gear Truck

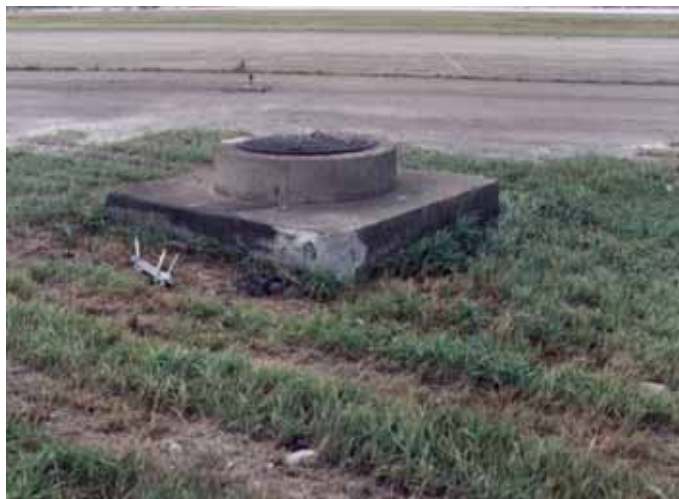
Fig 1-25 Concrete Manhole

The protruding manhole to the left of Runway 06 is an indirect cause of the occurrence. The location, structure and construction of the manhole failed to meet both domestic specifications, as well as those recommended by the International Civil Aviation Organization (ICAO), causing serious damages to the deviated aircraft when its landing gear collided with the manhole.

The protruding concrete manhole located on the grass strip adjoining Runway 06 and Taxiway S5 can be seen on Fig. 1-25. Collision marks caused by foreign objects and a band of black rubber deposits were found on the side of the manhole facing Taxiway S5 (Fig. 1-26). Two taxiway lights were damaged by the wheels.

3. The CAA should examine if the location, design, construction and structure of all fixed structures (including concrete manholes) around the runway strips at CKS Airport are in compliance with international standards, so as to protect the safety of any deviated aircraft; and
4. The CAA should assess whether the transverse slopes of the runway strips at CKS Airport are in compliance with specifications recommended by the ICAO, so as to protect the safety of any deviated aircraft.

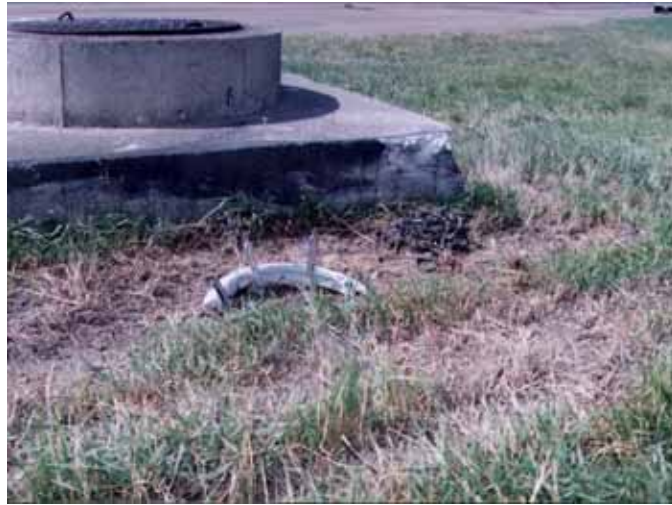
Fig. 1-26 Abrasion Marks and Rubber Deposits

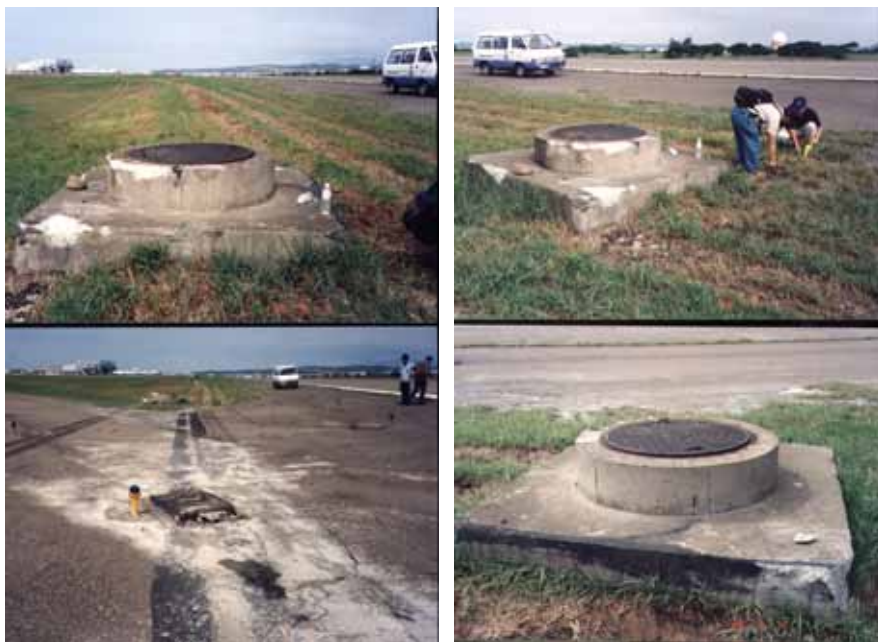
Grassed areas around the manhole slope at a 10° to 12° angle.

Fig. 1-30 Manhole Struck by Nose Gear

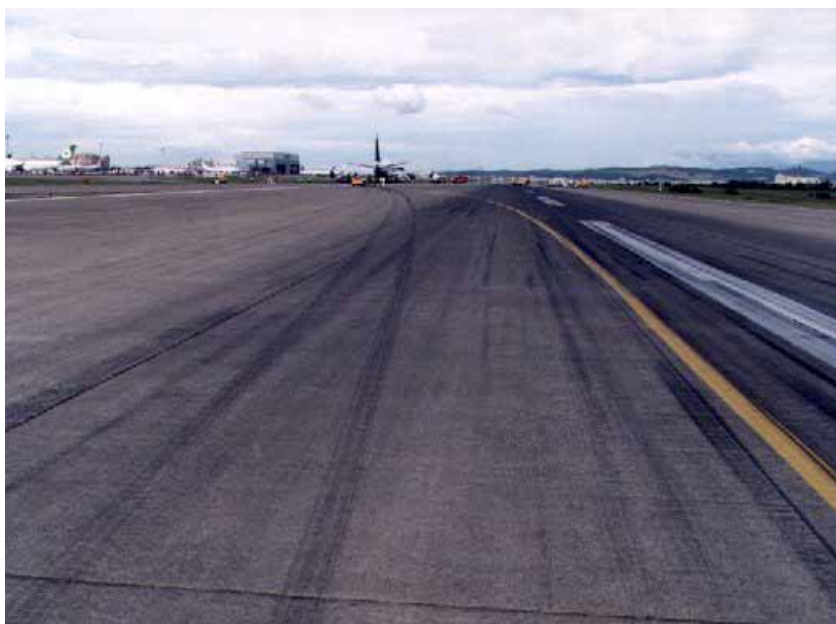
- Nosewheel: Two strips of dark nosewheel tracks were discovered after the aircraft deviated from the runway's centerline. The track left behind by the right wheel was visibly darker and wider.
- Mainwheel: No tracks were discovered at this time.

Fig. 1-33 Ground track between 0-150 meters.

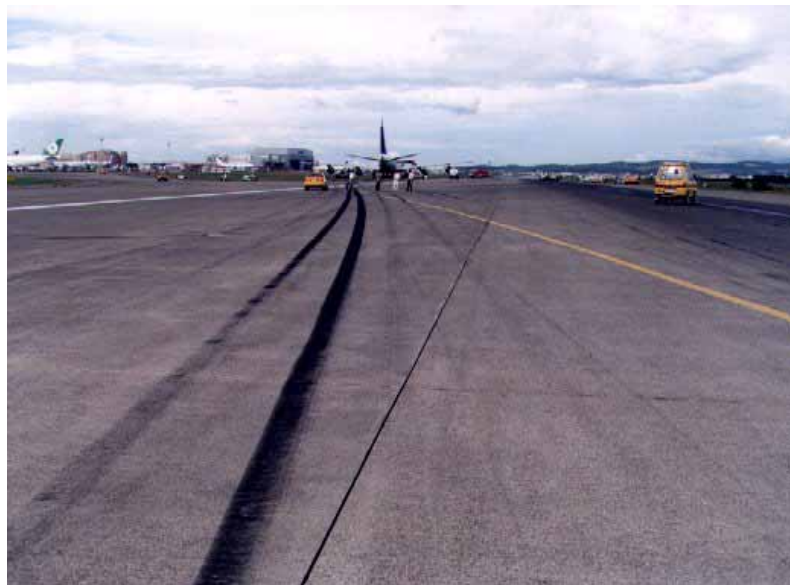
- Nosewheel: The right nosewheel track was widened and became darker in color; the right half side of the track started to become less visible. The track distance between the two nosewheels was narrower gradually.
- Mainwheel:
 - Right Body Gear: Two traces of lightly visible wheel tracks started to appear.
 - Right Wing Gear: No tracks were discovered.
 - Left Body Gear: Two traces of lightly visible wheel tracks started to appear.
 - Left Wing Gear: No tracks were discovered.

Fig. 1-34 Ground track between 150-180 meters.

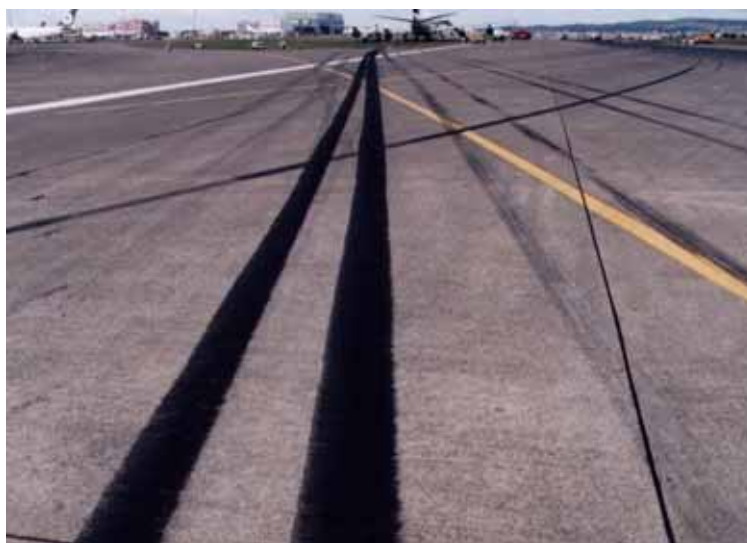
- Nosewheel: The left nosewheel track was darker and wider. The right nosewheel track was wider than the left nosewheel track. The track distance between the two wheels was narrower gradually.
- Mainwheel:
 - Right Body Gear: The two tracks became darker in color, with alternating dark and light strips in the tracks.
 - Right Wing Gear: Two strips of wheel tracks started to become visible and evident.
 - Left Body Gear: The two strips of wheel tracks started to form into four strips of smooth wheel tracks.
 - Left Wing Gear: No tracks were discovered.

Fig. 1-35 Ground track between 180-250 meters.

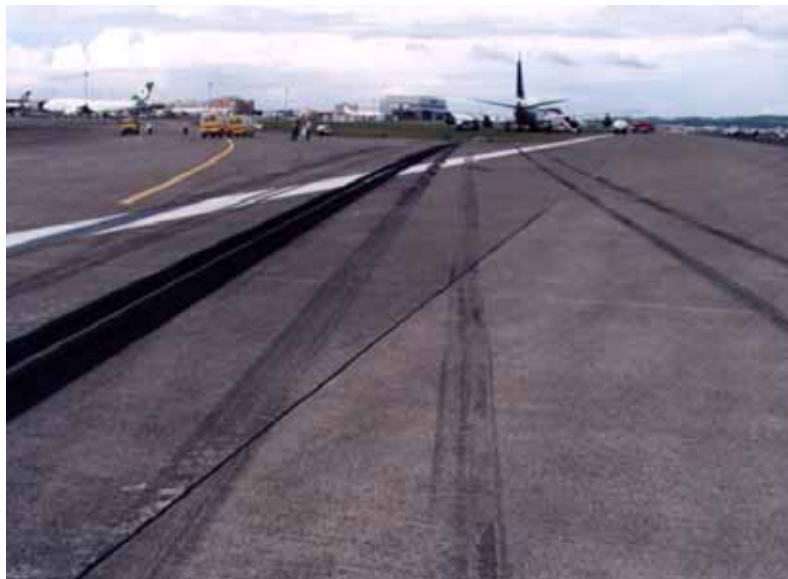
- Nosewheel: The left and right nosewheel tracks continued to be wider and become darker. The gap continued to become smaller.
- Mainwheel:
 - Right Body Gear: The two strips of wheel tracks were overlapped by another two strips of wheel tracks, and their colors became darker.
 - Right Wing Gear: Two strips of wheel tracks were clearly visible as was before.
 - Left Body Gear: The four strips of wheel tracks were smooth and the distance between them widened.

Left Wing Gear: No tracks were discovered.

Fig. 1-36 Ground track between 250-325 meters.

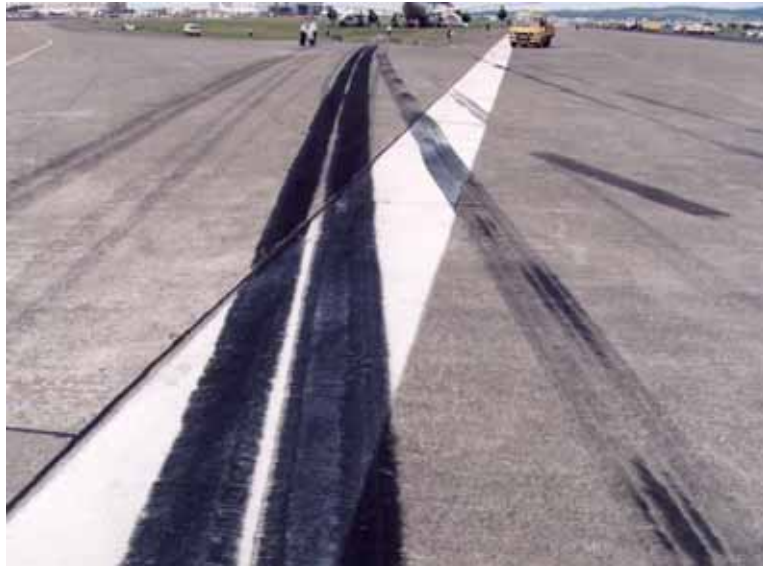
- Left Body Gear: The four strips of wheel tracks were visible. Starting from the outer edge, the gaps between the first and second, as well as that between the third and fourth tracks, continued to widen.

- Left Wing Gear: Two tracks started to become visible.

Fig. 1-37 Ground track between 325-400 meters.

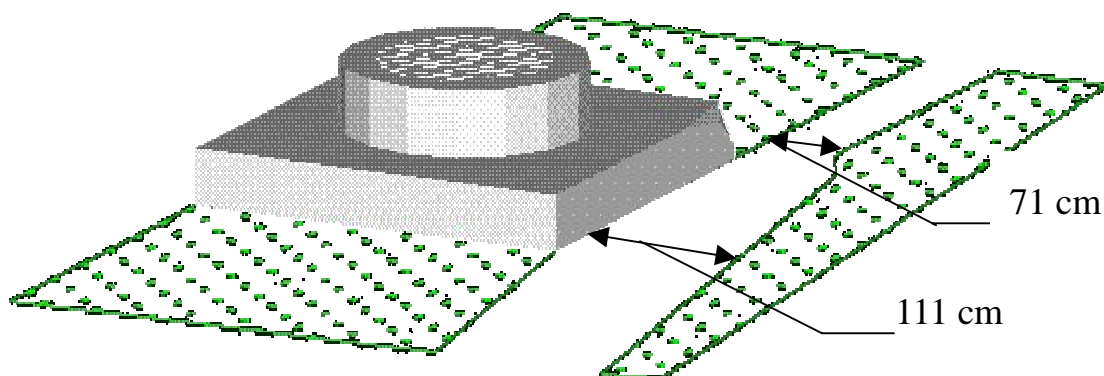
After running off the runway, the nosewheel left a 111-cm wide track on the grass area, and scrapped a protruded concrete manhole. The nosewheel left a 71-cm wide track (Fig. 1-38) on the grass area after it cleared off the protruding manhole.

Fig. 1-38 Nosewheel tracks on the grass area.

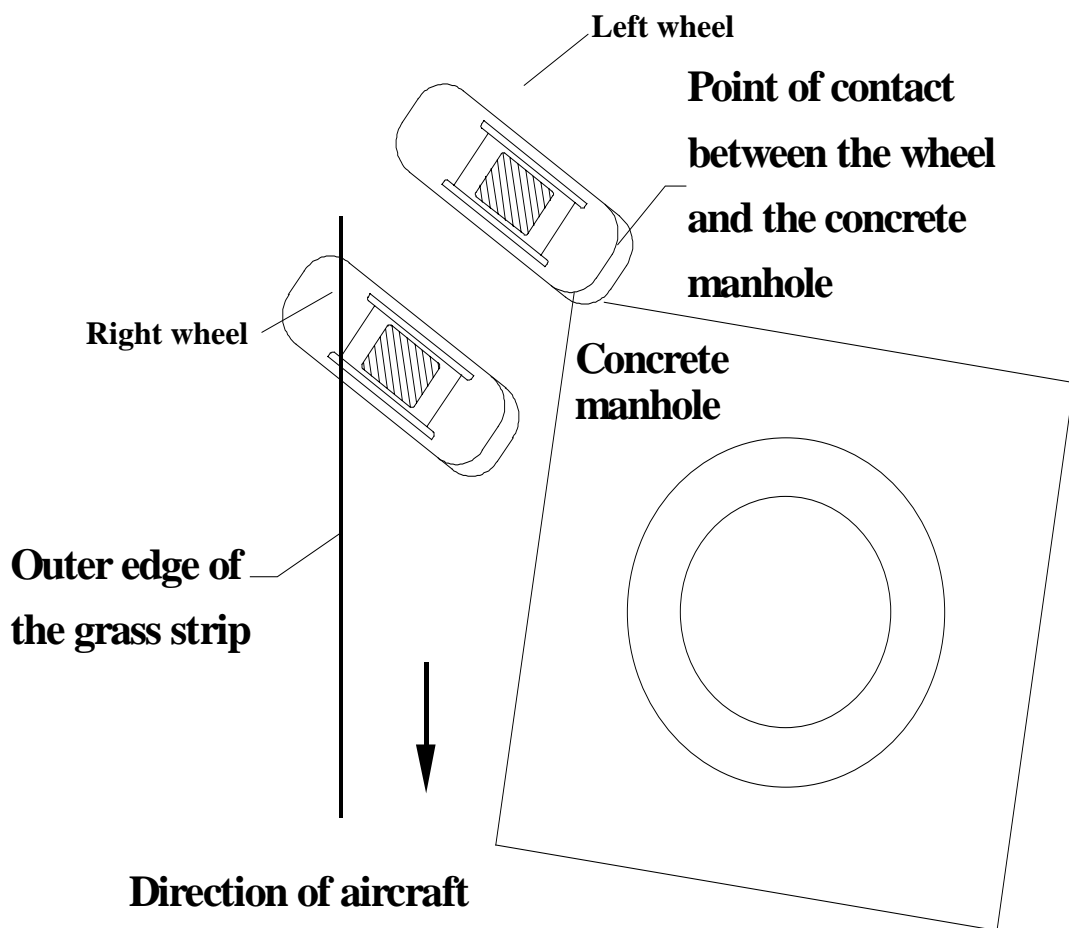
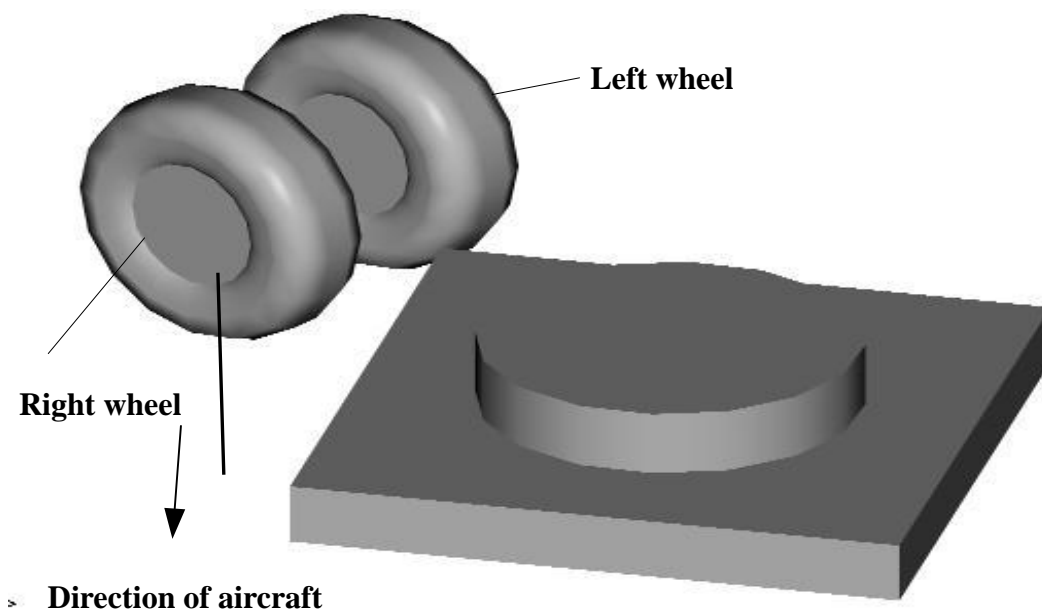
As shown in Figures 2-6 and 2-7, the right side of the left wheel came into collision with the concrete manhole. From the wreckage, a rupture of the right sidewall due to collision with a foreign object was discovered, where the cut was parallel to the base of the concrete manhole. After the collision with the base of the manhole, the left tire continued to roll and slip forward until the right wheel came into collision with the

manhole base. From the wreckage, a hub of white marks was discovered on the right sidewall of the left tire, and black tire marks were discovered on the base of the manhole. The marks should be the result of the right sidewall scrubbing against the manhole after the left tire has ruptured.

Fig. 2-6 Top view of the collision between the left wheel and the concrete manhole.

Fig. 2-7 Three-dimensional view of the collision between the left wheel and the concrete manhole.

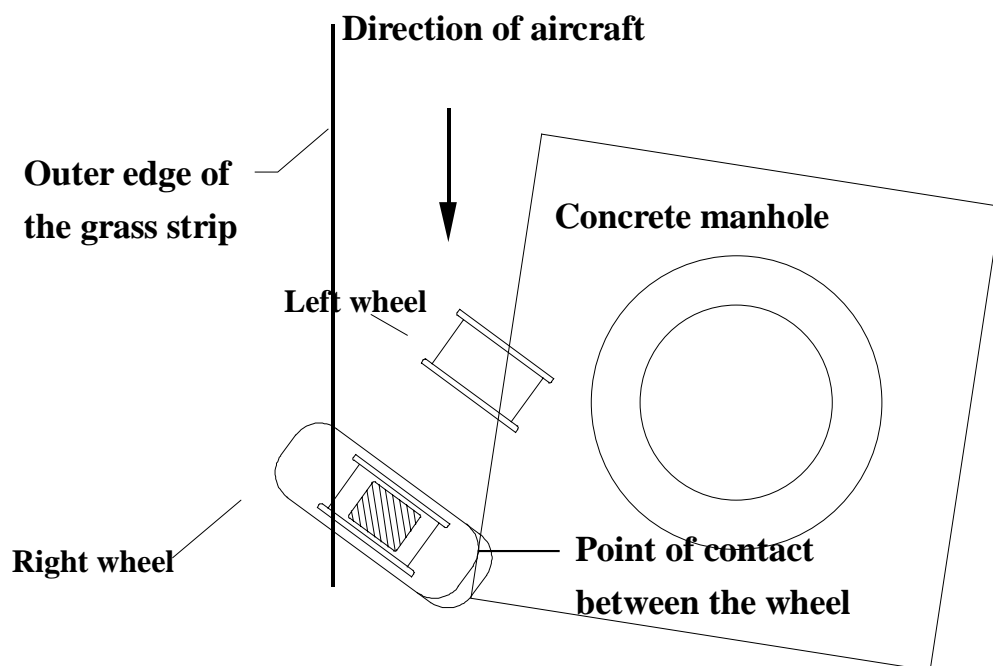
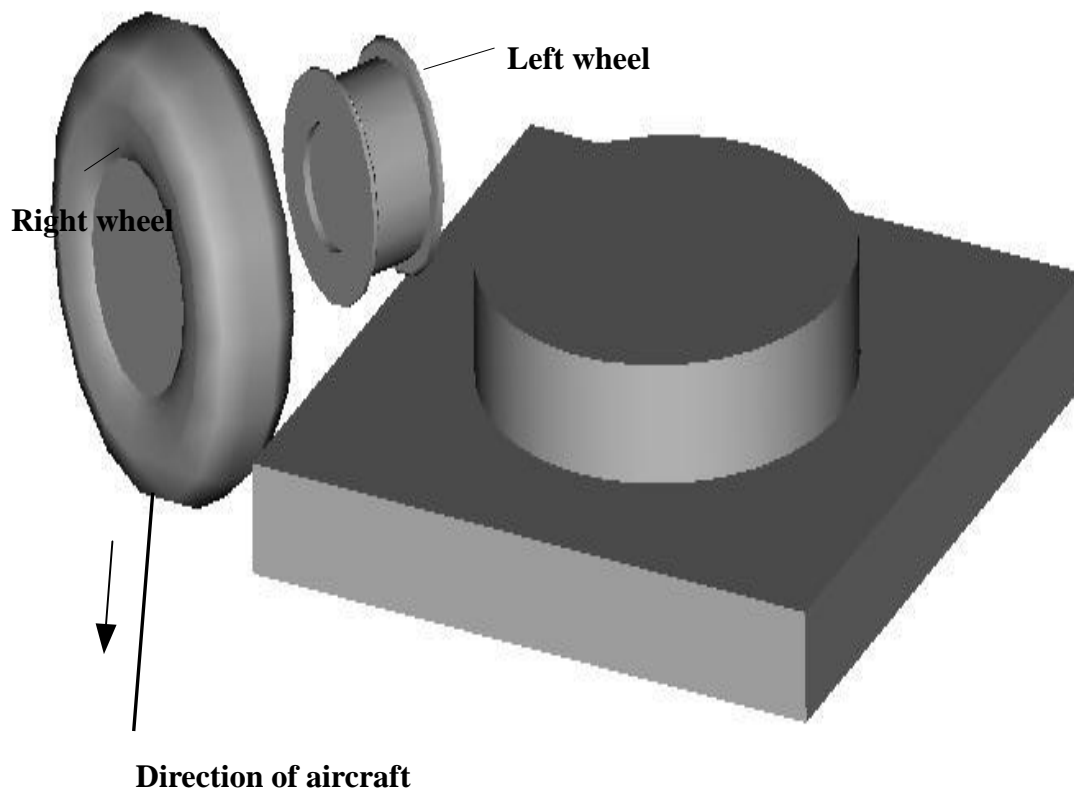
As shown in Figures 2-8 and 2-9, the right wheel left shoulder came into contact with the outer edge of the base of the manhole first; thus the remaining travel distance would only damage the tread and the left sidewall. From the wreckage, white marks were discovered on the right wheel left shoulder, which might have resulted from the collision with the base of the manhole. The fan-shaped scratch marks on the tread should be the result of the short contact between the cylindrical-shaped tread and the flat-surfaced manhole base. Since the left wheel hub was elevated due to the height of the right wheel, it was higher than the cement manhole base and therefore did not come into contact with cement base.

Fig. 2-8 Top view of the collision between the right wheel and the concrete manhole after the left tire had ruptured.

Fig. 2-9 Three-dimensional view of the collision between the right wheel and the concrete manhole after the left tire had ruptured.

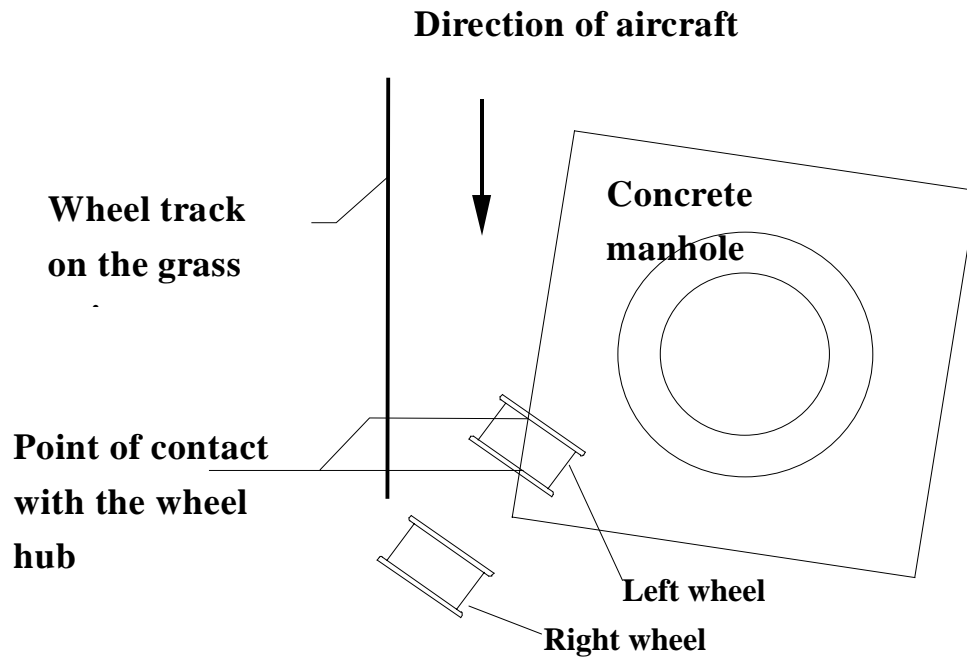
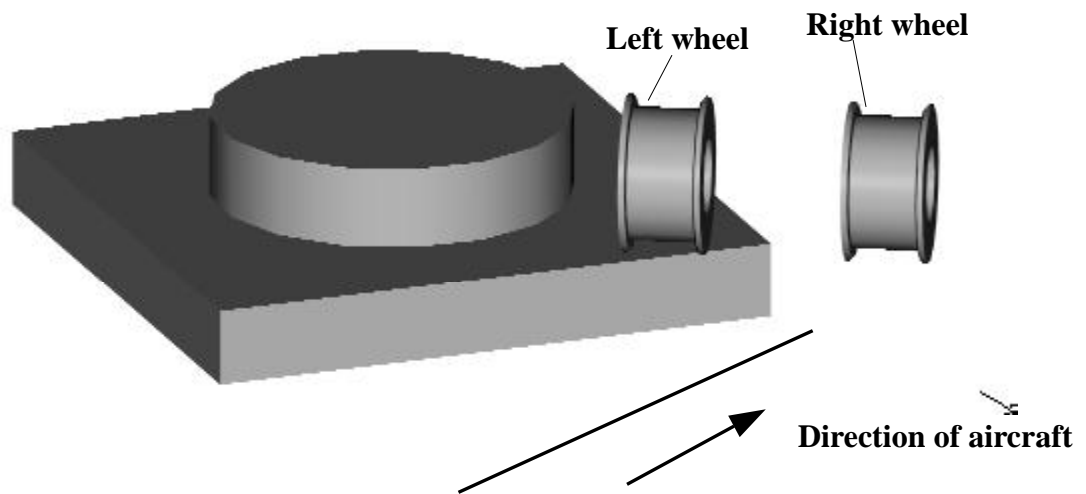
As shown in Figures 2-10 and 2-11, the height of the cement base was 29 centimeters. Since the height of the tire was 33 centimeters (according to the tire manual), the left wheel hub was supported by the right tire and did not come into contact with the cement base after the left tire had ruptured. When the right tire ruptured, the left wheel hub lowered due to the weight of the aircraft and ultimately came into collision with the cement base. This was evidenced from the dents found on the lateral

flanges of the left wheel hub, and on the broken corners found at the edge of the cement base.

Fig. 2-10 Top view of the collision between the left wheel hub and the concrete manhole after the right tire had ruptured.

Fig. 2-11 Three-dimensional view of the collision between the left wheel hub and the concrete manhole after the right tire had ruptured

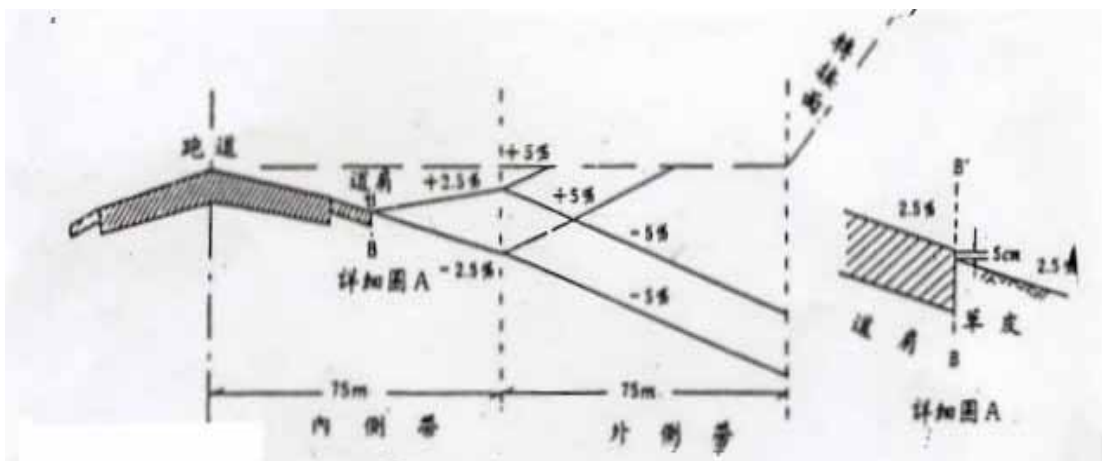
Fig. 2-14 Traverse slope of the runway strip.

The angle of elevation of the grass area as measured was -10 degrees.

The cowl of #1 engine of China Airlines B18253 came into contact with the grass surface after the aircraft ran off the runway. Thus from the physical appearance of the aircraft (Fig. 2-15) and assuming that the left wing gear ran into a grass area with the same slope, the angle of elevation of the runway's inner strip exceeded 6.9 degrees, that is, the grass areas ran over by the left and right wing gear had a difference in elevation of 134 centimeters. The traverse slope exceeded 12.1%, which does not comply with the above guideline.

Therefore, due to safety concerns, the traverse slopes of the runway strips at the CKS airport should be appropriately modified.
