# 國家運輸安全調查委員會

## 事實資料報告

中華航空公司 CI202 班機

於松山機場落地時三套主飛控電腦失效

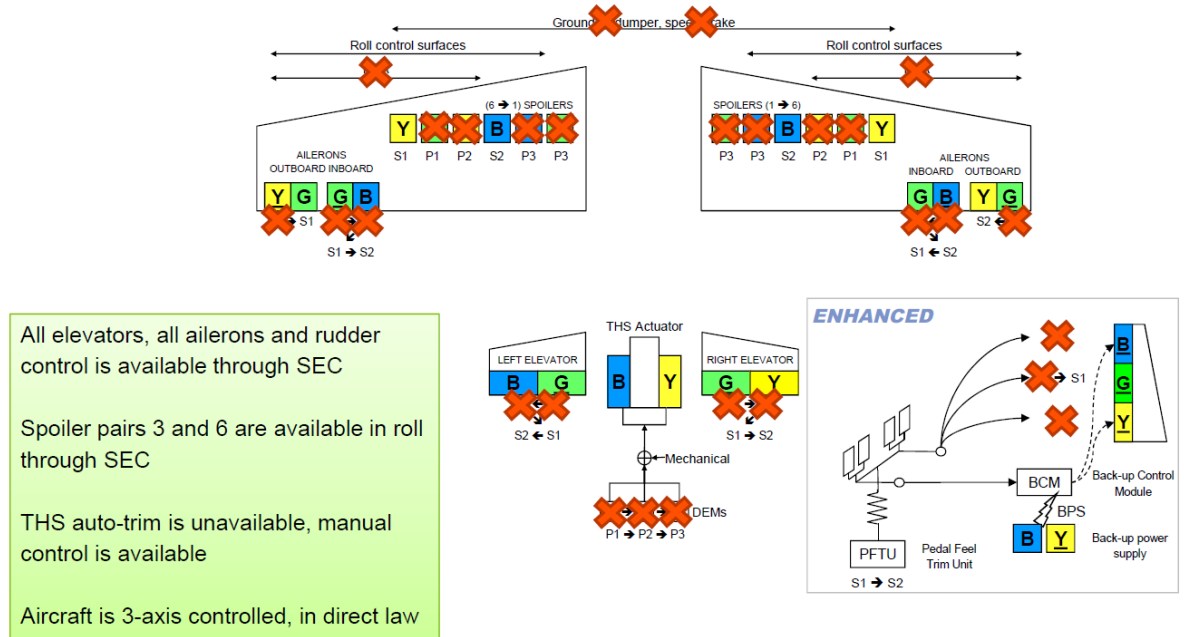
圖 1.6-10 三套 FCPC 失效飛行控制面失效示意圖

如圖 1.6-10 所示，當三套 PRIM 飛控電腦均失效後（P1、P2、P3），FCPC 便轉移控制權至飛行控制輔助電腦（S1、S2），同時：

- 方向舵踏板（rudder paddle）控制鼻輪轉向失效，僅剩手動轉向；
- 自動煞車系統（autobrake）失效；
- 反向推進器（thrust reverser）失效。

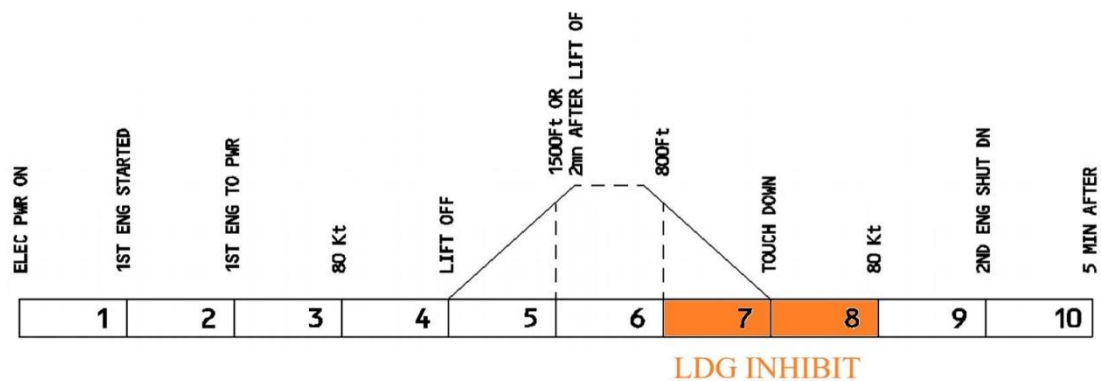
圖 1.6-11 落地階段 ECAM 訊息抑制示意圖

本事件發生時，正處於飛行高度 800 呎至落地後地面速度 80 節之間「LDG INHIBIT」階段，如圖 1.6-11 所示。

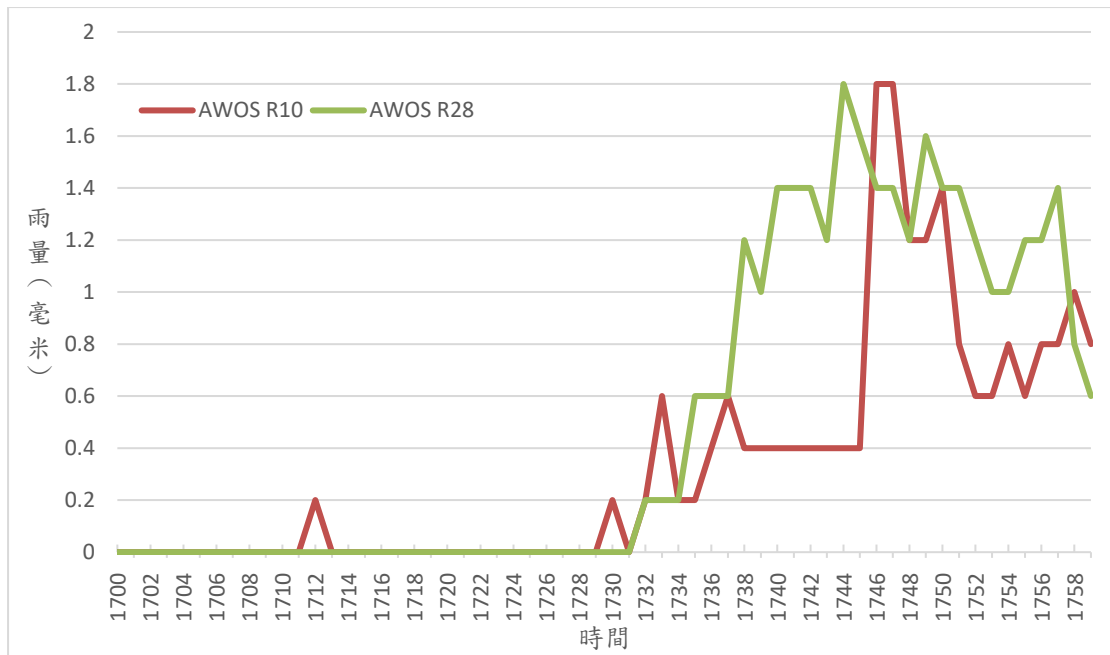
圖 1.7-5 AWOS 降水量

事故前 6 分鐘 AWOS R10 累積降水量 5.2 毫米 (大雨)、AWOS R28 累積降水量 8.8 毫米 (大雨)，如圖 1.7-5 所示。

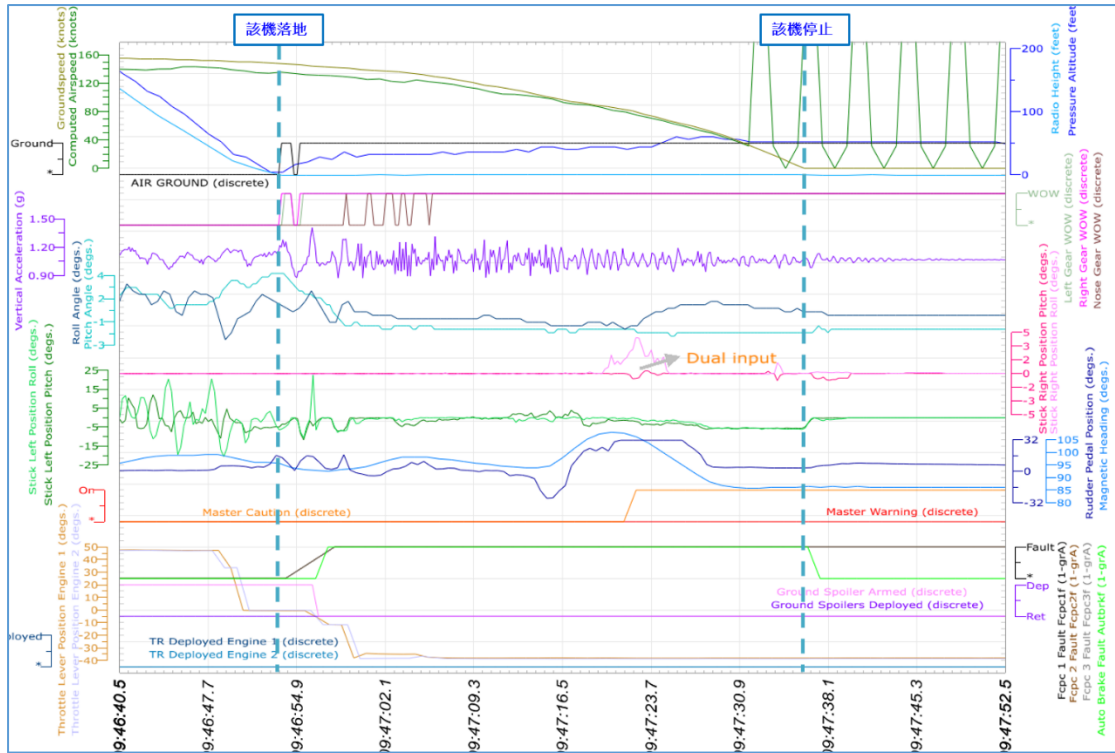
圖 1.11-3 落地階段操作相關參數圖

航機落地至停止過程中，部分地面擾流板觸地後展開又立刻收回，反推力裝置全程未作動。

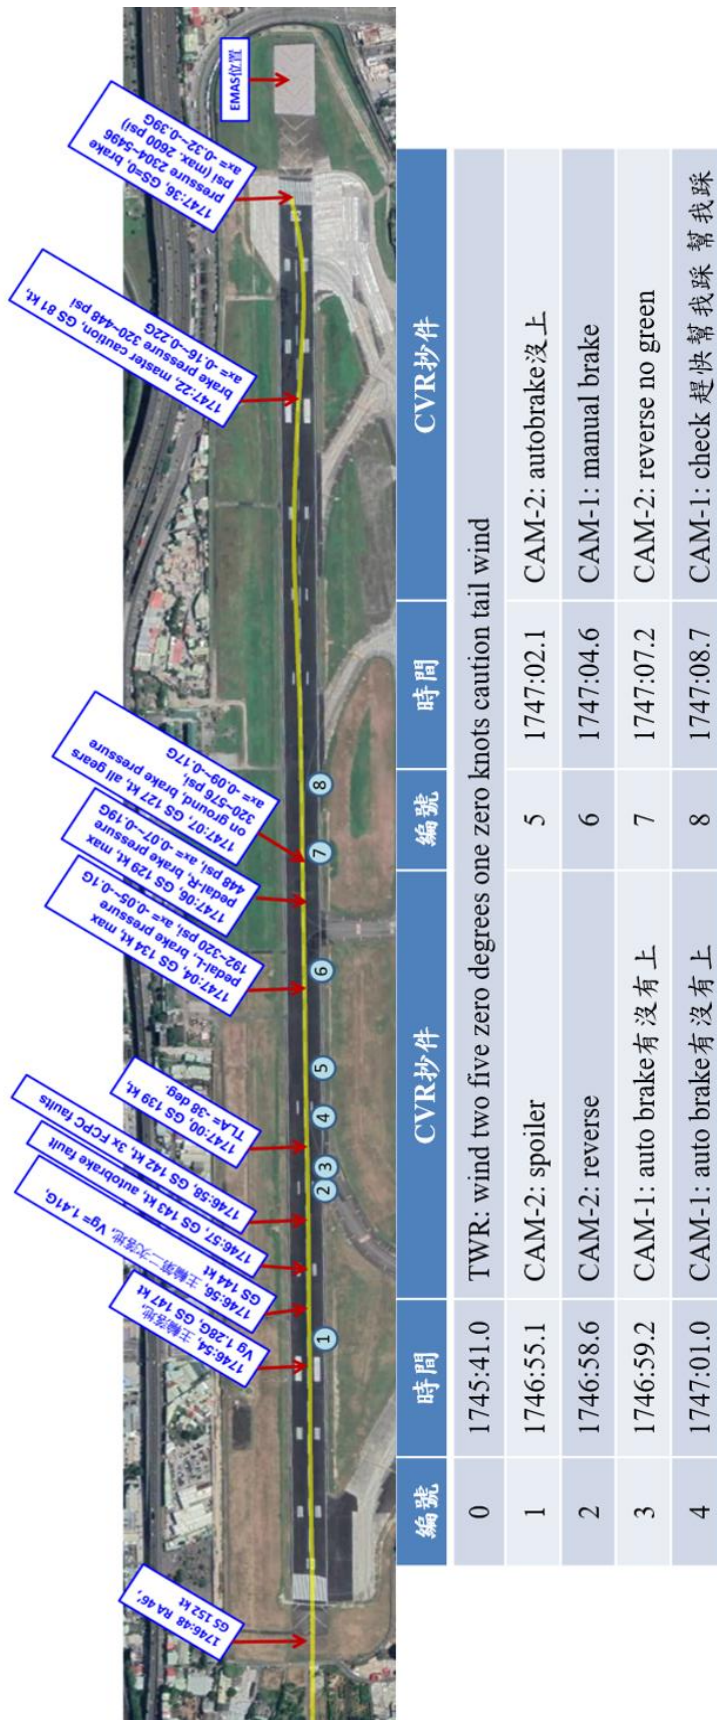
圖 1.11-5 事故發生階段之軌跡與有關參數及 CVR 抄件套疊

11. 臺北時間 1746:57 時，地速 144 浬/時，中度自動煞車備動解除，自動煞車故障狀態出現並持續至 1747:36 時止。
12. 臺北時間 1746:58 時，地速 142 浬/時，三套主飛控電腦故障狀態出現；第 1、2、4 號擾流板可用狀態解除，此後全部 12 項擾流板角度持續記錄在收起位置，或收起位置與 22 度之間，並以每 4 秒循環變化。

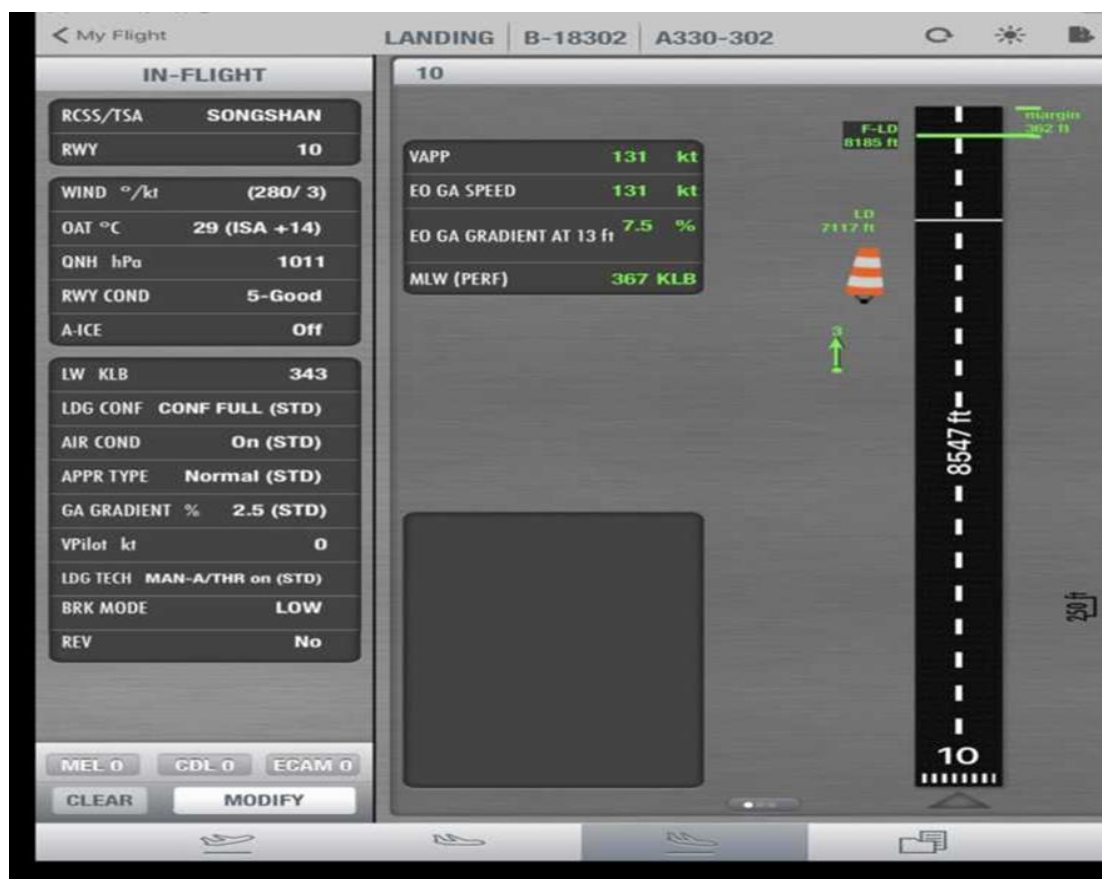
圖 1.17-1 落地性能計算資料

根據華航提供之事故機落地性能計算資料，飛航組員係於航機下降高度前準備進場簡報時，使用 1700 時松山機場 ATIS 資訊 L: RWY 10 280/3 260V320 7000M-TSRA FEW1400 FEW CB1400 BKN2500 BKN5000 29/27 QNH 1011 之天氣資訊計算落地性能。自動煞車 (autobrake) 之設定為：低度 (LO)，跑道煞車性能狀況為：好 (Runway condition Good)。得出落地距離 (Landing Distance) 7,117 呎，加成落地距離 (Factor Landing Distance) 為 8,185 呎，如圖 1.17-1。
