國家運輸安全調查委員會

事實資料報告

中華航空公司 CI202 班機

於松山機場落地時三套主飛控電腦失效

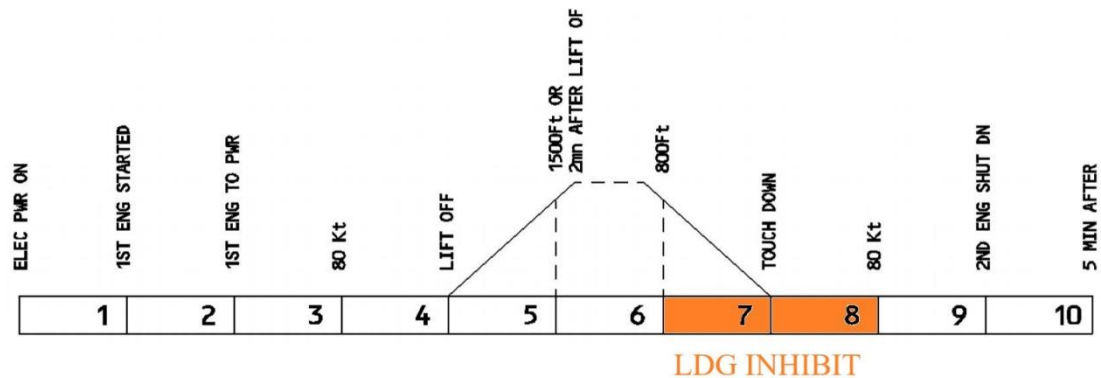
圖 1.6-11 落地階段 ECAM 訊息抑制示意圖

本事件發生時，正處於飛行高度 800 呎至落地後地面速度 80 節之間「LDG INHIBIT」階段，如圖 1.6-11 所示。
