Elit'Avia Malta Limited Flight EAU52P

Bombardier BD-700-1A10

Abnormal Runway Contact during Landing

**Aviation Occurrence Investigation Factual
Report**

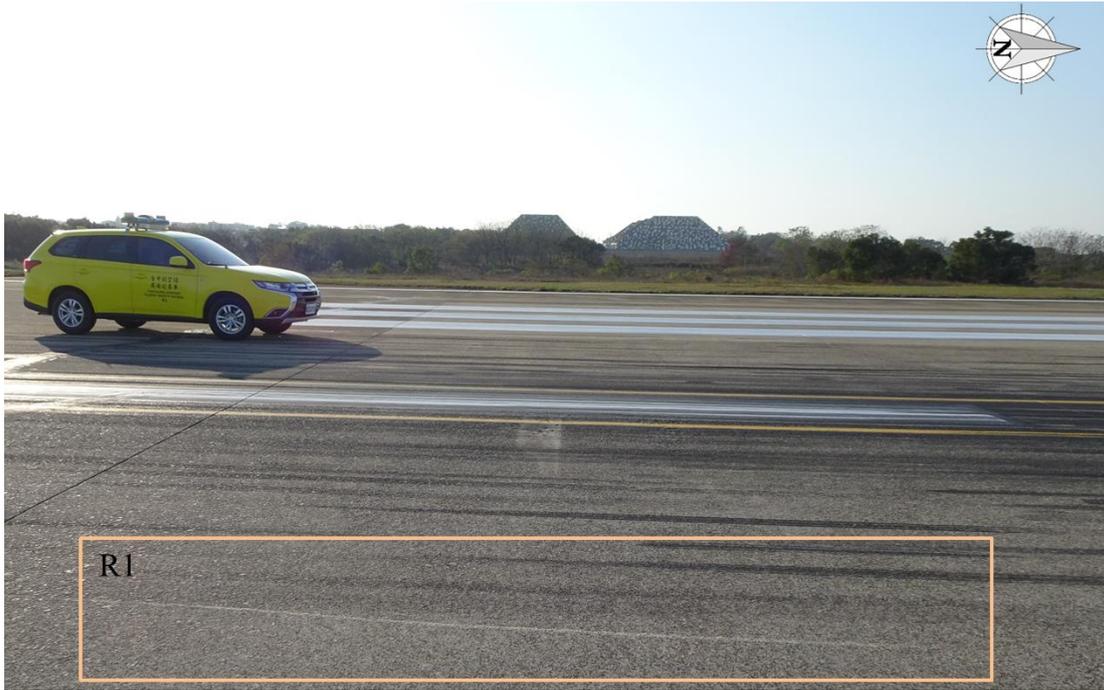
Figure 1.12-3 First wing mark (R1)

The investigation team arrived at RCMQ Airport around 1515 hours on the occurrence day, and then searched for significant wing contact marks on the runway 36 surface around 1537 hours. The team utilized global positioning system (GPS) equipment and a camera to conduct a ground survey of the occurrence site. The team found the first (right) wing mark (R1) at about 503 feet from the runway threshold, then the three parallel (left) wing marks (L1 to L3) were found about 636 feet from the runway threshold.

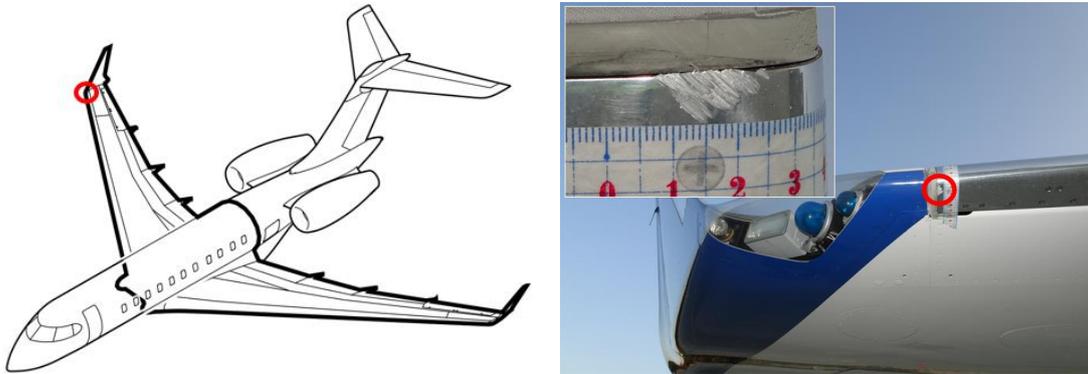
Figure 1.12-5 Right slat

An abrasion was detected on the right end bottom of the most outboard slat on the right wing; the abrasion area was about 0.75 sq.cm.

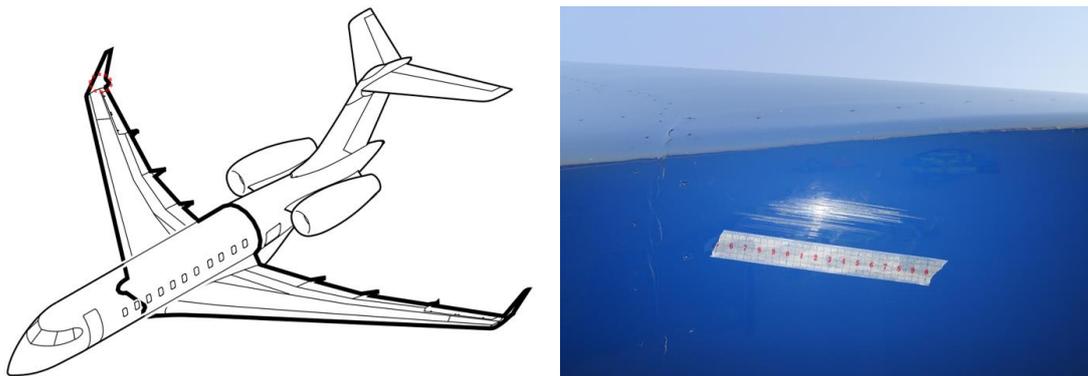
Figure 1.12-6 Middle bottom of the right winglet

An abrasion was detected on the middle bottom of the right winglet; the abrasion area was about 18 sq.cm.

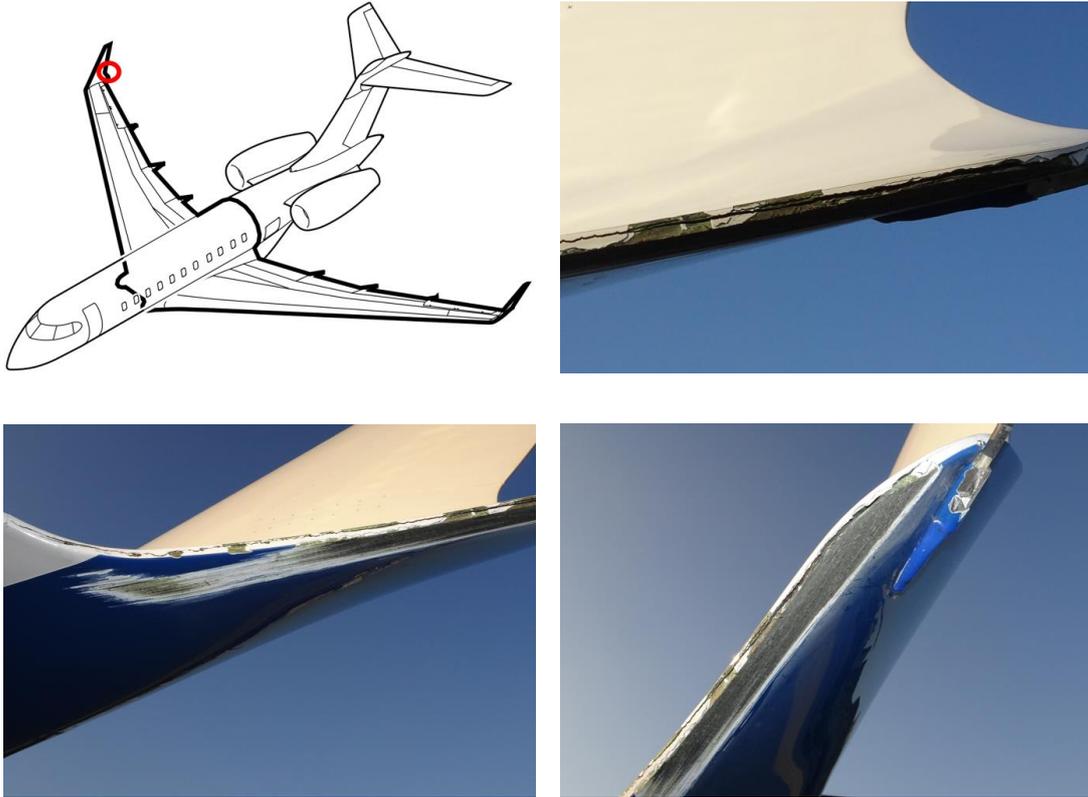
Figure 1.12-7 Trailing edge of the end of right wing

An abrasion was detected on the very end of right wing and split into 2 delaminations at the trailing edge. The damage area abraded on the trailing edge connects with the winglet trailing edge, the length of separation at the trailing edge was about 40 cm long, and the abrasion area was about 100 sq.cm.

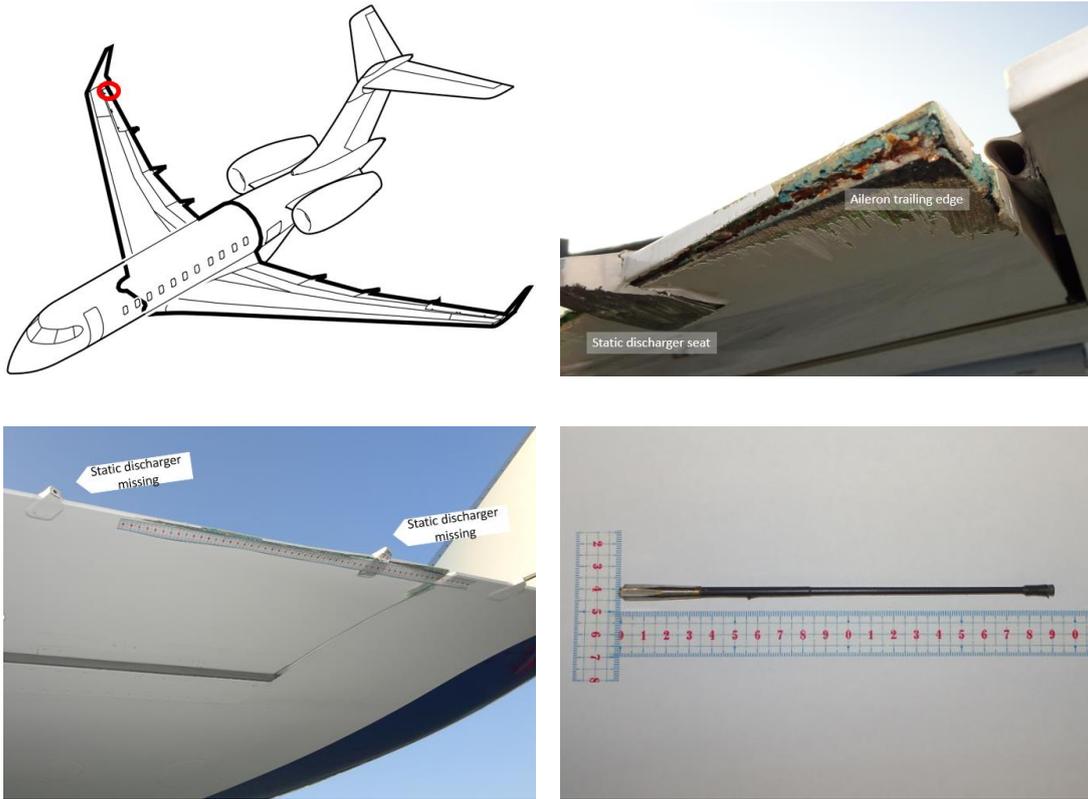
Figure 1.12-8 right aileron

An abrasion was detected on the right end of the aileron and split into two delaminations at the trailing edge, the aileron had severe damage at the right end trailing edge corner. The abrasion damage extended into the honeycomb in the aileron trailing edge corner, the abrasion area was about 158 sq.cm. The length of separation at the right end of the aileron was about 48 cm long.

The outboard two static wicks on the aileron were lost, one of the detached static wicks was found at the right wing touchdown zone. The most outboard static wick location was worn down to the aileron surface by abrasive contact.

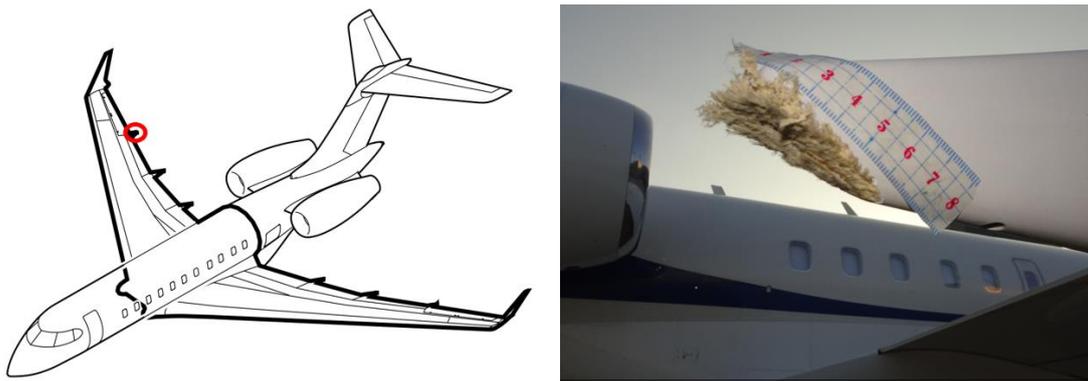
Figure 1.12-9 Right outboard flap fairing

Severe abrasive wearing was detected on the aft end of the most outboard flap fairing on the right wing; the area of wear was about 13 cm long and 3 cm wide.

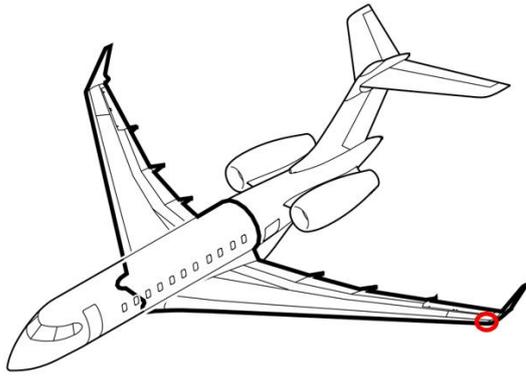
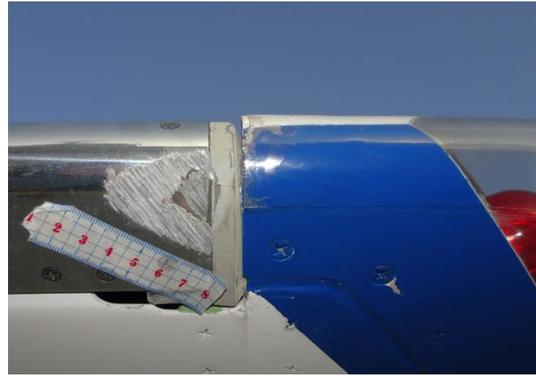
Figure 1.12-10 Left slat

An abrasion was detected on the right end bottom of the most outboard slat on the left wing; the abrasion area was about 13 sq.cm.

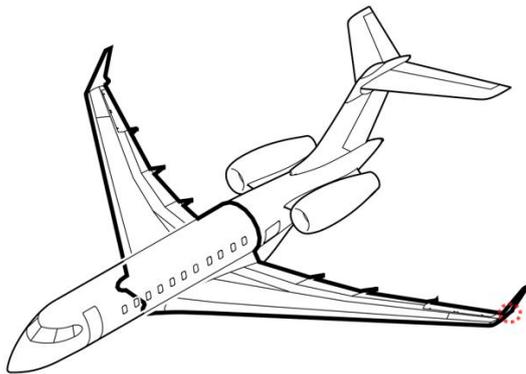
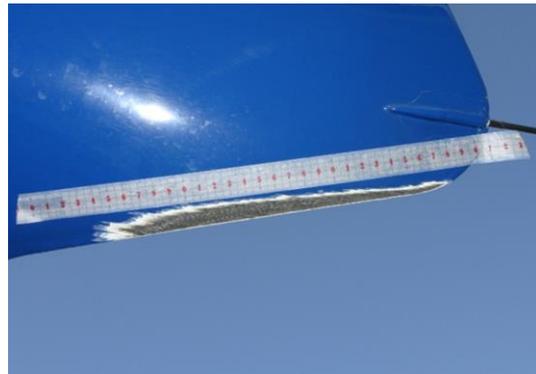
Figure 1.12-11 Trailing edge of the end of left wing

An abrasion was detected on the very end of the left wing, abraded on the trailing edge at the connection with winglet trailing edge, the length of separation at the trailing edge was about 25 cm long, and the abrasion area was about 25 sq.cm.

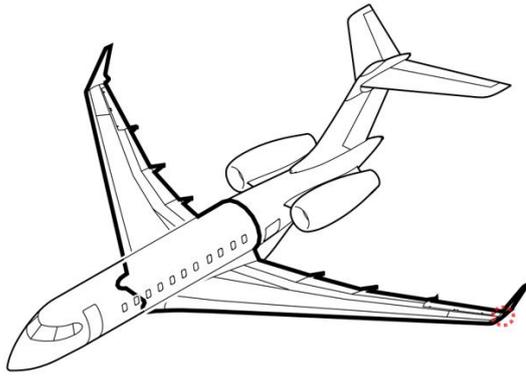
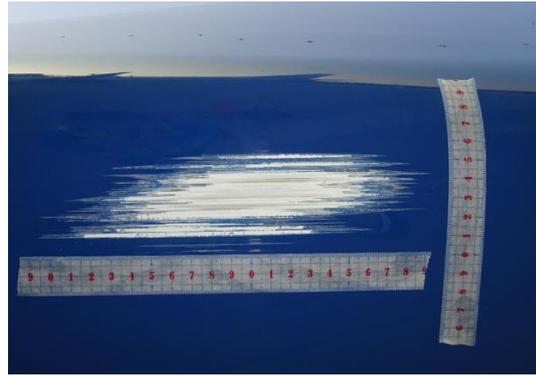
Figure 1.12-12 Middle bottom of the left winglet

An abrasion was detected on the middle bottom of the left winglet; the abrasion area was about 78 sq.cm.

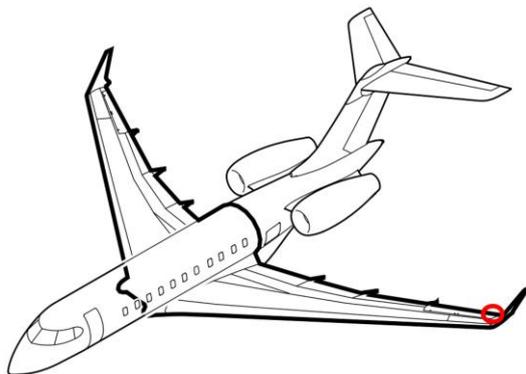
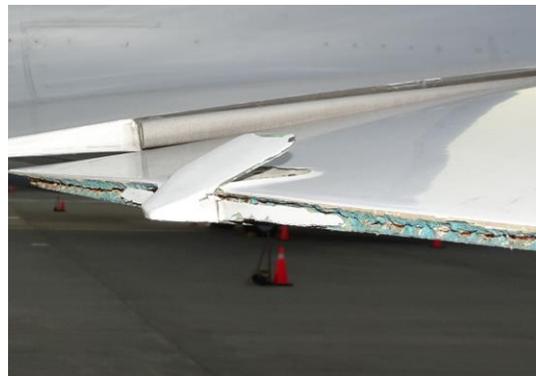
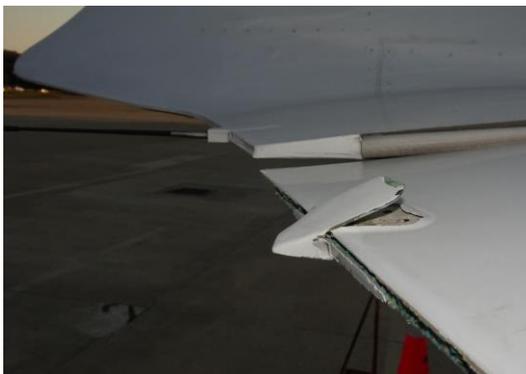
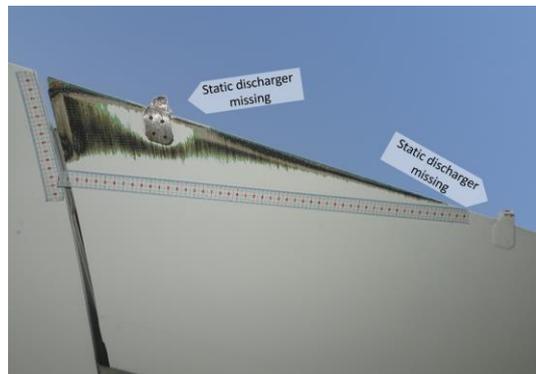
Figure 1.12-13 Left aileron

An abrasion was detected on the right end of the aileron and split into two delaminations at the trailing edge, the aileron had severe damage at the right end trailing edge corner. The abrasion damage extended into the honeycomb in the aileron trailing edge corner, the abrasion area was about 245 sq.cm. The length of separation at the left end of the aileron was about 48 cm long.

The outboard two static wicks on the aileron were lost. The most outboard static wick location was worn down to the aileron surface level by abrasive contact, the upper structure of the static wick was detached.

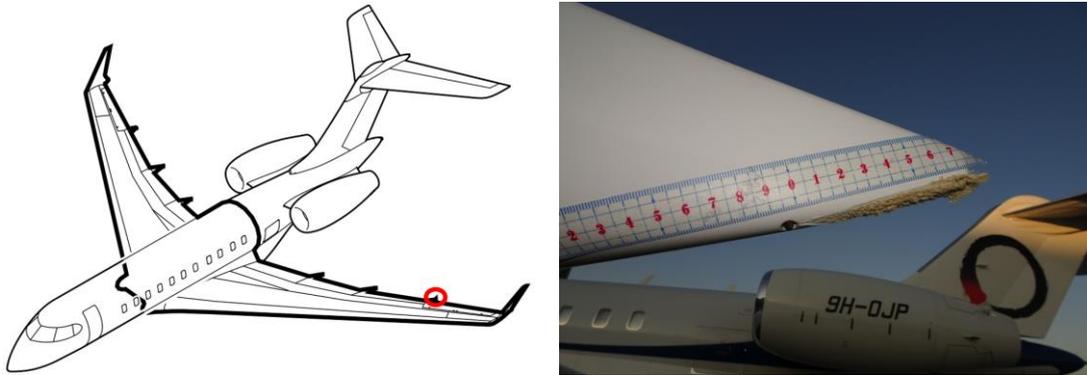
Figure 1.12-14 Left outboard flap fairing

Severe abrasive wearing was detected on the most outboard flap fairing at the end tail on the left wing; the size of the abraded area was about 7 cm long and 1.5 cm wide.
