國家運輸安全調查委員會

調查報告

中華航空公司 CI922 班機

爬升階段 1 號發動機起火

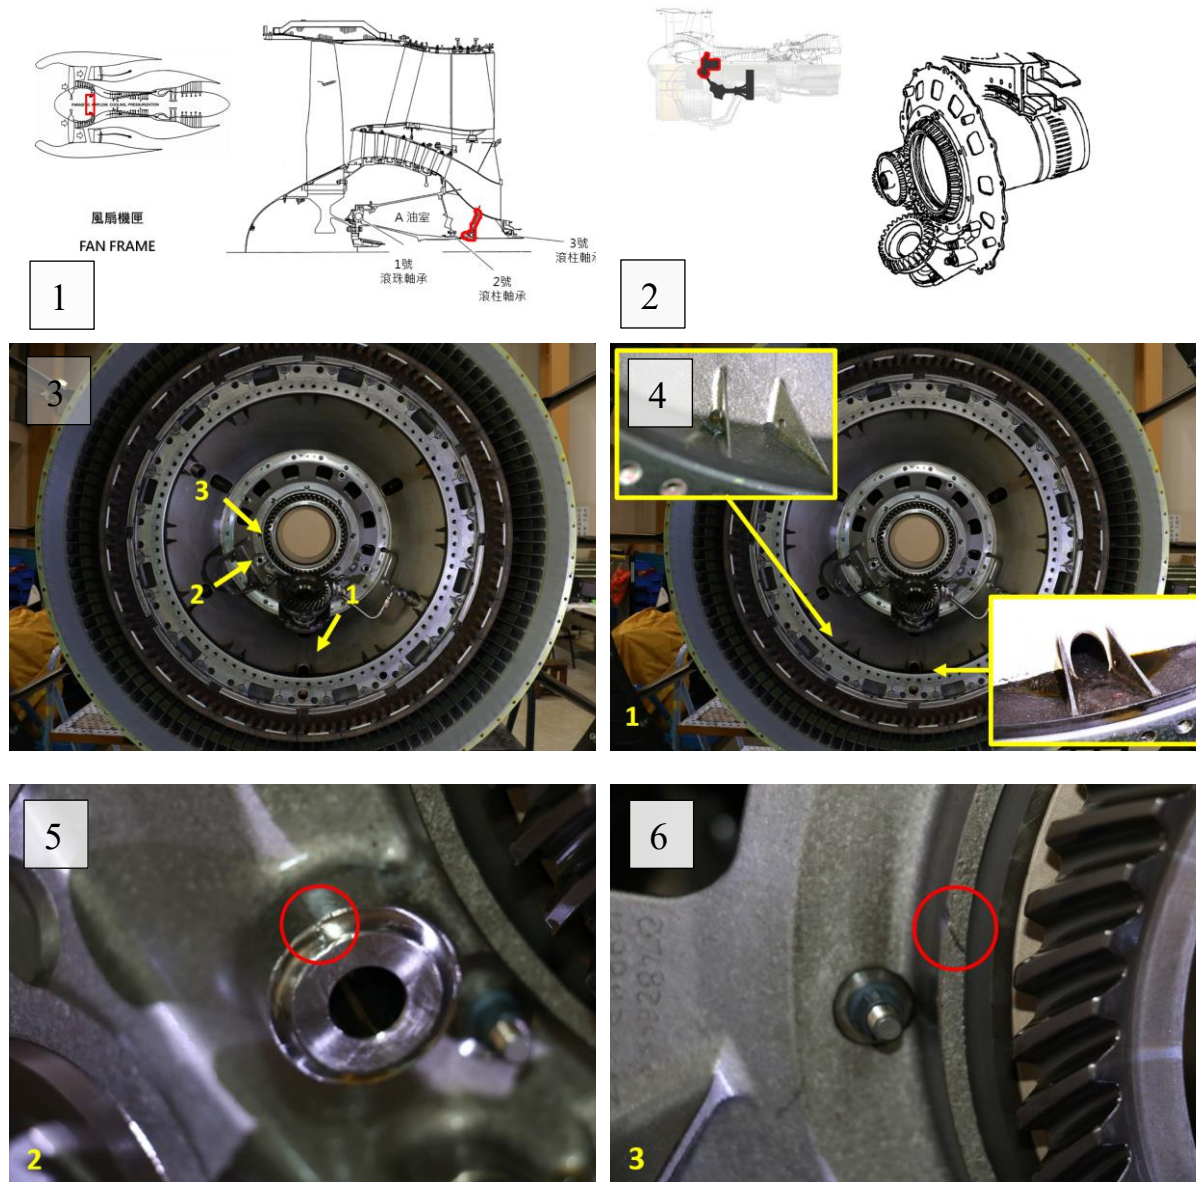
圖 1.16-3 風扇機匣內部損傷狀況

風扇機匣 7 點鐘位置結構樑處發現長一約半吋金屬片，機匣底部有較多金屬粉末及金屬油泥殘留；輸入齒輪箱 (inlet gearbox, IGB) 承座凸緣及埠口有表面各一處擊傷，詳圖 1.16-3-1~6。

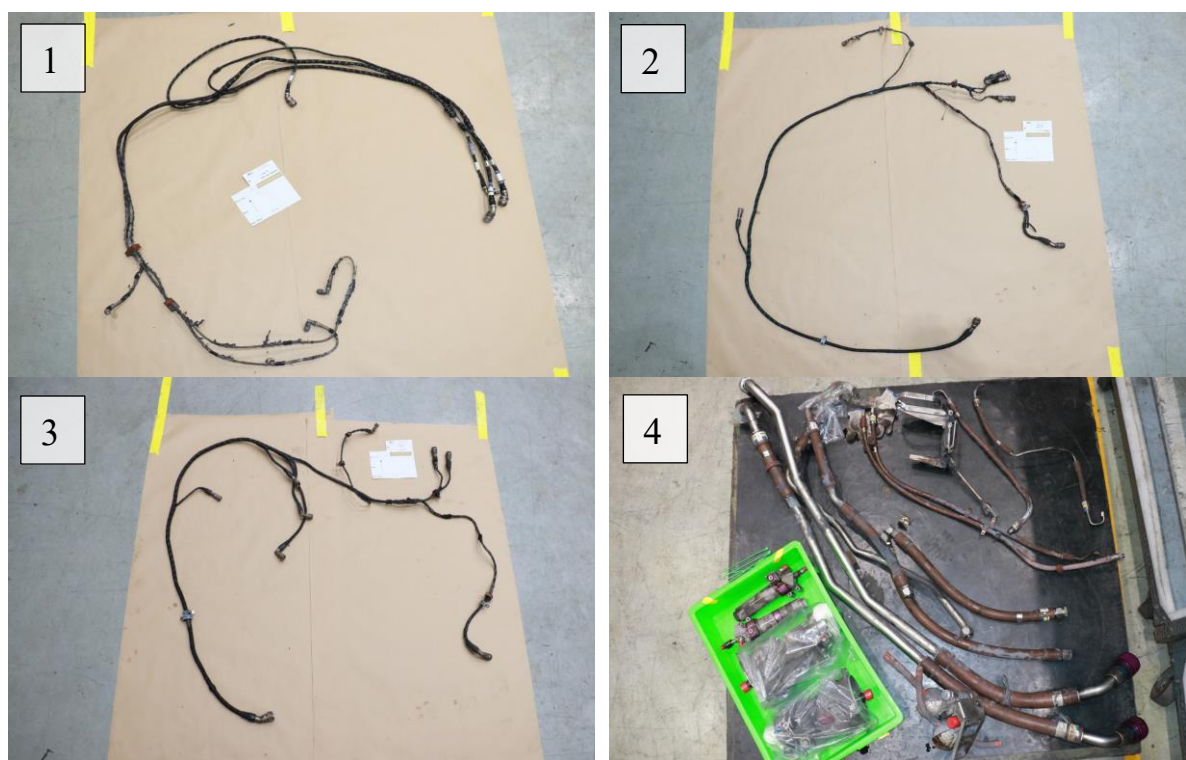
圖 1.16-5 線束及附件管路檢查

靠近高壓通氣管破裂處之發動機附件、液壓、氣體管路明顯有炭色燻黑物質附著，等電器線束線段外部保護套有高溫燒損剝落，電器接頭目視狀況良好無火損，詳圖 1.16-5-1~4。

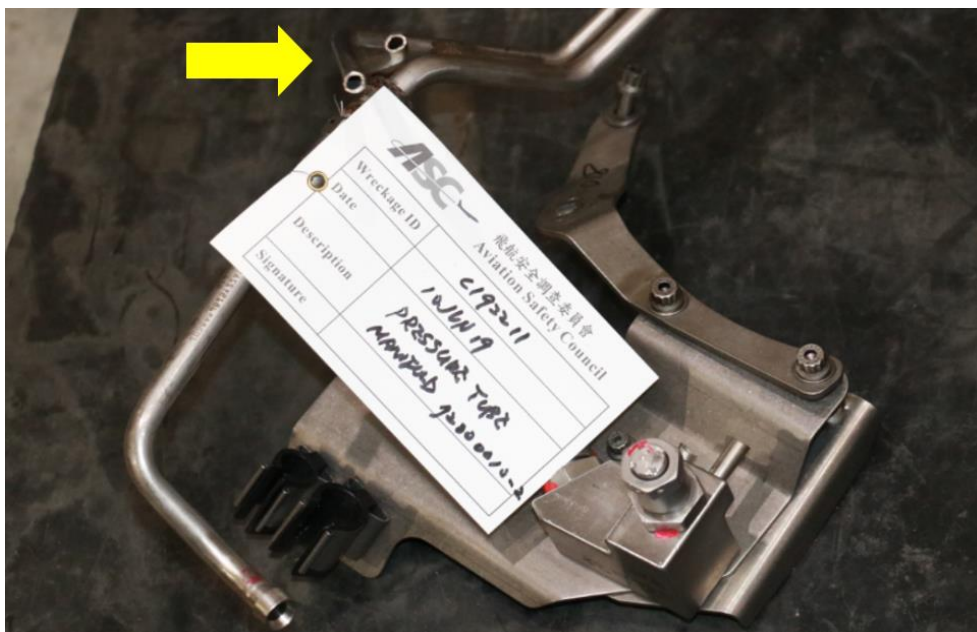
圖 1.16-7 火警偵測組件及壓力歧管

P25 /P49 壓力歧管斷裂，詳圖 1.16-7。

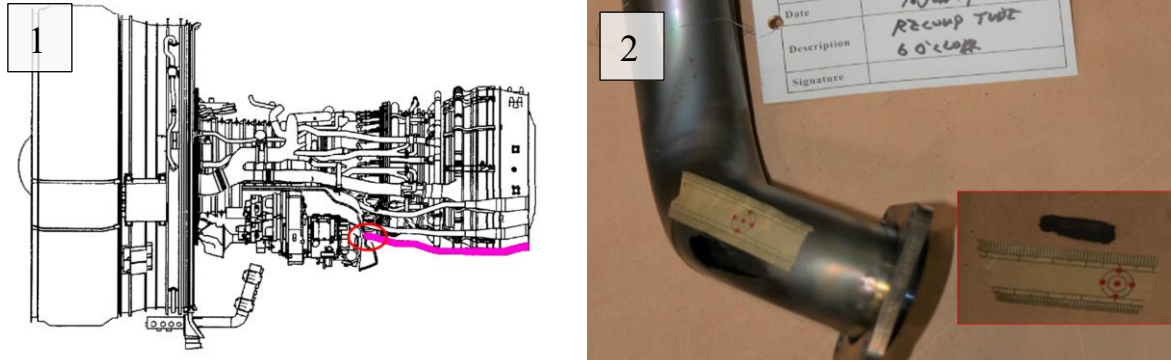
圖 1.16-9 6 點鐘 LPRC 導管燒穿

6 點鐘 LPRC 導管上游端初彎折處有一約 1.8*0.5 吋燒穿破孔。管內發現一約 1*0.3 吋金屬碎片，詳圖 1.16-9-1~2。

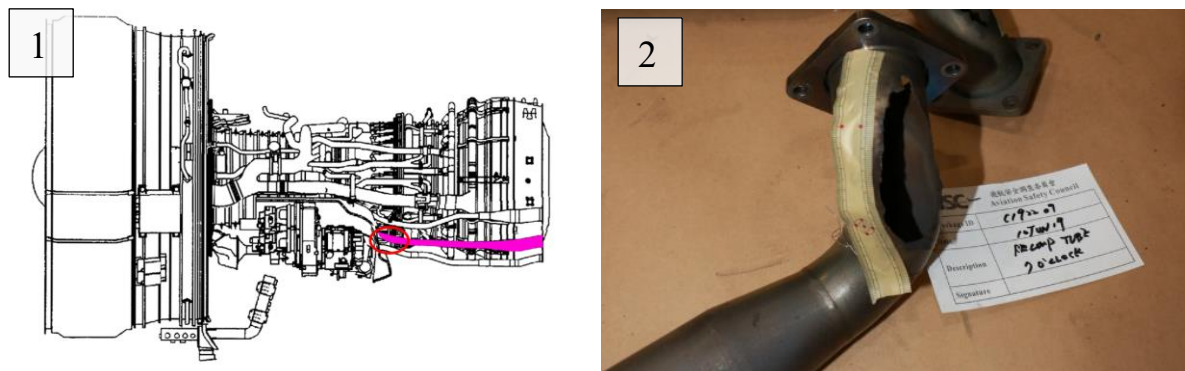
圖 1.16-10 7 點鐘 LPRC 導管燒穿

7 點鐘 LPRC 導管上游端初彎折處有一約 4*1.2 吋燒穿破孔，詳圖 1.16-10-1~2。

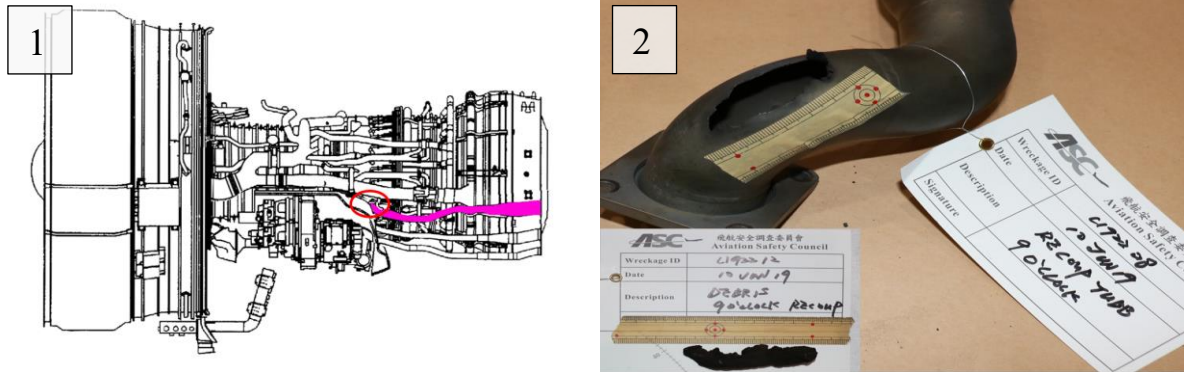
圖 1.16-11 9 點鐘 LPRC 導管燒穿

9 點鐘 LPRC 導管上游端初彎折處有一約 2*0.8 吋燒穿破孔。管內發現一約 2.5*0.8 吋金屬碎片，詳圖 1.16-11-1~2。

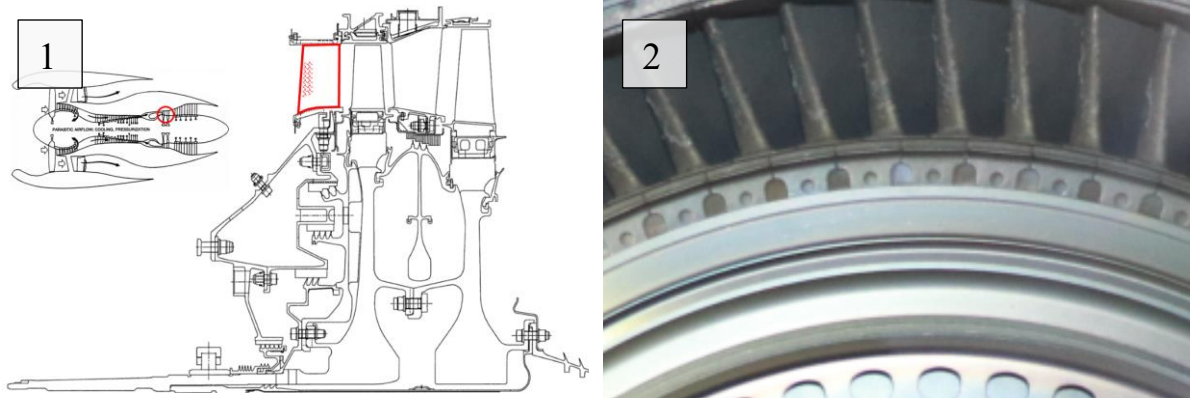
圖 1.16-16 第 1 級 HPT 定子損傷

第一級 HPT 定子前緣有裂縫情形，詳圖 1.16-16-1~2。

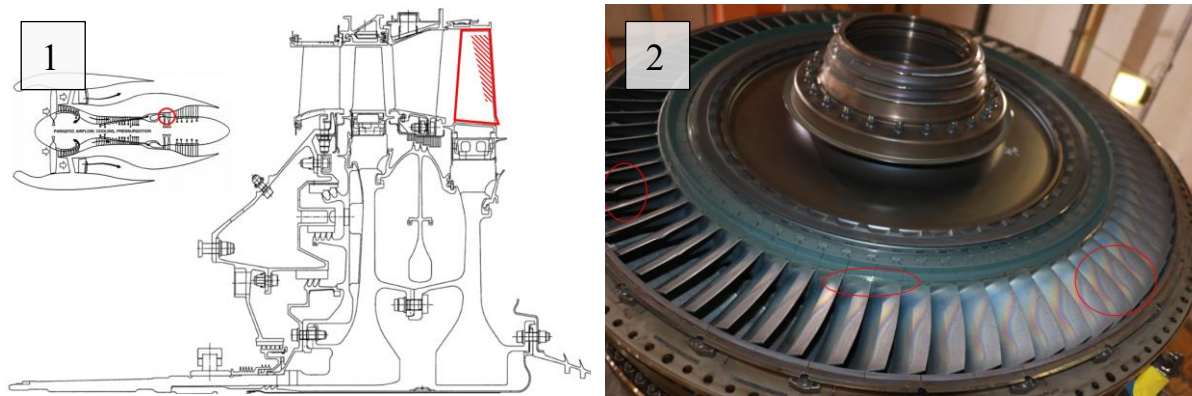
圖 1.16-17 第 2 級 HPT 轉子損傷

第 2 級 HPT 轉子全數葉尖方面後緣有金屬高溫受熱變色跡象，葉根平台（platform）部分、渦輪盤（disk）表面，3 片葉片後緣有擊傷破裂，以及葉片固定座（retainer）後緣有磨擦痕跡，詳圖 1.16-17-1~2。

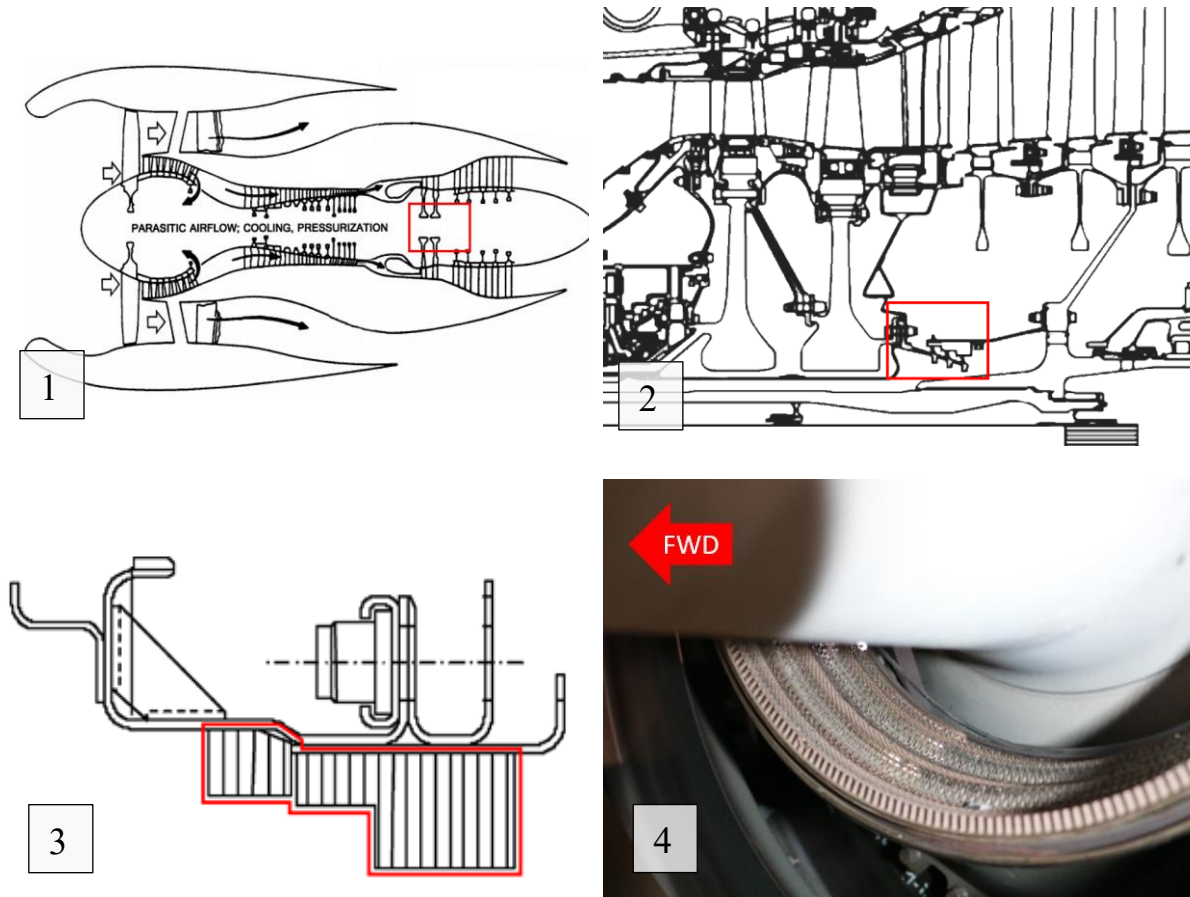
圖 1.16-18 HPT 轉子氣封後方氣封定子蜂巢結構損傷

第 2 級 HPT 中間定子氣封 (interstage stationary air seal) 之蜂巢結構有內緣環狀磨擦削損狀況，詳圖 1.16-18-1~4。

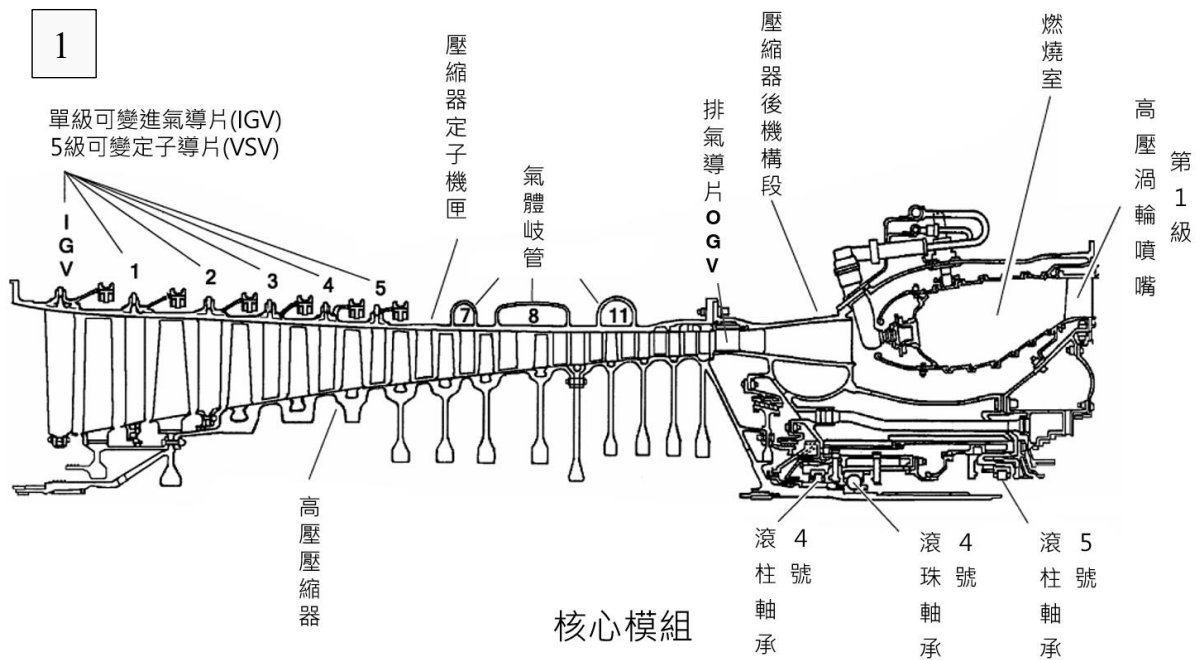
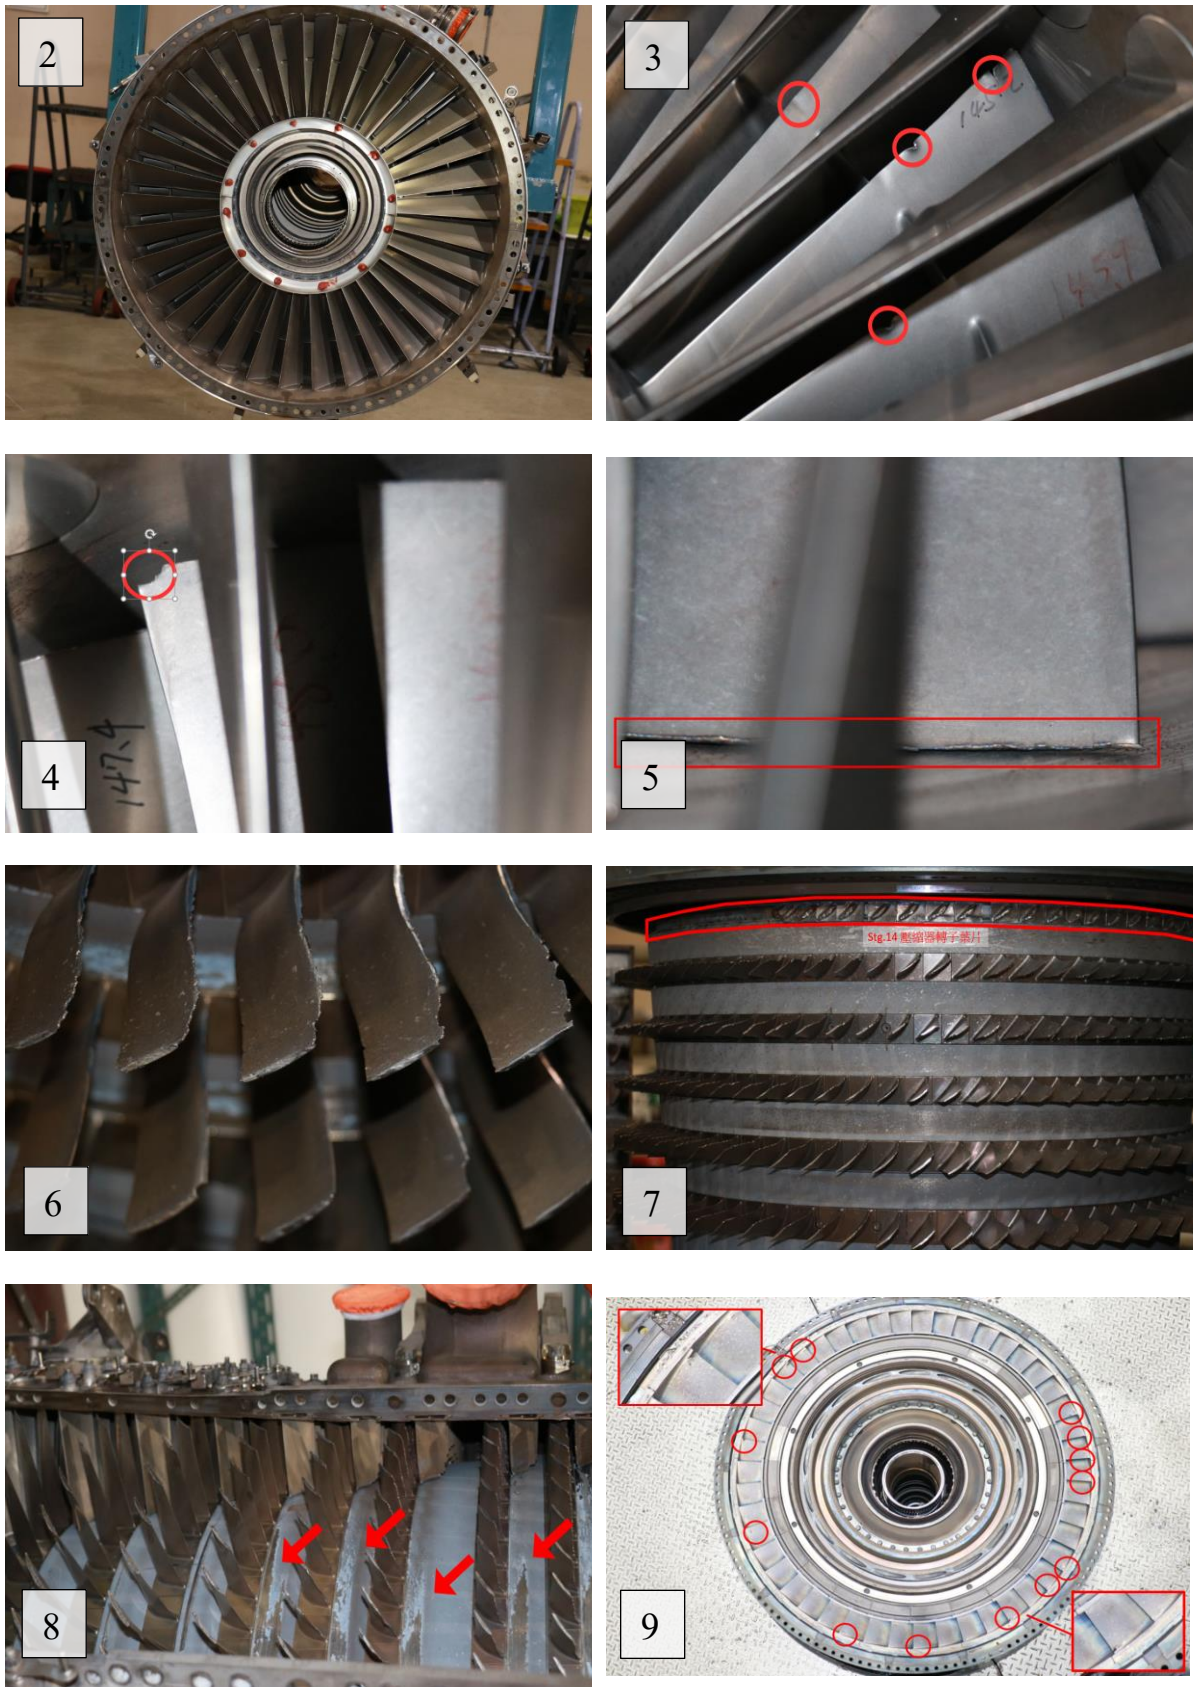
圖 1.16-20 壓縮器損傷狀況

以目視觀察，第一級 HP 壓縮器進氣導片 (inlet guide vane, IGV) 狀況良好，第一級轉子前緣有葉尖磨擦、撕裂與彎角擊傷狀況，詳圖 1.16-20-3~5。

壓縮器轉子及定子之葉片普遍後緣及葉尖處磨擦與擊傷，且前緣亦有擊傷、彎曲及磨擦之損壞情形，上述損壞越靠近壓縮器後機構段，狀況越嚴重，詳圖 1.16-20-6~7，壓縮器轉子軸上有與相對位置定子機匣葉片之葉尖磨擦狀況，詳圖 1.16-20-8。排氣導片 (outlet guide vane, OGV) 前緣有多片撕裂傷、裂痕及缺角損傷，詳圖 1.16-20-9。

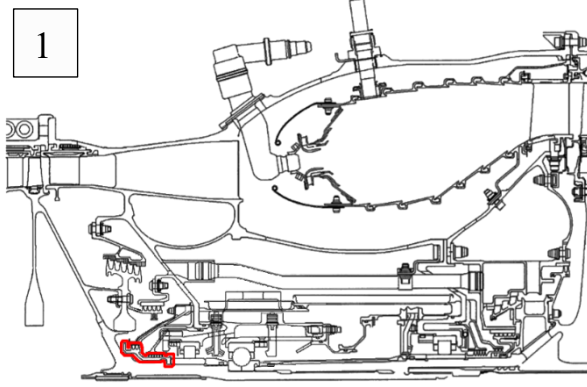
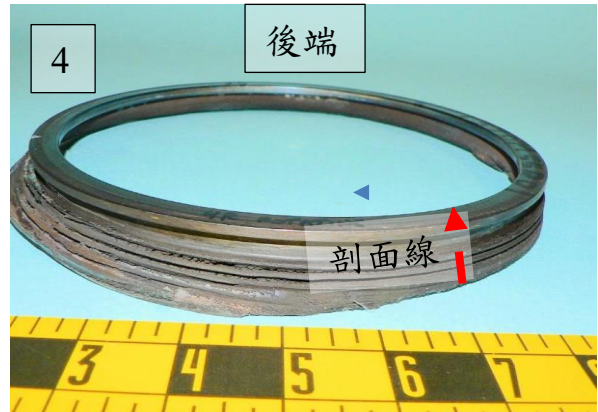
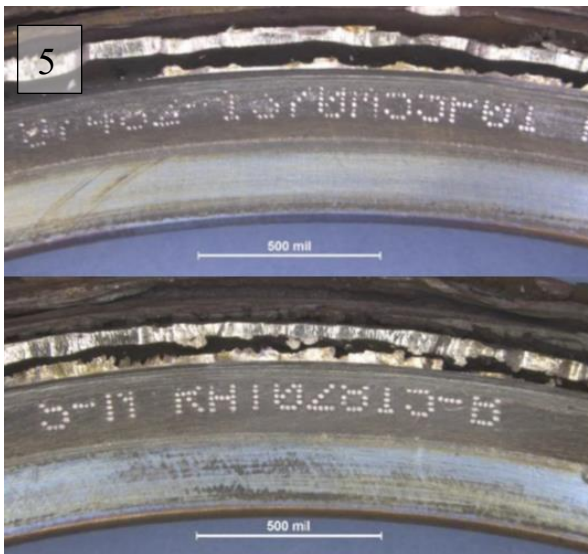
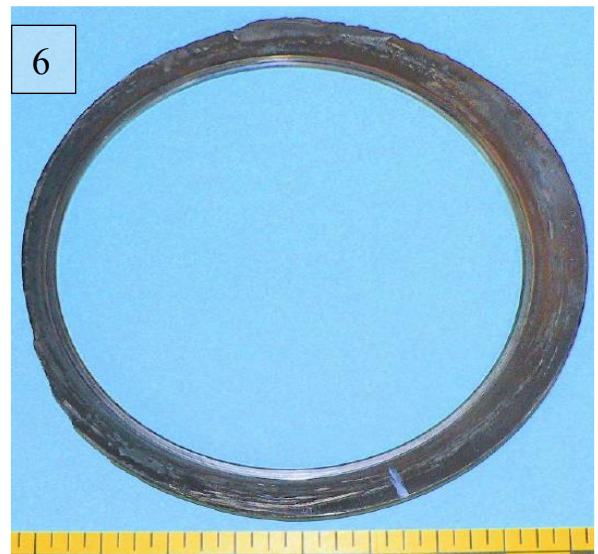
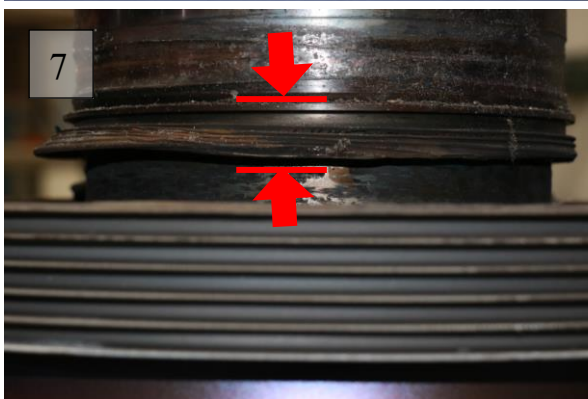
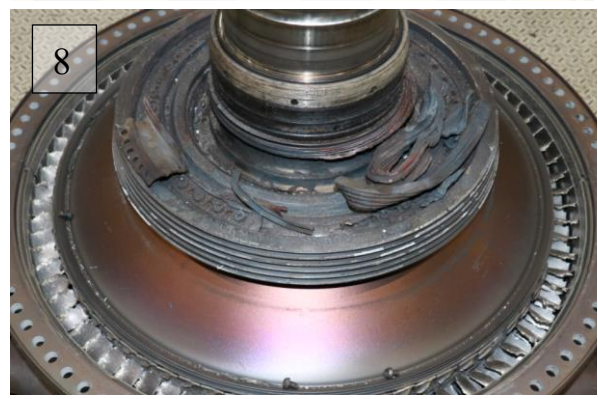
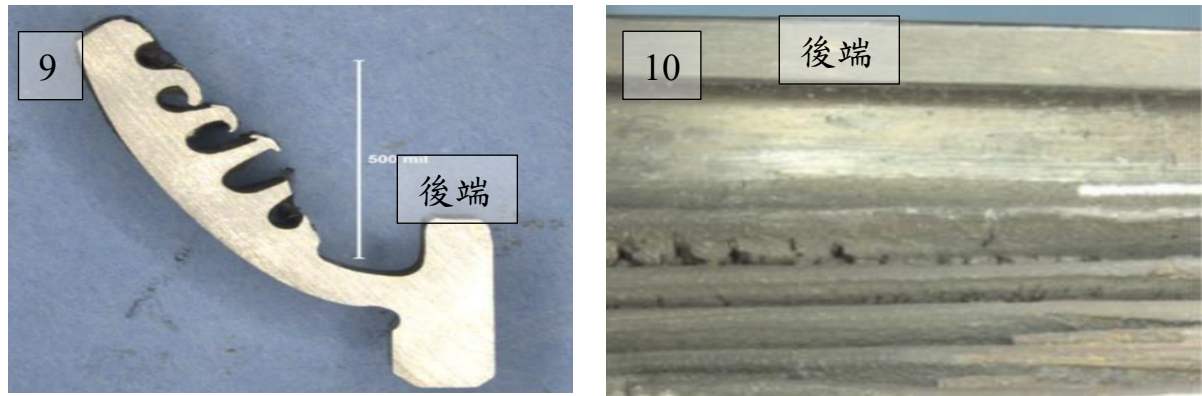
圖 1.16-22 4R 轉子氣/油封損傷狀況

1. 事故機於爬升過程中 1 號發動機經歷高振動及火警，係因該發動機於前次進廠維修其 4R 定子氣/油封安裝失準，使定子氣/油封橢圓化變形，導致與 4R 轉子氣/油封之間隙過小；在操作過程中定子及轉子氣/油封發生深磨擦，並產生高溫，溫度並超出設計承受範圍，4R 轉子氣/油封的材料強度受高溫而降低，且在高速旋轉之離心力作用下，4R 轉子的氣/油封齒條向外變形擴展，進一步增加轉子與定子的磨擦深度；嚴重磨擦及超溫導致的 4R 氣/油封轉子與定子嚴重受損，使滑油油室之密封失效。
2. 4R 定子及轉子氣/油封受損破裂碎片撞擊 4R 轉子排氣軸封，使排氣軸封嚴重受損，HPRC 的高溫/高壓氣體失去排氣軸封隔離後進入滑油室，造成滑油室失火燃燒，燃燒的高壓高溫油氣，進入並燒穿 LPRC 氣管及 B/C 油室管路，並從燒穿之破口處洩出造成發動機艙高溫及觸發火警。

4R 轉子氣/油封前段氣封斷裂遺失，斷裂處約莫位於後段刀齒第一級正前方至第三級左右位置一帶，詳圖 1.16-22-4，因部件受損但仍留有部分可辨識件號 1370M55P01 及序號 RAT02815-B，詳圖 1.16-22-5，轉子遺損的程度在圓周上非均勻分布，詳圖 1.16-22-6。後半部各級刀齒外緣大致完好仍可辨識基本外型，詳圖 1.16-22-7~8，惟前段刀峰有軸向明顯受擠壓造成塑性變形，後段刀齒部分材料遺損，且整體後半部結構有嚴重輻向往外側彎曲之變形，詳圖 1.16-22-9~10。

- Part severely damaged (轉子嚴重損壞)
- Forward seal teeth rack missing (前段氣封齒條失損)
- Aft seal teeth rack intact, but reduced in axial length by plastic deformation and loss of metal. (後段油封齒條完整，惟軸向長度因塑性變形而縮短且有部分金屬失損)
- The fracture surfaces were coated with metal splatter and could not be observed (斷裂表面因有金屬飛濺物覆蓋無法進行觀察)
- The part deformed radially outward from overheating/CF force. (有因受超溫及離心力所造成之徑向向外之變形)
- No material-type discrepancies observed (EDS¹¹, hardness, microstructure) (材料無不符合規範之情形(光譜分析、硬度、微觀結構))

1. 加強發動機施工工單的完整性，若因故須偏離手冊內容時，除必須使用獲得原廠接受之替代方案外，並應於工單上反映替代方案所陳述之文件及程序，以減少現場施工過程遺漏工序之風險及完整保留施工紀錄。(TTSB-ASR-21-11-001)
2. 檢視及評估發動機工廠維修所需特殊工具之取得流程與時程管控，以及時取得所需之特殊工具，避免使用替代方案，以降低風險。(TTSB-ASR-21-11-002)
3. 檢視及評估發動機工廠組裝工單，有關類似本案 4R 定子氣/油封安裝工作，若未被正確執行可能造成的失效會危及飛機的安全操作，列為維護重點項目。(TTSB-ASR-21-11-003)

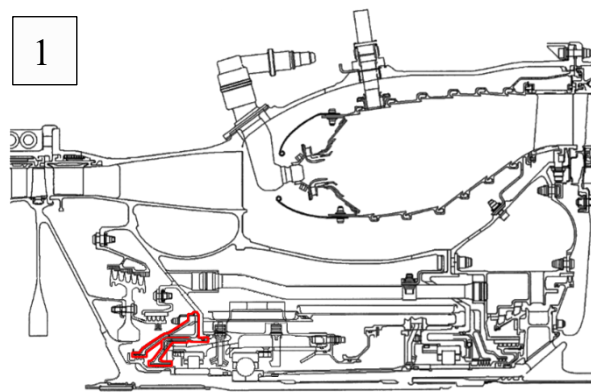
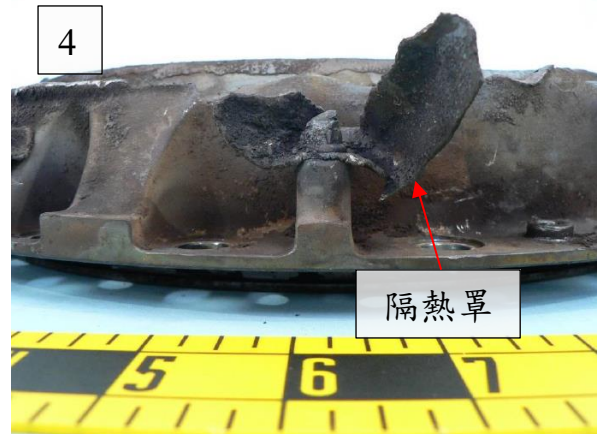
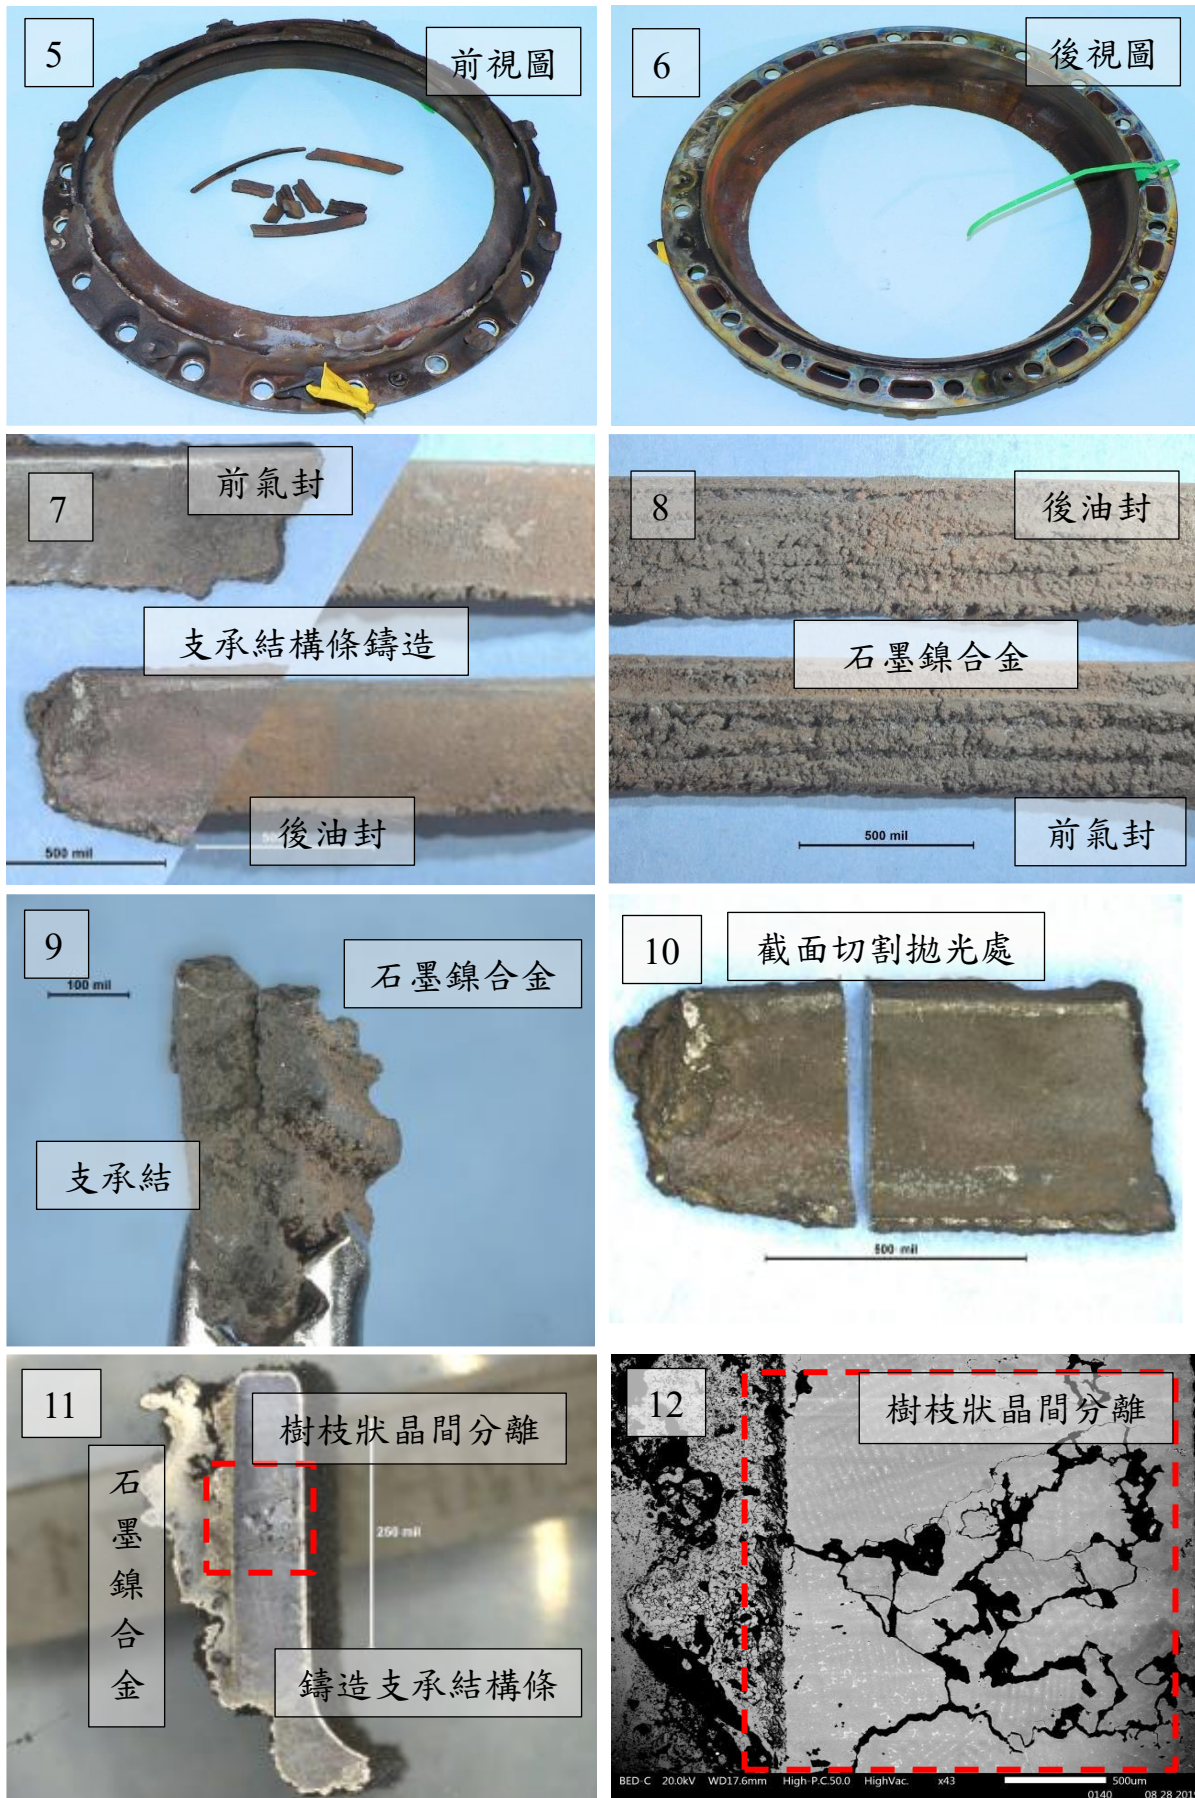
圖 1.16-23 4R 定子氣/油封損傷狀況

- Part severely damaged with evidence of fire（定子有嚴重火損情形）
- Both Outer (Air) and Inner (Oil) portions of seal support fractured（定子氣封和油封（原文報告以內、外部註解）支承結構均破損）
- Evidence of heavy rubs on both seal lands (Air and Oil)（兩處氣封磨擦面（氣與油封）都有嚴重磨擦的跡象）
- Evidence of incipient melting of rub land backing strips (pre-fire

damage) (磨擦面之支承結構條有初始熔化現象(火災前之損壞))

- Thickness of Nickel-Graphite bond coat conforming in undamaged locations (無損壞的石墨鎳合金之塗層厚度一致)
- Signs of melting with inter-dendritic separations observed. (支承結構條有樹枝狀晶間分離的熔融跡象)
- Thermal shield almost entirely missing (隔熱罩幾乎完全失損)
- Liberated fragments of part located in cavity under rotating CDP Seal bore. (定子脫離之破片留滯於 CDP 轉子氣封之孔洞空間中)

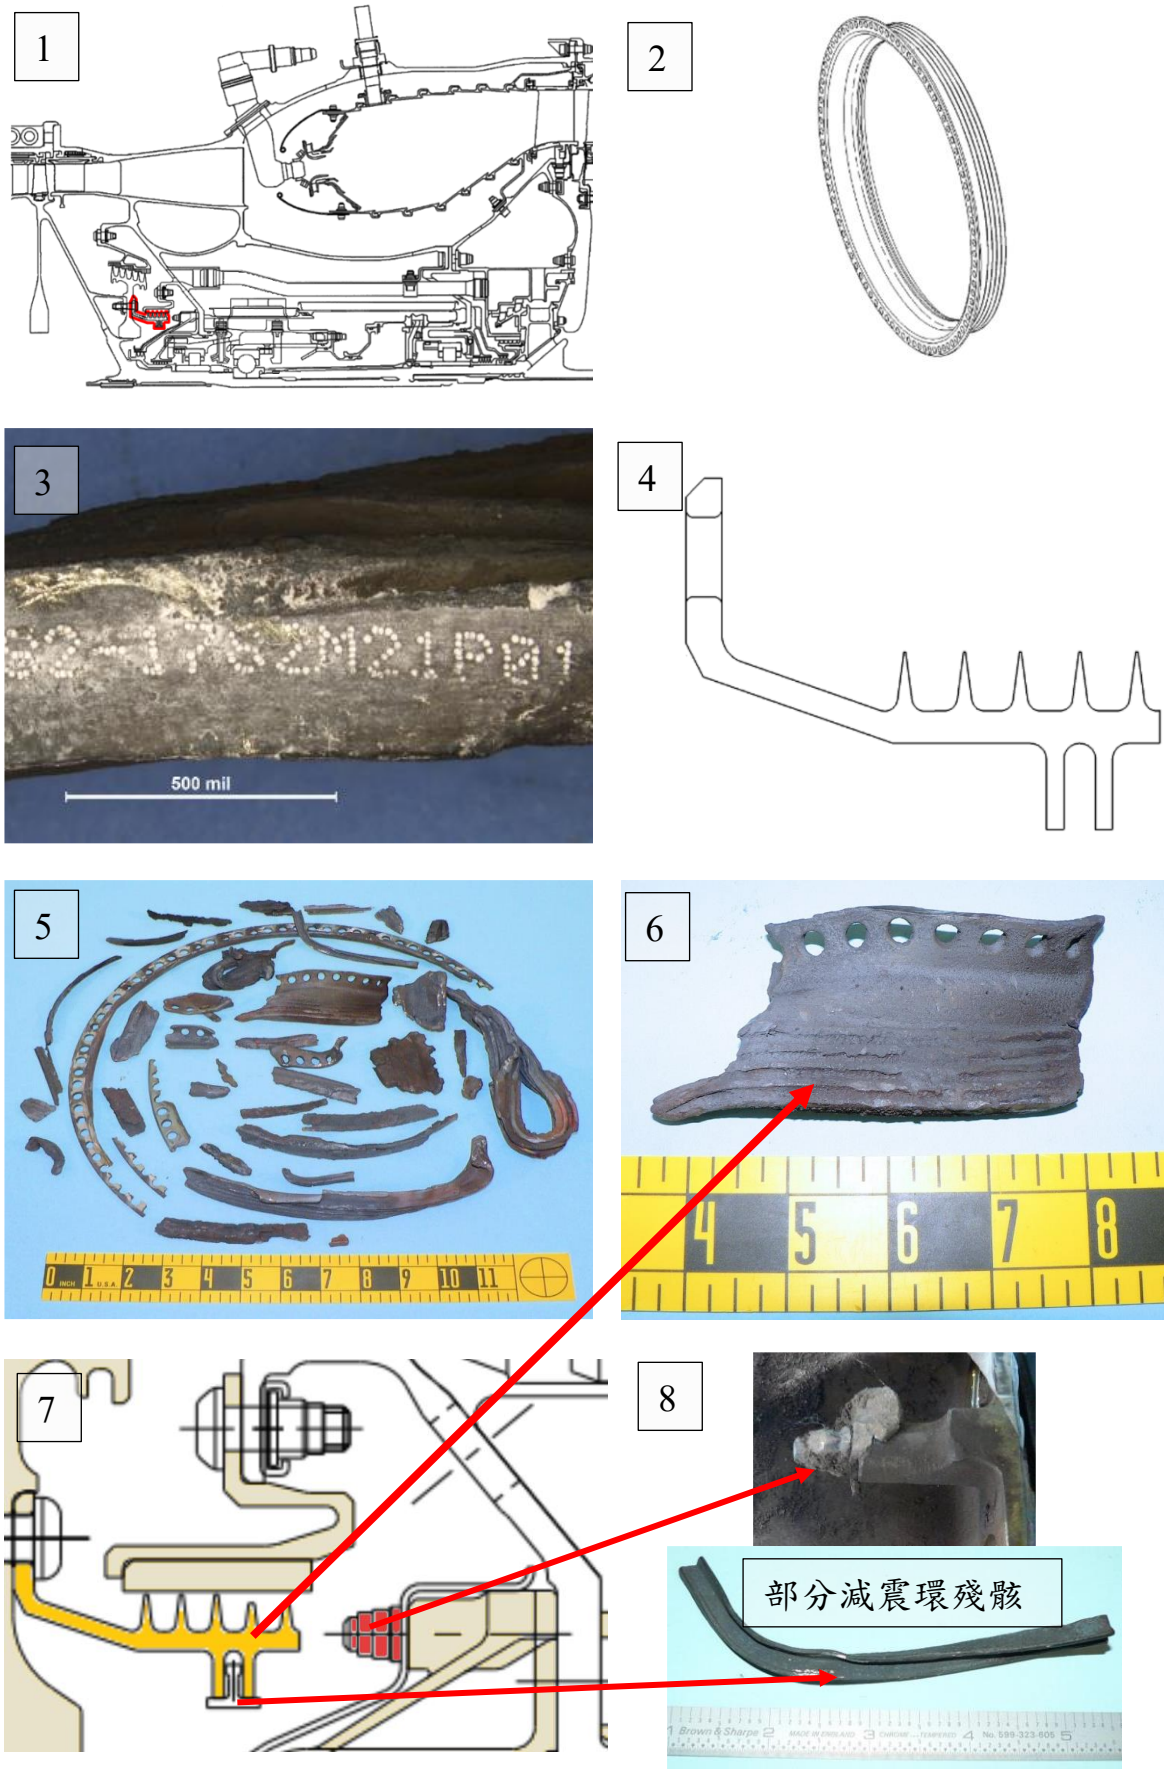
圖 1.16-24 4R 轉子排氣軸封

4R 轉子排氣軸封，在事故的過程中解離成數段殘骸，4R 轉子排氣軸封裝附於 CDP 轉子氣封上，事故後仍有部分脫離之凸緣留於原安裝處，仍留於 CDP 轉子氣封上，其固定螺桿以人工方式破壞以遂後續拆解，詳圖 1.16-24-1~6；殘骸碎片中發現有殘餘之減震環（damper ring）破碎段，詳圖 1.16-24-8，大部分斷裂面皆嚴重受脫落部件擊傷或金屬噴濺，4R 轉子排氣軸封仍可見件號為 1782M21P01，序號無法辨識，其正後方之 4R 定子氣/油封安裝座部分螺桿外觀完整，螺樁前緣平面無接觸磨損痕跡，詳圖 1.16-24-7、8。

- Part was reduced to fragments during the event. Portions of the flange were still connected to the CDP rotating seal. (4R 轉子排氣軸封於事故中已遭解離為碎片。部分凸緣結構仍留於 CDP 轉子氣封上)
- All fracture surfaces were badly damaged by flying debris and metal splatter. (所有斷裂表面皆被脫離的碎塊和金屬飛濺物嚴重破壞)
- No material-type discrepancies observed (EDS, hardness, microstructure). (材料無不符合規範之情形 (光譜分析、硬度、微觀結構))
- A section of the damper ring was recovered (lack of damper ring excluded as root cause). (殘骸碎片中發現有 1 段殘餘之減震環，故事故肇因排除因未裝減震環所引起)
- No contact on aft face (P/N marking surface)->failure prior to rotor shift. (轉子背面 (件號標記側) 無接觸痕跡，顯示轉子在轉子位移前已失效)

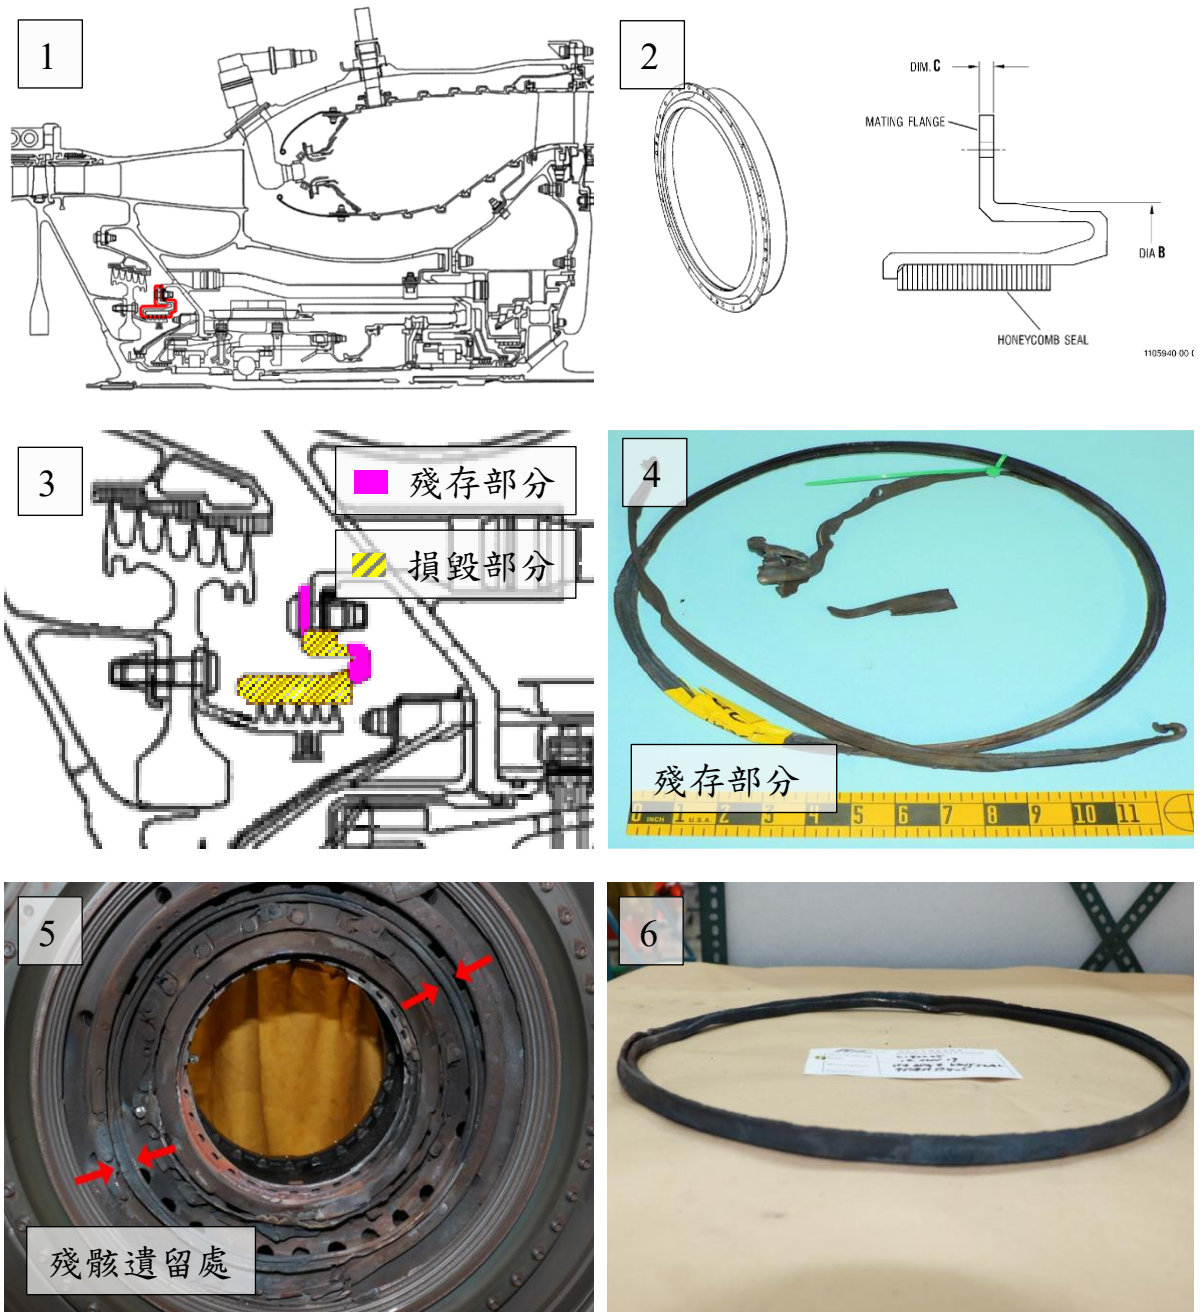
圖 1.16-25 4R 定子排氣軸封

- Only fragments of the 4R stationary vent seal remained. No part markings could be found. (4R 定子排氣軸封僅殘存部分碎片，無零件標記可供辨識)
- No honeycomb was left intact after the event (事故後轉子之蜂巢構造已損毀)
- EDS confirmed the part was manufactured from IN-718, and where the honeycomb was, a Ni-Si braze was present. This is consistent with the honeycomb having been present. (透過能譜儀確認該零件是由金屬材質 IN-718 所製造，並且在應有蜂巢結構所在處有鎳-矽焊的反應，顯示此處曾有蜂巢結構。)

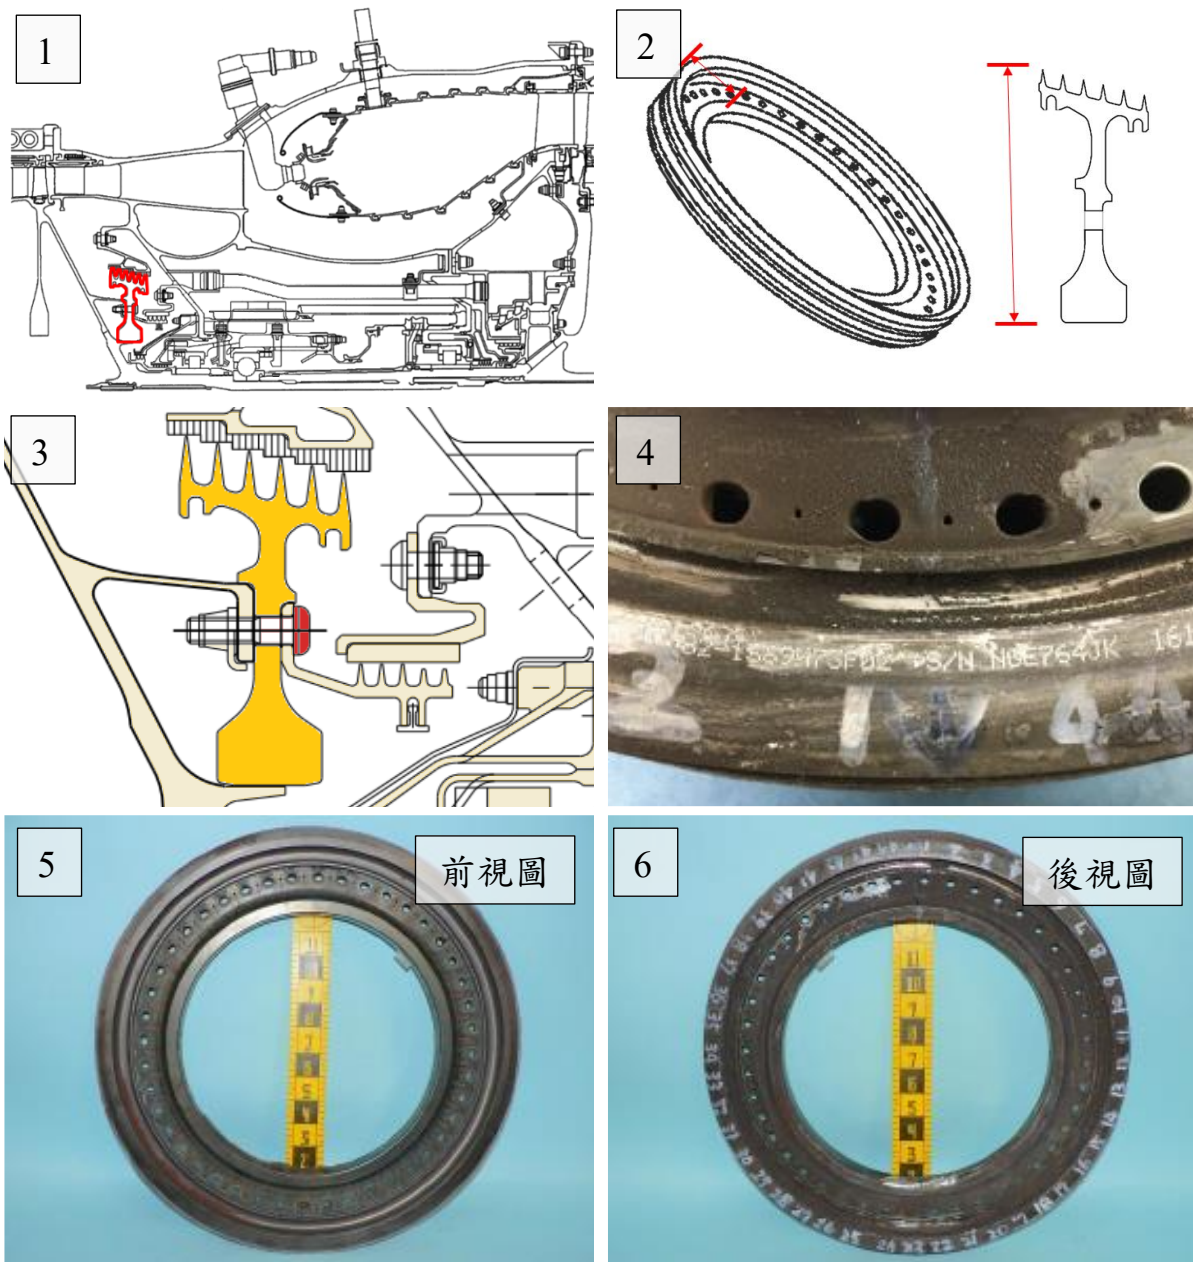
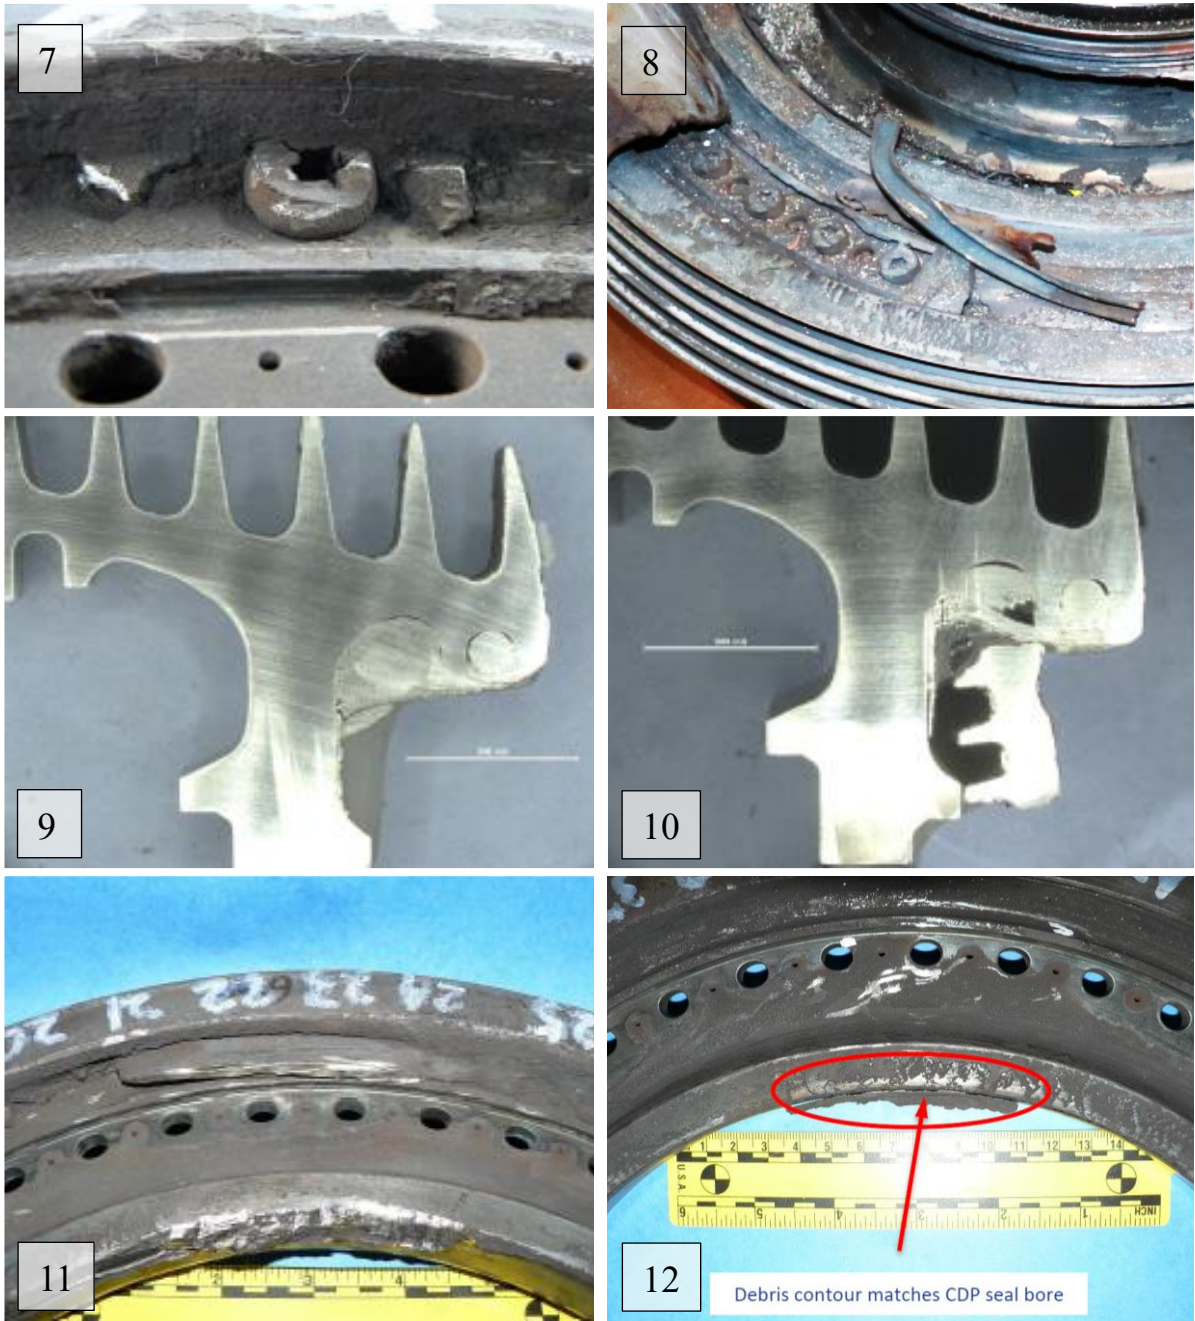
圖 1.16-26 CDP 轉子氣封

後緣有較明顯受噴濺及衝擊之損傷，後緣減震環卡槽位置有金屬融屑堆積，榫槽空隙被填滿且覆蓋，該處在事故後部分事證受到破壞，為後續拆解作業必要之彎折及切削，詳圖 1.16-26-7~8。刀齒結構內緣凹槽內發現有一段仍完整可辨識之 4R 轉子排氣軸封卡滯於該空間，GE 公司實驗室將 CDP 氣封進行截面分析，確認事故前有安裝相關緣減震環 (damper ring)，詳圖 1.16-26-10~11。內緣靠近後緣位置發現一弧狀融屑堆積，詳圖 1.16-26-12。

- Forward side in good condition. (前端狀況良好)
- Damage to aft side, including impacts and metal splatter. (後端有損傷，包含撞擊及金屬噴濺)
- Seal teeth in good condition with no geometrical defects. (轉子刀齒狀況良好，無幾何變形)
- Forward and aft damper wires present (檢查結果均發現前、後減震環)
- Cavity under aft seal teeth filled with debris. (後端刀齒下方之空間遭碎屑填補)
- Copper-bearing alloy consistent with 17-4 stainless from the 4R rotating air/oil seal adhered to bore of CDP seal. This indicates 4R rotating air/oil seal failed before anything else deposited material there. (附著於 CDP 轉子氣封後端內緣上之合金，為含銅軸承合金的 17-4 不銹鋼材質之 4R 轉子氣/油封相符，顯示 4R 轉子氣/油封比附著在此其他任何被發現之物質更早失效。)
- After the 17-4 debris, small pieces of cast IN718 were observed. These

are likely from the 4R stationary air/oil seal. This indicates 4R stationary air/oil seal failed after the 4R rotating air/oil seal. (17-4 合金材質之後，發現有小塊 IN-718 鑄件碎片，較可能為來自 4R 定子氣/油封，顯示 4R 定子氣/油封失效在轉子失效之後。)

- Rot Vent Seal bolt heads worn from rubbing contact with 4R Stat Vent Seal after rotor shift. (因轉軸位移後，CDP 轉子氣封上固定轉子排氣軸封上之螺桿頭與 4R 定子排氣軸封產生接觸而磨損。)
