國家運輸安全調查委員會

調查報告

中華航空公司 CI922 班機

爬升階段 1 號發動機起火

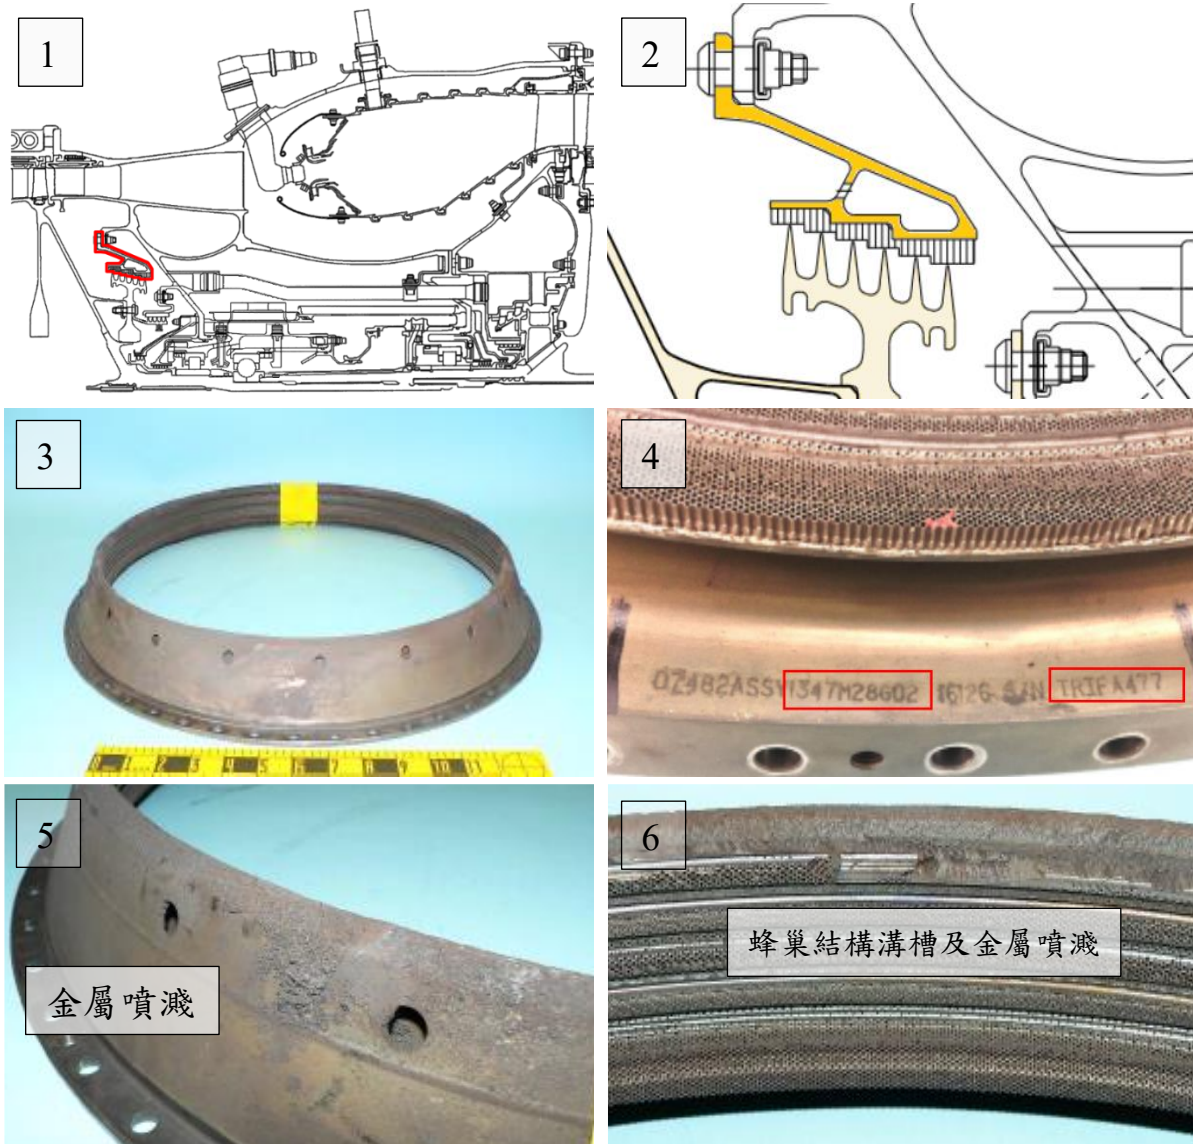
圖 1.16-27 CDP 定子氣封

CDP 定子氣封外觀及結構狀況良好，外緣有噴濺之固化金屬。後緣及內緣蜂巢結構有固化噴濺之金屬，部分蜂巢結構損傷。定子上可見件號 1347M28G02，序號 TRIFA477 標示，詳圖 1.16-27-1~8。

- Apart from some light metal spray (debris), no major distress observed. (除了少量金屬(碎屑)噴濺，未發現明顯的損傷)
- The honeycomb was intact with deep grooves from the CDP 氣封 (uniform around circumference). (蜂巢結構完好，且有因 CDP 轉子氣封所致的深槽溝(整圈圓周都相同))
- Metal spray (debris) had accumulated on the aft end of the seal including on some of the honeycomb. (金屬噴塗(碎屑)積聚在定子的後端，包括部份的蜂巢結構)
- Some of the aft end of the honeycomb was also damaged. (部份的末端蜂巢結構亦有損壞)

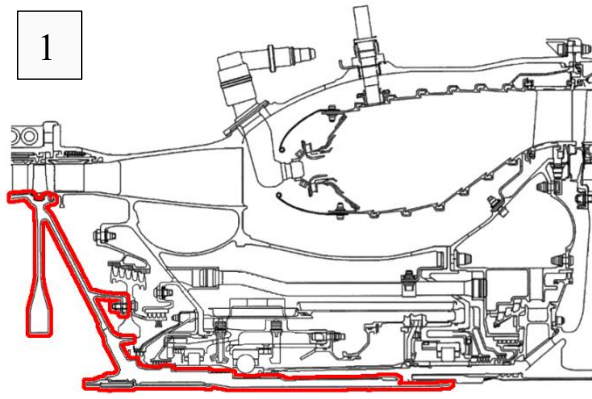
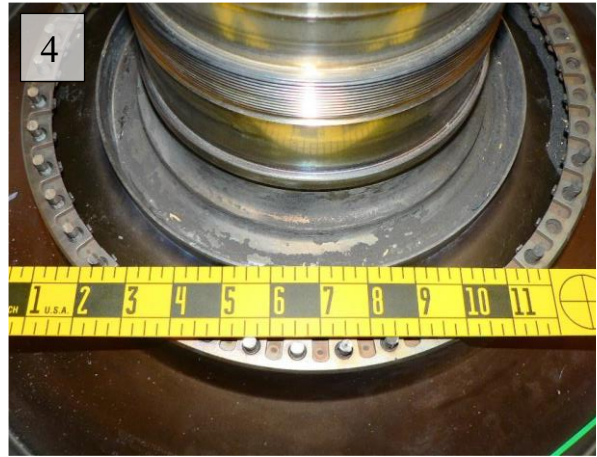
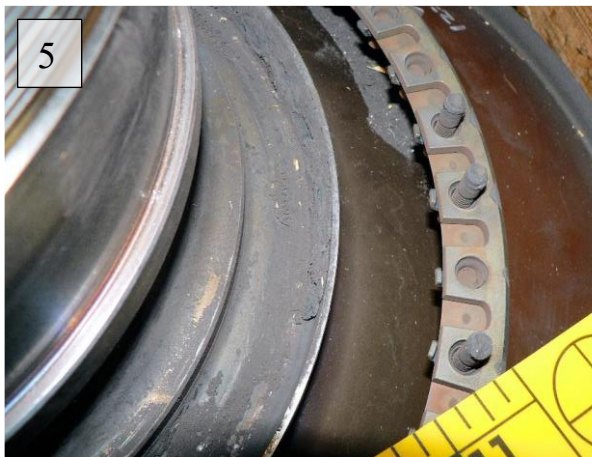
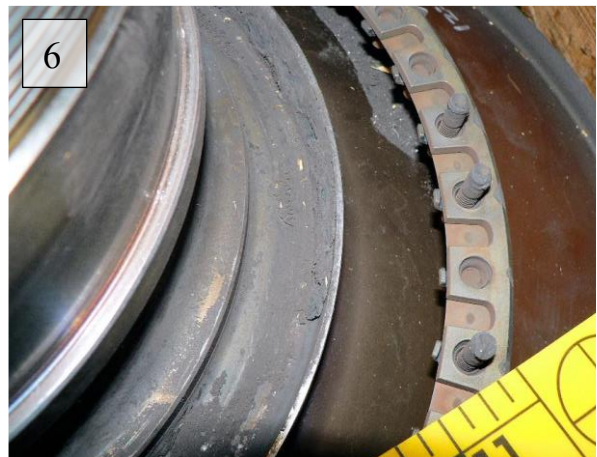
圖 1.16-28 HPC 段軸

- The HPC Spool was examined from the shoulder where the 4R rotating air/oil seal seats to the cavity forward of the CDP seal bore. (HPC 軸段起自安裝 4R 轉子氣/油封之軸肩檢查至 CDP 轉子氣封安裝孔前之空隙。)
- In those areas, debris had accumulated at multiple locations. The debris in the flange cavity consisted of a fine powder. (在上述區域中，多處積有碎片情形，且凸緣空隙中的碎屑則由更微細之粉末集成。)

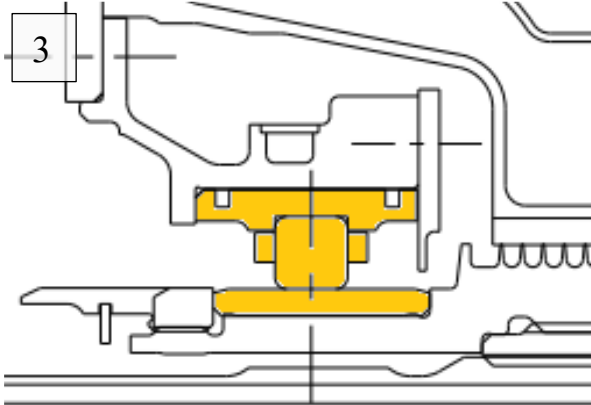
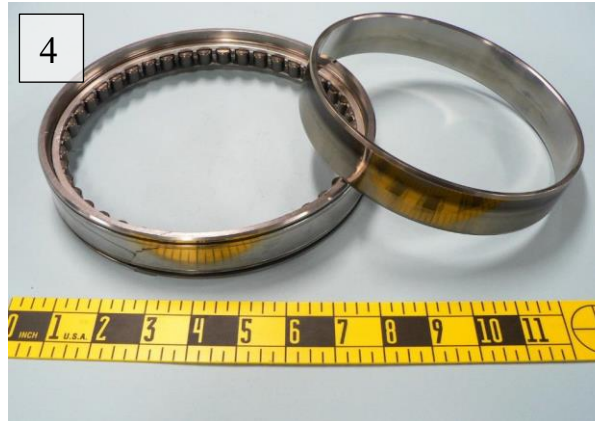
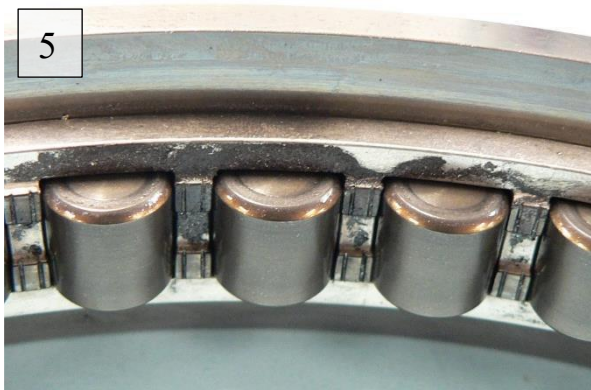
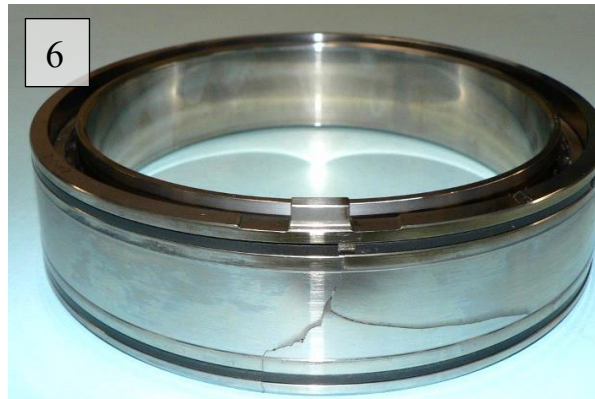
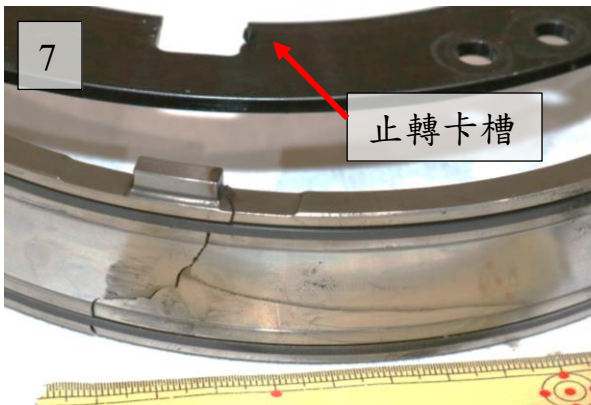
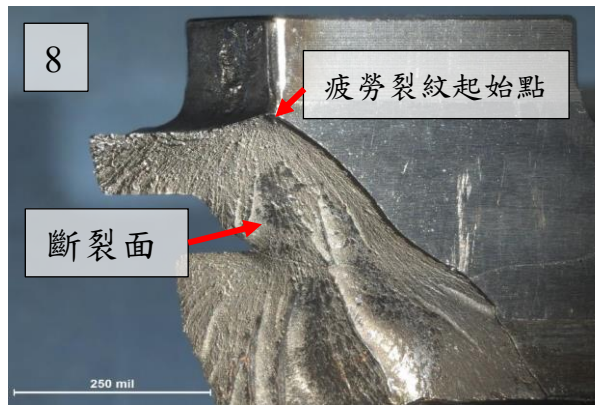
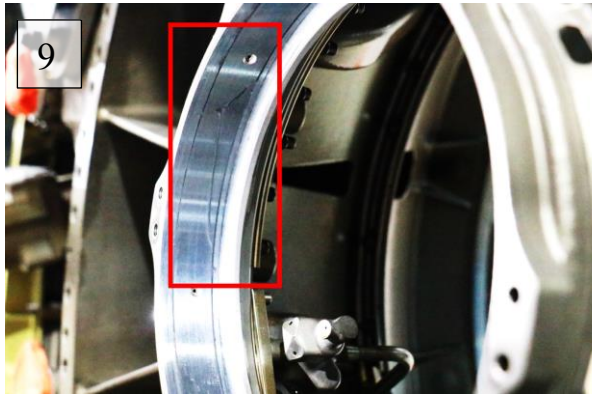
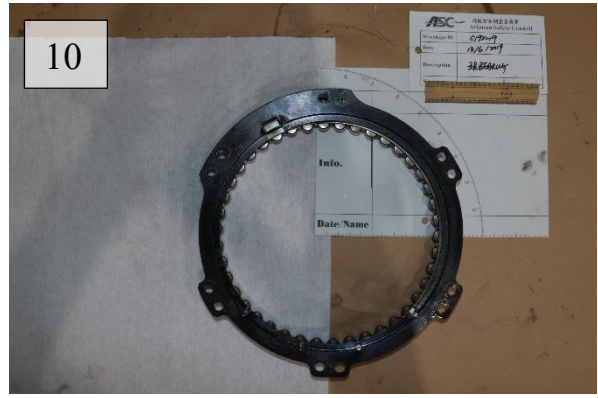
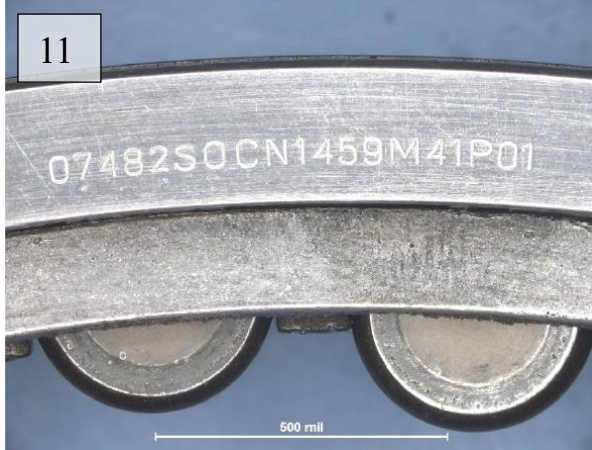
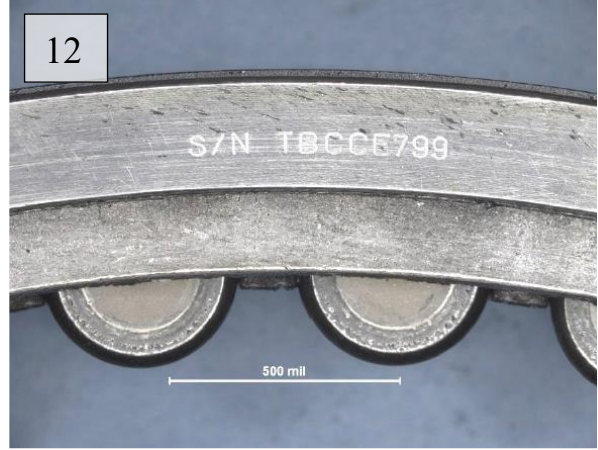
圖 1.16-29 3R 軸承

3R 軸承狀況大致良好，詳圖 1.16-29-1~5，外表除外環有一出自止轉銷邊角延伸，長邊約 3 吋，短邊約 1 吋之「人」字形裂紋，裂痕側止轉卡槽邊緣受力變形，詳圖 1.16-29-6~7。內環及滾柱狀況大致無嚴重損壞情形，拆卸時軸承外表仍呈現油潤狀況，且無發現鏽蝕狀況，惟滾道有些微受熱變色，滾柱邊緣及滾道側壁有細微壓痕，惟無發現有堅硬外物汙染的狀況。3R 軸承室內壁上遺留與 3R 軸承外環破裂型狀相對應的印痕，詳圖 1.16-29-9-10。軸承外環上標有件號 1459M41P01 及序號 TBCCE799，詳圖 1.16-29-11~12。

- 3R bearing received oil-wetted with some slight heat tinting and a fractured outer ring. (GE 公司接收時 3R 軸承外表仍呈現油潤狀況，略有些微熱損變色及外環破裂情形)
- Roller exhibited end wear and micro spalling from hard contact with outer ring shoulders. (滾柱因與外環肩部有硬接觸出現之邊緣磨損，和些微剝落之狀況)
- No corrosion or hard particle contamination. (無腐蝕或硬顆粒外物汙染)
- Minor denting of inner and outer ring raceways and roller surfaces, consistent with rolling over debris. (內環和外環滾道以及滾柱表面皆有輕微凹陷，與滾落碎屑的跡象吻合。)
- No material-type discrepancies observed. (未見材料不符的狀況。)
- The outer ring fracture originated at the double radius on the anti-rotate feature near the inner diameter of the part. Propagation was either overload, or high amplitude fatigue. (外環斷裂係源自軸承內徑靠近的止轉卡槽上約兩倍半徑處，該破裂的增展可能因過載或高震幅疲勞所致，詳圖 1.16-27-8。)
- Suggests 3R outer ring fracture due to loss of HPC Shaft support (after

4R, 4B, 5R Bearing failure) -> 3R is a “damper” bearing with clearance between outer ring OD and housing ID. This clearance can generate an impact load when shaft support is lost. (3R 的外環可能由於失去 HPC 轉軸的支撐而斷裂 (在 4R、4B 及 5R 軸承皆失效後)，3R 軸承與外環外緣和軸承室內環之間，具有間隙使此軸承有阻尼的作用，但是當軸失去支撐時，該間隙會因受載而造成衝擊損傷。)

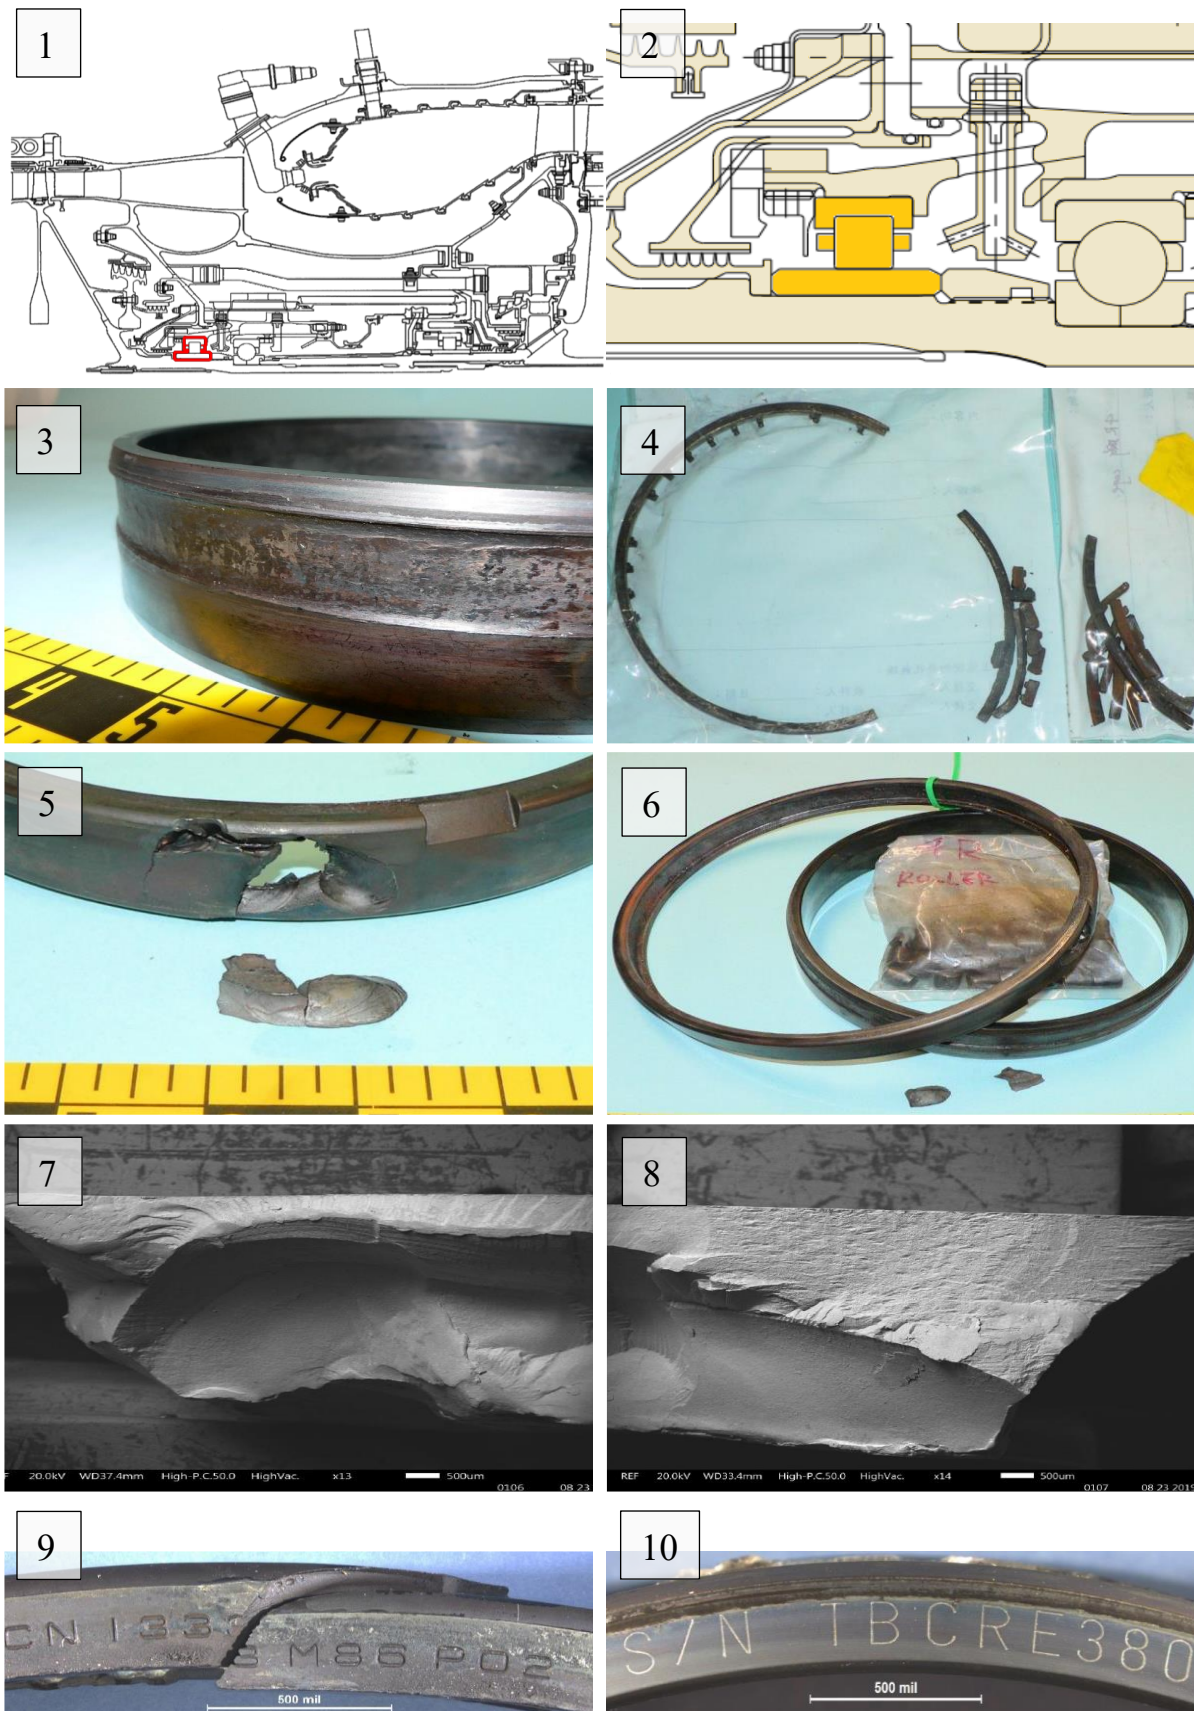
圖 1.16-30 4R 軸承

4R 軸承內環表面有一道較深，且與滾柱高度相仿之受壓沉之金屬形變；所有 4R 滾柱皆脫離維持架，滾柱維持架斷成多段，其軸向跨柱斷面平整，有疲勞型態之破壞，詳圖 1.16-30-3~6。4R 軸承外環破裂，經電子顯微鏡可見金屬破斷處增長的疲勞裂紋，主要來自滾道表面，因軸承組件有較明顯的塑性變形及破壞，故未能取得軸承初始失效之證據，詳圖 1.16-30-7~10。4R 軸承內外環可辨識件序號字樣，詳圖 1.16-30-9~10。

- 4R bearing components were received “dry” –indicative of oil starvation/overheating(GE 公司接收時 4R 軸承外表呈現乾燥情形，顯示軸承缺乏潤滑油及過熱的狀況)
- Outer ring was fractured with two liberated fragments (外環破裂，有兩個脫離的碎片)

- The outer ring crack initiated at the highly distressed raceway surface and propagated by fatigue (外環裂紋始於高度磨損的滾道表面，且因疲勞而擴展)
- Inner and outer ring raceways were plastically deformed (hence, all evidence of corrosion, spalling, sliding, hard particle contamination were masked) (內環和外環滾道皆有塑性變形(故所有腐蝕、剝落、滑動、硬顆粒外物污染的跡象皆被掩蓋)。)

- Rollers were barrel-shaped, consistent with sliding and/or stick-slip motion. Rollers suffered from both wear and plastic deformation from overload. (滾柱有桶狀塑型現象，與滾子滑動及黏滯滑動的跡象吻合，滾柱曾遭過載而磨損和塑性變形。)

- The cage had fractured into multiple fragments and the fracture surfaces were consistent with fatigue propagation. (滾柱維持架斷裂成多段碎片，斷面與疲勞增生的跡象吻合。)
- No material-type manufacturing discrepancies were identified. (未察覺有材料相關不符規狀況。)

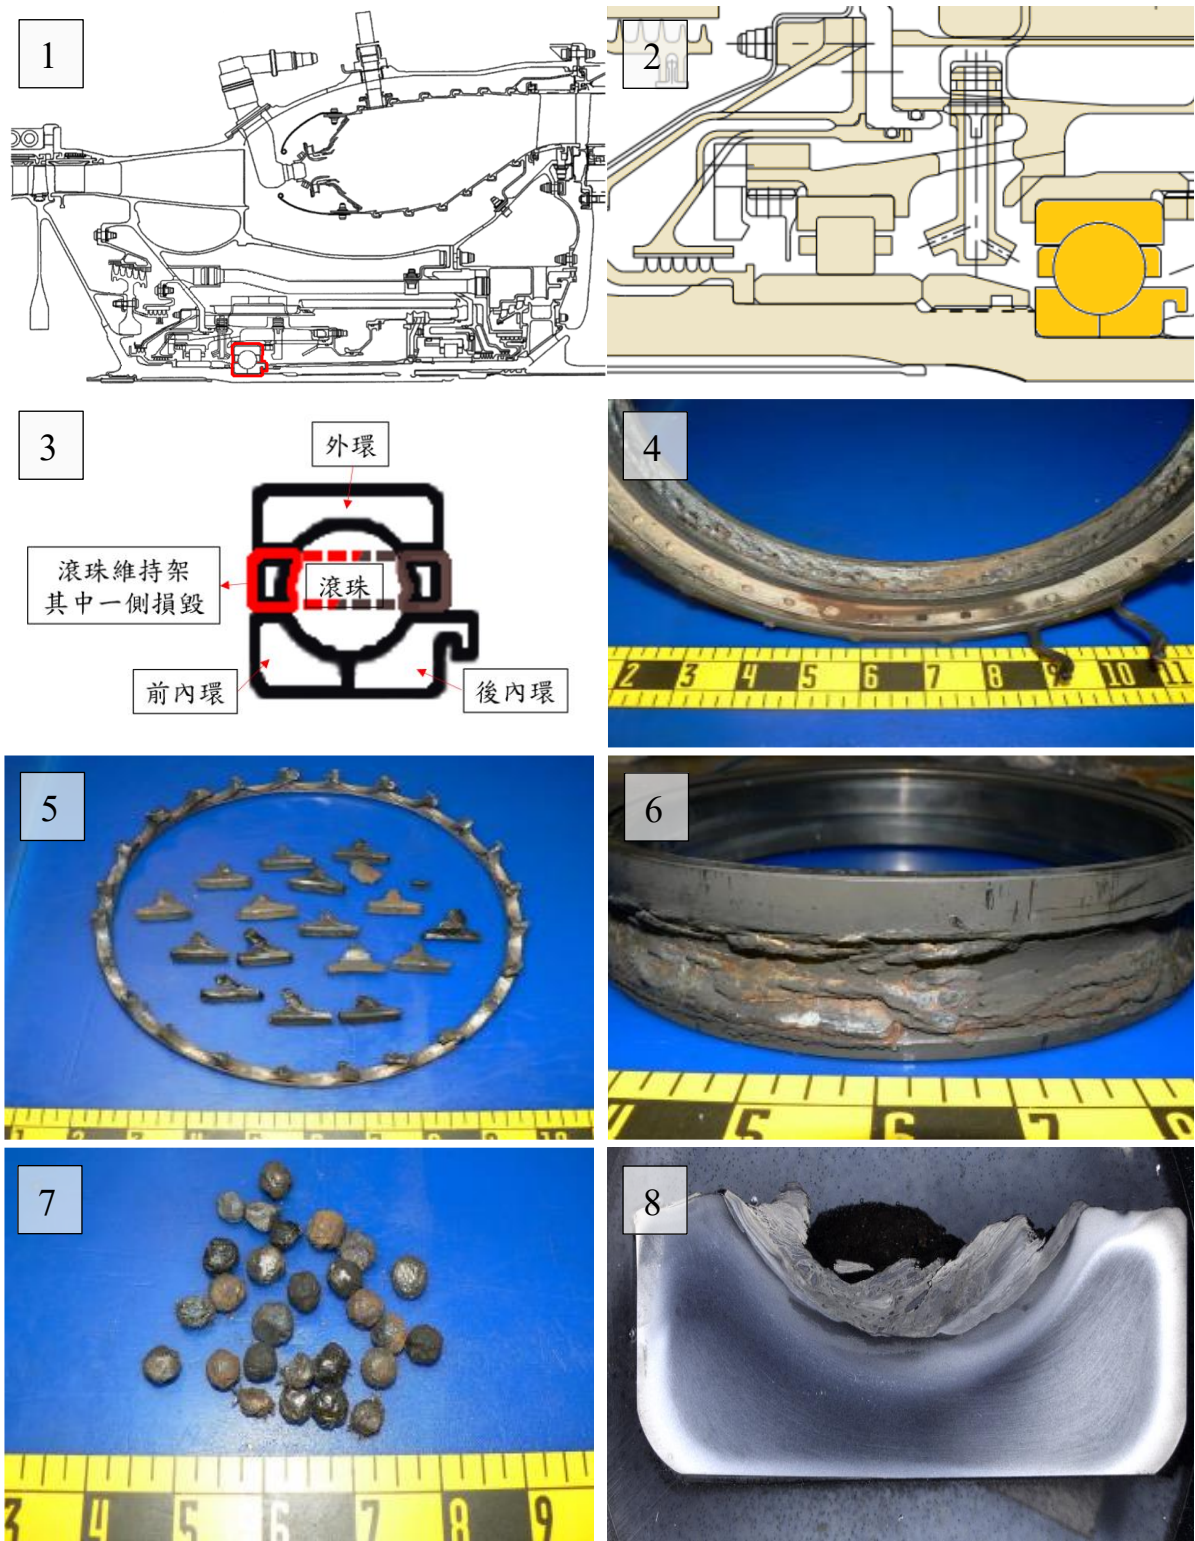
圖 1.16-31 4B 軸承

4B 軸承嚴重損壞，詳圖 1.16-31-1~3，外環卡滯於 4B 軸承室內，詳圖 1.16-31-4；所有維持架隔框全數斷裂，詳圖 1.16-31-5；4B 軸承內環因滾珠嚴重破壞，使軸承前內環與後內環遭受熔融之金屬材料沾附且焊固，使其與後方之鉗固螺帽 (spanner nut) 無法正常自 4B 軸承室卸除，詳圖 1.16-31-6。受損之滾珠仍剩餘部分金屬材質全數於軸承室內尋獲，詳圖 1.16-31-7。4B 軸承內外環材料硬度一致；觀察受蝕的微結構有熱損現象，詳圖 1.16-31-8。

- Bearing components received “Dry” (not oil-wet) -> indicative of oil-starvation/overheating. (GE 公司接收時 4B 軸承外表呈現乾燥 (無油濕) 情形，顯示軸承可能缺乏潤滑及過熱的狀況。)
- Outer ring still installed in 4B bearing support (外環仍留於 4B 軸承室上。)
- Cage severely distressed with all the cage pocket bridge sections fractured and liberated. One cage side rail was intact, but the other was fractured. (滾珠維持架嚴重損壞，所有滾珠維持架槽位連結處皆斷裂並脫離。滾珠維持架框柱有一側仍維持完整，而另一側斷裂損毀。)
- Inner rings were fused together by solidified ball material (內環遭凝固的滾珠材料熔融在一起。)
- The balls lost most of their mass with diameters significant under min. (滾珠材料嚴重磨耗，其直徑明顯低於下限值。)
- Outer ring raceway covered with solidified ball material. (外環滾道上有凝固的滾珠材料覆蓋。)
- EDS confirmed that the inner and outer rings and the balls were produced from the correct materials (經 EDS 確認內環、外環以及滾珠皆使用正確的材料製造。)

- Hardness measurements on the inner and outer rings were conforming to drawing requirements (內、外環的硬度測量值皆符合設計要求。)

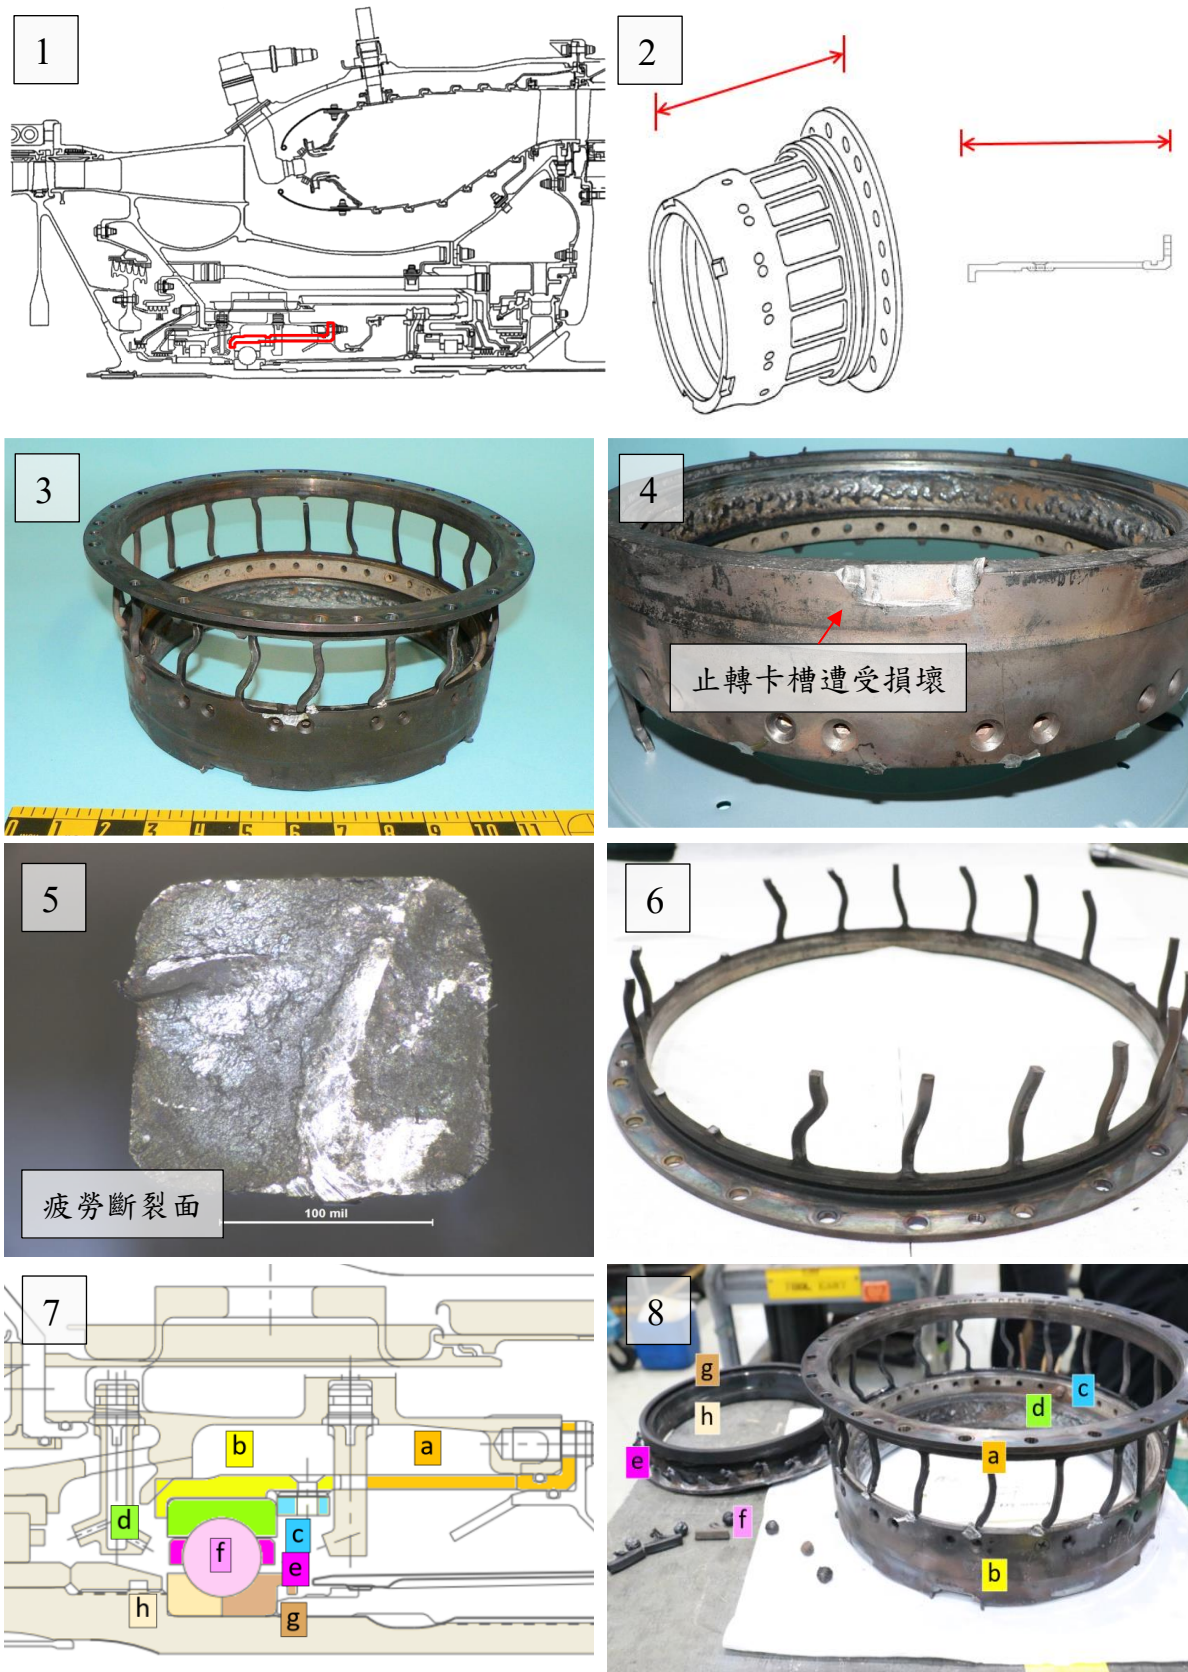
圖 1.16-32 4B/4R 軸承室

4B/4R 軸承室嚴重損壞，連結前後部份之撓性支桿（spring fingers）全數自其中一端斷裂，使其結構分離為兩部分，支桿有局部彎曲及受軸向扭矩變形的現象，詳圖 1.16-32-1~3、5。軸承室上 4 處止轉槽兩側卡緣皆有損壞情形，詳圖 1.16-32-4。

4B 外環卡滯於軸承室內無法卸除，外環內軸承滾道殘有大量金屬熔融後固化之現象。檢測時軸承室無滑油殘留。透過觀察支桿斷裂表面發現，13 個斷裂面呈現有變色的疲勞紋路，7 個帶有粗糙的灰色變暗的疲勞紋路詳圖 1.16-32-5，軸承室各部位置圖解對照詳圖 1.16-32-7~8。

- Part was dry (free of liquid oil) when received at GE Aviation. (GE 公司接收時 4B/4R 軸承室外表呈現乾燥 (無液態滑油))
- All spring fingers/beams were bent and fractured. (所有撓性支桿皆彎曲且斷裂)
- Thirteen of twenty (13/20) of the spring fingers had fracture surfaces consistent with fracture during the event. (20 個撓性支桿中有 13 個 (13/20) 具有與事故過程所造成之斷裂一致的斷面。)
- Some had fractured during disassembly and small fatigue cracks on the fracture surfaces. (部分因拆卸時段裂，且斷面有微小疲勞裂紋。)
- The fingers appear to have buckled by an axial load. (撓性支桿呈現因軸向負載而有彎曲狀況。)
- The microstructure of the spring finger indicates that the metal exceeded the austenite temperature (>1500F) during the event. (撓性支桿的微觀結構顯示於事故期間該金屬曾超過沃斯田鐵 (austenite) 溫度 (>1500°F) 。)
- The all four anti-rotation slots on the 4R bearing housing had sustained damaged. (4B/4R 軸承室上之 4 個止轉卡槽全遭受損壞。)

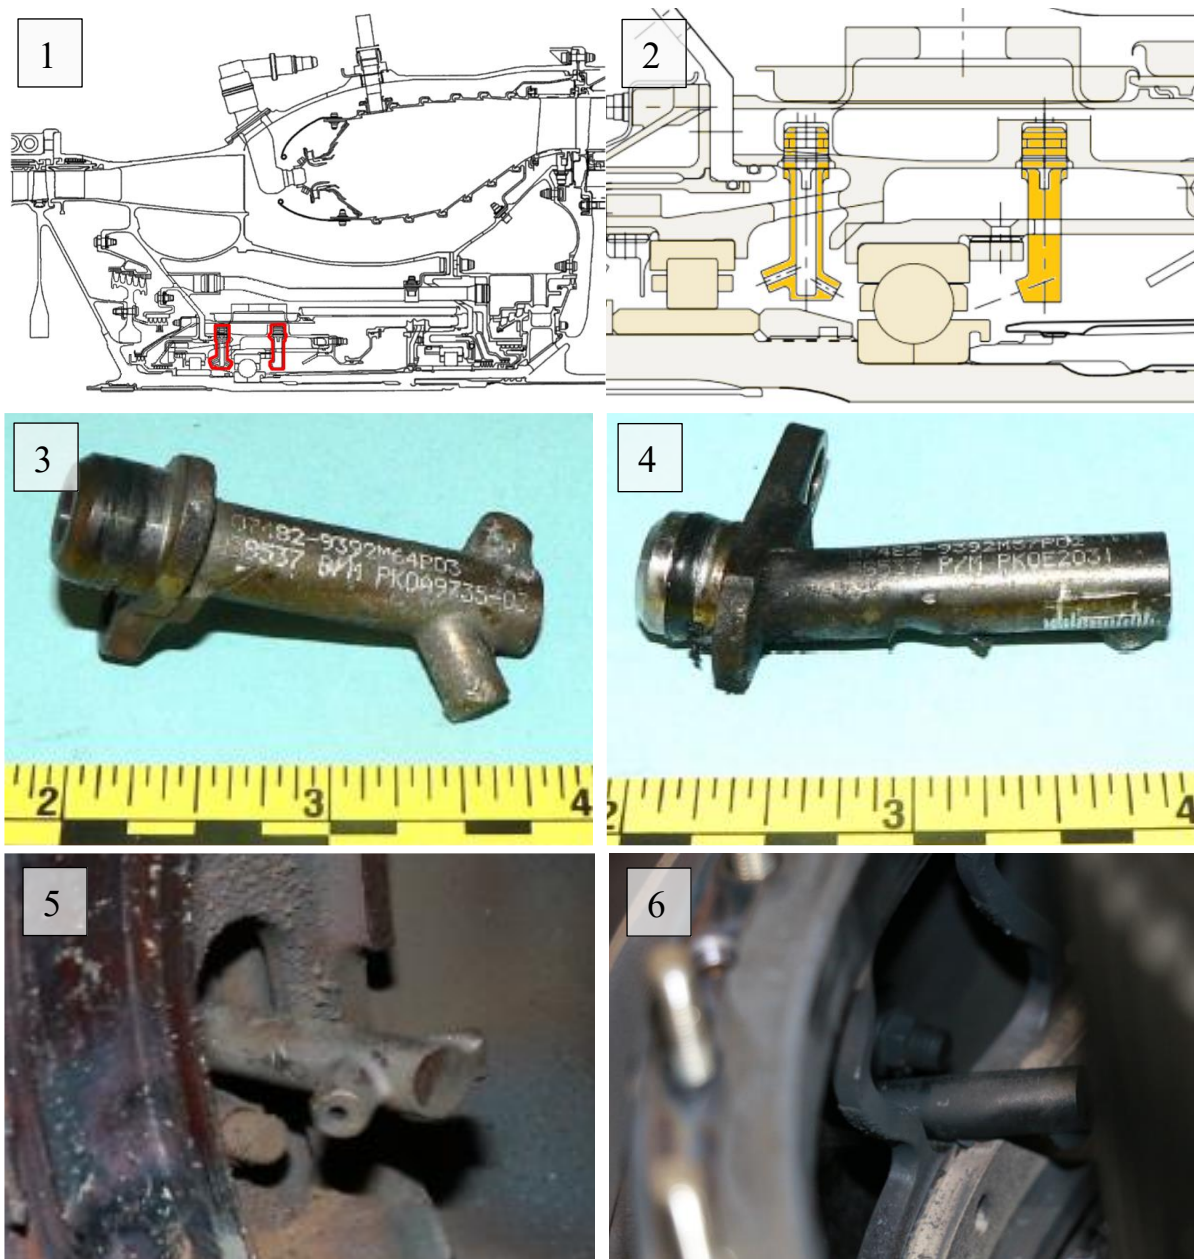
圖 1.16-33 4B/R 油室滑油噴嘴

4B 滑油噴嘴可見件號為 9392M57P02，噴嘴本體金屬表面有損傷，目視檢查無證據顯示事故時有阻塞情形。因事故過程之衝擊，4R/4B 滑油噴嘴有些微外部撞擊之損傷，可辨識該件件號為 9392M64P03，拆卸後經初步通氣檢測，滑油進出埠口無阻塞情形，詳圖 1.16-33-1~6。

- Both nozzles were clear of any flow-path obstructions. (兩具滑油噴嘴的流路皆無任何障礙物。)
- External damage from impact observed on both oil nozzles. (兩具滑油噴嘴皆觀察到的撞擊引致的外部損壞。)
- 4R/4B Nozzle exhibits gross distortion resulting from buckling of 4B Bearing spring fingers under axial load. (4R/4B 滑油噴嘴因 4B/4R 軸承室上受軸向負載而彎曲之撓性支桿而產生嚴重變形。)

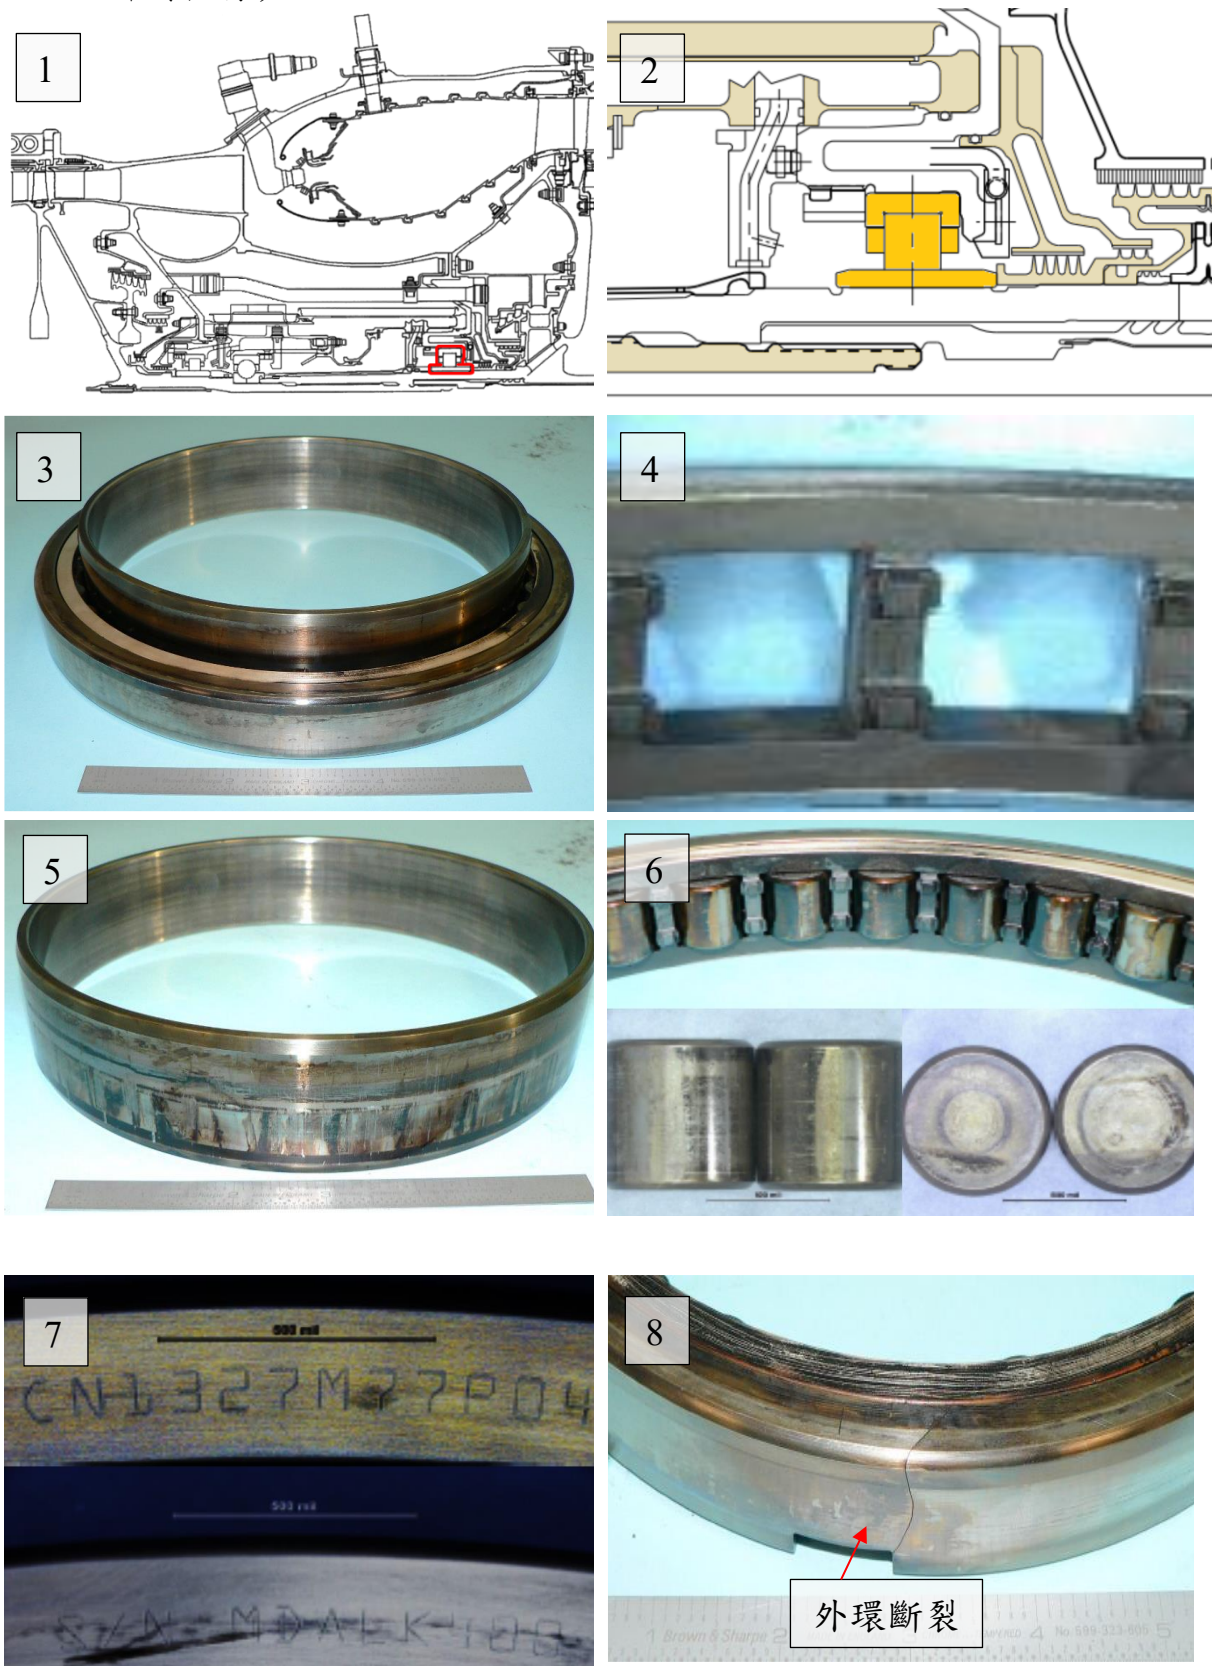
圖 1.16-34 5R 軸承

5R 軸承內環及滾柱狀況良好無損傷，兩者接觸表面有濕潤油漬及曾受高溫之變色狀況，但無破損、凹陷或其他受應力變形跡象，惟部分滾柱圓面有輕微環狀刮痕，但無滾道受異物汙染或腐蝕現象，詳圖 1.16-34-1~6。5R 軸承是由 C 油室上卸下，軸承本體可見其件號為 1327M77P04，序號 MDALK400，詳圖 1.16-34-7。5R 軸承外環無明顯受應力表徵，惟有一穿透其中一側止轉槽卡緣之裂痕，詳圖 1.16-34-8。

- Part was oil-wetted when received at GE Aviation, but exhibited considerable oil coking and varnishing. (GE 公司接收時 5R 軸承外表仍呈現油潤狀況，惟油色頗顯焦深且亮澤情形。)
- Outer ring was fractured at the anti-rotation slot with two origins (at corners of raceway slot and shoulders). (外環在止轉槽處產生破裂，有兩處增展起源之裂縫 (位於滾道槽和肩部的邊角處))

- Outer ring fracture morphology was consistent with crack propagation at high stresses (high amplitude fatigue) (外環斷裂的形態與高應力 (高震幅疲勞) 下的裂紋擴展狀態吻合)
- Rollers were covered with oil coke and varnish. No evidence of corrosion, spalling, or hard particle contamination. (滾柱上覆有較明顯表面油質焦化 (coking) 且亮澤狀況，無腐蝕、剝落或硬顆粒外物污染的跡象)

- Roller surfaces covered with fine dents from rolling over debris (滾柱表面因曾輾壓過外物碎屑而產生許多細小凹痕)
- Inner and outer rings partially covered with coke and oil varnish. Fine denting observed, but no indications of spalling, corrosion, or hard particle contamination (觀察內、外環部分區域表面有焦化油質和光澤。觀察到細微的凹痕，但沒有剝落、腐蝕或硬顆粒污染的跡)

- Hardness checks on rollers and rings found hardnesses were conforming

to the part drawing (滾柱與外環材料的硬度檢查得知與部件設計圖說所列相符)

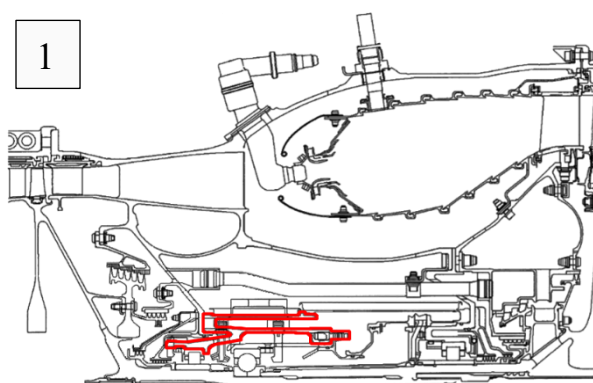
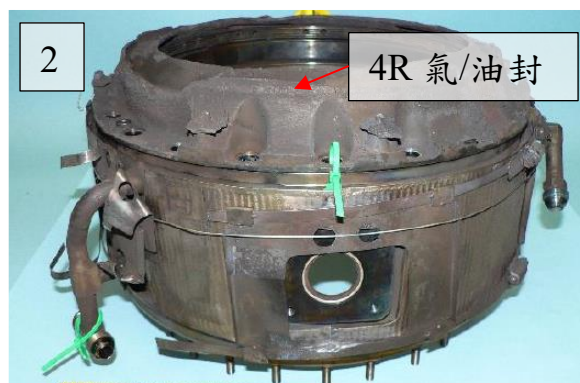
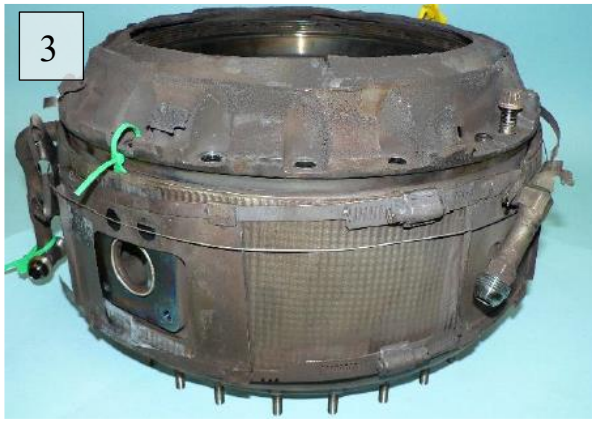
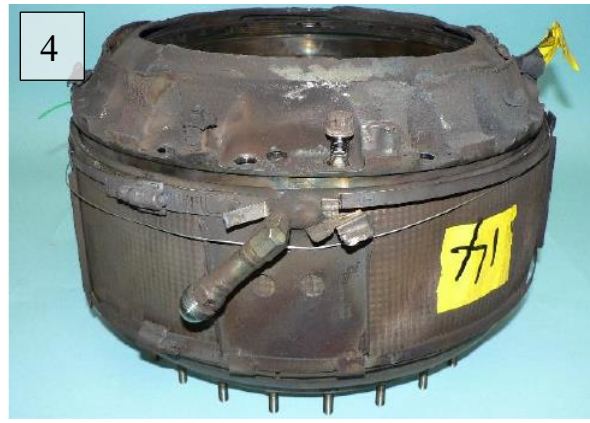
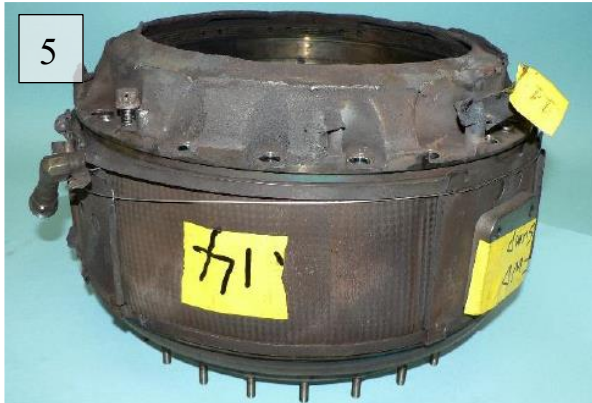
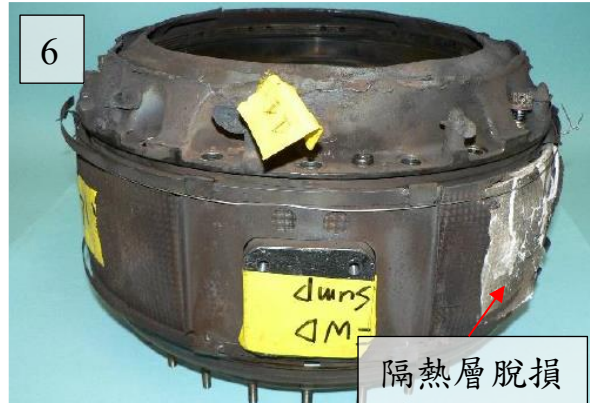
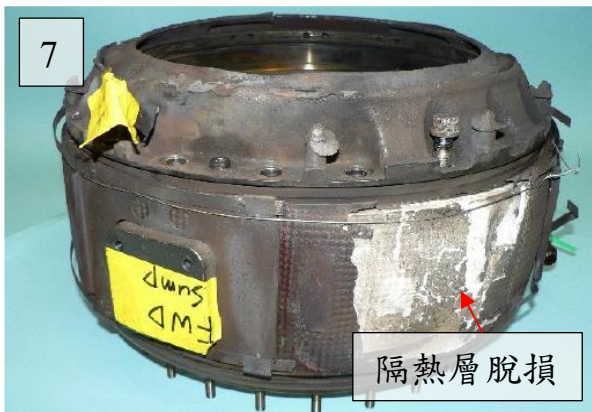
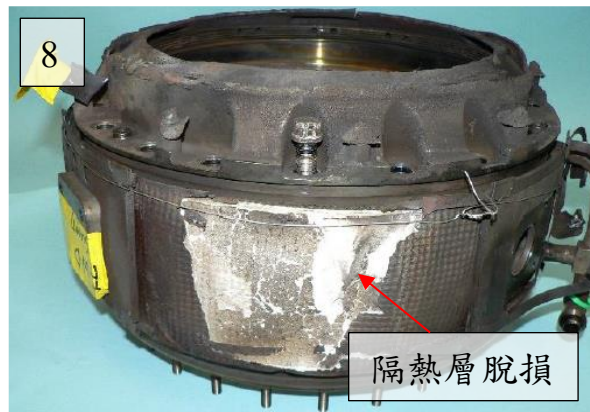
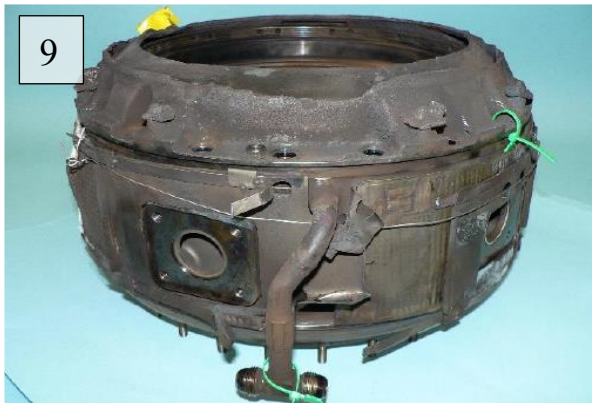
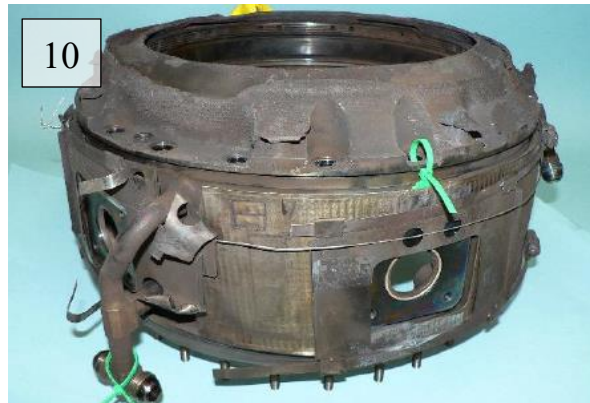
圖 1.16-35 前油室及隔熱罩

前油室前端結構為與 4R 定子氣/油封接合之支撐(詳圖 1.16-35-1~11); 事故後其外部隔熱罩仍由保險絲鎖固, 隔熱罩表面約於 8 至 10 點鐘位置有燒損剝落狀況(圖示中綠色束線帶為 12 點鐘位置), 詳圖 1.16-35-1~8。內部除有熱損變色、滑油燃燒痕跡與金屬噴濺狀況, 無其他結構上之破壞或失效情形, 詳圖 1.16-35-9~12。

- Sub-assembly of Fwd Sump Housing, 4R Stationary Air/Oil Seal and Thermal Blankets fit-up to show overall hardware condition. (試裝前油室次組件、4R 定子氣/油封和隔熱罩等次總成以觀察整體部件狀況)
- Apart from localized distress to Thermal Blanket, Fwd Sump Housing is generally in good condition. (除隔熱罩局部損壞之外, 前油室整體狀況良好)
- Internal cavity of Fwd Sump Housing is dry and exhibits evidence of fire damage. (油室的內部乾燥, 且有火損的狀況。)

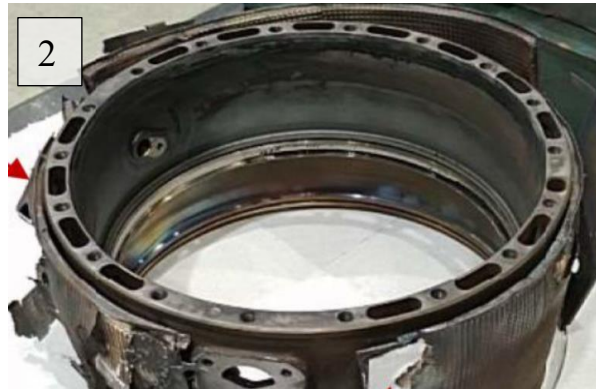
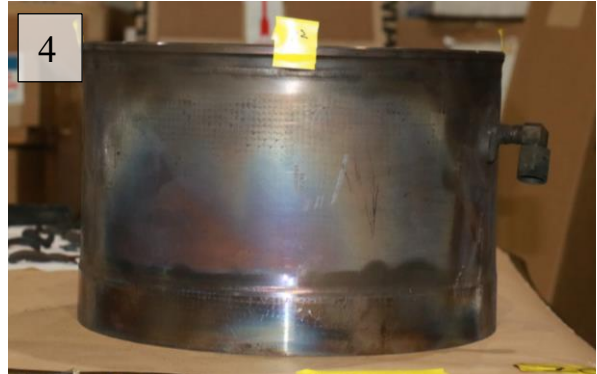
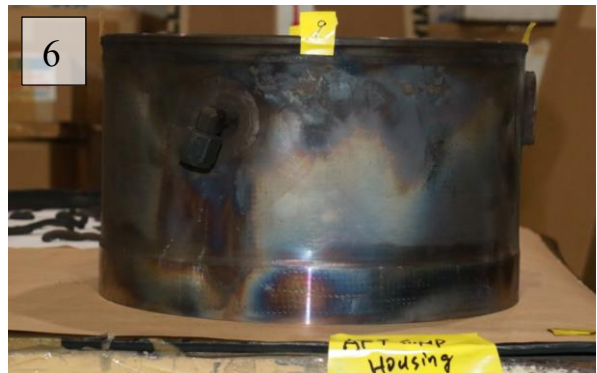
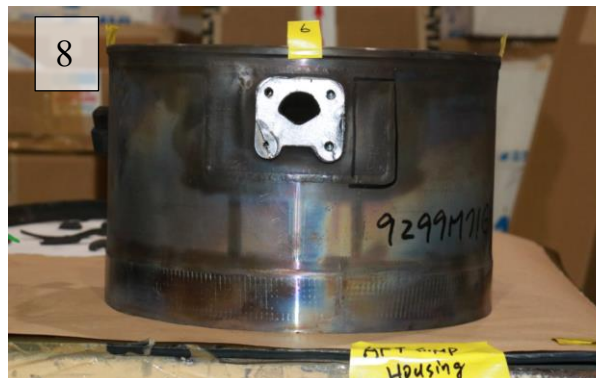
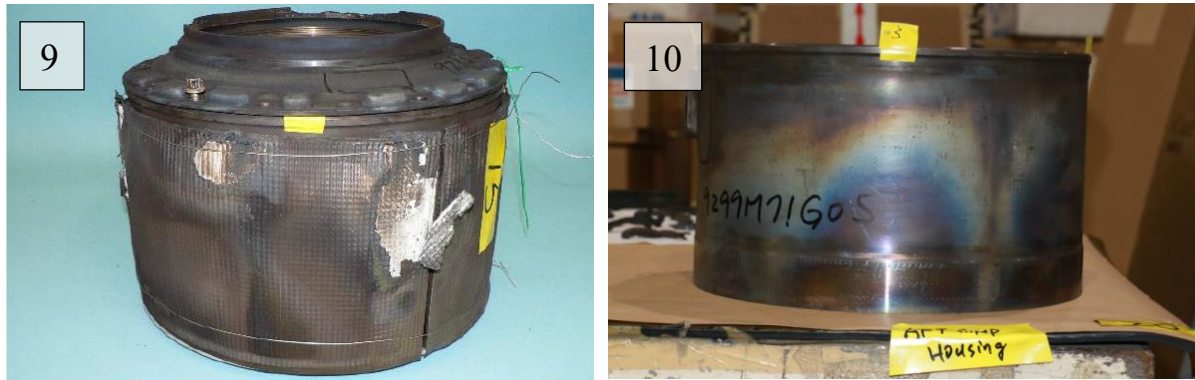
圖 1.16-36 後油室及隔熱罩

- Sub-assembly of Aft Sump Housing, 5R Stationary Air/Oil Seal and Thermal Blankets fit-up to show overall hardware condition. (試裝前油室次組件、5R 定子氣/油封和隔熱罩等次總成以觀察整體部件狀況。)
- Apart from localized distress to Thermal Blanket, Aft Sump Housing is generally in good condition. (除隔熱罩局部損壞之外，後油室整體狀況良好)
- Internal cavity of Aft Sump Housing is dry and exhibits evidence of fire damage. (油室的內部乾燥，且有火損的狀況。)

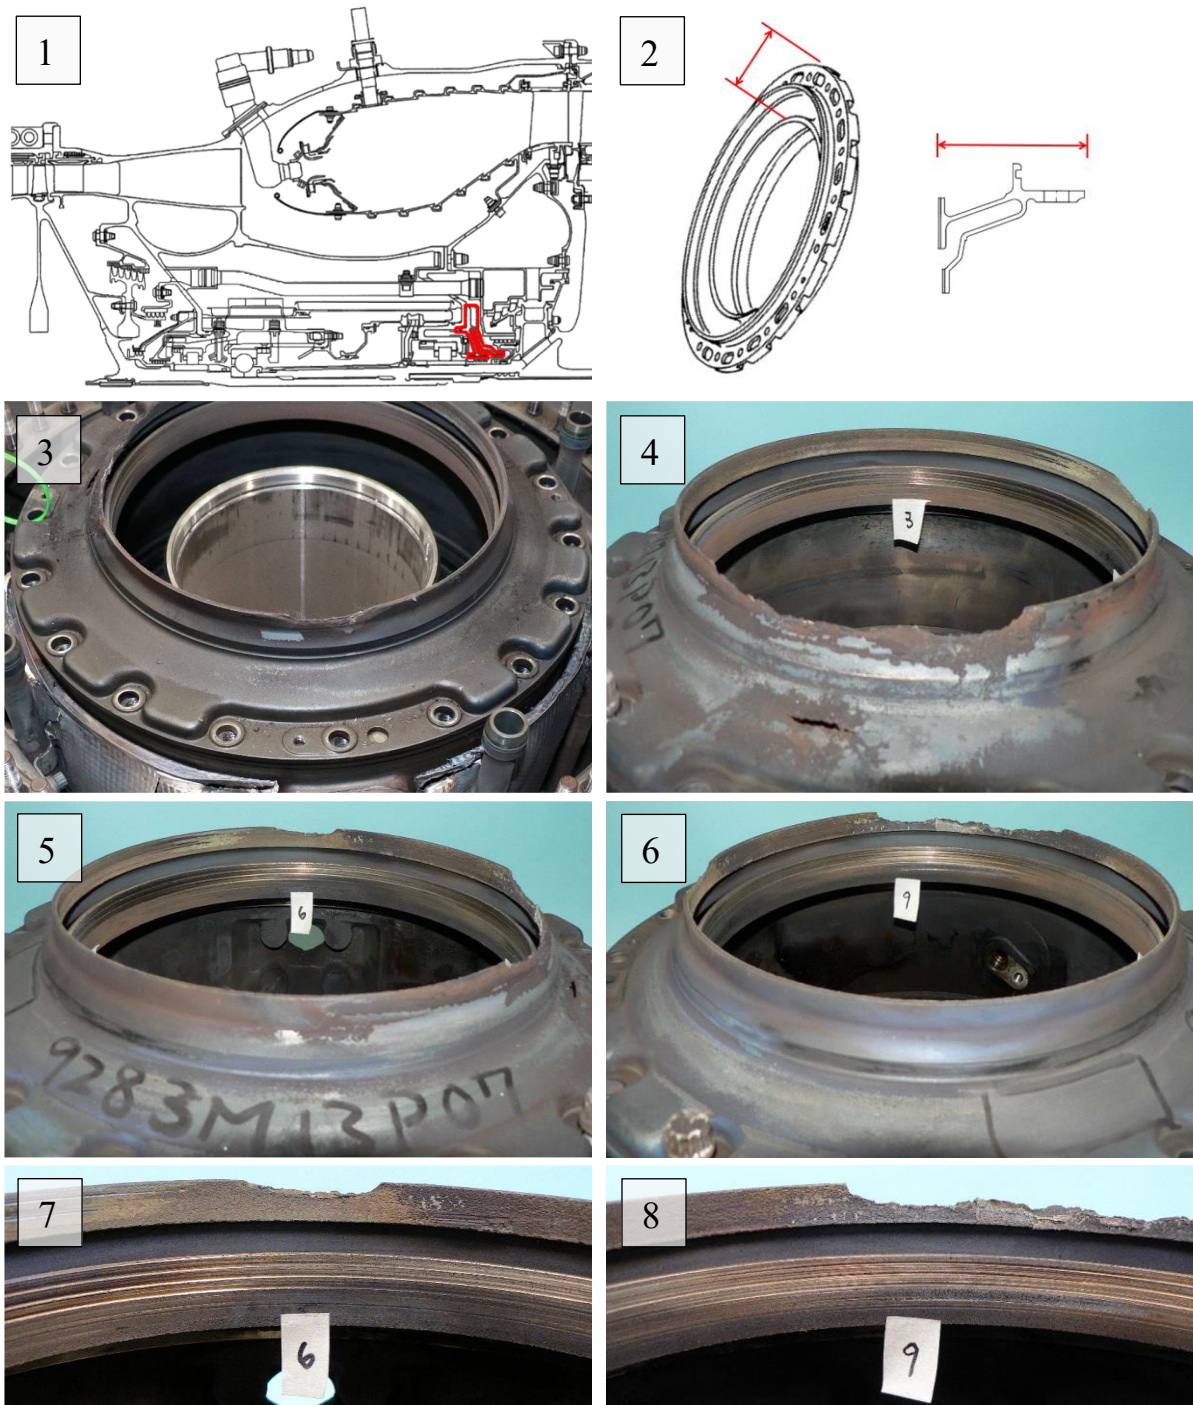
圖 1.16-37 5R 定子氣/油封

後方氣封較凸出之支承結構條，位於 6 點鐘及 9-11 點鐘有 2 處由內部向外燒損的跡象，且末端材質脫落，尤以約 9-11 點鐘位置較明顯，且該處支承結構面上有 1 處燒穿破孔，氣封磨擦面約於 3-5 點鐘位置有與 5R 轉子氣/油封刀峰磨擦之痕跡，詳圖 1.16-37-1~8。

- Light rubs observed in 5R Stationary Air/Oil seal abradable. (定子可觀察到輕微擦痕)
- Thermal distress/burn-through observed in three locations: two circumferential locations on seal land, with one location being significantly more severe and one location in seal support. (在 3 個位置觀察到熱損/燒穿狀況，其中 2 個位於定子氣封磨擦面的圓周上，

其中 1 處受損明顯較為嚴重；另 1 個則在定子的支承結構上)

- Evidence of fire damage at aft side of sump. (油室後側有火損的跡象)

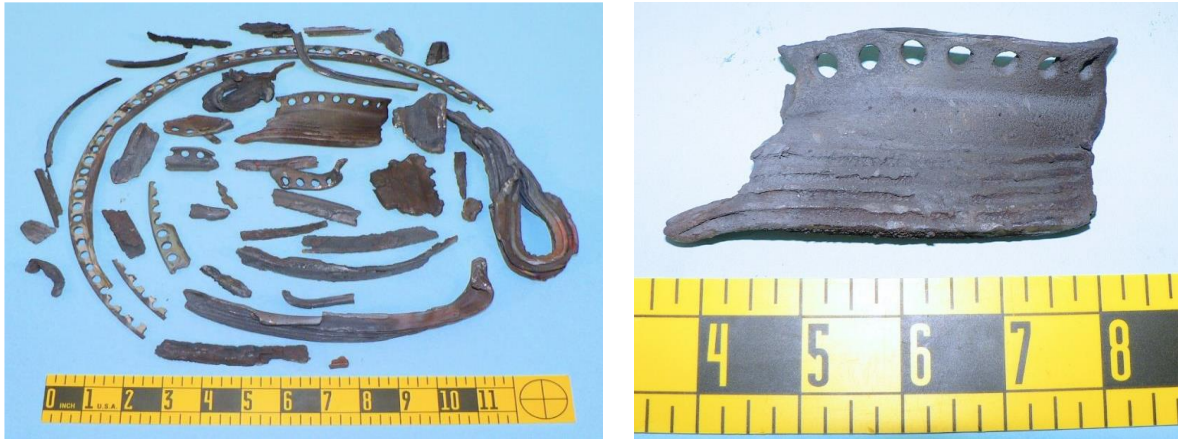
圖 2.4-5 4R 定子氣/油封

- e) 4R 轉子排氣軸封，在事故的過程中解離成數段殘骸，仍有部分脫

離之凸緣留於原安裝處 (CDP 轉子氣封上)，殘骸碎片中發現有殘餘之減震環 (damper ring) 破碎段，大部分斷裂面皆嚴重受脫落部件擊傷或金屬噴濺，其正後方之 4R 定子氣/油封安裝座部分螺桿外觀完整，尖端無接觸磨損痕跡。(第 7 項)
