國家運輸安全調查委員會

調查報告

中華航空公司 CI922 班機

爬升階段 1 號發動機起火

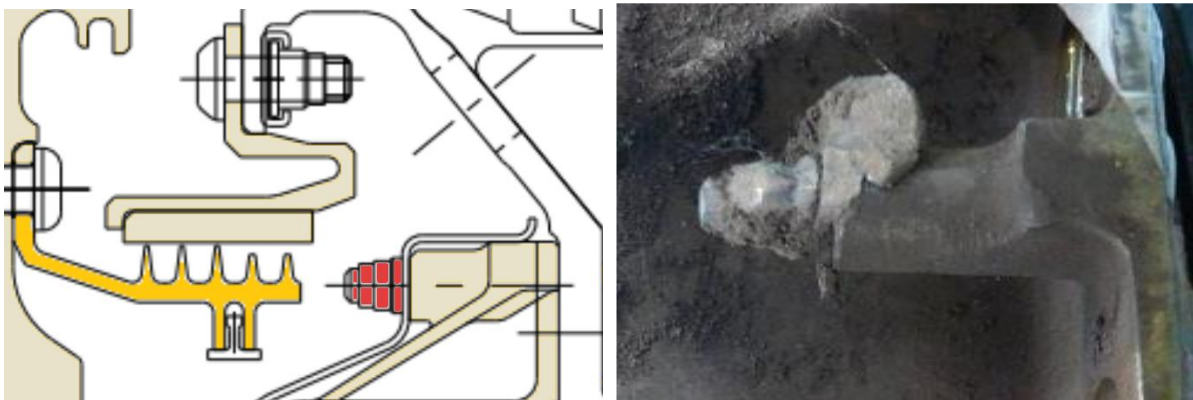
圖 2.4-6 4R 定子氣/油封安裝座螺桿

離之凸緣留於原安裝處 (CDP 轉子氣封上)，殘骸碎片中發現有殘餘之減震環 (damper ring) 破碎段，大部分斷裂面皆嚴重受脫落部件擊傷或金屬噴濺，其正後方之 4R 定子氣/油封安裝座部分螺桿外觀完整，尖端無接觸磨損痕跡。(第 7 項)

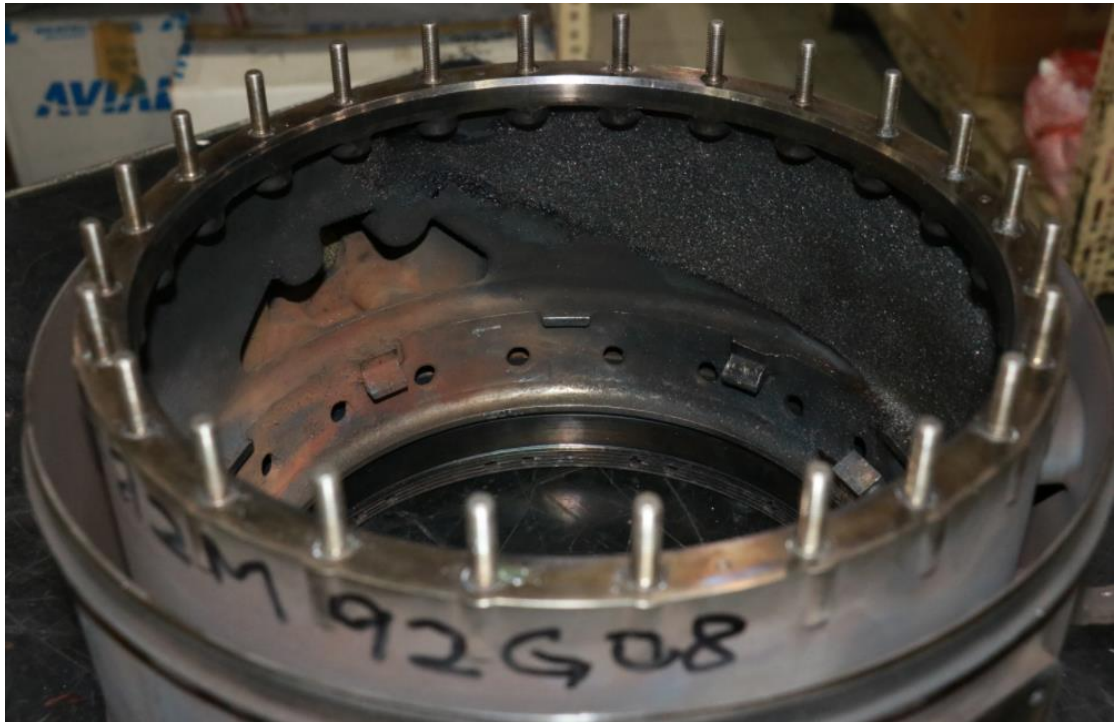
圖 2.4-7 油室內部熱損變色與金屬噴濺狀況

- f) 前油室其外部隔熱罩表面約於 8 至 10 點鐘位置有燒損剝落狀況。內部除有熱損變色、滑油燃燒痕跡與金屬噴濺狀況，無其他結構上之破壞或失效情形。(第 8 項)

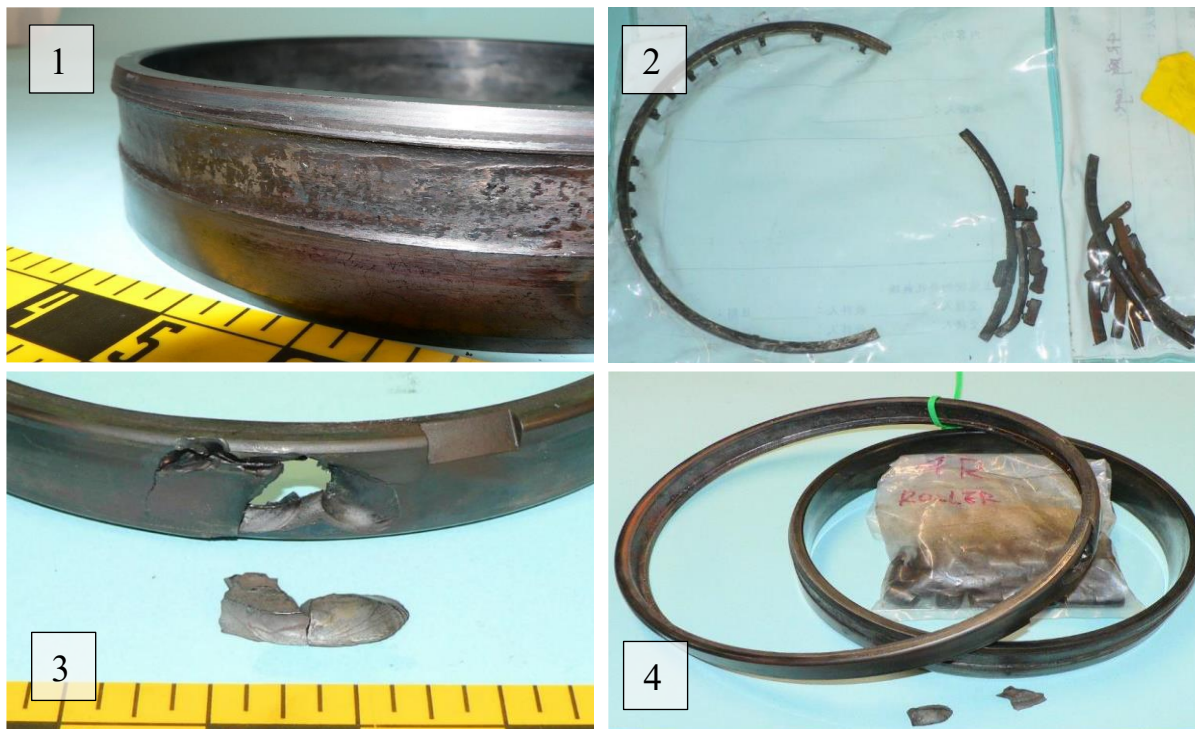
圖 2.4-8 4R 軸承受損狀況

- g) 4R 軸承內環表面嚴重損傷，4R 及 4B 軸承其滾柱與滾珠直徑皆明顯縮小，其材料均轉移至軸承滾道，3R、4R 及 5R 軸承外環均因大幅度振動造成過負荷斷裂。(第 8 項)

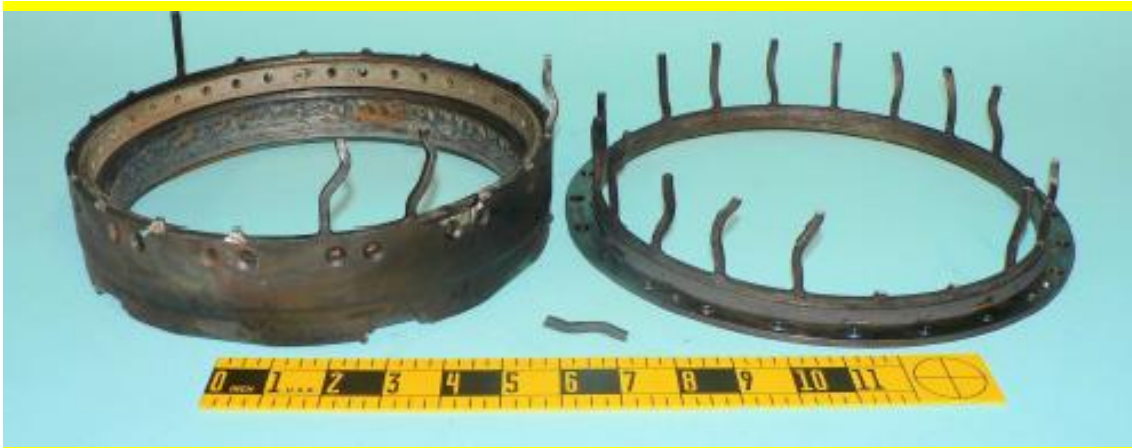
圖 2.4-9 4B/4R 軸承室受損狀況

- h) 4B/4R 軸承室嚴重損壞，連結前後部份之撓性支桿(spring fingers)全數自其中一端斷裂，使其結構分離為兩部分，支桿有局部彎曲及受軸向扭矩變形的現象。(第 10、11 項)
