**Elit'Avia Malta Limited Flight EAU52P**

**Bombardier BD-700-1A10, 9H-OJP**

**Abnormal Runway Contact during Landing at  
Taichung International Airport**

**Aviation Occurrence Investigation Final Report**

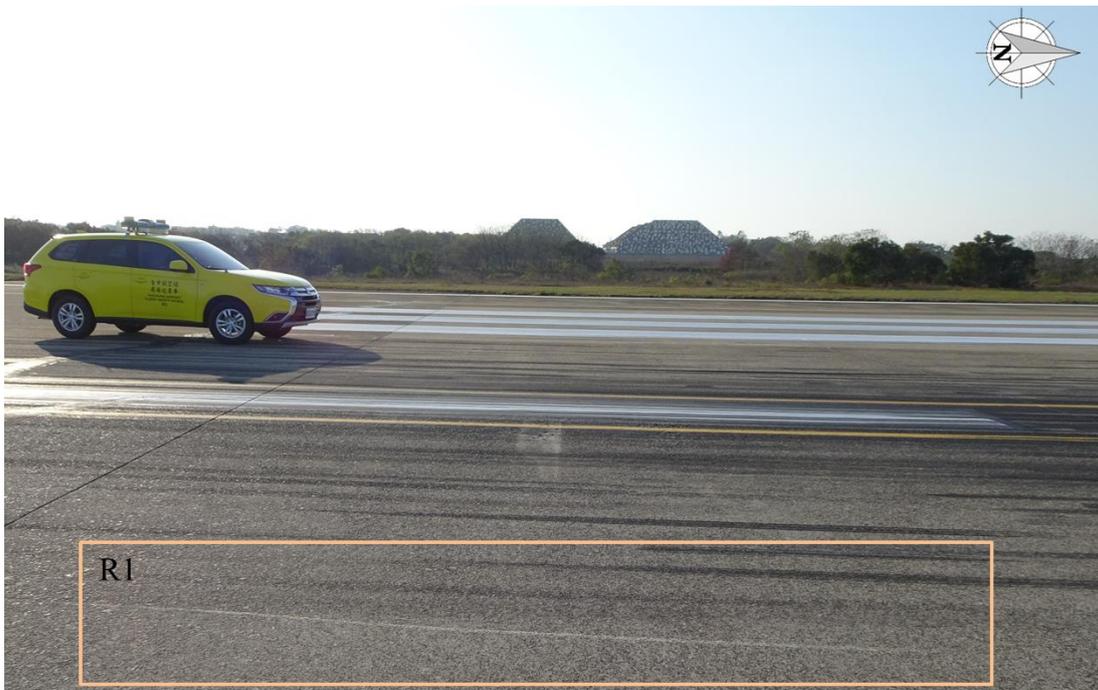
Figure 1.12-3 First wing mark (R1)

The investigation team arrived at RCMQ around 1515 hours on the occurrence day, and then searched for significant wing contact marks on the runway 36 surface around 1537 hours. The team utilized global positioning system (GPS) equipment and a camera to conduct a ground survey of the occurrence site. The team found the first (right) wing mark (R1) at about 503 feet from the runway threshold, then the three parallel (left) wing marks (L1 to L3) were found about 636 feet from the runway threshold.

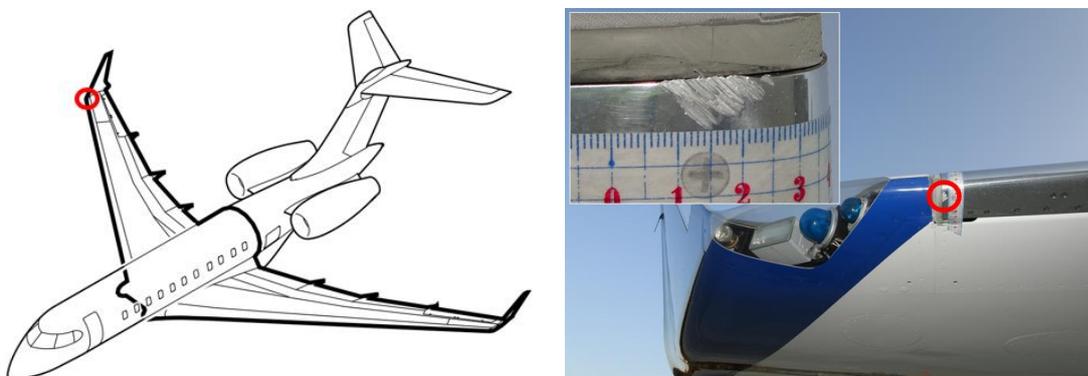
Figure 1.12-5 Right slat

An abrasion was detected on the right end bottom of the most outboard slat on the right wing; the abrasion area was about 0.75 sq.cm.

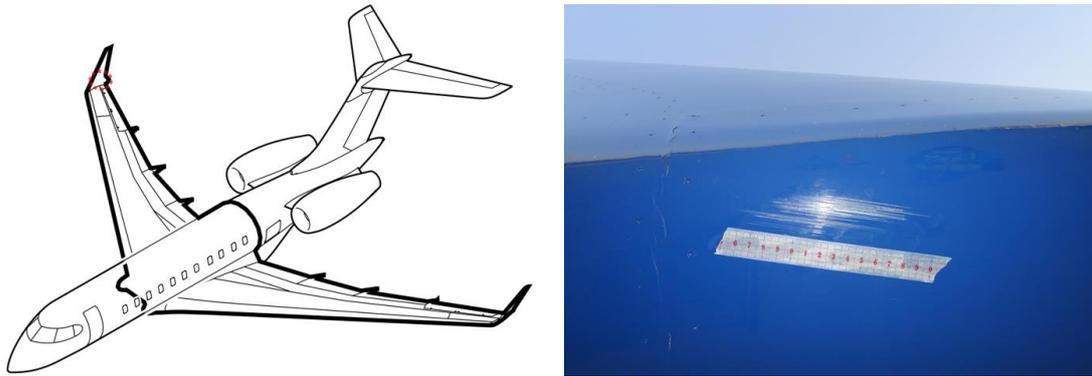
Figure 1.12-6 Middle bottom of the right winglet

An abrasion was detected on the middle bottom of the right winglet; the

abrasion area was about 18 sq.cm.

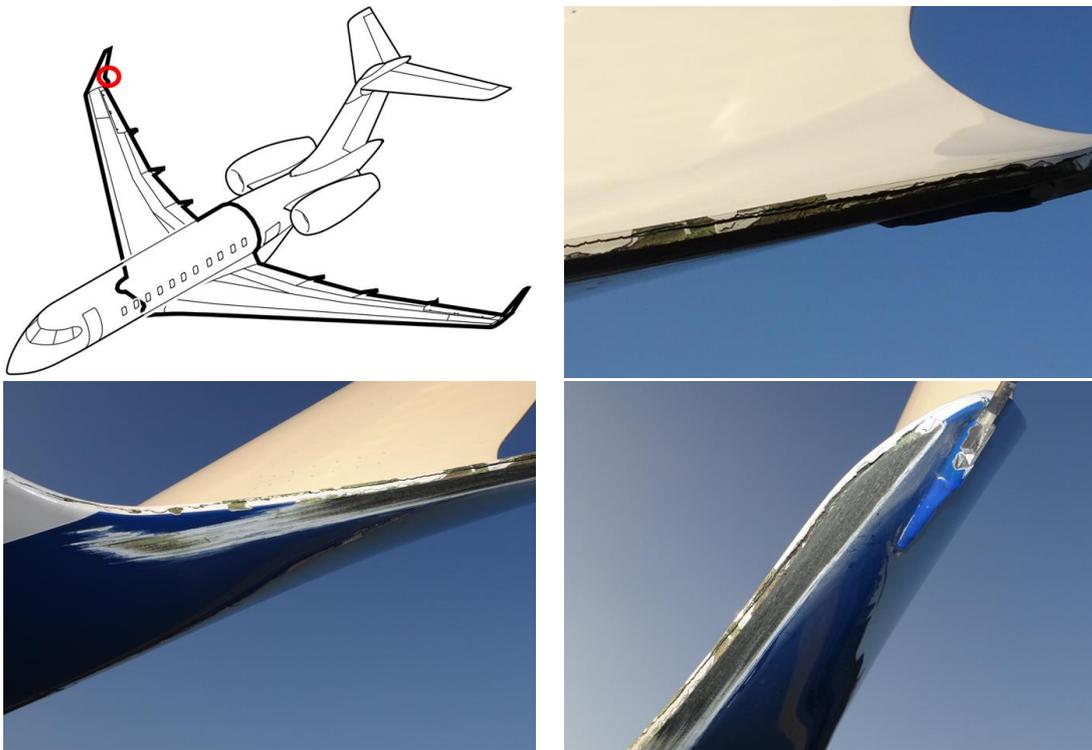
Figure 1.12-7 Trailing edge of the end of right wing

An abrasion was detected on the very end of right wing and split into 2 delaminations at the trailing edge. The damage area abraded on the trailing edge connects with the winglet trailing edge, the length of separation at the trailing edge was about 40 cm long, and the abrasion area was about 100 sq.cm.

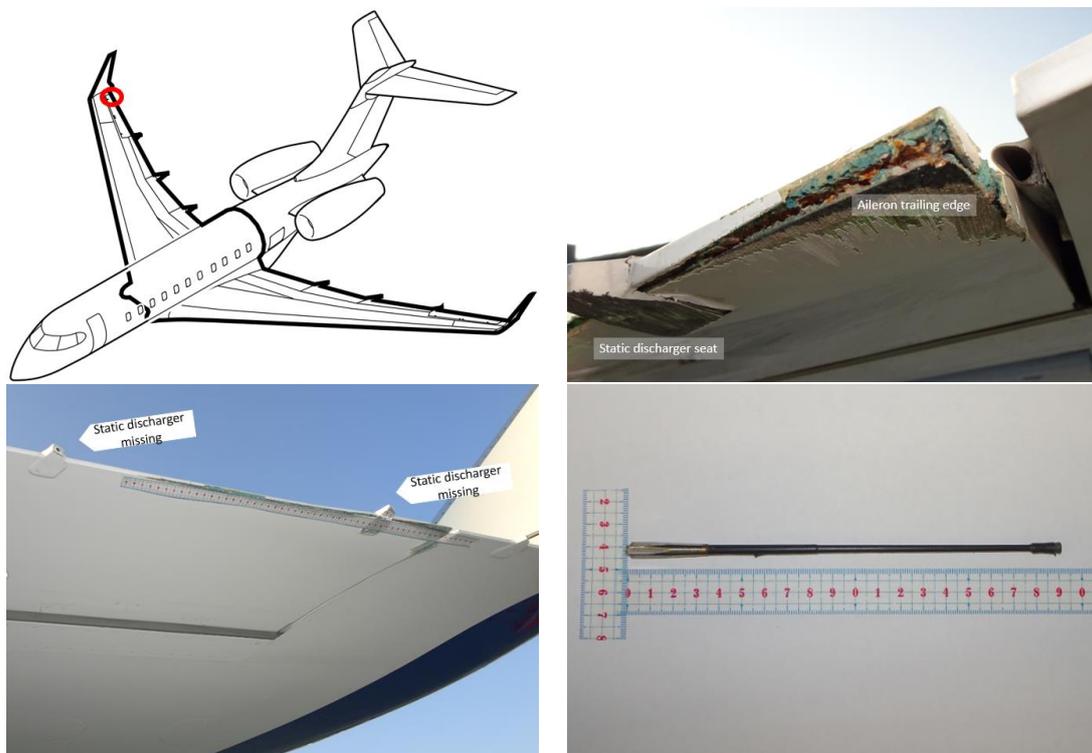
Figure 1.12-8 Right aileron

An abrasion was detected on the right end of the aileron and split into two

delaminations at the trailing edge, the aileron had severe damage at the right end trailing edge corner. The abrasion damage extended into the honeycomb in the aileron trailing edge corner, the abrasion area was about 158 sq.cm. The length of separation at the right end of the aileron was about 48 cm long.

The outboard two static wicks on the aileron were lost, one of the detached static wicks was found at the right wing touchdown zone. The most outboard static wick location was worn down to the aileron surface by abrasive contact.

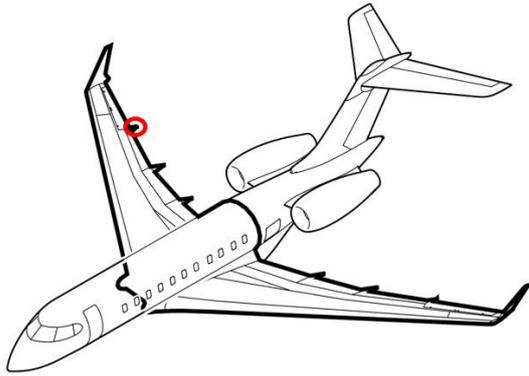
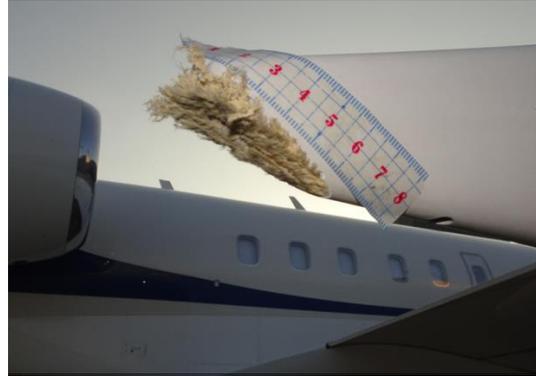
Figure 1.12-9 Right outboard flap fairing

Severe abrasive wearing was detected on the aft end of the most outboard flap fairing on the right wing; the area of wear was about 13 cm long and 3 cm wide.

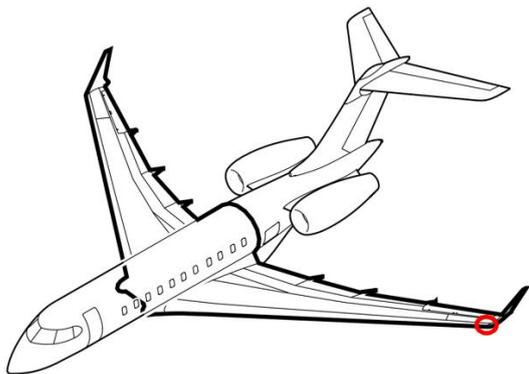
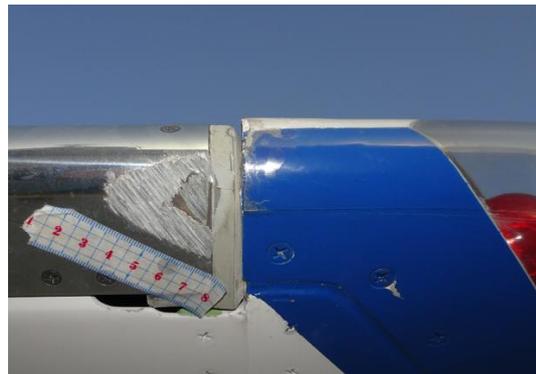
Figure 1.12-10 Left slat

An abrasion was detected on the right end bottom of the most outboard slat on the left wing; the abrasion area was about 13 sq.cm.

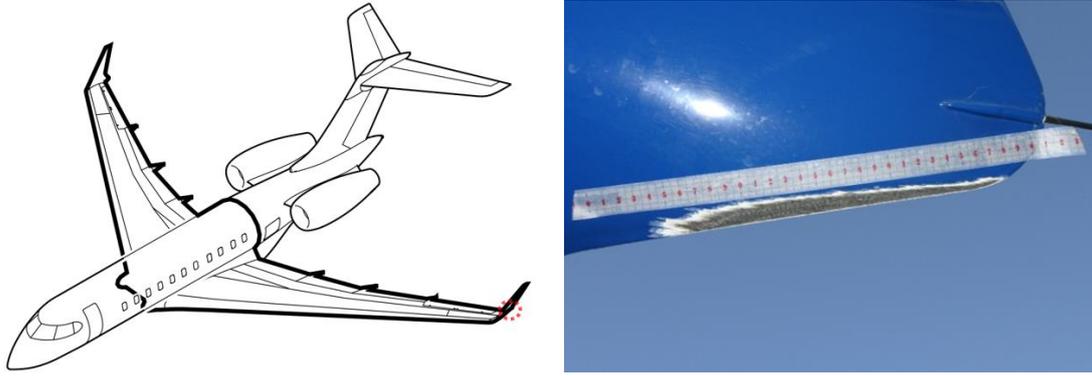
Figure 1.12-11 Trailing edge of the end of left wing

An abrasion was detected on the very end of the left wing, abraded on the trailing edge at the connection with winglet trailing edge, the length of separation at the trailing edge was about 25 cm long, and the abrasion area was about 25 sq.cm.

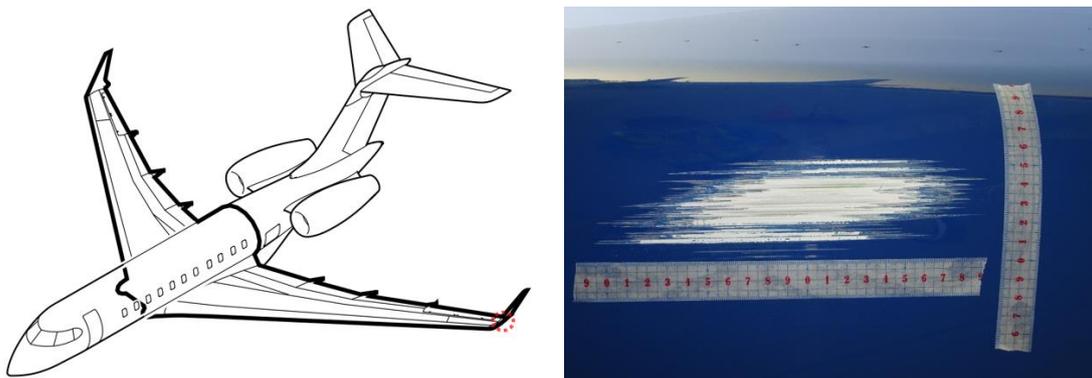
Figure 1.12-12 Middle bottom of the left winglet

An abrasion was detected on the middle bottom of the left winglet; the abrasion area was about 78 sq.cm.

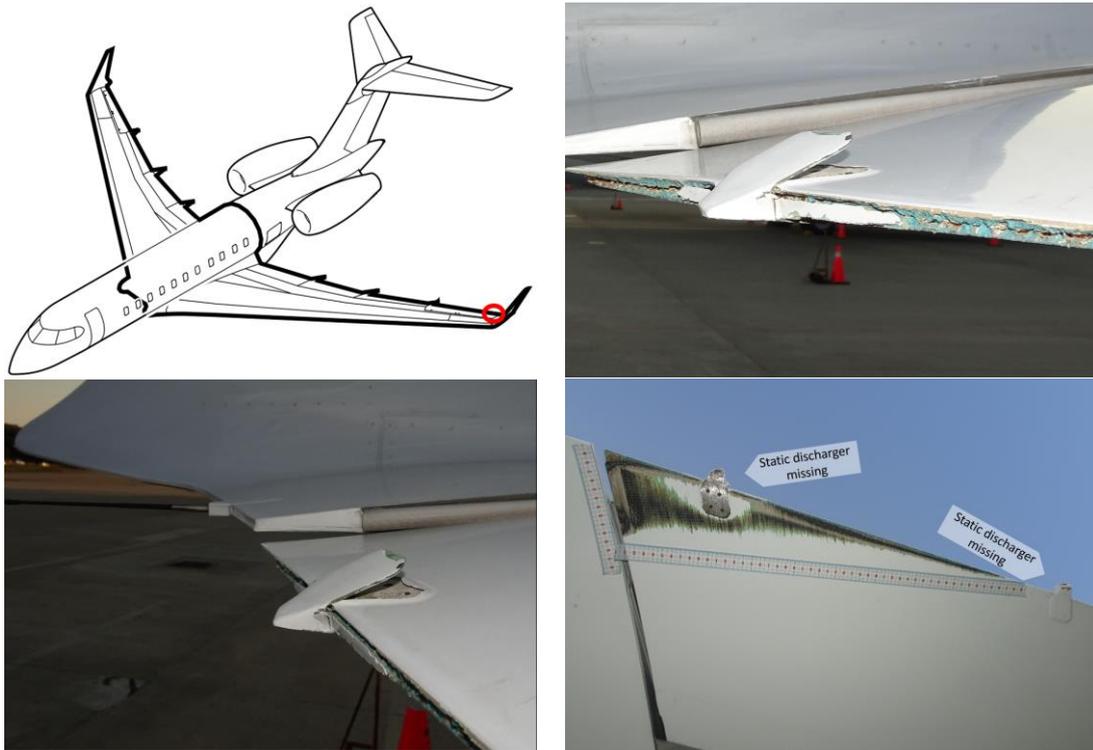
Figure 1.12-13 Left aileron

An abrasion was detected on the right end of the aileron and split into two delaminations at the trailing edge, the aileron had severe damage at the left end trailing edge corner. The abrasion damage extended into the honeycomb in the aileron trailing edge corner, the abrasion area was about 245 sq.cm. The length of separation at the left end of the aileron was about 48 cm long.

The outboard two static wicks on the aileron were lost. The most outboard static wick location was worn down to the aileron surface level by abrasive contact, the upper structure of the static wick was detached.

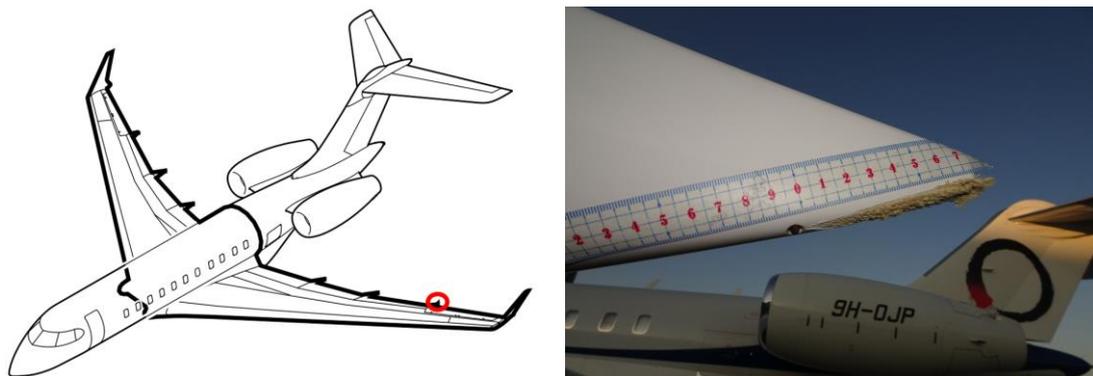
Figure 1.12-14 Left outboard flap fairing

Severe abrasive wearing was detected on the most outboard flap fairing at the end tail on the left wing; the size of the abraded area was about 7 cm long and 1.5 cm wide.
