國家運輸安全調查委員會

重大運輸事故 調查報告

Elit'Avia Malta Limited 航空公司 EAU52P 班機

於臺中國際機場落地時翼尖接觸跑道

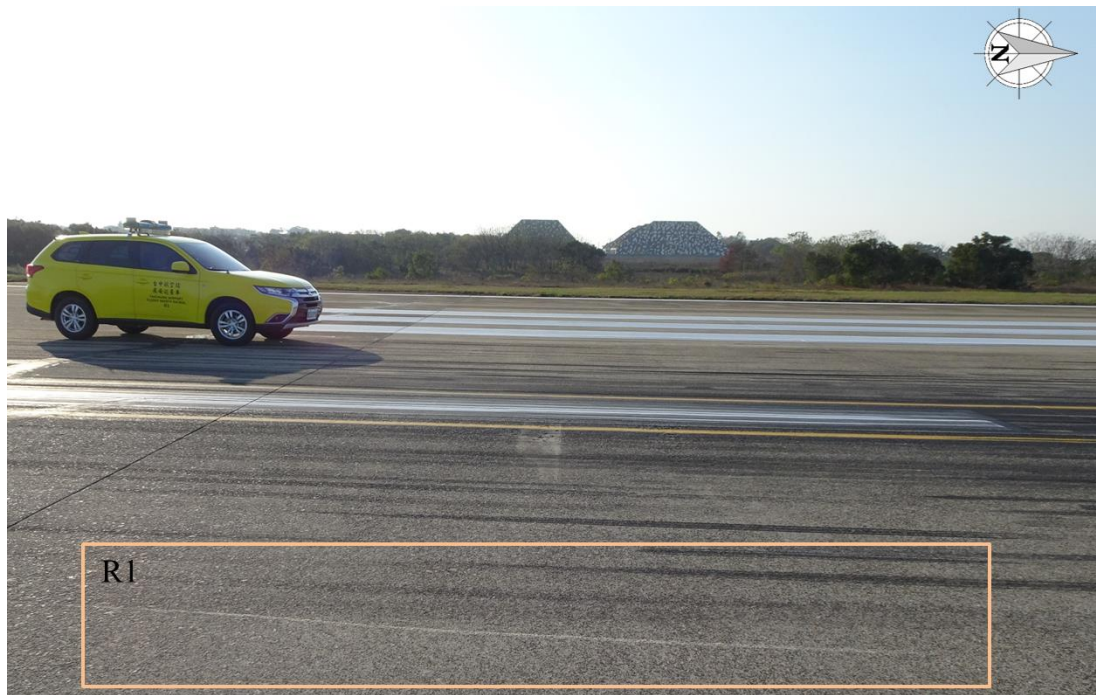
圖 1.12-3 第一道觸地痕跡 (R1)

編號.	測繪項目	與 36 跑道頭之距離 (呎)	長度 (呎)
1	第一觸地痕跡 (R1)	503~515	12
2	第二觸地痕跡 (L1)	636~652	15
3	第三觸地痕跡 (L2)	618~658	42
4	第四觸地痕跡 (L3)	633~650	17

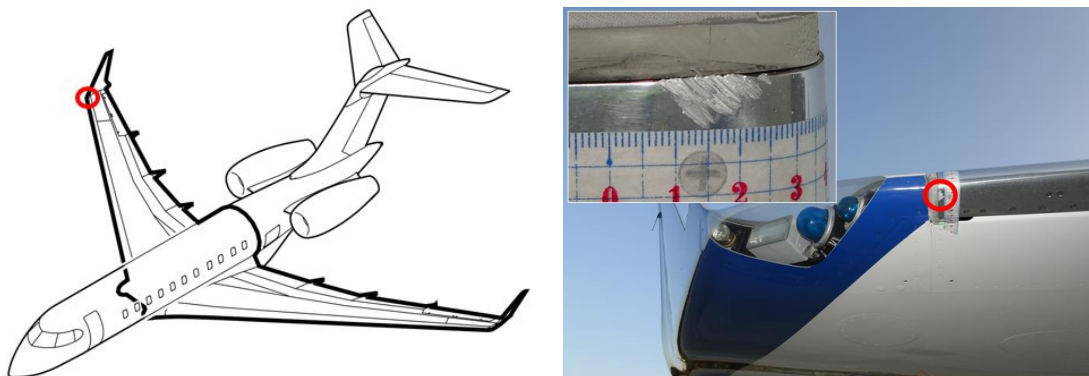
圖 1.12-5 右機翼前緣縫翼

右機翼前緣縫翼外側後緣發現一 0.75 平方公分之磨損，詳圖 1.12-5 所示。

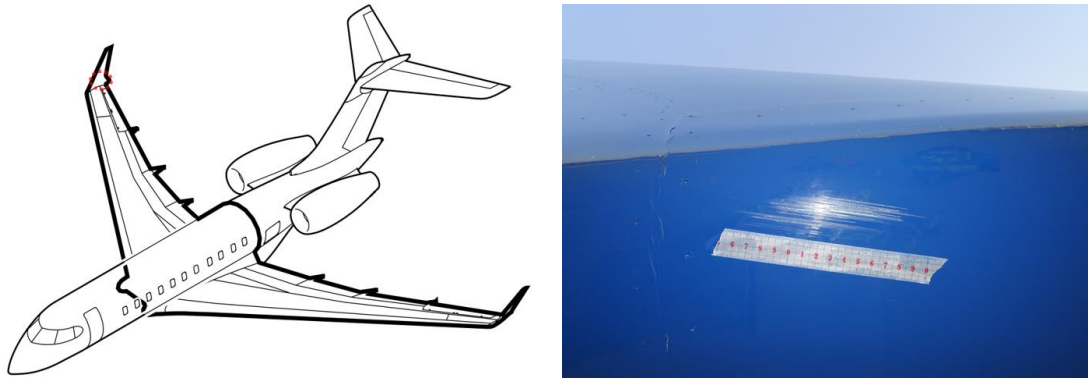
圖 1.12-6 翼尖小翼底部

右翼尖小翼底部中段磨損區域約 18 平方公分，詳圖 1.12-6 所示。

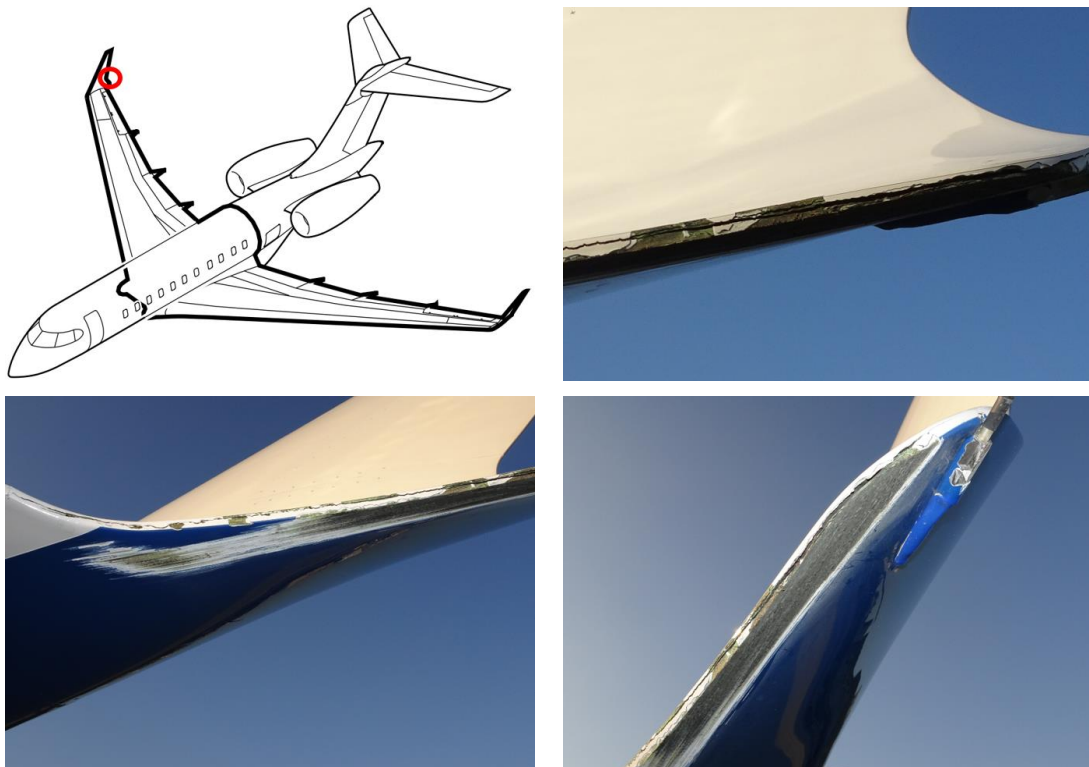
圖 1.12-7 右機翼末端後緣

右機翼末端後緣發現脫層分離，其翼尖與翼尖小翼連結之端處底部後緣有一長約 40 公分，約 100 平方公分之磨損區域，詳圖 1.12-7 所示。

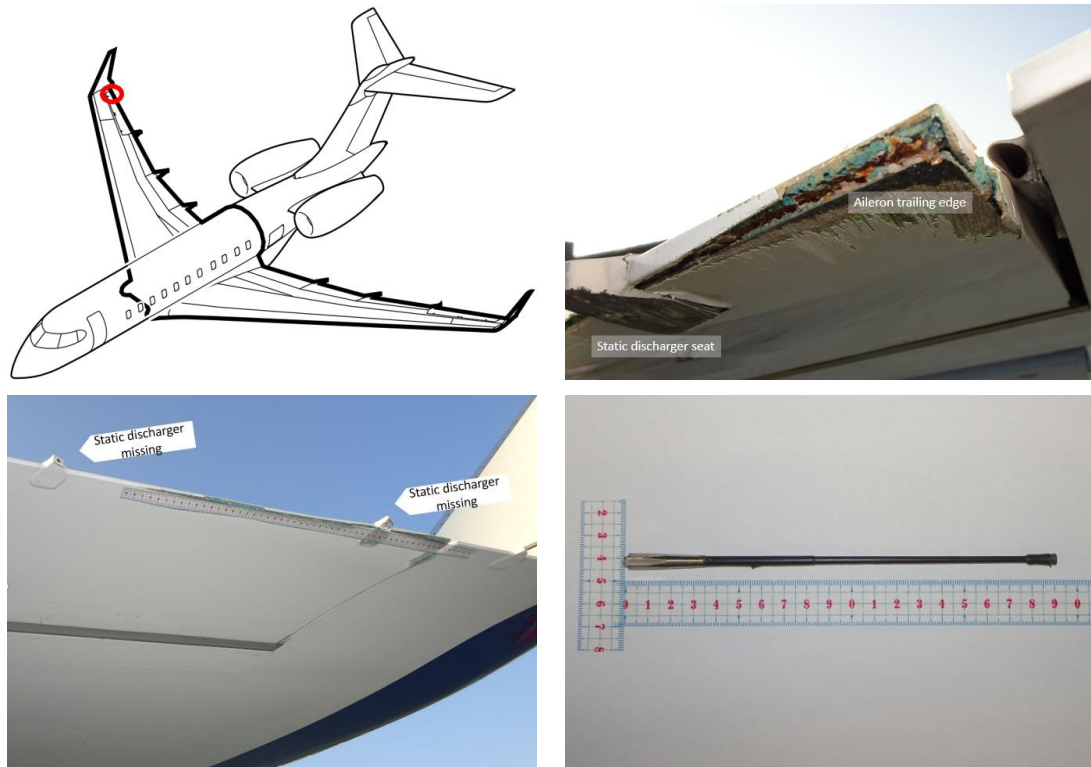
圖 1.12-8 右副翼

右副翼外側後緣轉角處受到較嚴重磨損且脫層分離。損傷部位深度磨

穿至內部蜂巢結構。損傷面積約 158 平方公分。右側後緣損傷長度約 48 公分。

右副翼最外側 2 支靜電釋放條遺失，其中 1 支靜電釋放條於右機翼觸地跑道區域被發現。最外側釋放條基座磨損至與副翼底面齊平，詳圖 1.12-8 所示。

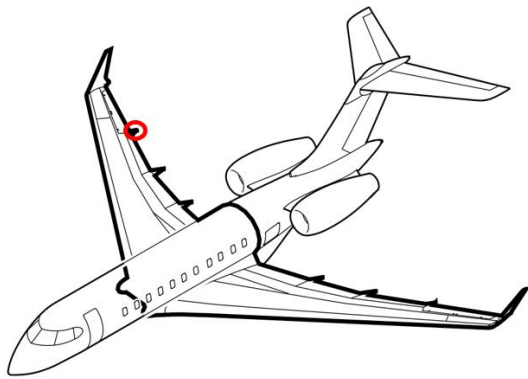
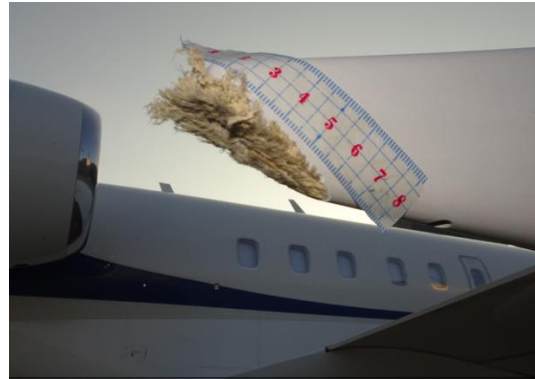
圖 1.12-9 右翼最外側派龍

右翼最外側派龍尾端發現一約 13 公分長，3 公分寬，較嚴重之磨穿受損，詳圖 1.12-9 所示。

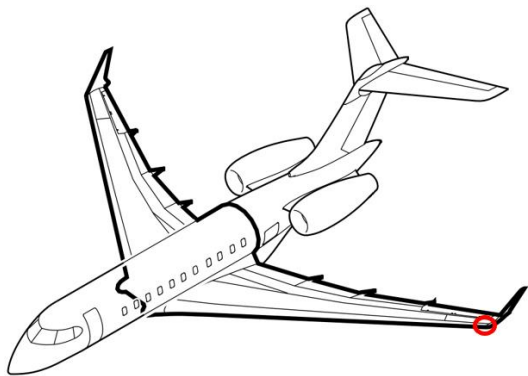
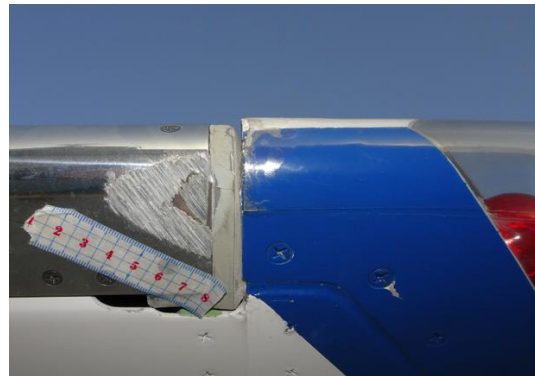
圖 1.12-10 左前緣縫翼

左機翼前緣縫翼外側前緣邊角發現一磨損區域，大小約 13 平方公分，詳圖 1.12-10 所示。

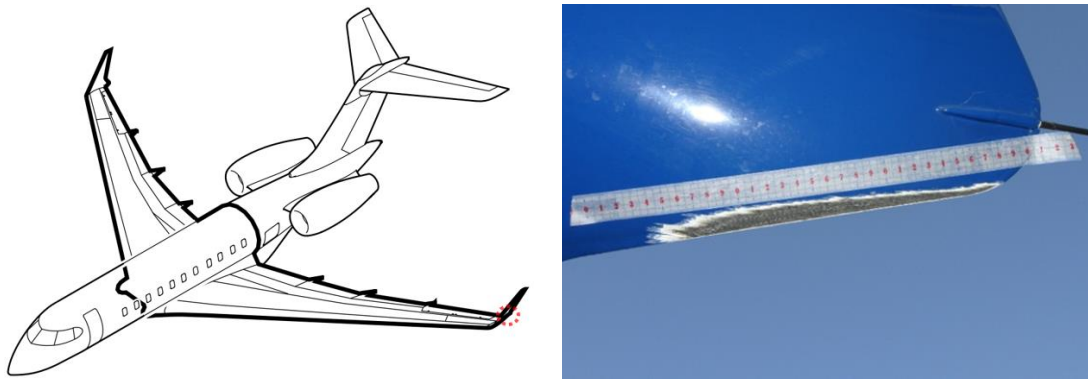
圖 1.12-11 左翼尖端處底部後緣

左機翼翼尖與翼尖小翼連結之端處底部後緣，發現一長約 25 公分之磨損，該磨損區域約 25 平方公分，詳圖 1.12-11 所示。

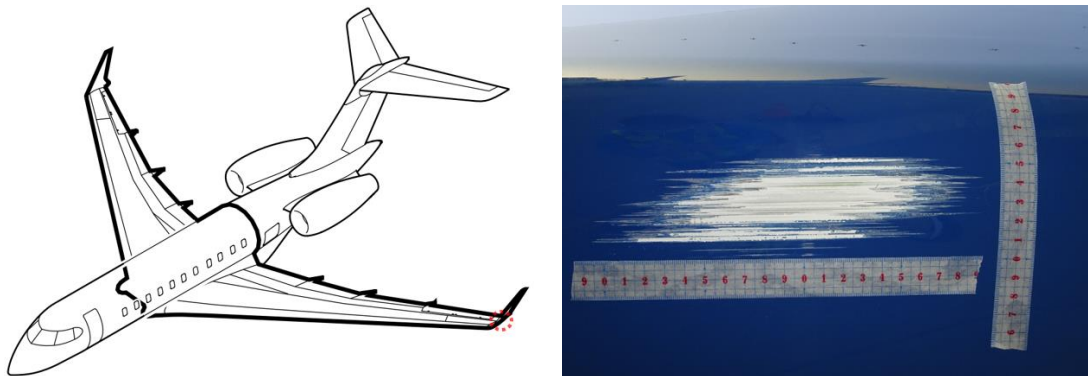
圖 1.12-12 左翼尖小翼底部

左翼尖小翼底部中段磨損區域約 78 平方公分，詳圖 1.12-12 所示。

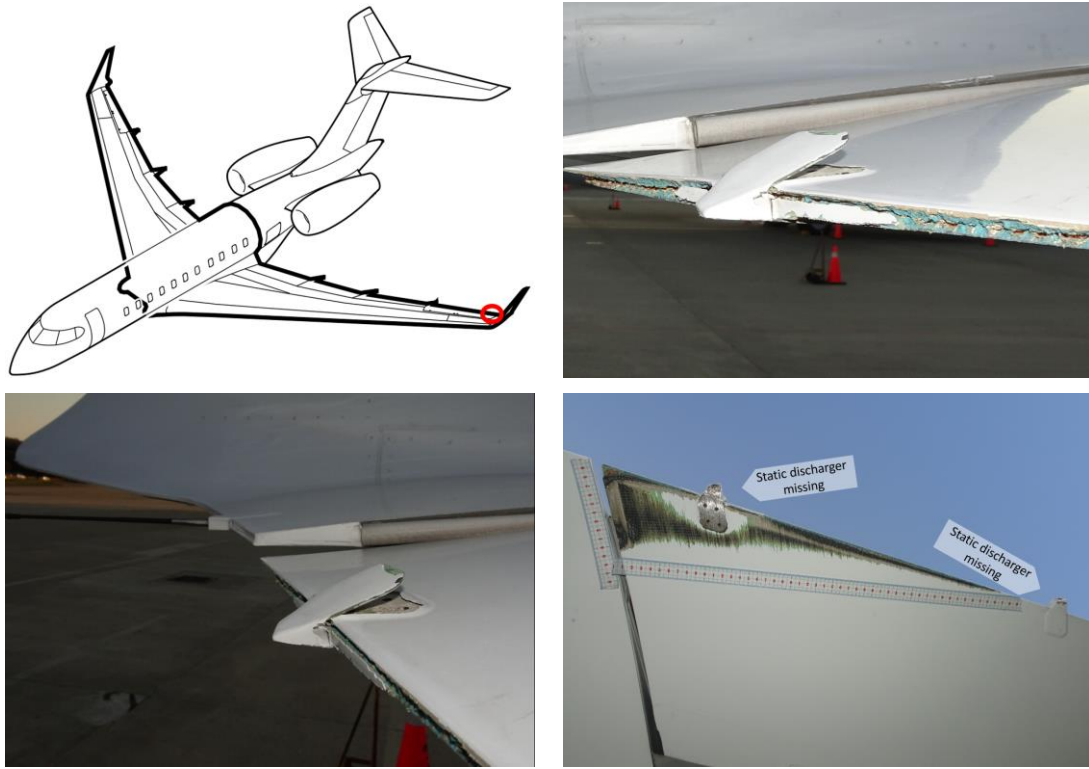
圖 1.12-13 左側副翼

左副翼左側邊角後緣轉角處受到較嚴重磨損且脫層分離。損傷部位深度磨穿至內部蜂巢結構。損傷面積約 245 平方公分。左側後緣損傷長度約 48 公分。

左副翼最外側 2 支靜電釋放條遺失，最外側釋放條基座磨損至與副翼底面齊平，且上部結構脫層，詳圖 1.12-13 所示。

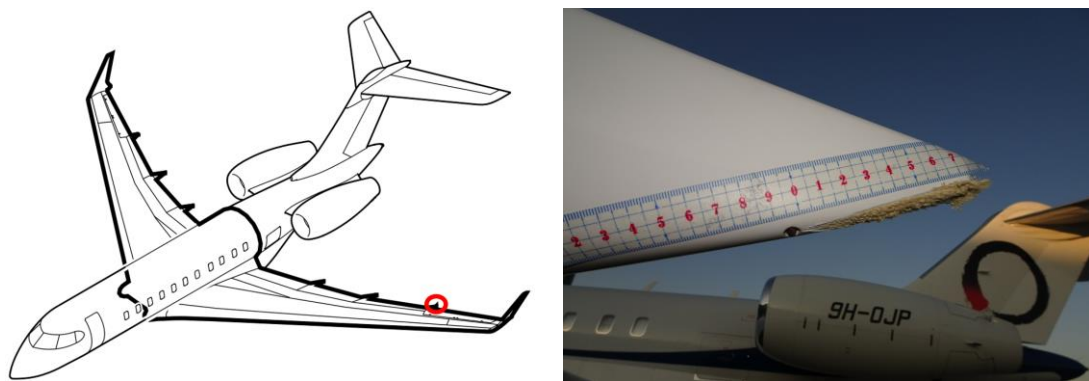
圖 1.12-14 左翼最外側派龍

左翼最外側派龍尾端發現一約 7 公分長，1.5 公分寬，較嚴重之磨穿受損，詳圖 1.12-14 所示。
