Executive Summary

Major marine occurrence report for working boat “Dongyang No.6”

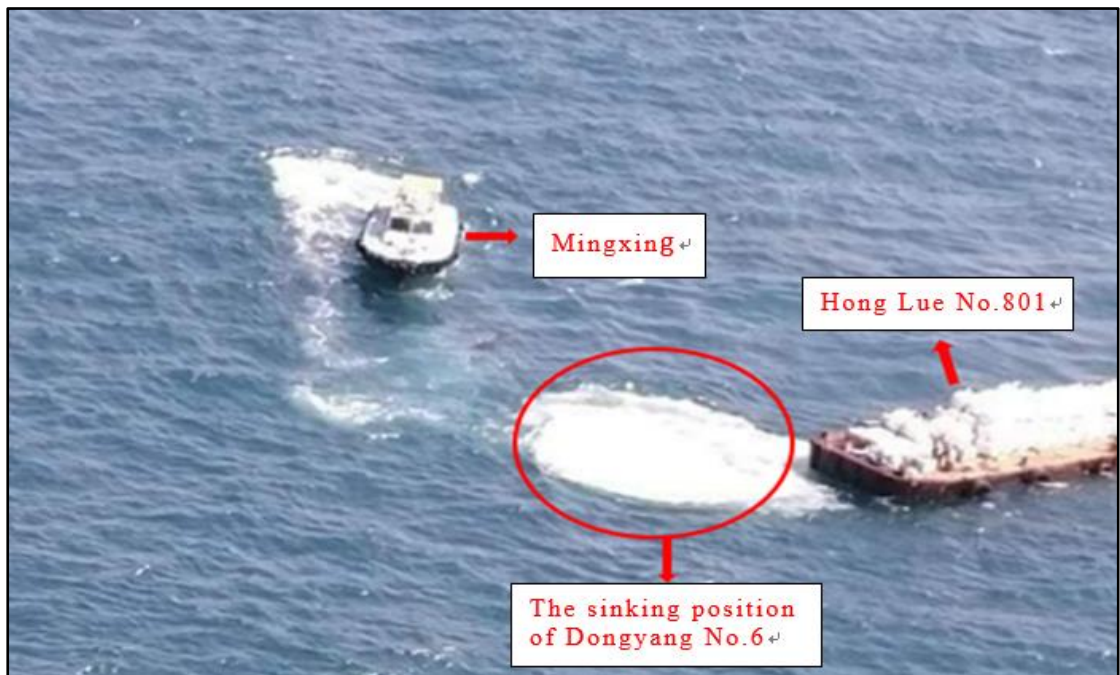
Figure 2 The sinking photo of Dongyang No.6

At approximately 13:23, Dongyang No.6 and Hong Lue No.801 met the Taiwanese shuttle boat Mingxing (Official No. 912400, Gross Tonnage 19.88) on the sea outside Bachimen Fishing Port. Dongyang No.6 and Mingxing jointly towed Hong Lue No.801 to Keelung Islet Pier. At approximately 14:00, Dongyang No.6 suddenly sank about 0.1 nautical miles outside Keelung Islet Pier (see Figure 2 for a sinking photo).

- (1) Dongyang No.6 is only allowed to navigate in the harbor and she is not a tugboat. When she was towing outside the harbor with moderate wind and wave conditions. Dongyang No.6 towing behavior exceeded the stress load of the boat's aft structure, resulting in damage to the stern hull and significant water ingress. The hull tilted to the portside and the drainage system was either ineffective or insufficient, resulting in the boat sinking.
- (2) Dongyang No.6 was an old working boat, and the shipwreck showed signs of severe corrosion and damage to the aft steel plate. Cracks and steel plate deformation were also present at the site of stern welding repair.
- (3) Two sailors on Dongyang No.6 sank into the sea with the hull. They drowned because they took too long to surface from the sunken boat.
