Taiwan Transportation Safety Board

Major Marine Occurrence Factual Data Report

**The Palau-flagged Container Ship ANGEL Sank off
near the Port of Kaohsiung**

Report number: TTSB-MFR-24-01-001

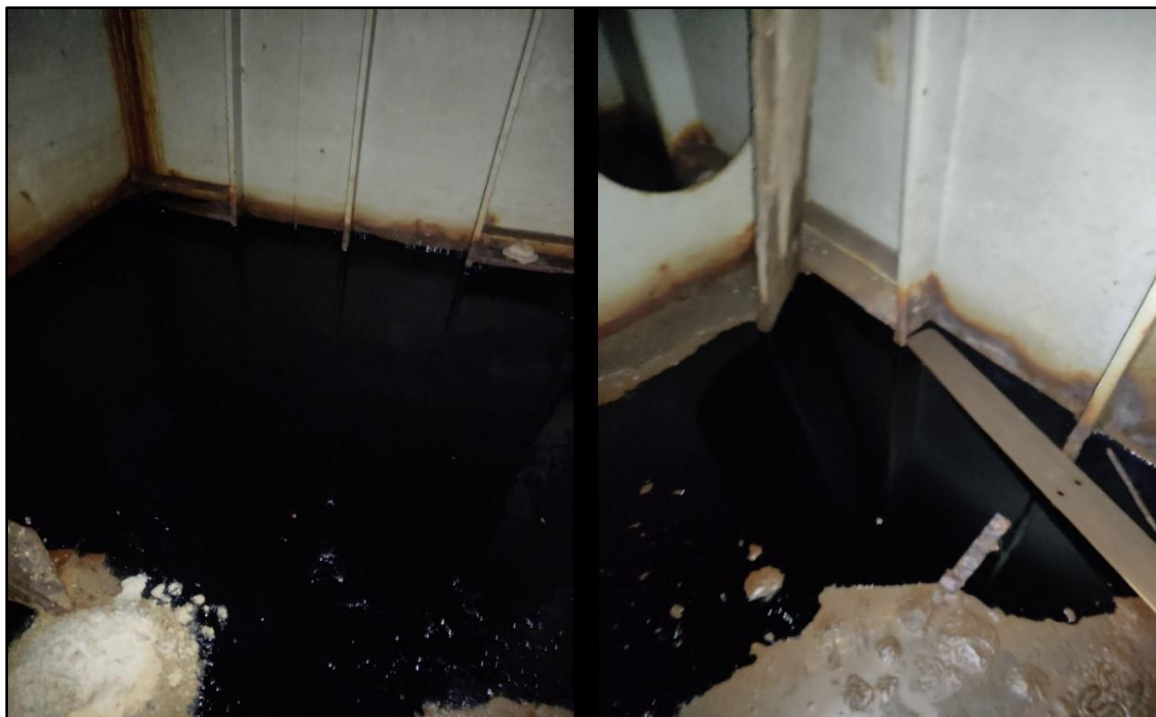
According to interview records and mobile phone records of the chief engineer, oil leakage occurred in the front section of the fourth cargo hold from June 2 (Fig.1.1-2). On June 19 and 20, the Master who received the ship reported to ZULU the water ingress in the cargo hold of the ANGEL.

Figure1.1-2 Photo of oil leak from the front section of the ANGEL's 4th cargo hold to the central aisle of the 4th cargo hold

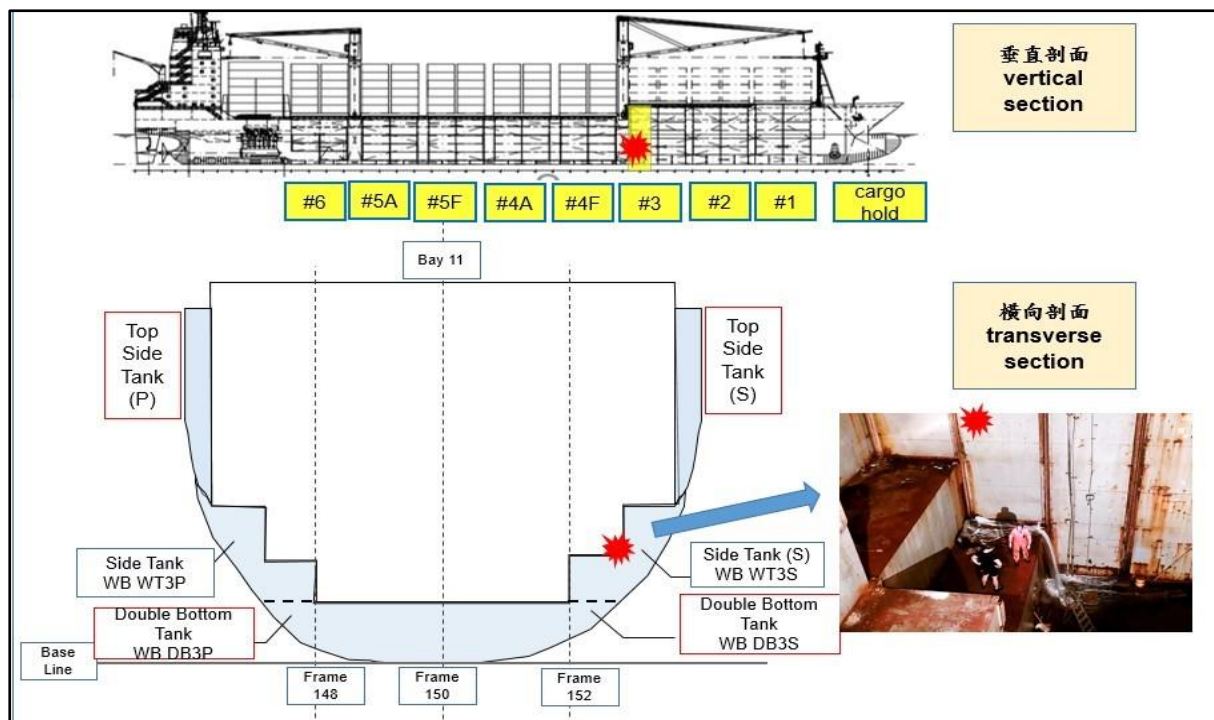
Based on interviews and relevant photos from the crew of the ANGEL, it was discovered that after the ship sailed from Colombo, a broken metal plate was found under the base of the container in the third cargo hold at "110504". This breakage resulted in the rupture of the third ballast waterside tank (starboard side no. WB-DT3S), causing water to leak into the third cargo hold. The water ingress reached a height of approximately 1.3 meters, with the remaining cargo (coffee beans) and bilge debris previously loaded floating on the water surface (Fig. 1.1-3 and 1.1-4).

Figure1.1-3 Schematic diagram of the ANGEL's cargo hold distribution and 3rd cargo hold ballast water

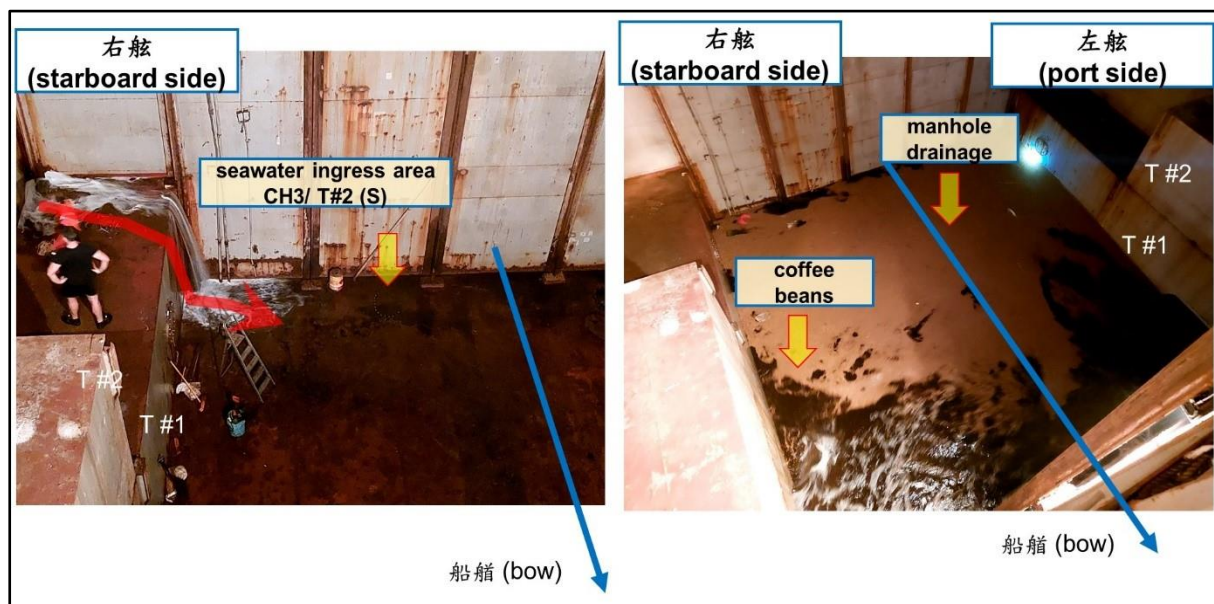
Figure 1.1-4 Photos of the ANGEL's 3rd cargo hold seawater ingress and appearance before cleaning by crew (before loading)

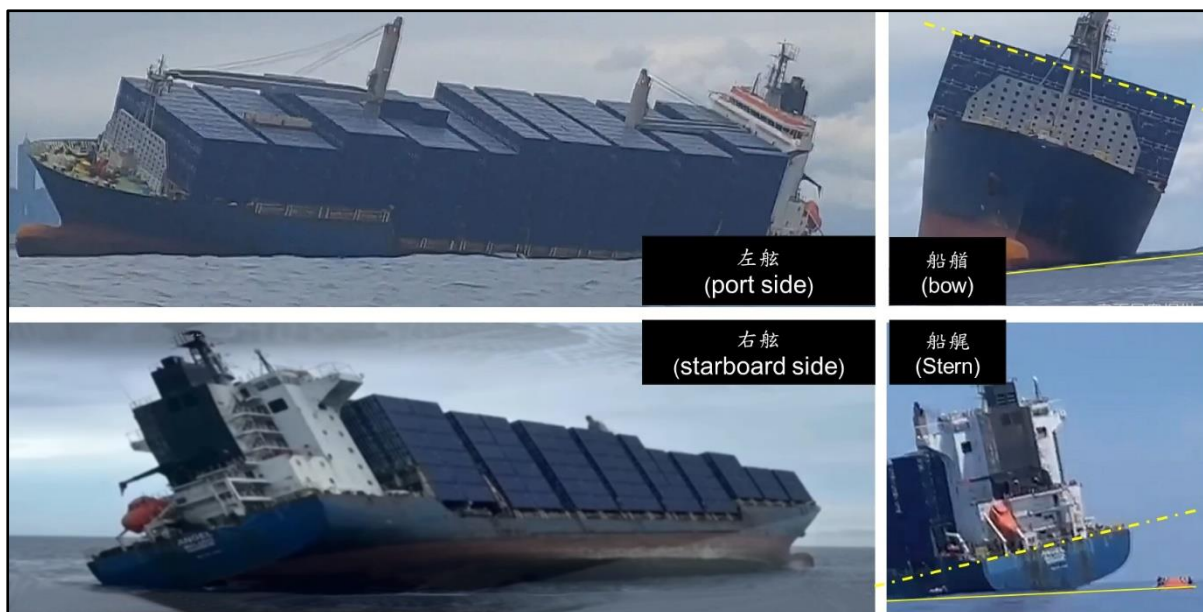
Figure1.1-5 Photos of the ANGEL's appearance during the period after being abandoned

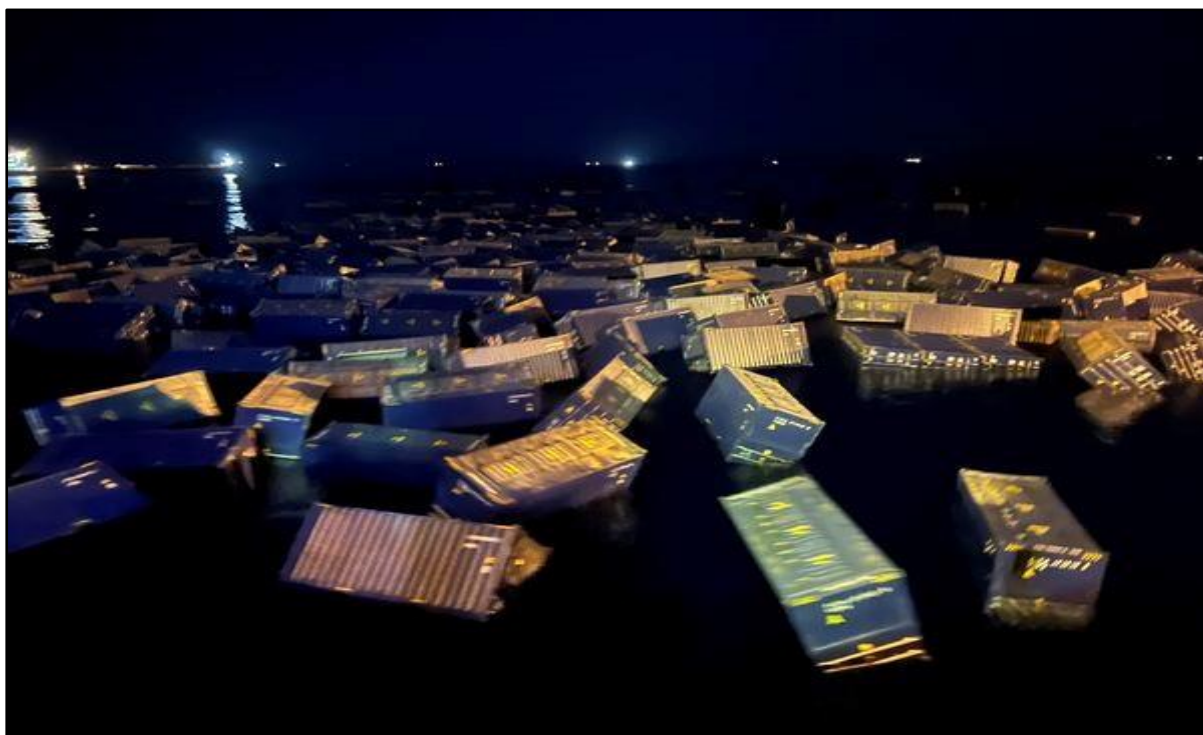
Figure1.1-6 The containers that fell off the ANGEL

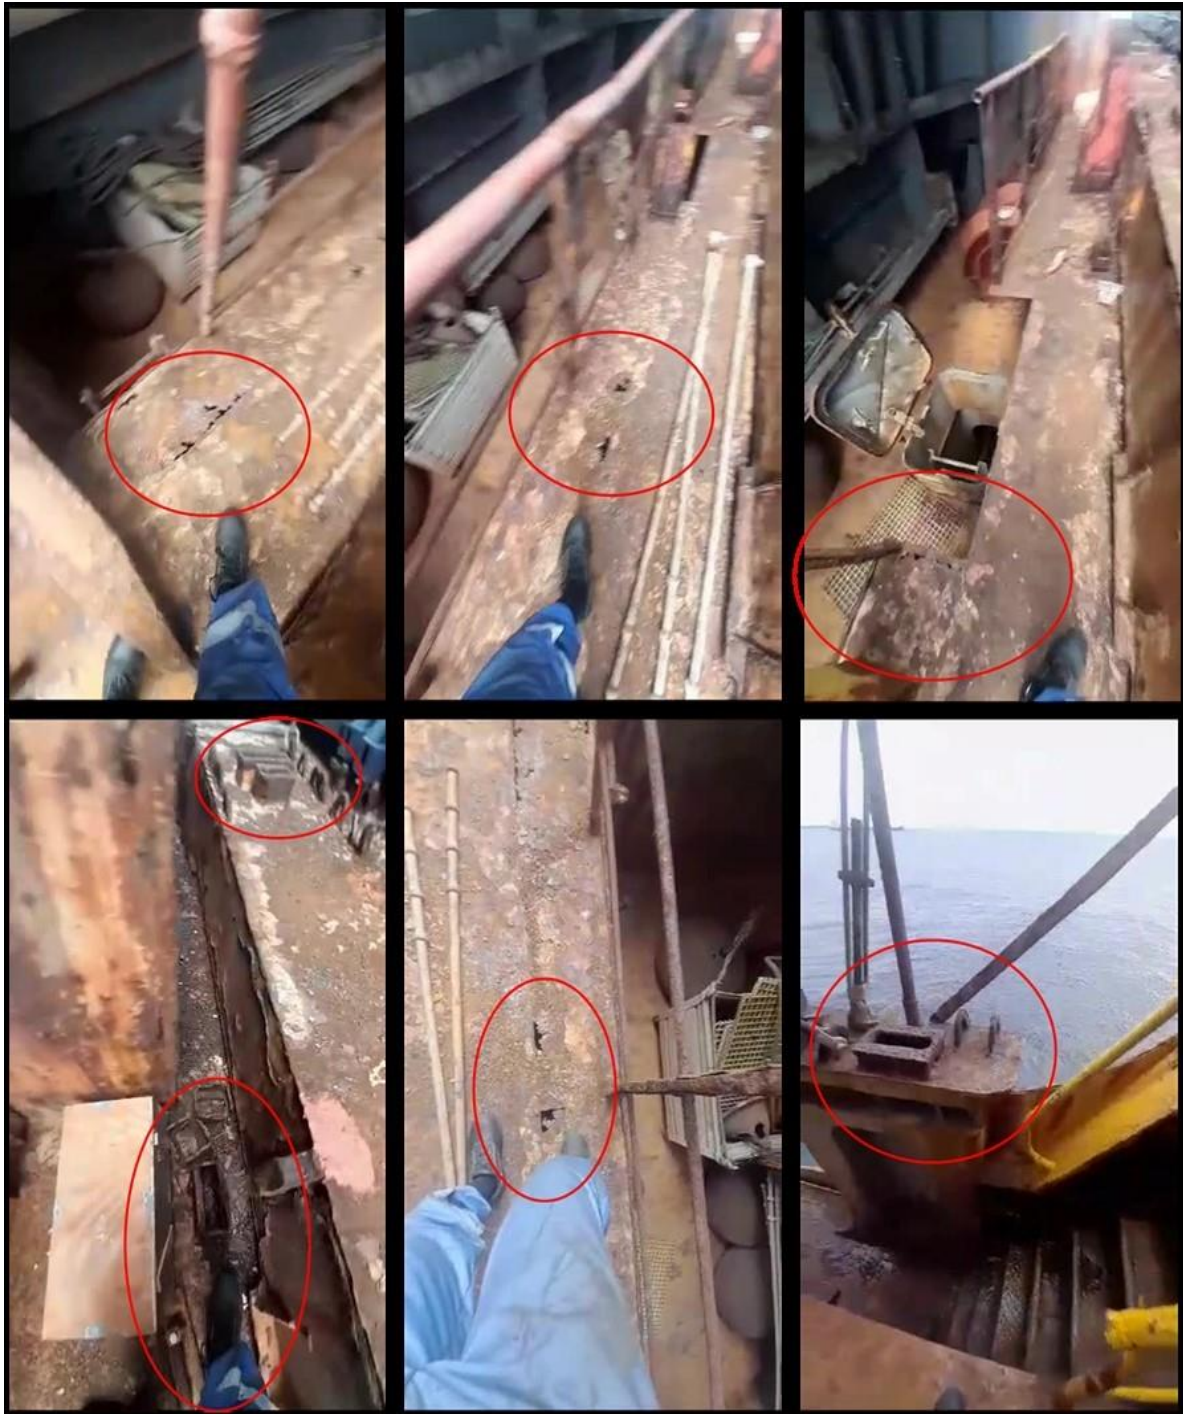
dialogue (foreign language translation) between the crew and the ABs in the film shows: "Everything is rotten and cannot be operated", " There are some holes in the deck walkway between the cargo holds, and it may break and fall if you step on it", "It's like hell", "The cargo hold is full of water", "The rust is very serious", etc. (Fig. 1.11-2)

Figure1.11-2 Photos of holes and rust on ANGEL's main deck

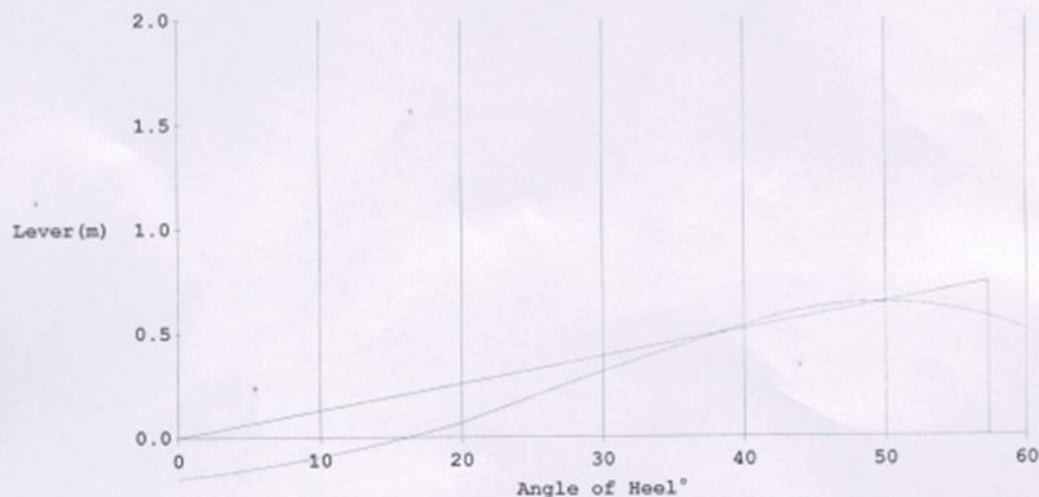
WARNING * GM is less than required minimum
WARNING * GZ Area to 30° < 0.055 M-Rads
WARNING * GZ Area to 40° < 0.090 M-Rads

PRESENT situation,
Simulated water in Hold N° 4,5 ~ 4,400mt

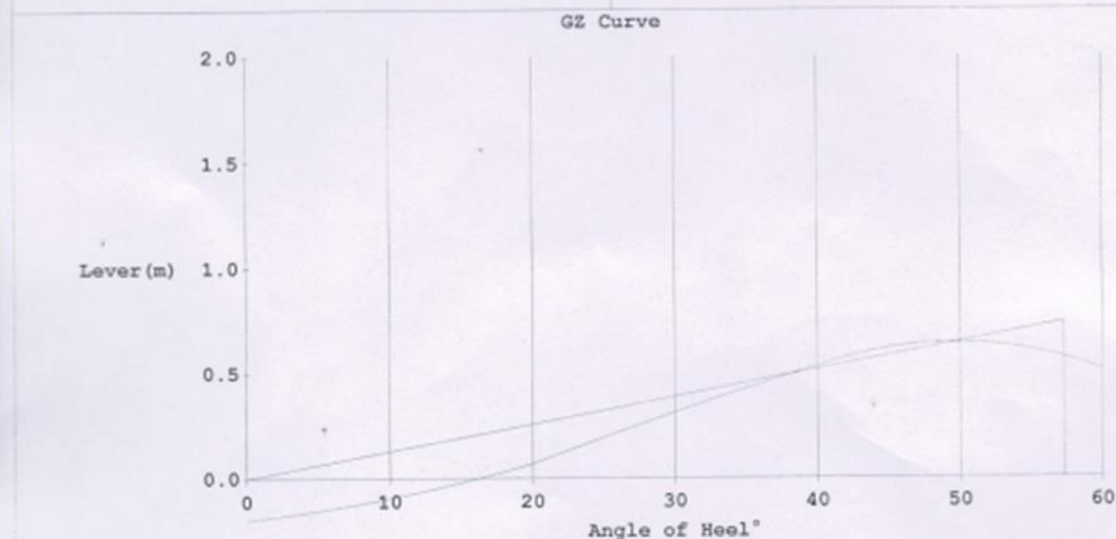
WARNING * GM is less than required minimum
WARNING * GZ Area to 30° < 0.055 M-Rads
WARNING * GZ Area to 40° < 0.090 M-Rads

present situation,
Simulated water in Hold N° 4,5 ~ 4,400mt
