Executive Summary

Final Report of the Vietnam flag bulk carrier "VIMC SUNRISE" Occurrence Investigation

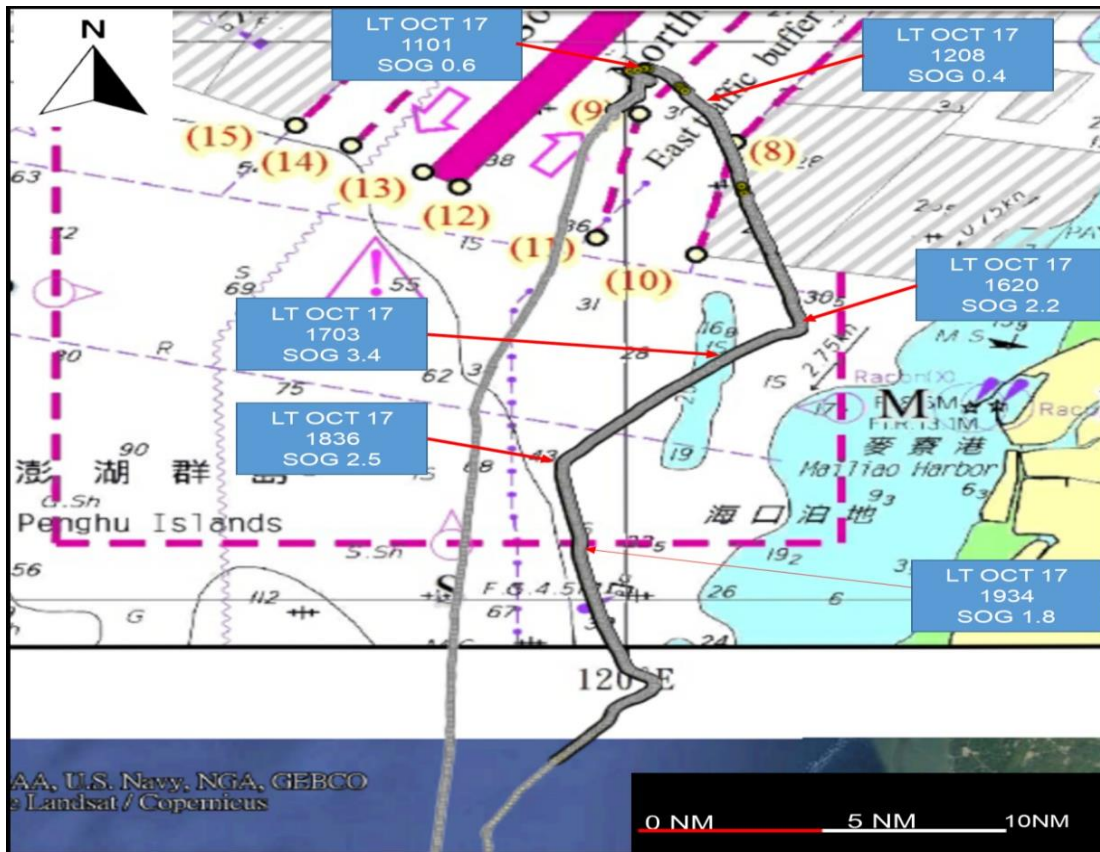
According to the Automatic Identification System (AIS) track and Marine Traffic website records, the “VIMC SUNRISE” passed through the warning line of the Changhua Wind Farm Channel at 0121 hours on October 17. At 0330 hours, the vessel entered the northbound lane of the Changhua Wind Farm Channel, with wind force ranging from 9 to 10 and wave heights from 4.2 to 6.1 meters. Around 1100 hours, the “VIMC SUNRISE” was approximately 15 nautical miles northwest of Mailiao Port, drifting southeast at a speed of 1 knot. From 1200 to 1604 hours, the vessel drifted southeast at a speed of 2.5 to 3 knots, with wind force ranging from 9 to 11 and wave heights from 5.2 to 6.2 meters. Please refer to Figure 1.1-1 for details.

Figure 1 actual path of VIMC SUNRISE (source: AIS, VDR)
