# **Executive Summary**

## **1. Brief description of the marine occurrence**

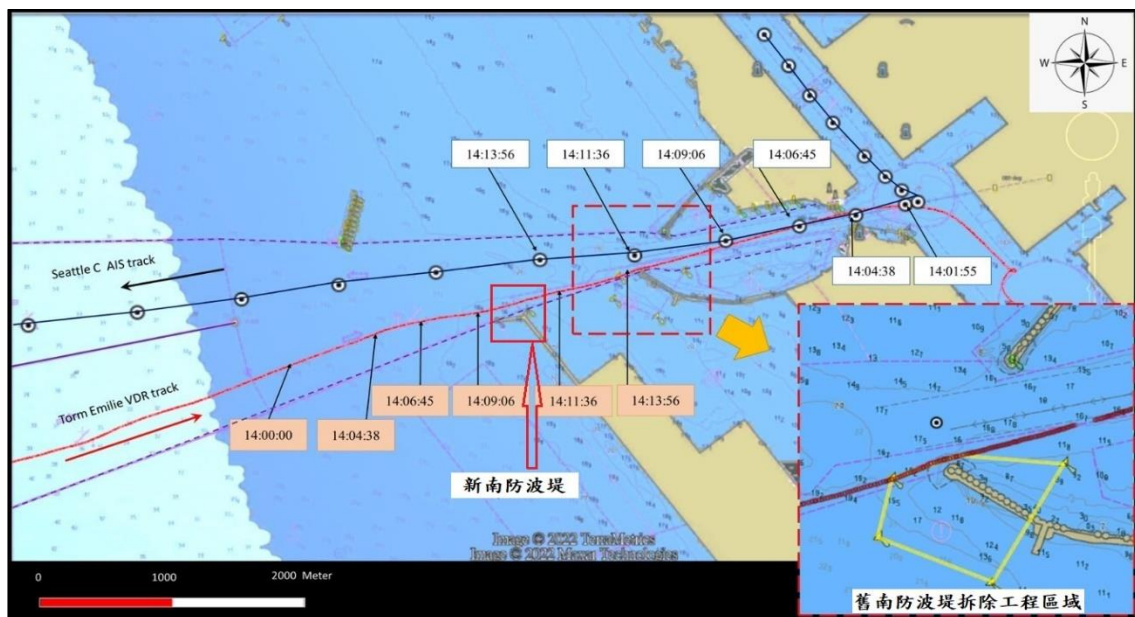
Figure 1 actual paths of TORM EMILIE and SEATTLE C.

At 1359:49 LT on February 1st, 2022, the ship arrived at the pilot boarding ground, then two pilots (hereinafter referred to as chief pilot, deputy pilot) embarked the ship, the Master and two pilots performed the exchange of information (MPX) at the bridge. In the meantime, the ship was located southbound on two-way routes, and due to the influence of currents, the heading of the ship was about 10 degrees southward from the course over the ground.

At 1408:45 LT, the "TORM EMILIE" was located 0.8 NM away from the new south breakwater when the VTS officer informed the pilots via VHF that the container ship Seattle C had passed through the Vessel Traffic Center (VTC). At

1409:06 LT, the bow of the "TORM EMILIE" had just passed the new south breakwater, and it was close to the southern boundary of the two-way routes. Both ships were heading towards each other. Between 1413:50 LT to 1414:15 LT, the starboard side of the hull contacted with the caisson of the old south breakwater, causing structural damage and water leakage. As a result, the ship listed to the starboard side at about 14 degrees. (refer to fig. 2)

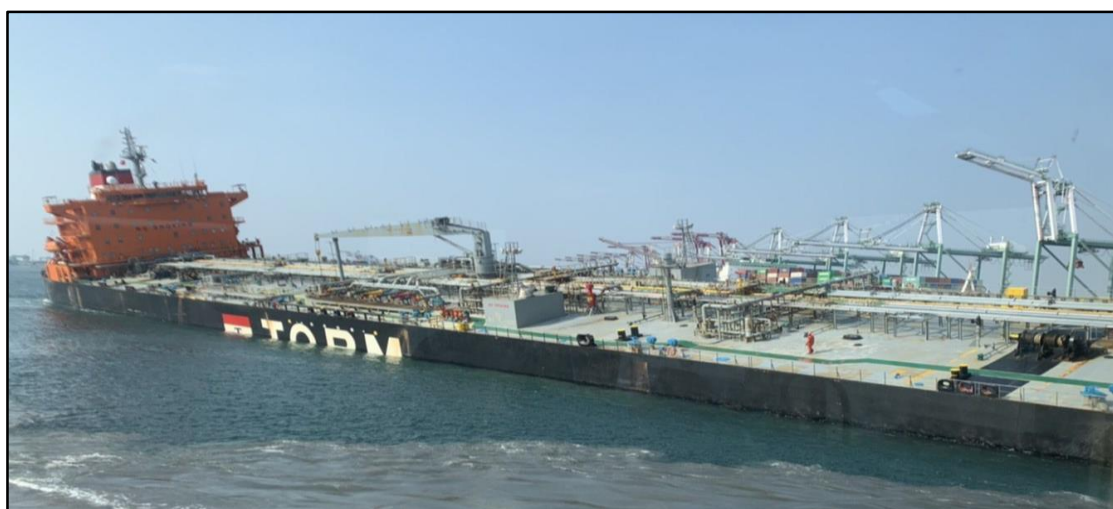
Figure 2 The TORM EMILIE after first contact, listed to starboard side.

3. After the two heading meet, the Master of the "TORM EMILIE" reminded the pilots that the water depth in the area was 10 meters. However, the chief pilot did not realize the risk and did not correct the ship's position back to the centerline of the route. The chief pilot failed to fulfill their responsibilities and obligations as a pilot and lacked vigilance in maintaining the port route and ensuring navigation safety. As a result, the ship made contact with a caisson

under the water surface, causing the ship list to starboard side by about 14 degrees.
