Released Final Report on TMRT Train Collision with Foreign Object Occurrence at Feng-le Park Station

Press release

Release date: June 20, 2024

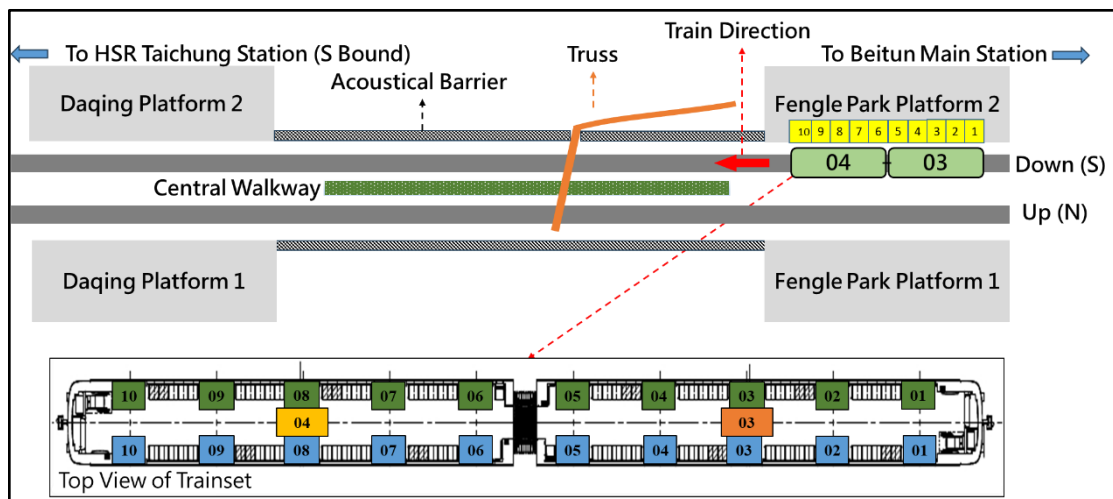
On May 10, 2023, a Taichung Mass Rapid Transit Corporation (hereinafter TMRT) train departed from Beitun Main Station and headed south to High Speed Rail Taichung Station. This train consists of two cars, numbered 03 and 04, carrying 1 train attendant and 47 passengers. At about 1227 hours, the train, running on the southbound track between Feng-le Park Station and Daqing Station, collided with the truss of a tower crane that had invaded the track area and caused damage to the train cab and doors on the right side of the train's operating direction to fall off. The occurrence resulted in the death of 1 passenger and injuries to 15 people (including 1 train attendant and 14 passengers), as shown in Figure 1.

Figure 1 Train doors, station platforms, track configuration and position of fallen truss (schematic diagram)

cover. At 1227:46, the train collided with the truss on the track at a speed of 43.7 km/h. At 1227:47, the truss penetrated the car from door 09 on the right side of the operating direction of car no. 04, struck the passenger sitting on the left side of the car facing the direction of travel, and then penetrated through the left window. The passenger was pushed out of the car and fell into the track area below. At 1227:52, the speed of the train dropped to 0 km/h.

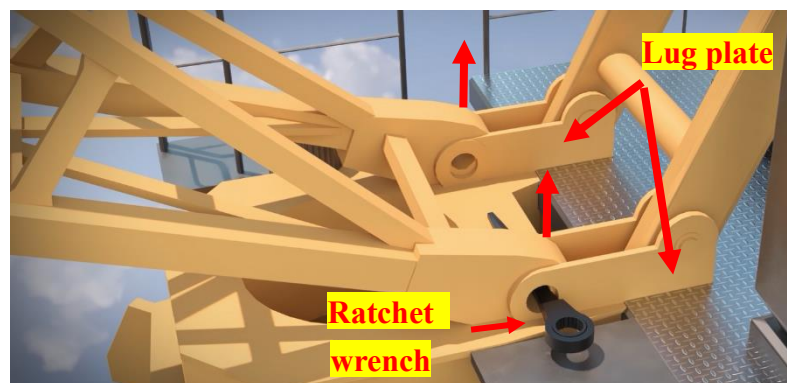
During the dismantling of the tower crane truss and the rotating base, Chia Yuan operators removed the latch between the root of the truss and the lug plate of the rotating base. Then they placed a ratchet wrench in the latch hole to temporarily hold it in place. Because the handle size of the ratchet wrench is smaller than the diameter of the latch hole, the root of the truss rose slightly, failing to remain parallel to the lug plate and therefore could not be loosened (see Figure 2). Chia Yuan operator then directed United Machinery operator to adjust the position of the tower crane truss by rotating the dismantling crane. During the process, the United Machinery operator may have lifted the tower crane truss diagonally (see Figure 3), causing the hoisting steel cable of the dismantling crane and the lifting point of the tower crane truss to form an angle and exceed the critical angle. Multiple rods of the dismantling crane truss were subjected to a pressure sufficient to bend or buckle, thus causing buckling and fracture. The tower crane truss fell onto Wenxin South Road after losing the hanging force of the dismantling crane, with a portion falling into the TMRT track area at 1227:03.

Figure 2 Rise of tower crane truss root (schematic diagram)

1. During the disassembling of the tower crane truss, after the operators removed the latch on one side between the root of the truss and the lug plate of the rotating disk, a ratchet wrench was placed in the latch hole to temporarily hold it in place. The operators then removed the latch on the other side from the latch hole, because the handle size of the ratchet wrench was smaller than the diameter of the latch hole, so the root of the truss rose slightly, thus failing to remain parallel to the lug plate and resulting in failure from being successfully loosened. Therefore, the operators adjusted the position of the tower crane truss by rotating the dismantling crane.

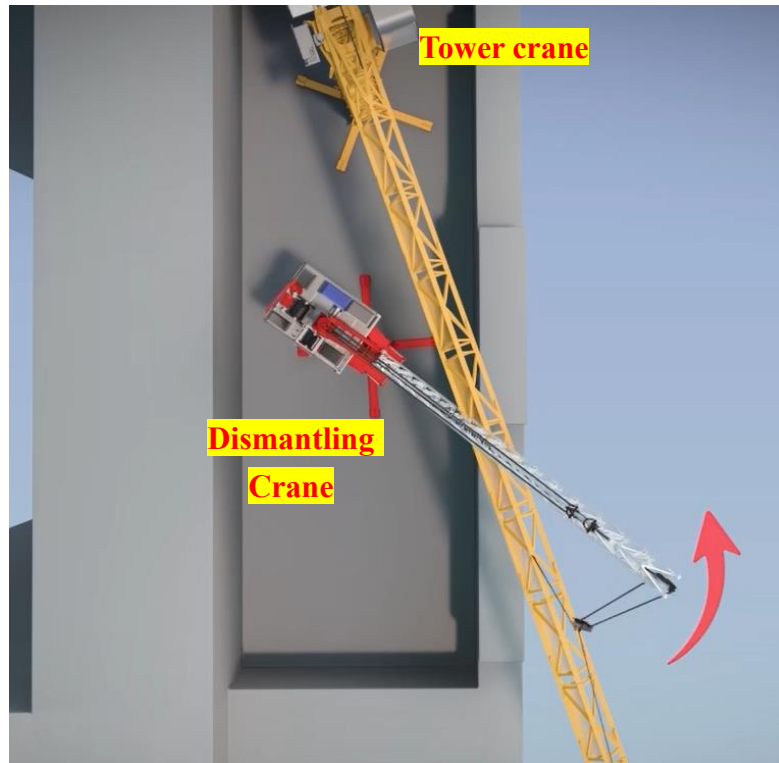
Figure 3 The dismantling crane lifts the tower crane truss diagonally (schematic diagram)

2. During the process of rotating the dismantling crane, the operator may have lifted the tower crane truss diagonally, causing the hoisting steel cable of the dismantling crane and the lifting point of the tower crane truss to form an angle and exceed the critical angle. Multiple rods of the dismantling crane truss were exposed to pressure sufficient to bend or buckle, resulting in buckling and fracture. Furthermore, initial plastic deformation occurred at the connection between sections 1 and 2, following which other sections of the truss began to bend and deform until fracture due to buckling finally occurred with the rods in section 4.

1. Require operators to abide by the “Regulations for Safety of Cranes and Hoist Equipment” when operating tower cranes, prohibit engaging in lifting operations in improper ways such as shaking or pulling objects, or lifting objects at an angle, which may cause truss to buckle and break due to improper stress.

1. Require the onsite conductor of lifting operations to remind dismantling machine operators not to engage in lifting operations in improper ways such as shaking or dragging objects.
