Taiwan Transportation Safety Board

Major Marine Occurrence Final Report

**The Palau-flagged Container Ship ANGEL Sank off
near the Port of Kaohsiung**

Report Number: TTSB-MOR-25-01-001

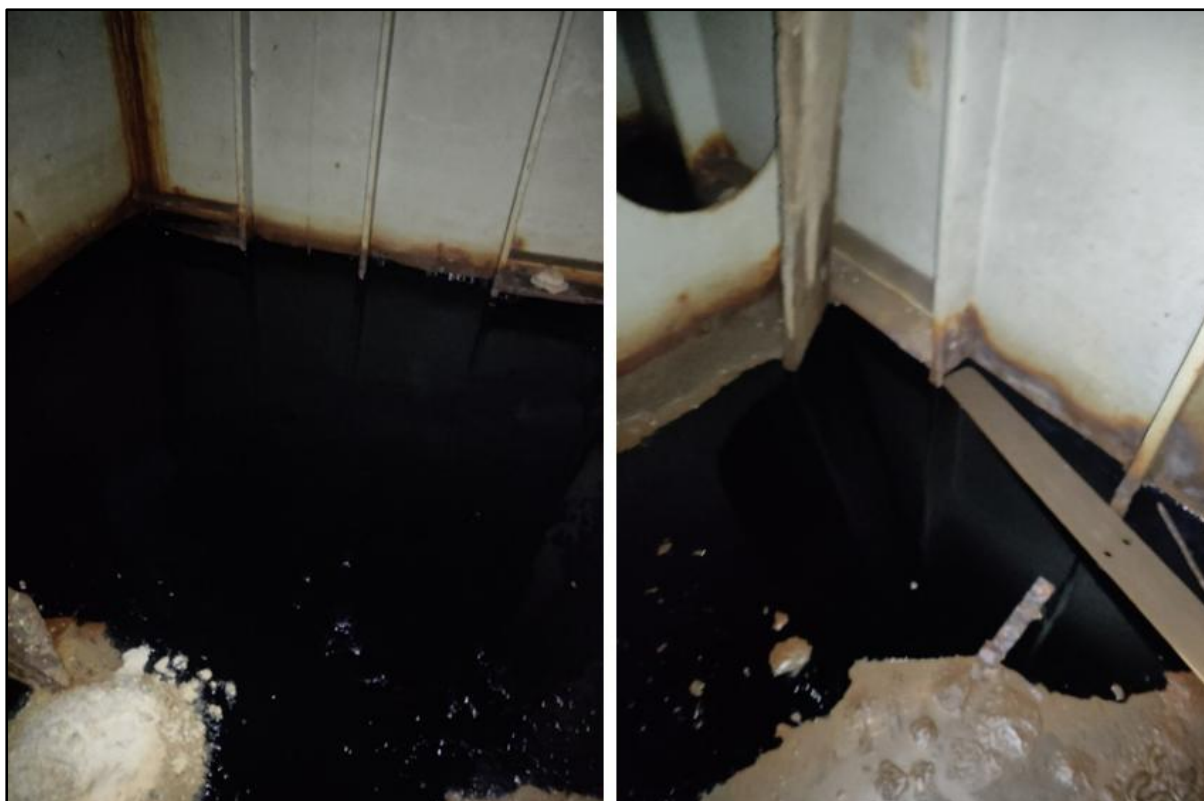
According to the interview record with the chief engineer of the ANGEL and his mobile phone records on June 2nd, 2023, there are photos showing fuel leaked from the front section of the cargo hold no.4 to the middle aisle of the cargo hold no.4 (as detailed in Figure 1.1-3).

Figure 1.1-3 Showing fuel leakage in the forward section of the cargo hold no. 4 on the ANGEL, reaching the middle passageway of the cargo hold no. 4.

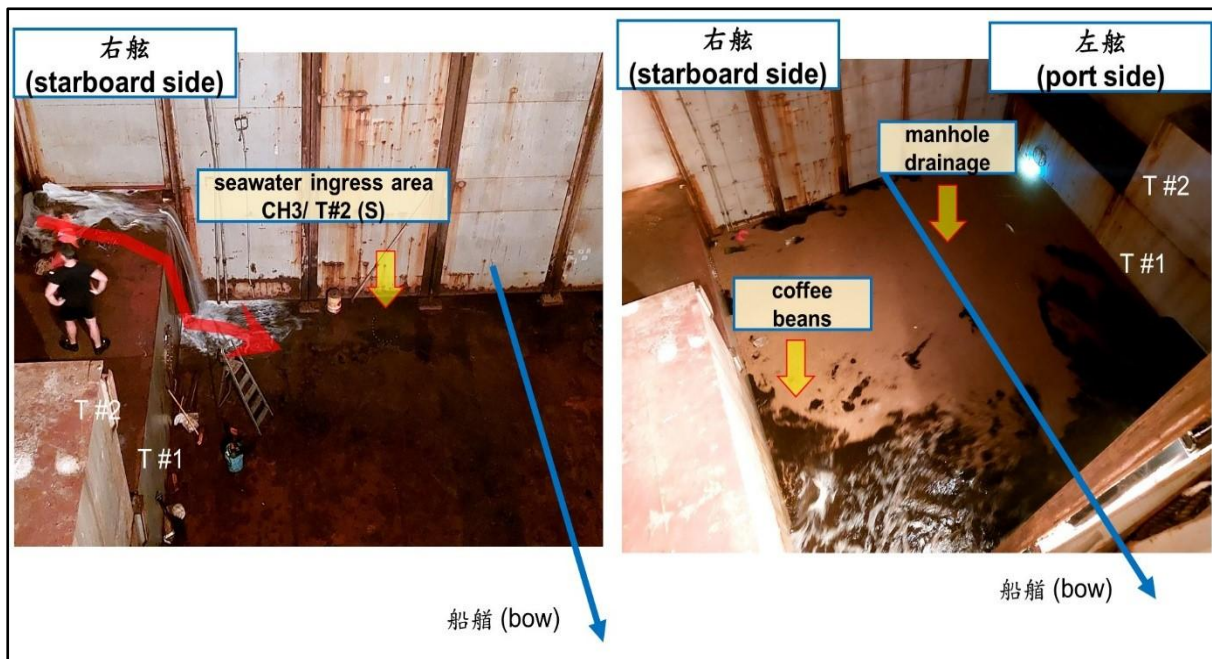
On June 26th, the Deck Log Book documented that the initial measurement of water ingress in cargo hold no.3 was 10 centimeters. Subsequent entries on June 27th indicated a rise in water ingress levels from 30 centimeters to 50 centimeters in cargo hold no.3, accompanied by a 5-degree listing to both the port side and starboard sides. The former master reported to the ZULU continued to operate the ballast water system and proceeded to engage the ballast water system and portable pumps for water pumping operations (refer to Figure 1.1-2).

Figure 1.1-5 Water ingress in the cargo hold no. 3 of the ANGEL, and the exterior view before the crew's cleanup efforts

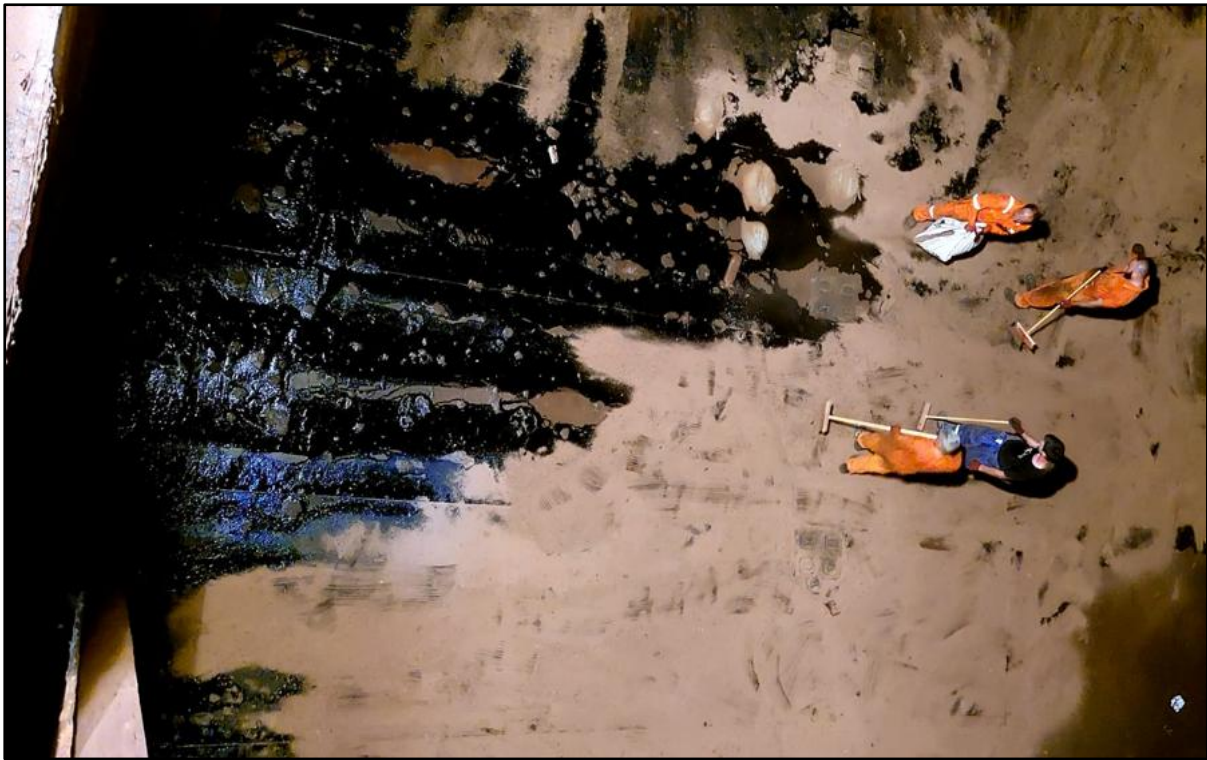
Figure 1.11-1 Crew cleaning up oil leakage in the cargo hold no.4

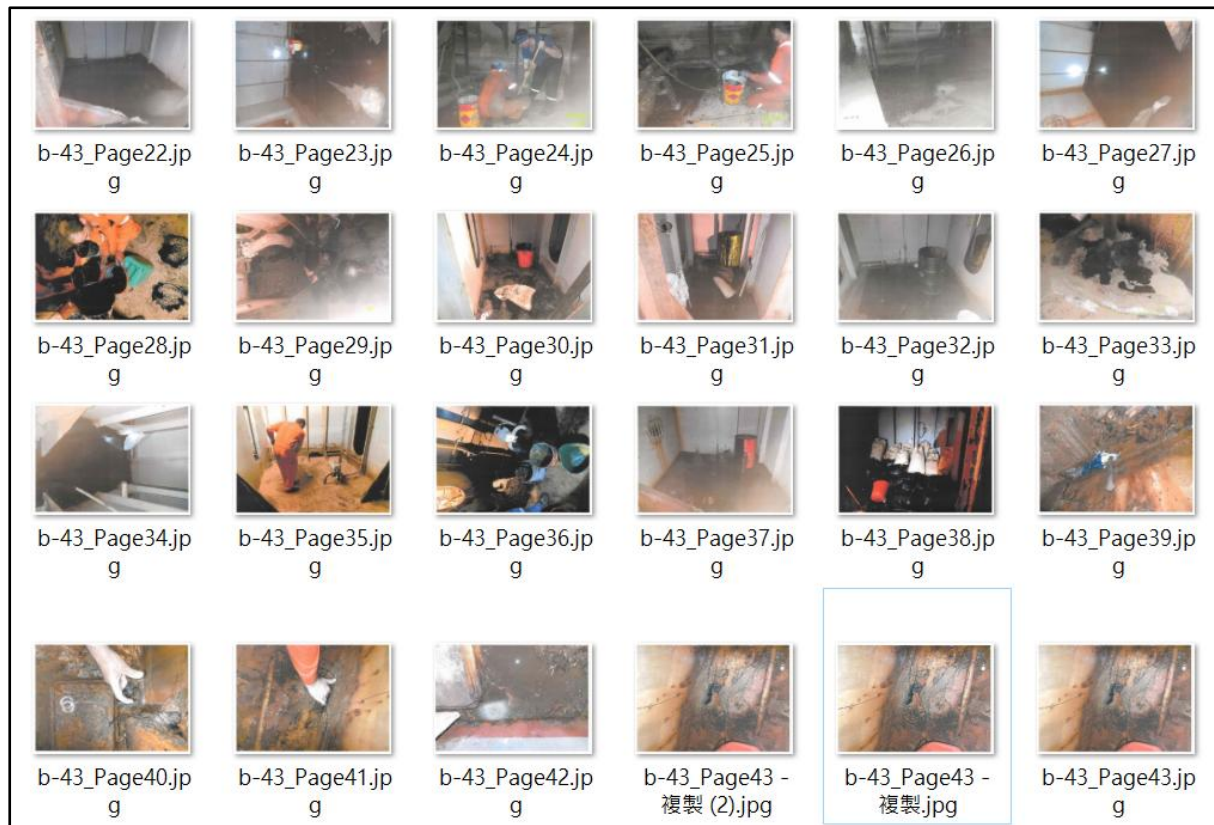
problems with the ship's hull condition, engine room equipment, company management, etc. was the same as AB A's statement, and photo evidence was provided. (refer to Figure 1.11-3).

Figure 1.11-3 Photos of damage and water accumulation in the cargo hold of the ANGEL, and corrosion between valves.

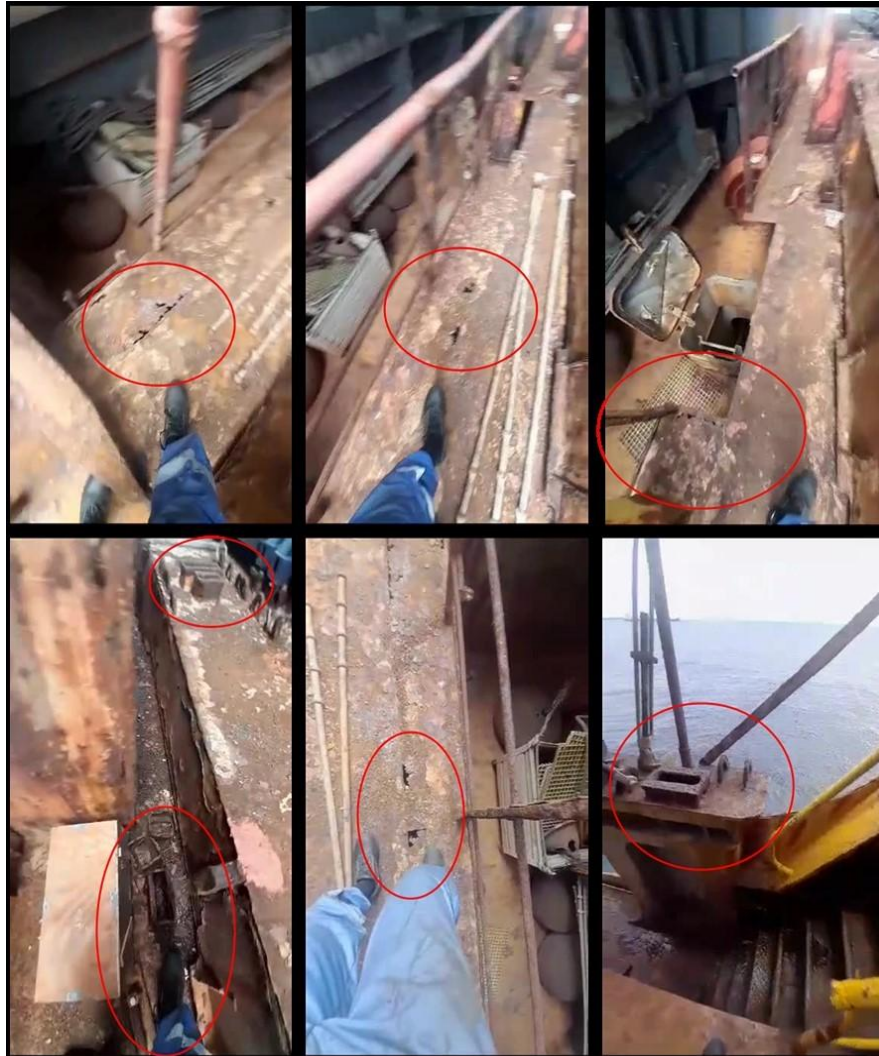
dialogue (foreign language translation) between the crew and the AB in the film shows them saying: "Everything is rotten and cannot be operated", and " There are some holes in the deck walkway between the cargo hold, and it may break and fall if you step on it", "It's like hell", "The cargo holds are full of water", "The rust problem is very serious", etc. (refer to Figure 1.11-4)

Figure1.11-4 Photos of holes and rust on the main deck of the ANGEL

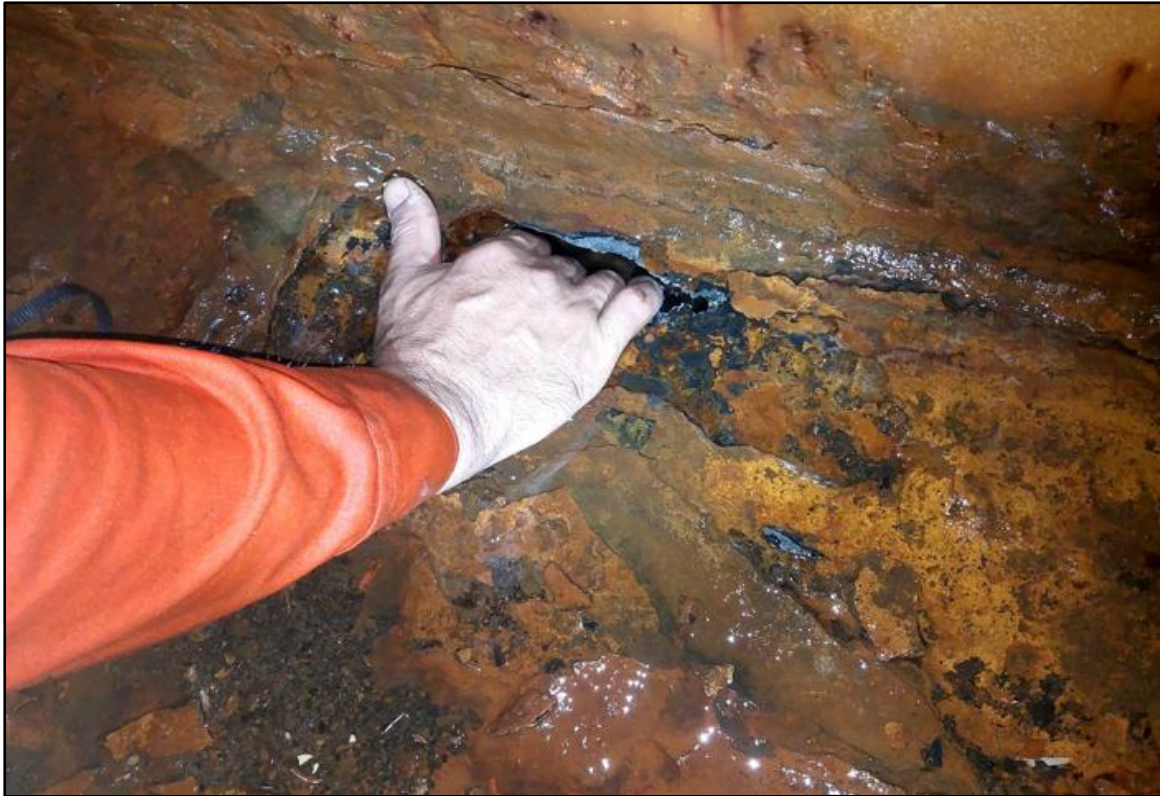
floor led to its rupture due to the pressure from the container weight. This caused ballast water from the ballast tanks beneath the no. 4 and no. 5 cargo holds to leak into the no. 4 and no. 5 cargo holds.

Figure 2.2-1 shows the appearance of the breached cargo hold bottom in the cargo hold no.3 of the ANGEL

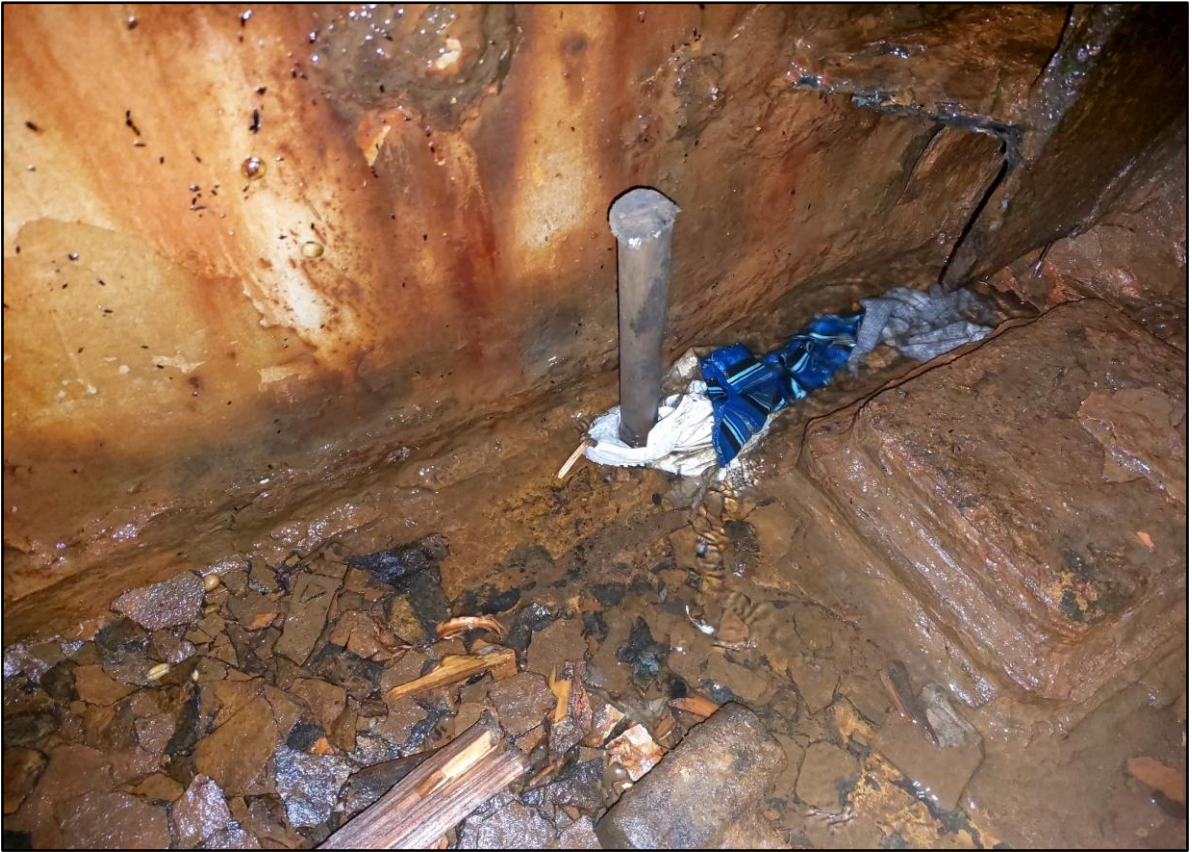
In summary, the ship's multiple sounding pipes were blocked, corroded, or broken, preventing the crew from measuring the ballast water quantities and calculating the ship's stability. Some of the corroded or broken sounding pipes and air pipes led to ballast water leaking into the cargo holds.

Figure 2.2-2 shows the ANGEL's crew using wooden plugs to temporarily seal the breaches in the cargo hold bottom sounding pipes.

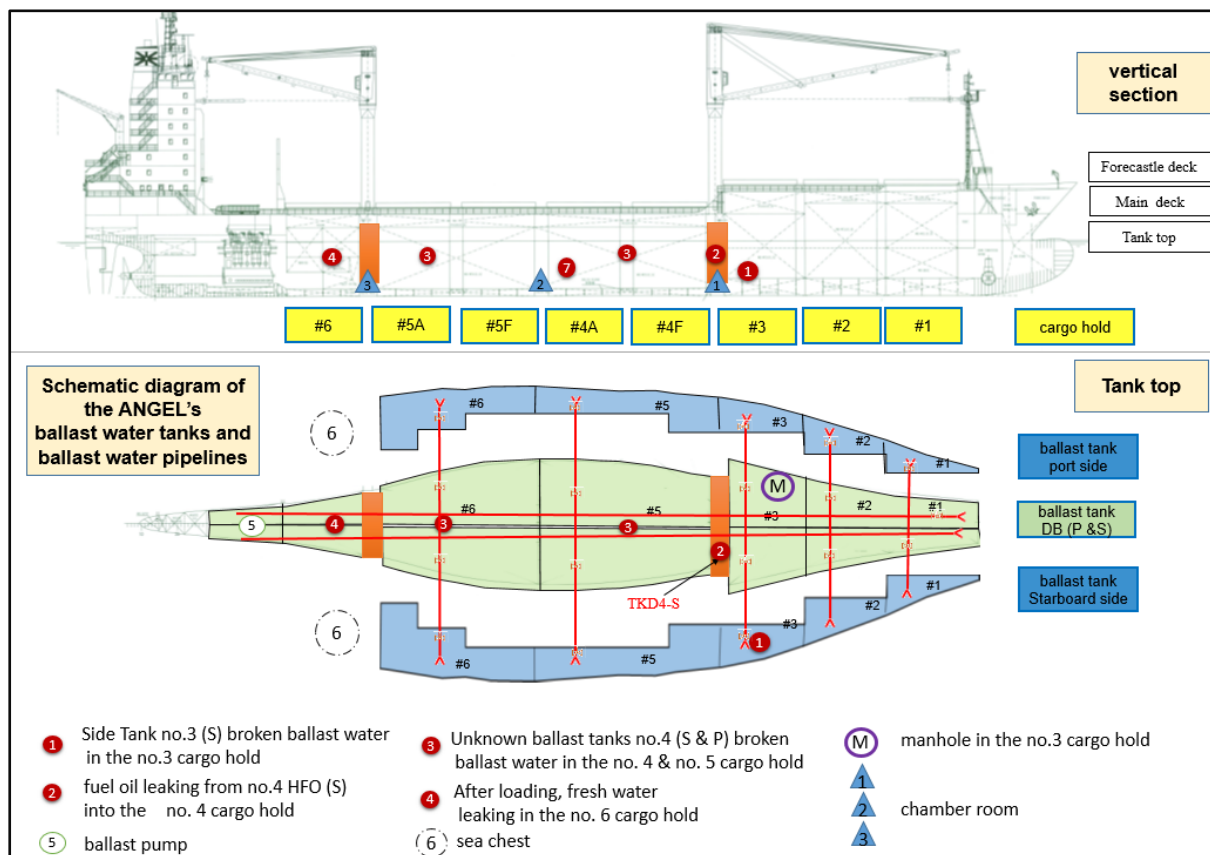
needed to adjust the ballast water levels, they had to manually operate the ballast water system between the valve chambers. the ANGEL's remote ballast water control system was malfunctioning. After departing from Dalian, the fully loaded cargo holds made it impossible for the crew to enter the cargo holds to handle the water ingress and leakage.

Figure 2.2-3 Illustrates the water ingress locations in the cargo holds of the ANGEL, as well as the locations of the ballast water tanks, ballast water piping, ballast water pumps, and sea chests.

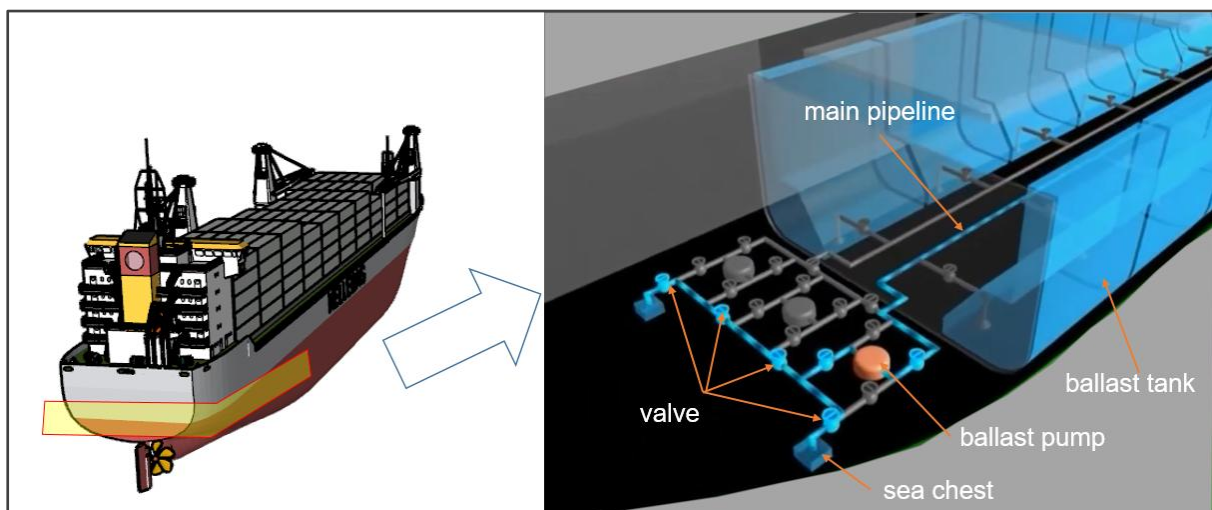
According to crew interview records, the ship's cargo hold bilge water system was inoperative, the bilge wells were blocked with debris, making it impossible for the crew to use pumps to drain the water in the cargo holds. The cargo hold bilge water system of a cargo ship is located at the pipeline extraction inlet of the cargo holds. In a cargo ship's cargo hold bilge water system, in addition to the valve controls, non-return valves (check valves) are also installed at the suction points in the cargo holds. If the non-return valves are not properly maintained, blocked by debris, or improperly operated, they may fail to close completely, allowing the external seawater to flow back into the cargo holds. According to the underwater hull inspection on July 14th, the divers did not find any puncture leaks in the hull. Therefore, it is very likely that the check valves of the ANGEL's bilge water system failed, causing the seawater outside the hull to enter the cargo hold from the sea chests through the bilge water system. The schematic diagram of the ANGEL's bilge water system and ballast water system pipelines is shown in Figure 2.2-4. (refer to section 1.11.8)

Figure 2.2-4 Schematic Diagram of the ANGEL's bilge system and ballast water system piping, ballast pump, valves, and Sea Chest.

In summary, the ship's bilge wells were blocked with debris, making it impossible to use the bilge water system's pump to drain the flooded water from the cargo holds. Additionally, the check valve in the bilge water system has failed, which is likely to cause seawater to flow back into the cargo holds through the bilge water system, resulting in further flooding in the cargo holds.

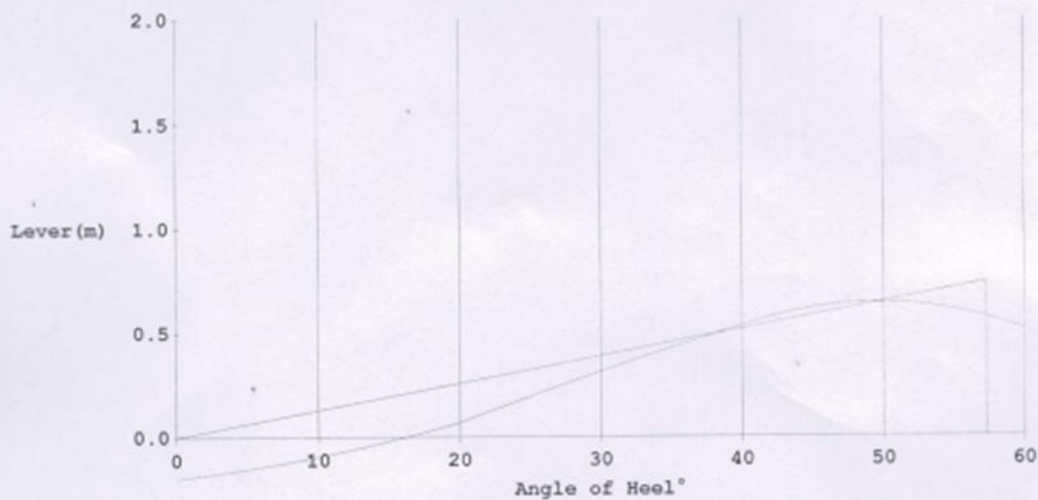
WARNING * GM is less than required minimum

WARNING * GZ Area to 30° < 0.055 M-Rads

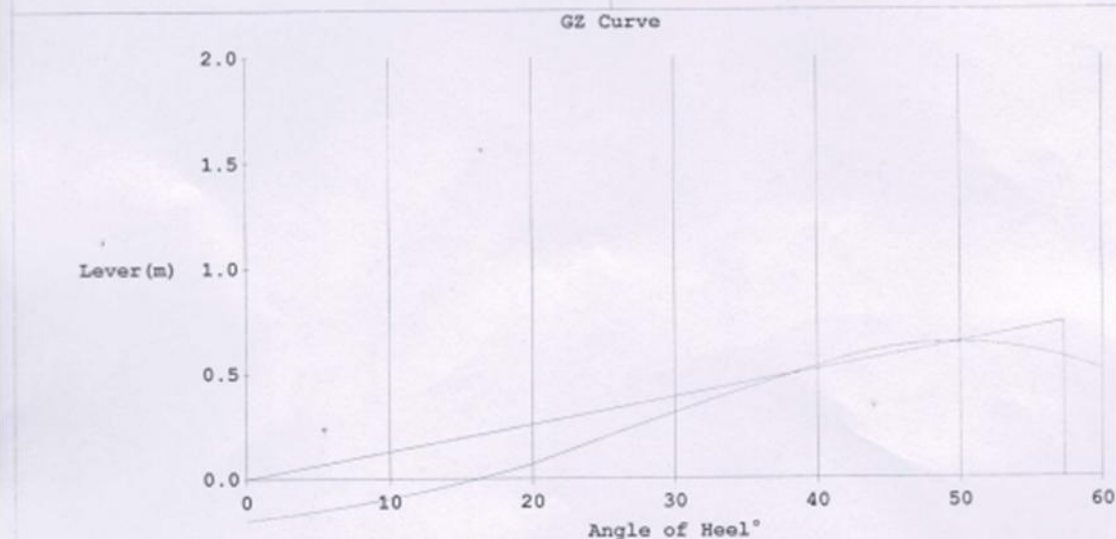
WARNING * GM is less than required minimum
WARNING * GZ Area to 30° < 0.055 M-Rads
WARNING * GZ Area to 40° < 0.090 M-Rads

Present situation,
Simulated water in Hold N° 4,5 ~ 4,400mt
