# Derailment with Airport Express train

RAIF Taiwan 21 – 24 October 2025

Mikael Hillbo, Senior Investigator Rail  
Swedish Accident Investigation Authority

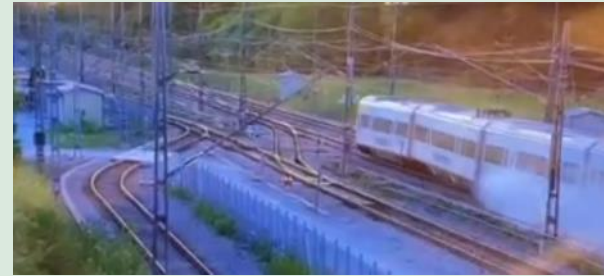
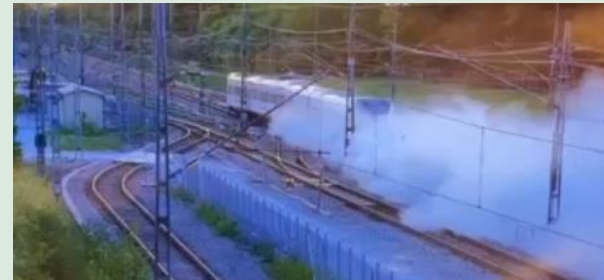
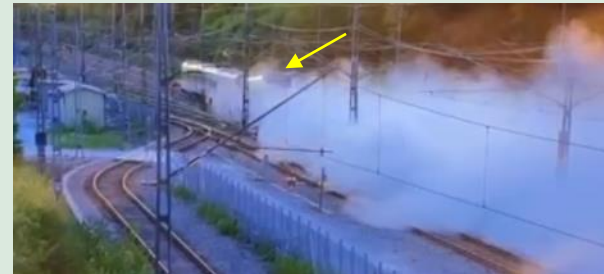
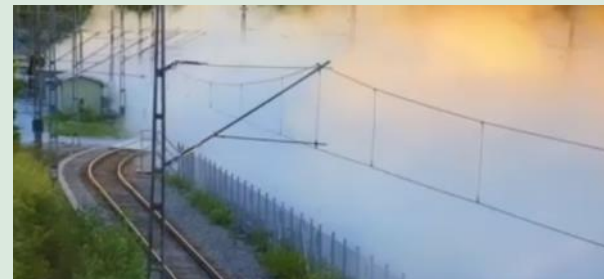
- A surveillance camera recorded the passing train
- Derailment occurred from axle seven
- Heavy smoke development from crushed ballast and concrete
- The derailed vehicles bounced over the subsequent switches

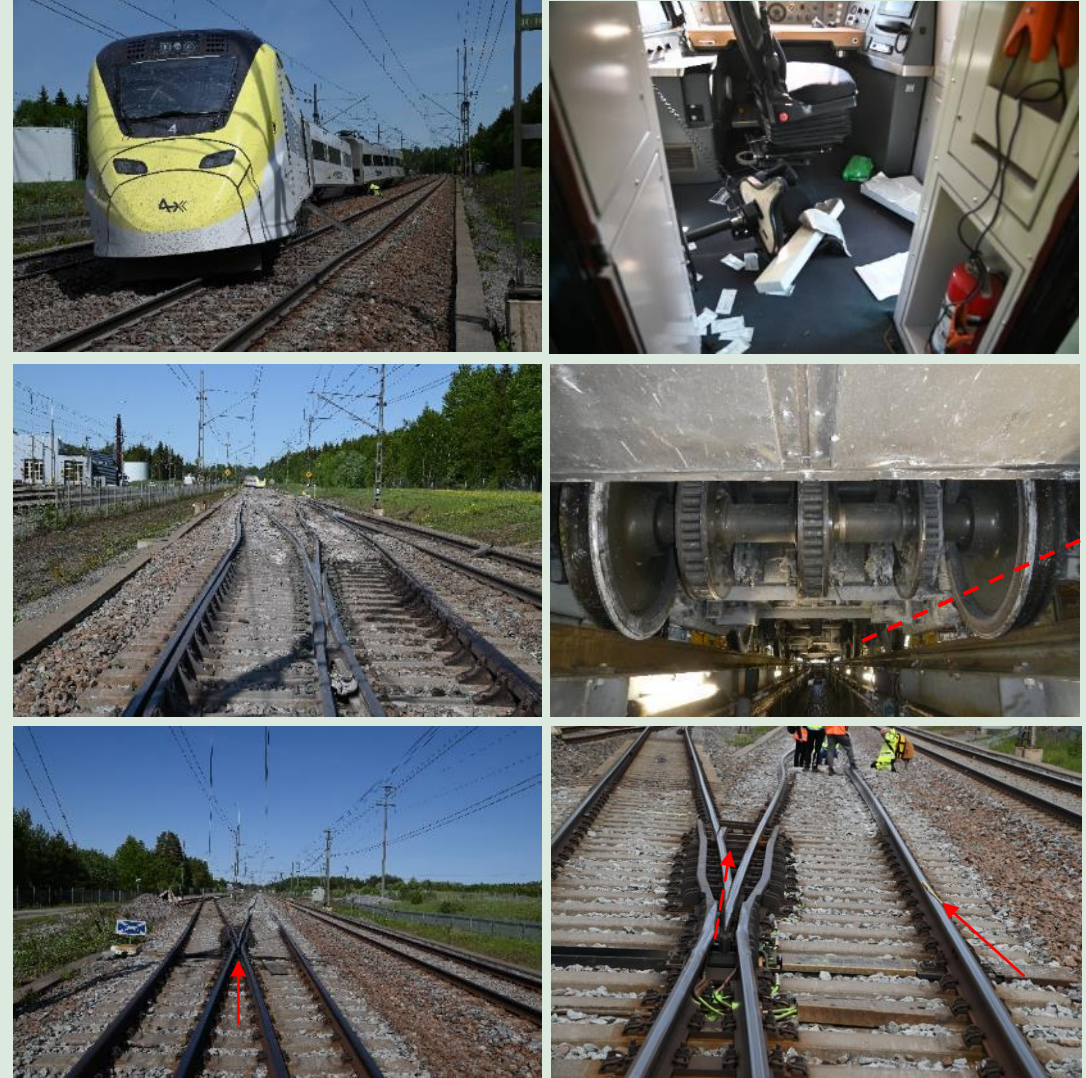
- Major damage to the derailed vehicles, but none that caused the derailment
- Significant damage to 900 meters of track and switches
- Bogie design guided the left rail
- In switch 106 – with movable crossing point – the crossing tip was in a middle position
- Marks parallel to the crossing where the right wheels had left the right rail

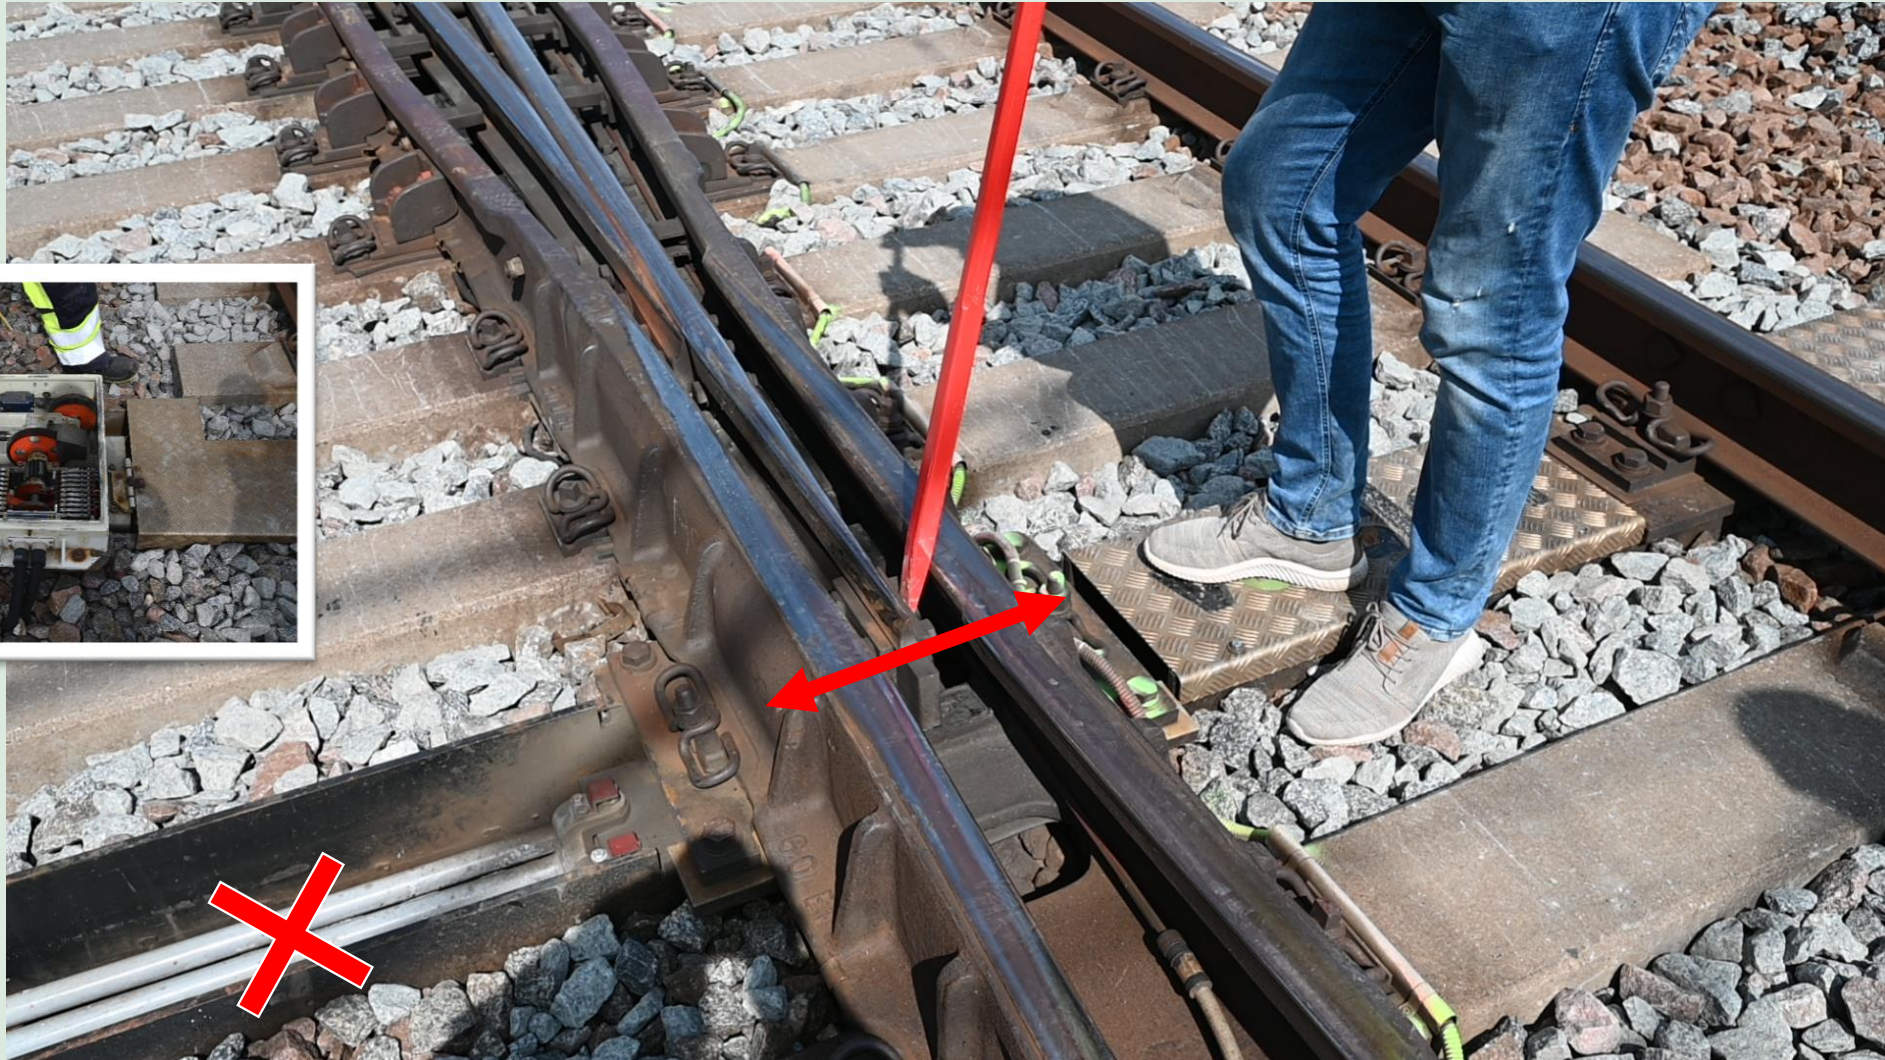
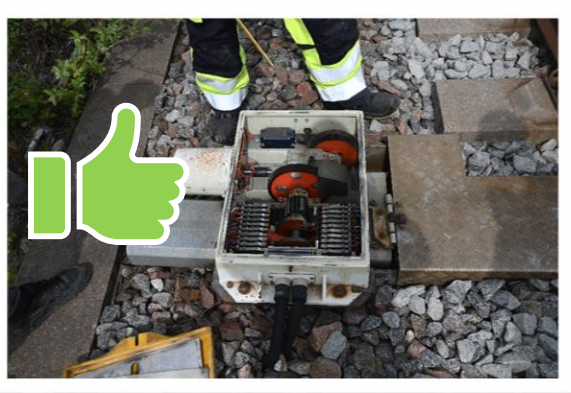
The drive connection plate beneath the moving crossing had broken

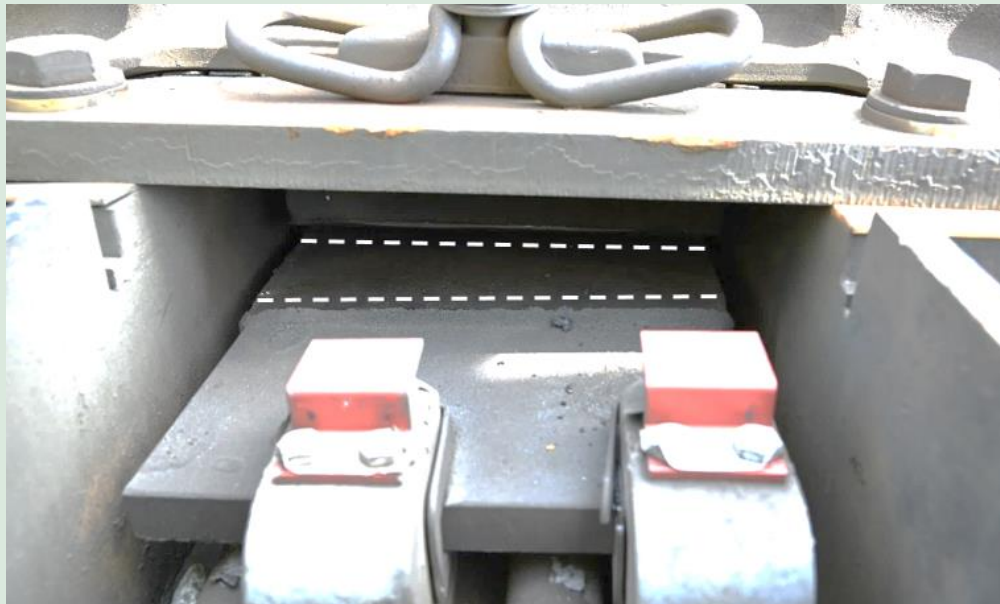
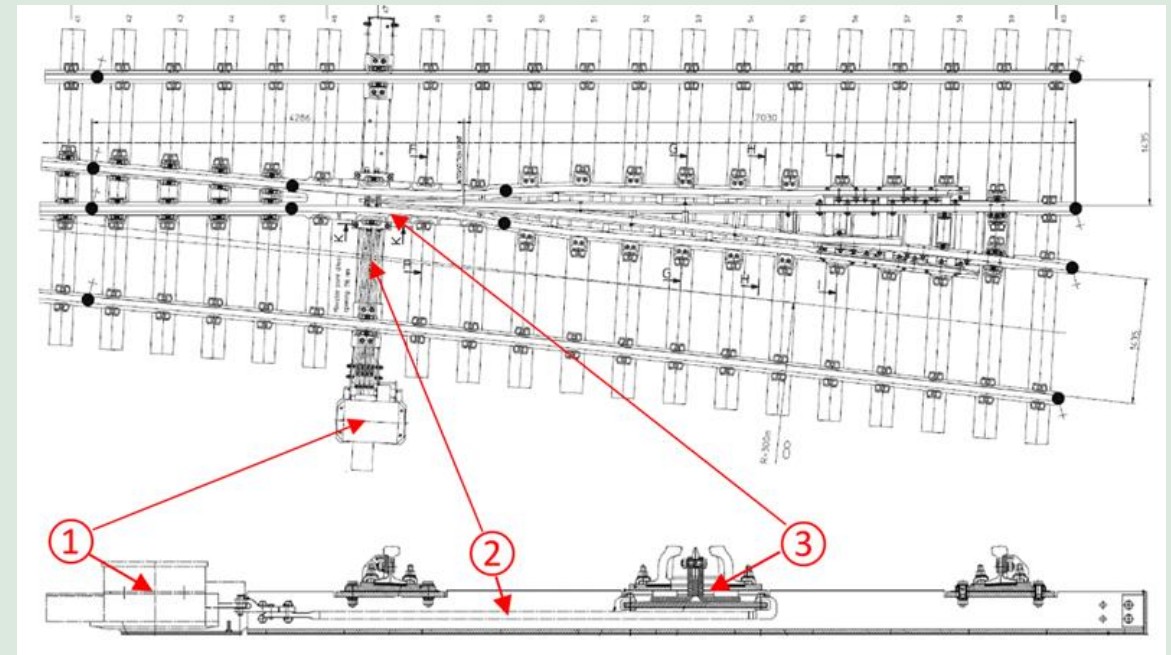
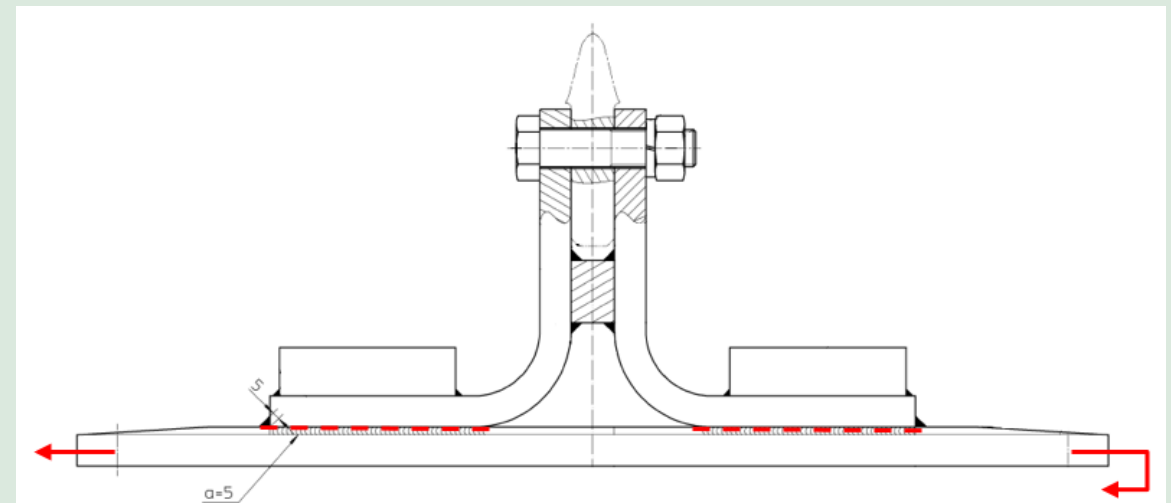
- A plate with two 90-degree brackets
- The brackets are welded to the plate
- Transfers force from the switch motor and pull rods to the movable crossing point
- Safety-critical function

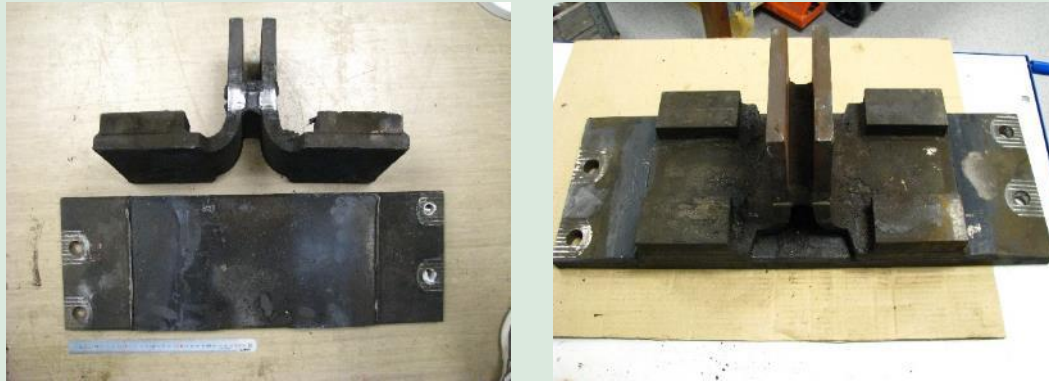
- The welds exhibited extensive fatigue cracks
- Final fracture in only half of the last weld
- Lack of fusion in the root of the four butt welds
- The welds were undersized compared to the drawing's specified 5 mm and did not meet the manufacturer's stated standard
- Lack of fusion also in the reference switch 103, but without signs of fatigue or cracks

- The direct cause of the derailment was the displacement of the movable crossing due to the failure of the weld joints on the drive connection plate
- Dynamic load cases from passing wheels and axles had caused fatigue cracks in the weld joints of the drive connection plate
- At the system level, the drive connection plate was not designed for the load cases and conditions present in switch 106
- Additionally, the rules and procedures for safety inspections and maintenance were not designed to identify and address deficiencies in the weld joints of the drive connection plate

- Investigate whether weld joints in newly manufactured drive connection plates should be dimensioned for dynamic load cases to minimize the risk of fatigue cracks and fractures
- Review and follow up on rules and procedures to ensure that welding work meets requirements and standards

- Examine drive connection plates using volumetric testing to ensure that the weld joints meet established requirements and to detect any hidden defects in load-bearing welds
- Review governing documents to ensure that weld joints in drive connection plates for movable crossings within the Swedish Transport Administration's infrastructure are inspected to the required extent to minimize the risks of fatigue cracks and fractures

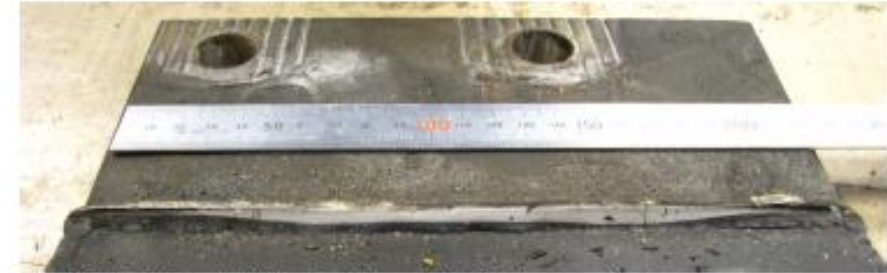
Figur 4. Svets 1 i ankomstsblok, ljusgrå del av sprickytan bedöms som restbrott.

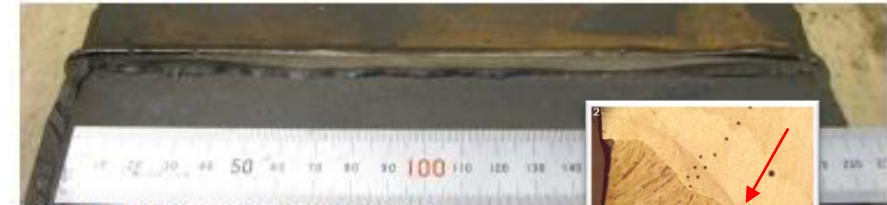
Figur 5. Svets 1 efter kapning och rengöring av plattan.

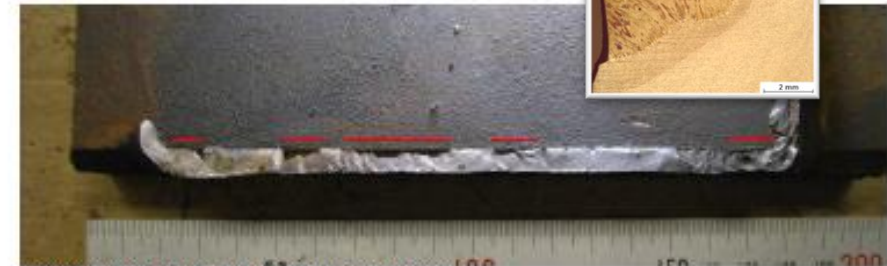
Figur 6. Svets 2, med de mest uppenbara rotfelen markerade.

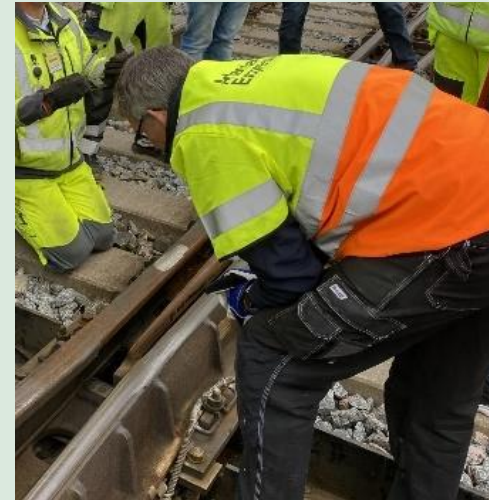
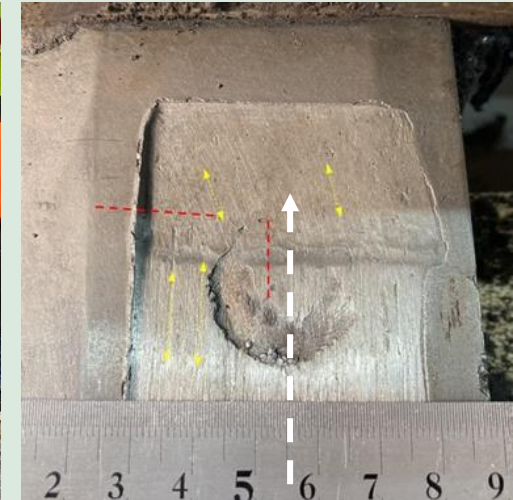
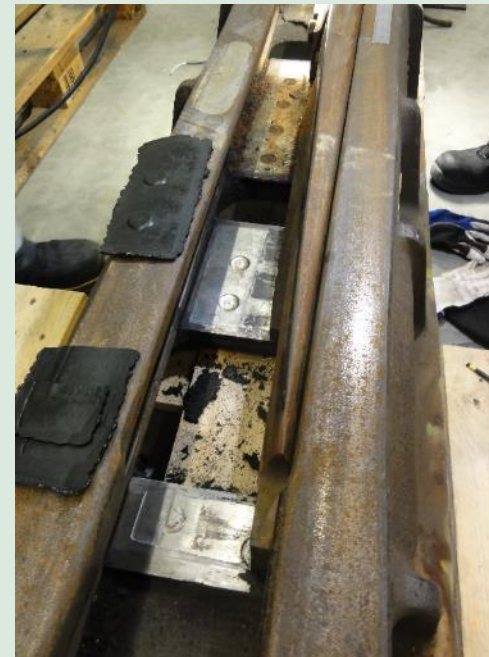
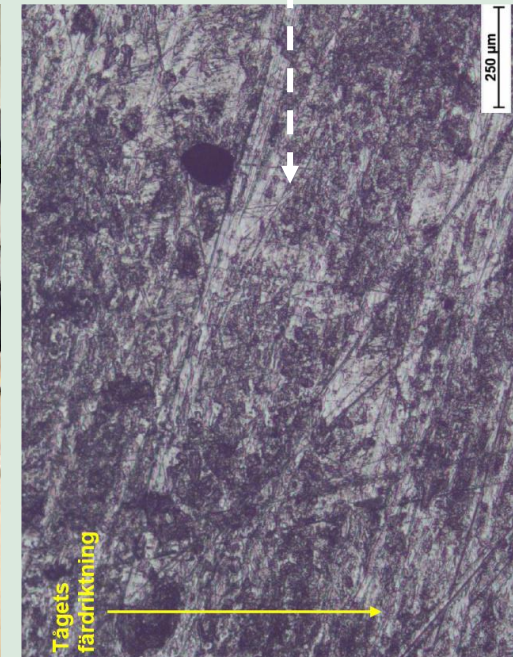
- Review of the crossing section together with our appointed metallurgical expert and specialists from the Swedish Transport Administration
- In-depth investigation of the crossing section in our workshop
- Molding of the plates under the moving crossing for microscope examination
- Diagonal marks on the plates clearly indicates the presence of movement and dynamics in the moving crossing
