# Passenger Train Derailment on Pingxi Branch Line

Jackie Chen  
2025.10.23

On February 12, 2024, Taiwan Railways Corporation, Ltd. (TRC) local train No. 4816, consisting of four cars, experienced a derailment after departing Lingjiao Station on the Pingxi Branch Line. The first and second axles at the front end of car No. 3 derailed.

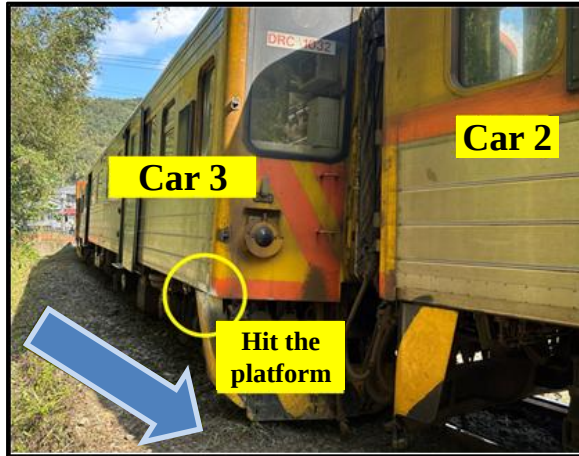
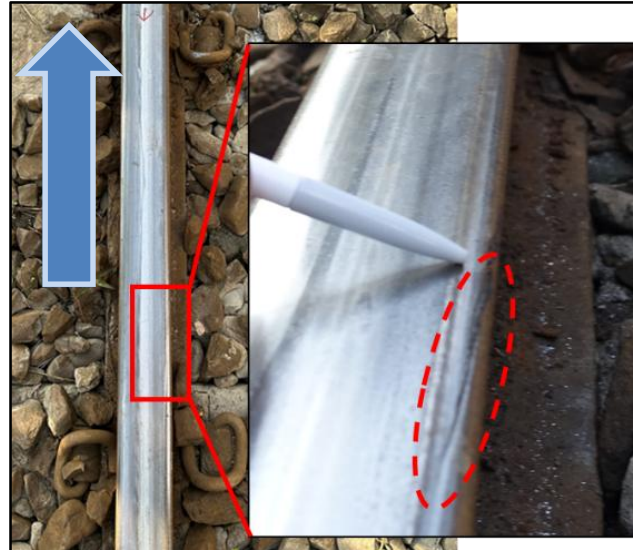
Left

# Accident Scene

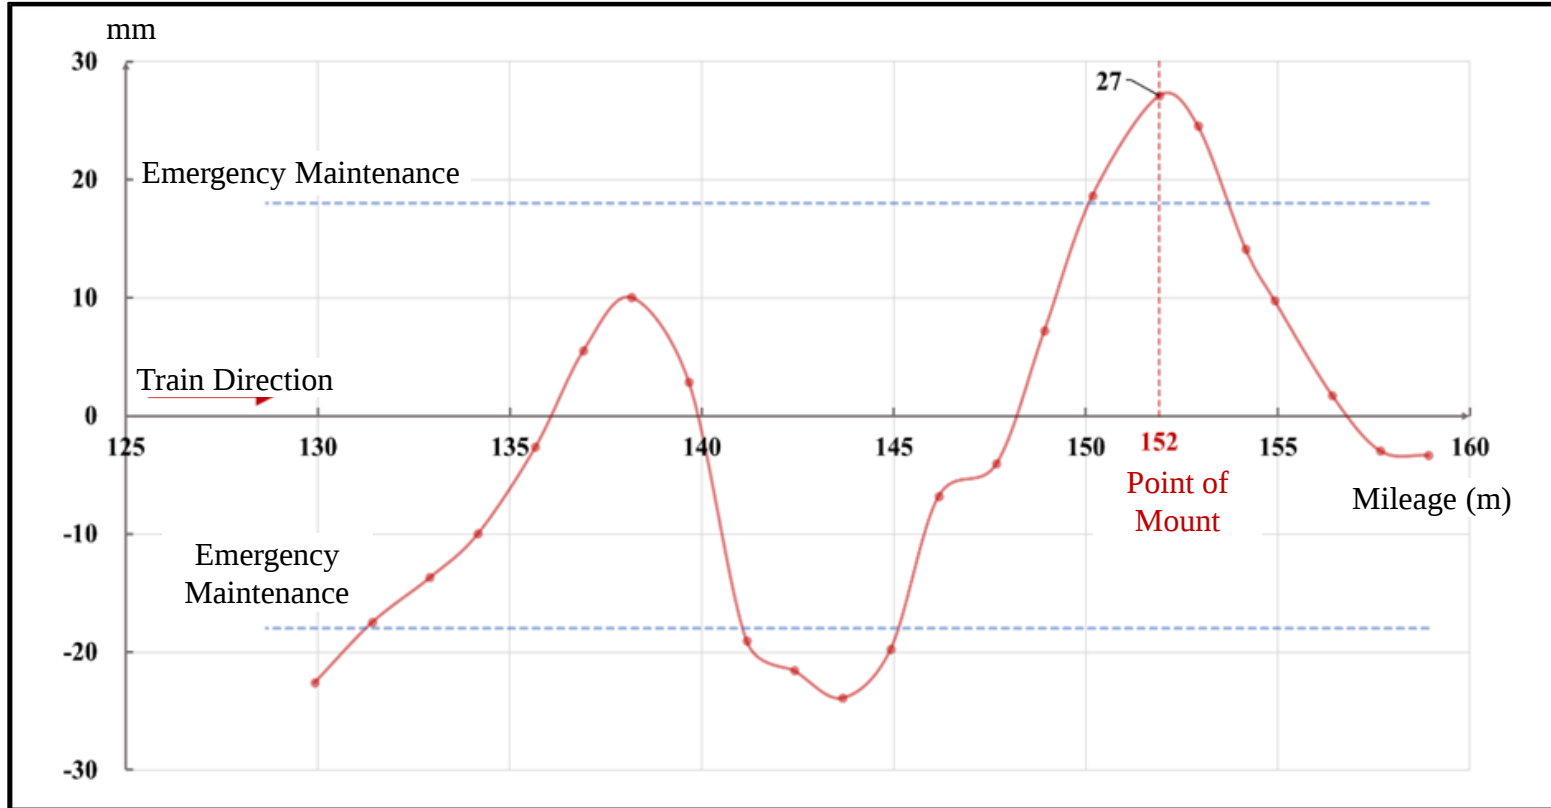
# Static Twist

Poor track geometry (Twist)

- Evaluate incorporating wheel load as a vehicle maintenance indicator and **establishing a wheel load management system.**
- Improve **drainage functionality** along the Pingxi Branch Line.
- Establish **repair deadlines** for rectifying track irregularities exceeding emergency maintenance thresholds and **reinforce post-maintenance inspection procedures.**
- Review and improve **rail wear inspection methods** to ensure compliance with regulatory standards.

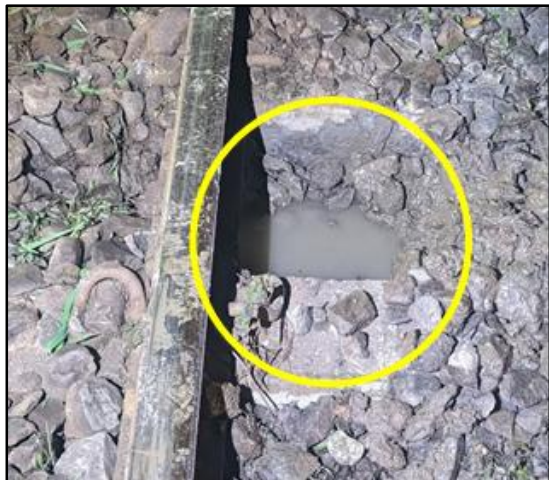
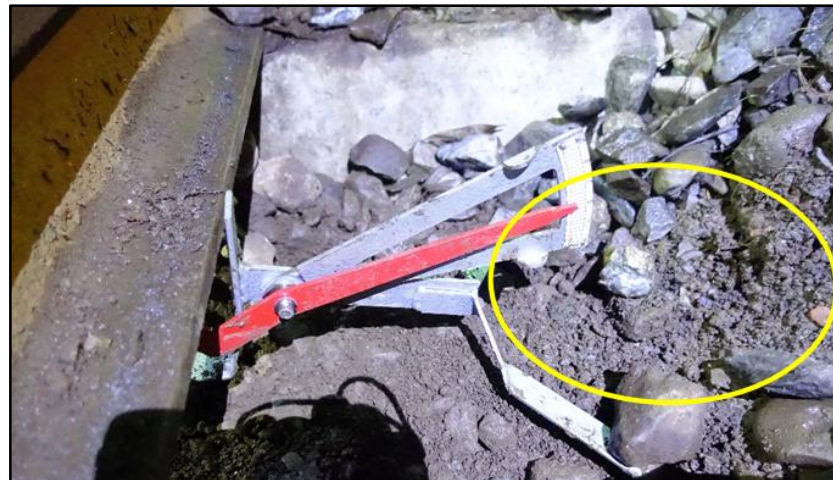
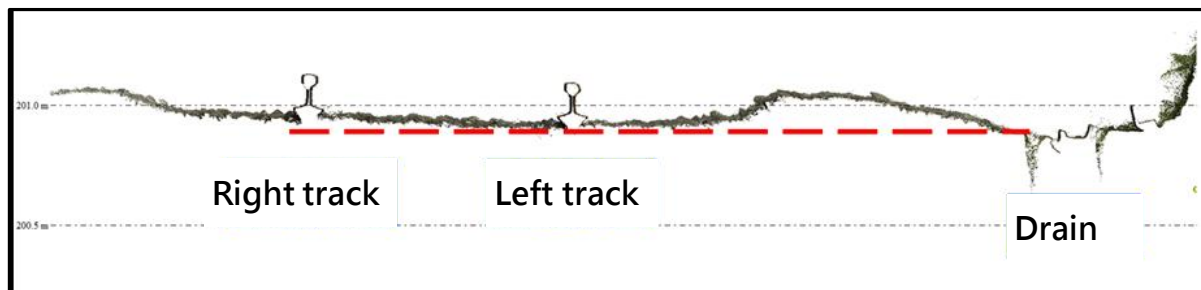
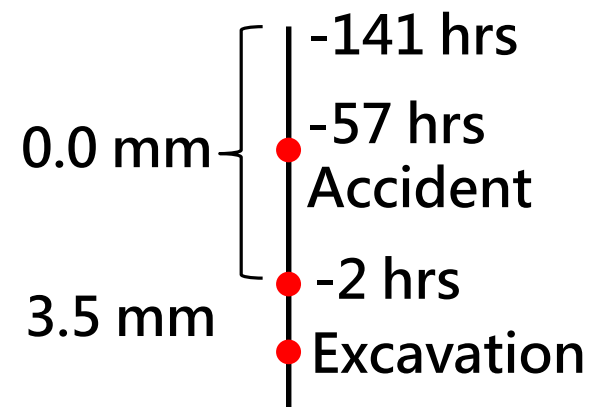
# Ballast

- Post-maintenance inspections are conducted only at isolated points
- No established time limits
- Ineffective drainage

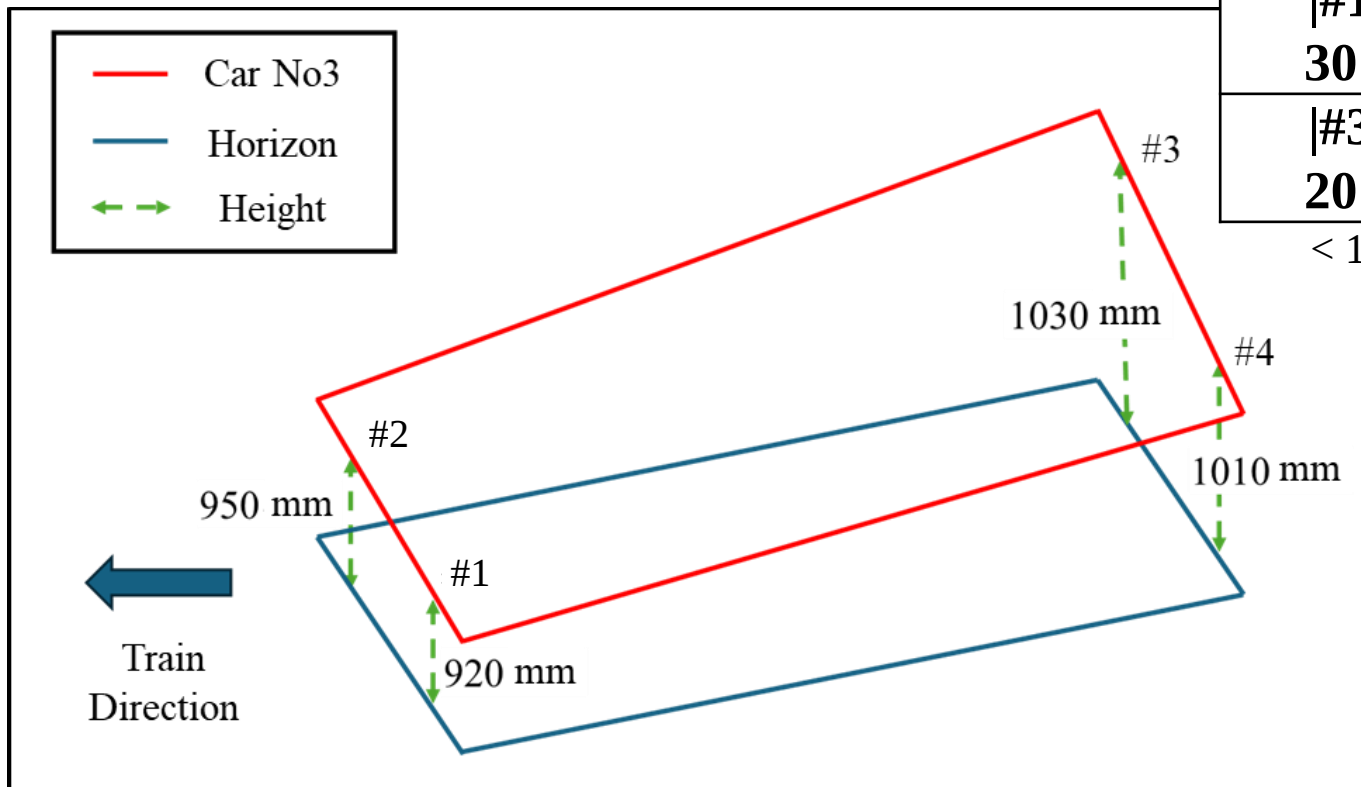
# Car Level

| Left – Right<br>Difference | Diagonal<br>Difference |
|---|---|
| $ \#1 - \#2 $<br>30 mm | $ \#2 - \#4 $<br>60 mm |
| $ \#3 - \#4 $<br>20 mm | $ \#1 - \#3 $<br>110 mm |
| < 10mm | < 20mm |

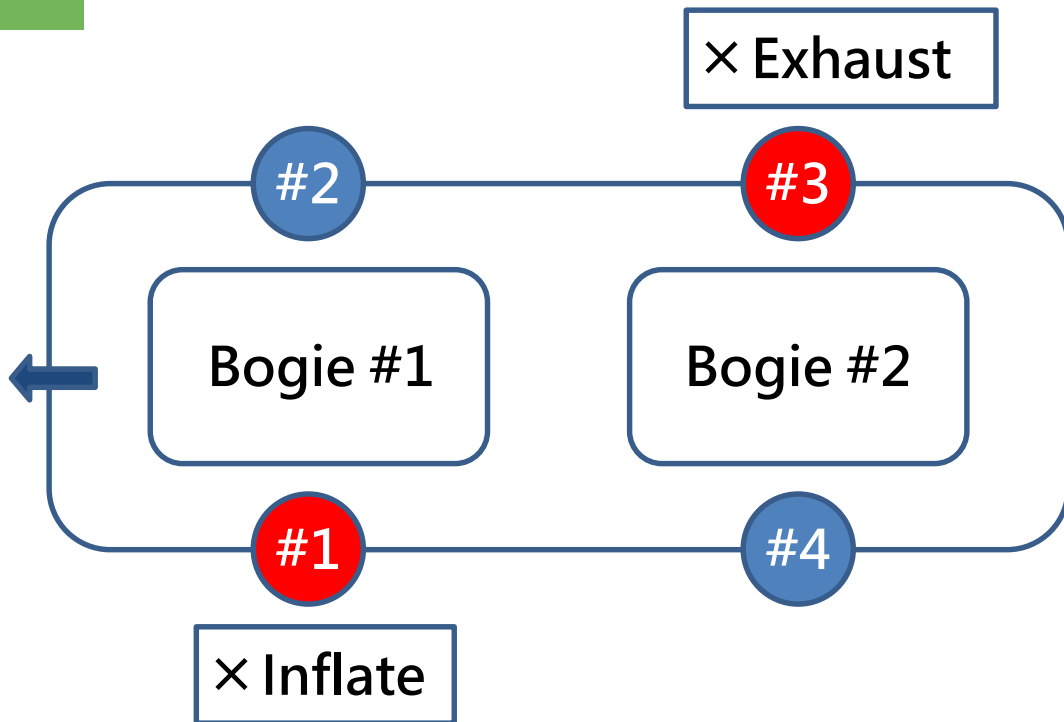
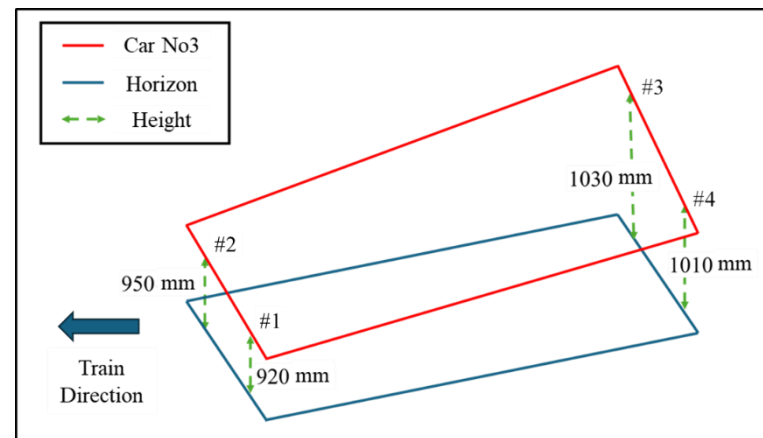
# Leveling Valve

Malfunction of the air spring leveling valves (#1 & #3)

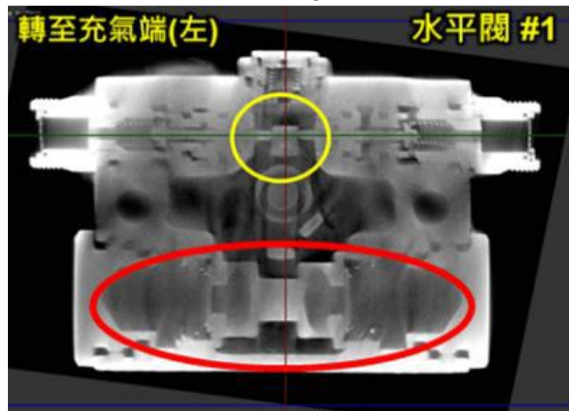
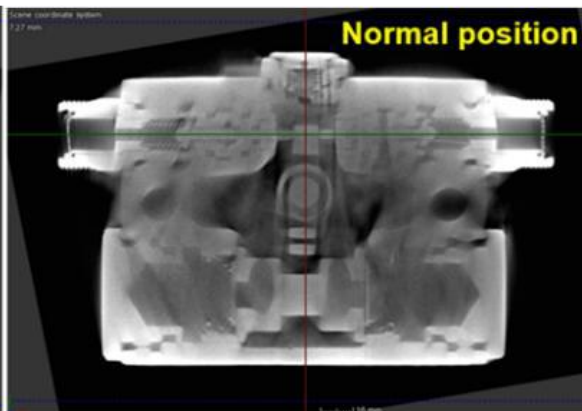
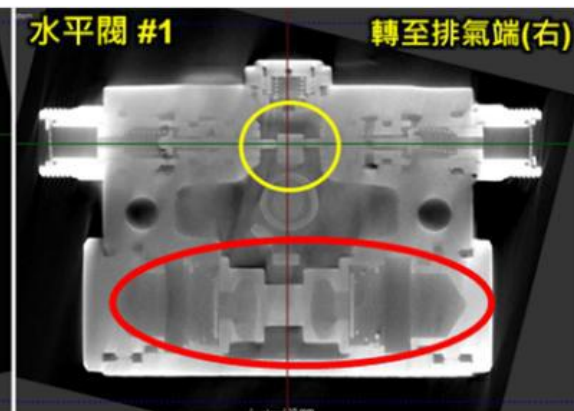
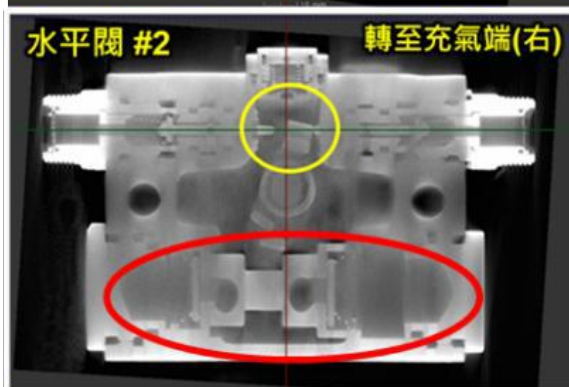
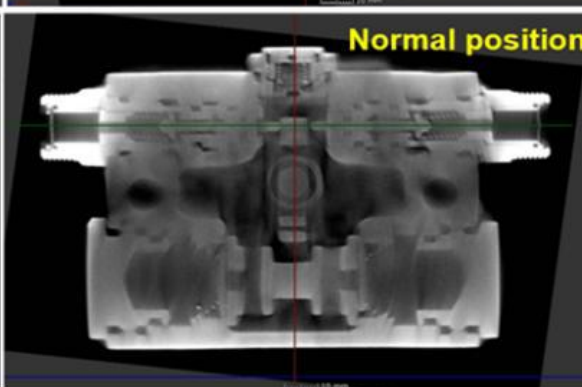
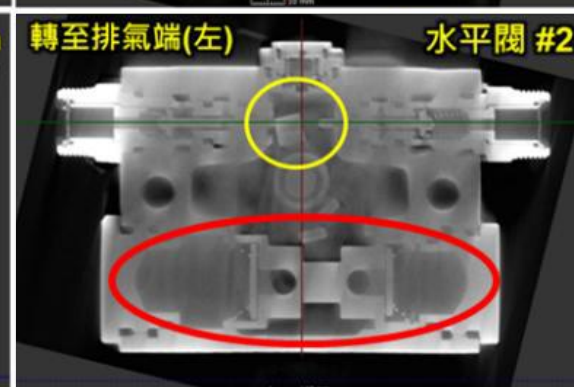
# Leveling Valve Failure Analysis

- Rust → Chips → Piston stuck → Leveling valve failure

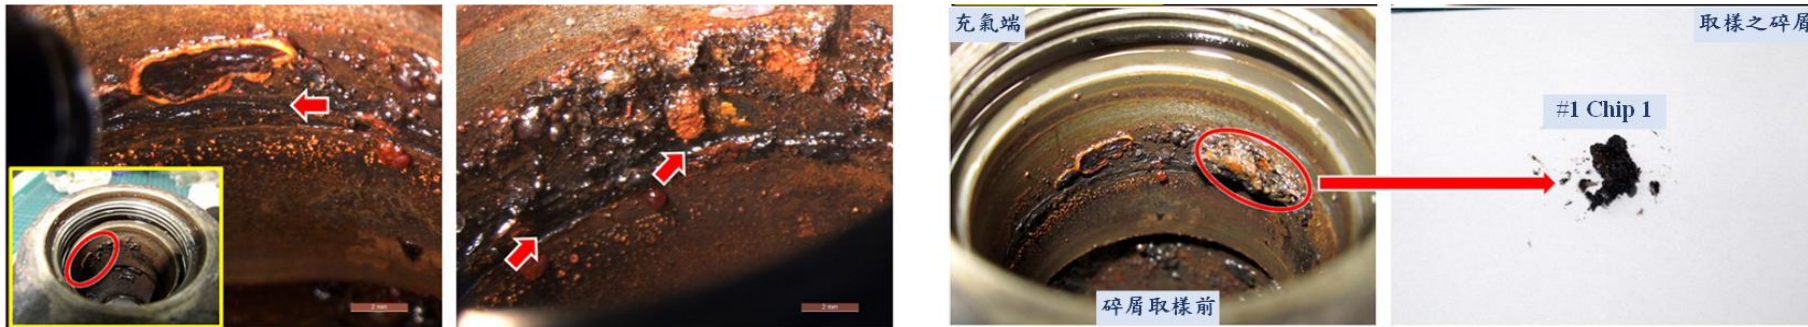
- Chips contain non-metallic elements
  - C、O → Metal corrosion
  - Si → Silicon oil
  - Small amounts of corrosive element: S → From outside

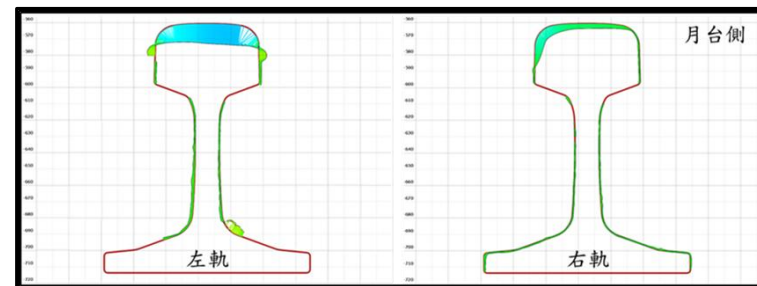
- The TRC's inspection systems are **unable to detect** the reduction rate of **rail cross-sectional area**, from Category A inspections to routine track patrols.
