# Tosa Kuroshio Railway Nakamura Line, Train derailment accident

Japan Transport Safety Board

Accident Type : Train derailment

Date and Time of Occurrence : June 2, 2023 at around 08:58 a.m.

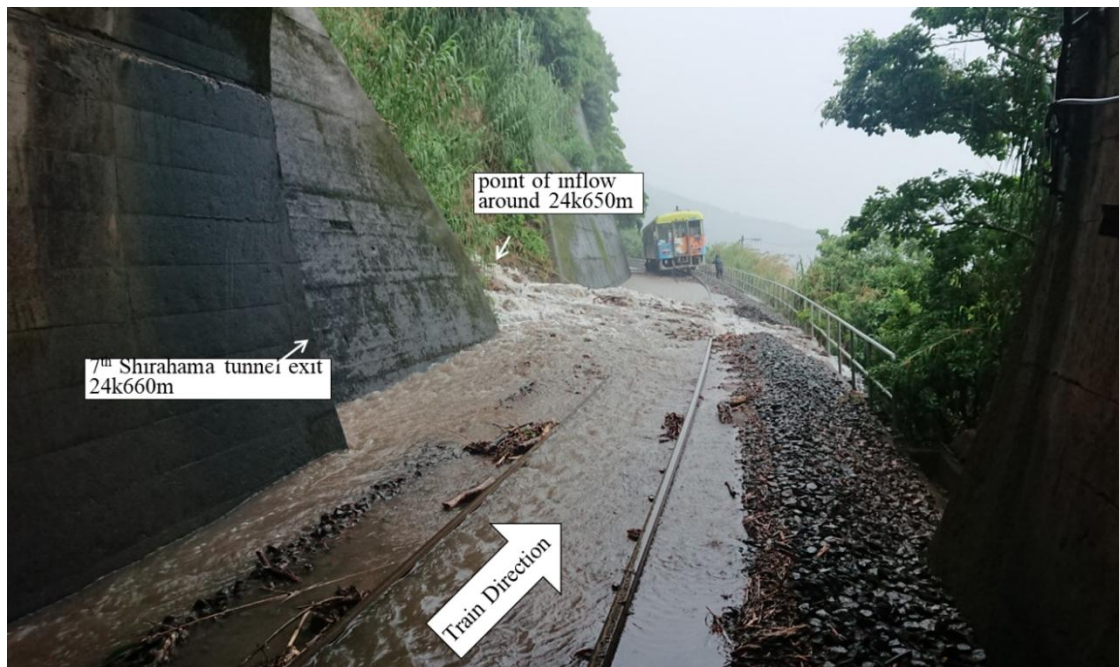
However, the train climbed onto the mud and sand at the same time as the brakes were applied. After the train ran over the sand, it continued for about 50 meters before coming to a stop. All two axles of the front bogie of the train had certainly derailed. There were no passengers on the train, and one driver and one track maintenance worker were on board, but they were not injured.

< Mud and Sand Inflow (Day of Accident) >

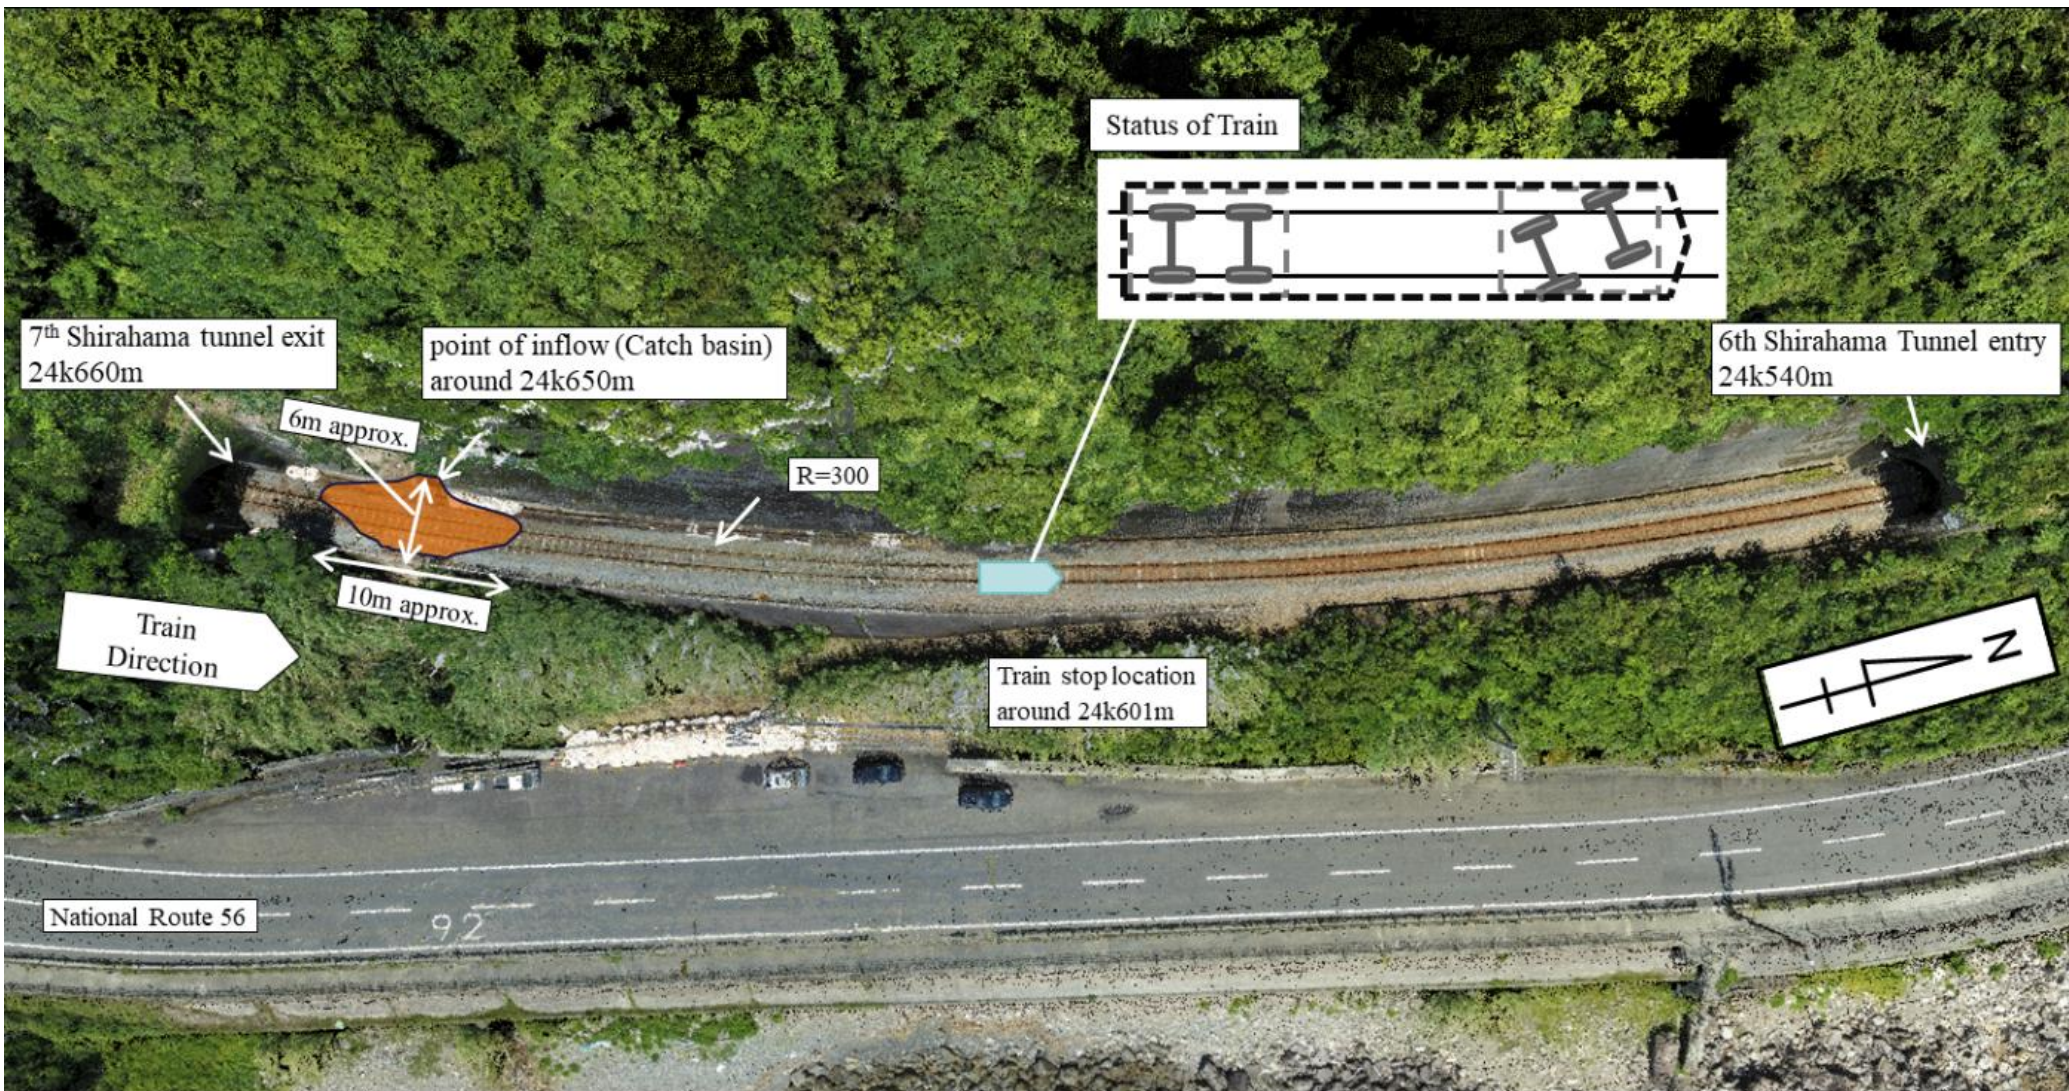
\* Images taken by drone and 3D scanner

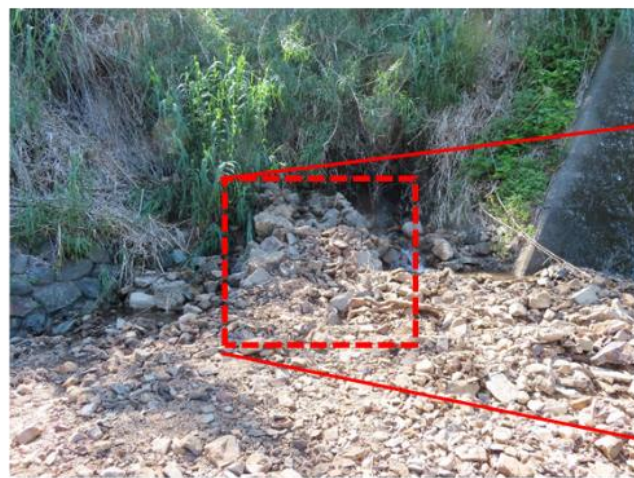
b: Photo taken on day after accident

It is probable that the slope collapsed because the slope was steep and the weight of the slope surface increased due to the rapid rainfall, causing the slope to become unstable.

It is probable that it was difficult to predict the collapse of the slope in advance and take steps to prevent the accident in advance.

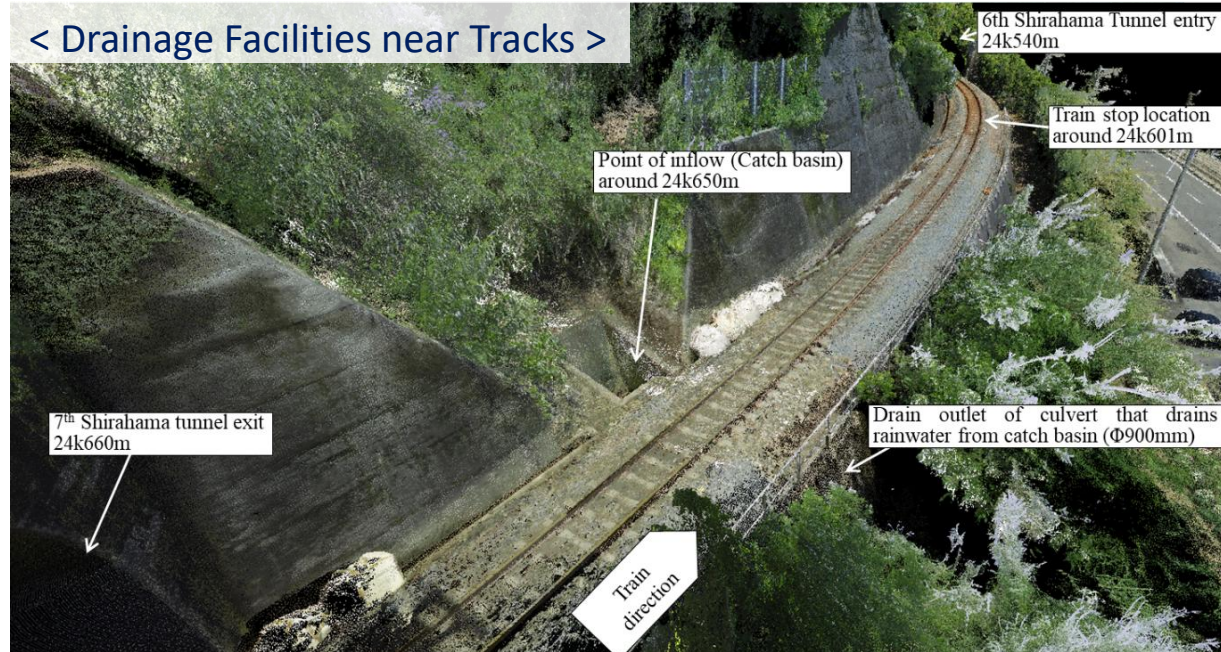
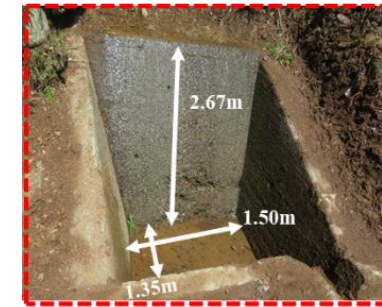
c Photo taken after removal of mud and sand

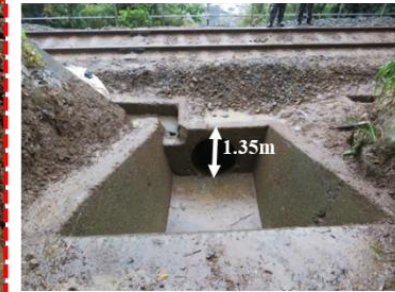
d Photo taken after removal of mud and sand
