Taiwan Transportation Safety Board

Factual Data Report

Boeing 747-8F, N613UP

**Engine Nacelle Strike during Landing at
Taipei/Taiwan Taoyuan International Airport**

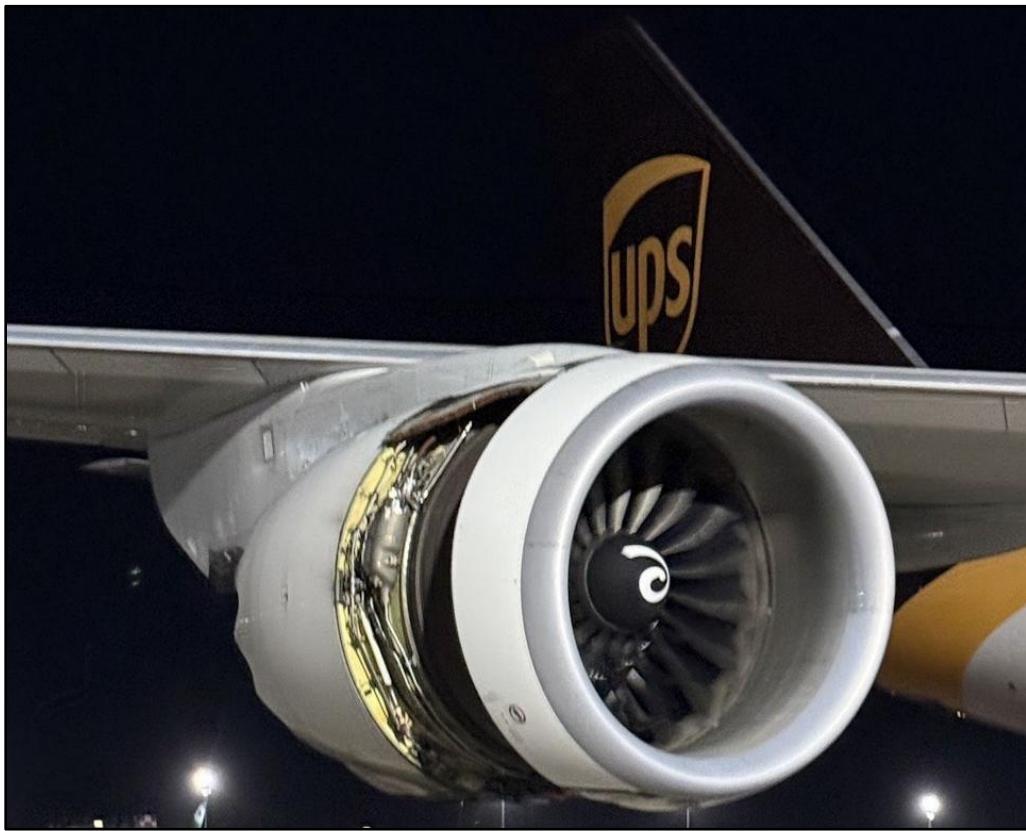
Figure 1.1-1 External appearance of the damage to No. 4 engine

During the post-landing walk-around, the crew discovered damage on the No. 4 engine and notified RCTP tower of the occurrence. Figure 1.1-1 shows the external appearance of the damage to No. 4 engine, while Figure 1.1-2 illustrates the FDR flight path of the occurrence flight.

The occurrence aircraft sustained damage to the lower portions of the No. 4 engine, the No. 4 engine nacelle, and the No. 3 engine nacelle as a result of ground impact. Subsequently, separated components caused minor damage to the right wing and fuselage. Detailed information is provided in Section 1.12.1.

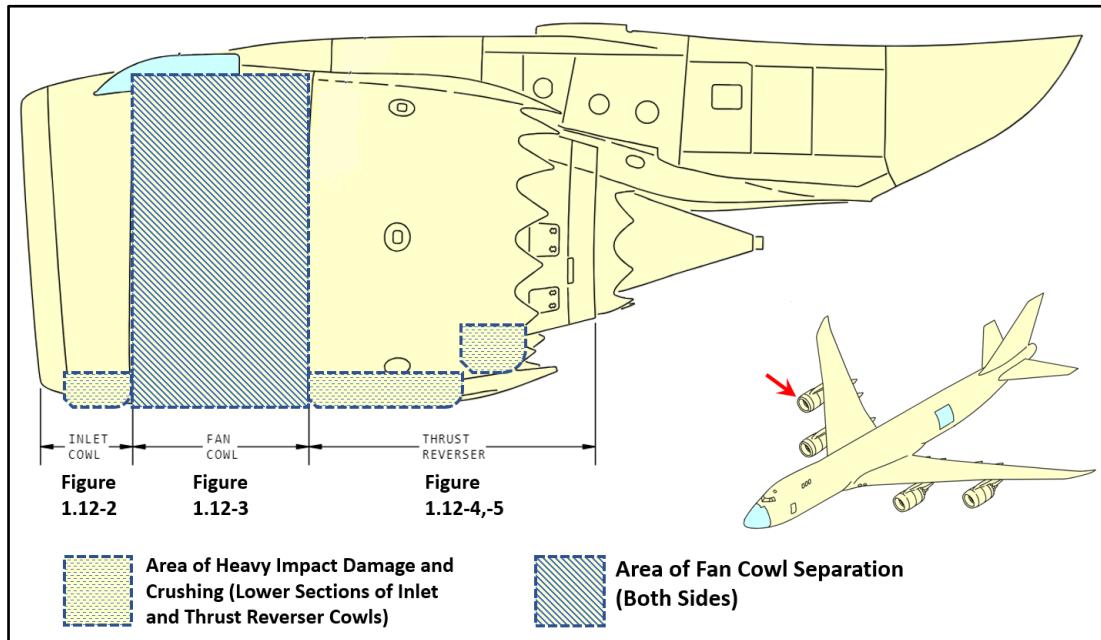
Figure 1.12-1 No. 4 engine nacelle damage areas

The nacelle consists of the inlet cowl, fan cowl, and thrust reverser cowl. Following the occurrence, the inlet cowl remained attached to the engine, and the thrust reverser cowl remained attached to the pylon; however, both exhibited impact and abrasion damage on their lower surfaces due to ground contact.

The No. 4 engine itself was compressed by the displaced inlet and thrust reverser cowls. The thrust reverser channel, attached to the aft portion of the fan case, was found fractured and separated. Several tubes and support brackets located in the lower section of the engine were deformed due to compression. Notably, the air starter was forced upward, causing a crack in the aft face of the accessory gearbox casing.

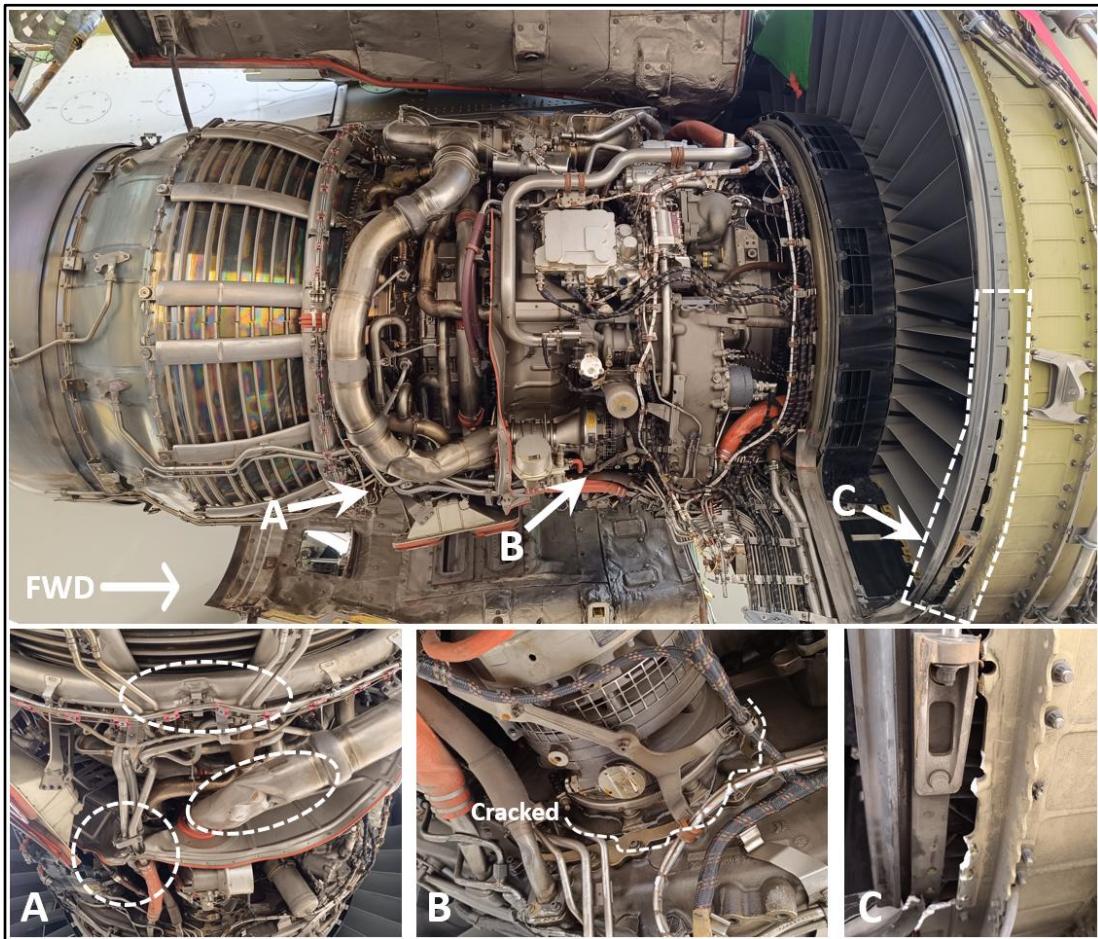
Figure 1.12-5 No. 4 engine damage areas (right side view)

Although the lower portion of the engine sustained damage, data recorded in the FDR indicates that the No. 4 engine continued to operate normally until it was shut down after taxi-in. The data also indicated that, following the ground impact, the engine oil quantity was approximately five quarts lower than that of the other engines.

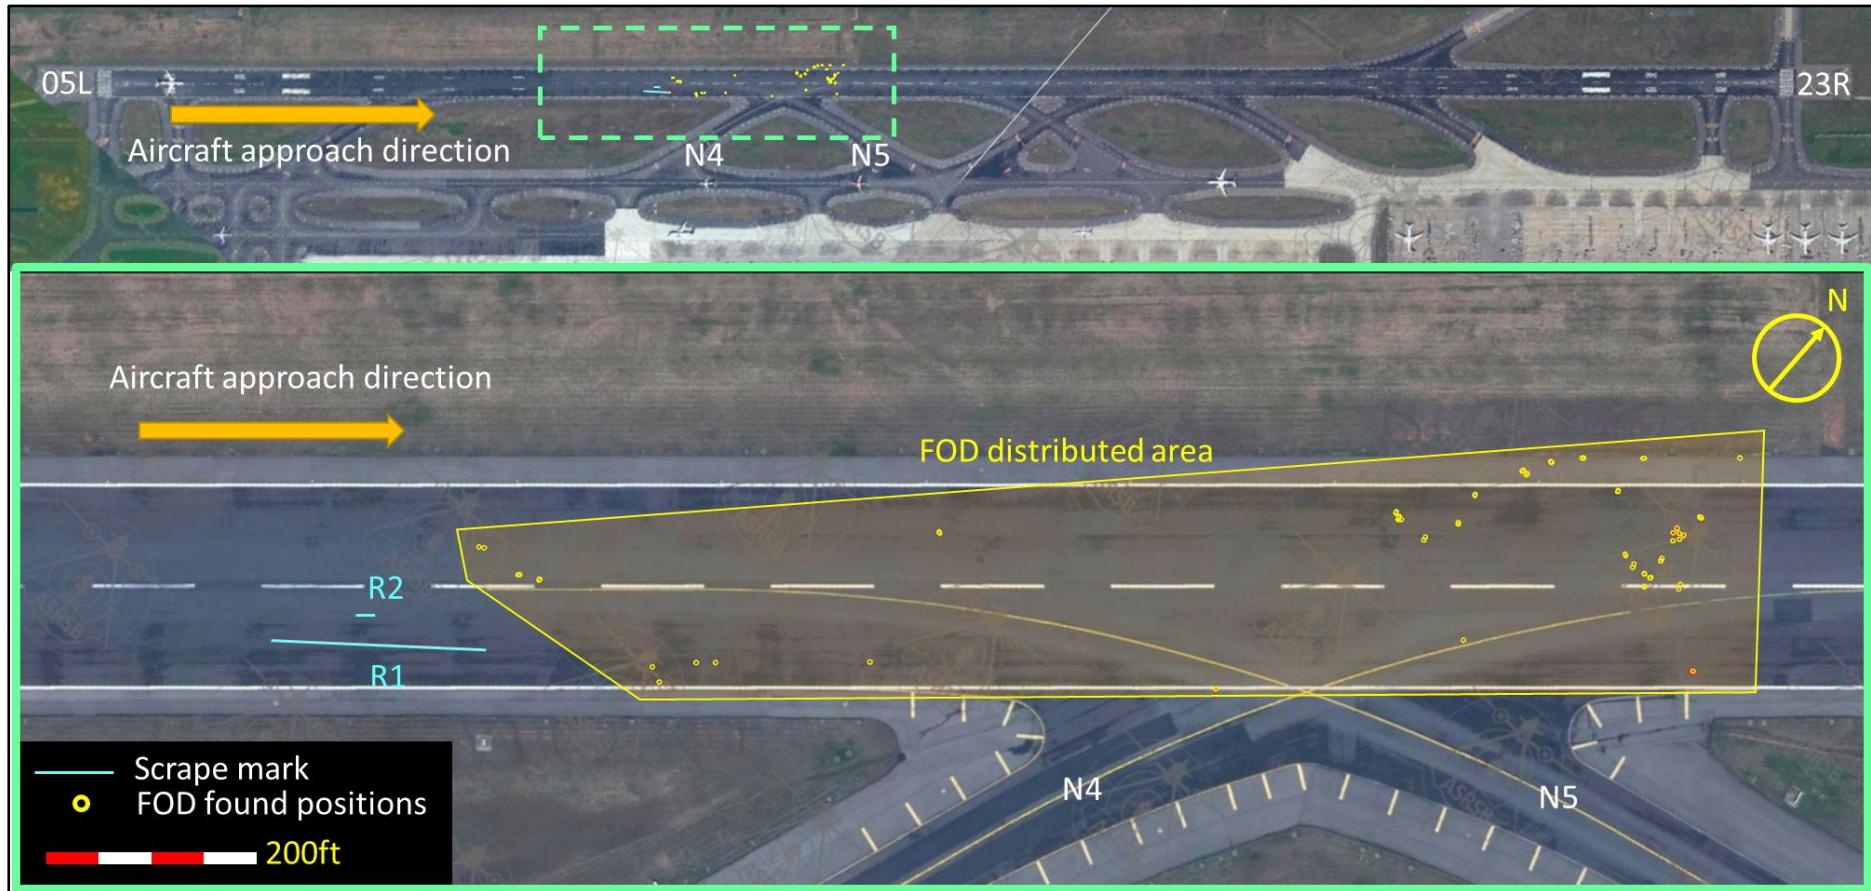
Figure 1.12-6 Distribution of site survey items on Runway 05L

No.	Site survey item	Distance from Runway 05L threshold (ft)	Length (ft)
1	Scrape mark of No. 4 engine nacelle (R1)	3,880~4,090	210
2	Scrape mark of No. 3 engine nacelle drain mast (R2)	3,965~3,985	20
3	About 40 debris from No. 4 engine	4,080~5,300	n/a

²² After 2 weeks from occurrence day, there are about 40 more smaller pieces debris found at nearby grass field (Runway Safety Area, RSA) northern from the paved runway.
