# **Taiwan Transportation Safety Board**

### **Final Report**

**UPS Airlines Flight 5X61**

**Engine Nacelle Strike during Landing  
at Taiwan Taoyuan International Airport**

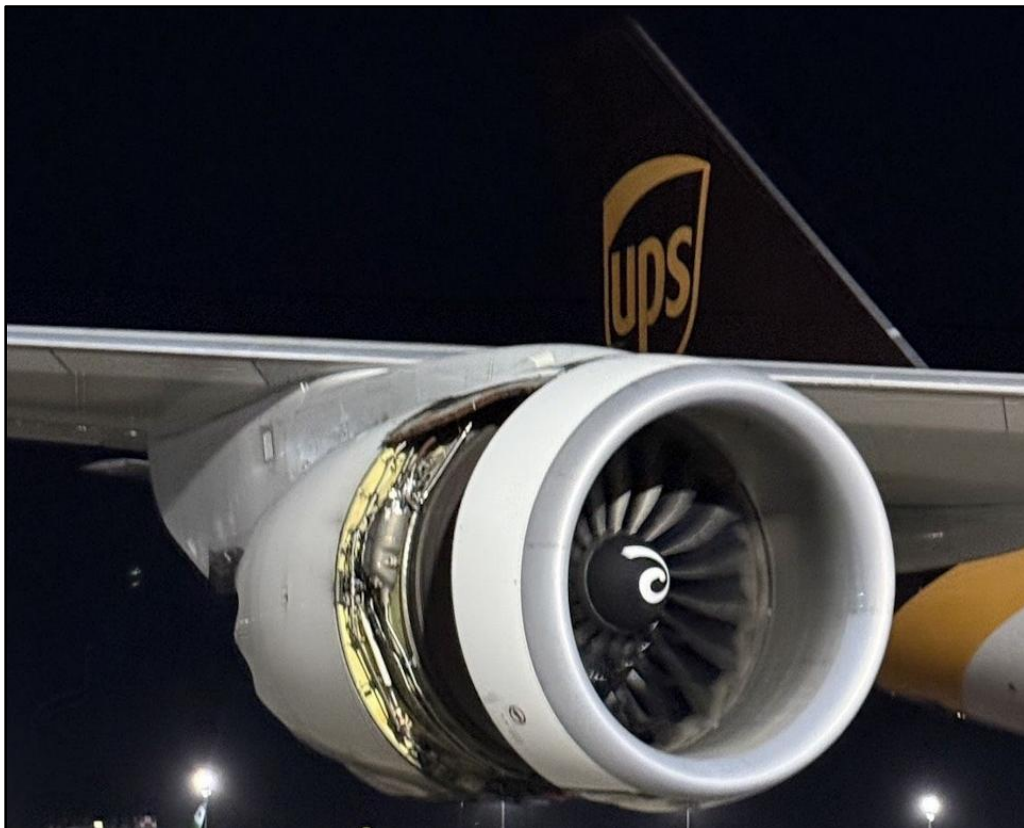
During the post-landing walk-around, the crew discovered damage on the No. 4 engine and notified RCTP tower of the occurrence. Figure 1.1-1 shows the external appearance of the damage to No. 4 engine, while Figure 1.1-2 illustrates the FDR flight path of the occurrence flight.

Figure 1.1-1 External appearance of the damage to No. 4 engine

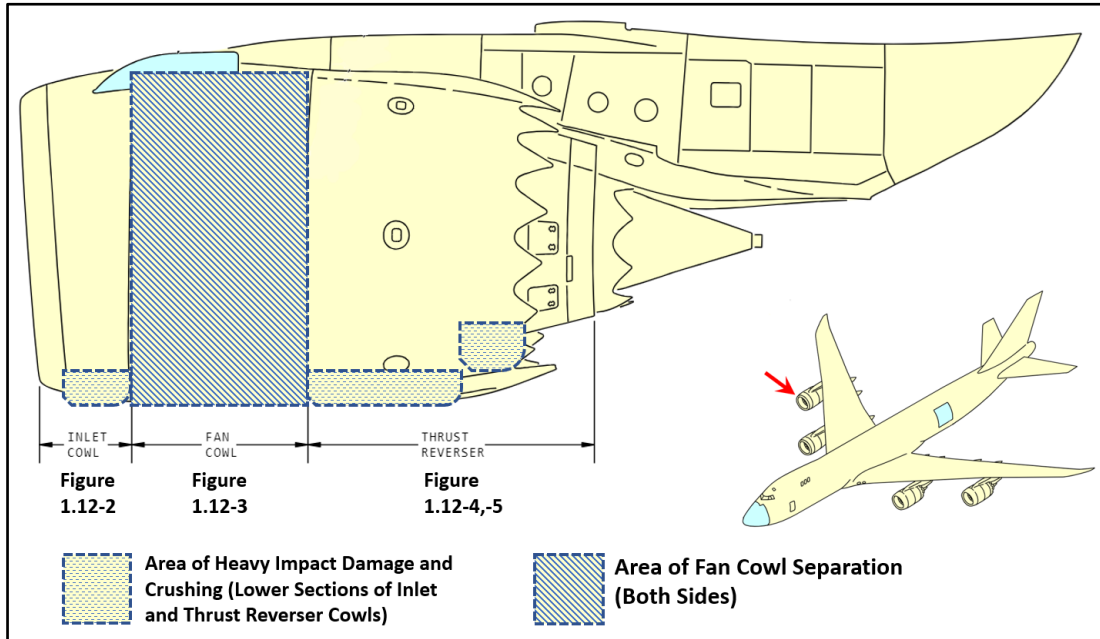
The nacelle consists of the inlet cowl, fan cowl, and thrust reverser cowl. Following the occurrence, the inlet cowl remained attached to the engine, and the thrust reverser cowl remained attached to the pylon; however, both exhibited impact and abrasion damage on their lower surfaces due to ground contact.

Figure 1.12-1 No. 4 engine nacelle damage areas

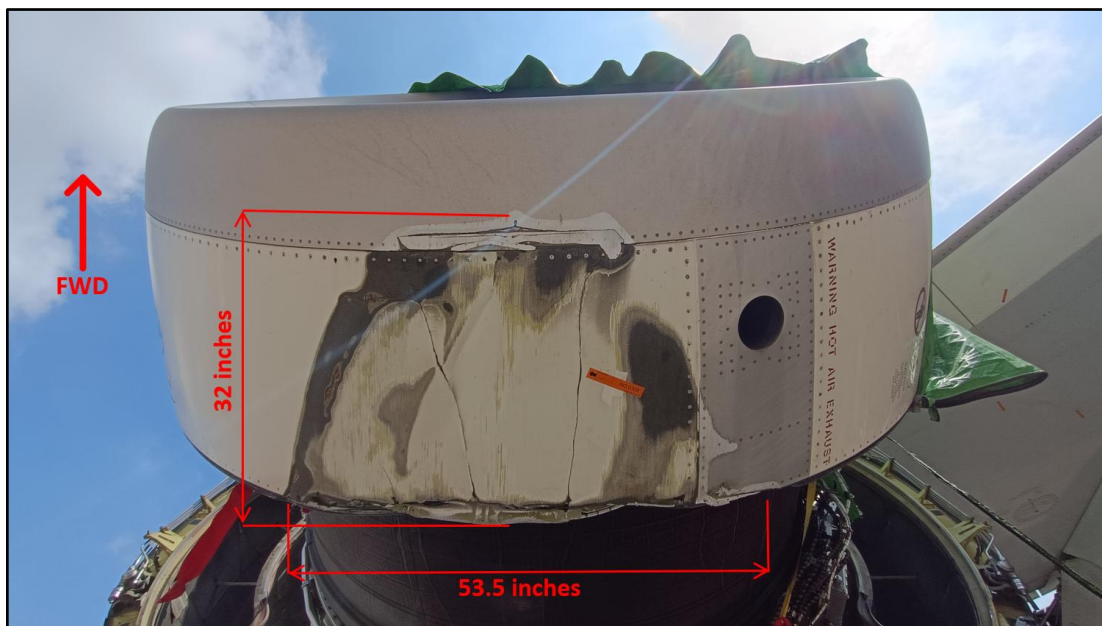
Figure 1.12-2 No. 4 engine inlet cowl damage areas (bottom view)

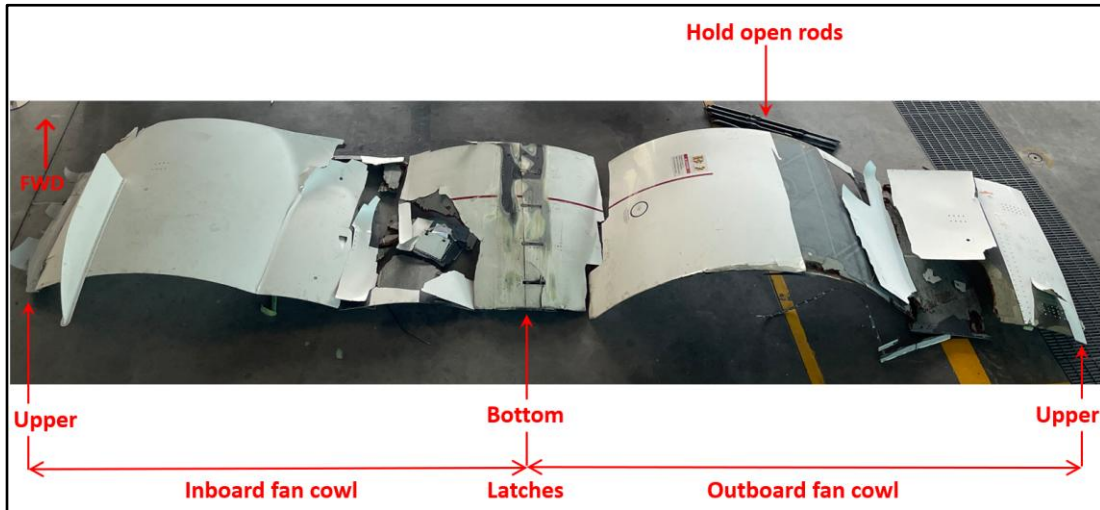
Figure 1.12-3 Reassembled fragments of the No. 4 engine fan cowl

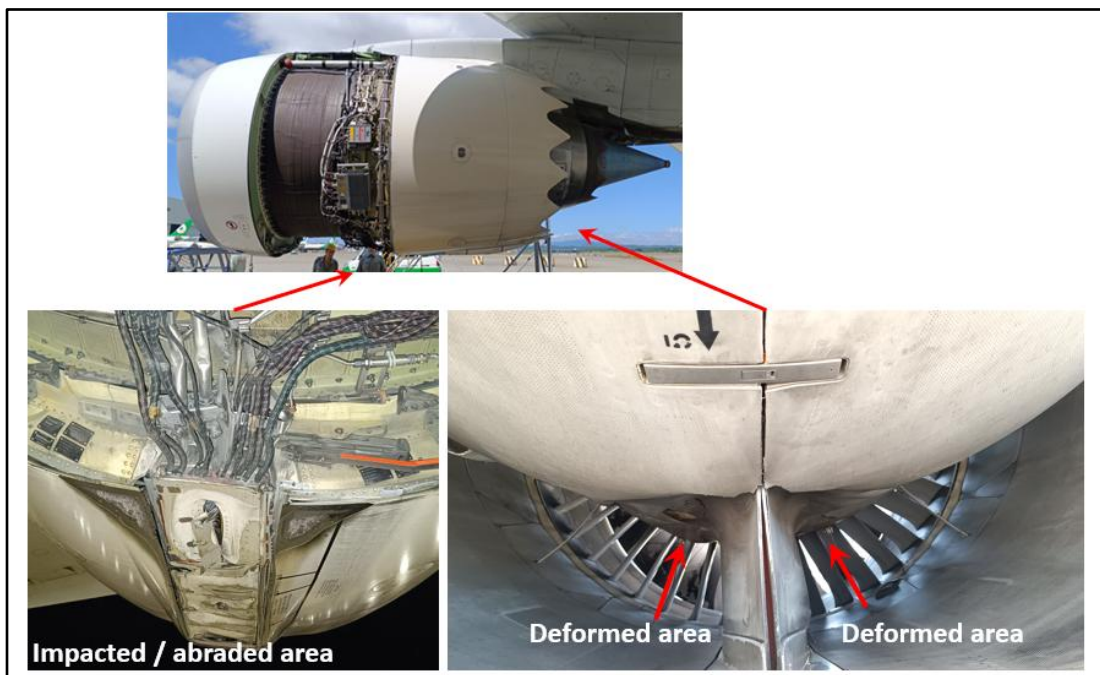
Figure 1.12-4 No. 4 engine thrust reverser cowl damage areas

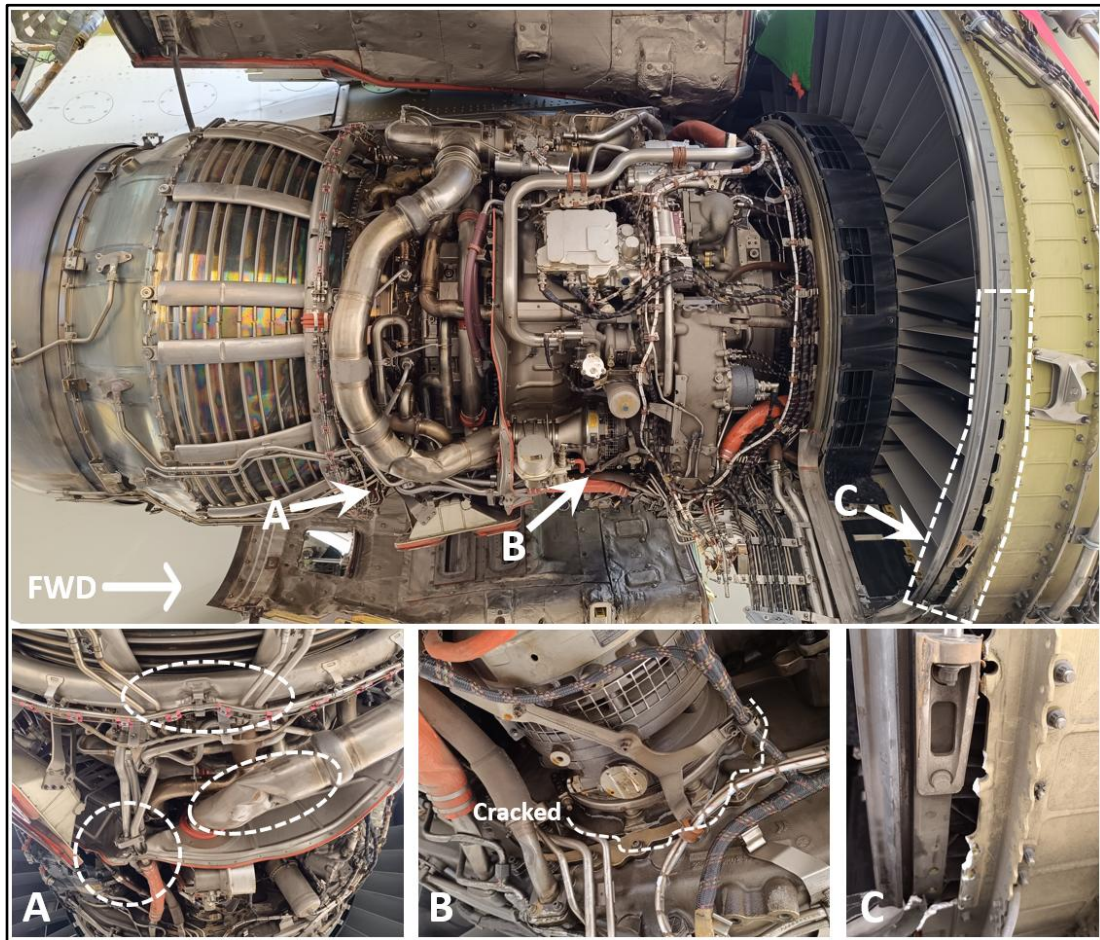
The No. 4 engine itself was compressed by the displaced inlet and thrust reverser cowls. The thrust reverser channel, attached to the aft portion of the fan case, was found fractured and separated. Several tubes and support brackets located in the lower section of the engine were deformed due to compression. Notably, the air starter was forced upward, causing a crack in the aft face of the accessory gearbox casing.

Figure 1.12-5 No. 4 engine damage areas (right side view)

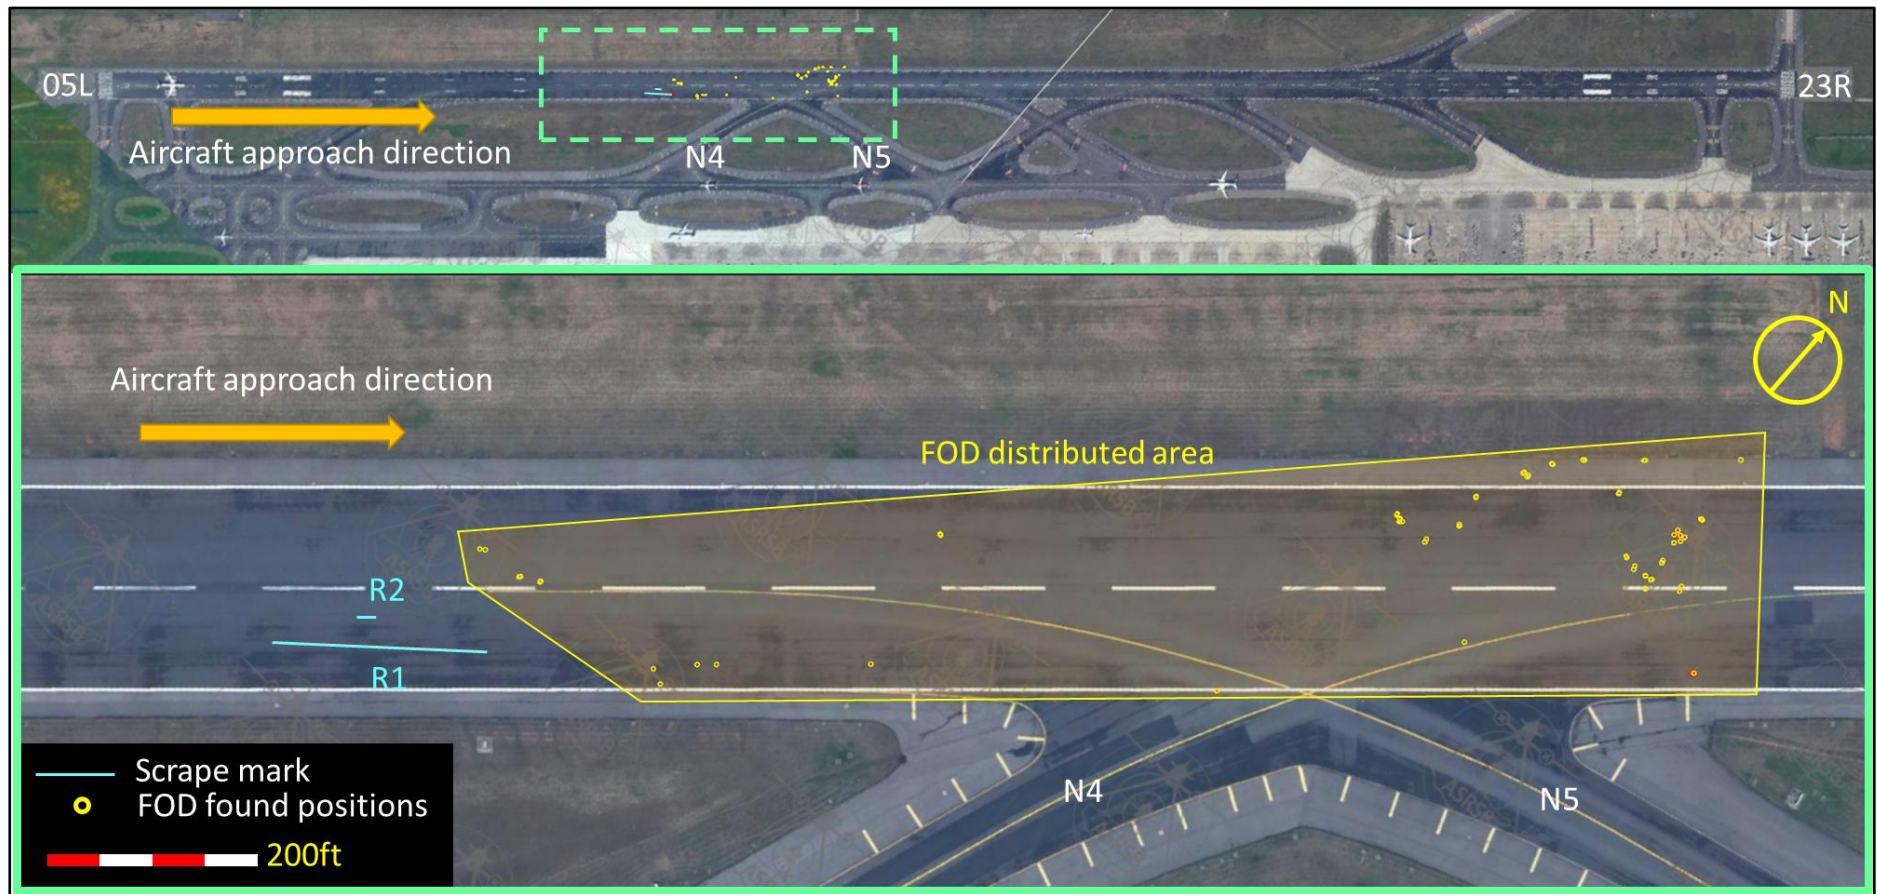
<sup>25</sup> After 2 weeks from occurrence, there are about 40 more smaller pieces of debris found at nearby grass field (Runway Safety Area, RSA) northern from the paved runway.

Figure 1.12-6 Distribution of site survey items on Runway 05L

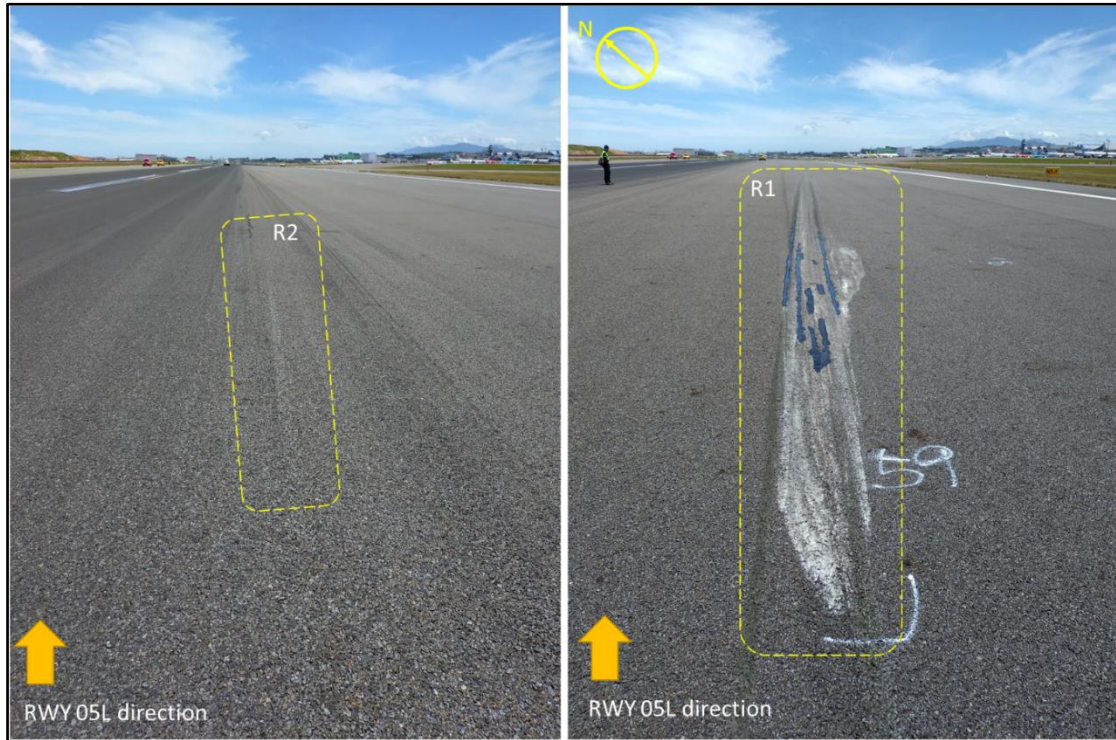
Figure 1.12-7 Scrape marks observed on Runway 05L
