# **Taiwan Transportation Safety Board**

### **Final Report**

**UPS Airlines Flight 5X61**

**Engine Nacelle Strike during Landing  
at Taiwan Taoyuan International Airport**

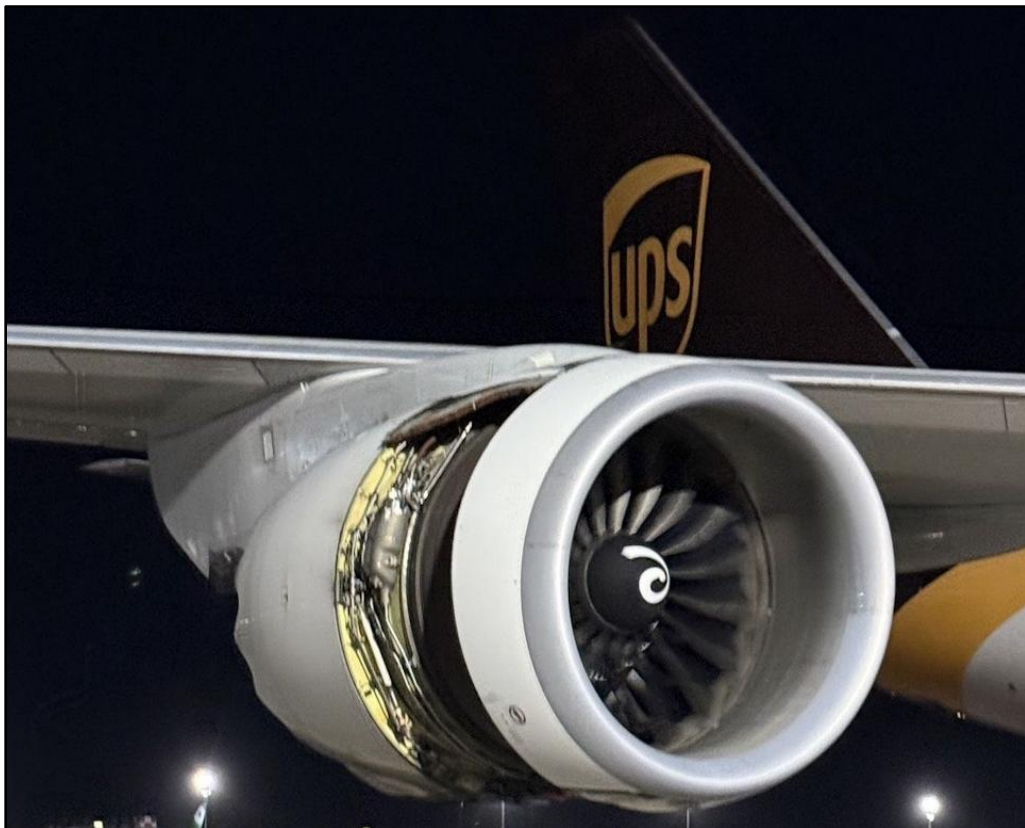
During the post-landing walk-around, the crew discovered damage on the No. 4 engine and notified RCTP tower of the occurrence. Figure 1.1-1 shows the external appearance of the damage to No. 4 engine, while Figure 1.1-2 illustrates the FDR flight path of the occurrence flight.

Figure 1.1-1 External appearance of the damage to No. 4 engine

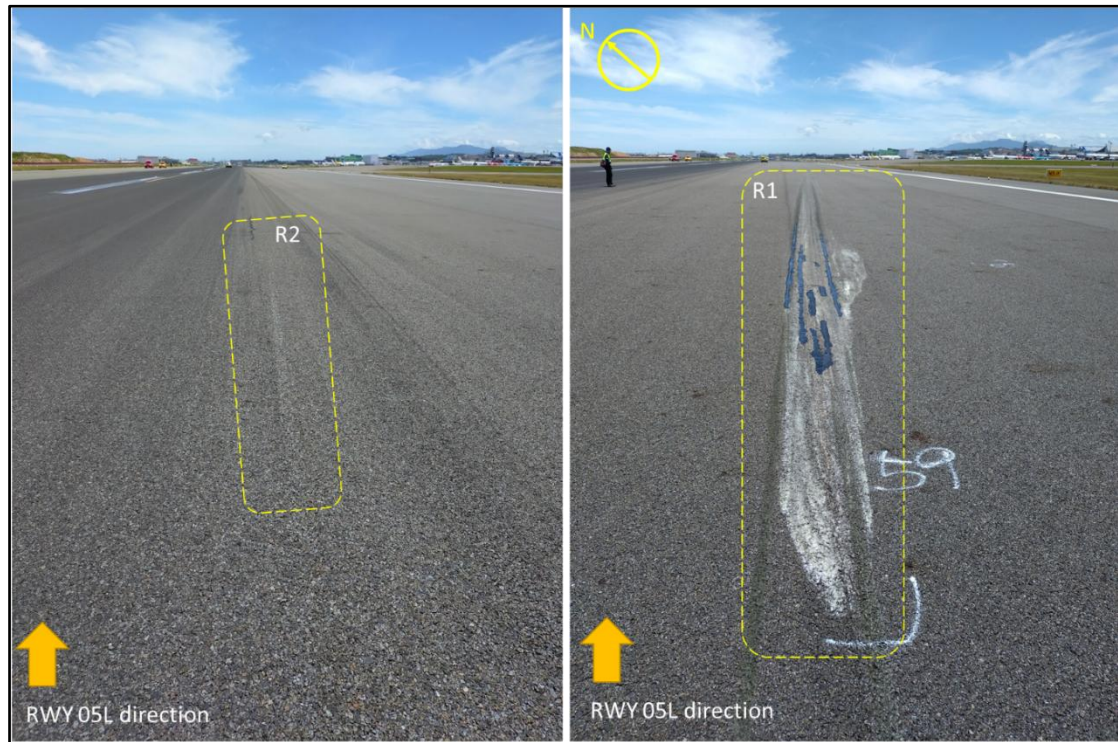
Figure 1.12-7 Scrape marks observed on Runway 05L
