台灣航業股份有限公司

2020船舶航行資料紀錄器技術研討會-台灣航業

航務部 紀華傑 副理
工務部 鄭啓佑 課長

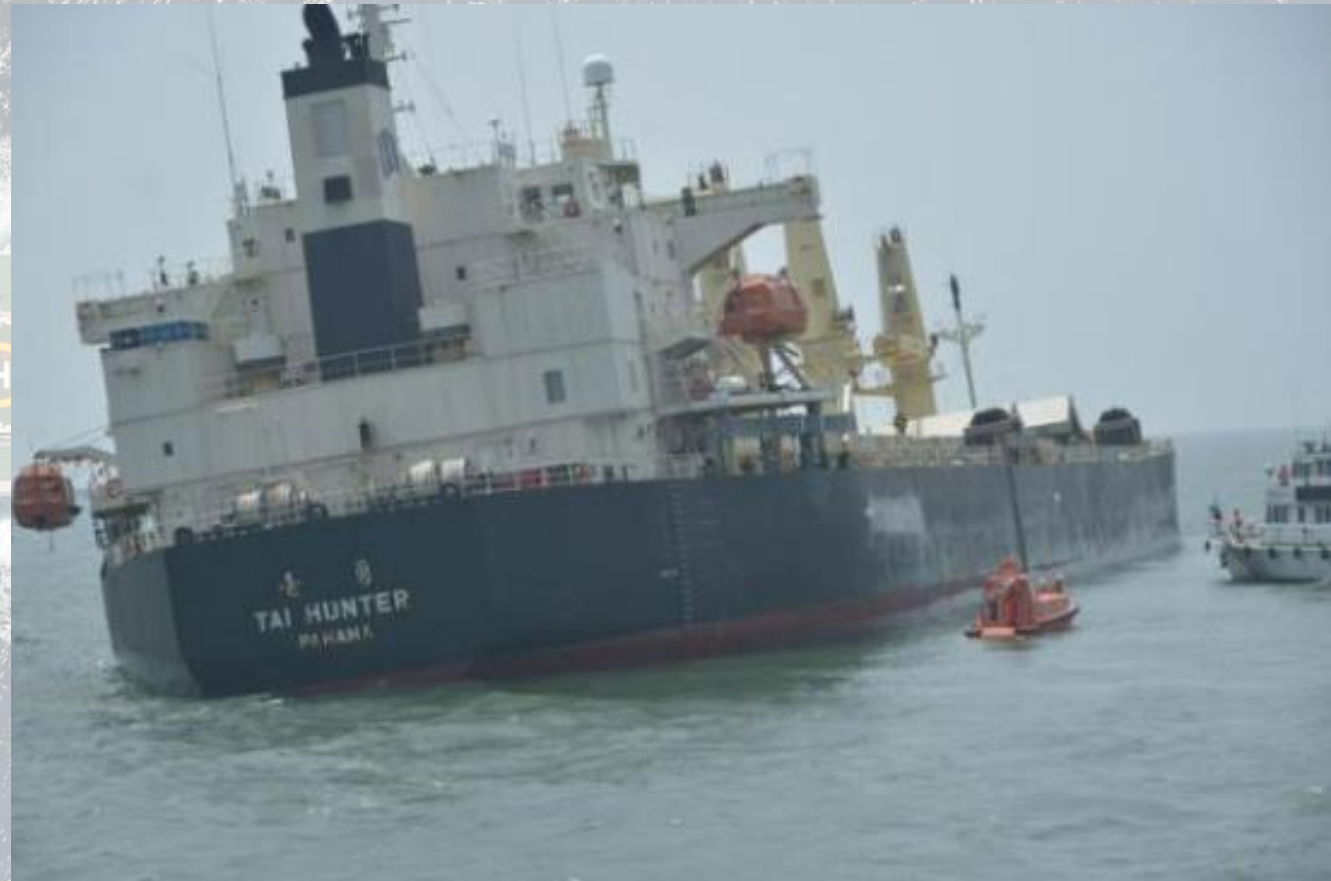
M.V. “Tai Hunter”-2019年8月擱淺

- 地點:寧德及福州交界水域
- 事故:因讓船未注意海圖警示該區域底下之礁岩，導致擱淺事故。
- 事故調查:各相關單位皆須藉由VDR回放作為相關調查證據。

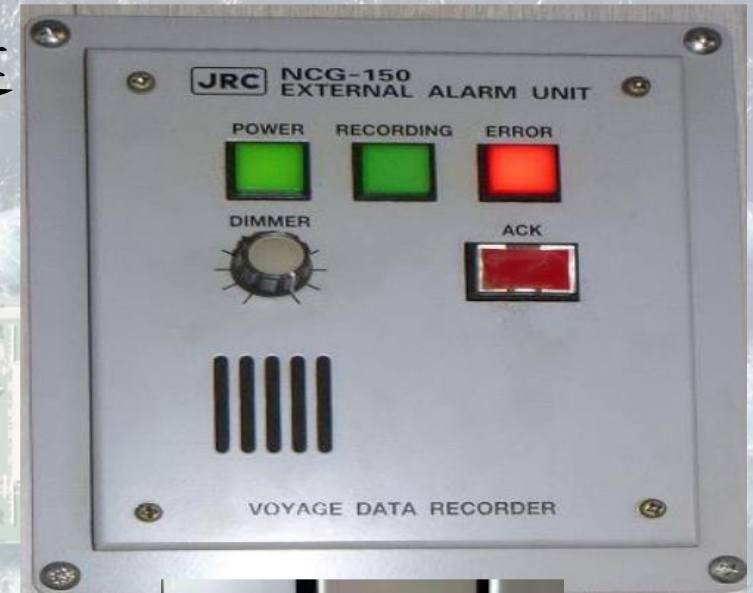
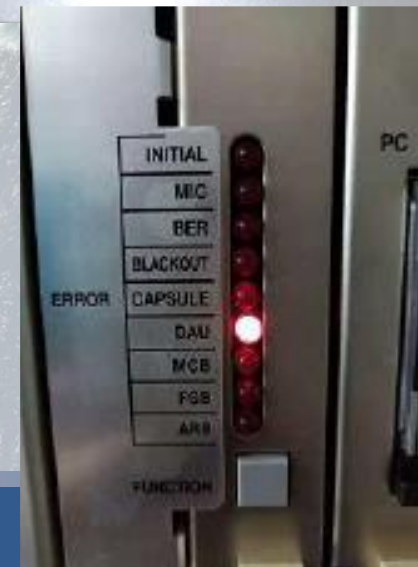
M.V. “Tai Hawk”-PSC缺陷

事故:該輪VDR顯示ERRO信號，於卡達港口遭PSC開缺。

1. DAU ERRO亮燈主因為連結至VDR相關航儀設備遭關閉。
2. 因靠泊時公司政策要求將相關航儀設備關閉以延長設備壽命，且船上不知其ERRO警示碼原意，無法立即處理。
3. 預防:技術通告型式，通告船隊。
