維修與飛航事故調查 (HFACS-ME)

飛航安全調查委員會

維修相關調查案例介紹

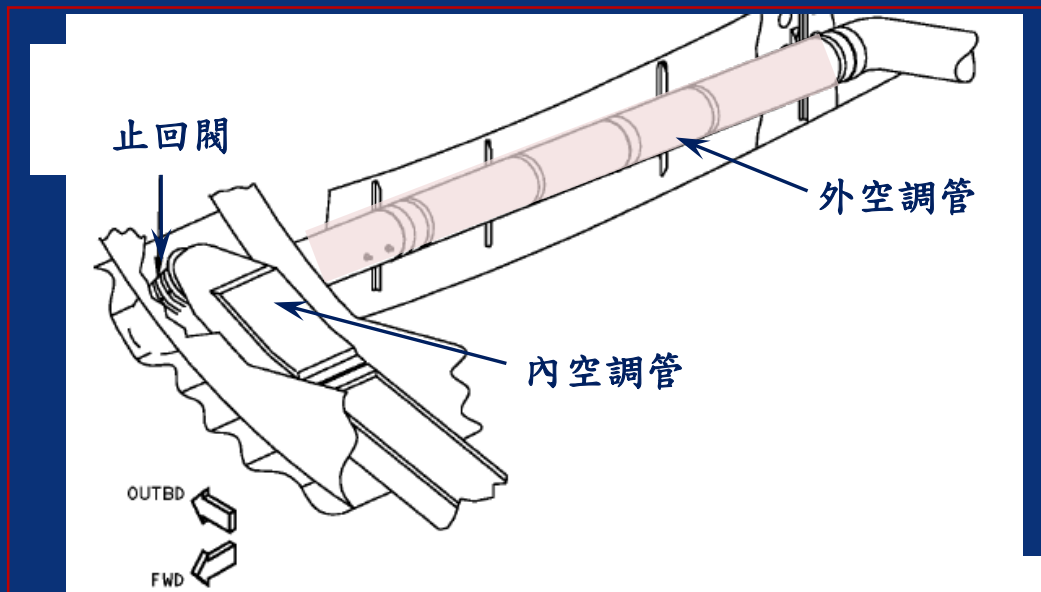
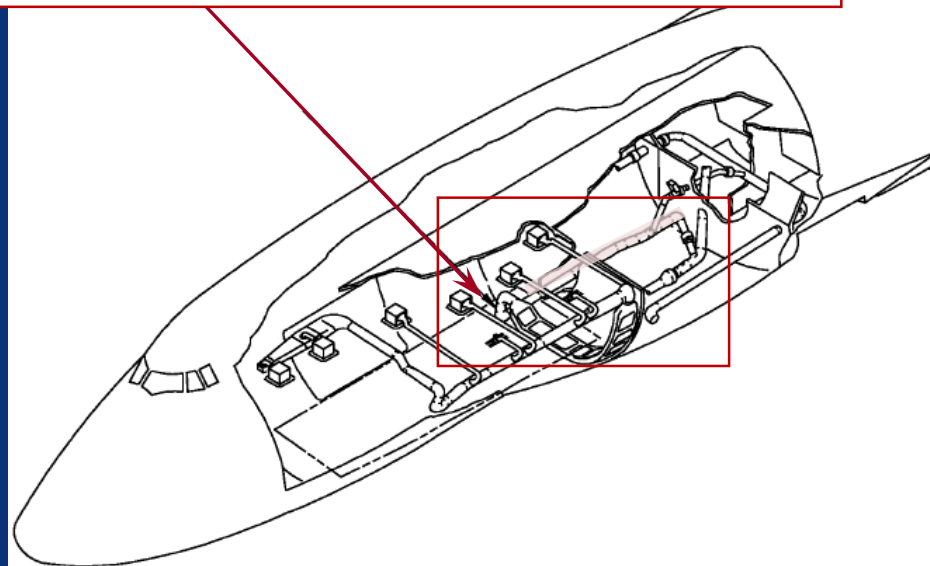
脫落空調管位置

- 檢查空調系統管路時發現，供應至前貨艙之3號空調機管路自止回閥與機身加壓艙耦合處脫落。

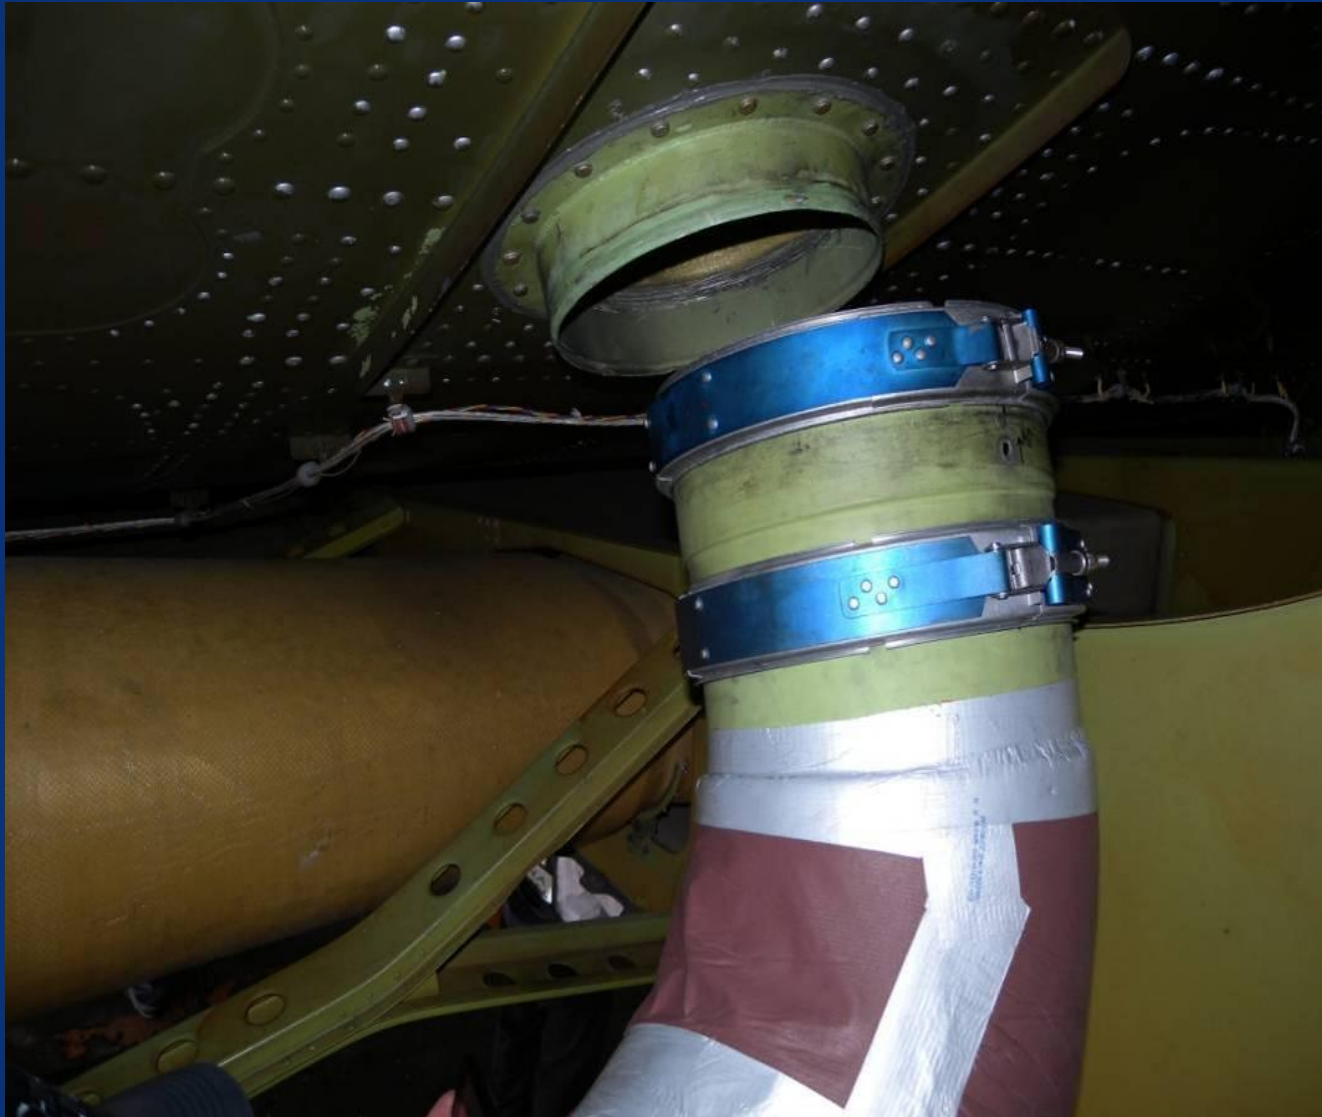
空調管脫落情形(一)

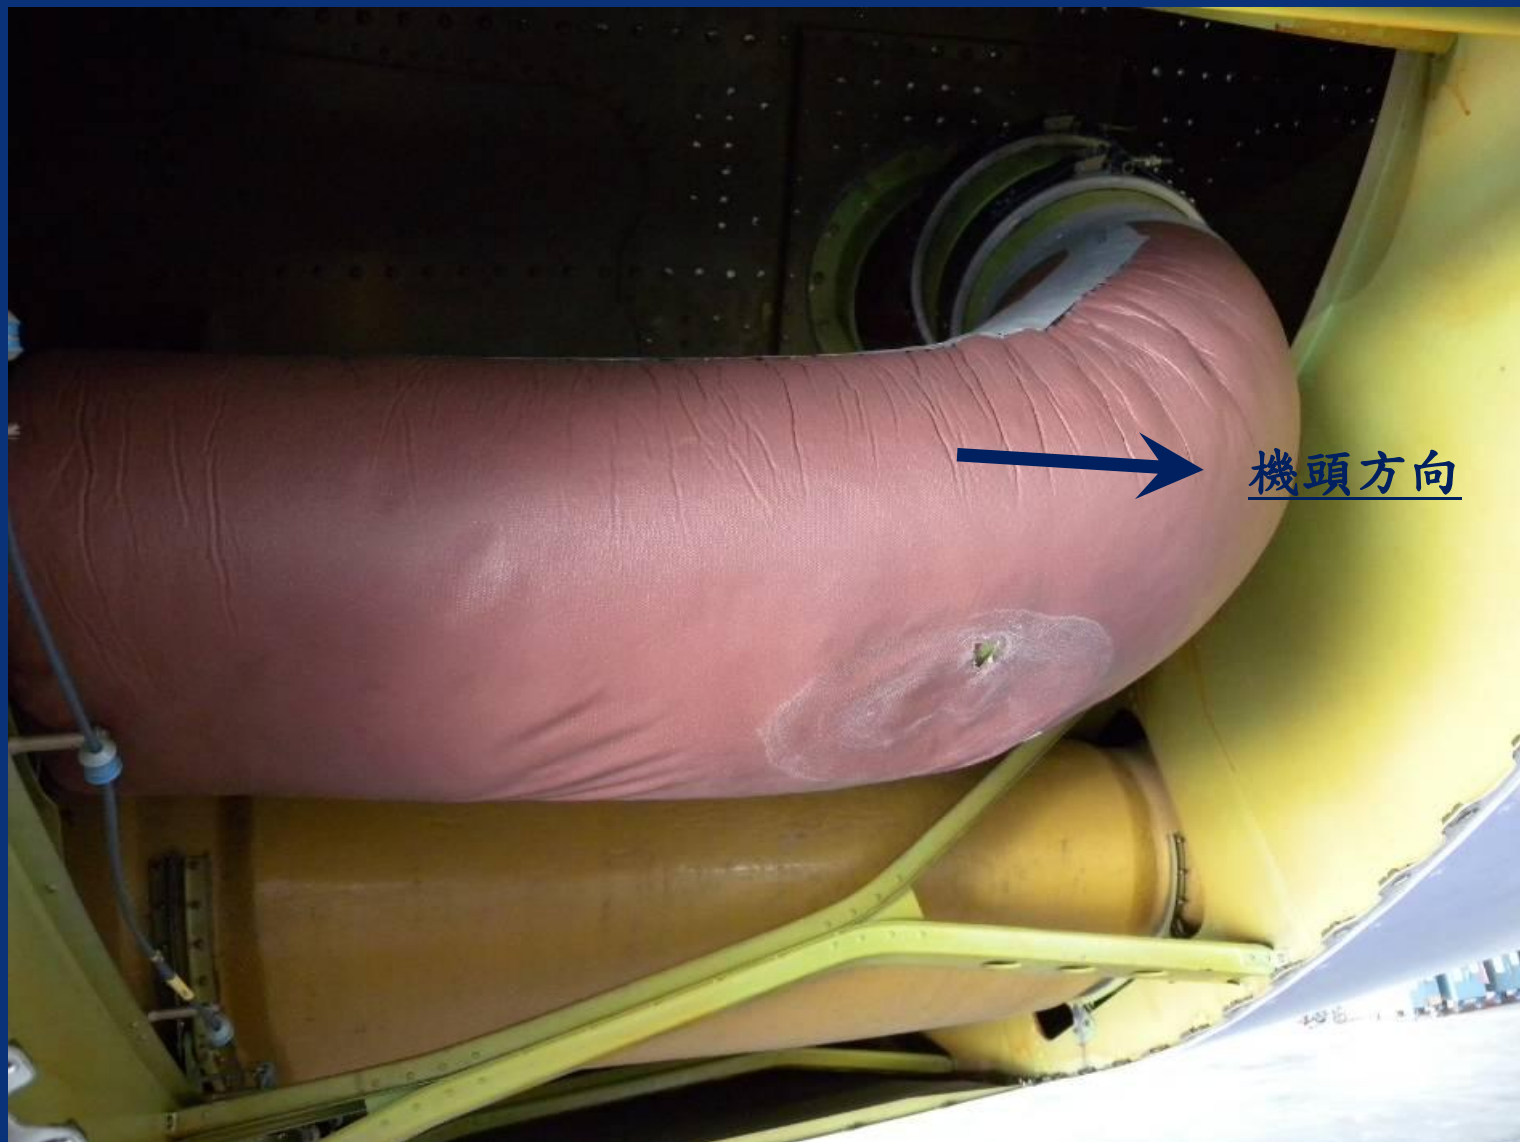
空調管脫落情形(二)

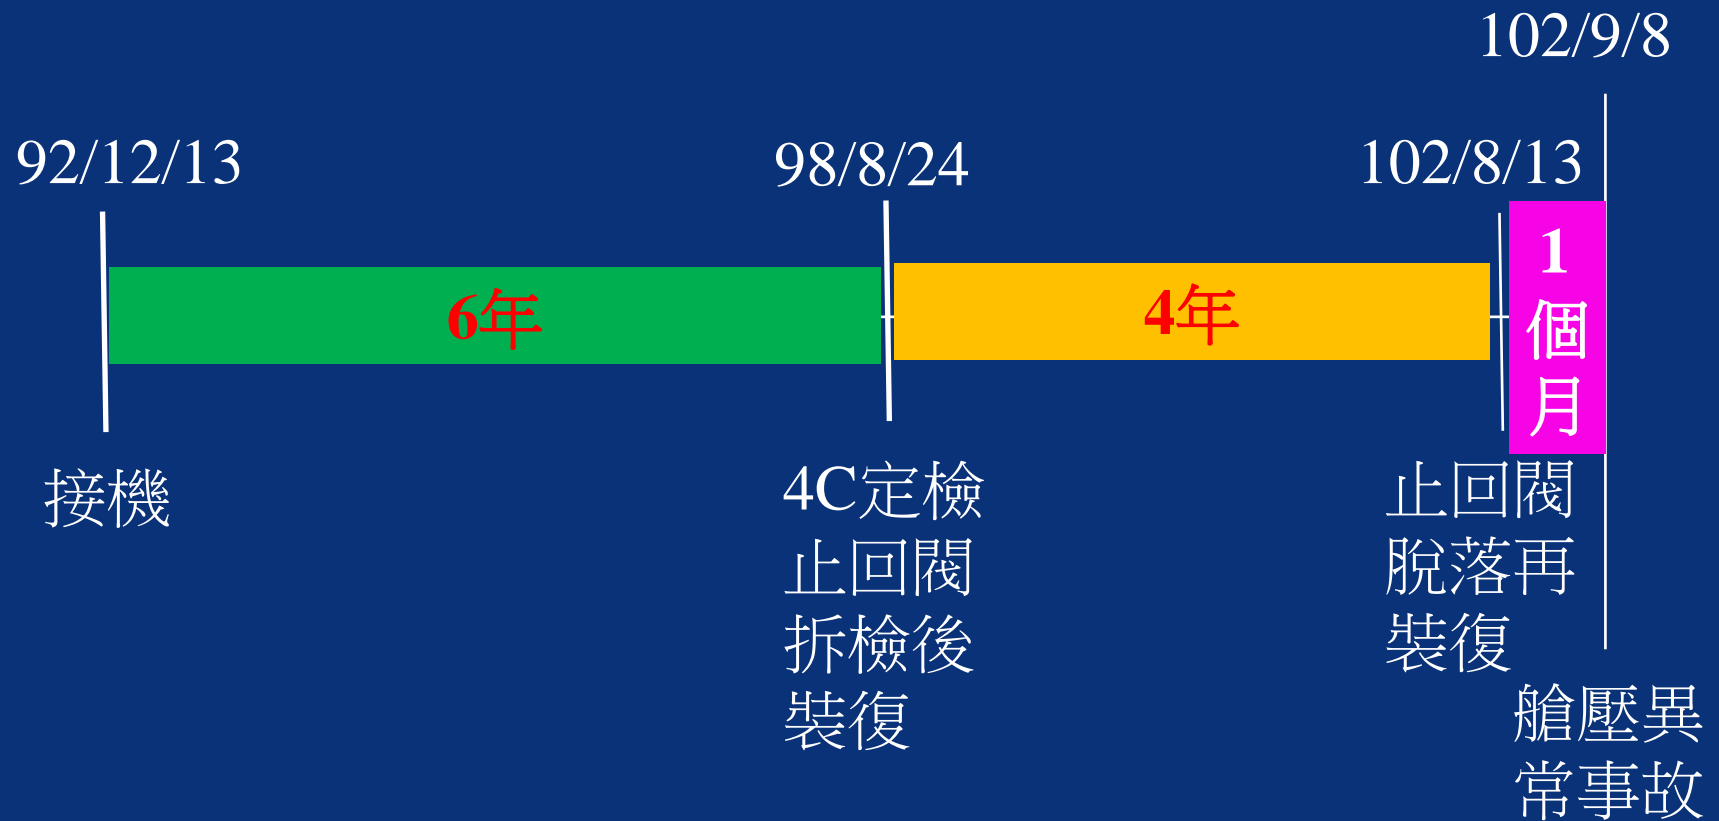
止回閥連續脫落事件簿

- 該機於民國102年8月12日駕駛員報告「STS MSG ZONE TEMP」，維修員據報檢查CMC發現「FWD CGO DUCT TEMP SENSOR/WIRING FAIL(T1657)」訊息。
- 該機於民國102年8月13日，於執行管路溫度感測器檢查更換時，發現空調管塌陷、感溫器損壞。

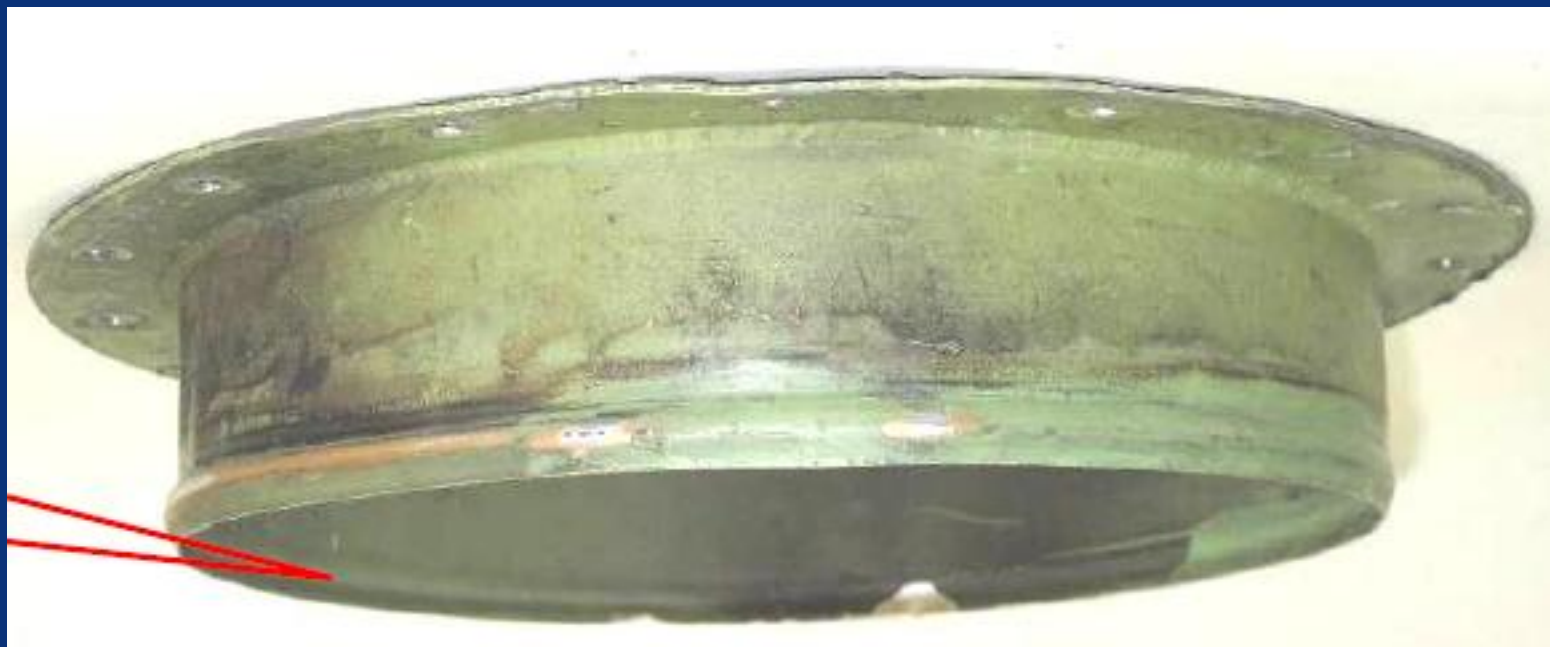
變形之凸緣

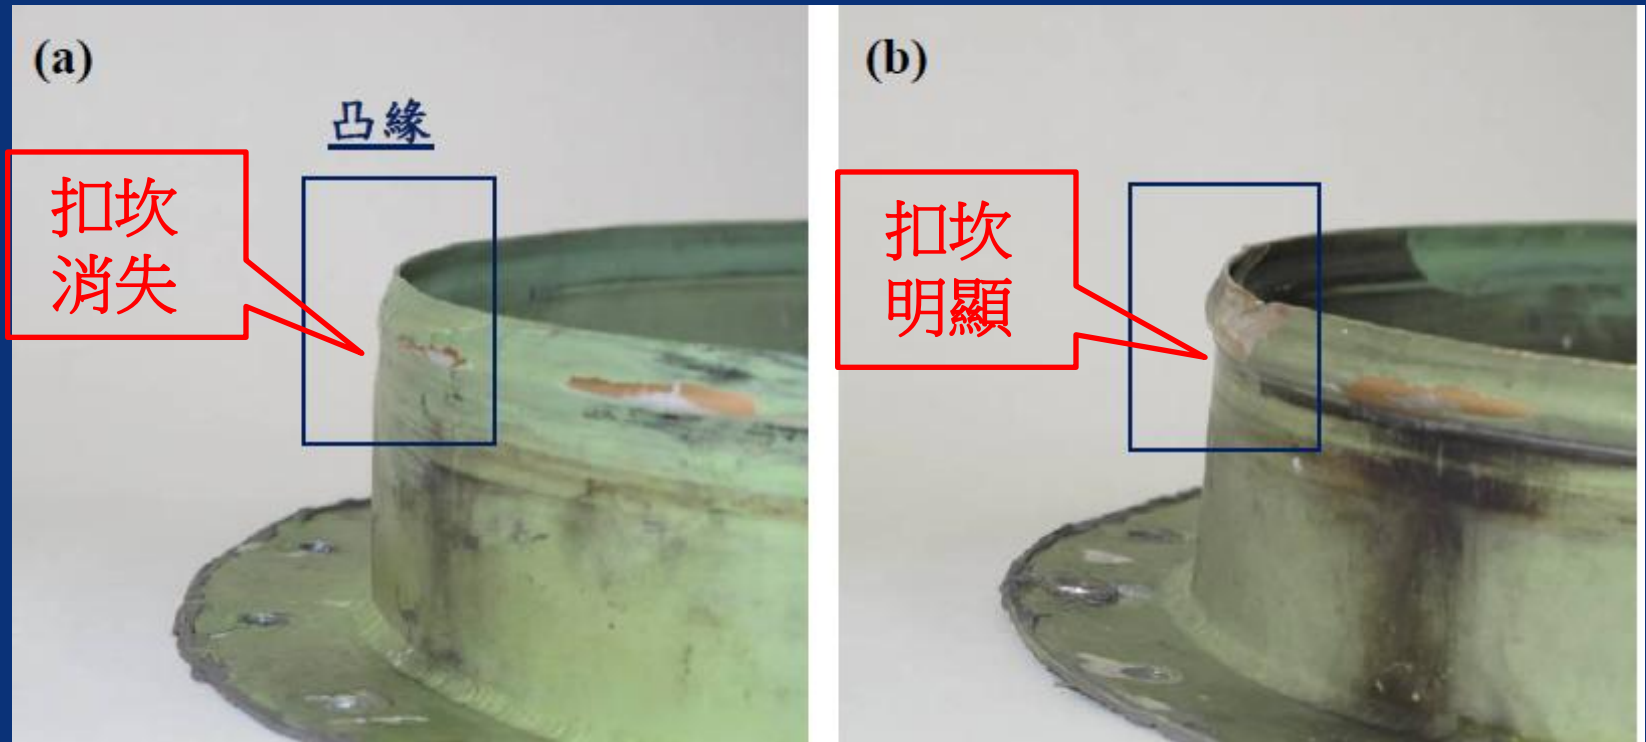
變形之凸緣

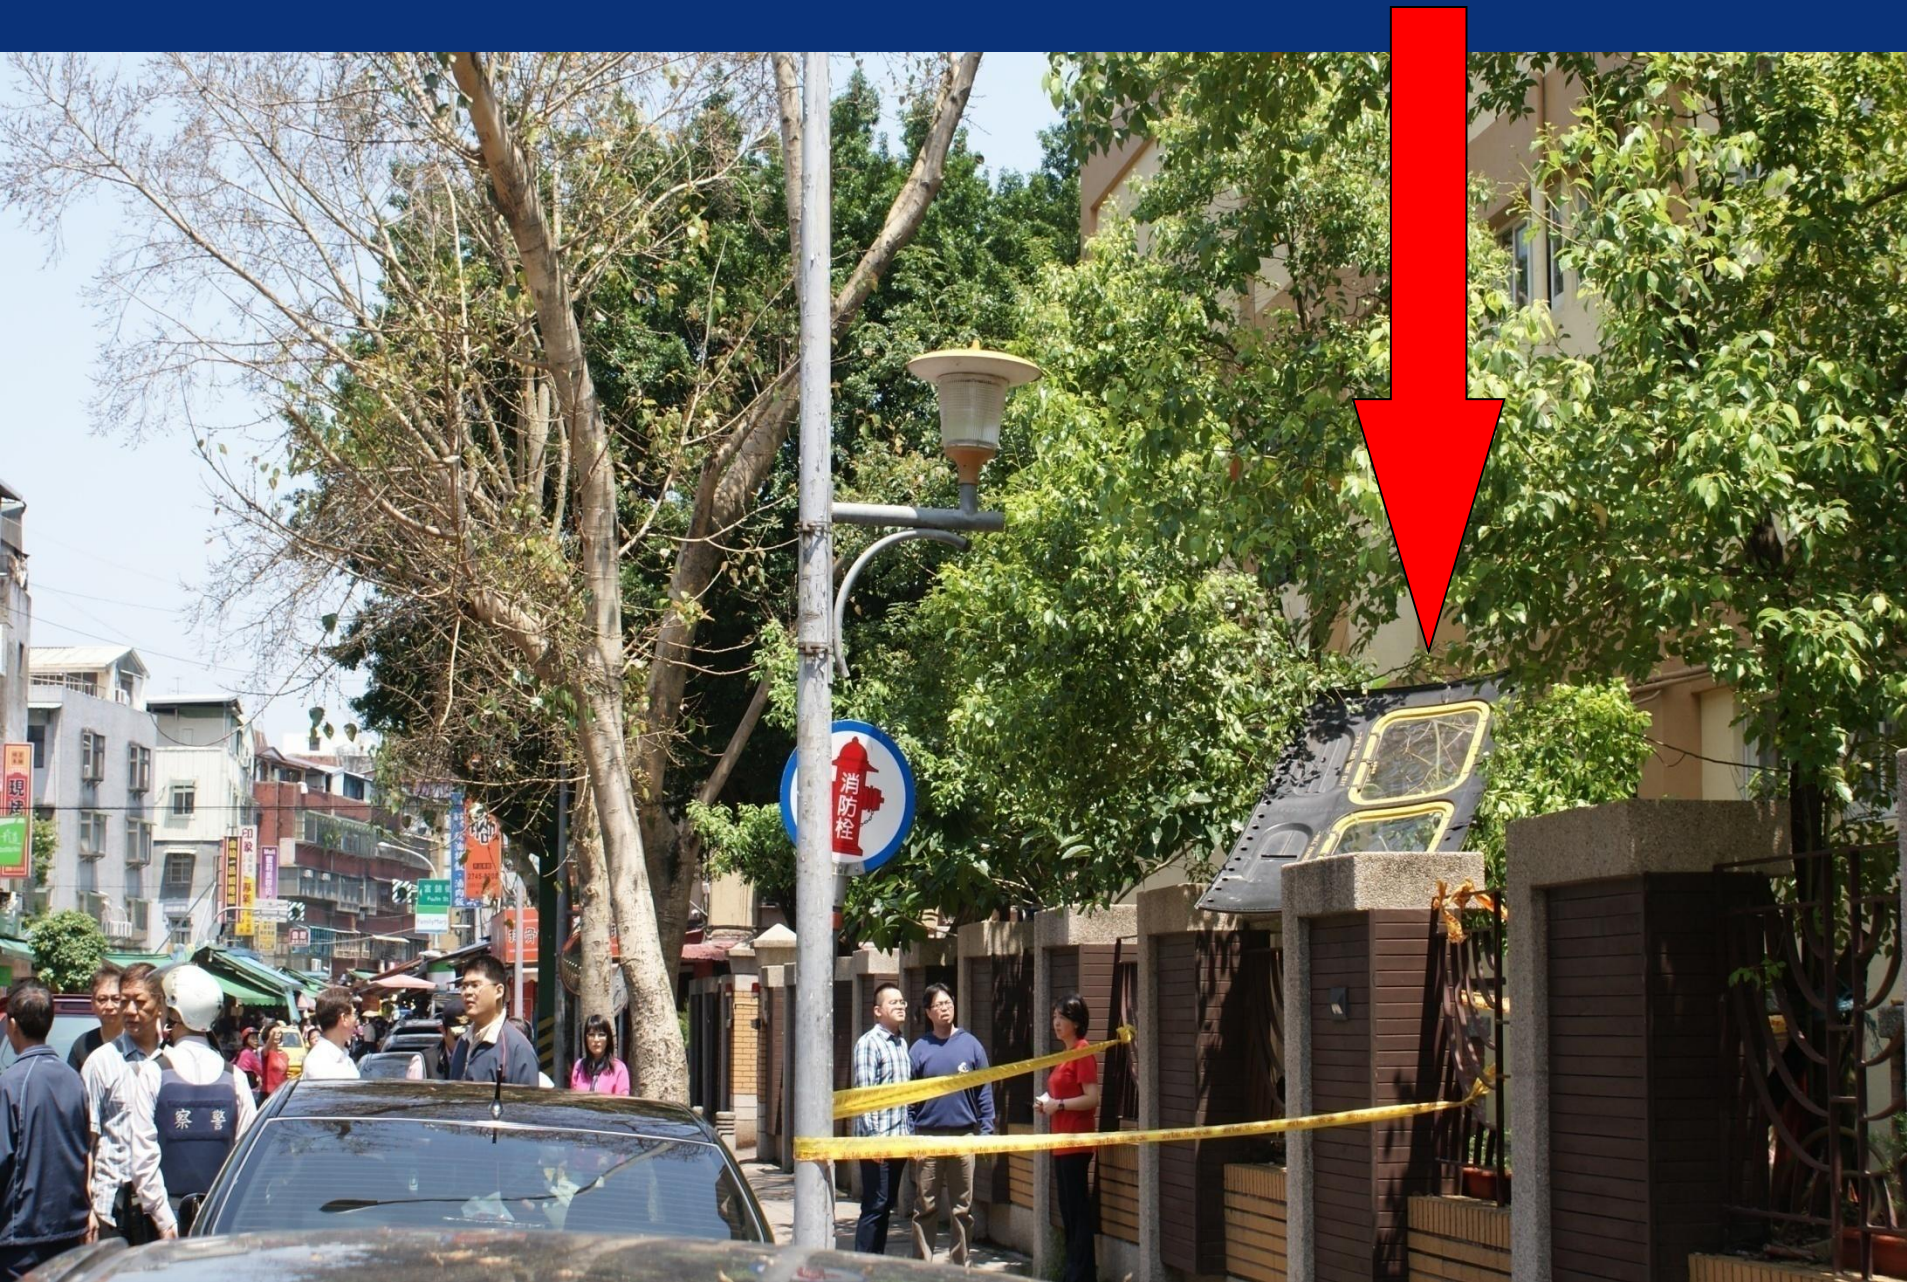
- ❖ 該機從松山機場向東起飛，預計經鶯歌到桃園縣復興鄉山區實施高高度飛行訓練，起飛至航線三邊時（民權東路上空）左貨艙門掉落台北市民生國中圍牆。
