Taiwan Transportation Safety Board

Major Transportation Occurrence Final Report

China Airlines Flight CI202

The aircraft experienced multiple system failures

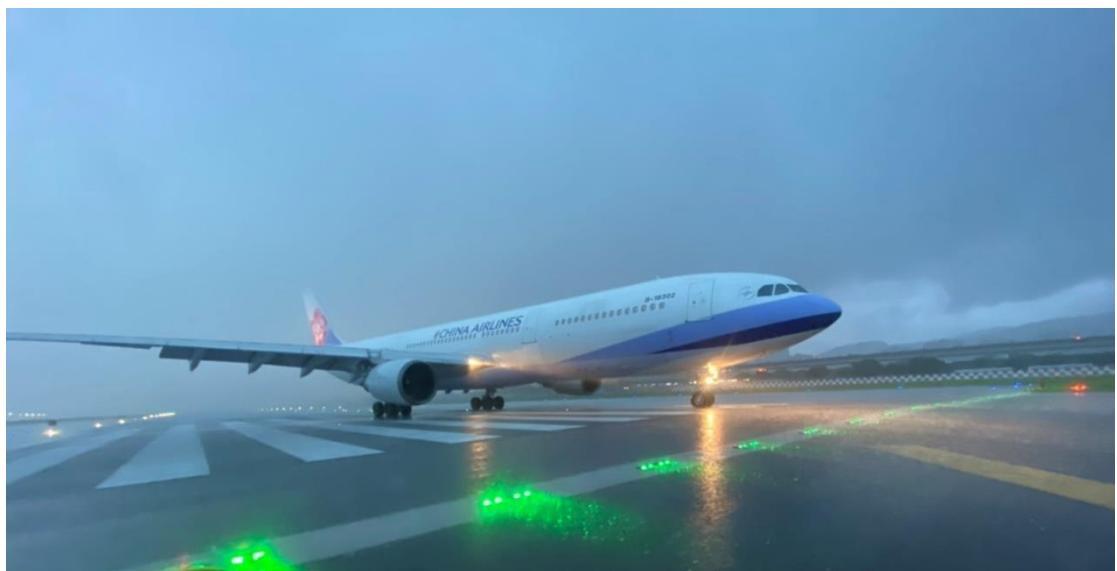
Until 1747:36 when the aircraft came to a full stop at 30 ft before the end of the runway, the aircraft brake pressure and longitudinal acceleration

rate fluctuated from 128 psi to 2,560 psi and from -0.05g's to -0.47g's respectively during this period.

Figure 1.1-1 The aircraft stopped at the end of runway 10

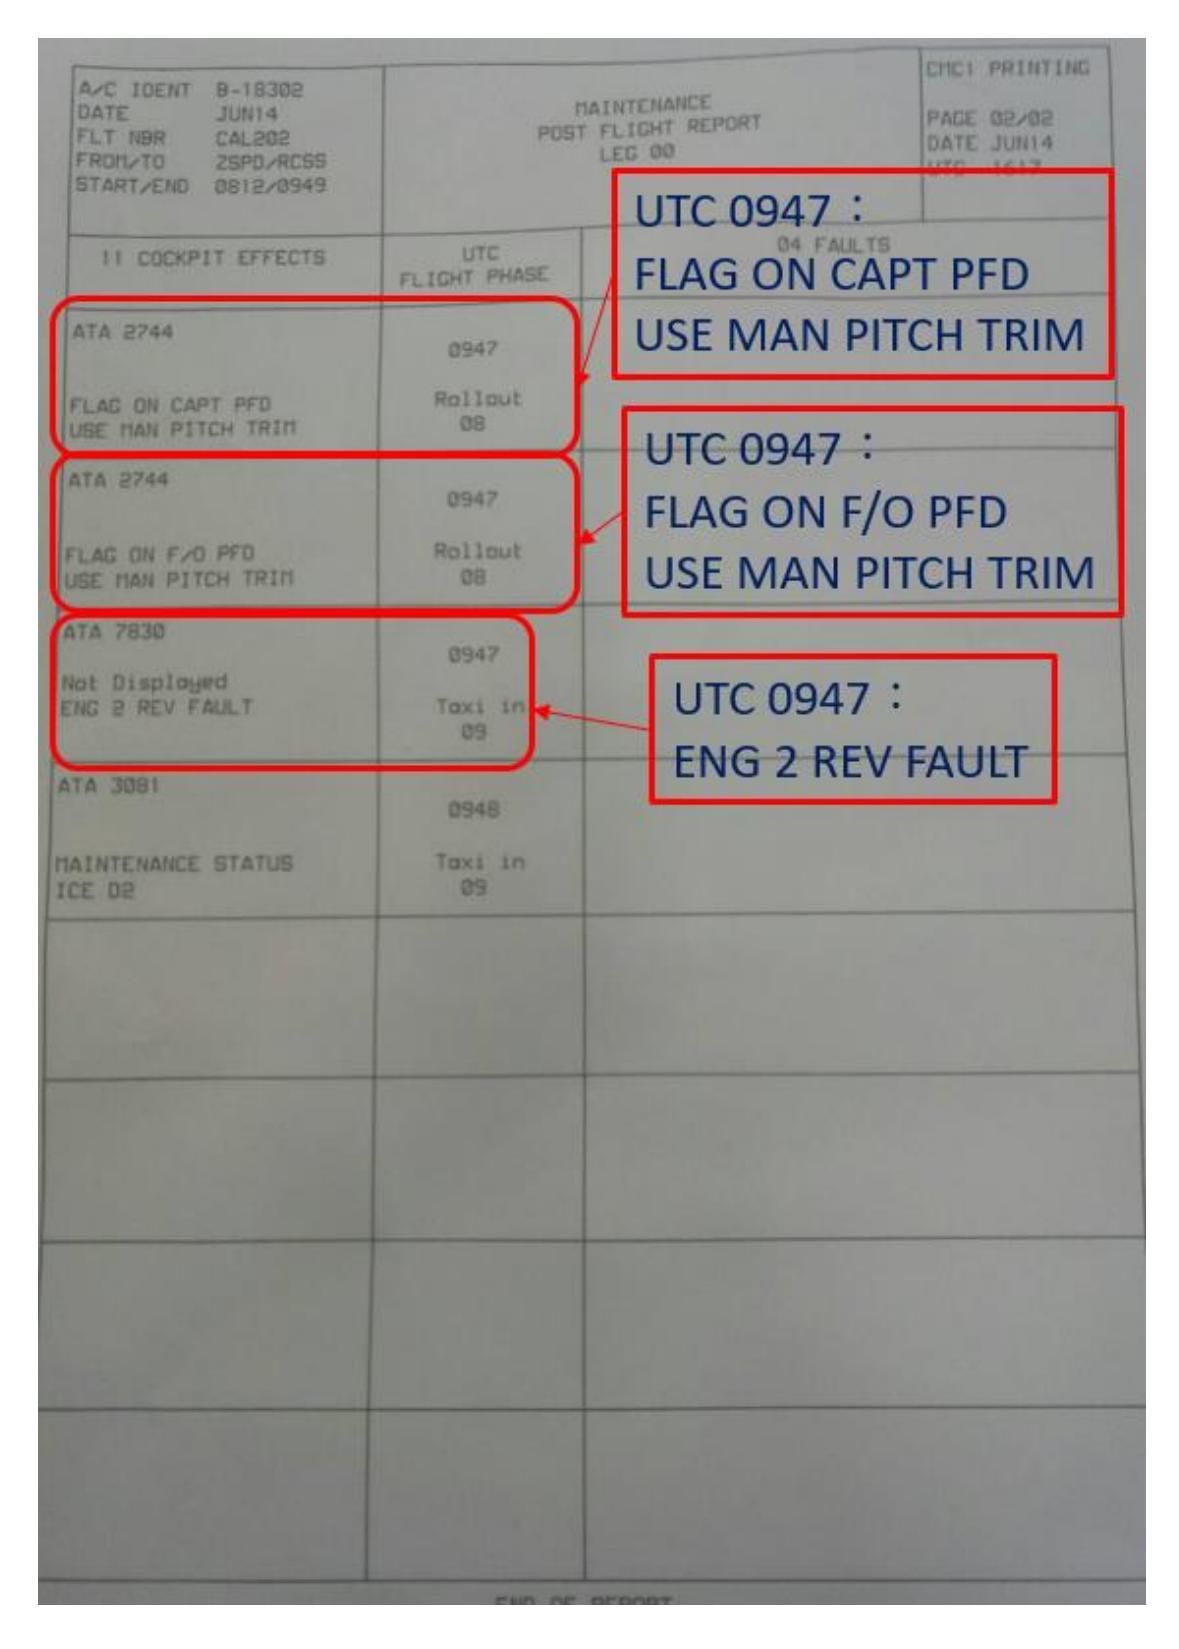
Figure 1.6-2 PFR 2/2

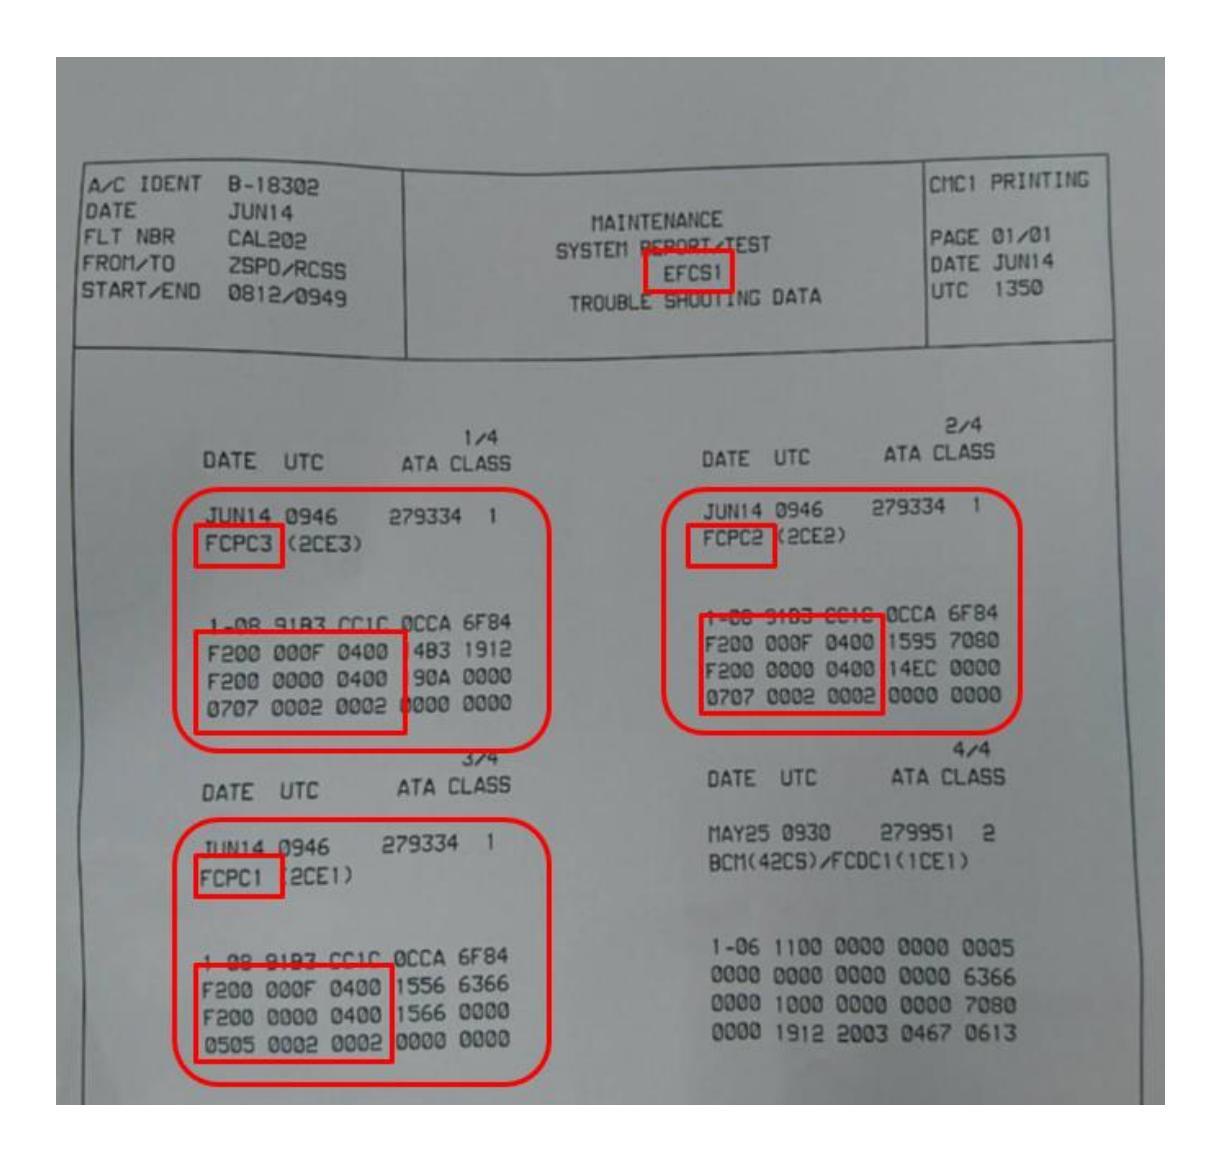
in Figure 1.6-3 and Figure 1.6-4. Both EFCSs indicate that all 3 FCPCs showed the same fault messages.

Figure 1.6-3 EFCS1 trouble shooting data

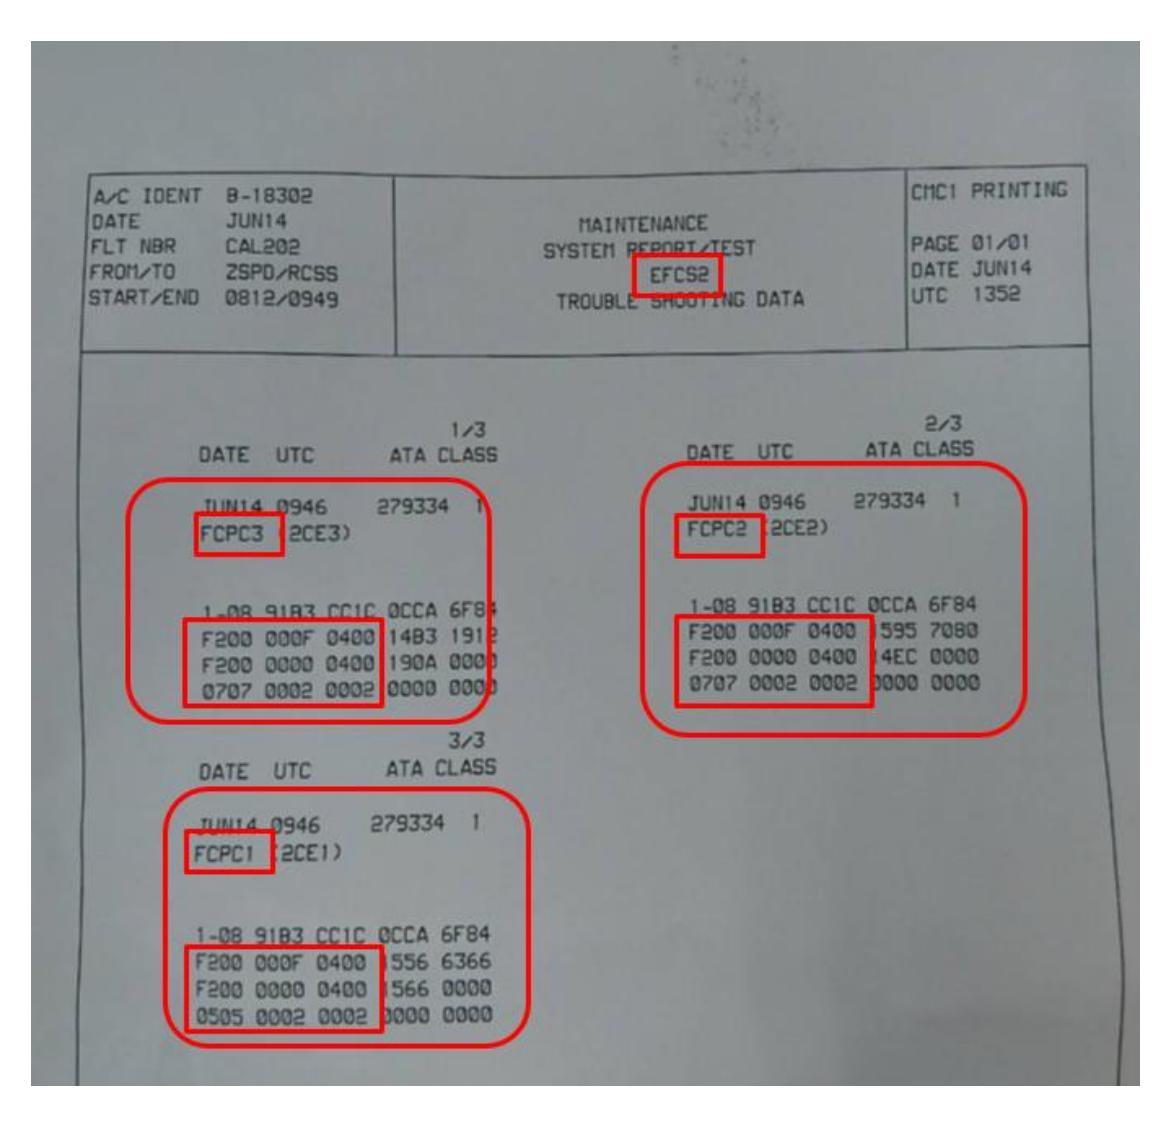
Figure 1.6-4 EFCS2 trouble shooting data

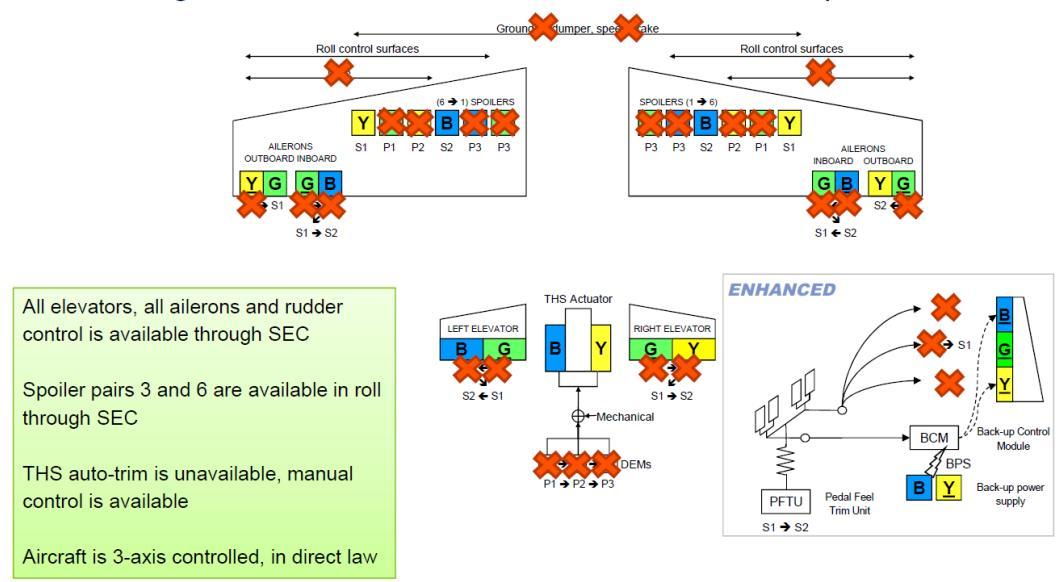
As a consequence of the three FCPCs (P1, P2, P3) loss, the master control of the flight control system is changed over to flight control secondary computer FCSC(S1, S2), with the following repercussions,

- flight controls reconfigured from normal law to direct law;
- speed brake and ground spoilers only no.3 and no.6 available for roll operation;
- loss of nose gear steering by rudder pedals; (tiller still available) ;
- autobrake loss;
- thrust reverser loss

Figure 1.6-10 All 3 FCPC loss consequences

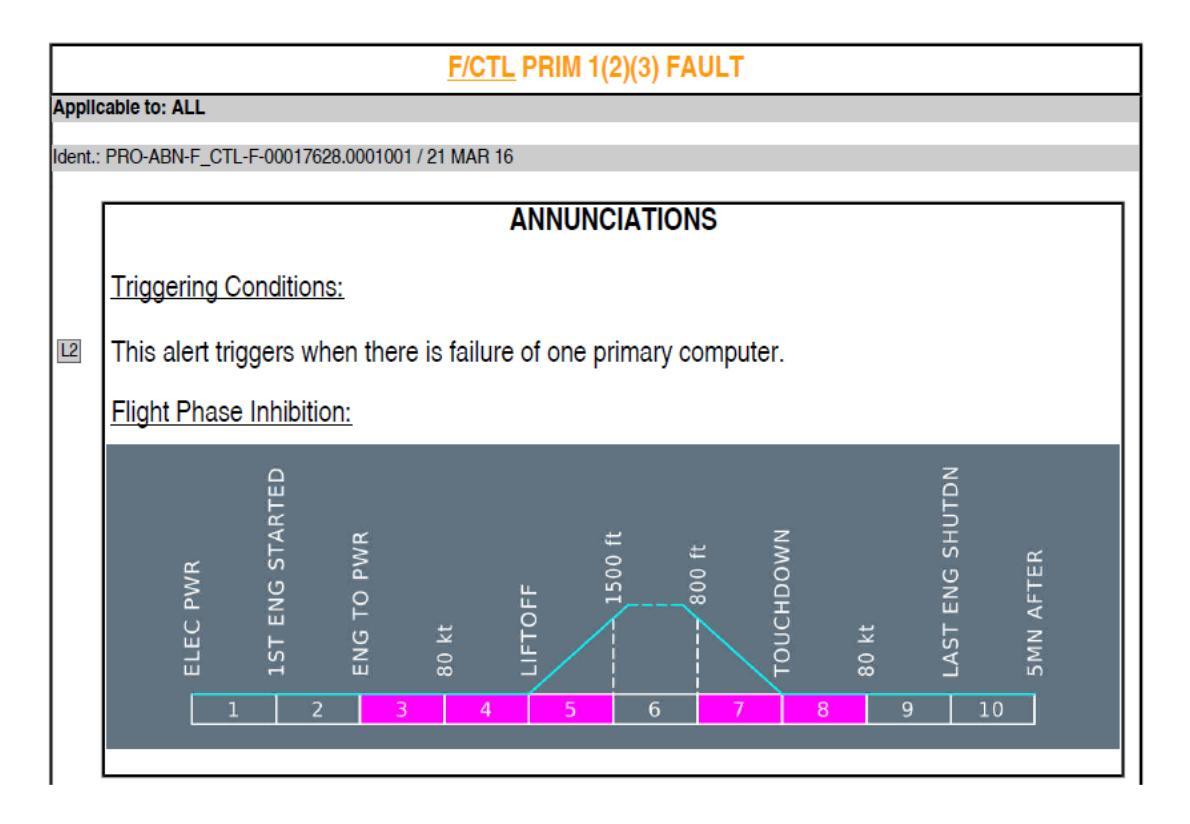
In order to reduce work load from pilots, ECAM (electronic centralized aircraft monitor, ECAM) inhibits unnecessary alert/warning/caution messages in some flight phases such as phase 3, 4 and 5 (takeoff) or phase 7 and 8 (landing). In the occurrence flight, the F/CTL PRIM 1, PRIM 2, and PRIM 3 fault messages were inhibited as indicated in Figure 1.6-11.

Figure 1.6-11 F/CTL PRIM 1(2)(3) FAULT message inhibit.

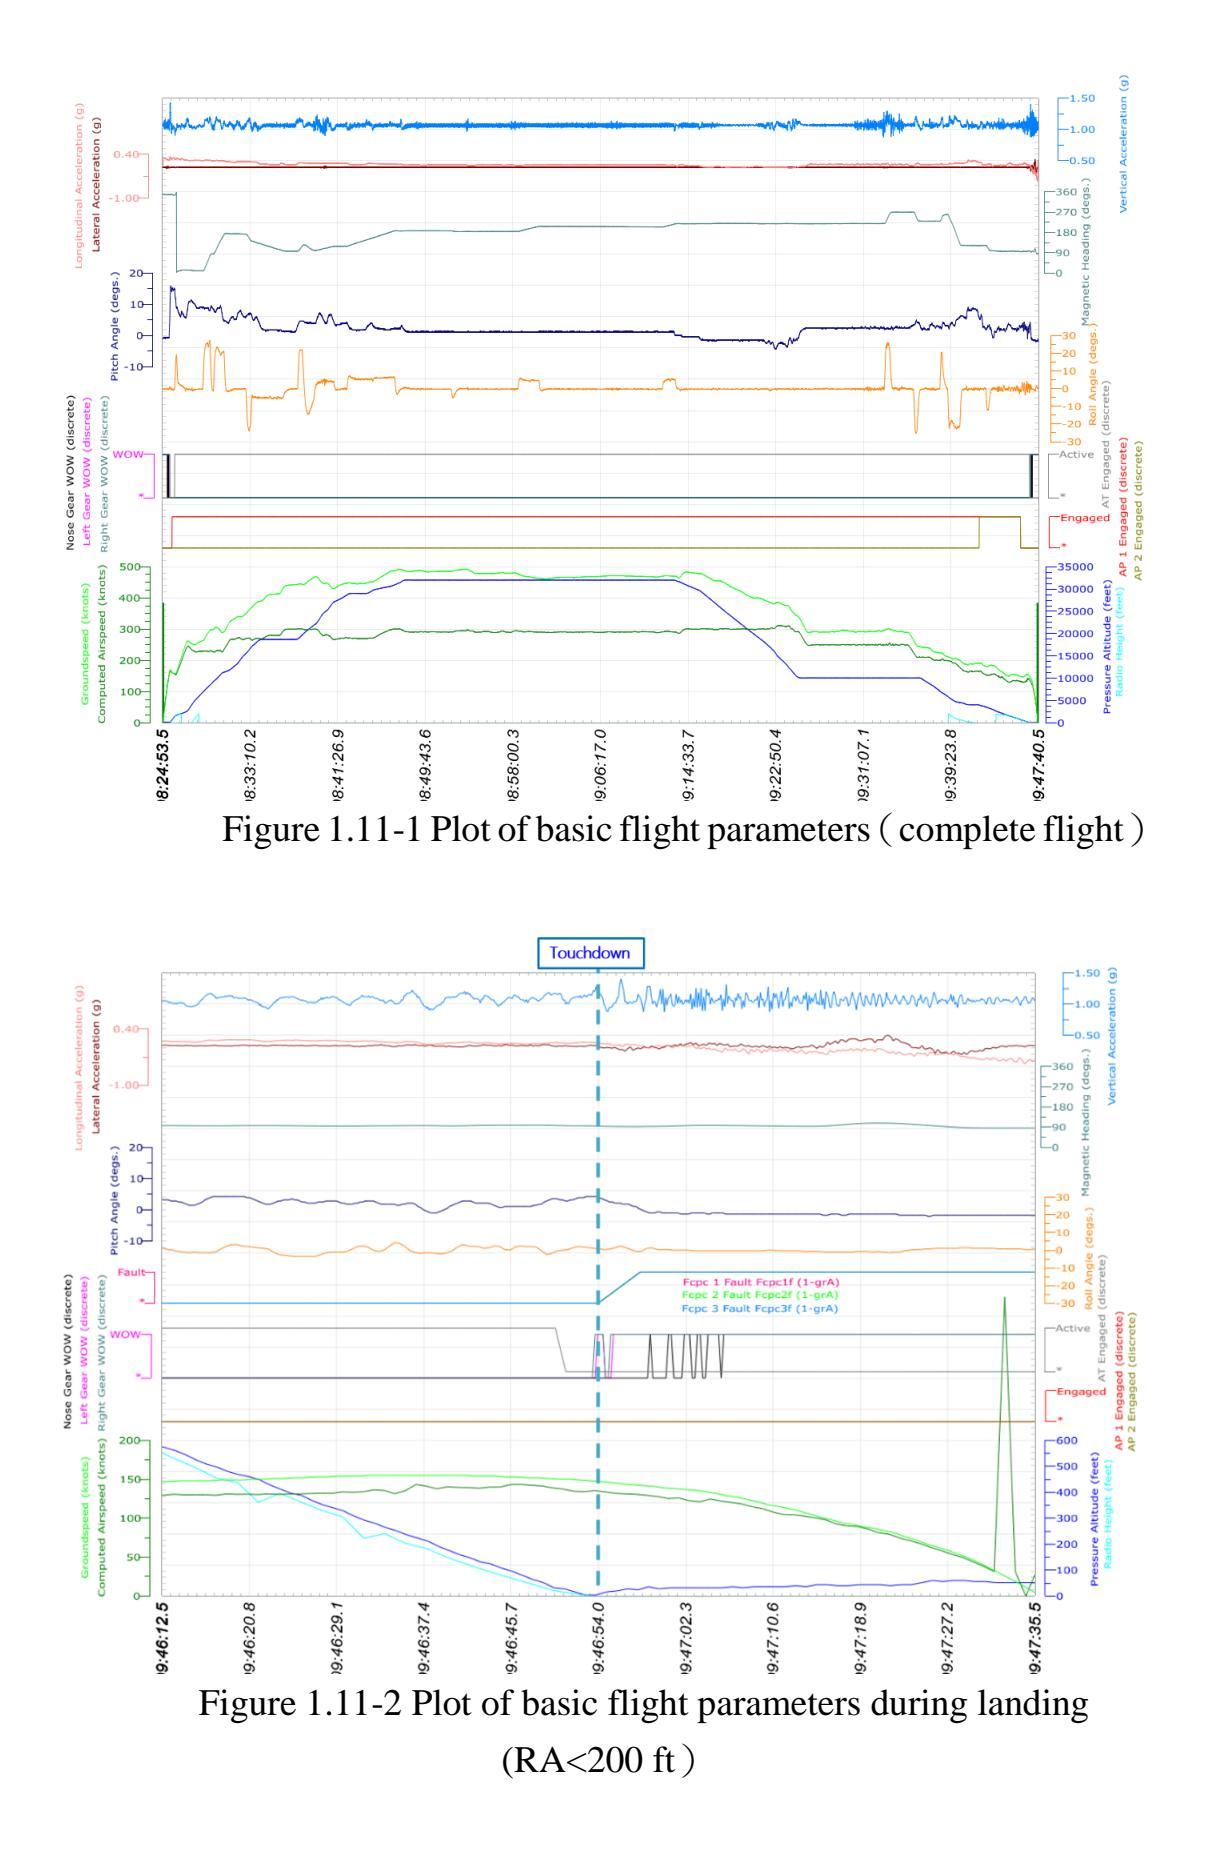
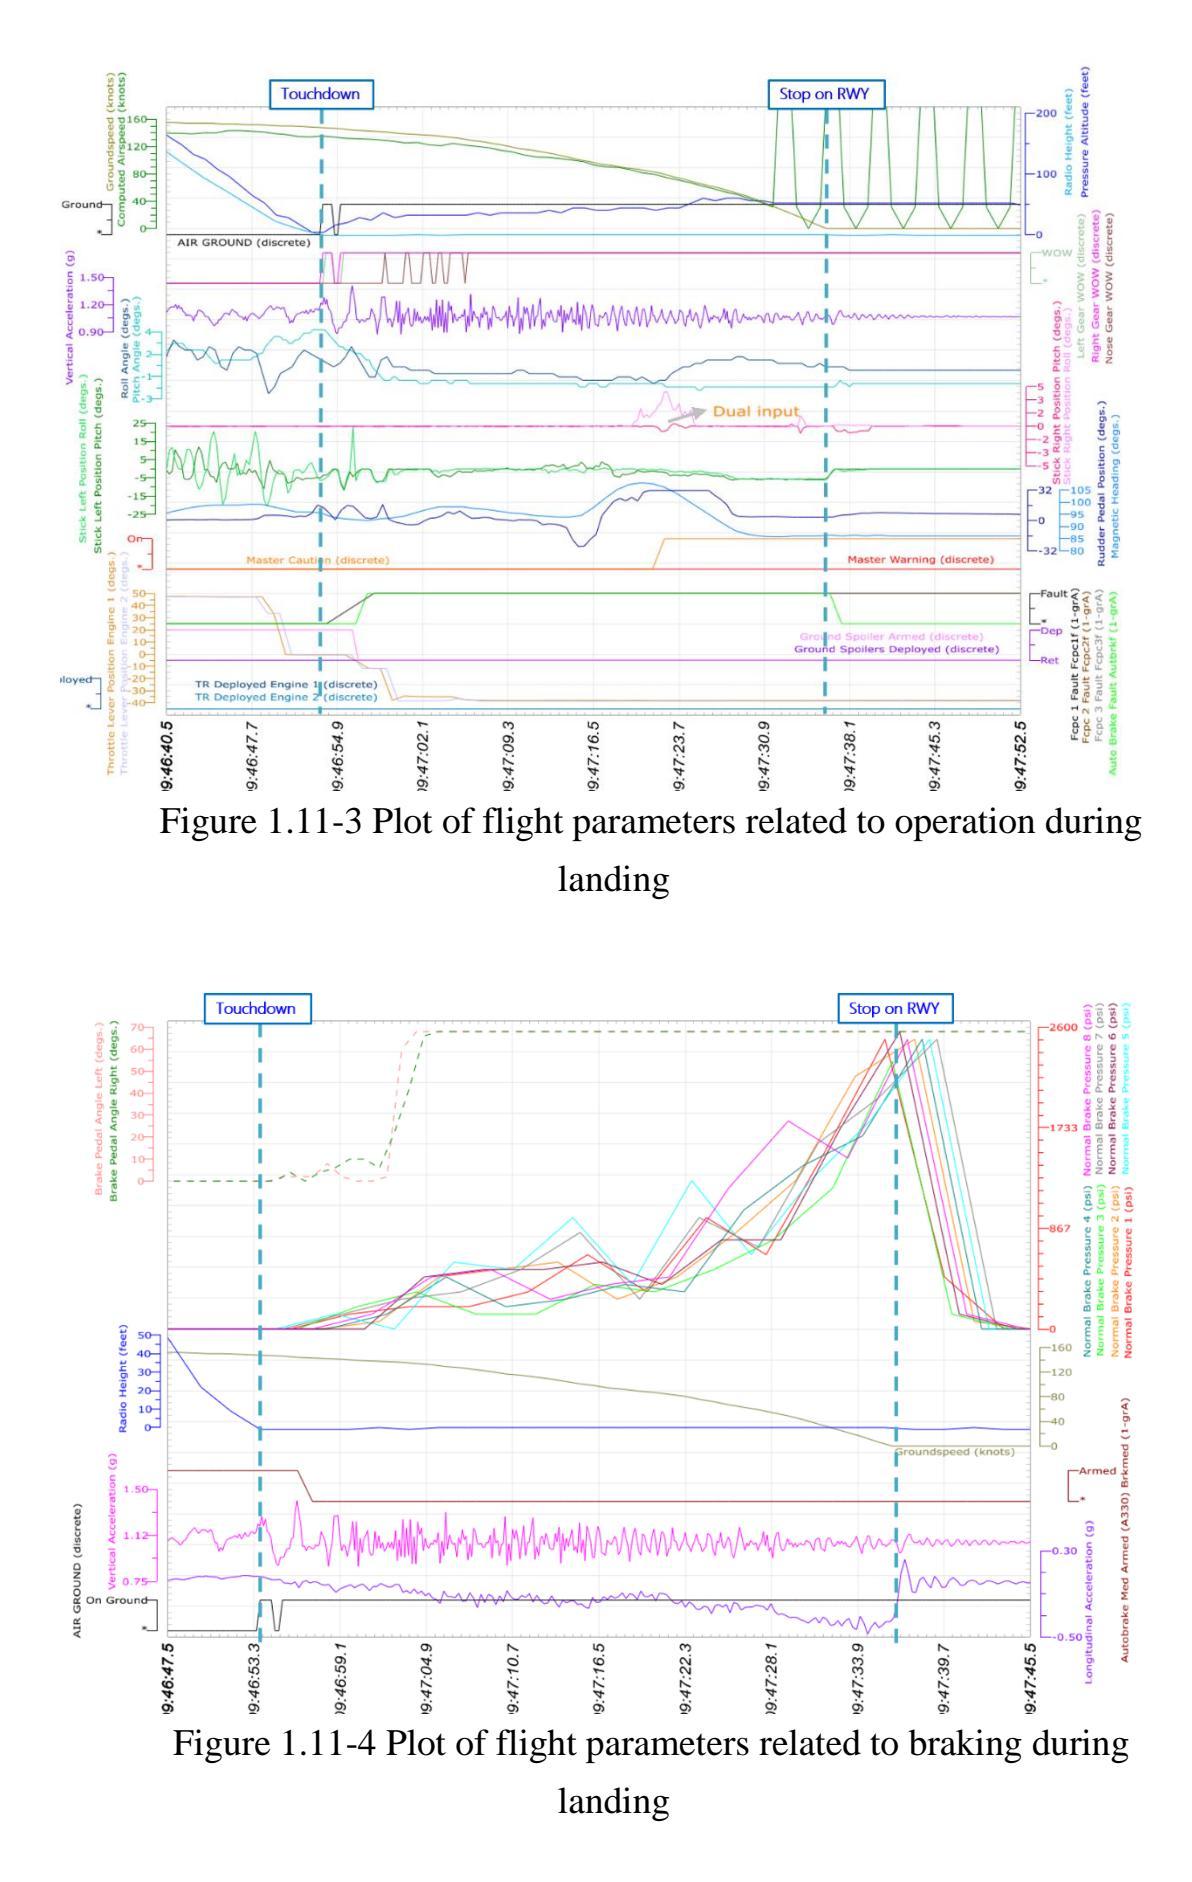
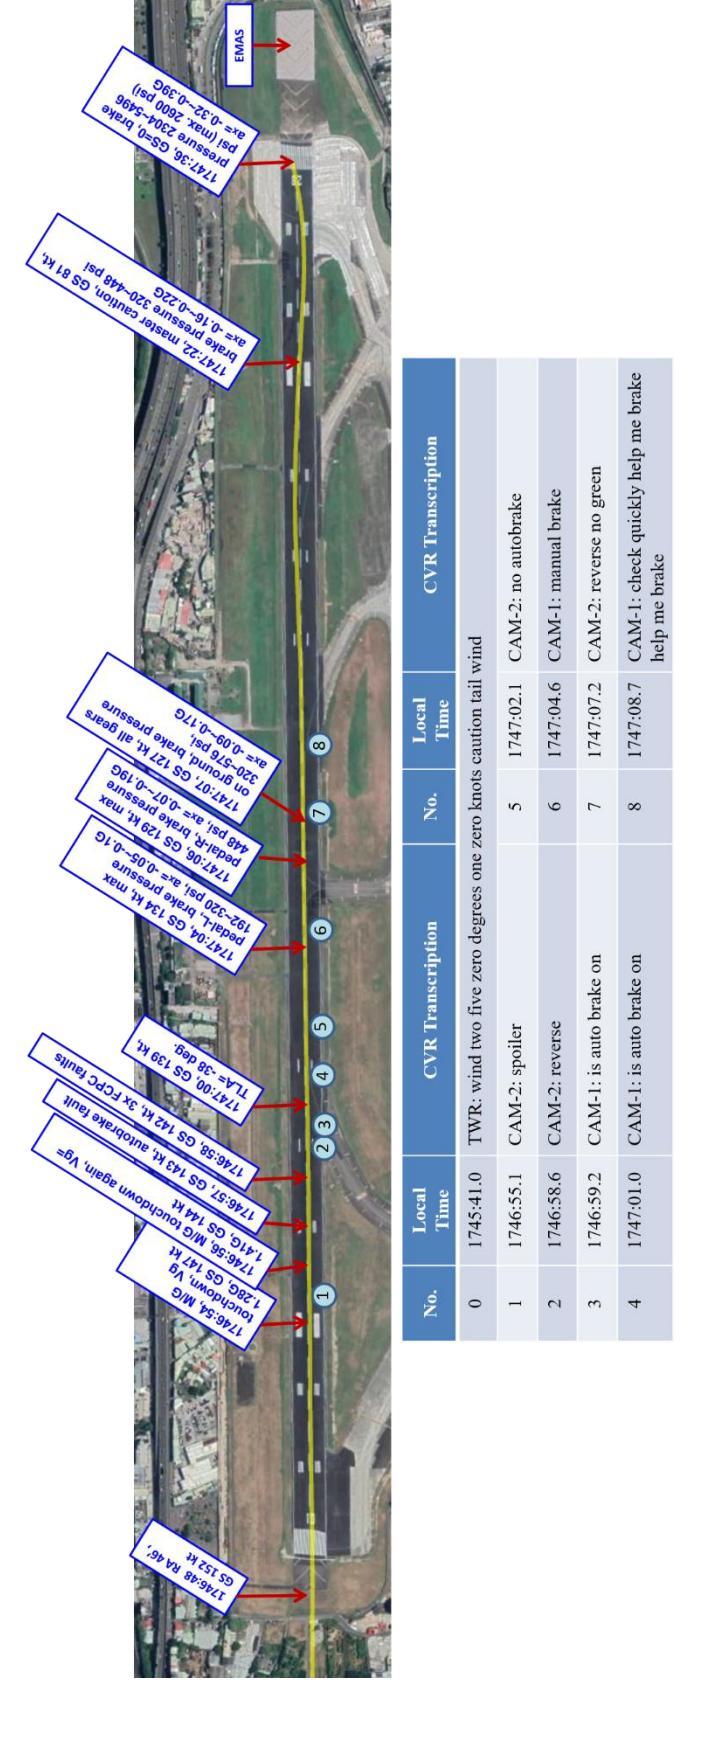
During its landing roll, ground spoilers deflected momentarily. Thrust reversers did not activate at all.

Figure 1.11-5 Aircraft ground track, key events, and CVR transcript

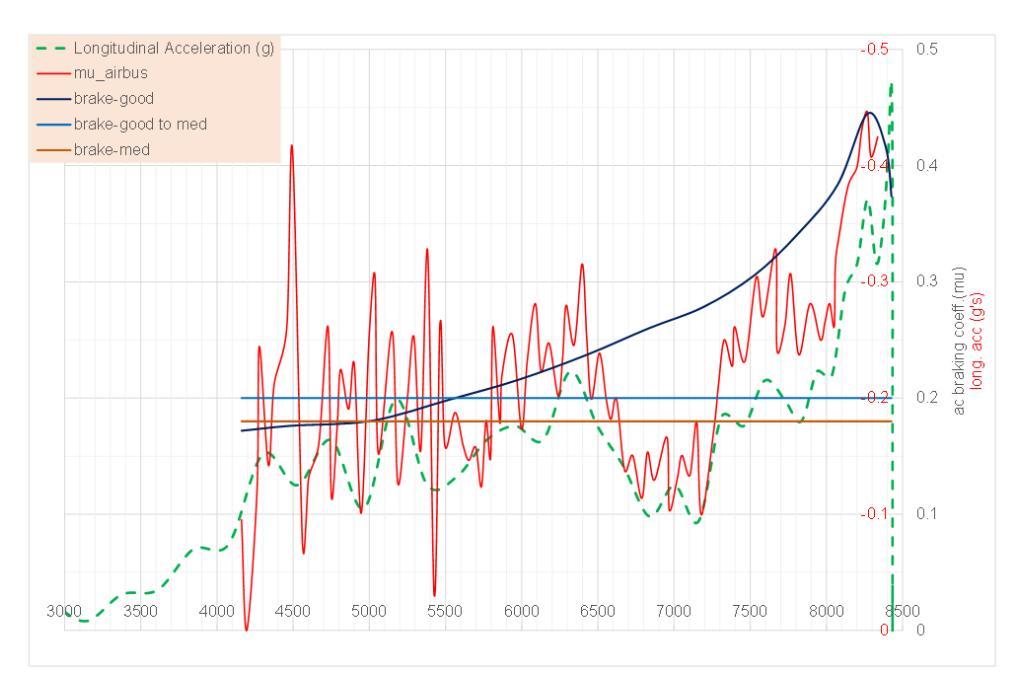
- Between the region of 4,300 feet and 6,400 feet of runway 10, the deceleration performance of occurrence flight was "good".
- Between the region of 6,400 feet and 7,300 feet of runway 10, the deceleration performance of occurrence flight was between "poor" and "medium".
- Between the region of 7,300 feet and 8,000 feet of runway 10, the deceleration performance of occurrence flight was between "medium to good" and "good".
- Between the region of 8,000 feet and 8,400 feet of runway 10, the deceleration performance of occurrence flight was "good".

With the FDR data plot of brake pedal angle, braking pressure and the ground trajectory of the occurrence flight (figure 1.11-5), it was found that the deceleration performance of the occurrence flight between 6,600 feet and 7,300 feet from the threshold of runway 10 deteriorated. It might be due to the runway marking and rubber deposit on the touchdown zone of runway 28.

Figure 2.7-1 Landing distance and deceleration performance
