**Aviation Safety Council
Taipei, Taiwan**

**CI611 Accident Investigation
Factual Data Collection
Group Report**

Recorders Group

ASC-AFR-03-06-001

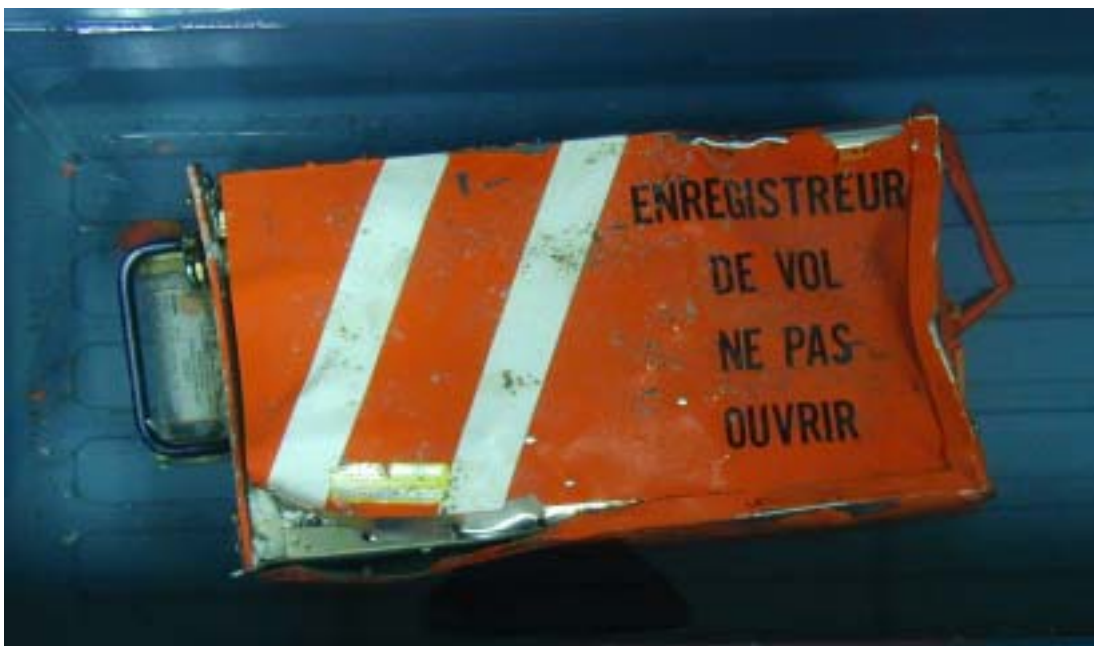
The CVR unit arrived at the ASC lab in a water cooler submerged in fresh water (Figure 1.11-1). The exterior of the CVR was seriously dented and distorted. The front panel including the handle and underwater locator beacon was still attached. The protective dust cover had to be cut in several places before it could be removed. The interior crash enclosure appeared to be in good condition. There were only a few minor scratches and dents noted. The interior tape reel assembly was wet. The recording media was wet but otherwise appeared to be in good condition. The tape was not broken but had minor damages. There were no signs of any fire or heat damage noted to either the exterior or the interior of the unit. The Dukane underwater locator beacon that was installed on the CVR was seriously contaminated but operated normally during underwater recovery process.

Figure 1.11-1 Damaged CVR in the cooler

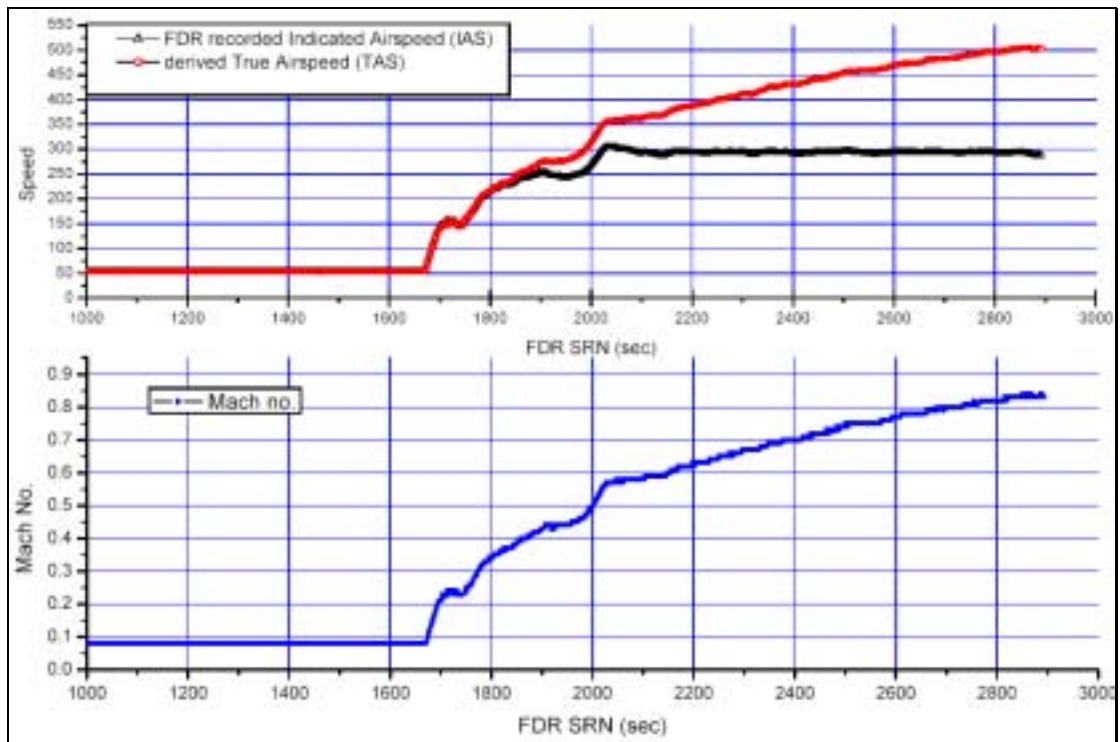
Figures 1.11-6 and 1.11-7 show the results of these calculations. In Figure 1.11-6, the recorded indicated airspeed points are shown. The True Airspeed is also shown in Figures 1.11-6 and 1.11-7, which is derived from air density ratio and indicated airspeed. The rate of climb is derived from the altitude change rate in feet per minute.

Figure 1.11-6 (a) China Airline 611- Airspeed, True airspeed and Mach number

Figure 1.11-6 (b) China Airline 611- Airspeed, True airspeed and Mach number (detail)

The results of these corrections and derivations are presented in Figure 1.11-6 to 1.11-9. The “A” Figures present the results for the entire flight; the “B” Figures show the last 3 minutes of the FDR data in more detail.

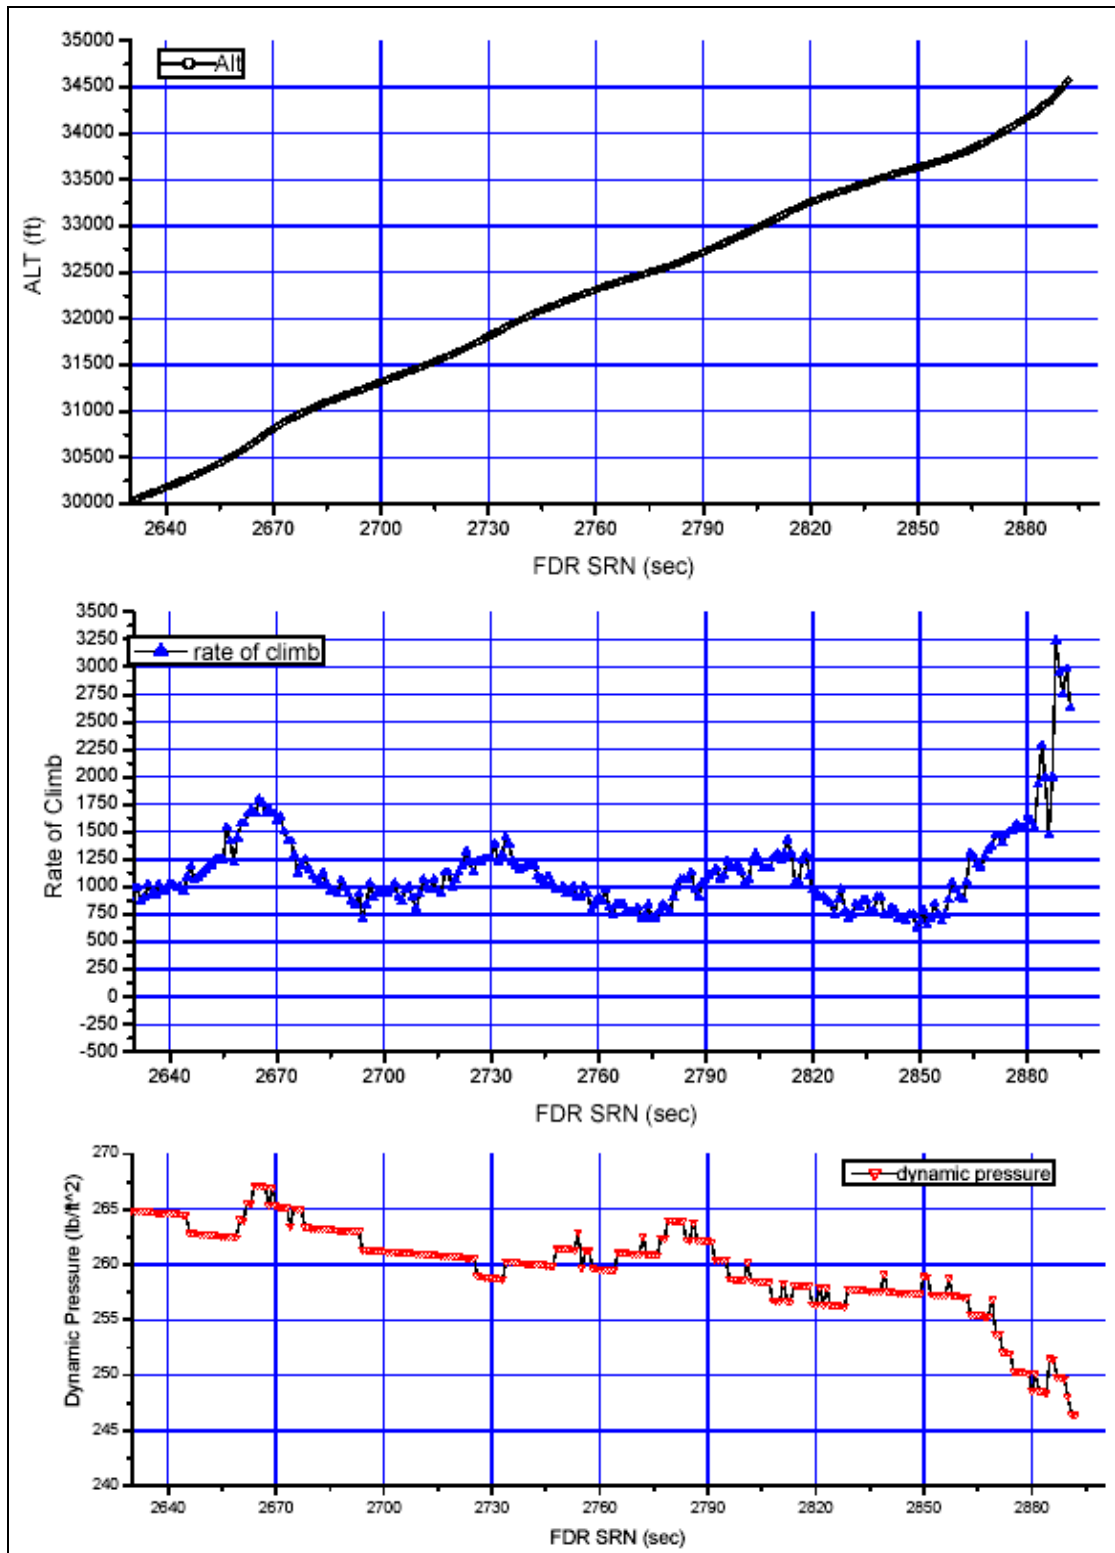
Figure 1.11-7 (a) China Airline 611- Altitude, rate of climb and dynamic pressure

Figure 1.11-7 (b) China Airline 611- Altitude, rate of climb and dynamic pressure (detail)

In summary, between FL300 and FL 330, the average rate of climb and dynamic pressure of CI611 flight is 1080 ft/min, and 262.7 lb/ft², respectively. In 30 seconds, the average rate of climb and dynamic pressure of CI611 flight is 1672 ft/min, and 251.9 lb/ft², respectively.

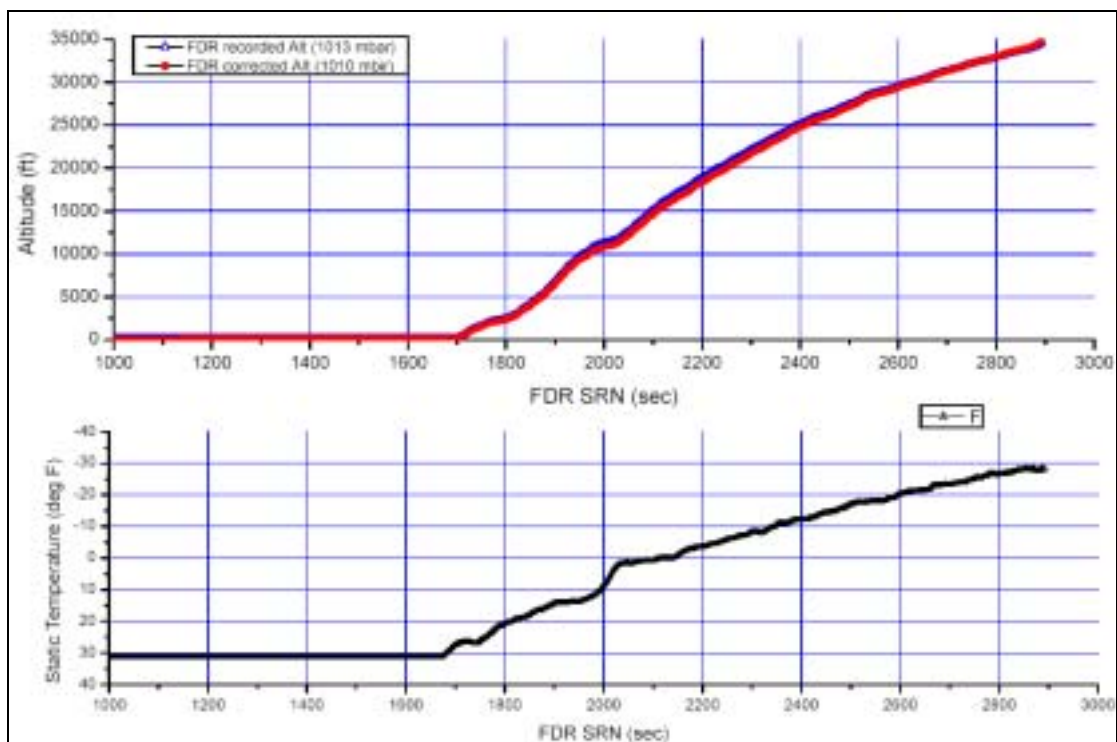
The results of this calculation are shown in Figure 1.11-8 as the line labeled "FDR corrected alt" The line labeled "FDR recorded alt" is the readout parameter of FDR. Figure 1.11-9 shows the pressure altitude of FDR and Mode C altitude of the aircraft transponder. FDR stopped recording at time 07:27:58.9 UTC (34573 ft), and last transponder beacon was received at time 07:28:14 UTC (34843 ft or 10620m, Xiamen site), and 07:28:03 UTC (34900ft, Makung site).

Figure 1.11-8 (a) China Airline 611- pressure altitude, corrected altitude and static temperature

Figure 1.11-8 (b) China Airline 611- pressure altitude, corrected altitude and static temperature

The altitude recorded by the FDR is pressure altitude; i.e., altitude in the standard atmosphere corresponding to the static pressure sensed at the aircraft's static port (1013 mbar). The altitude in the actual atmosphere corresponding to the local static pressure generally does not equal to the pressure altitude, and it is insufficient to simply adjust the pressure altitude for the local sea level pressure. Since the lapse rate of pressure with altitude does not match the lapse rate in the standard atmosphere to estimate the actual altitude of CI611, the recorded pressure altitude is adjusted to account for the 1010mbar altimeter setting.

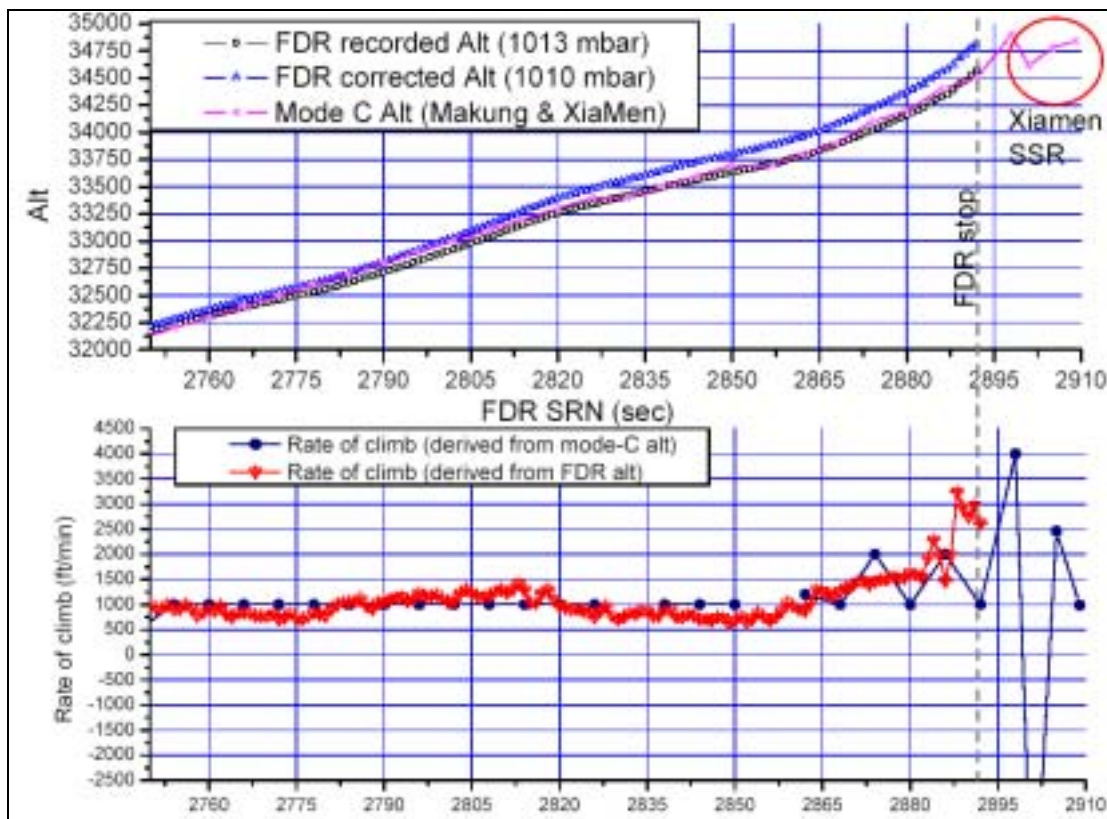
Figure 1.11-9 China Airline 611- comparison of altitude, rate of climb (FDR Vs. Radar)

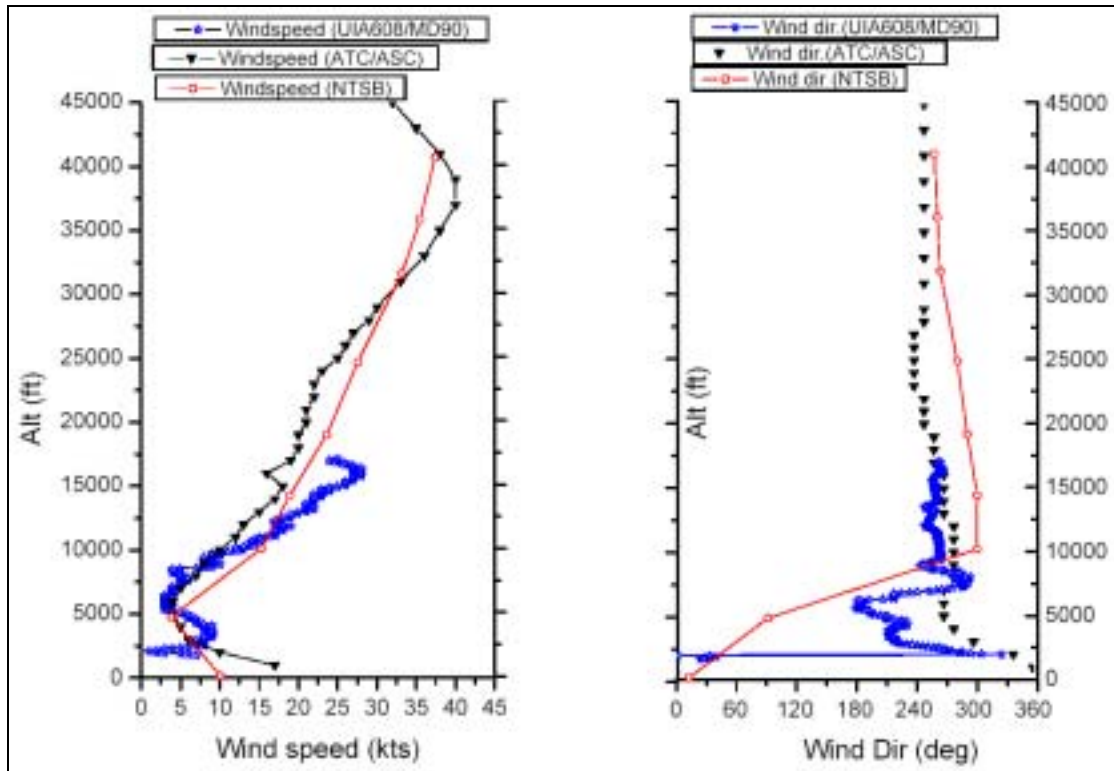
Based upon meteorological data collected from Makung Airport, CAA and NTSB performed similar wind profile calculation along CI611 flight path, Figure 1.11-12 compares the wind profile between the UIA608 and the ground based calculation results).

Figure 1.11-12 Comparison of wind profile (ground based calculation Vs. On-board data of UIA608)

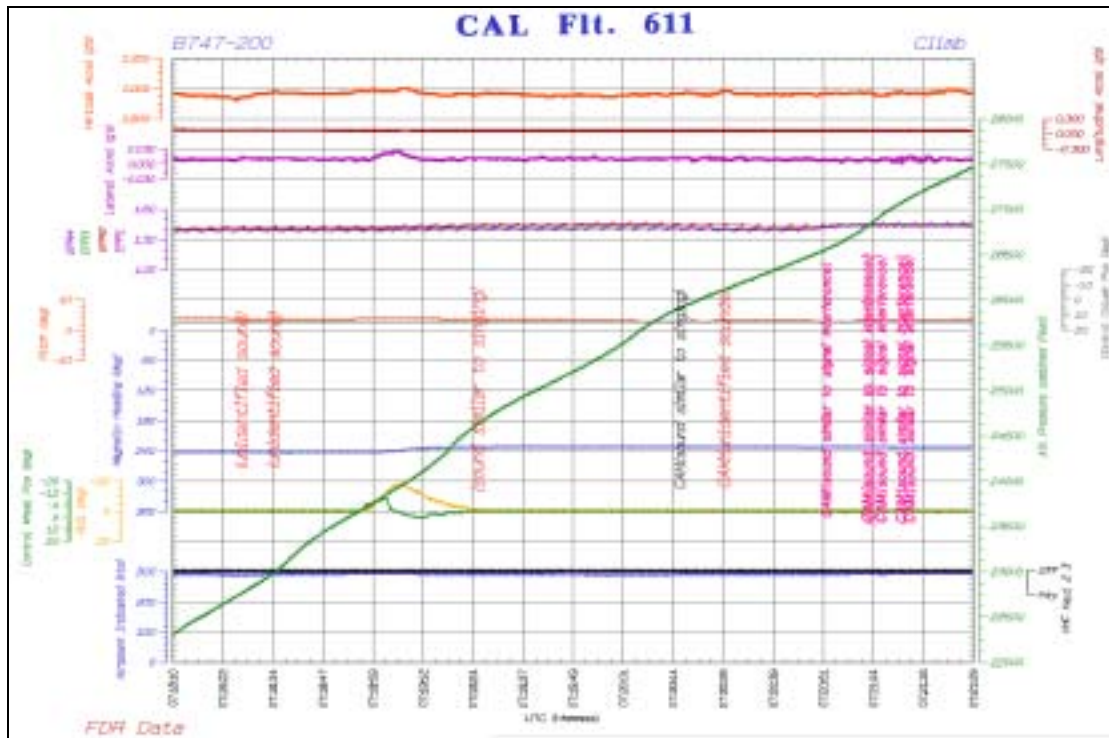
Figure 7 FDR data plots of Cl611 (during 22,000 ft and 28,000ft, with CVR unidentified sound and interference signal)

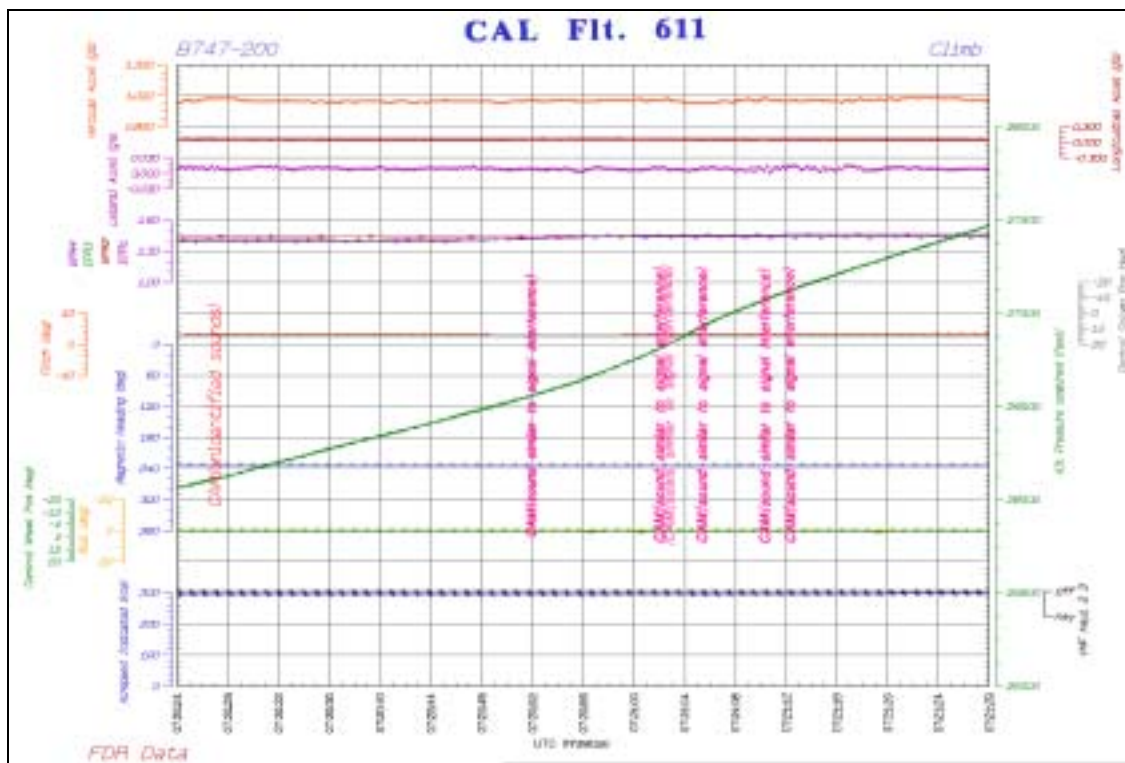
Figure 8 FDR data plots of Cl611 (during 25,000 ft and 28,000ft, with CVR signal interference)

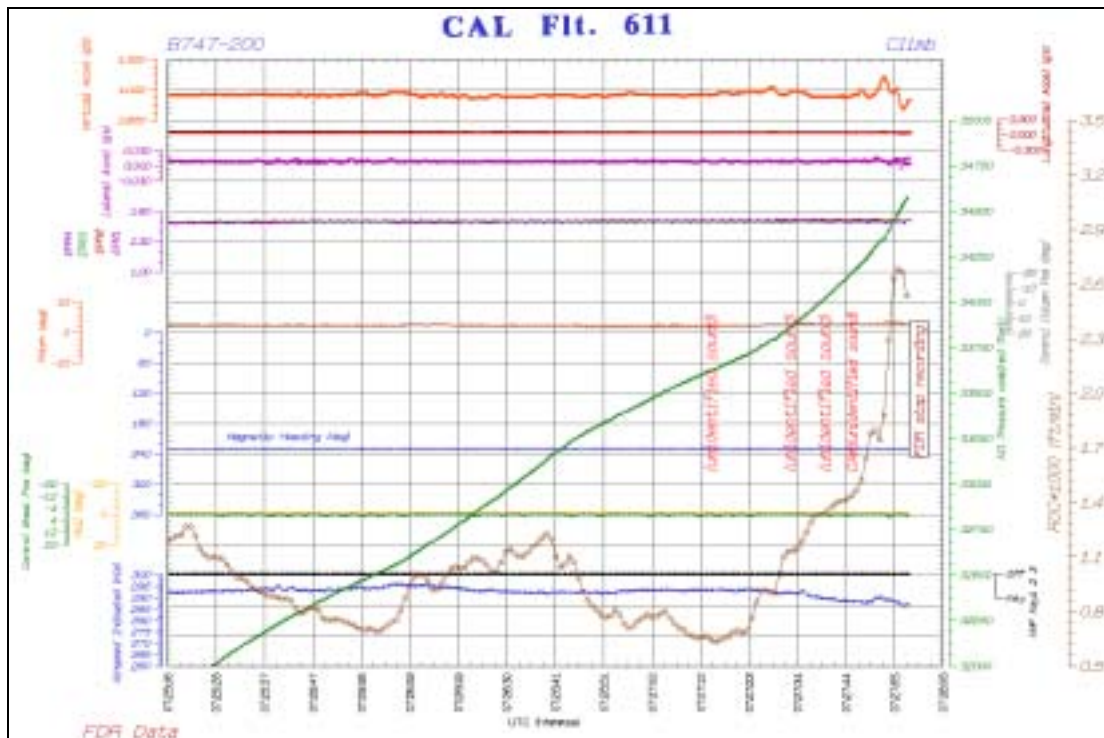
Figure 10 FDR data plots of CI611 (during 32,000 ft and 35,000ft, with CVR unidentified sound)
