**Aviation Safety Council
Taipei, Taiwan**

**GE791 Accident Investigation
Factual Data Collection
Group Report**

Recovery Group

ASC-GRP-03-10-001

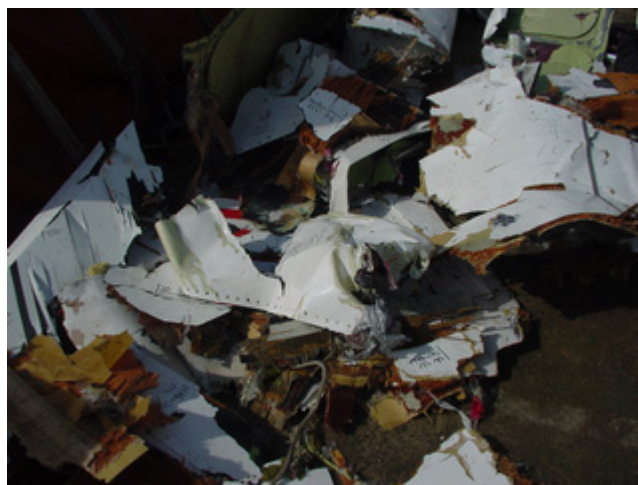
Floating wreckage: The floating wreckages found by Navy and Coast Guard was 87 pieces. Most of them are honeycomb of wing trailing edge, flaps, rudder, and elevators engine cowling and so on (refer to Figure 1.18-14). Some of them are clothing. The biggest one was number 55, which was a roll of clothing (210 cm X 17 cm). The smallest one is a taco meter of engine rpm (10cmX1cm)

Figure 1.18-14 Floating wreckages

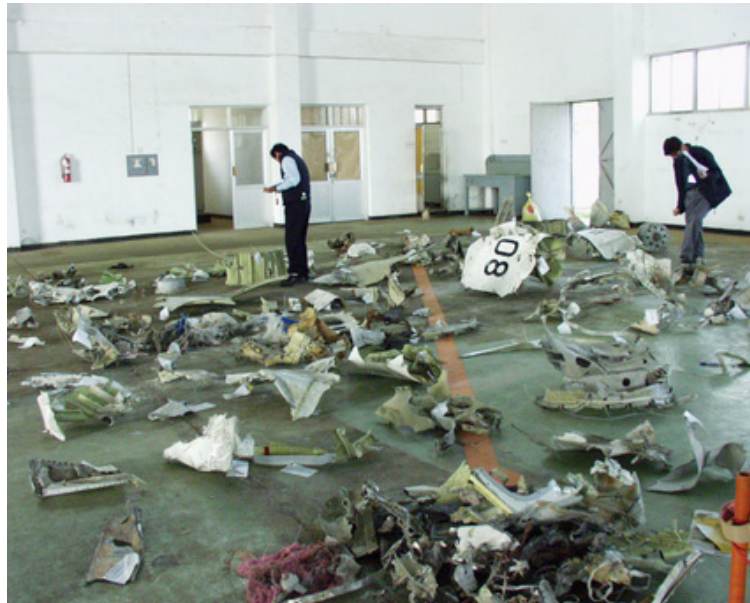
Underwater wreckage : The Ocean Hercules recovered 10 pieces of wreckage and trawling operation recovered 102 pieces. Most of them are from of wing structure, fuselage skin, landing gears, wheel, stringer and frame (refer to Figure 1.18-15). The biggest piece is a cargo floor (no.198 with size

of 205cmX135cmX6cm). The smallest one was fuselage skin (no.152 with size 24cmX8cmX0.2cm).

Figure 1.18-15 Underwater wreckagerecovered by trawling operation

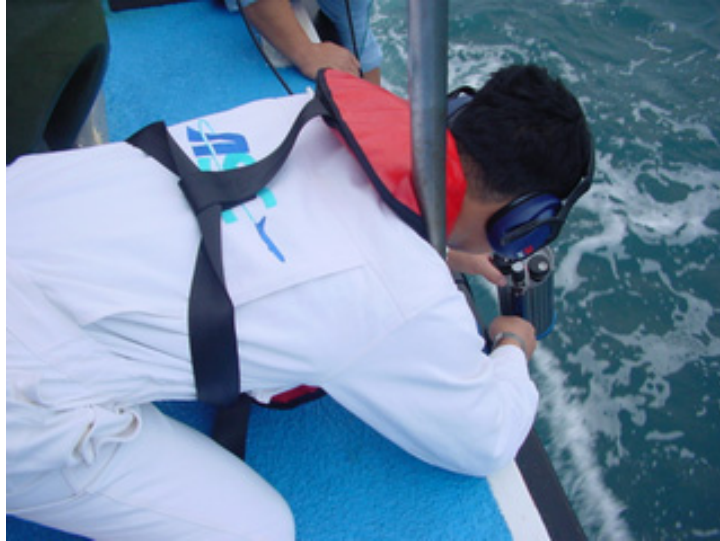
The navel ship has sonar search and sound perceiving device, and began operation soon after the negotiation meeting. The Coast Guard on the other hand, teamed with ASC and CSIST in the operation (Figure 1.18-21~22). The NSC vessel Ocean Research II mainly used sonar side scan to conduct wide range search operation, while SMIT Ocean Hercules conducted underwater filming to confirm target objects. Details of operation units as follows: mode

Figure 1.18-21 Search flight recorders with pinger receiver

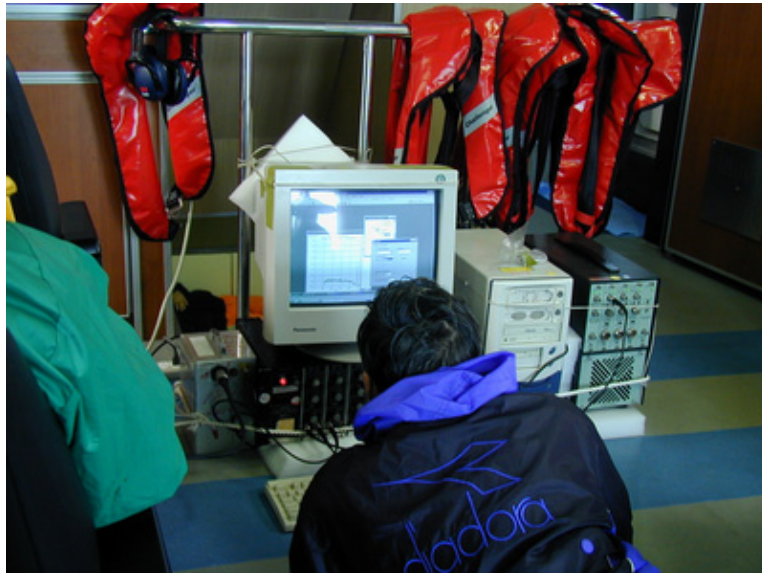
Figure 1.18-22 CSIST engineers searched flight recorders at Coast Guard boat.

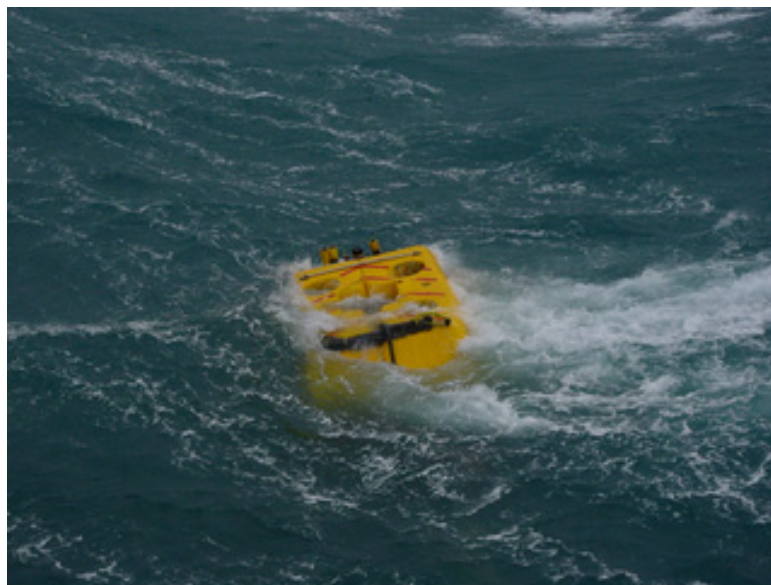
On January 10th, 2003, marine weather at wind 7 kt, gust 9 kt, seas 4 m, underwater current 5kt to 6 kt. Although the condition was over operation criterion, but nonetheless Ocean Hercules sailed to the accident site, and attempted dynamic positioning to release the ROV for underwater search. However, due to rough seas, the dynamic positioning system suffered power cut several times, thus the attempt had to be aborted, and the ROV also could not operate in such strong current. The wind slowed down at 1600, and ROV began search operation. Areas of ROV search operation are NP-1, NP-2, NP-3, NP-5, NP-6 (Figure 1.18-27), only at NP-1 were small pieces of wreckages found.

Figure 1.18-27 ROV operation_launching

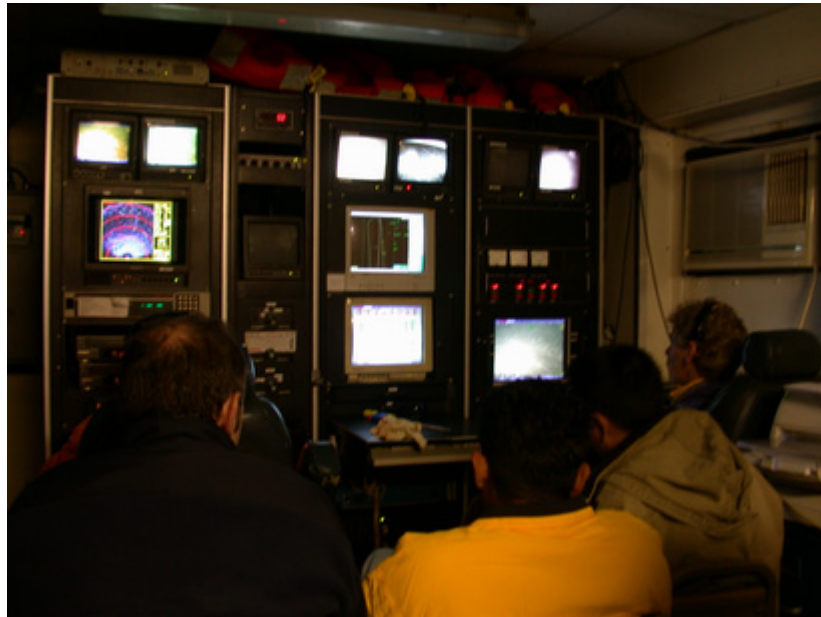
Later, the underwater coordinates provided by Ocean Research II were used to plan sonar side scan range. Several target objects were found after twelve hours, their spread range were similar to the Ocean Research II data. When the current slowed down, an area of 350m² with 25m grids was mapped, and ROV was sent down to scan at 50m in diameters(Figure 1.18-28).

Figure 1.18-28 Visual check with ROV video camera and forward sonar scanning

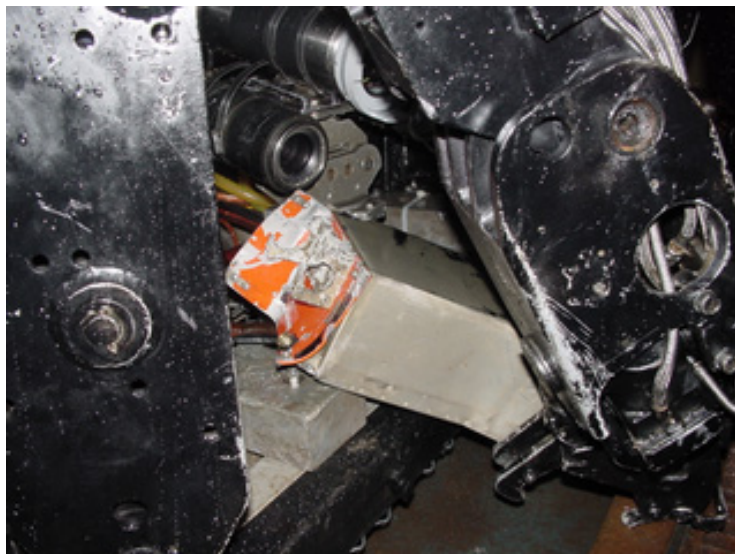
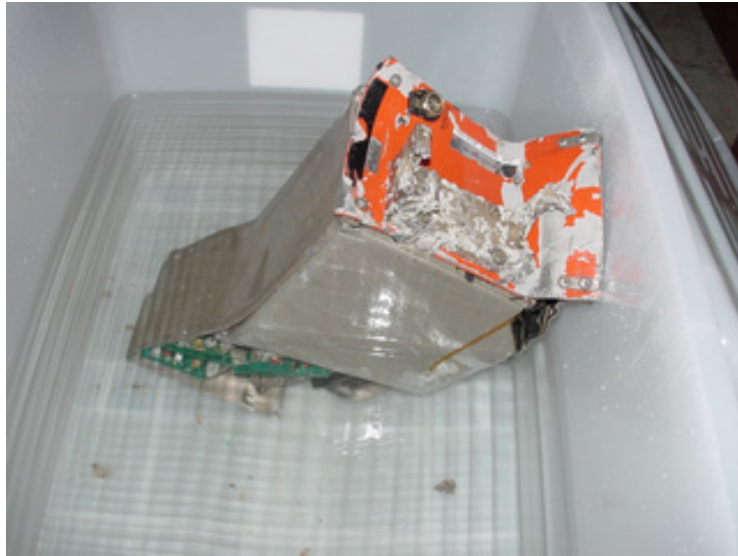
At 1740 on January 13th, 2003, ROV discovered CVR fore part (Crash Survivable Unit, CSU) , its pinger being lost, and without the orange casing. At 1900 ROV mechanical arm salvaged CVR (Figure 1.18-31,32), and subsequently discovered wreckages.

Figure 1.18-31 CVR recovered by ROV

Figure 1.18-32 CVR closed view while recovered
