**Aviation Safety Council**

**GE235 Occurrence Investigation  
Factual Data Collection  
Group Report**

**Flight Recorders Group**

**ASC-FRP-15-07-005**

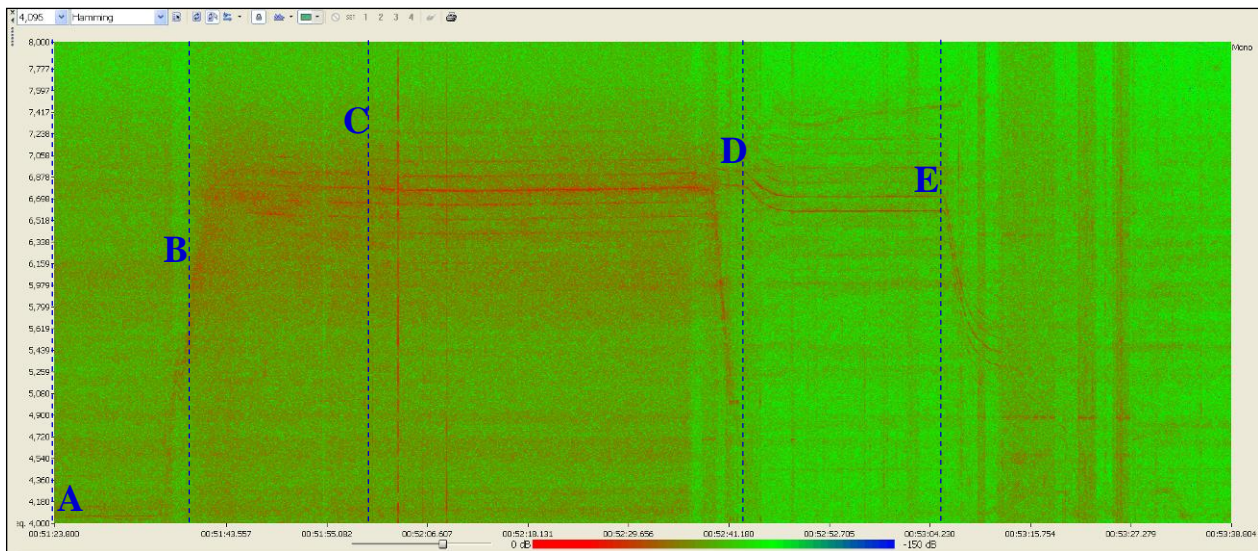
Figure 1.11-4 presents some selected CVR transcript and superposing with the relevant spectrogram that contains audio information from the CAM track between 1051:23.8 hrs and 1053:38.8 hrs. Both engines operated normally prior to 1052:39 hrs when the first sound of engine dropped off was heard. The trend matches the observation from FDR data that, engine no.2 propeller speed (denoted as NP) dropped immediately right after the autofeather of engine no.2. At 1052:43.0 hrs, Pilot Flying (denoted as PF) said that “*i will pull back engine one throttle*”; and at 1053:06.4, PF said that “*pull back number one*”, FDR data indicated that no.1 engine NP dropped off immediately.

Figure1.11-4 GE235 Spectrogram of the CAM recording

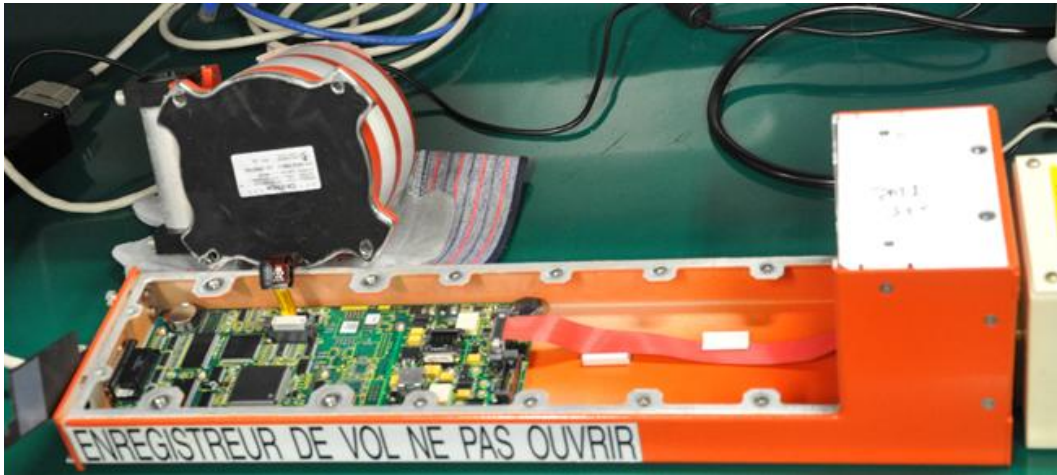
Figure1.11-5 Connecting the CSMU of GE235 FDR to chassis

The FDR was recovered by ASC Go-team at the tail section of main wreckage at 1605 hrs on Feb. 4th. Upon the first inspection by ASC investigators, it was evident that the FDR did not have any punctures, fire, or other penetration traces, and was found in good condition. After cleaning and drying the CSMU and chassis, ASC investigators used normal procedure to download FDR raw data, shown as in Figure 1.11-5.

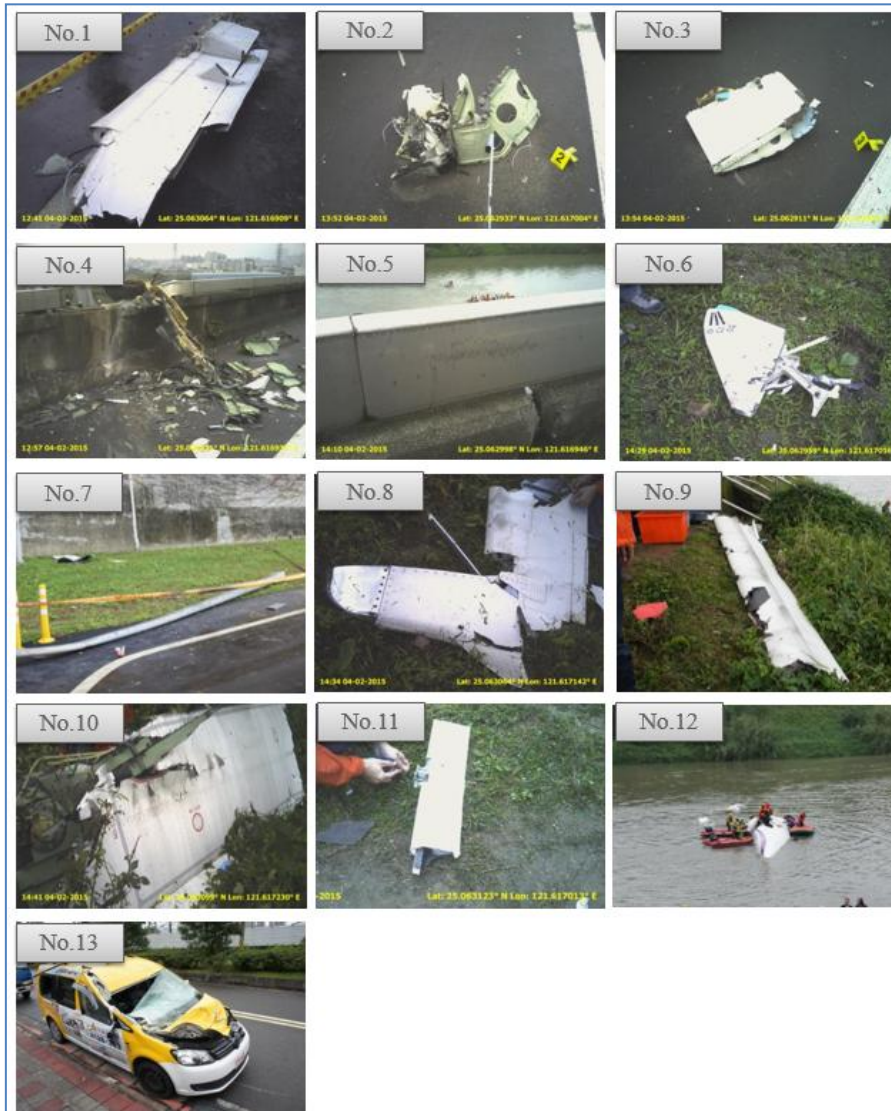
Figure 1.12-3 Site survey- wreckage identification numbers and photos.

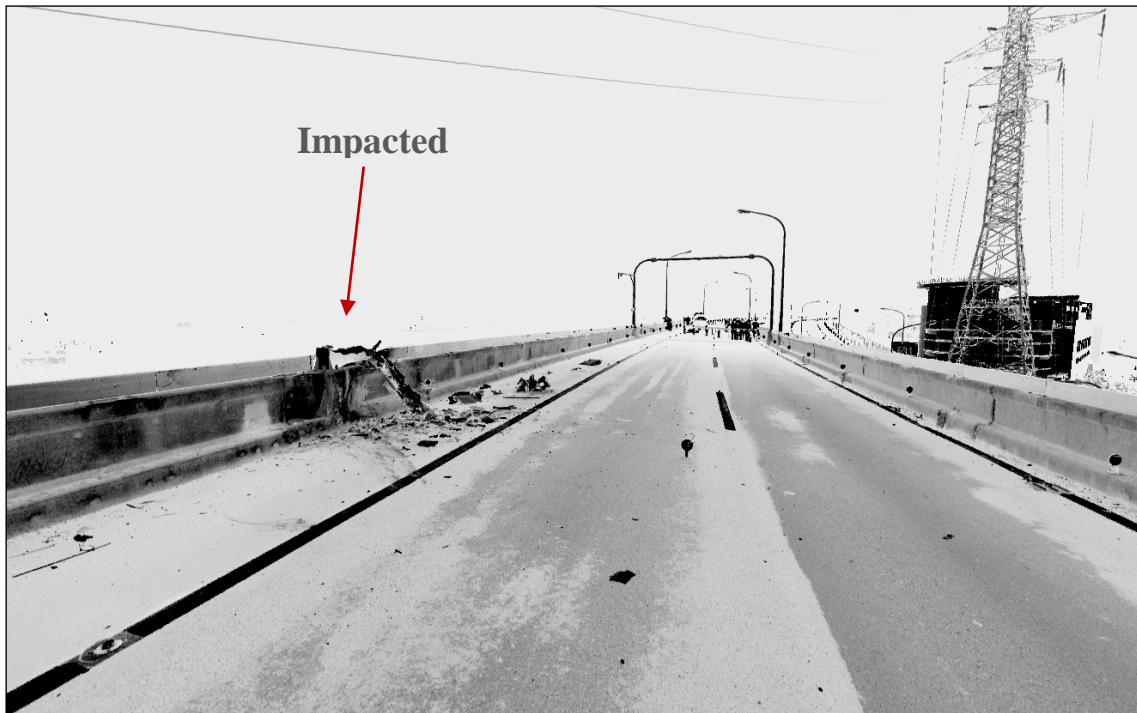
While ASC was conducting the site survey, the Criminal Investigation Bureau (CIB) performed parallel investigation and utilized its 3D LIDAR on the Huan-Dong Blvd to collect the impact information. CIB scanned the area near the first impact point, and provided ASC the survey result. The LIDAR data was recorded as three-dimensional point clouds. The height of street light were 7 meters, and the width of the Huan-Dong Blvd was 10 meters. There were some electrical power transmission lines above the Huan-Dong Blvd, over 20 meters high. Figure 1.12-4 shows the point clouds of the crash site, and the impacted barrier on the Huan-Dong Blvd was reconstructed by a LIDAR scanner. In addition, the

Figure 1.12-4 Perspective view of the point clouds at crash site (Huan-Dong Blvd.)

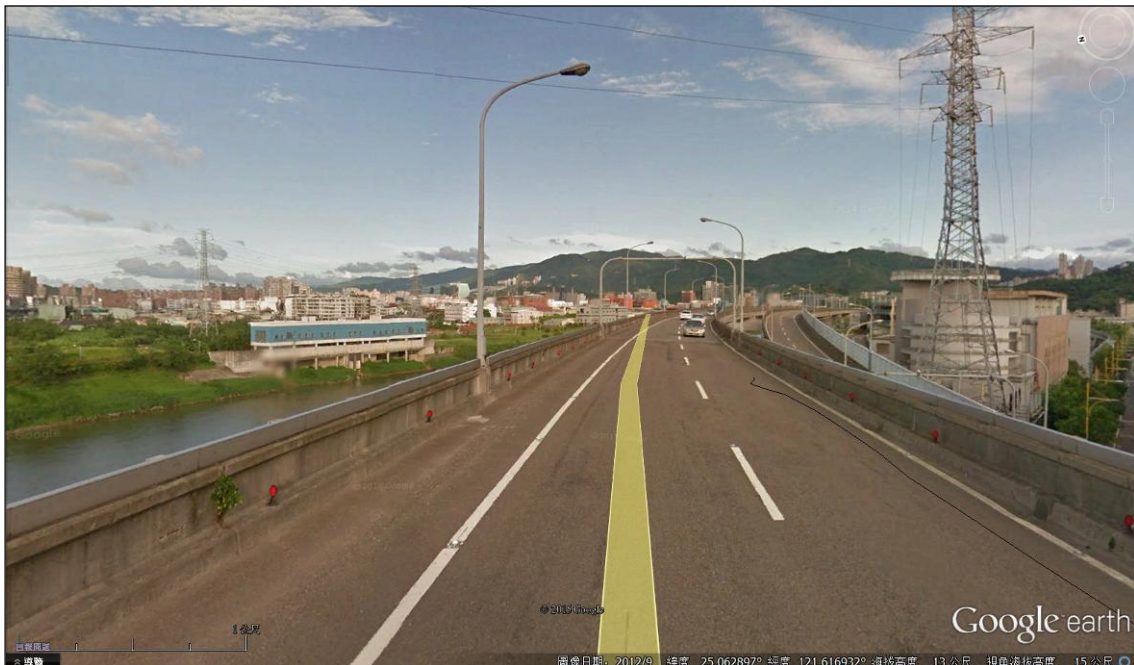
perspective view of the occurrence site was collected from Google 3D view browser in Figure 1.12-5.

Figure 1.12-5 Perspective view of the Huan-Dong Blvd, which reconstructed by Google.

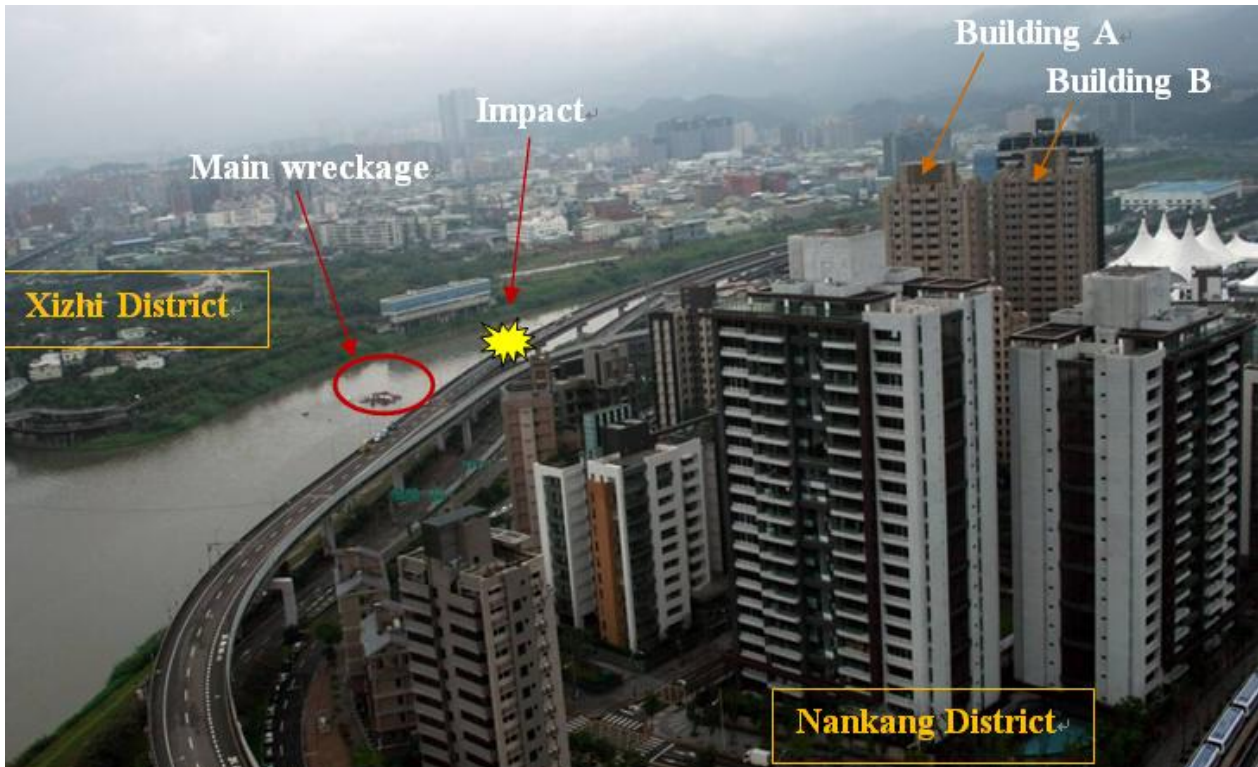
Figure 1.12-7 Aerial photo of crash site taken from a rescue helicopter

ASC a set of precise digital terrain data and aerial photos, and ASC created the surface models of the taxi, part of Huan-Dong Blvd, and street lights. Flight path and related ground building models were illustrated in Google Earth, shown in Figure 1.12-6. There are two building marks (denoted as A and B) equipped with video camera that captured last few moment of the flight, the relevant video frame presented at section 1.12.1.3. Figure 1.12-7 shows an aerial photo of the crash site taken from a rescue helicopter.

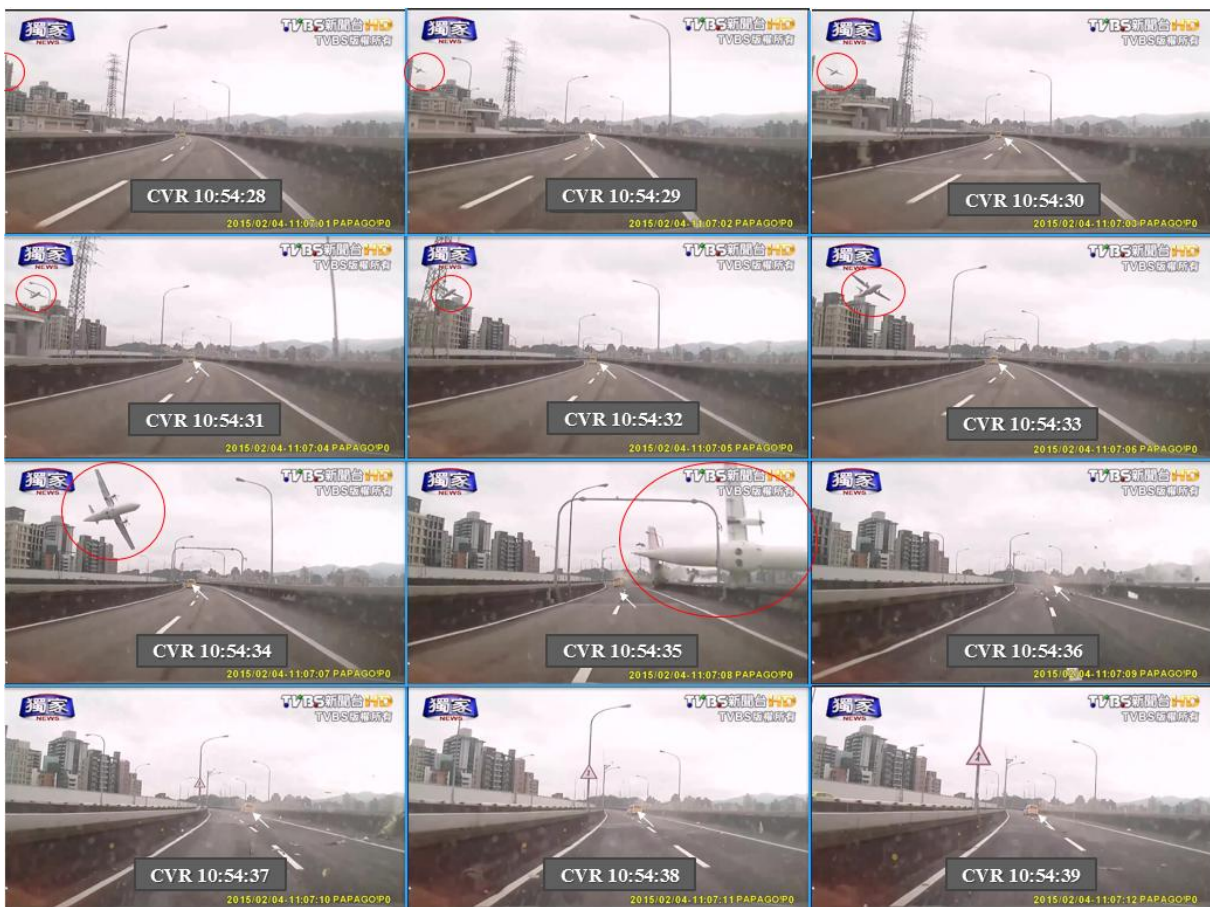
After the occurrence, ASC investigators collected traffic surveillance video at Huan-Dong Blvd and several dashcam videos from nearby vehicles. Several videos showed that the aircraft hit a taxi, impacted the viaduct, and then crashed into Keelung River. All videos were examined during the investigation. When the occurrence happened, two ground vehicles (noted as black color and silver color) were traveling westbound on Huan-Dong Blvd. Their dashcam videos contained clear images and were helpful for the investigation. To correlate the time of video and flight recorders, the unidentified sound (1054:34.8 hrs) of CVR before aircraft crash was used to be the common event of the aircraft hitting the taxi and viaduct on the video. Relevant video snapshots of the silver car dashcam with CVR time are shown in Figure 1.12-8, the copyright of video was authorized by TVBS for public publication.

Figure 1.12-8 Dashcam video snapshots extracted from the silver car (authorized by TVBS)

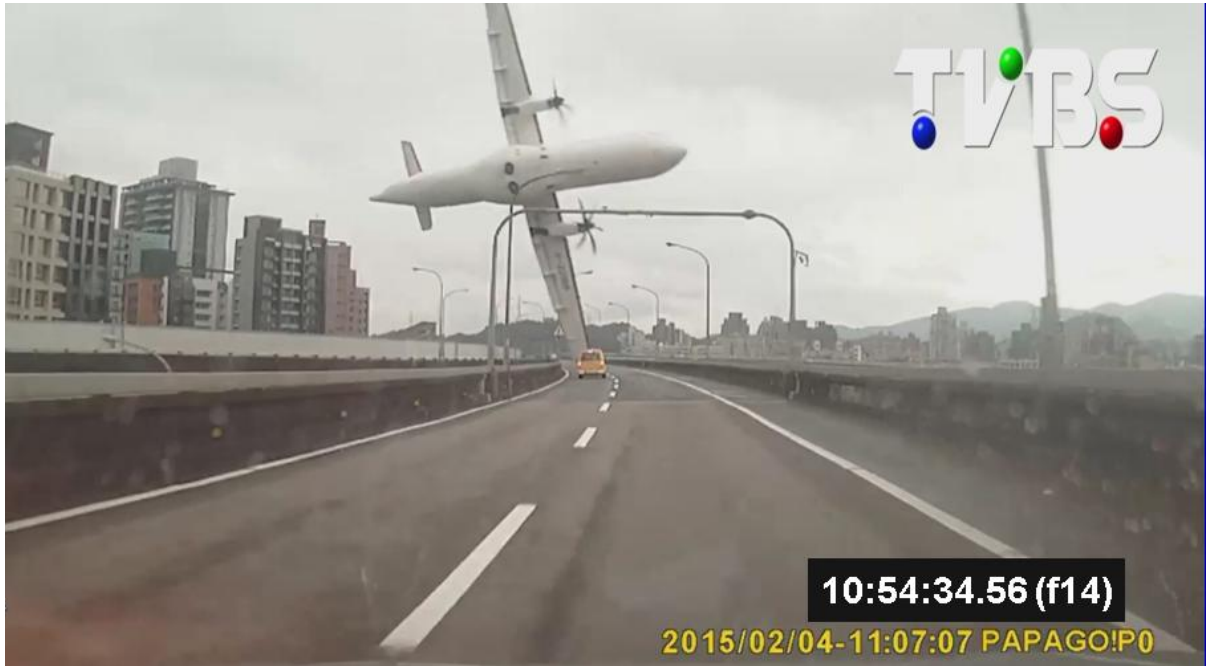
Figure 1.12-9 The 14<sup>th</sup> frame of dashcam videos of the silver car (CVR 1054:34.56 hrs)

meaning that a frame equals to 0.04 second. Based on the dashcam video and the site survey data, the aircraft banked to left at about 90 degrees and the distance between the taxi and the barrier was about 9 meters. The aircraft flew 9 meters in 5 frames (0.2 seconds), shown in Figure 1.12-9 to Figure 1.12-11. Figure 1.12-11 showed that the aircraft impacted the north barrier of Huan-Dong Blvd, represented by the 19th frame of the video timing at 1107:07 hrs, which can be correlated to CVR time as 1054:34.76 hrs.

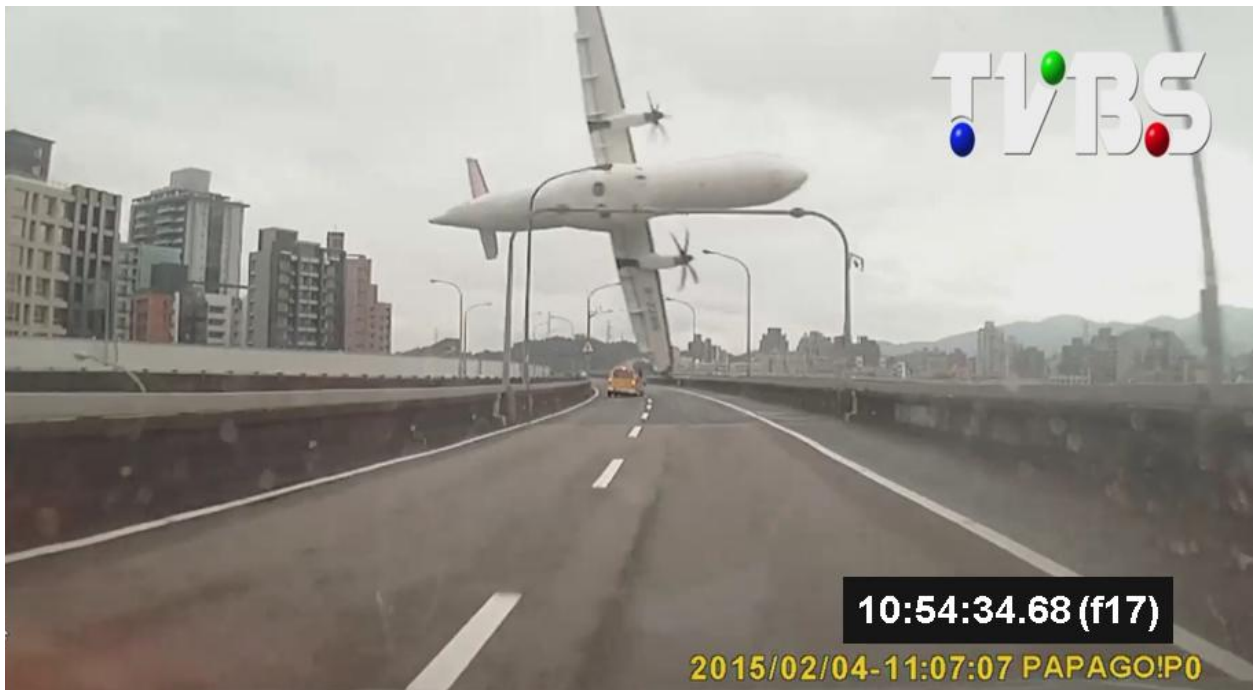
Figure 1.12-10 The 17<sup>th</sup> frame of dashcam videos of silver car (CVR 1054:34.68 hrs)

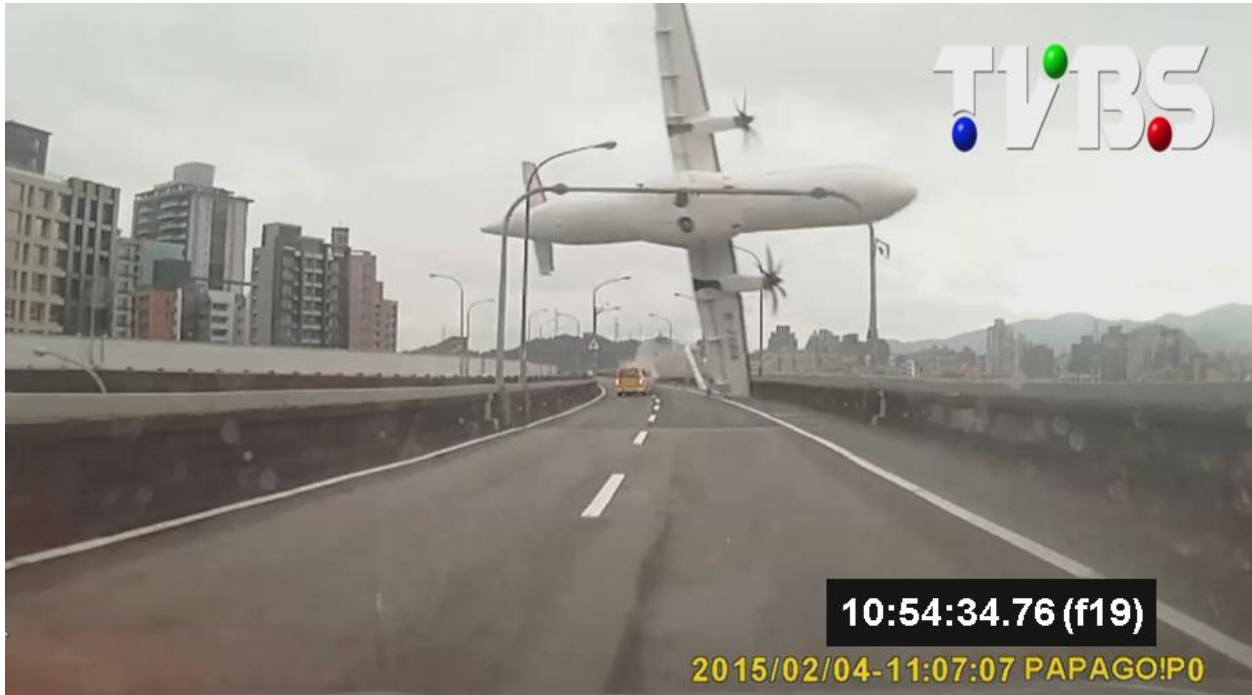
Figure 1.12-11 The 19<sup>th</sup> frame of dashcam videos of silver car (CVR 1054:34.76 hrs)

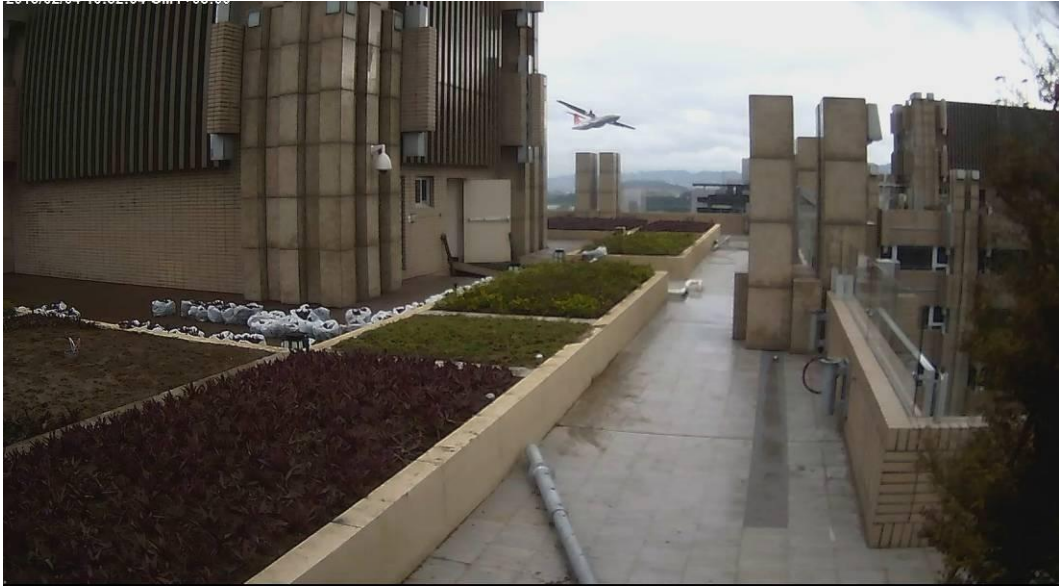
Figure 1.12-12 Surveillance videos snapshot of channel 19 in building B

ASC investigators also collected six surveillance videos from the buildings in Jingmao 2nd Rd. Positions of building A and building B are shown in Figure 1.12-6. The videos showed that the aircraft passed near building A before it impacted the Huan-Dong Blvd. Three surveillance video clips were clear, some of video snapshots were shown in Figure 1.12-12 to Figure 1.12-14. Figure 1.12-15 showed surveillance videos location at the roof of building A and the flight path was on its western side. The height above ground of building A was 74 meters. The HAE at the roof of building A was 107 meters, and the HAE on ground near building A was 33 meters.

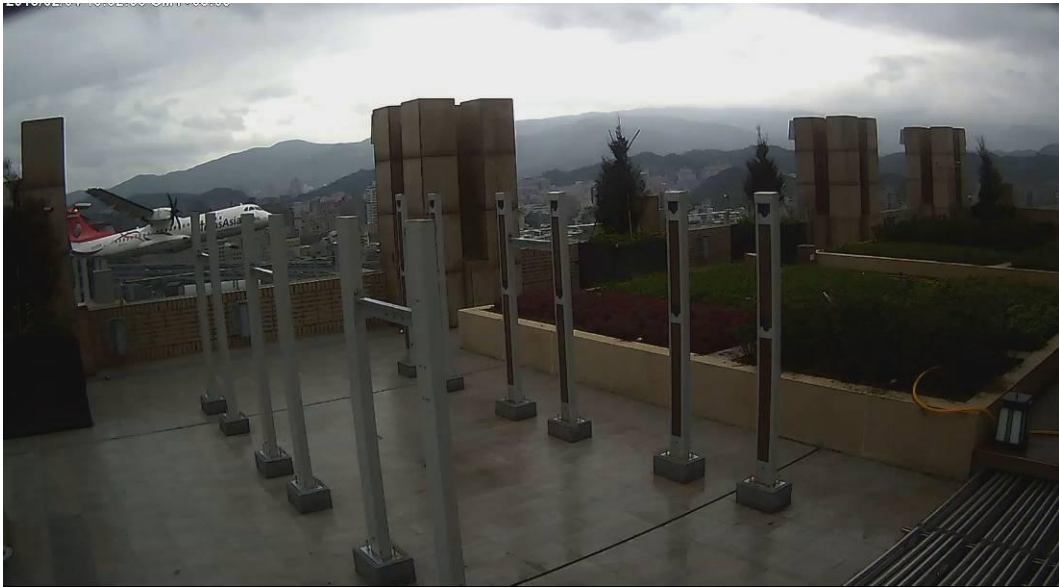
Figure 1.12-13 Surveillance video snapshot of channel 26 in building A

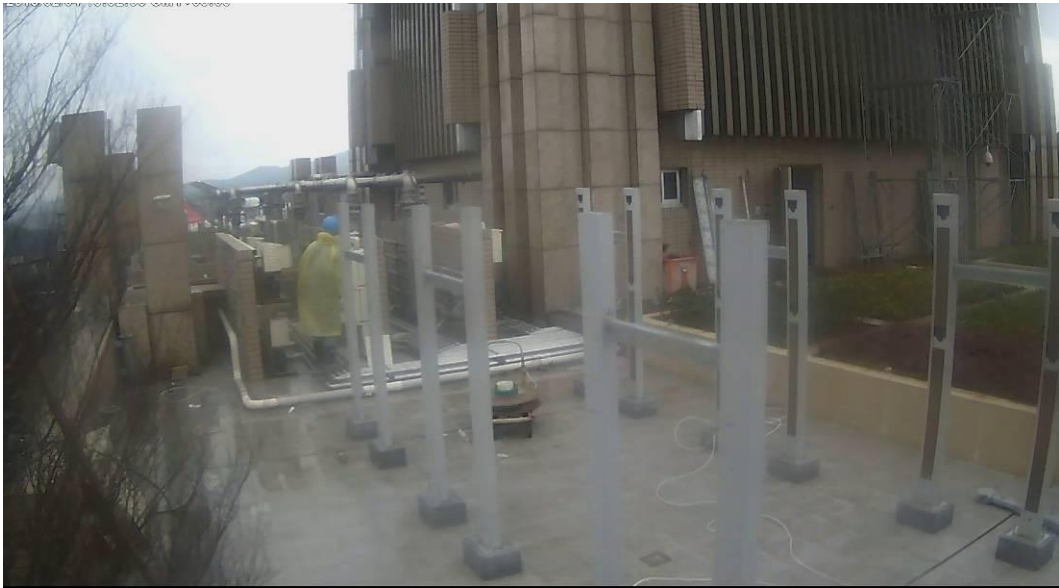
Figure 1.12-14 Surveillance video snapshot of channel 32 in building A
