# 國家運輸安全調查委員會

## 重大運輸事故調查報告 第二冊

南方澳大橋斷裂重大公路事故

報告編號：TTSB-HOR-20-11-001

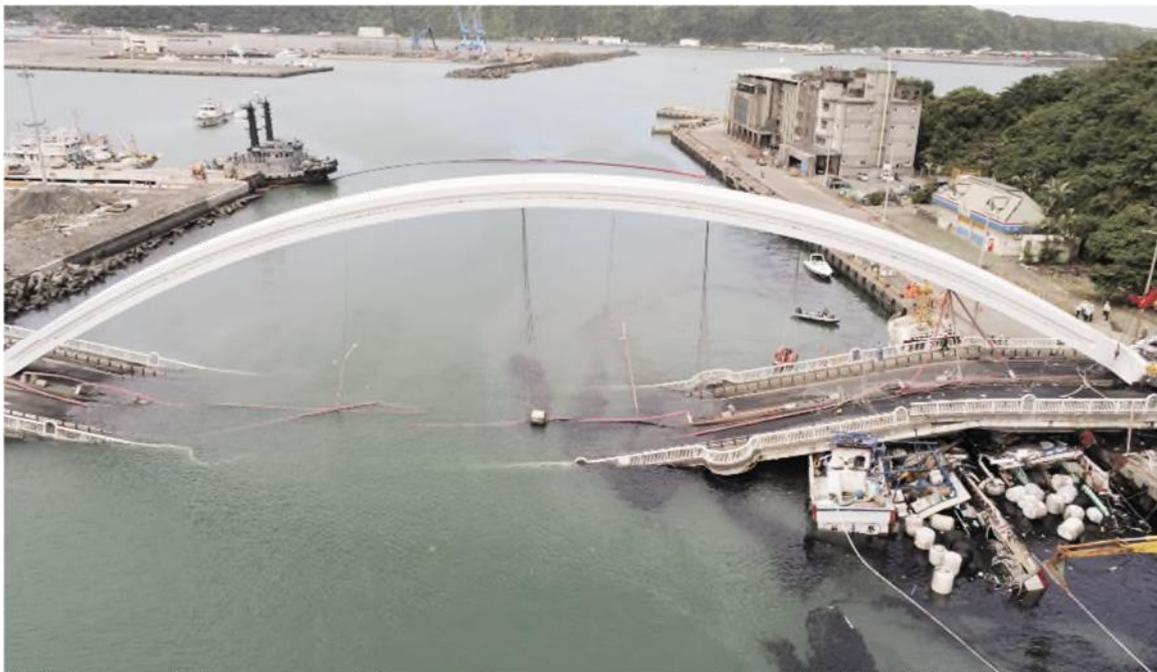
圖 1、事故後吊索狀況

依據本會先遣小組空中測繪資料及國震中心提供 LiDAR 掃描成果，第 2、3、4、6 及部分第 5、7、8、9、10 束吊索脫離或斷裂後完全浸泡於海水中，詳圖 1 至圖 7。

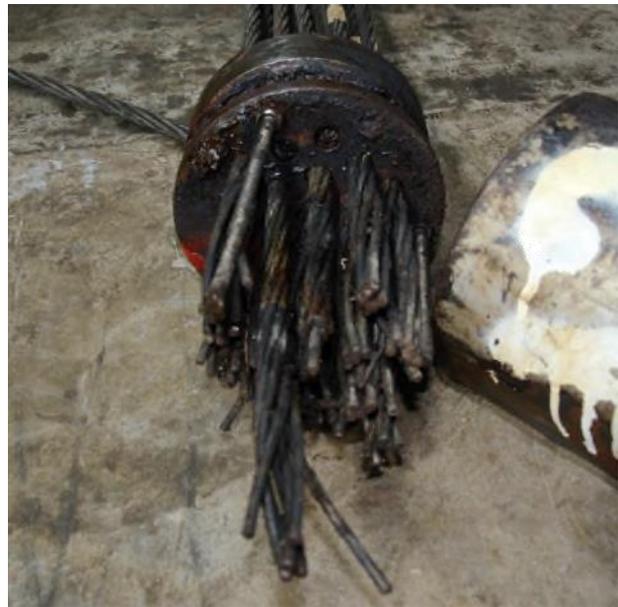
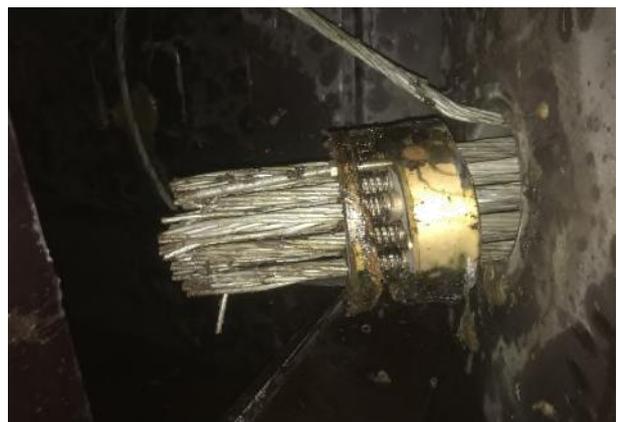
拱架端：

- 17 束絞線末端呈現輕微退絞現象

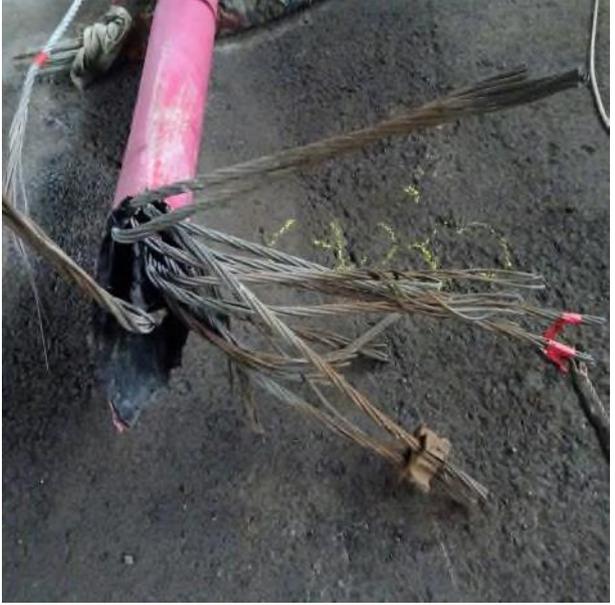
<p>橋面端：</p> <ul style="list-style-type: none"><li>● 17 束末端脫離錨頭<ul style="list-style-type: none"><li>◇ 7 束且解離</li><li>◇ 2 束輕微退絞</li><li>◇ 2 束表面有夾片壓痕，末端完整</li><li>◇ 2 束仍帶有破斷錨頭結構碎片</li><li>◇ 2 束無特殊發現</li></ul></li></ul>

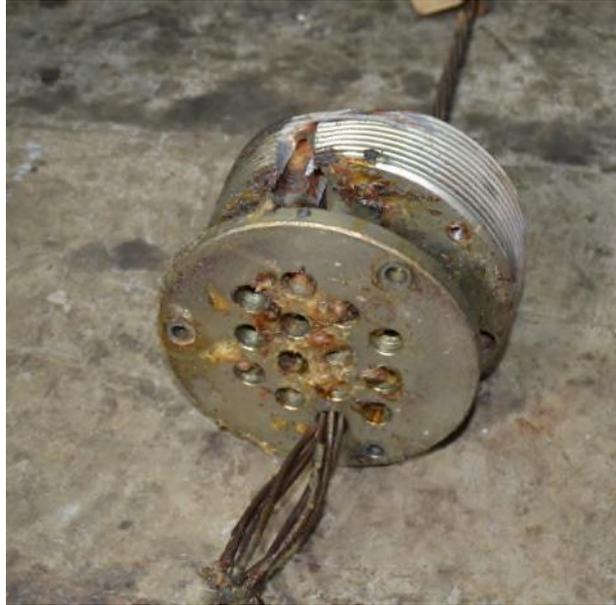
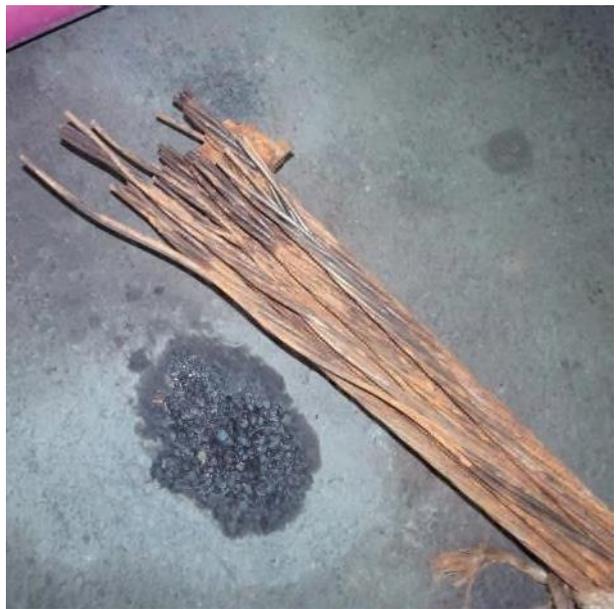
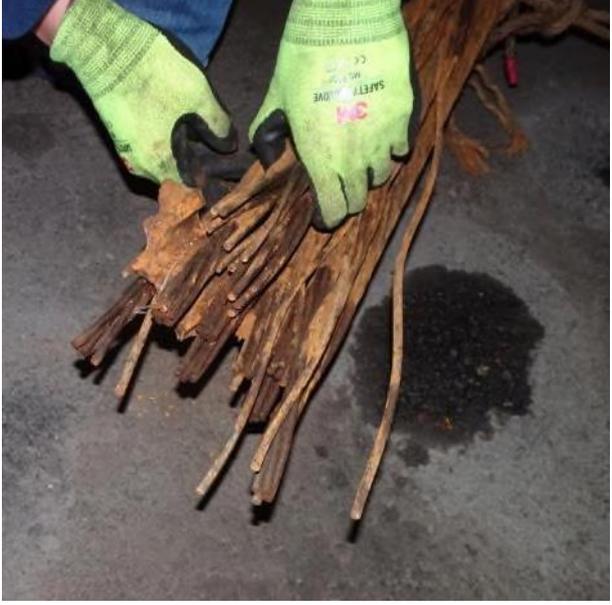
- 13 束鋼絞線，12 束末端脫離錨頭，1 束退絞解離仍留於錨頭上，末端輕微退絞解離
  - ◇ 其中 3 束表面有夾片壓痕，末端完整
  - ◇ 其中 1 束末端完整情中兩束仍帶有破斷錨頭結構碎片
  - ◇ 其中 9 束輕微退絞
- 13 束末端表面均呈現鏽蝕現象

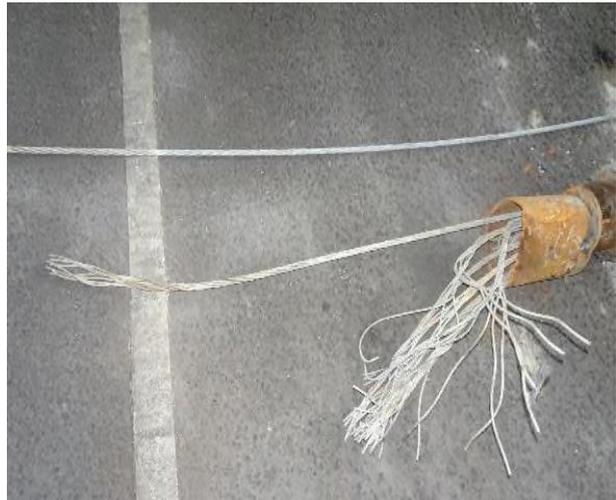
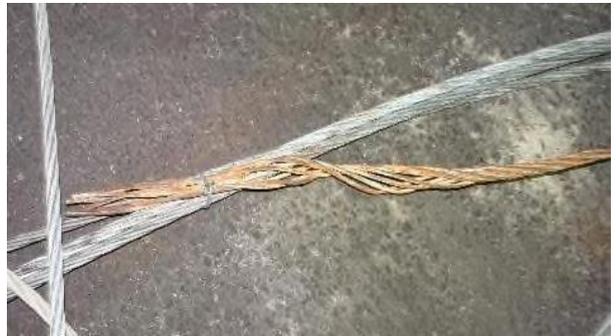
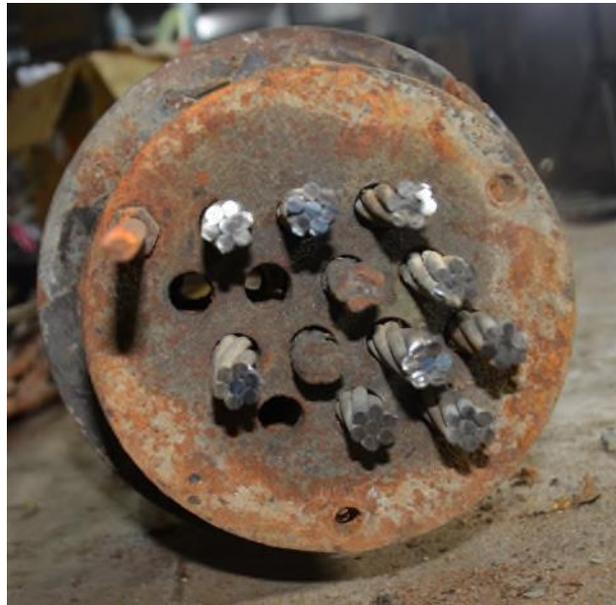
- 13 束末段退穿出錨頭夾片處且尾端退絞解離四散
- ◇ 1 束末端輕微表面鏽蝕及鳥籠現象

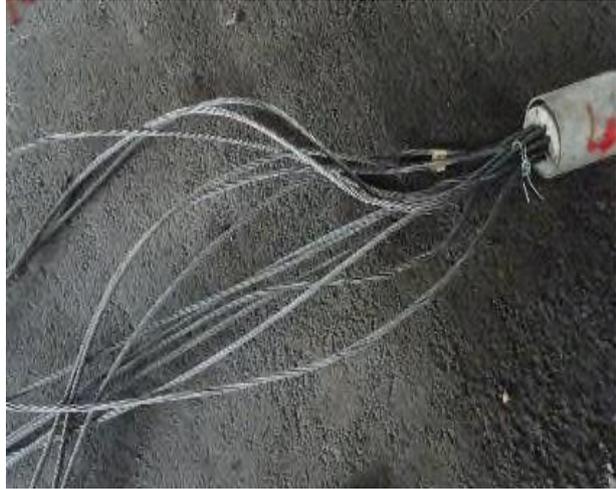
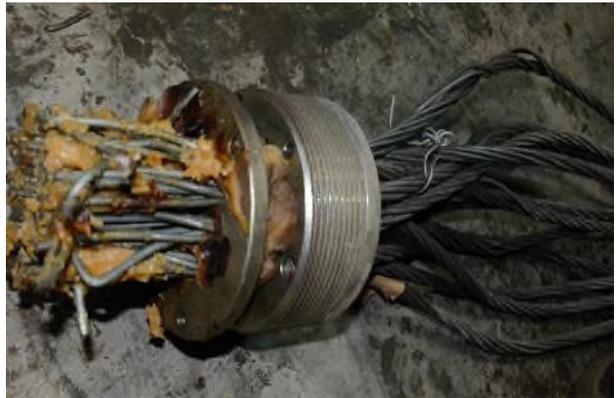
- 13 束其中 12 束接近錨頭處退絞輕微烏籠，另一束狀況良好

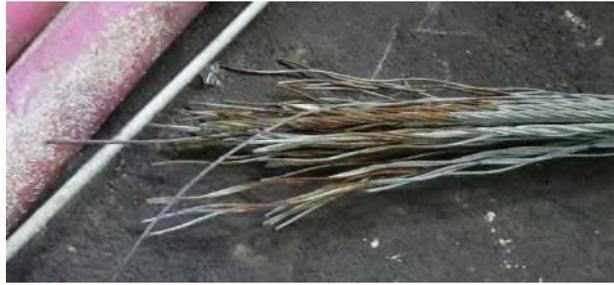
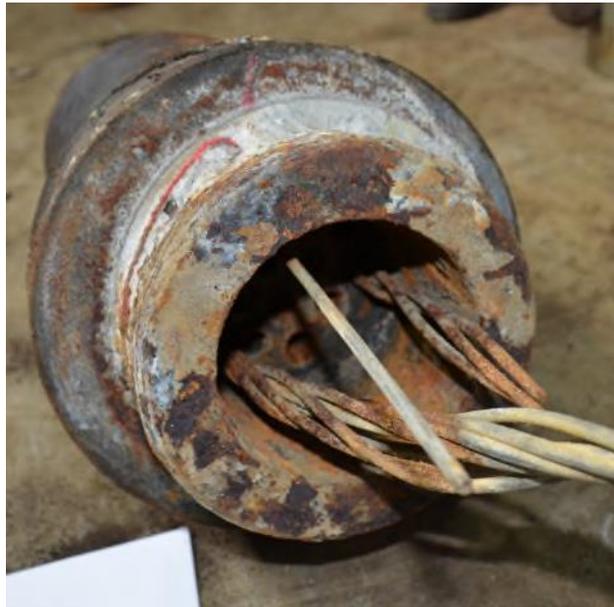
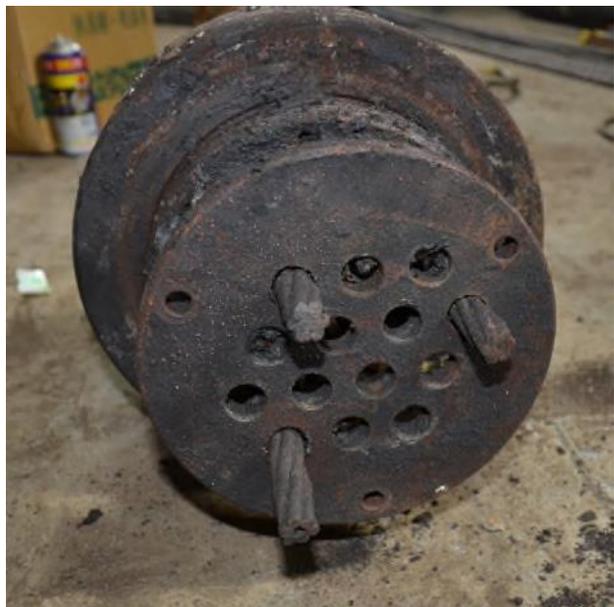
- 13 束末端退絞解離四散且輕微鏽蝕
  - ◇ 10 束末端脫離錨頭
  - ◇ 3 束有頸縮斷裂現象，位置靠近下錨頭但仍留於錨頭上，其中 2 束有烏籠現象，1 束有心線遺落現象

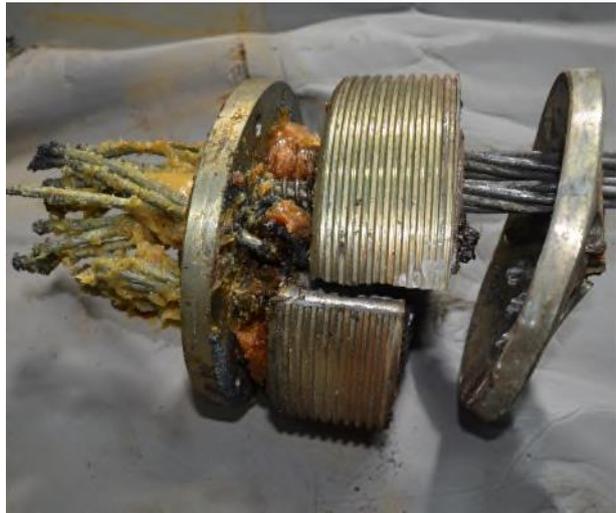
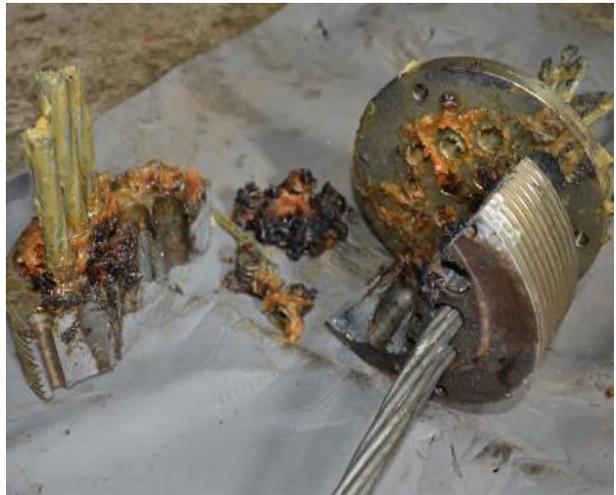
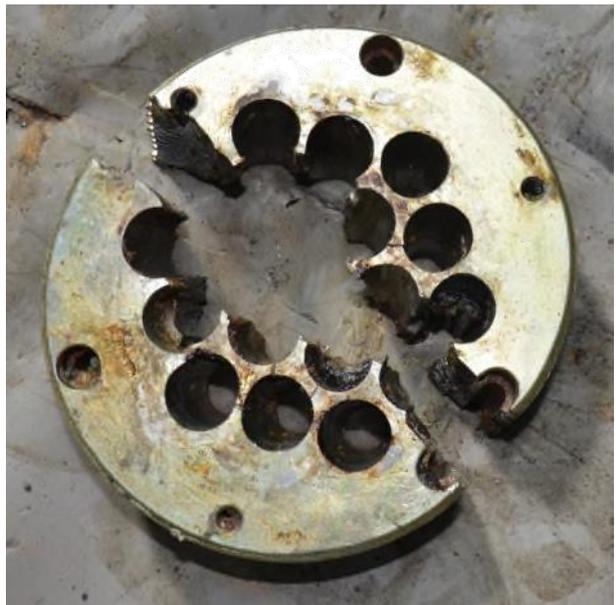
- 13 束鋼絞線中：
  - ◇ 2 束鋼絞索未斷留於破裂錨頭內
  - ◇ 3 束鋼絞線斷於夾片處線頭留於錨頭內
  - ◇ 8 束位於錨頭中央部分脫離錨頭，部分連帶錨頭破裂碎片之鋼絞線段遺失

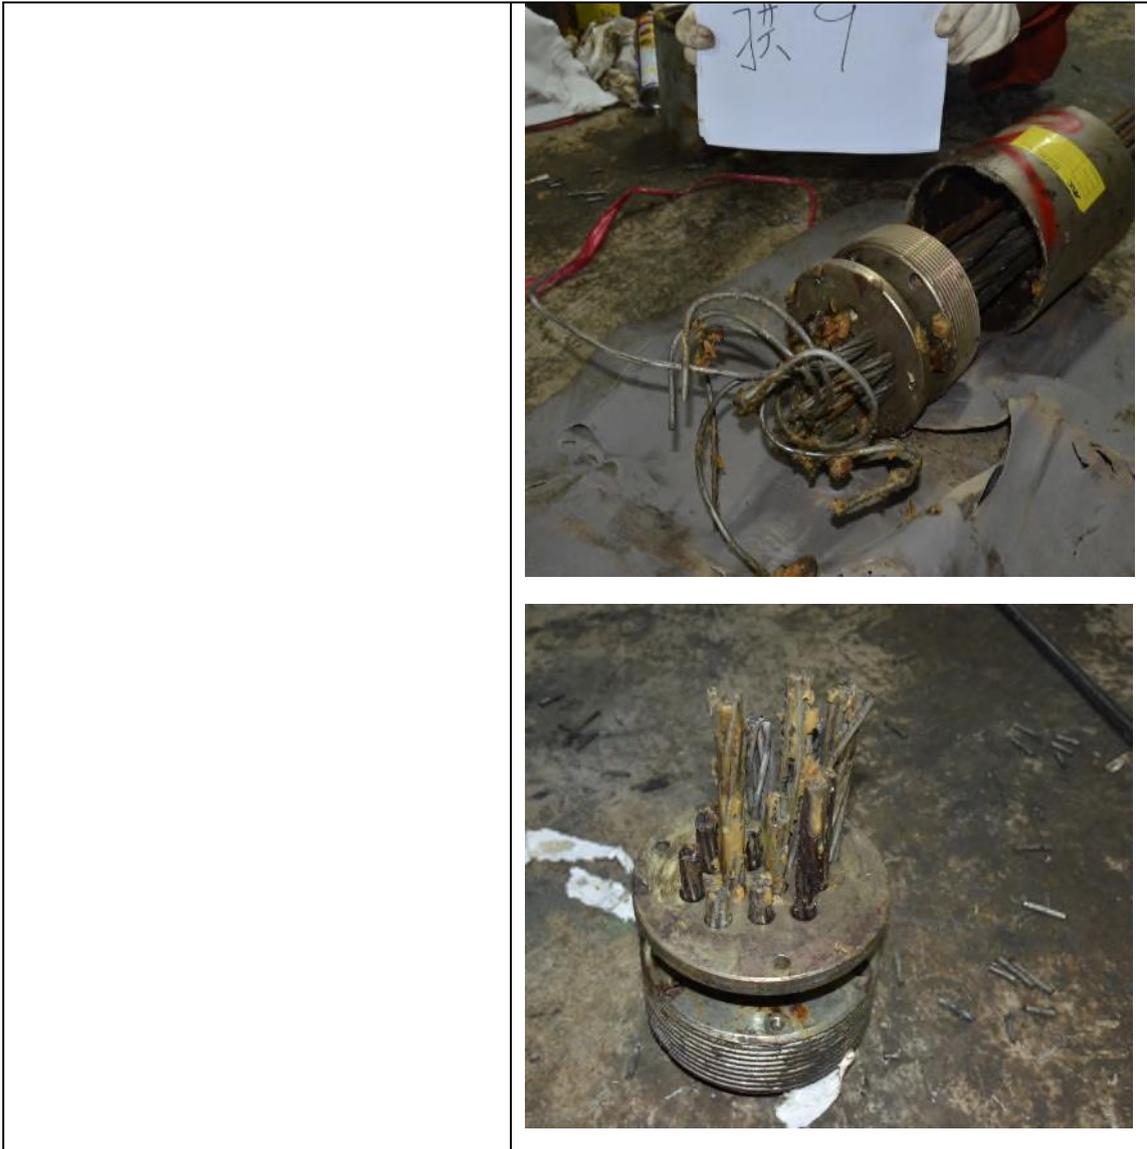
- 13 束皆留於錨頭上：
  - ◇ 開蓋後鋼絞索纏繞於外殼內頂端
  - ◇ 多束尾端退絞解離
  - ◇ 帽蓋桶殼內鋼絞索未鏽蝕

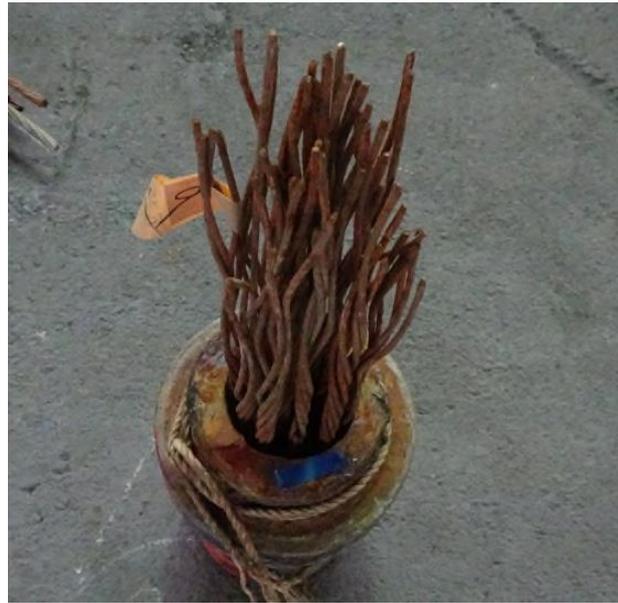
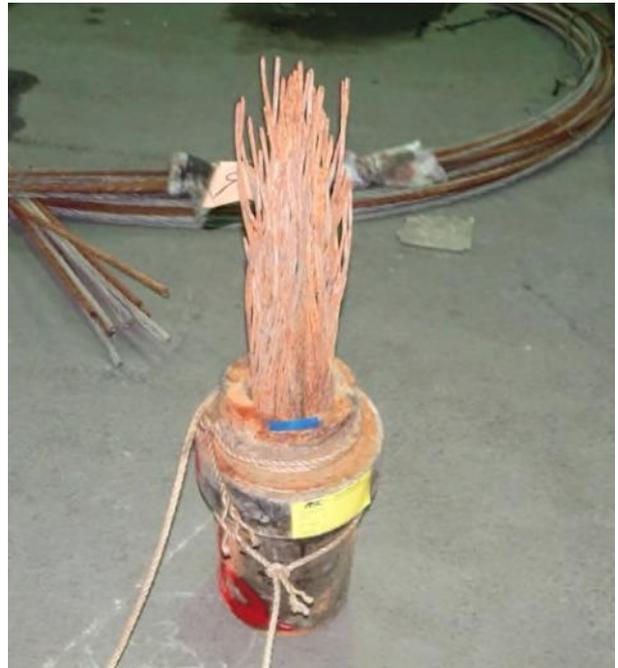
- 13 束皆留於錨頭，且：
  - ◇ 有頸縮斷裂現象
  - ◇ 靠近錨頭處退絞解離
  - ◇ 斷裂處嚴重鏽蝕

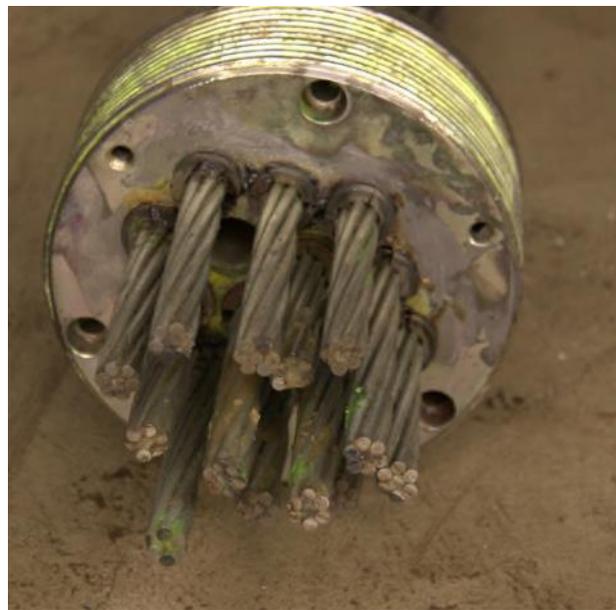
- 13 束仍留於錨頭上，外觀完整

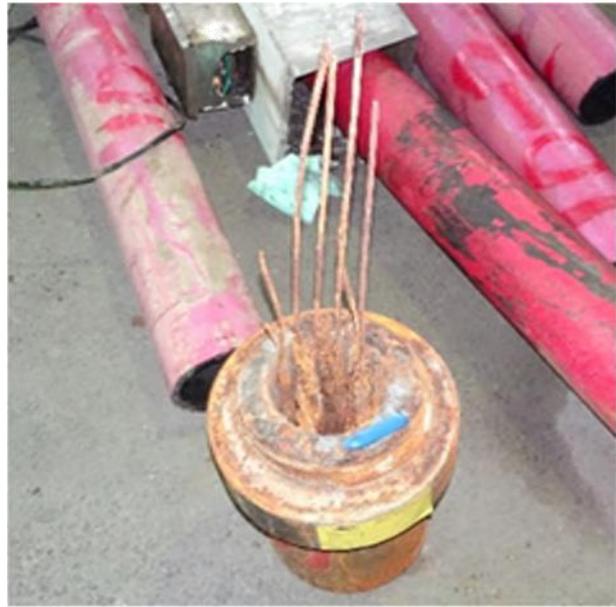
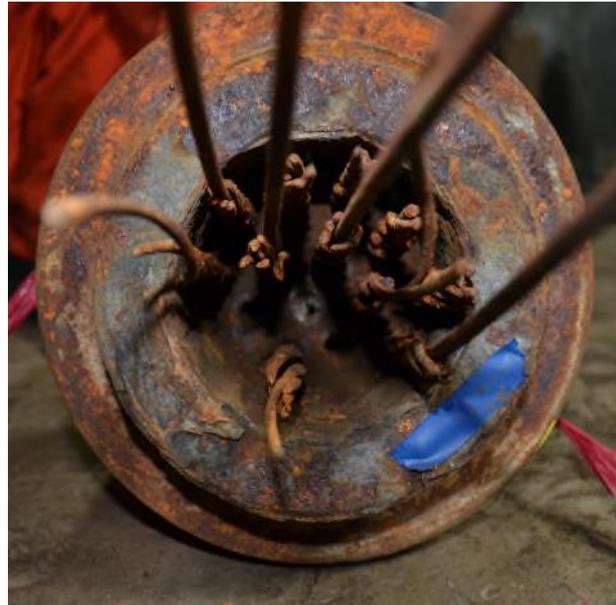
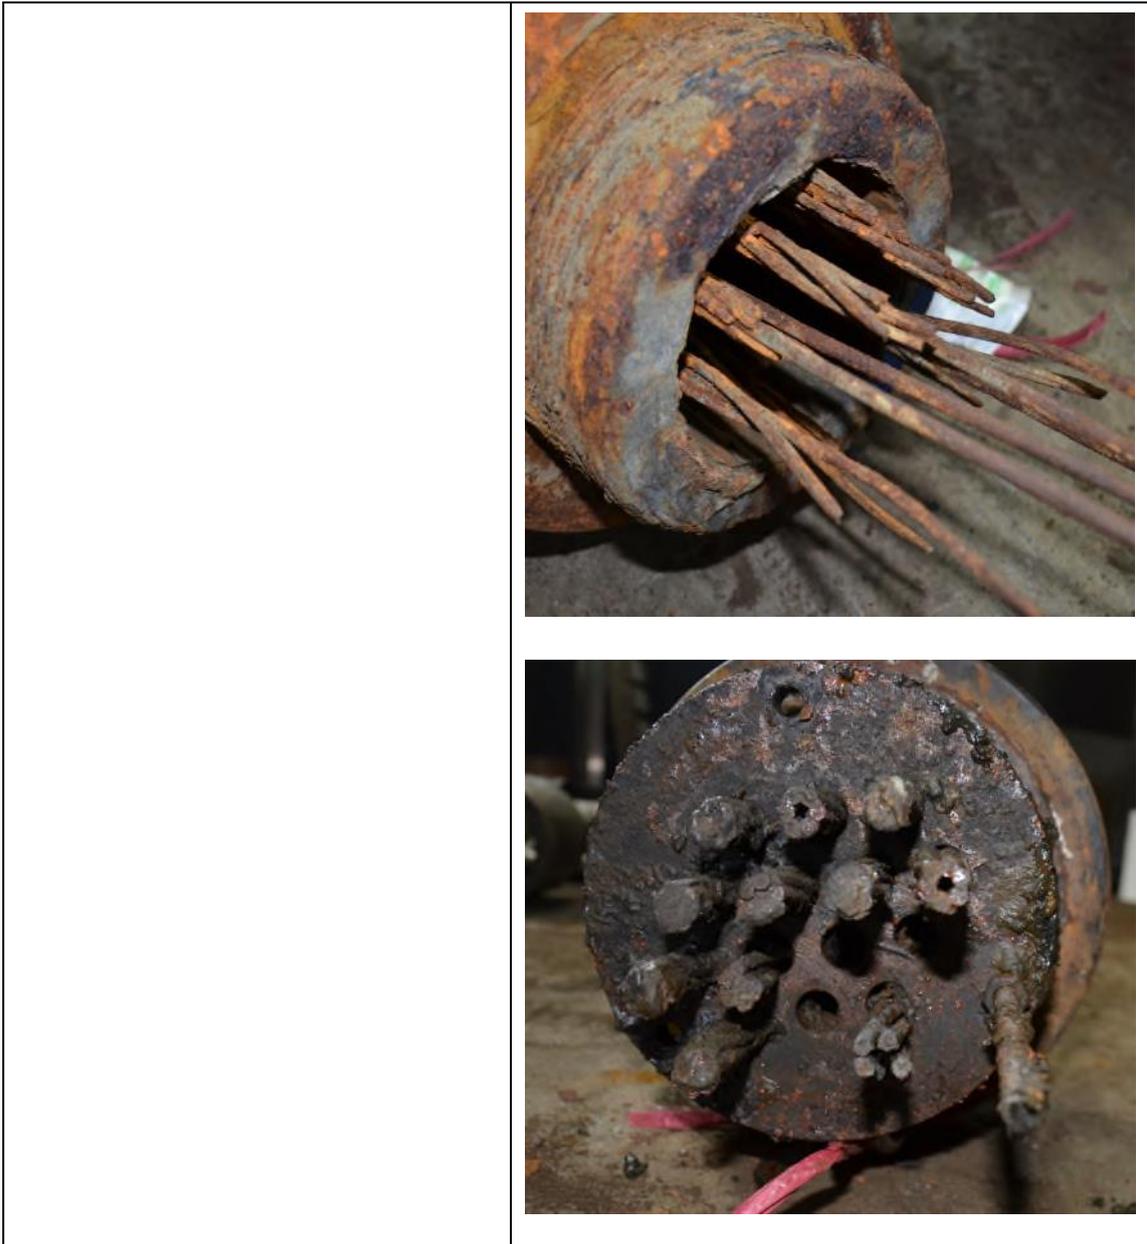
- 13 束鋼絞線中：
  - ◇ 11 束於接近錨頭處斷裂，有頸縮現象，另 2 束未留於錨頭內，斷裂區域嚴重鏽蝕
  - ◇ 其中 4 束有心線遺落退出現象

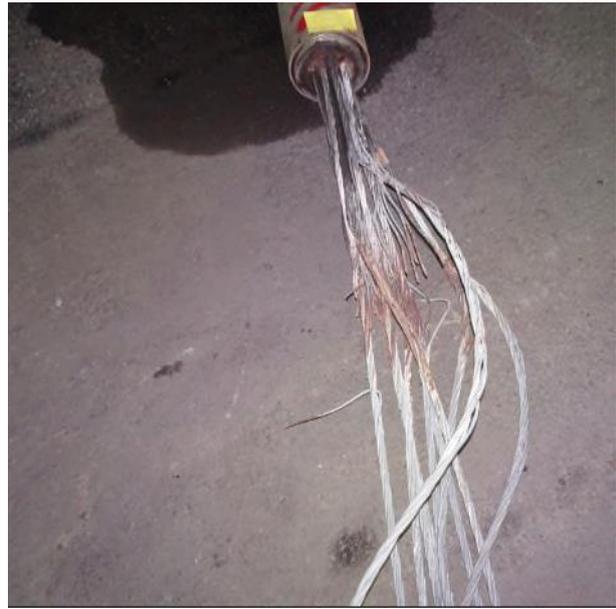
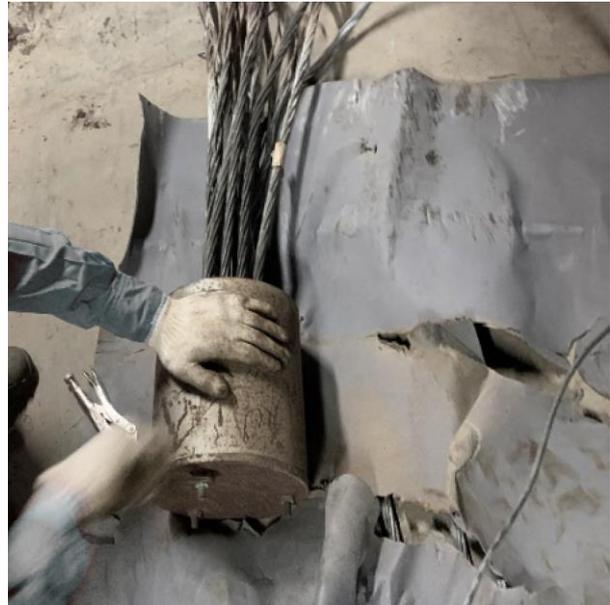
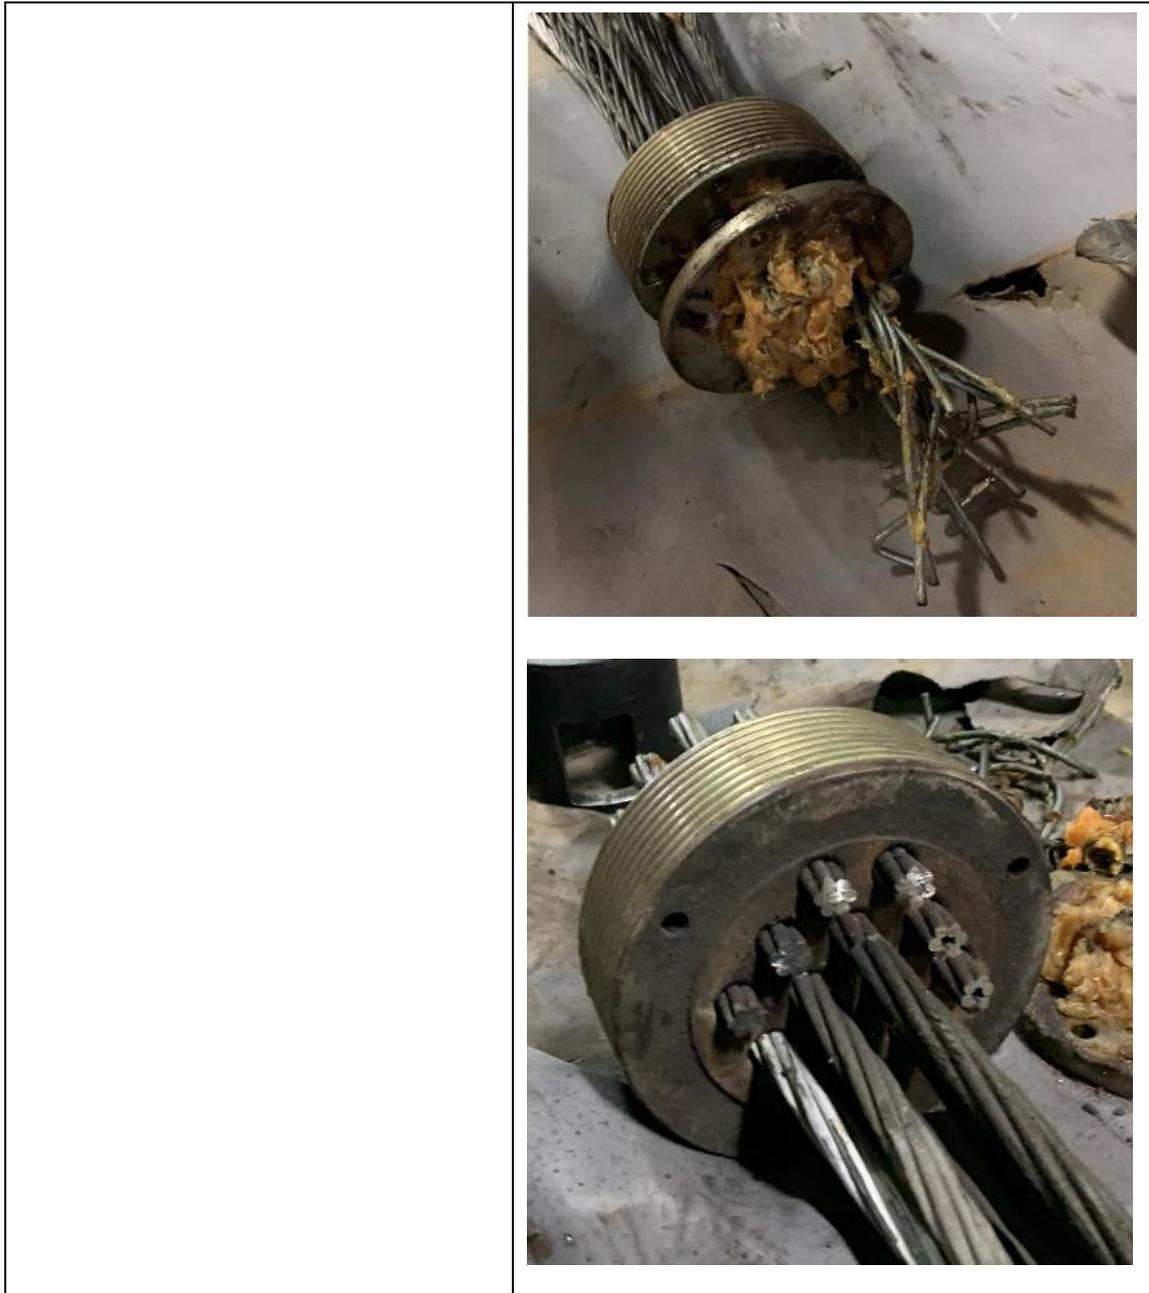
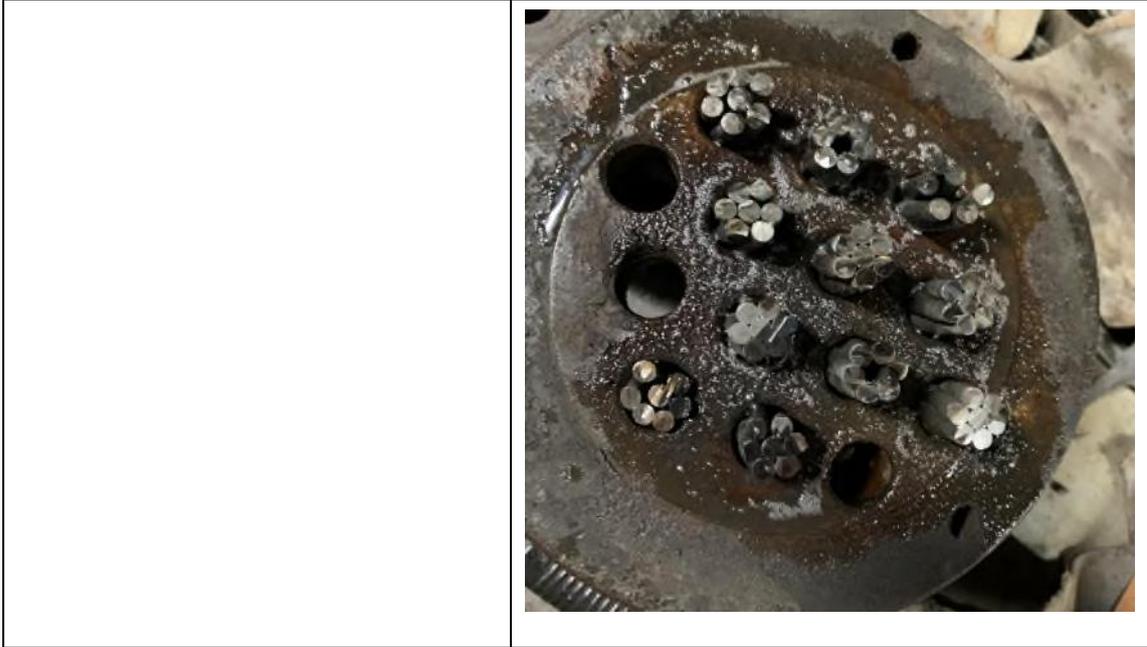
- 13 束皆留於錨頭內：
  - ◇ 7 束有輕微烏籠現象
  - ◇ 4 束靠近錨頭處有部分斷裂現象，斷裂處呈現鏽蝕現象
  - ◇ 2 束無異常發現
- 去除帽蓋後，發現其中 2 束自錨頭退出，退絞頂住帽蓋頂端，4 束錨頭處輕微退絞解離，另 3 束有心線遺失現象

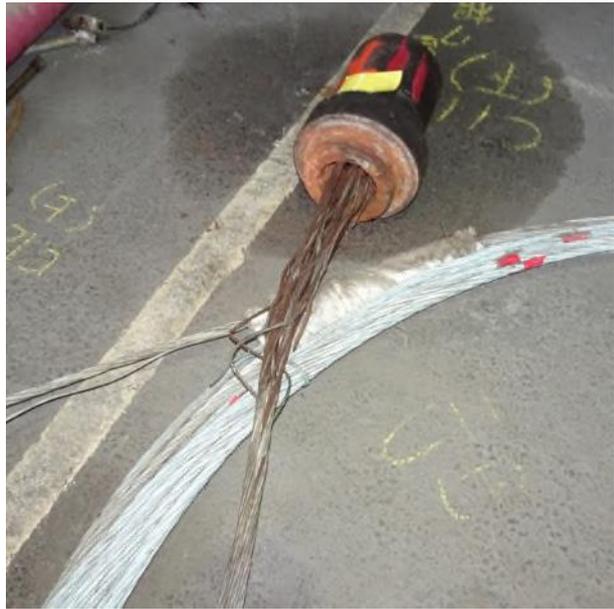
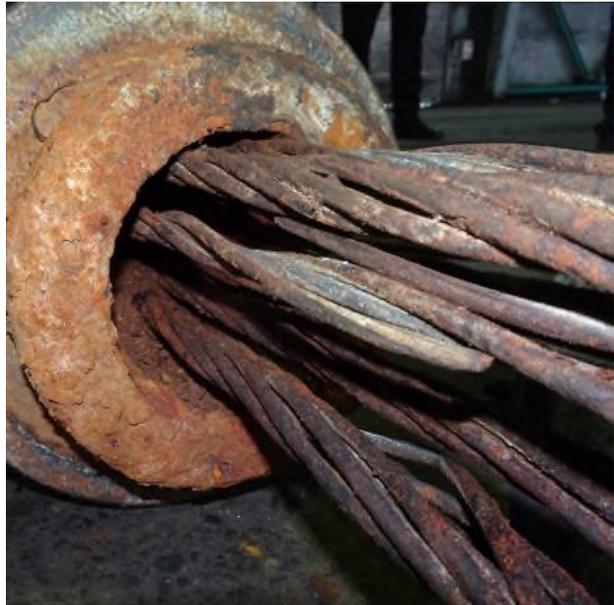
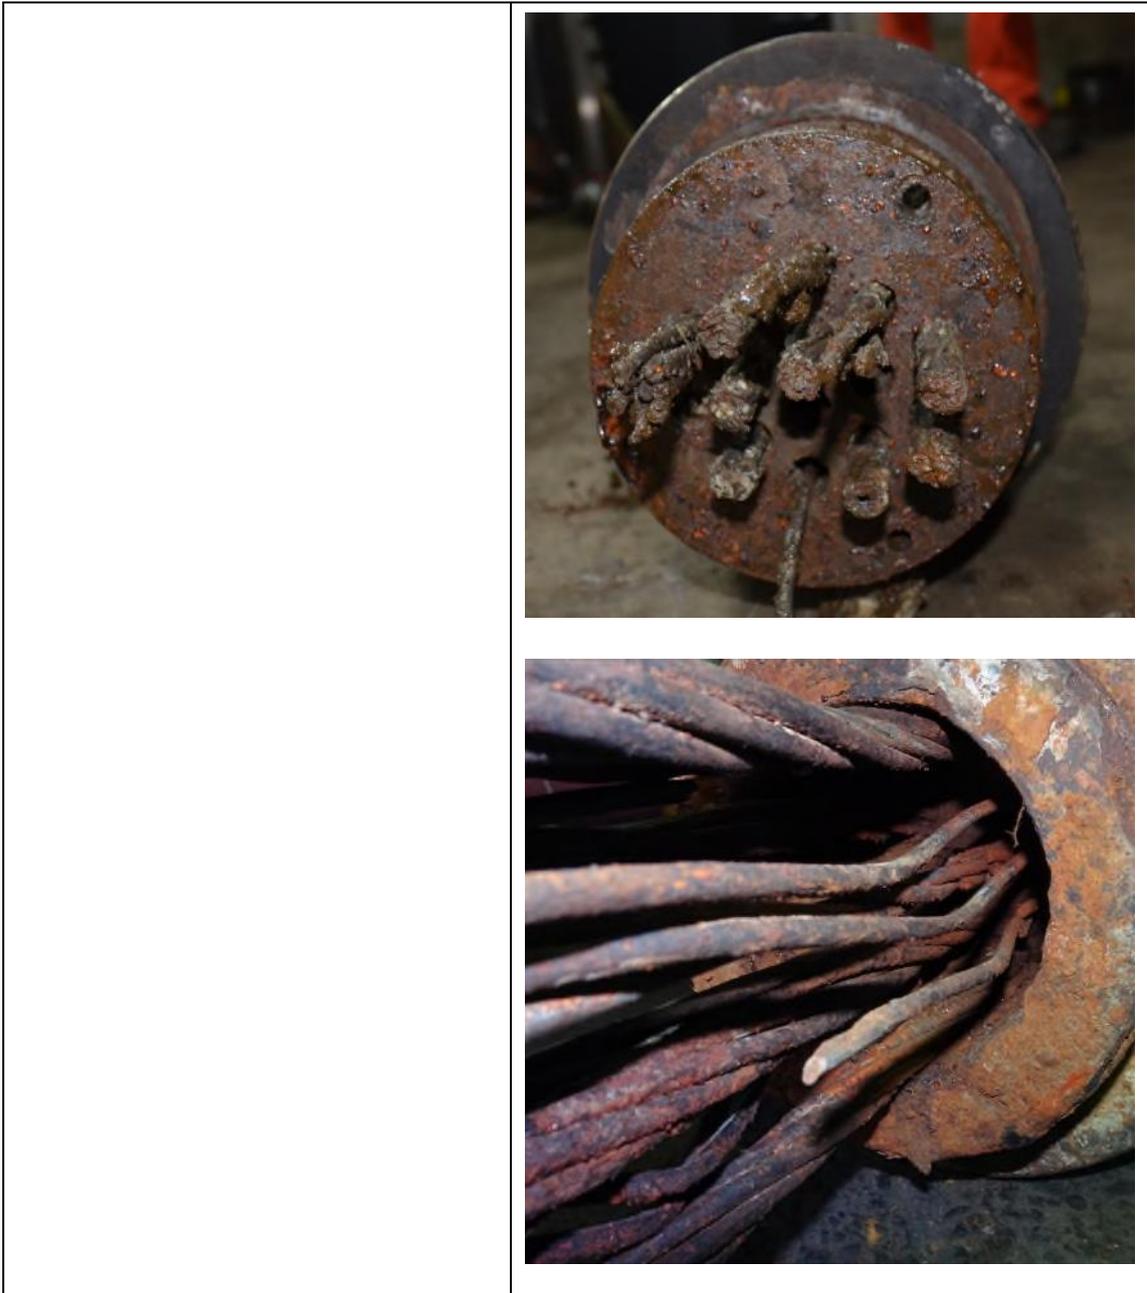
- 13 束鋼絞線中：
  - ◇ 10 束錨頭處有斷絲、頸縮斷裂及退絞解離現象，其中 2 束有心線遺失，1 束心線遺落
  - ◇ 3 束未斷
  - ◇ 接近錨頭位置部分有表面鏽蝕現象

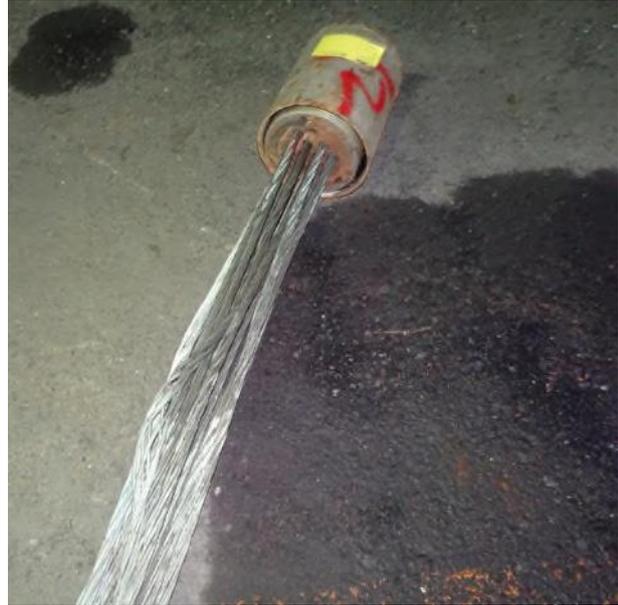
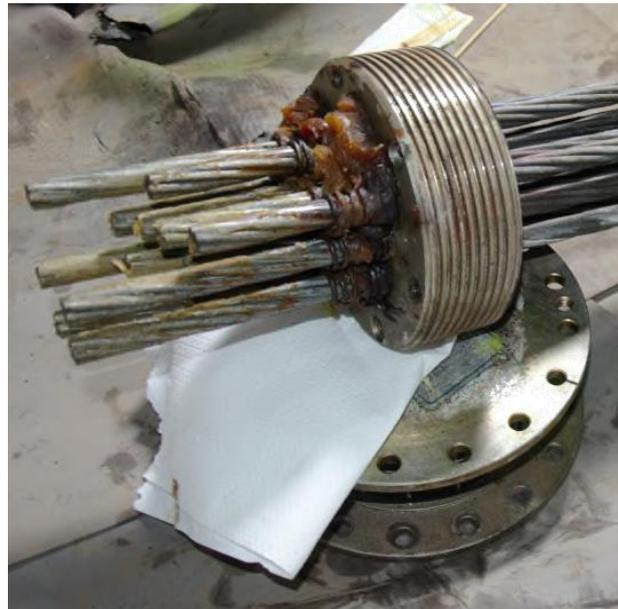
- 13 束末端完整
  - ◇ 其中 3 束於近錨頭處發生輕微烏籠現象

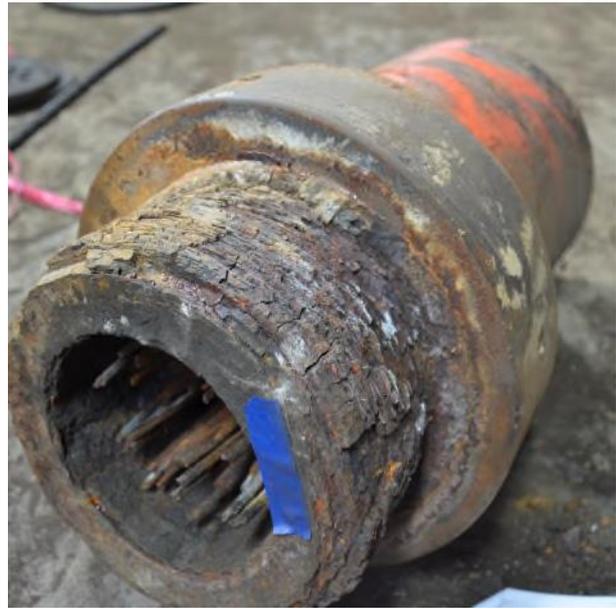
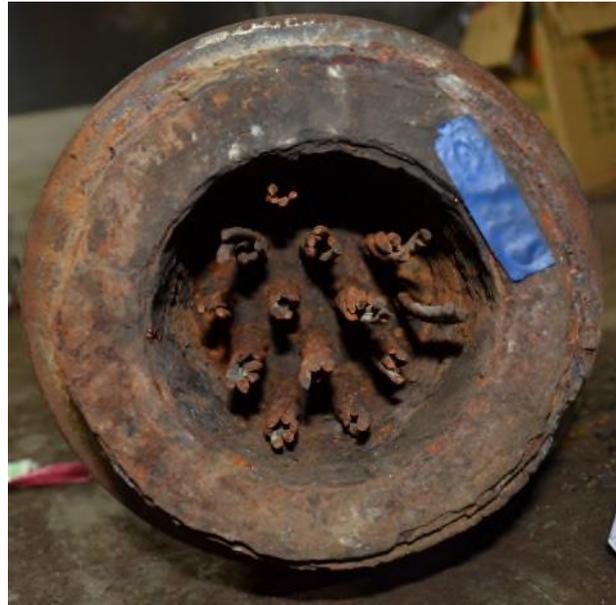
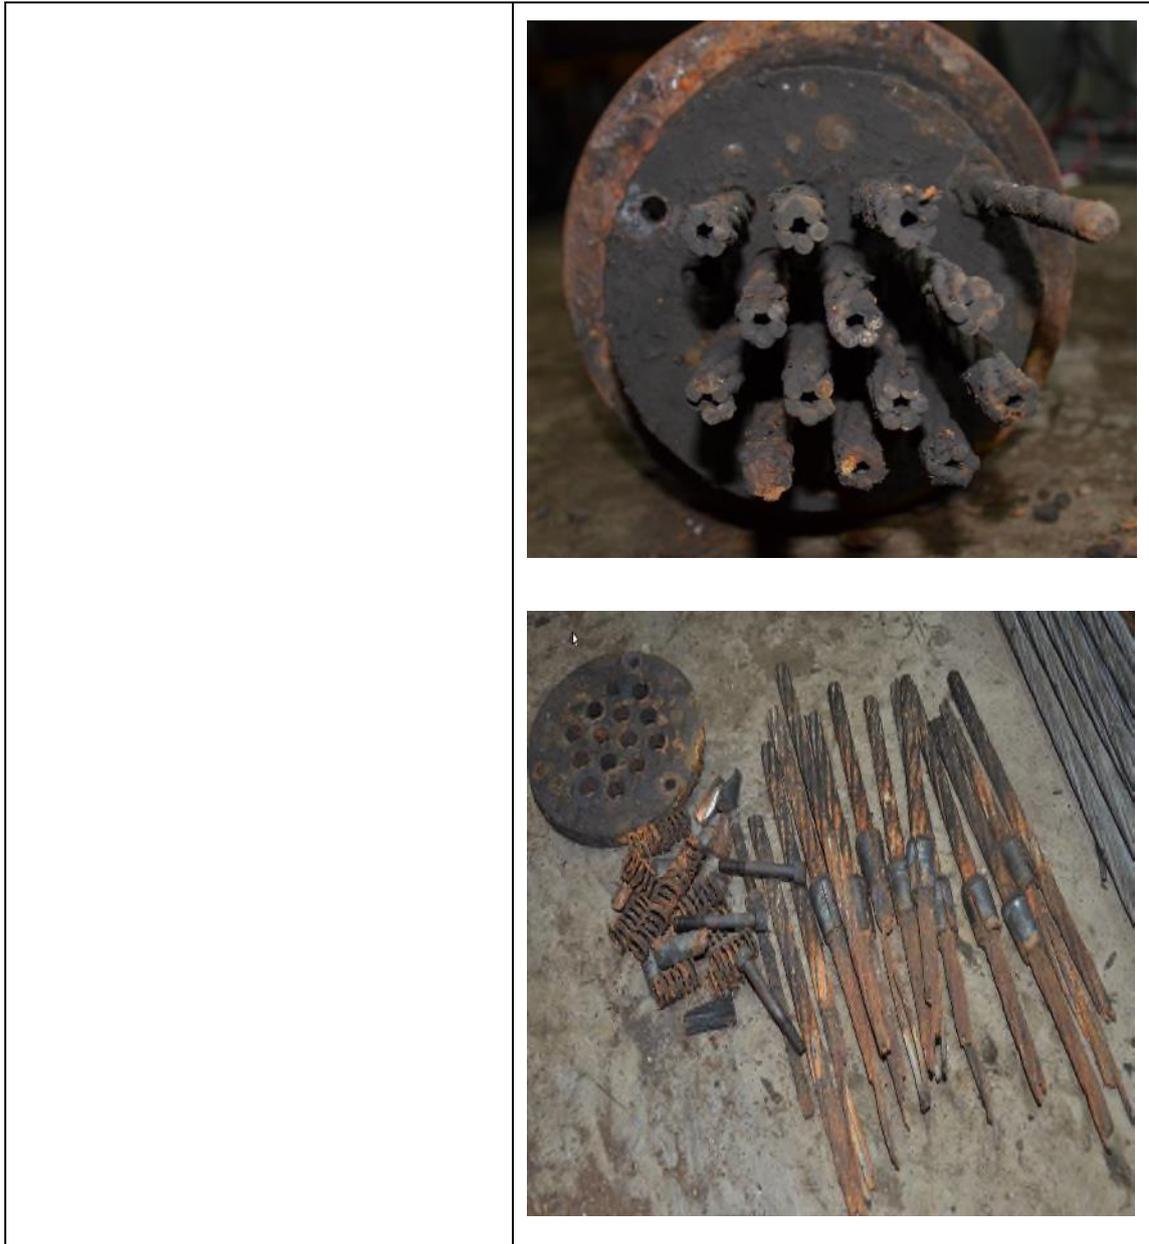
- 13 束錨頭處鋼絞索頸縮  
斷裂現象
  - ◇ 10 束心線遺失退離
  - ◇ 斷於錨頭內殘線嚴重  
鏽蝕

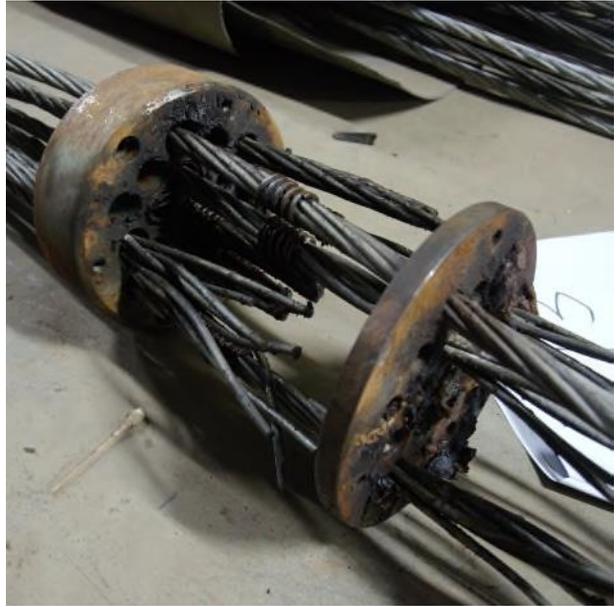
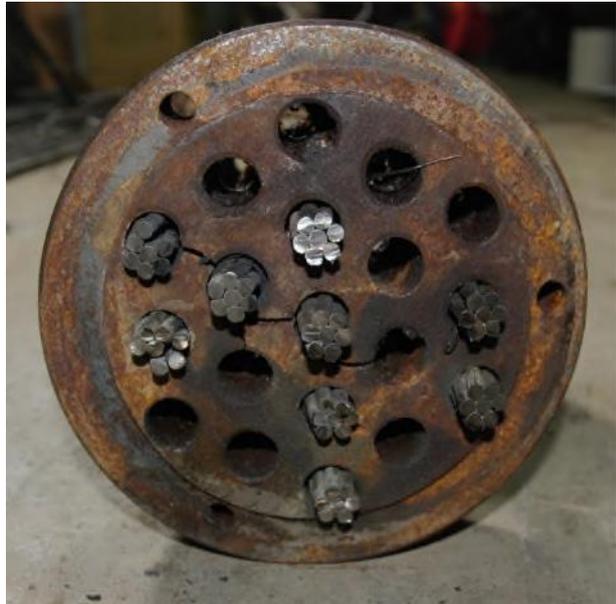
- 17 束鋼絞線中：
  - ◇ 8 束末端脫離錨頭
  - ◇ 9 束末段退穿出錨頭處約 2 公尺，尾端解離四散

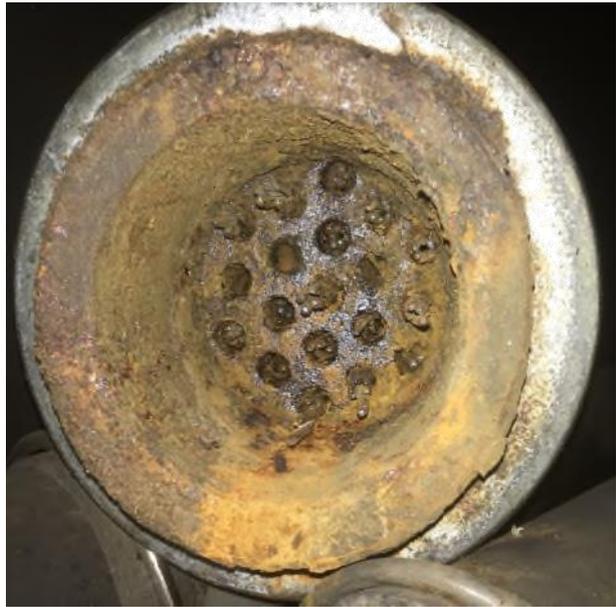
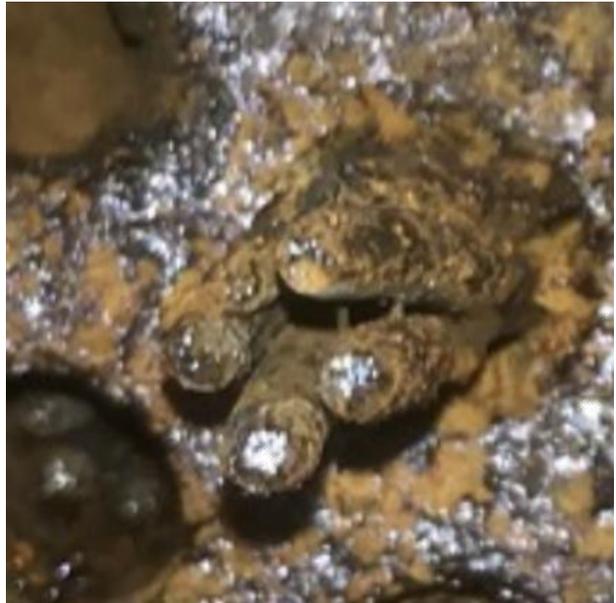
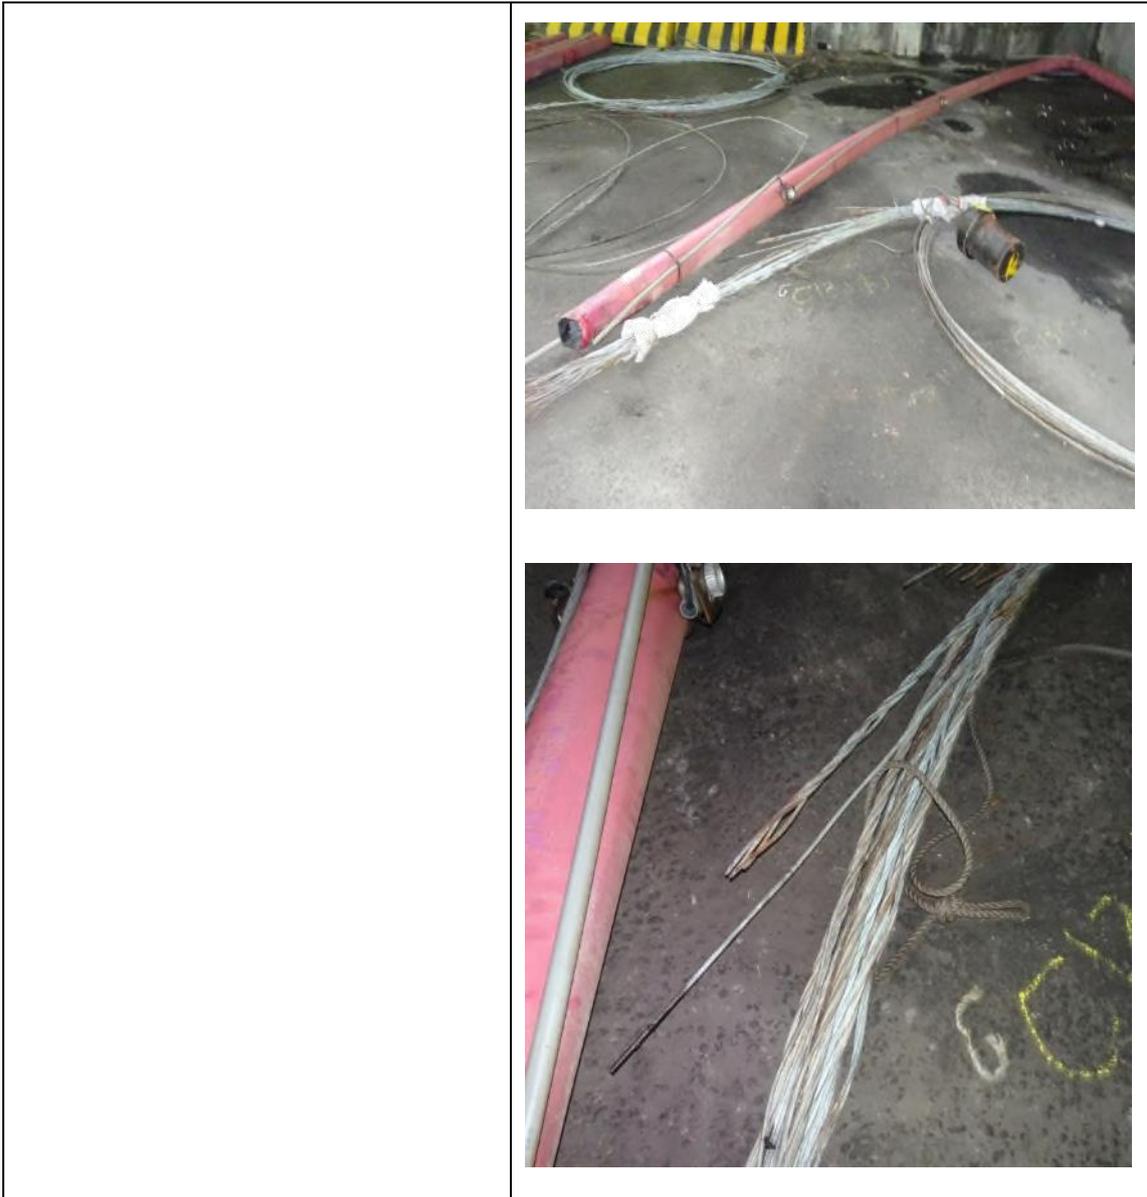
- 17 束皆斷於靠近錨頭夾片處
  - ◇ 部分鋼絞線斷面未完全鏽蝕，核心處仍呈現金屬光澤
  - ◇ 9 束末端解離四散且有頸縮斷裂現象，其中 6 束留有較長心線
  - ◇ 留於錨頭上之殘線嚴重鏽蝕且部分有心線抽出現象

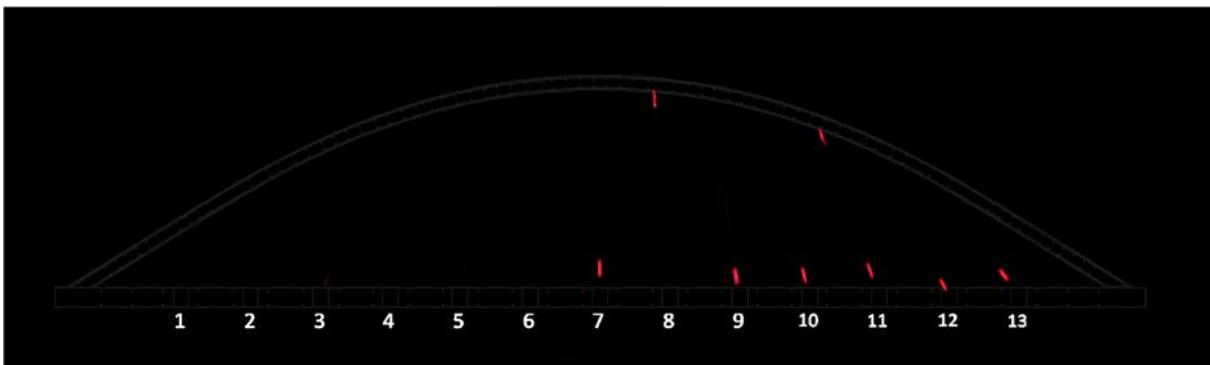
圖 10、頸縮斷裂狀況

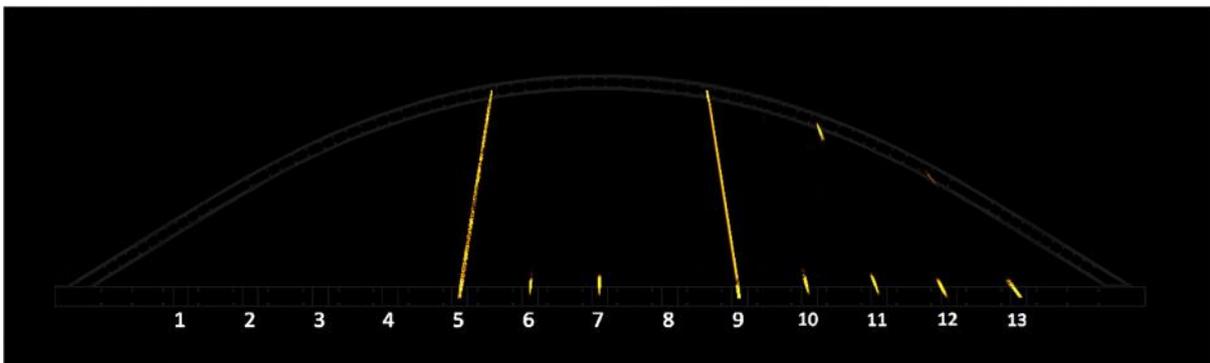
圖 11、鏽蝕狀況
