# 國家運輸安全調查委員會

## 重大運輸事故調查報告 第二冊

南方澳大橋斷裂重大公路事故

報告編號：TTSB-HOR-20-11-001

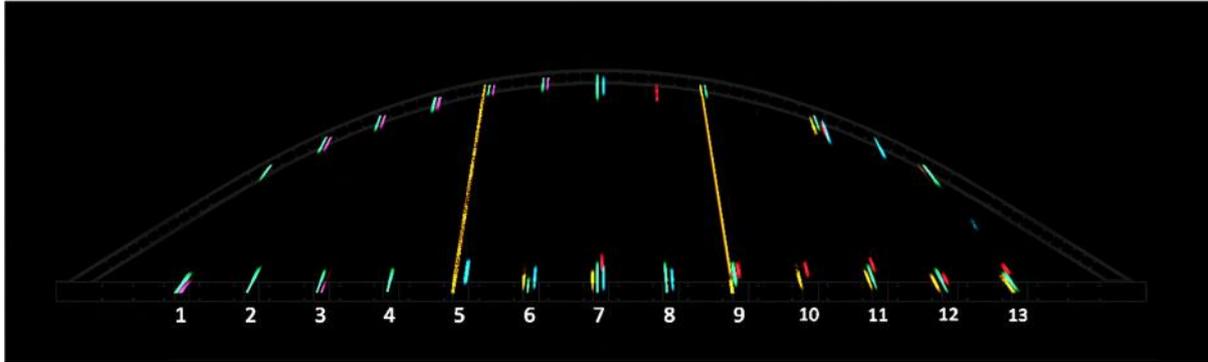
圖 12、吊索顯著破壞狀況總覽

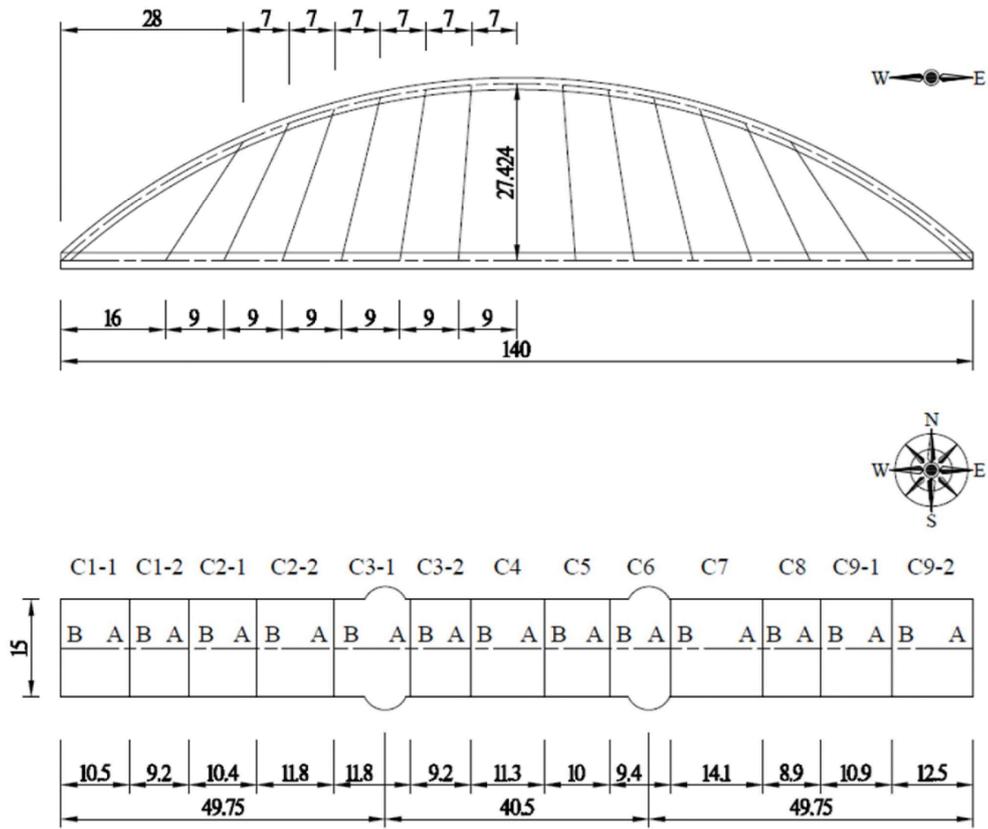
圖 1.2 橋梁立面圖、平面圖與節塊編號

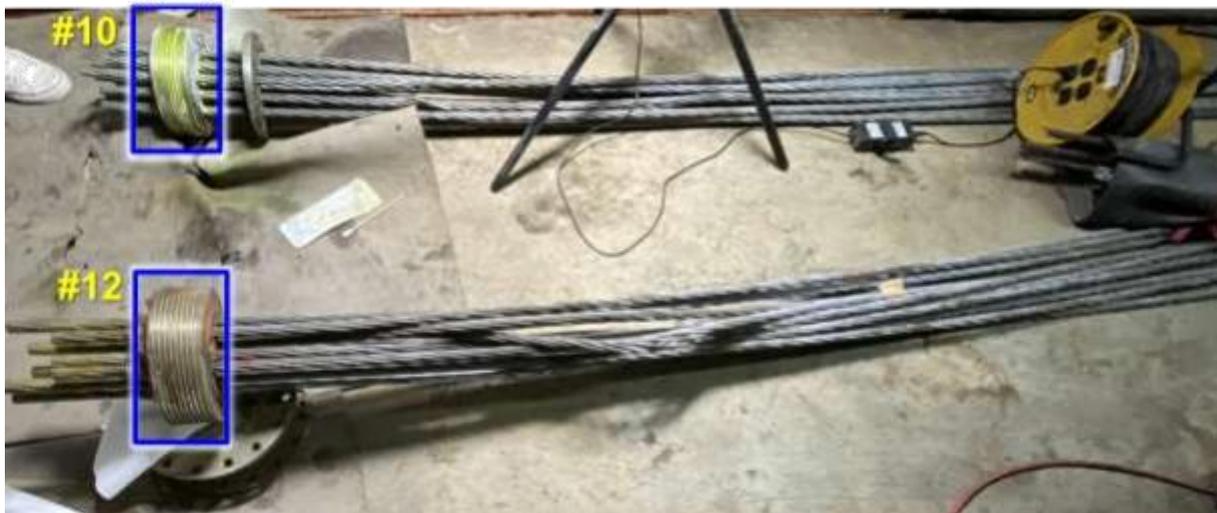
圖 1 為上拱錨頭 10 號及 12 號連同鋼絞線之外觀，兩錨頭之上表面因未被帽蓋保護，皆有較明顯之生鏽現象。在進行螢光檢驗前，先去除表面髒污及油污，避免影響判斷，但由於錨頭心部為 13 束鋼絞線貫穿之孔位，不易清理，故螢光檢驗主要針對側面及上下表面外圍處進行。上拱 10 號錨頭側面共發現兩處有表面裂紋，皆位於側面螺紋之齒峰位置，如圖 2 中紅色方框標示處，圖中 A 處裂紋有向下延伸，如圖 3 所示，但目視判斷其深度較淺約至接近齒底處。而 B 處裂紋位於連續三齒之齒峰位置，且紋路筆直，疑似表面刮傷造成。錨頭上下表面之外圍則未發現明顯裂紋存在，如圖 4 所示。上拱 12 號錨頭未被套筒保護之上表面有較多鏽斑，側面亦可觀察到鏽斑，如圖 5 所示。螢光檢驗發現側面亦有 2 處有表面裂縫，如圖 6 所示，但亦屬位於齒峰之筆直紋路，且深度很淺；上下表面則無發現明顯裂紋。由螢光檢驗探傷結果可知，上拱 10 號及 12 號兩個錨頭在側面皆發現兩處疑似表面裂紋，但目視判斷其深度皆相當淺，研判不會對後續拉伸試驗有重大影響。

圖1 上拱錨頭 10 號及 12 號連同鋼絞線之外觀

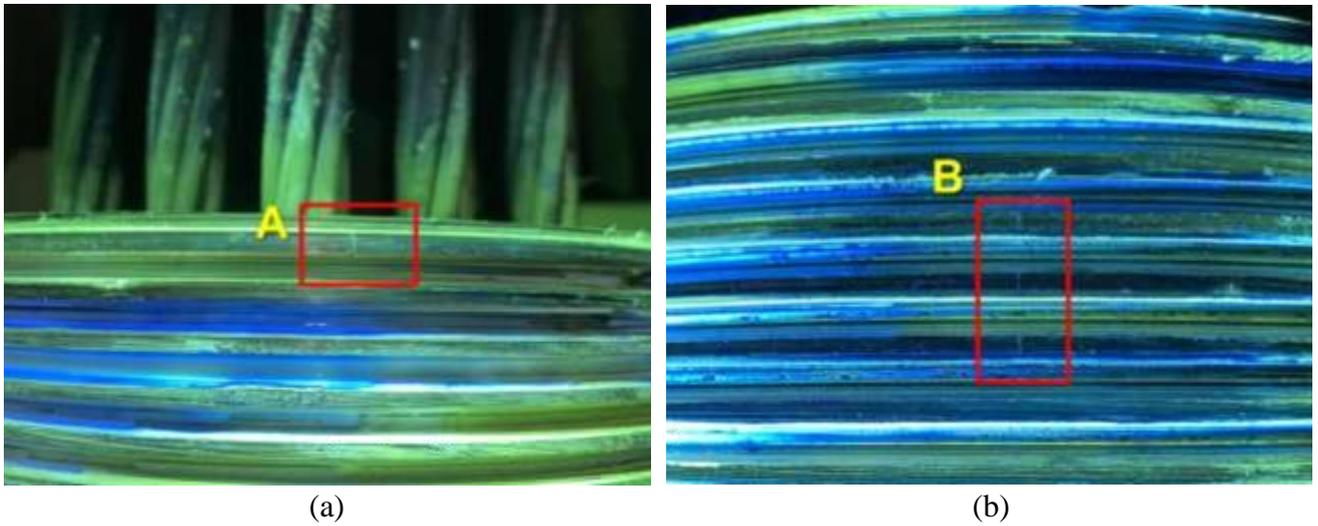
圖2 上拱錨頭 10 號側面螺牙處之表面裂紋

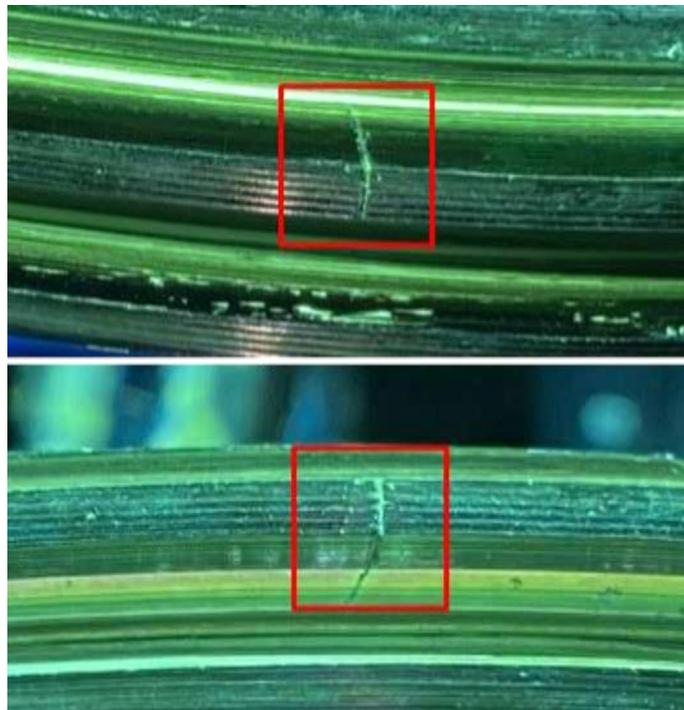
圖3 上拱錨頭 10 號 A 處表面裂紋放大觀察照片

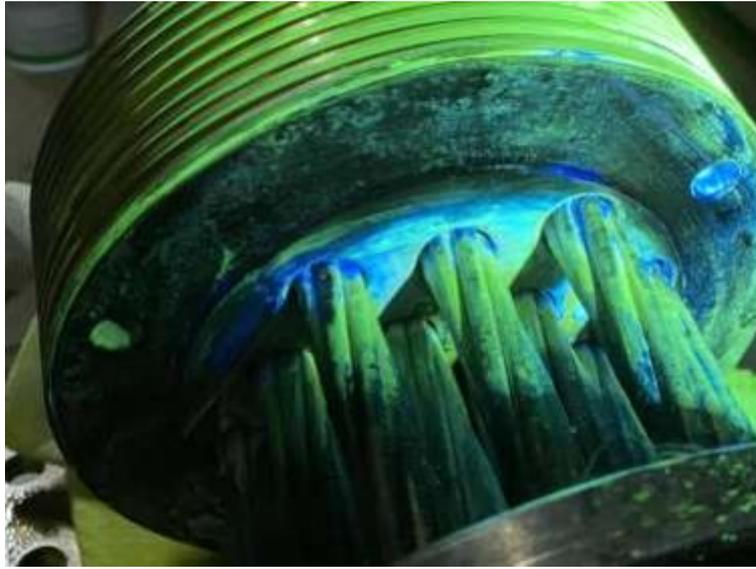
圖4 上拱錨頭 10 號上表面之螢光檢驗照片

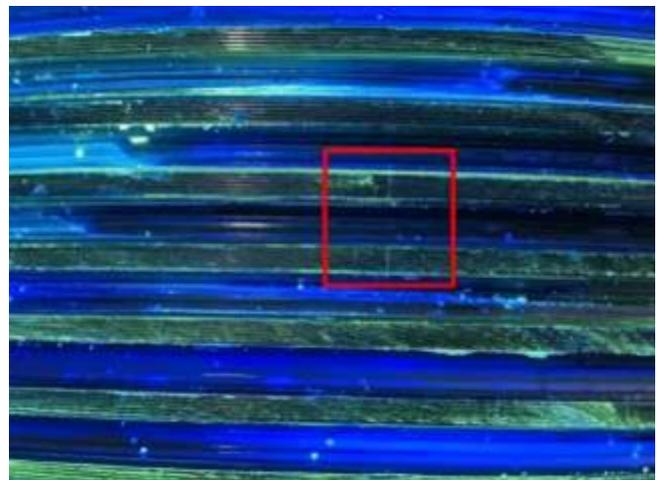
圖6 上拱錨頭 12 號側面螺牙處之表面裂紋

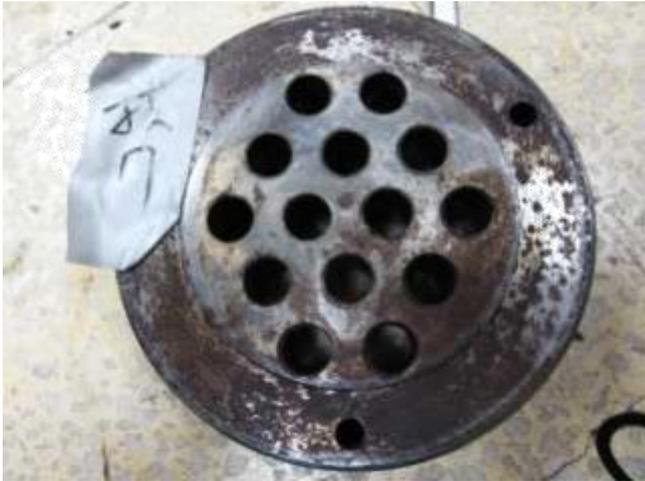
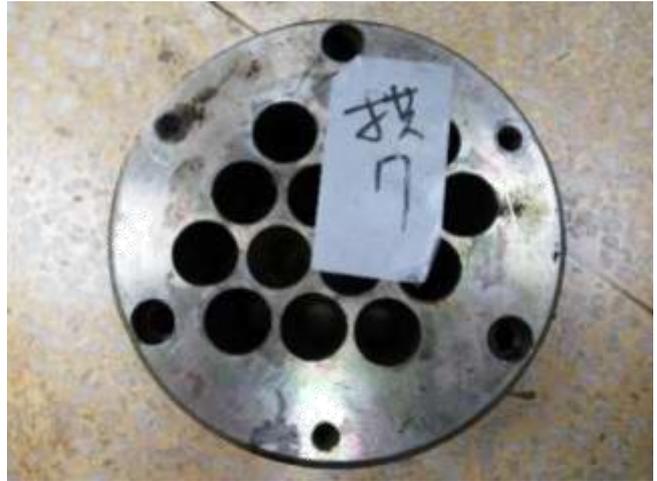
圖 7~圖 9 為三件錨頭外觀照片，錨頭之上表面皆有鏽蝕現象，特別是 9 號及 11 號鏽蝕更嚴重，而下表面因有帽蓋保護，氧化程度相對較輕微，仍可明顯觀察到表面鍍層。在進行 CT 檢驗之前先以目視檢查方式檢驗錨頭表面是否有明顯傷痕或裂紋，此外，為避免表面髒污影響檢測結果，在 CT 檢驗之前亦先以酒精去除工件表面之油污後再進行檢測。圖 10 為上拱錨頭 7 號之外觀傷痕檢視照片，於側面之螺紋齒峰處可觀察到表面受撞擊之凹痕，如圖 10(a)(b)中箭頭所指處，但目視判斷其凹痕深度較淺；另於錨頭之螺孔處亦發現有受到撞擊造成之變形痕跡存在，如圖 10(c)(d)中箭頭所指處。圖 11 為上拱錨頭 7 號之 CT 檢驗圖片，其內部並無發現明顯裂紋存在。圖 12 為上拱錨頭 9 號之外觀傷痕檢視照片，於上表面與側面交接處之第一階螺紋，發現有螺牙變形斷裂位移之現象，且左右兩邊皆有發現，如圖 12(a)(b)所示；由上表面相對位置觀察可發現有相對應之變形壓痕存在，如圖 12(c)(d)所示，此變形導致下方螺牙變形斷裂，由其形貌判斷為圓形狀物體壓迫或撞擊所導致變形。圖 13 為上拱錨頭 9 號之 CT 檢驗圖片，其內部並無發現明顯裂紋存在。圖 14 為上拱錨頭 11 號之外觀傷痕檢視照片，於側面螺牙發現一處有裂縫存在，如圖 14(a)(b)中箭頭所指處（二圖為同一道裂紋），此外於側面之多處齒峰位置，也發現有許多凹痕或撞擊之痕跡，如圖 14(c)(d)(e)中箭頭所指處；圖 15 為上拱錨頭 11 號之 CT 檢驗圖片，可觀察到圖 14(a)(b)中之裂縫，但其裂縫深度約到齒谷位置，並未往內部延伸，而內部亦無發現有明顯裂紋存在。

圖7 上拱錨頭 7 號外觀

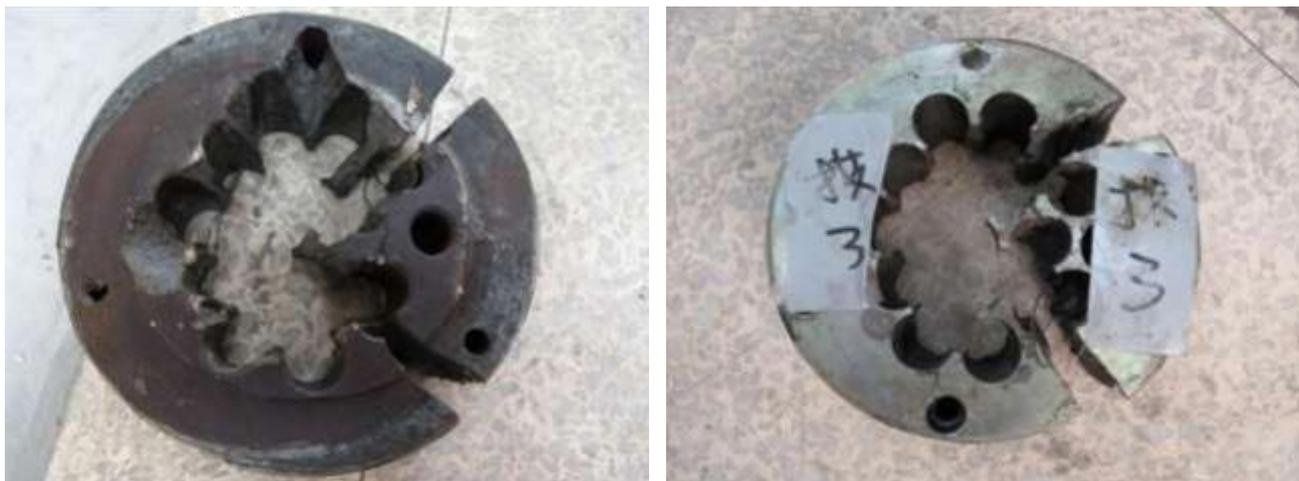
為了解錨頭使用之材質強度，規劃進行拉伸試驗。取上拱 3 號錨頭進行試驗，錨頭外觀如圖 16 所示，事故發生時已破裂，故選取肉厚較多的位置進行取樣，並加工為拉伸試棒，取樣位置及加工後與安裝後外觀如圖 17 所示，共取兩件試樣，編號為#1 及#2，拉伸試驗結果如表 2 所示。

圖 16 上拱錨頭 3 號外觀

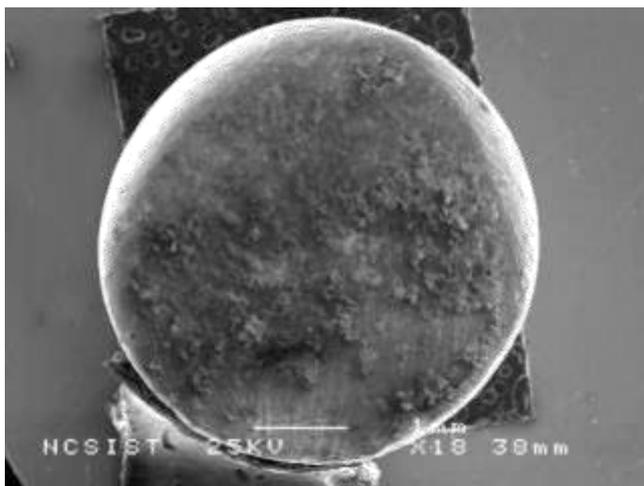
由於一般相機對於斷面細部觀察之解析度有限，而光學顯微鏡之景深較淺，亦無法對斷裂面進行細部觀察，故以掃描式電子顯微鏡(SEM)對各鋼線之斷面進行觀察。因鋼線試樣數量多，照片數量亦相當龐大，故本節僅列出具代表性之不同類型斷裂面照片，如圖 49～圖 54所示。圖 49為編號 8-2-1 鋼線之斷面 SEM 照片，為平整之斷面，並且可觀察到平行之加工痕跡，此種斷面多出現在芯線，平行加工痕跡為鋼線原始切割斷面，此類斷面顯示鋼線並非受拉伸斷裂，而是由鋼絞線束中抽出，故仍保留原始平整斷面。圖 50為編號 8-2-2 鋼線斷面 SEM 照片，該斷面為一斜面且較平整，為分解應力較大之平面斷裂，偏向脆性斷裂，但亦可觀察到其表面不平整，已有受表面鏽蝕影響。圖 51則為編號 9-4-2 鋼線斷面 SEM 照片，為不規則頸縮之形貌，顯示鋼線受拉伸應力時有發生頸縮，但因受鏽蝕影響而呈現不規則形貌。圖 52為編號 9-4-7 鋼線斷面 SEM 照片，為較對稱之頸縮斷面，但其斷面細部觀察可看到斷裂引起之裂隙。圖 53為編號 9-8-3 鋼線斷面 SEM 照片，屬於較複雜之斷面型態，疑似有頸縮變細之情形，但斷面又有偏向脆斷之形貌，研判亦有受鏽蝕之影響。圖 54為編號 9-2-5 鋼線斷面 SEM 照片，此種斷面可明顯看出為鏽蝕影響程度較大之斷裂面，斷面上並可觀察到較深之鏽蝕孔。

圖49 編號 8-2-1 鋼線(芯線)斷面 SEM 照片

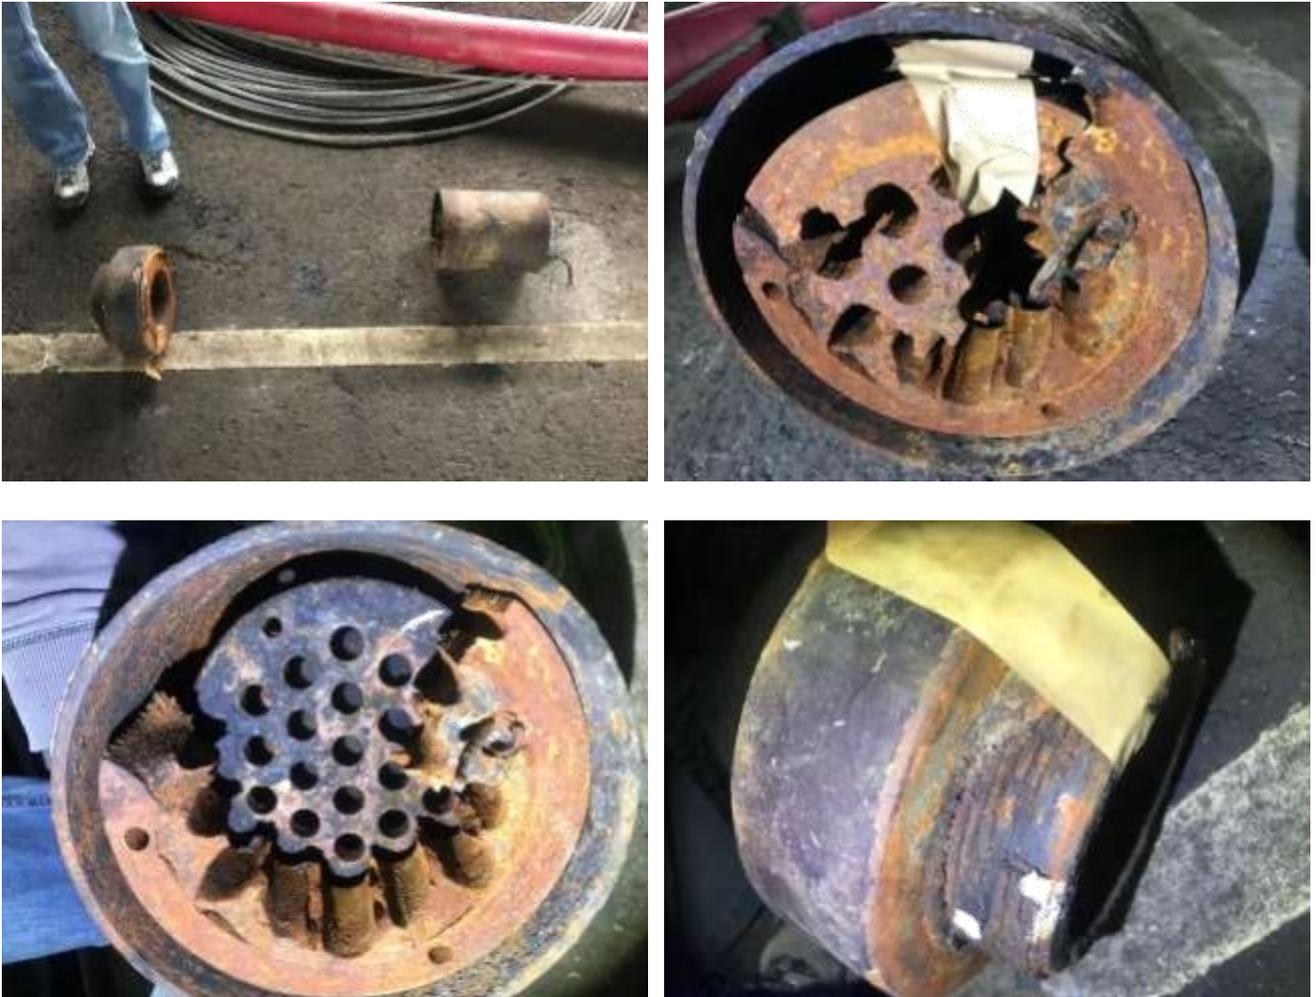
橋面端試樣因事故發生時部份隨橋體一同墜入海中，故部份橋面端試樣浸泡在海水中一段時間後才被打撈起，橋面 1~13 號錨頭外觀如圖 59~圖 71 所示。由於許多橋面端錨頭仍有鋼絞線殘留其上，且多數仍與承壓環及螺紋調整管相連，故經外觀檢視後，即送至國震中心進行拆解，將各部件分離，再送至本院進行相關分析。圖 72~圖 84 為拆解後橋面 1~13 號錨頭外觀照片，可知除橋面 1 號錨頭破裂外，其餘橋面 2~13 號錨頭並無破裂，但皆有生鏽情況，惟各錨頭生鏽程度略有差異。此外，隨同拆解後錨頭一併送至本院的部件尚有各錨頭拆解後之相關配件，包含承壓板、殘留之鋼絞線、夾片等，各編號橋面錨頭之相關配件外觀照片則如圖 85~圖 97 所示。

圖59 橋面 1 號錨頭拆解前外觀

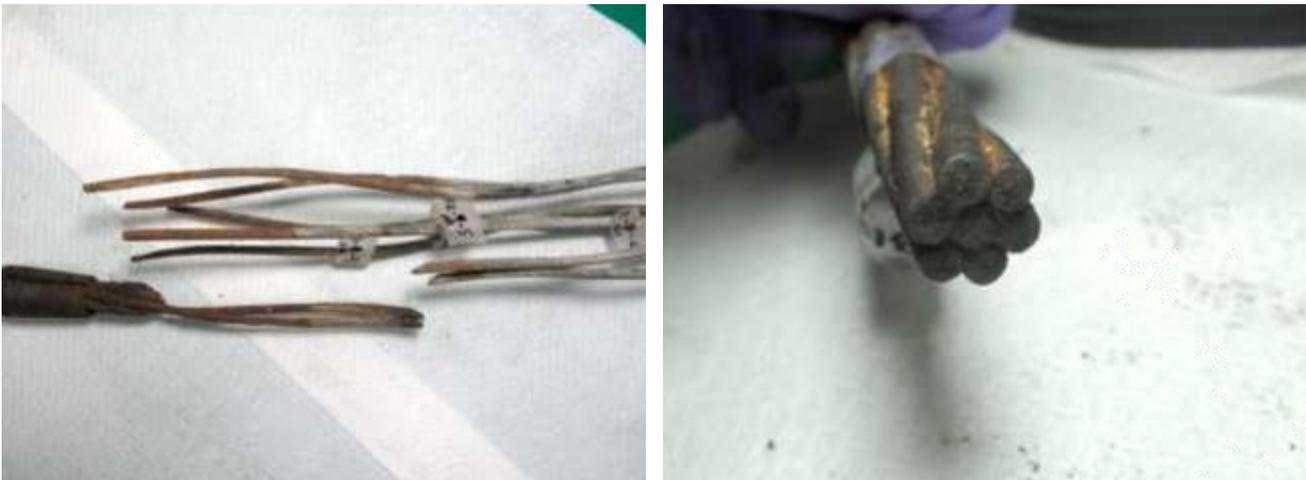
圖170 橋面第 12-1 束與上拱 12-10 束對應外觀(左)及橋面第 12-1 束底部外觀(右)

及橋面 12 號錨頭殘留各線束外觀(圖 142~圖 154)，可發現上拱各線束之芯線皆為平整面，僅 12-10-7 及 12-11-7 兩芯線為拉伸破斷面，顯示 13 束中有 11 束之芯線被抽出，故末端仍保持平整面，而 12-10-7 及 12-11-7 兩芯線為拉伸破斷面，顯示另一端應留在橋面端線束中，而比對橋面 12 號錨頭殘留線束，可發現恰有 12-1 及 12-9 兩線束仍保有 7 線(圖 142及圖 150)，其餘 11 束皆為 6 線，故可確認上拱 12-10 及 12-11 兩線束對應到橋面 12-1 及 12-9 兩線束。此外，再比對此四線束，可發現橋面 12-1 束有兩鋼線長度較長(如圖 142)，而上拱 12-10 線束恰有兩線較短，故可確認此兩線束為同一鋼絞線束斷裂之兩端，如圖 170 中所見，因此此鋼絞線束最適合作為斷裂處上下端生鏽程度差異之比對。

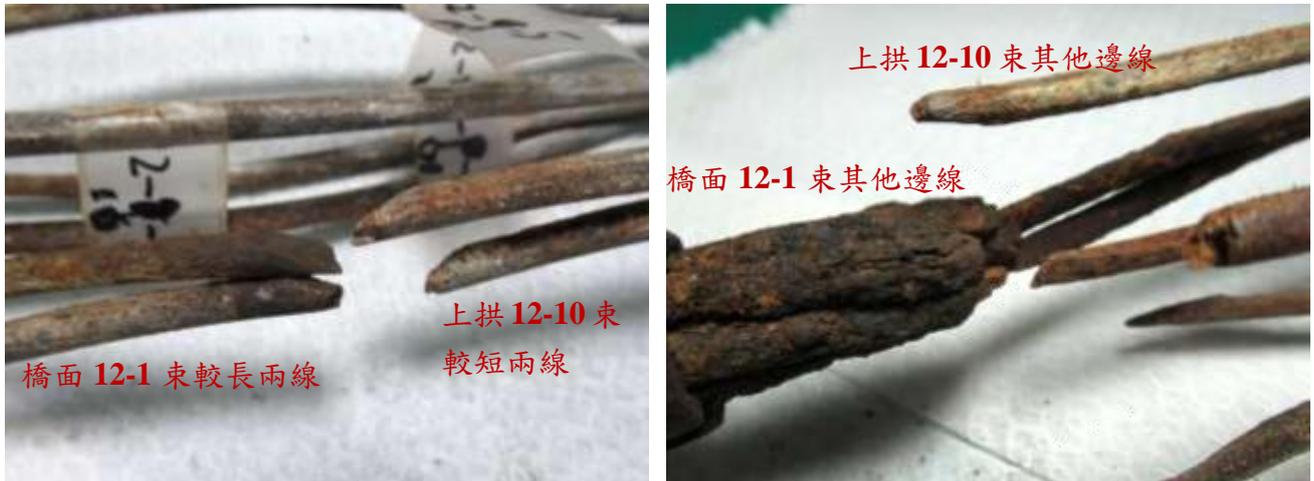
5. 為了解生鏽與斷裂之時序，深入比對斷裂處兩端之生鏽程度差異。圖 171 為前述用以比對生鏽程度差異之鋼絞線束斷裂處兩端外觀比對照，可發現不論是較長的兩線或是其他較短的五線，橋面端的鋼線生鏽情況明顯較嚴重，較短的五線甚至已生鏽成蓬鬆狀而有層狀剝離的現象，而比對斷裂處兩端芯線的狀況亦是如此，如圖 172 所示，橋面端芯線一樣有較嚴重的生鏽情況。細部檢視橋面端 12-1 束鋼線鏽蝕情況如圖 173 所示，較長之兩鋼線在其他五線斷裂位置也有明顯鏽蝕情況，導致該處明顯變細，可推論在此處外在環境有較強的腐蝕因子，導致線材腐蝕嚴重。理論上，此處所在位置不應有太強的腐蝕環境存在，但由圖 59~圖 71 橋面錨頭拆解前外觀可知橋面錨頭周遭部件皆鏽蝕嚴重，除錨頭本身有生鏽情況外，多件螺紋調整管更嚴重鏽蝕，出現膨脹及層狀剝離情形，推論橋面端錨頭多數有積水情況，在水面與空氣交界處再加上海水鹽分作用，腐蝕環境較一般嚴重，長時間反應下才有此嚴重鏽蝕之情況。而同一線束斷裂處，橋面端與上拱端生鏽程度差異則意味著鋼線斷裂後，上拱端線材已較脫離嚴重腐蝕環境、橋面端線材則仍保持在該腐蝕環境中，因此若能確認橋面端線材斷裂處斷面鏽蝕深度，即可推測斷裂發生在事故發生當時或是更早以前即發生。

圖171 橋面第 12-1 束與上拱 12-10 束斷裂處上下端邊緣對應外觀

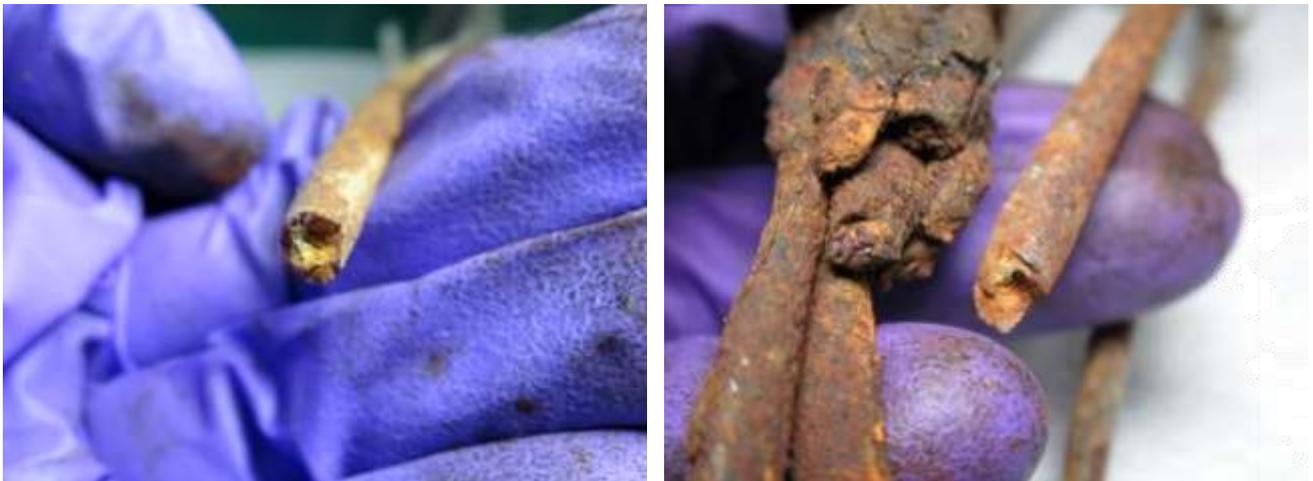
圖172 上拱 12-10 束芯線斷面外觀(左)及與橋面第 12-1 束芯線對應情形(右)

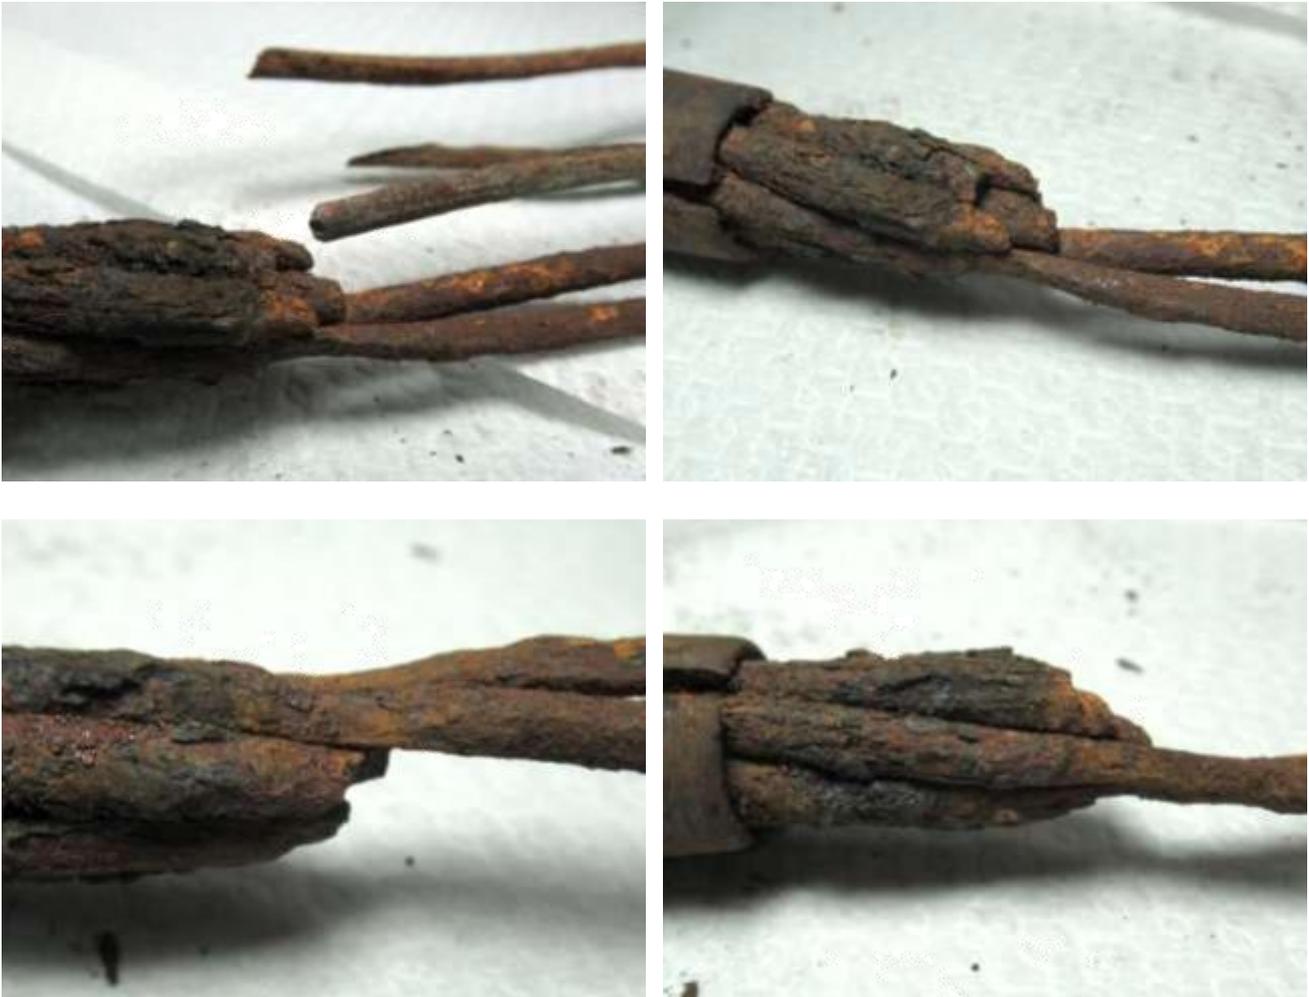
圖173 橋面第 12-1 束鏽蝕外觀

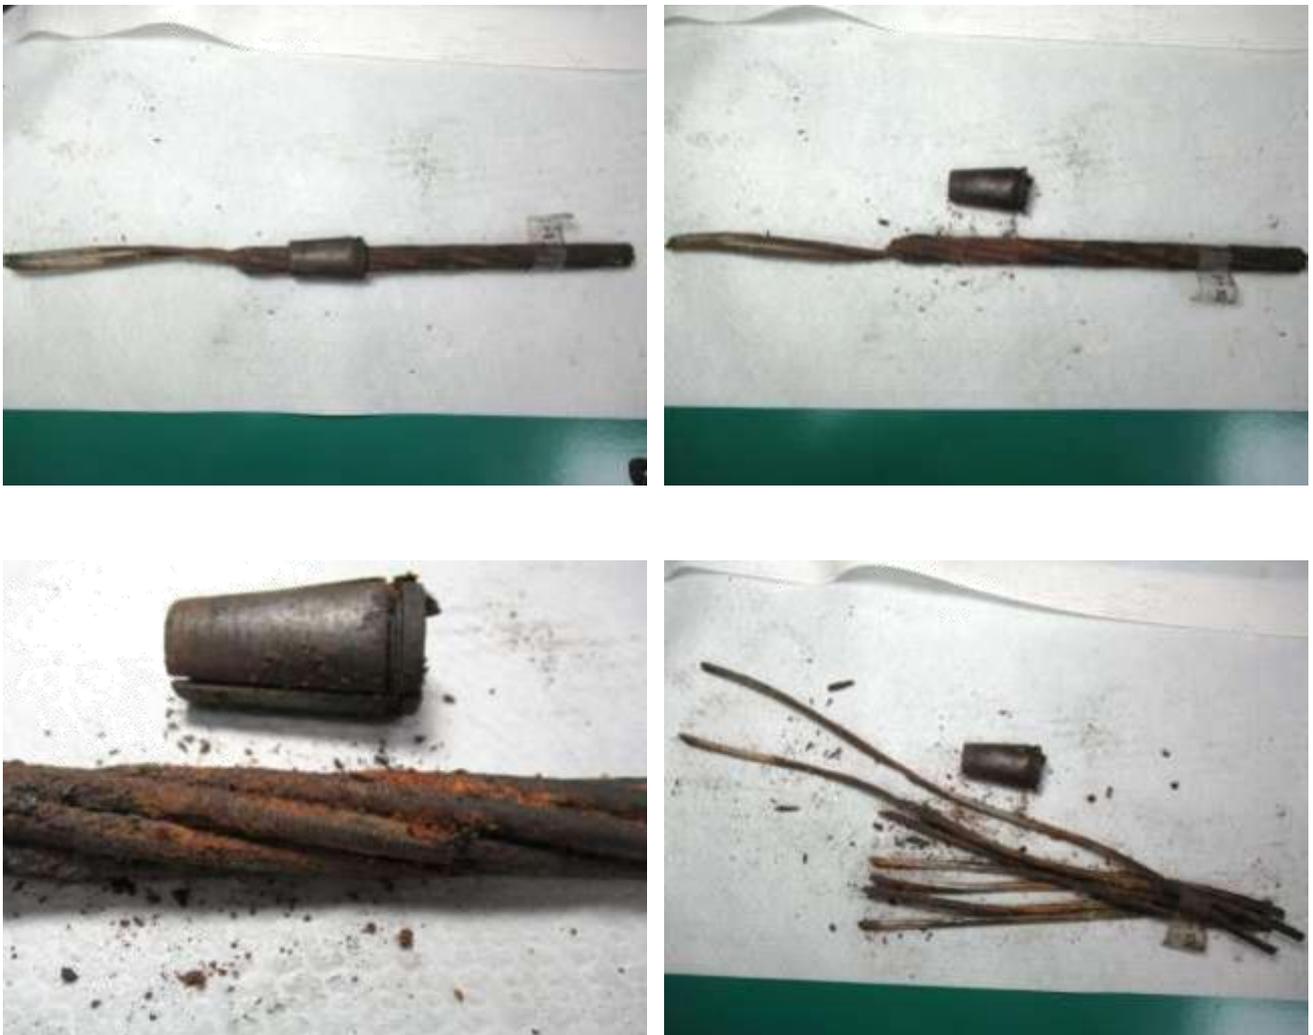
6. 為確認斷裂處兩端鋼線鏽蝕深度差異，擬進行線材剖面金相分析。先將橋面端 12-1 束進行拆解，如圖 174 所示，拆解後外觀則如圖 175 所見，可發現鋼線彼此包覆住之內部表面仍可看到殘留之鍍鋅層，故內部表面鏽蝕程度相對較輕微，尤其是芯線被邊線較完整包覆，因此除上端斷裂處鏽蝕較嚴重外，其他表面則有較多鍍鋅層或鋅層氧化殘留之形貌，如圖 176 所見。先將橋面端 12-1 束之芯線切取一適當長度，並另取一邊線線段，進行縱剖面鑲埋研磨拋光，而上拱端則取 12-10-7 芯線與 12-10-6 邊線，一樣進行縱剖面金相製備，再進行四段線材之剖面金相比對。圖 177 及圖 178 即為斷裂處上下端芯線與邊線縱剖面外觀照片，由剖面觀察可知不論是芯線或邊線，不論是上拱端或橋面端，斷裂處皆已有再生成相當厚度的鏽蝕層，且橋面端的鏽蝕層更厚，已達 mm 等級，已非新鮮鋼線斷裂後浸泡在海水中所能產生的氧化層厚度，故可確認此線束早在事故發生前早已斷裂，且由鏽蝕深度並非數週或數月可造成，應更早之前即已斷裂。

圖174 橋面第 12-1 束鋼線拆解過程

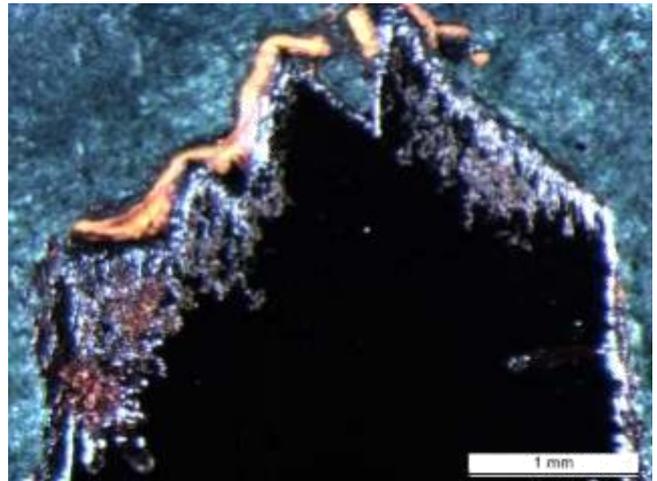
(d) 橋面 12-1 束芯線高倍率

圖177 第12股其中一束鋼絞線之芯線斷裂處上下端剖面實體顯微鏡觀察照片

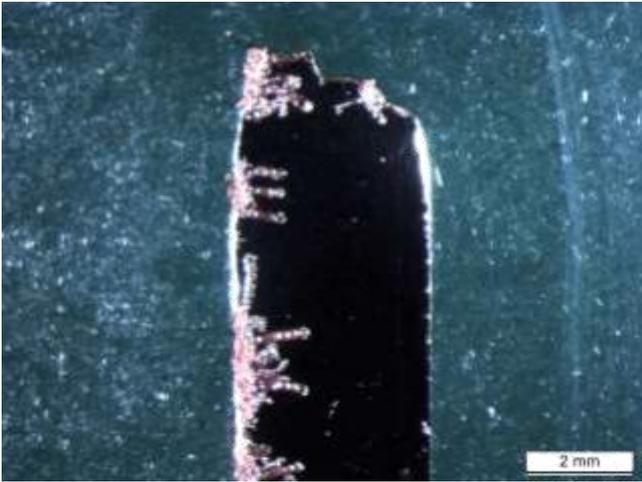
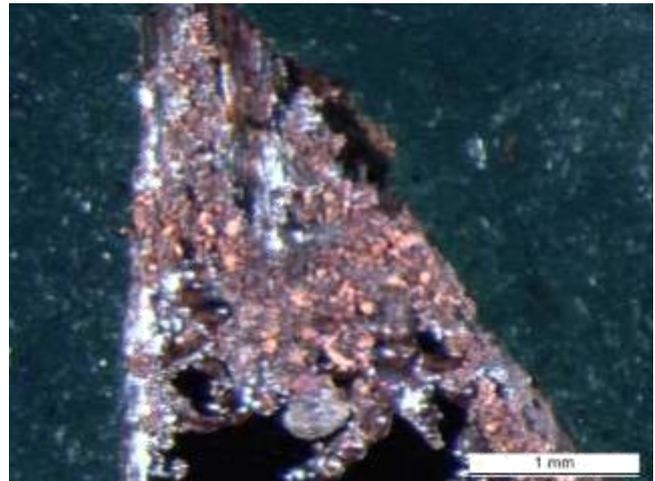
(a) 上拱 12-10-6 邊線低倍率

(d) 橋面 12-1 束其一邊線高倍率

圖178 第 12 股其中一束鋼絞線之邊線斷裂處上下端(非同一線)剖面實體顯微鏡觀察照片

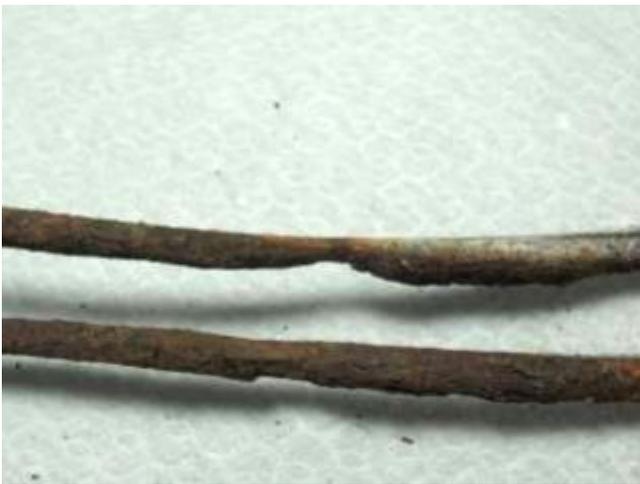
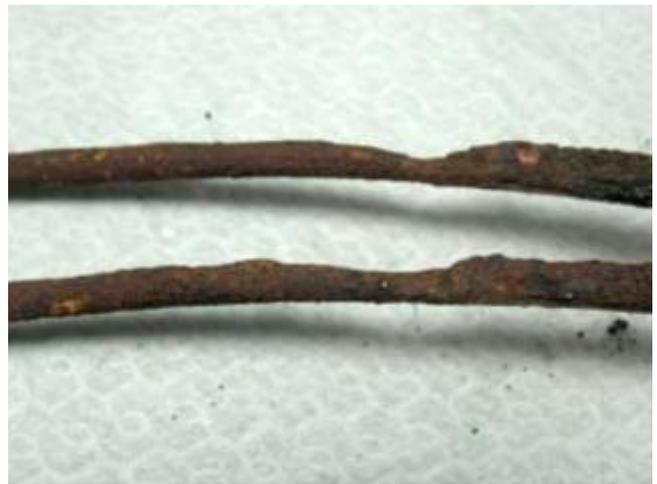
7. 此橋面 12-1 束鋼絞線尚可獲得更多訊息，由於其有兩線較長，而較長之兩線在其他五線斷裂處亦有嚴重鏽蝕情形，如圖 179 所示，因此可推論此束鋼絞線之七鋼線並非同一時期斷裂。經量測較長兩線之中段腐蝕嚴重位置，如圖 180，該處肉厚僅剩約 3 mm，寬度僅剩約 4 mm，亦即剩餘的線材已不到原本線徑的三分之一，應已無法承受正常之載重，但卻未從此處斷裂，顯然是因為上方已先斷裂，故此處已不再承受應力，故可知此二線為七線中最先斷裂。由圖 170 可知此二線斷裂處與另五線斷裂處之間之鋼線表面皆有鏽蝕情況，可推論原此橋面錨頭積水深度可能達兩線斷裂位置，此二線在該處先發生鏽蝕，而在應力作用下加速了應力腐蝕，導致此二線先斷裂，而後積水深度逐漸降低，故此過程中線材表面皆持續有生鏽情形，而降至五線斷裂處時維持了較長的時間(或水面在此深度附近反覆升降)，導致此處鏽蝕較嚴重，而未斷的五線因仍有應力作用故腐蝕較快終至斷裂，較長的兩線無應力加速腐蝕，故僅有較嚴重鏽蝕而未斷裂。

圖179 橋面第 12-1 束之兩條較長邊線鏽蝕中段外觀

8. 由以上各點之討論，可確認有部份鋼絞線束或鋼線，在事故發生前早已因鏽蝕及應力加速腐蝕作用而斷裂，同一錨頭的線束在部份線束已斷裂的情況下，將承受更大的應力，若外在腐蝕環境並未消除，則將更加速應力腐蝕導致斷裂。因此雖然錨頭材質強度及孔位設計無法承受全部線束總強度的應力，但若有部份鋼絞線束因鏽蝕而斷裂的錨頭，只要殘餘線束總強度小於錨頭孔位設計強度，錨頭就不會因應力過大而破裂，反之，只要錨頭上未斷線束超過一定數量或全部未斷，則事故發生時突來的大應力將導致上拱錨頭破裂，也因此本案有部份上拱錨頭破裂、部份卻無破裂之情況。雖然錨頭的材質強度和孔位設計搭配不足以負荷全部線束的總強度，但在全部鋼絞線未斷的情況下，應力平均分配，並不會發生錨頭破裂的情況，因此，本案事故的主因仍是鏽蝕導致鋼絞線斷裂所導致，當斷裂的線束逐漸增加，剩餘未斷的線束及其所在的錨頭承受應力亦逐漸增加，當應力大於錨頭所能承受之強度，即會發生破裂，而一旦有一錨頭破裂，其原本所負載的應力將再分配至其他未斷線材，因而引發連鎖反應，造成錨頭連續破裂而造成斷橋事故。

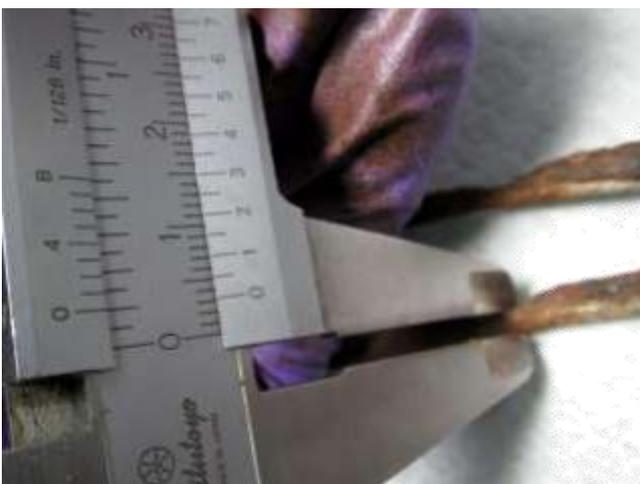
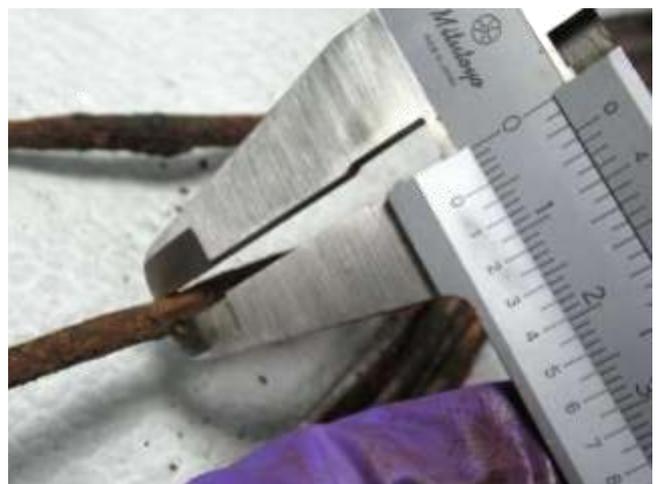
圖180 橋面第 12-1 束之兩條較長邊線鏽蝕中段肉厚及寬度量測情形

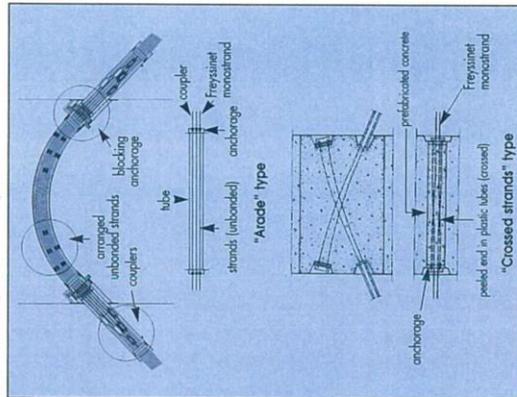
Fig. 23 illustrates two types of such devices. Additional information can be provided on request.

Fig. 23 - Types of special "saddles"

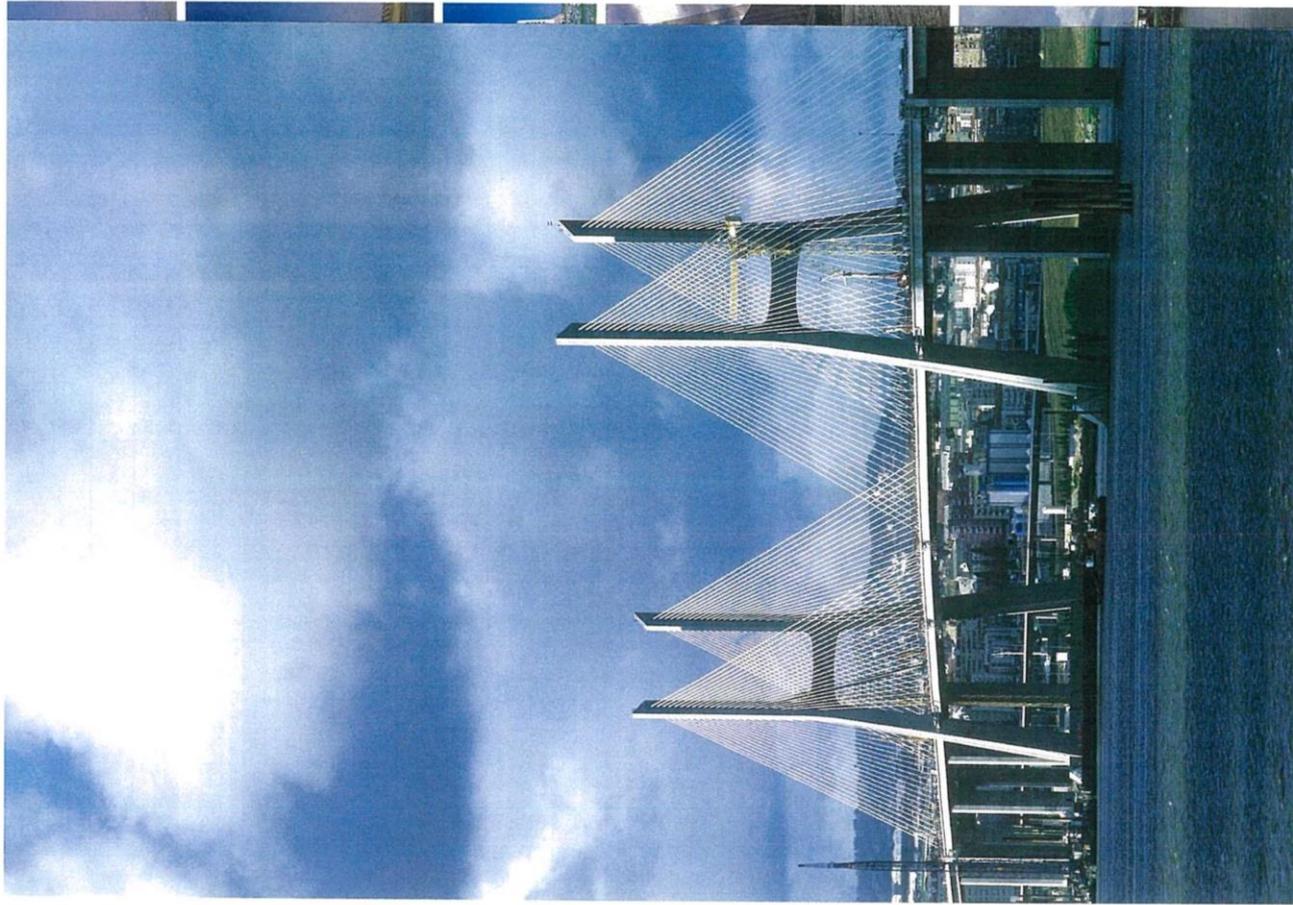
The latter have mainly been subjected to tensile (sometimes combined with bending) fatigue tests, followed by ultimate tensile strength tests. The test conditions and the acceptance criteria are, at least, those specified by the Recommendations for Stay Cable Design, Testing and Installation, published by the Post-Tensioning Institute (USA).

Fig. 34 - test summary diagram
