# Case of Freight Train Derailment on a 153 m Radius Turnout

October 23, 2025

Aviation and Railway Accident Investigation Board (ARAIB)

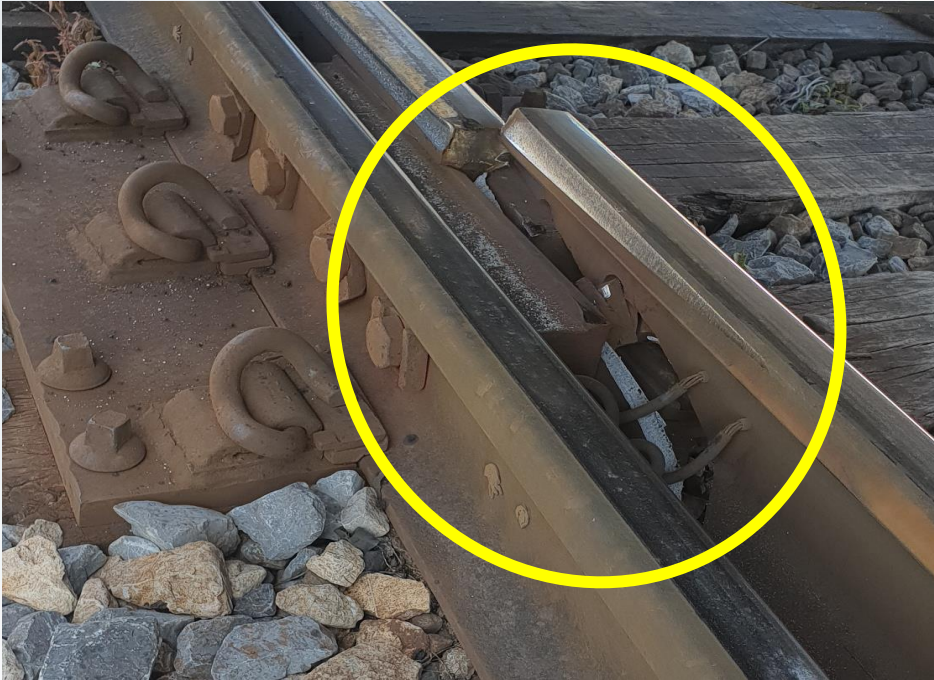
- ✓ Damage: The vehicles, track, and signal were damaged

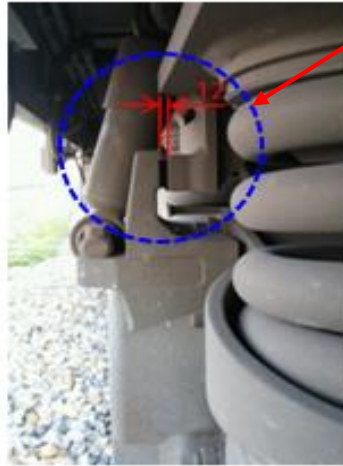
Lateral displacement between axle and bogie frame : 12mm

Bogie frame

Primary suspension spring
