# NORTH EAST LINE (NEL) SIGNAL PASSED AT DANGER (SPAD) INCIDENT ON 4 NOVEMBER 2023 - RAIIF 2025

# Case Study: NEL SPAD Incident (1/4)

**When:** 4<sup>th</sup> November 2023 / **Where:** Sengkang Depot Examination Building E1 Track to Headshunt H2 Track

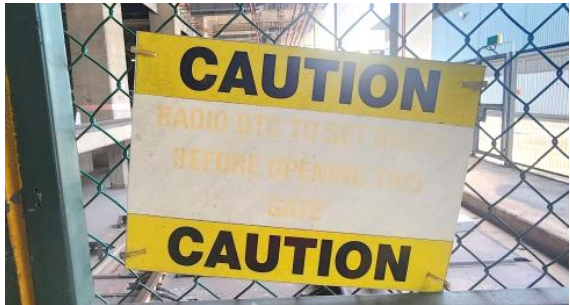
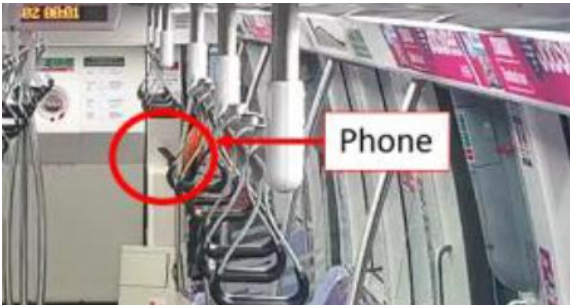
Faded signage

| Contributing Factors | Details |
|---|---|
| Faded Signage | The visual warning sign instructing DD to contact DTC before opening the Examination Building Train Access Gate had faded and was ineffective as a reminder |

| CAPA | Details |
|---|---|
| Improved Signage | Replaced faded signs with brighter, more prominent ones to reinforce safety reminders |
