# Panel Discussion Theme 2:

## The necessity of installing audio and device recording devices in train driver cabs and challenges in promoting their implementation

Masakazu Adachi

Senior Railway Accident Investigator, the Japan Transport Safety Board

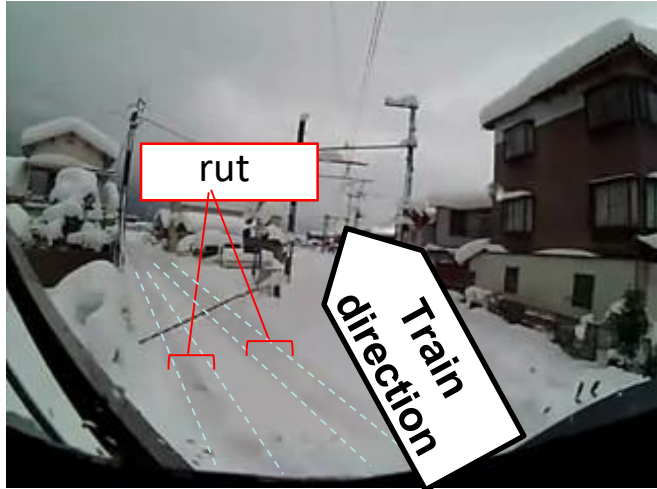
Time 13:46:12

Train is running near the beginning of the level crossing

Train derailment (Ohmi railway)

Occurred on December 27, 2018

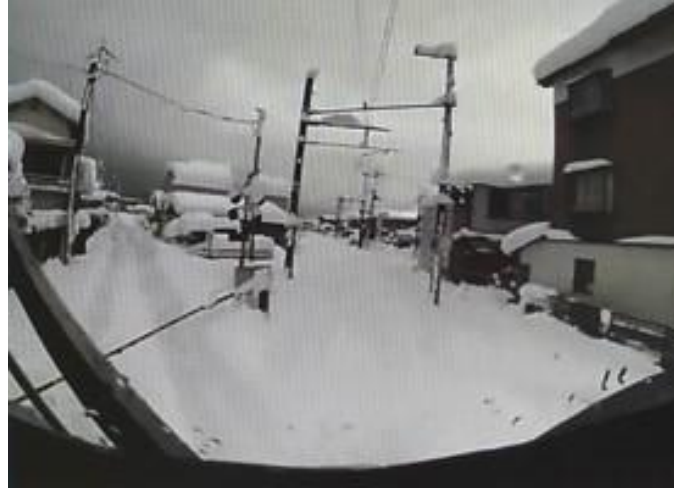
Time 13:46:14

Train vibrated slightly while passing through the crossing.

Time 13:46:16

While traveling near the end of the crossing, an abnormal noise was happened and the train was shaken.

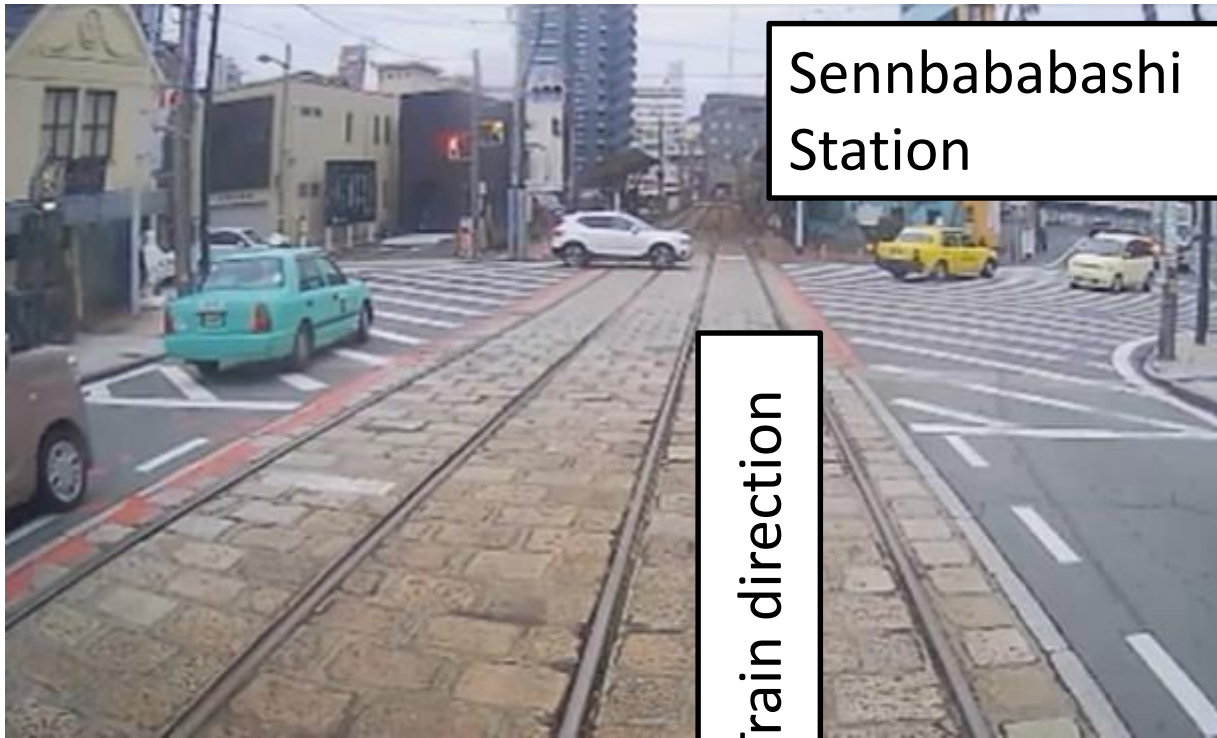
(a) Footage from the rear-view drive recorder  
( When stopped )

## Dangerous trouble in vehicle (Kumamoto City Transportation Bureau)

Occurred on February 23, 2024

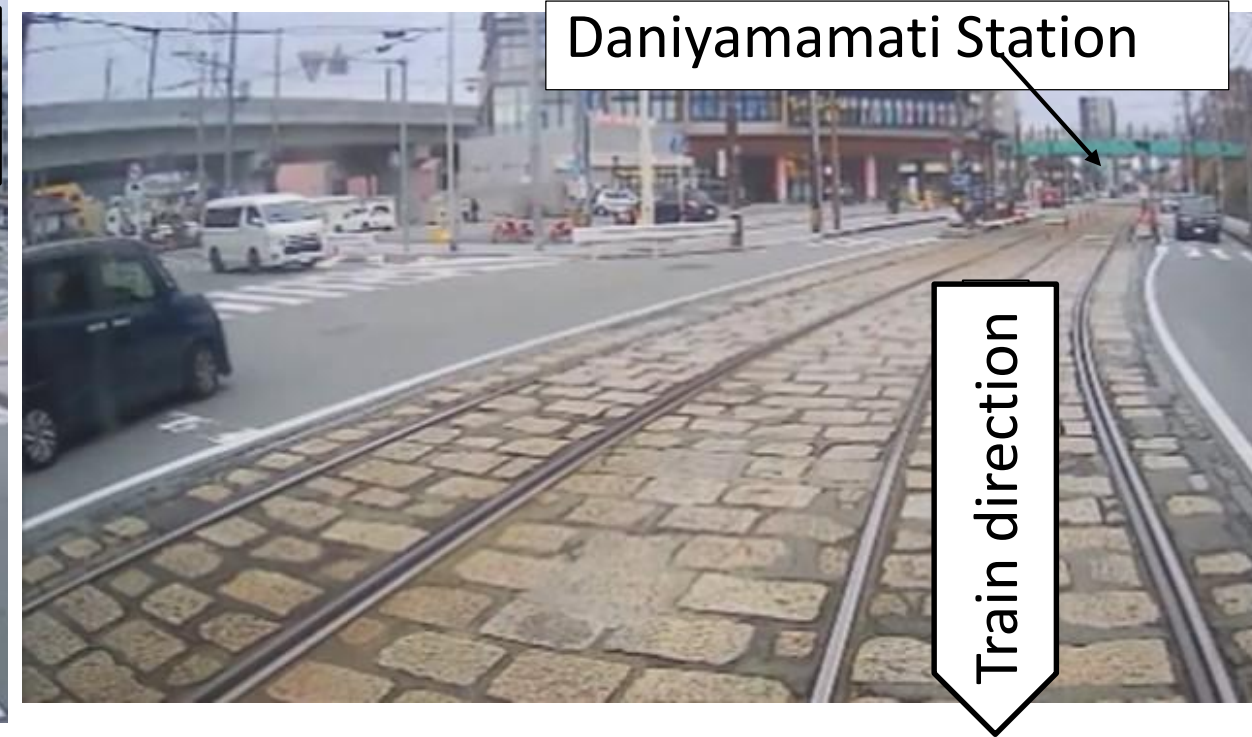
(b) Footage from the rear-view drive recorder  
( When stopped )
