# Extreme weather events

RAIIF 2025, Taiwan  
Conference Keynote

# Findings – what happened

# Melbourne derailment

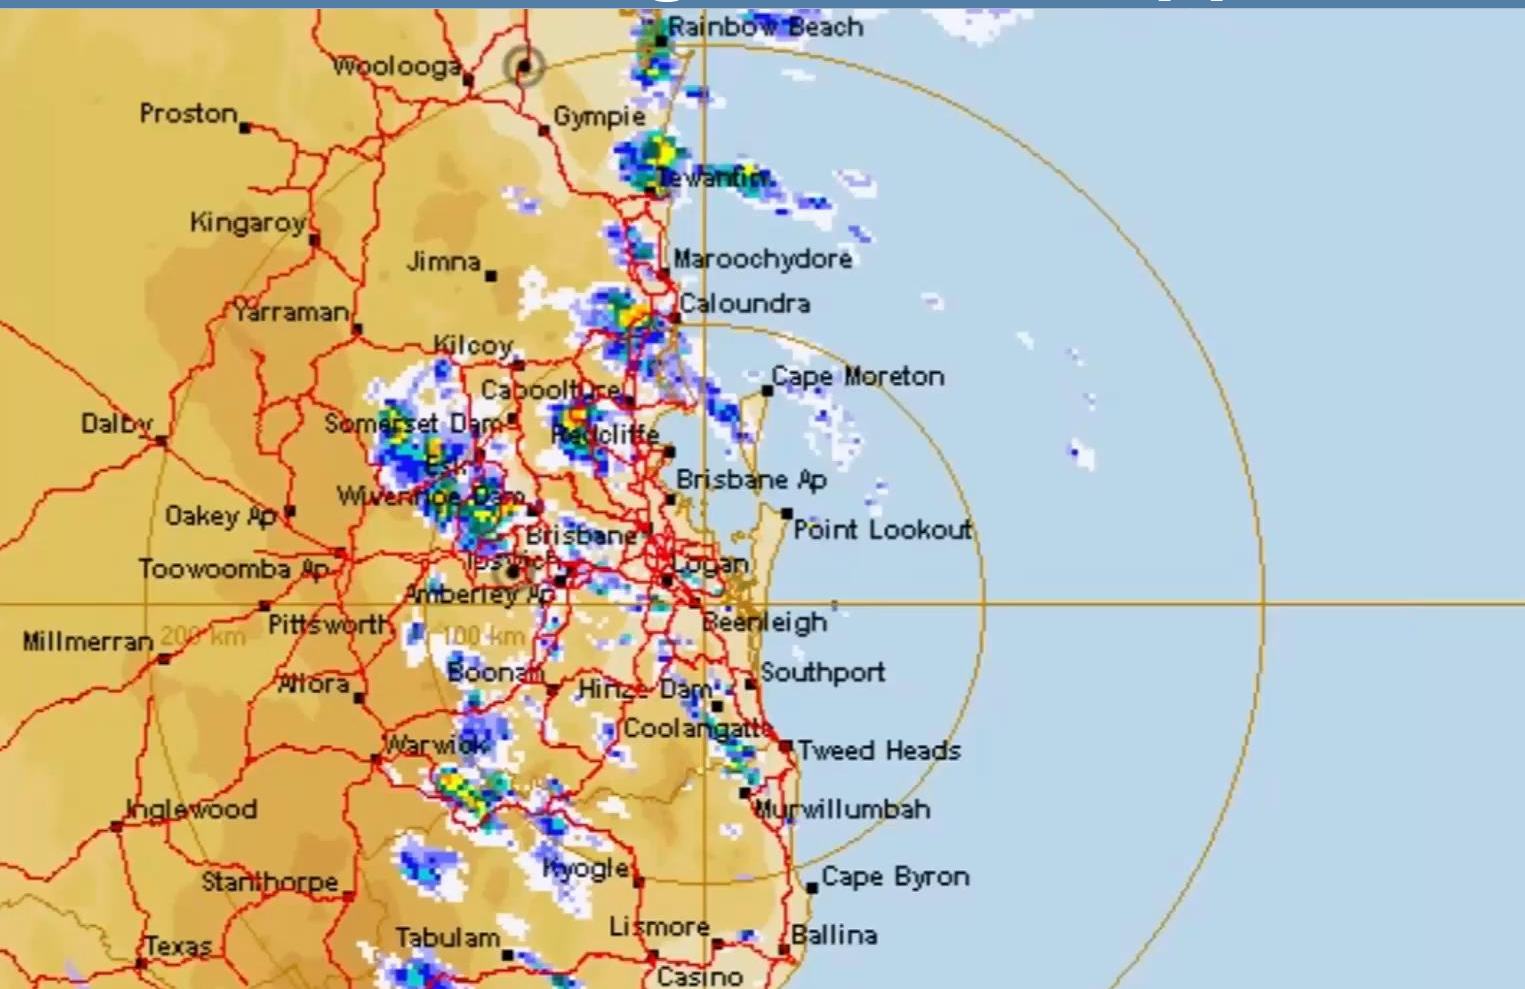
Light Moderate Heavy

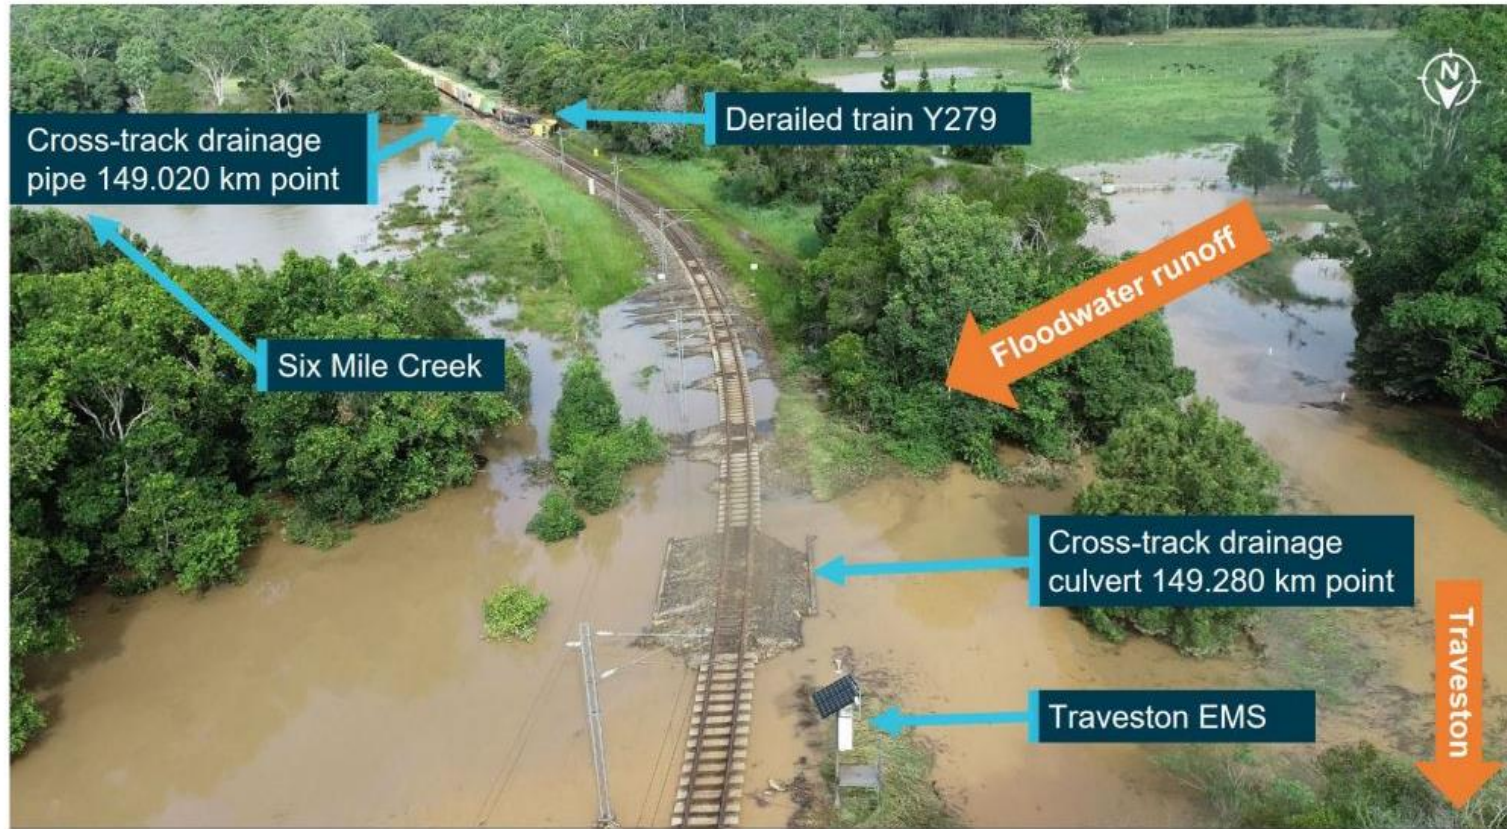
Source: ATSB

The image taken later on the day of the derailment shows the relative locations of the derailed train Y279, cross-track drains and the Traveston weather station.

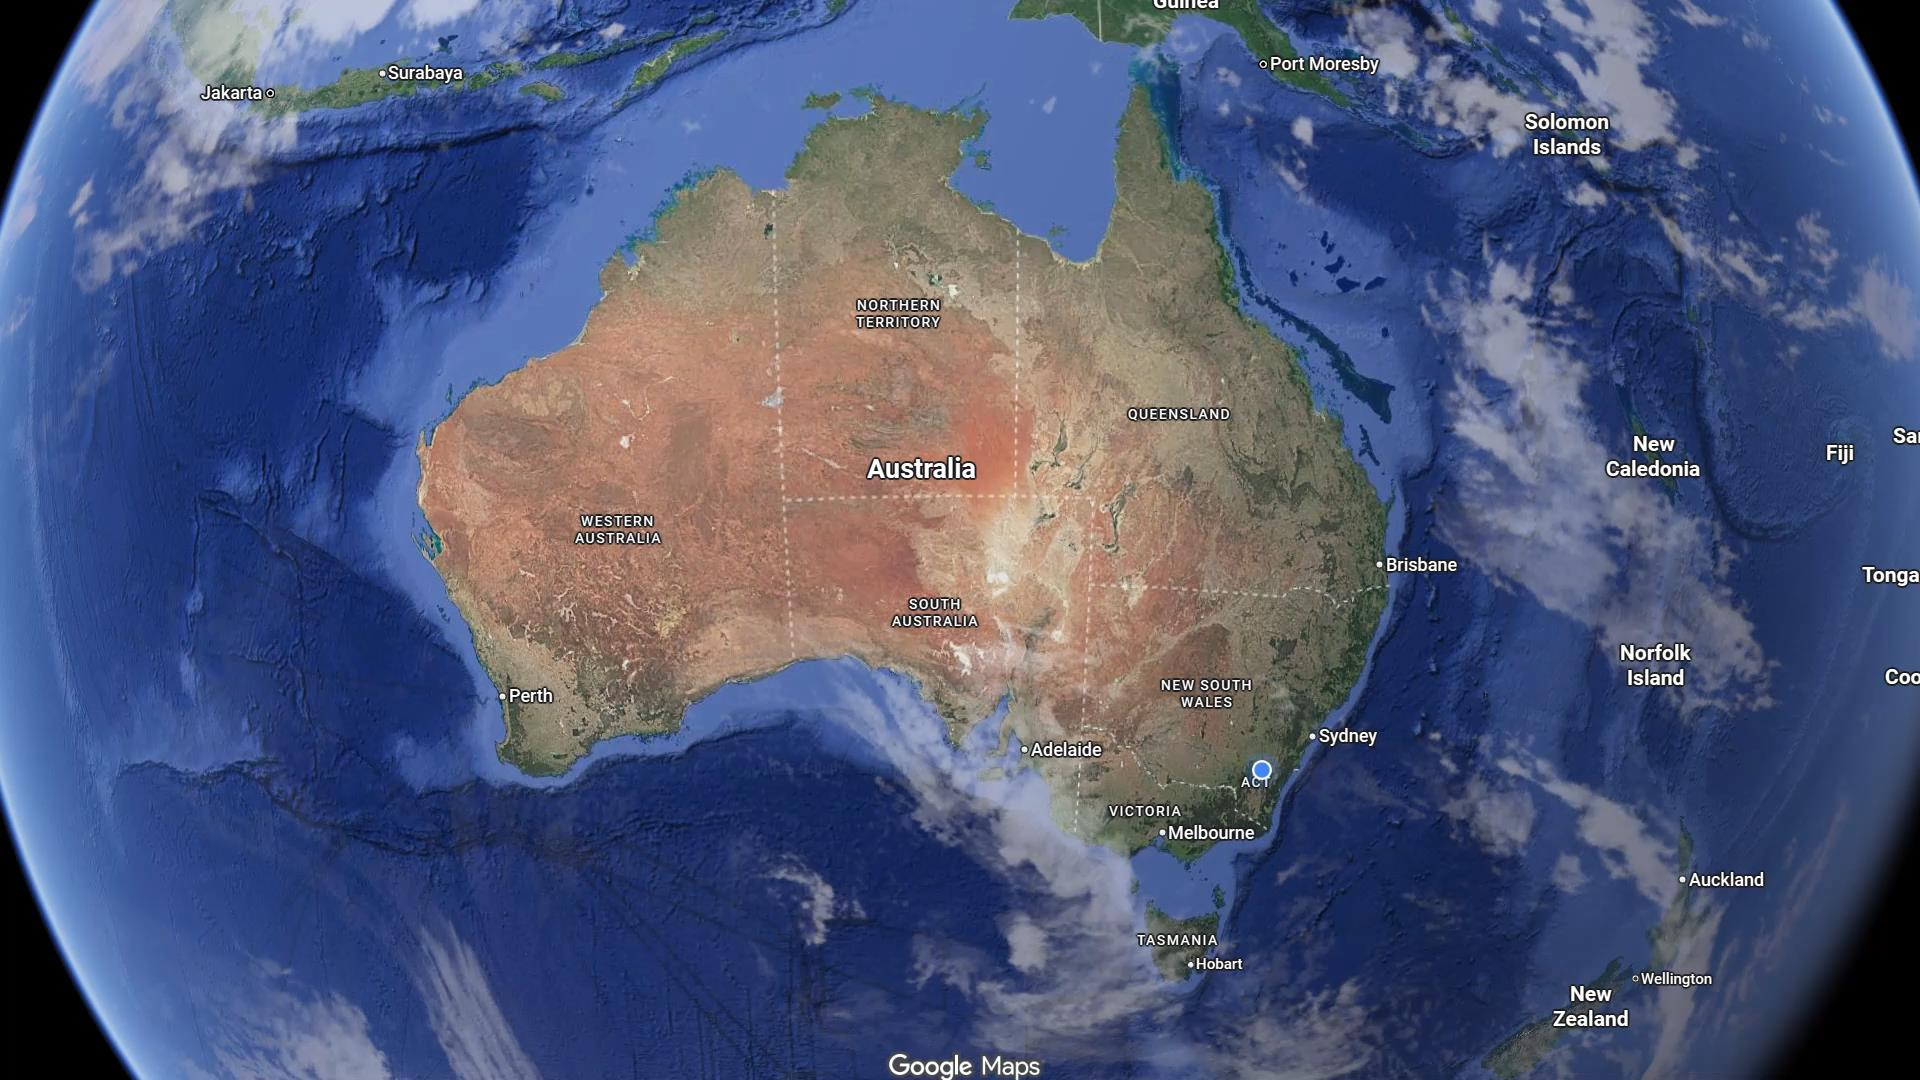
The emergency exit pathway through a side window, was inadequate to ensure a prompt and limited access by emergency services.

The infrastructure manager has since implemented:

- enhanced alarm notification systems,
- upgraded training programs,
- improved equipment serviceability protocols, and
- strengthened operational procedures to manage adverse weather events.

The operator has developed an access and egress compliance strategy

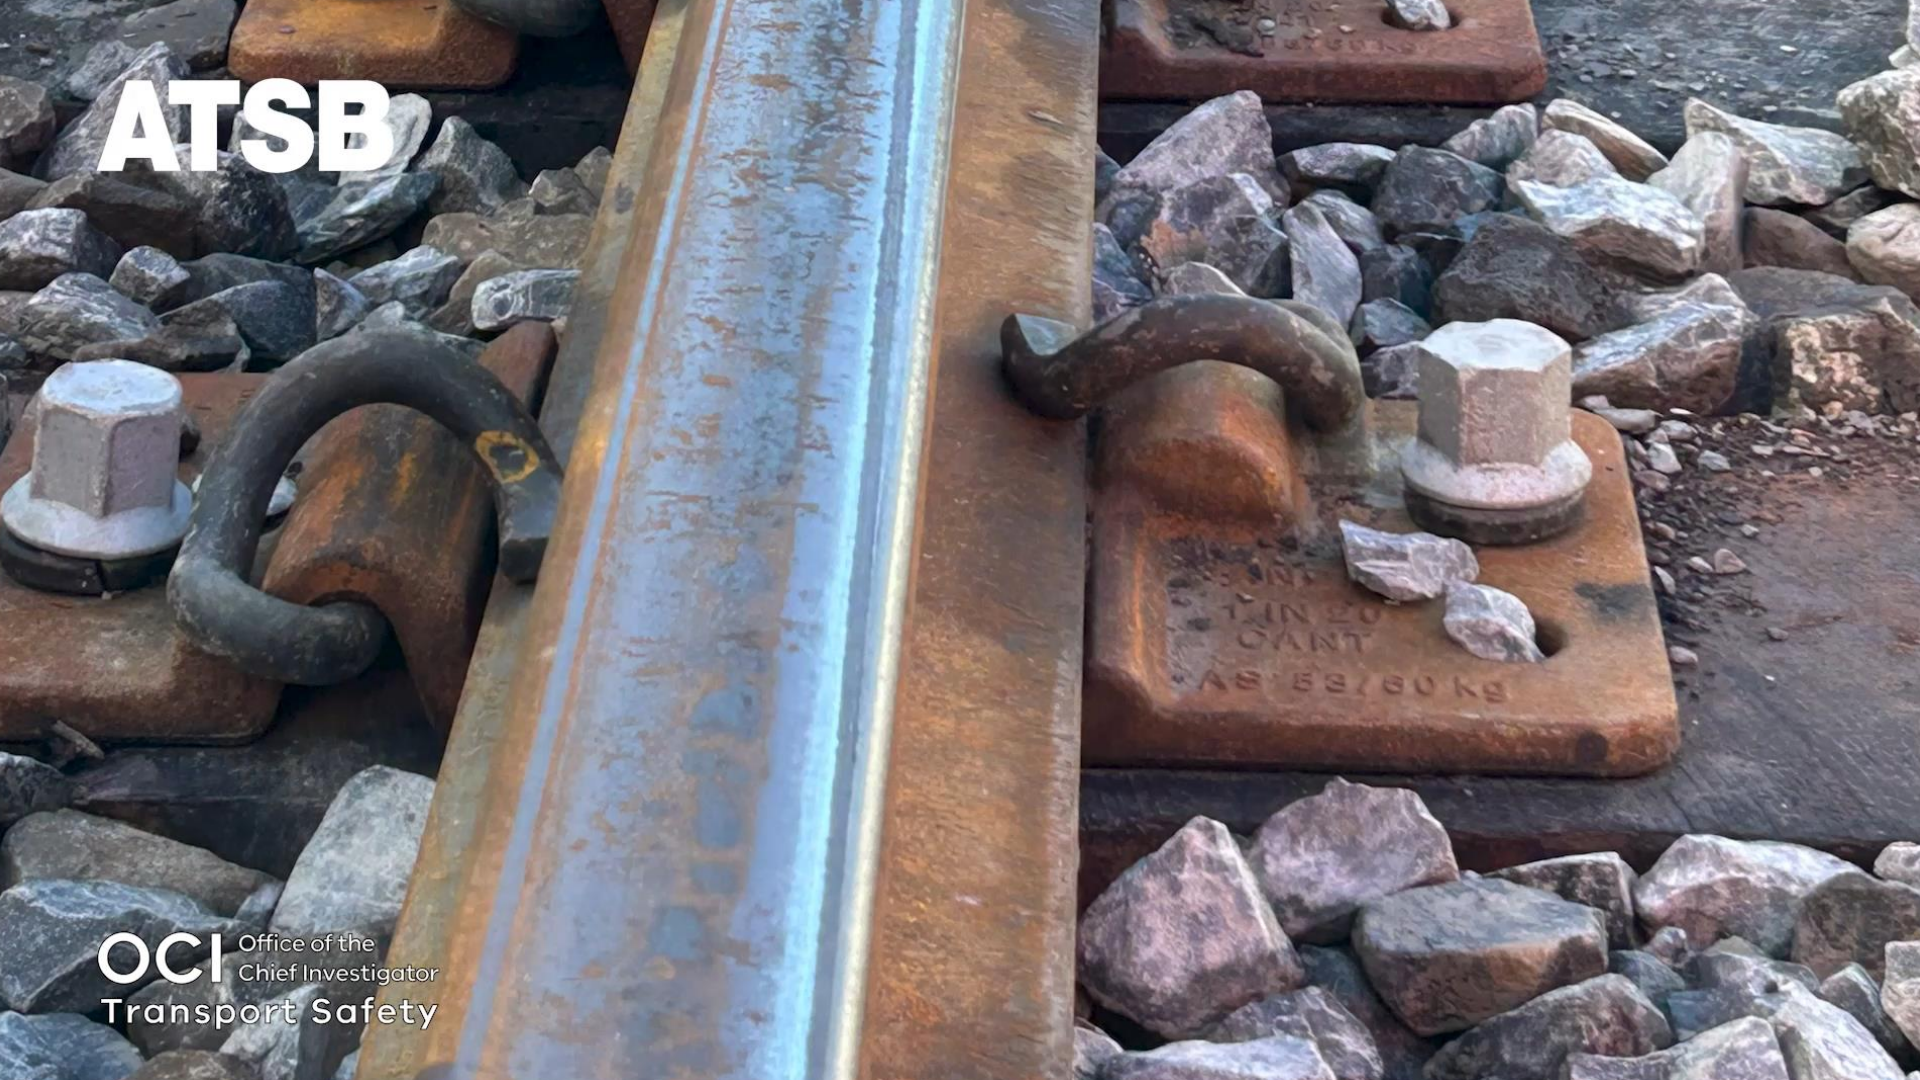
A close-up photograph of a railway track. A rusty metal rail runs vertically through the center. To the left and right of the rail are metal fasteners (clips) with large hexagonal nuts. The fasteners are mounted on a base plate. The rail and fasteners are surrounded by grey gravel. The background is slightly out of focus, showing more of the track and gravel.
