## 航空器失事調查報告

ASC-AAR-02-04-002

中華民國89年10月31日  
新加坡航空公司 006班機  
BOEING 747-400 型機  
國籍登記號碼 9V-SPK  
於中正國際機場  
起飛時撞毀在部分關閉跑道上

# 摘要報告

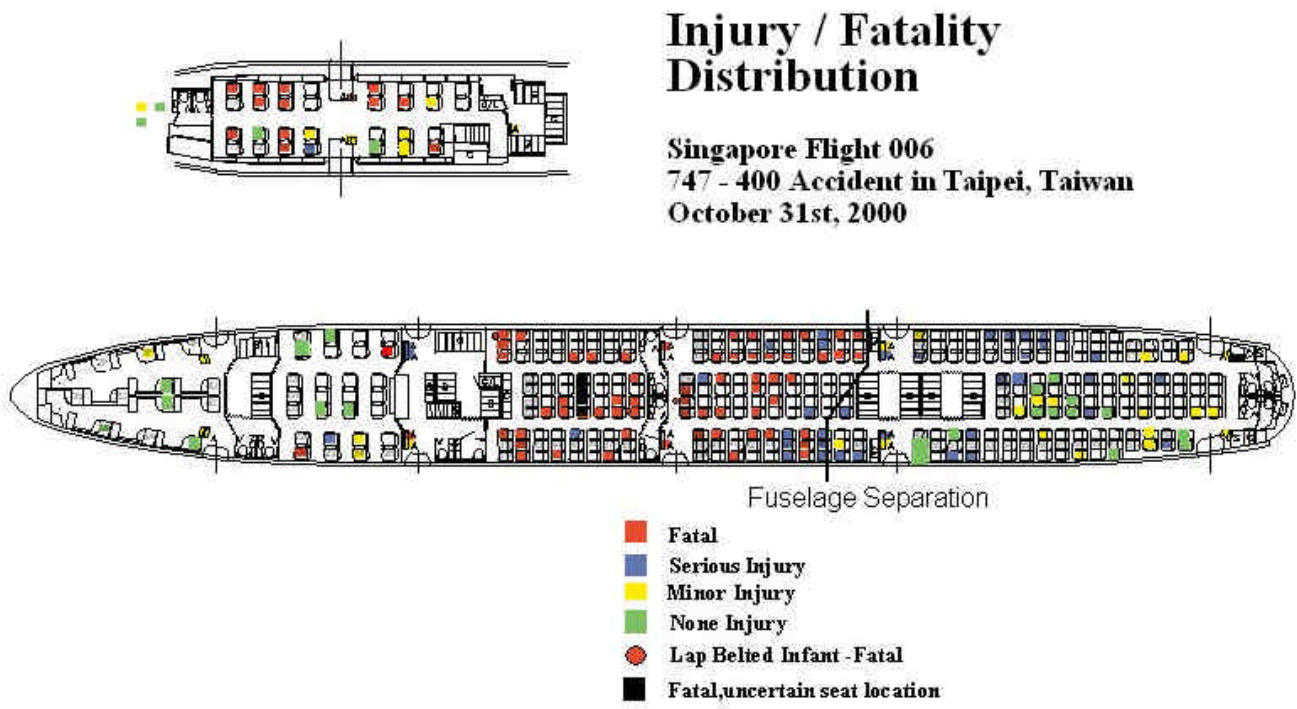
圖 1.2-1 人員傷亡分佈圖

上艙 19 名乘客中計有 12 人罹難，死亡率為百分之六十三（12/19）；主艙中大部份罹難乘客分布於 31 排至 48 排的經濟艙區域中，此區域 76 名乘客中有 64 人罹難，罹難率為百分之八十四（64/76），另 12 名乘客均受重傷。

圖 1.2-1 顯示乘客座位分布及其受傷程度，資料來源為航空公司之乘客座位表及部份乘客訪談，由於失事前部份乘客也許自行換過座位，因此此圖並不能完全反應失事當時乘客真實座位。

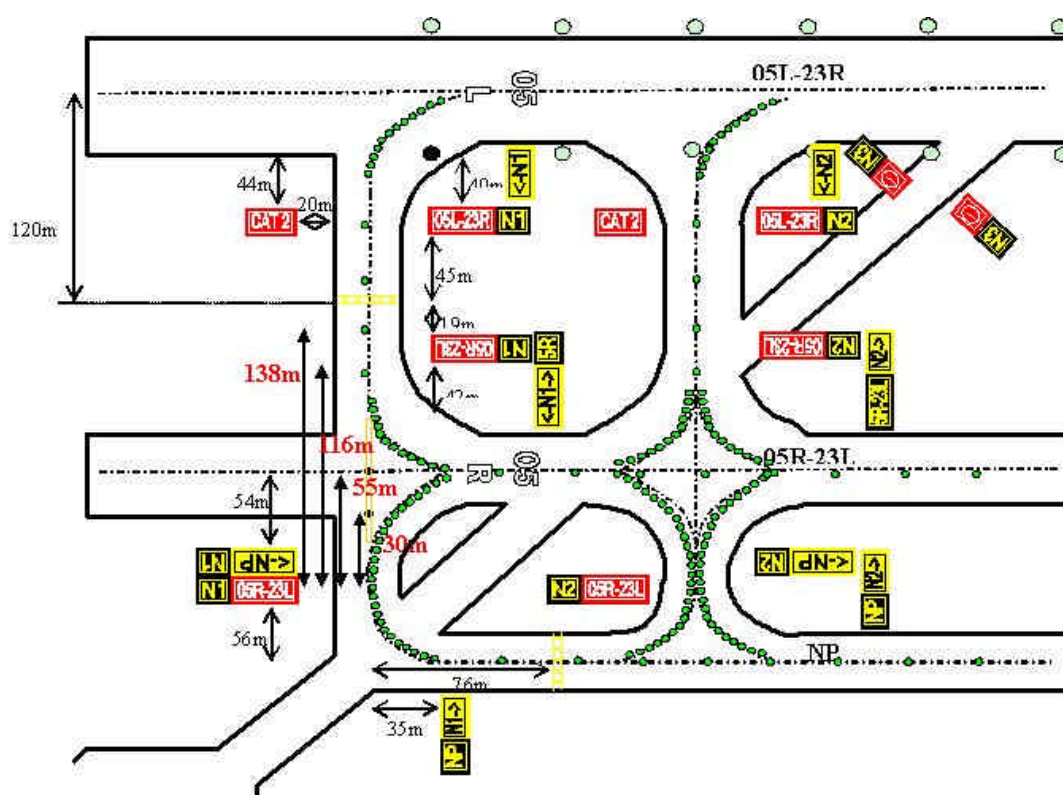
圖 1.10-9 N1 滑行道中心線燈間距

機沿 NP 滑行道滑行時，滑行道直線部份之中心線燈間距為 30 公尺。當其沿彎道右轉進入 N1 滑行道時，其中心線燈間距變為 7.5 公尺，直到與 N1 滑行道中心線直線之切點。此時航機繼續沿彎道進入 05 右跑道，而中心線燈間距仍為 7.5 公尺直至與 05 右跑道中心線相切處。之後，沿著 05 右跑道之滑行道中心線綠燈間距又恢復為 30 公尺，此時航機可沿 N1 滑行道朝 05 左跑道前進，然至 05 左跑道等待位置前之直線部份，共有四盞滑行道中心線燈，此滑行道中心線燈位置分別距切點（彎曲之 NP 滑行道中心線標線與 N1 滑行道中心線標線直線部份交會點）30 公尺、55 公尺、116 公尺及 138 公尺（如圖 1.10-9）。

本會人員於現場蒐證時（民國八十九年十一月四日），發現在切點後第一盞滑行道中心線燈故障，第二盞燈則不夠亮，如圖 1.10-10。

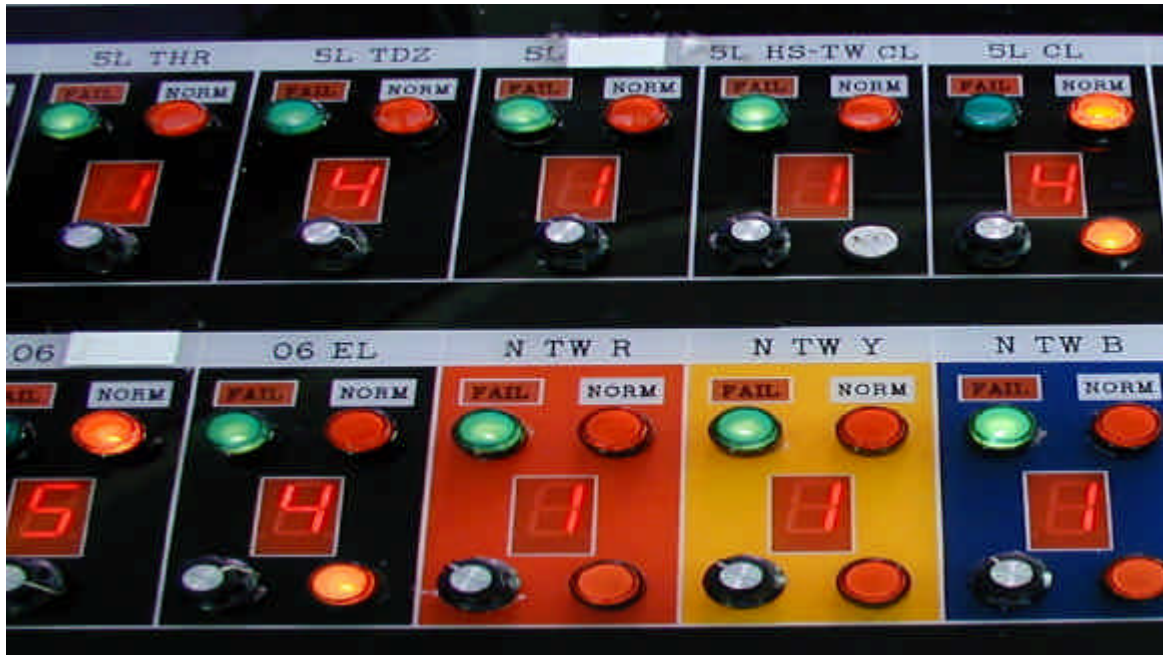
圖 1.10-13 機場燈光控制面板

中正機場跑道及滑行道燈光由塔台內之個別按鈕操作。不同燈光迴路亦各有單獨旋鈕提供機場燈光亮度選擇。圖 1.10-13 顯示塔台內之燈光控制面板。

<sup>16</sup> 「迴路互鎖」(interlock) 係防止多個燈光系統同時使用之機制，如在中正機場有迴路系統裝置，05 右跑道邊燈及中心線燈開關即不能同時開啟。

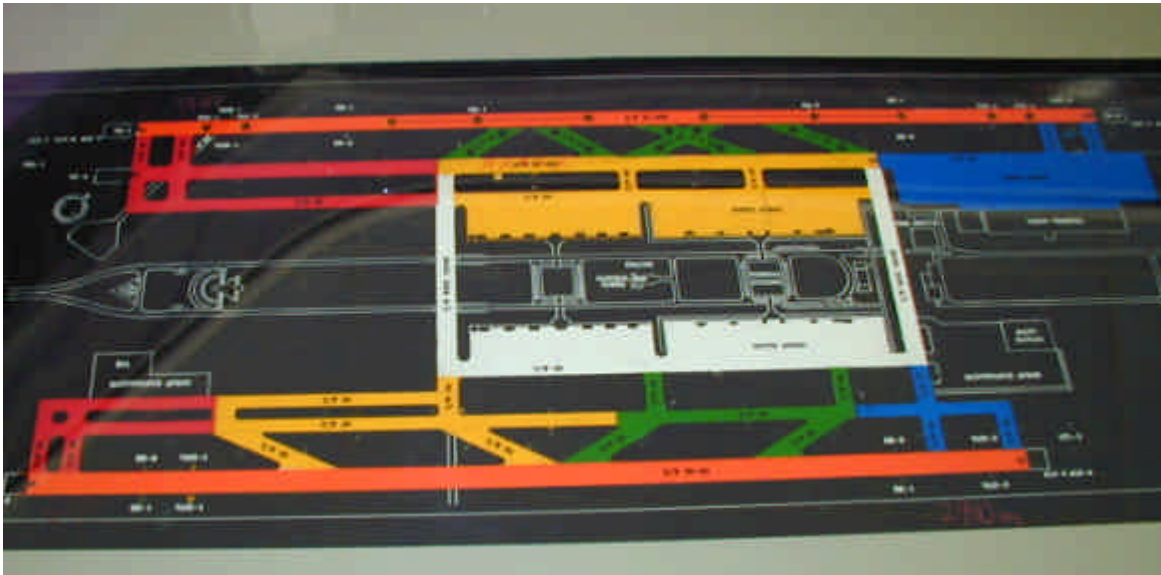
圖 1.10-14 中正機場燈光控制配置圖

此燈光系統於 1979 年裝置，當時國際民航公約第十四號附約標準與建議措施未要求此類燈光須有互鎖機制。該附約修訂後，中正機場亦未加設燈光互鎖機制。

中正機場航管程序規定，05 右/23 左跑道有航空器起飛時，NP 滑行道不能同時使用。因 05 右跑道與滑行道燈光無互鎖，因此塔台管制員間須相互協調，並以人工操作配合該跑道所需求之燈光。（如圖 1.10-13 及 1.10-14 燈光控制面板所示）

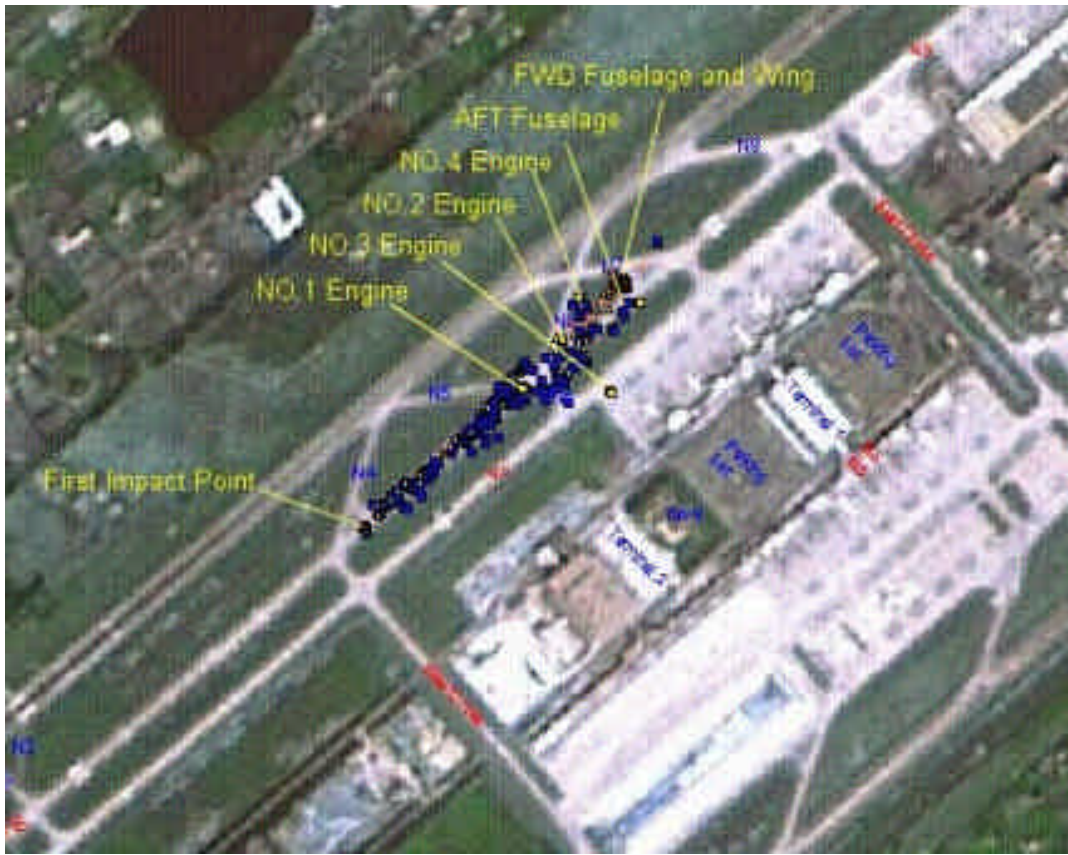
圖 1.12-2 殘骸與機場相關位置

初始撞擊點於距跑道頭 4,080 呎處（圖 1.12-3），殘骸自此沿 05 右跑道散佈（圖 1.12-2），機身於站位 1560<sup>19</sup>處斷成兩截，前機身停止於距跑道頭 6,840 呎處，朝向方位 085 度，左右兩翼附於其上；後機身平躺於跑道上，朝向方位 040 度，依訪談記錄，機身曾因救難而被移動，原位置約朝向方位 130 度且向左側傾倒（圖 1.12-4、5）。

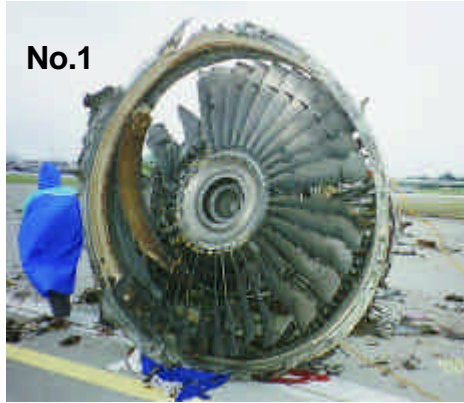
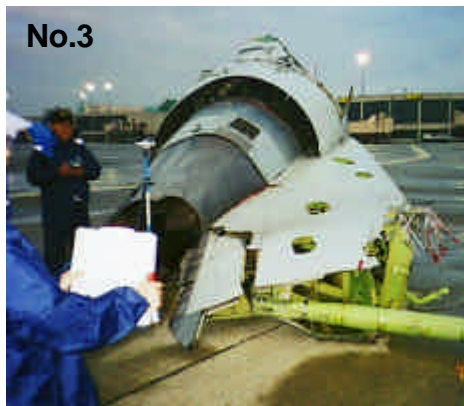
圖 1.12-12 四具發動機

現場尋獲之四具發動機皆與機身脫離，檢視發現在撞擊前，發動機並無葉片脫離或遭火燒跡象。（圖 1.12-12）

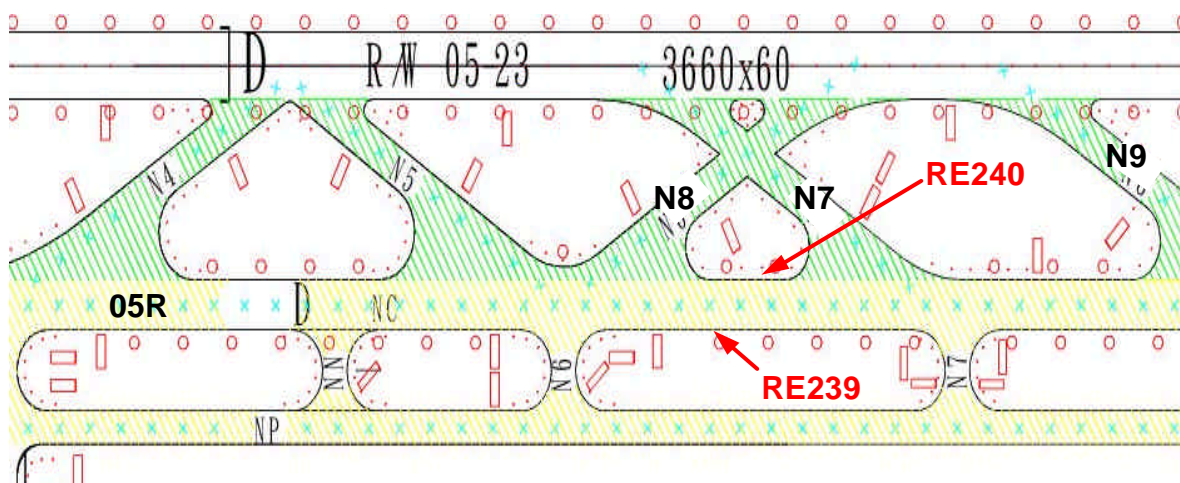
圖 1.12-13 跑道邊燈 RE239 與 RE240 之位置

兩條帶著接頭的跑道邊燈電線，分別於 05 右跑道右邊及左邊編號 RE239 位置及 RE240 位置處尋獲。RE239 位於距 05 右跑道頭 6270 呎處，RE240 則位於距 05 右跑道頭 6,670 呎處。兩電線均發現於失事時殘骸通過之路徑上。其位置如圖 1.12-13 所示。在 RE240 位置附近之地面車輛胎痕及殘骸碎片分佈如圖 1.12-14 所示。

RE239 電線發現時未連接於任何地面之插座。雖說發現時鄰近有些破碎燈具，然無法確定該電線屬那一盞跑道邊燈。

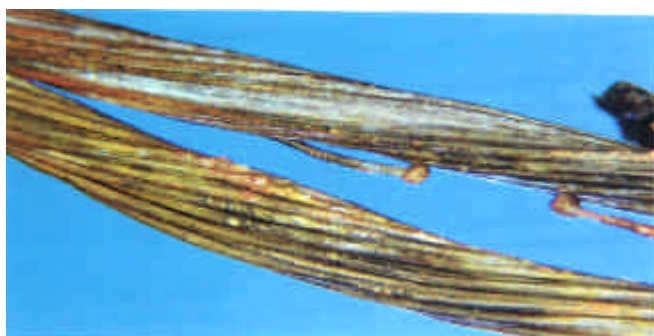
圖 1.16-7 RE240-1 靠近脫落絕緣層之局部熔融現象

兩份報告皆指出，RE240 電線放電現象發生之時間，無法自測試決定。

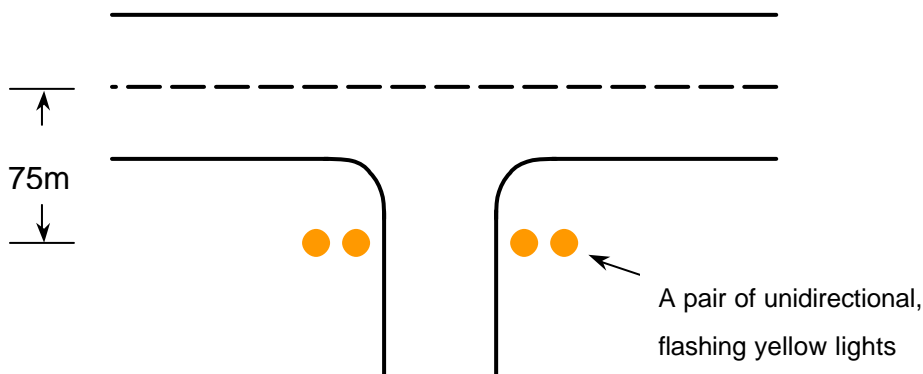
圖 2.3-1 A 型之跑道警戒燈

根據 1999 年版之國際民航公約第十四號附約第 1 冊第 5.3.20.1 節，中正機場應架設 A 型之跑道警戒燈（如圖 2.3-1 所示）。依美國聯邦航空總署民航通告 AC120-57A 第 8b 段所述，跑道視程低於 365 公尺時，應使用跑道警戒燈。民航通告 AC150/5340-28 亦提及跑道警戒燈為明確警告任何人已接近使用中跑道之等待位置。中正機場未於 N1 滑行道距 05 左/23 右跑道中心線大於 75 公尺之距離處設置 A 型跑道警戒燈，不符國際民航公約第十四號附約之標準。

若中正機場能按國際民航公約第十四號附約之標準，於 N1 滑行道兩側距 05 左/23 右跑道中心線 75 公尺處架設跑道警戒燈，則該燈距 NP 滑行道中心線為 249 公尺，距 N1 滑行道轉入 05 右跑道處約 175 公尺。失事當晚跑道視程為 450 公尺，飛航組員或能增加一前方為第二類儀降跑道（即 05 左）之線索，詳如第 2.5 節。

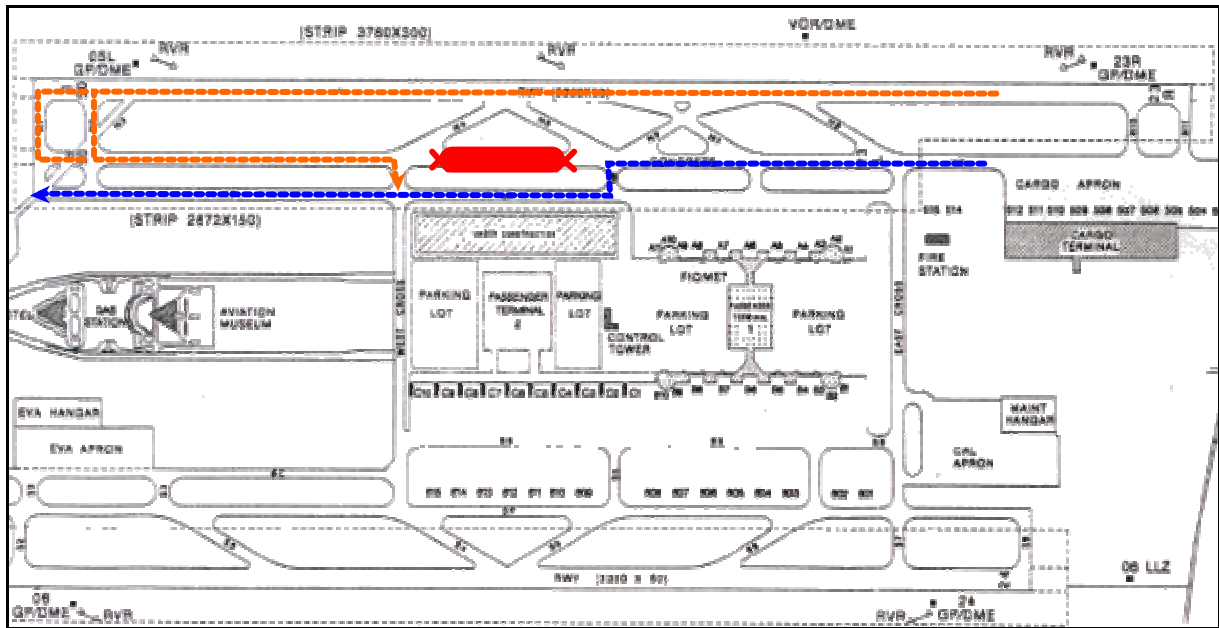
圖 2.3-2 05 右跑道施工時之滑行路徑

民航局官員說明，05 右跑道除施工部分，其餘仍供滑行之用。對於用 23 右跑道落地之航空器，從 N2 或 N1 滑行道脫離後，朝東經由 05 右跑道滑行至停機坪非常有用。05 右跑道兩端，係貨機使用 05 左跑道起飛時，由貨機坪西向滑行加入 NP 滑行道前之主要滑行路徑（圖 2.3-2）。使用 05 右跑道施工區以外部分滑行，可增加滑行容量，

然而，本會認為 05 右跑道施工區有兩項安全缺失。首先，根據國際民航公約第十四號附約第 1 冊第 7.1.3 節（標準），緊鄰施工區應有關閉標線，但並無在 05 右跑道頭標線處漆上關閉標線之要求。其次，根據同一標準第 7.1.4 節，施工區設置之護欄必須易碎。混凝土材質護欄不合國際民航組織標準及建議措施。雖此兩項缺失並未涉及 SQ006 失事。

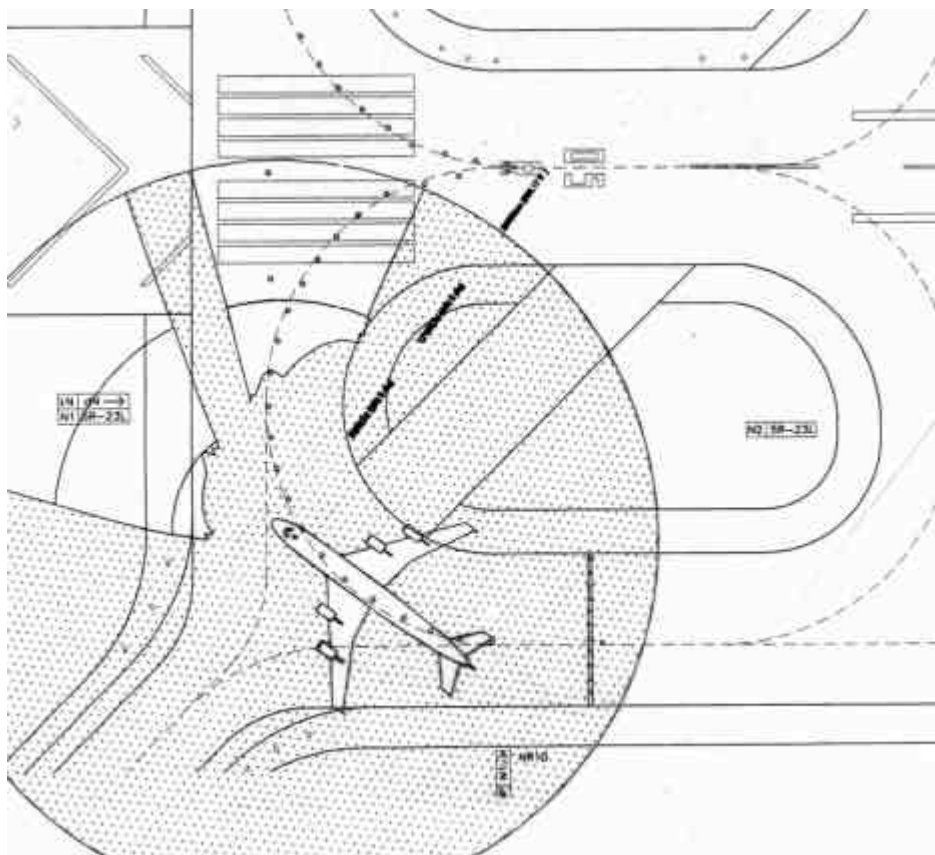
在第 1.16.6 節駕駛員視野研究中指出，駕駛員於駕駛艙內透過擋風玻璃上雨刷清除部分往外看時，能清楚看到機場之視野有限。然而，該研究指出，當航機由 NP 滑行道經由 N1 滑行道轉入 05 右跑道時，以下項目應該是可以從駕駛艙內看到：N1 滑行道指示牌及指引往 05 左跑道之 N1 滑行道中心線燈；05 右跑道指示牌；05 右跑道頭標線與跑道方位標線；及 05 左跑道指示牌。調查指出，當航機由 NP 滑行道轉入 N1 滑行道時（詳見圖 2.5-1），由 CM-1 之目視參考點應該可以透過擋風玻璃看到「N1/5R-23L」指示牌，圖 2.5-1 中清楚的區域代表 CM-1 於滑行時眼睛能夠看見的範圍。CM-1 表示，航機由 NP 滑行道轉入跑道期間，他一直看著駕駛艙外面並以滑行道中心線燈作為航機

圖 2.5-1 由 NP 滑行道轉入 N1 滑行道接近 05 右跑道時，正駕駛員之視野。其中環繞航機的圓圈代表以 CM-1 目視參考點為圓心之 100 公尺半徑範圍內。此參考圖係假設駕駛員直視正前方且未移動頭部。

另外，「N1/5R-23L」指示牌本身會發光，且當航機轉彎時，該指示牌與航機間的距離約為 60 公尺，以當時跑道能見度（RVR）450 公尺的情況判斷，當航機由 NP 滑行道轉入 N1 滑行道時，從駕駛艙內應該能夠看得見該指示牌。

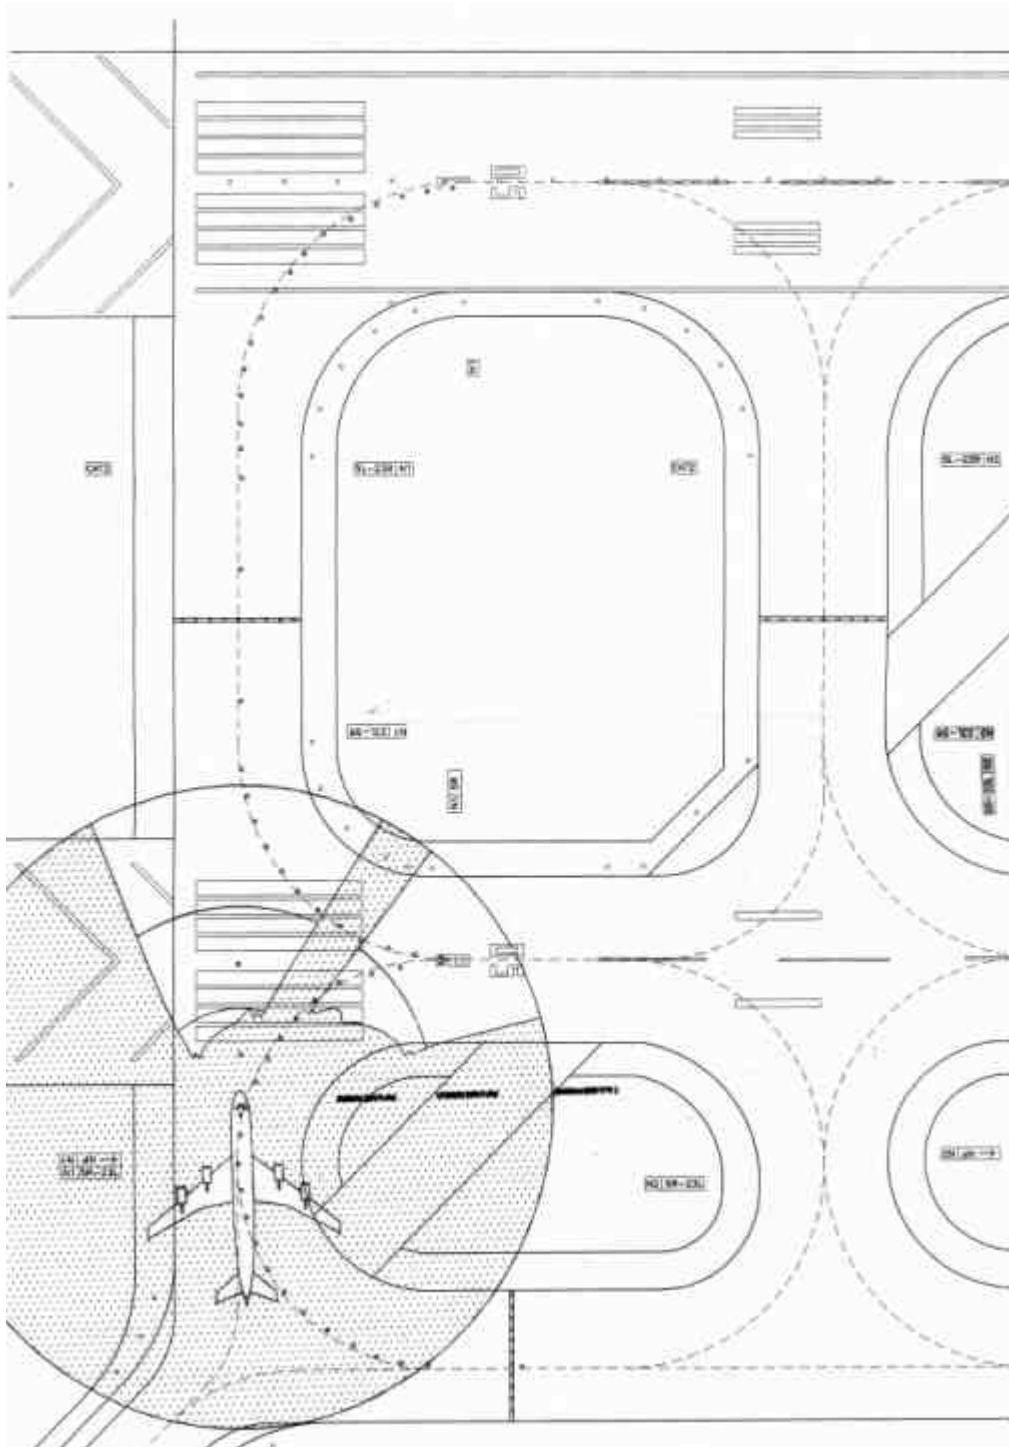
當航機行進入 N1 滑行道，正要轉入 05 右跑道時（詳見圖 2.5-2），由 CM-1 之目視參考點，應該可以透過擋風玻璃看到 05 右跑道上之「鋼琴鍵」與指引往 05 左跑道之 N1 滑行道中心線燈。CM-1 之目視參考點亦應可透過 CM-2 擋風玻璃看到跑道方位標線「05」與「R」，且駕駛艙與 05 右跑道方位標線、指引往 05 左跑道之 N1 滑行道中心線燈及 05 右跑道上之「鋼琴鍵」間之距離皆在 120 公尺內。

基於以上證據及模擬滑行資料，本會認為，當航機由 NP 滑行道轉入 05 右跑道時，若飛航組員有試著向機外搜尋，當時之能見度應該足以讓駕駛員看見跑道方位標線或指示牌，以作為駕駛員確認航機當時位置及地面導航之依據。

圖 2.5-2 沿著 N1 滑行道接近 05 右跑道頭及 05 左跑道時，正駕駛員之視野。此時 05 左跑道能見度為 450 公尺，N1 滑行道於 05 右及 05 左跑道間之距離為 214 公尺。此參考圖係假設駕駛員直視正前方且未移動頭部。
