# 國家運輸安全調查委員會

## 重大運輸事故 調查報告

遠東航空股份有限公司 FE3060 班機

於臺中清泉崗機場落地時短暫偏出跑道

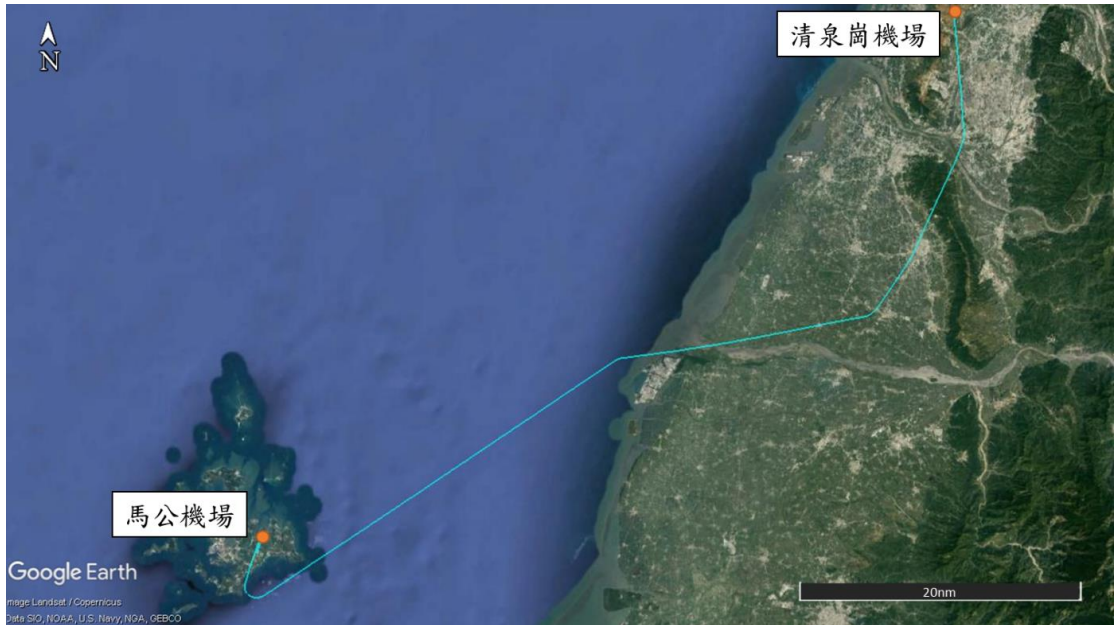
圖 1.1-1 事故機全程飛航軌跡圖

PM 於訪談時表示距跑道頭約 1 哩時，目視航機落地燈照到跑道道面有反光，且可看到水波紋，表示跑道有積水。PF 表示航機觸地剎那，瞬間向左偏，立刻放下鼻輪修正，但航機仍然向左偏出跑道，修正回跑道後，將航機停止於距跑道頭約 7,000 呎處並通知塔臺航機可能因出跑道受損，建議派員至現場檢視。經地面人員確認航機除右主輪轂有草外無其他損傷後，始將航機滑回停機位置。該機自馬公機場起飛至臺中機場全程飛航軌跡如圖 1.1-1，落地期間偏出跑道之軌跡如圖 1.1-2。

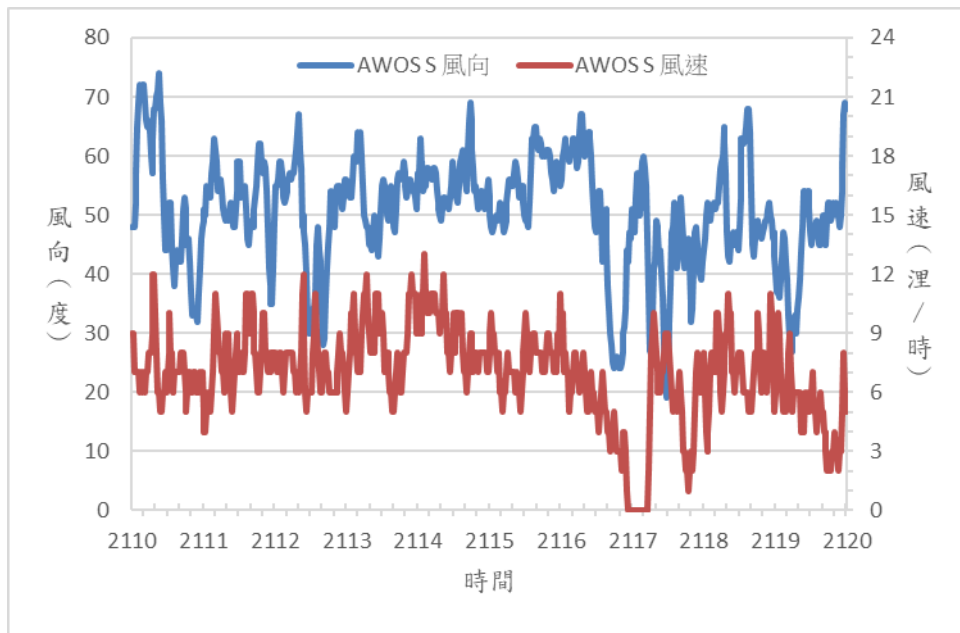
圖 1.7-4 AWOS S 風向風速

臺中機場地面自動氣象觀測系統 (automated weather observation system, AWOS) 設置於跑道兩端及中段附近 (設置地點如圖 1.7-3)，提供天氣中心及塔臺即時之天氣資訊顯示，相關天氣紀錄如圖 1.7-4 至圖 1.7-6 所示。自 2118:00 時 (該機無線電高度為 200 呎) 至 2118:29 時 (該機左偏後返回跑道)，AWOS S 風向為 030-070 度，風速 3-11 浬/時；AWOS C 風向為 040-060 度，風速 5-8 浬/時；事故前 6 分鐘 AWOS S 之跑道視程大於 2,000 公尺，累積降水量 0.4 毫米 (降雨強度為中度)。

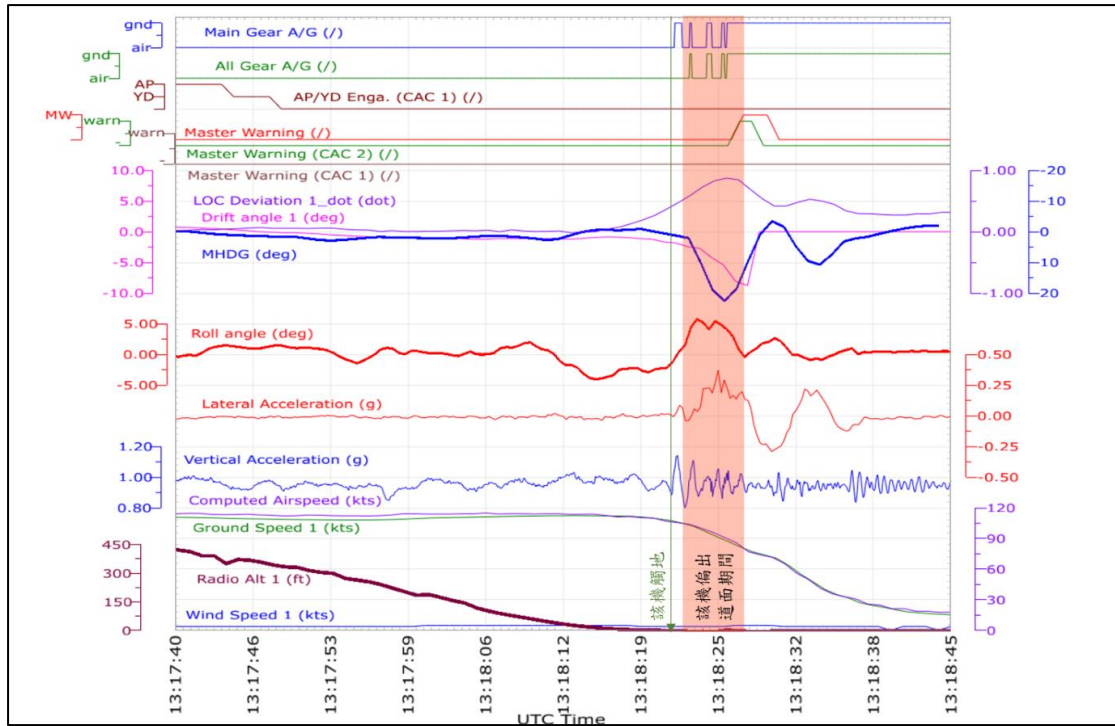
圖 1.11-1 落地階段之飛航資料繪圖 (一)

7. 2118:26 時，該機左主輪於距跑道頭約 2,640 呎，距跑道邊線外側最遠約 15 呎，空速 96 浬/時，地速 92 浬/時，磁航向 19 度。
8. 2118:28 時，該機左主輪於距跑道頭約 2,880 呎返回跑道，空速 86 浬/時，地速 81 浬/時，磁航向 19 度，此時主警告「master warning」及「master warning (CAC2)」參數作動並持續 3 秒，儀表板上的發動機警告顯示 (engine warning display, EWD) 頁面亦出現「ENG 2 FLAME OUT IN FLIGHT」程序，並於 1 秒鐘後轉變為「ENG 2 FLAME OUT ON GROUND」的程序。
9. 2118:36 時，該機於距跑道頭約 3,640 呎，跑道中心線左側約 50 呎處滑行，地速 35 浬/時，磁航向 8 度，EWD 顯示程序轉變為「AFTER LANDING」程序並持續至該機停止滑行。
10. 2119:21 時，該機停止於距跑道頭約 4,530 呎，跑道中心線左側約 60 呎處，左右發動機仍維持正常運轉。
11. 2136:07 時，該機以自身動力再度開始滑行進入滑行道，約 2146 時停止於臺中航空站停機坪，約 2148 時 FDR 停止記錄。
12. 圖 1.11-1 及圖 1.11-2 為事故機落地階段之飛航資料繪圖，圖 1.11-3 為事故機起飛至落地飛航軌跡圖。
