**Aviation Safety Council
Taipei, Taiwan**

**SQ006 Accident Investigation
Factual Data Collection
Group Report**

Ground Operation Group

**February 21, 2001
ASC-FRP-01-01-002**

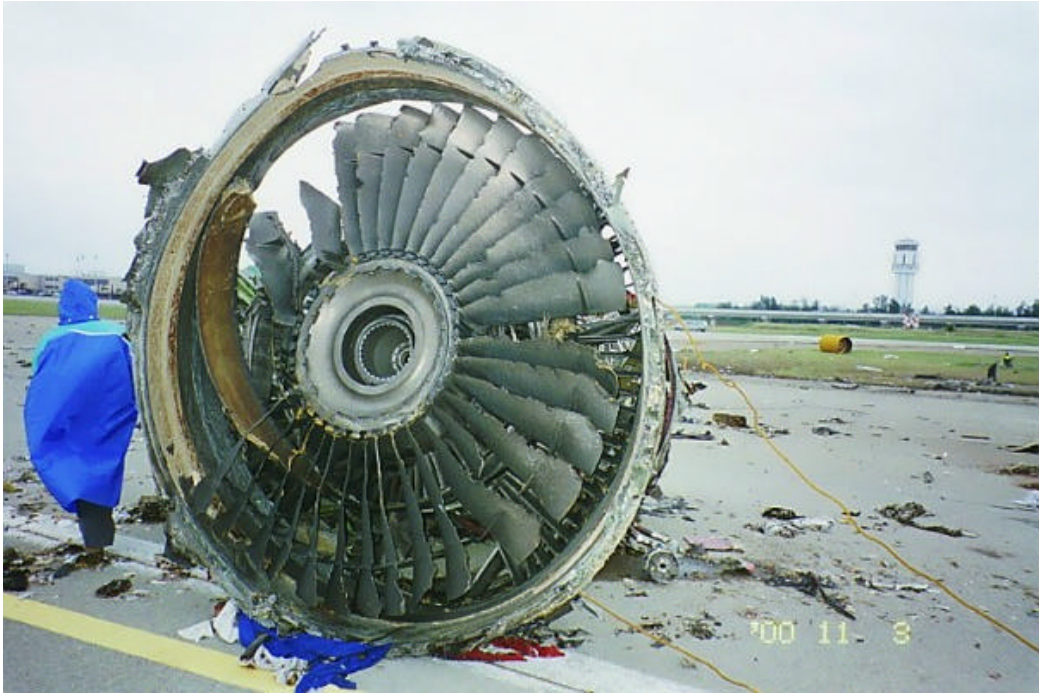
Fig. 1.12.3.3-1 No. 1 Engine

Major components scattered along the crash path on runway 5R were found in a heavily damaged shape condition caused by impact force and post-crash fire.
