**Aviation Safety Council
Taipei, Taiwan**

**CI611 Accident Investigation
Factual Data Collection
Group Report**

Injury Documentations Group

ASC-AFR-03-06-001

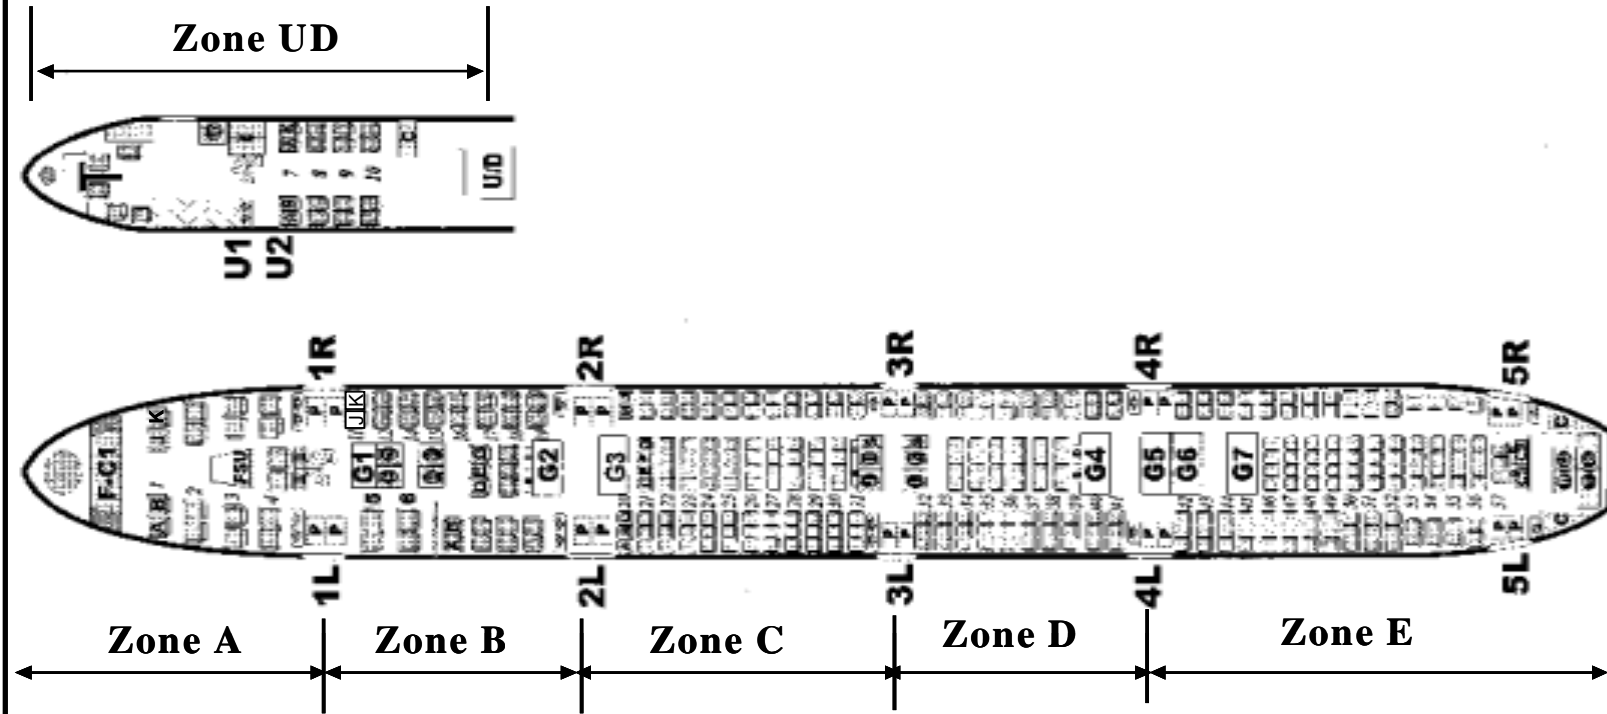
CI 611 Cabin Configuration Diagram

The CI611 aircraft had 3 Flight Crew Seats and 2 Observer Seats in cockpit (no observer in this flight), 16 Cabin Crew Jump Seats, 22 First Class Seats, 16 Business Class seats in Upper Deck, 30 Business Class seats and 288 Coach Class Seats in the main Deck. The cabin is divided into 6 zones –Zone A to E, and Zone UD as shown in Figure 1.2-1.
