**Aviation Safety Council
Taipei, Taiwan**

**CI611 Accident Investigation
Factual Data Collection
Group Report**

Structure Group

ASC-AFR-03-06-001

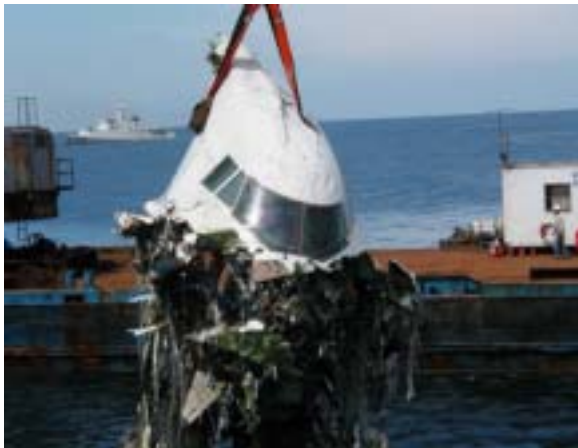
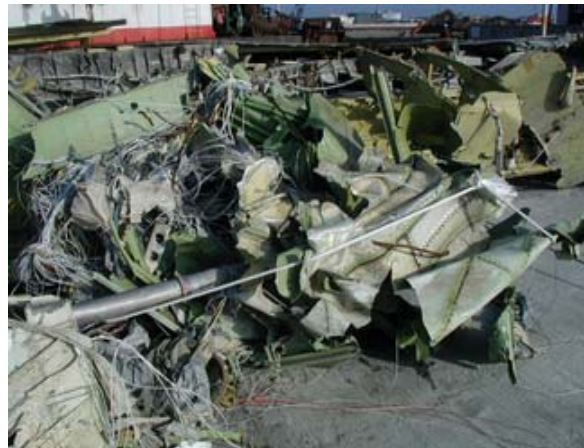
Figure 1.12-3 (a) Cockpit Structure-Item 545-left photo, (b) Item 705 distorted section 42 skin- right photo

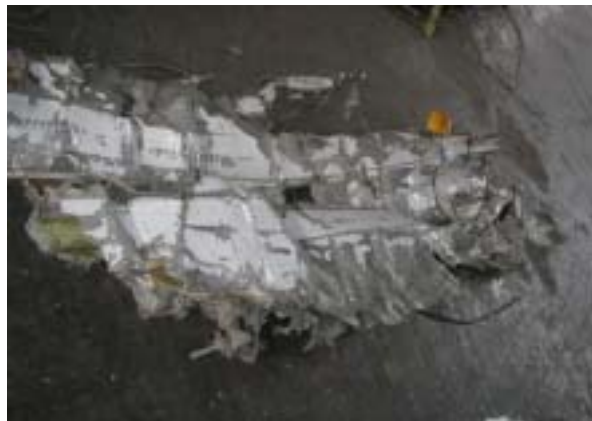
In sections 41 and 42, the portions of structure in the crown region were less fragmented (larger segments) than portions of structure recovered from the lower fuselage. The largest piece of structure recovered in the crown area (item 487) extended from below the main deck window belt on the Left Hand Side (LHS) to below the upper deck floor on the RHS. Most of the frame and upper deck floor beam segments were still attached. While the upper deck floor beams were fractured and the skin was folded in the crown region, the majority of the panel retained its original contour. The cockpit structure (item 545 [Figure 1.12-3(a)]) was found to be relatively intact aft to STA 500 and essentially retained its original shape. Much of the structure below these two items was found in smaller segments and with greater distortion (see items 655, 656, and 705 [[Figure 1.12-3(b)]]. Many belly segments showed general upward deformation of the skin panel between stringers and frames (see items 876 [[Figure 1.12-3(c)], 969, 973, and 1088).

Figure 1.12-3 (c) Item 876 belly skin with upward deformation

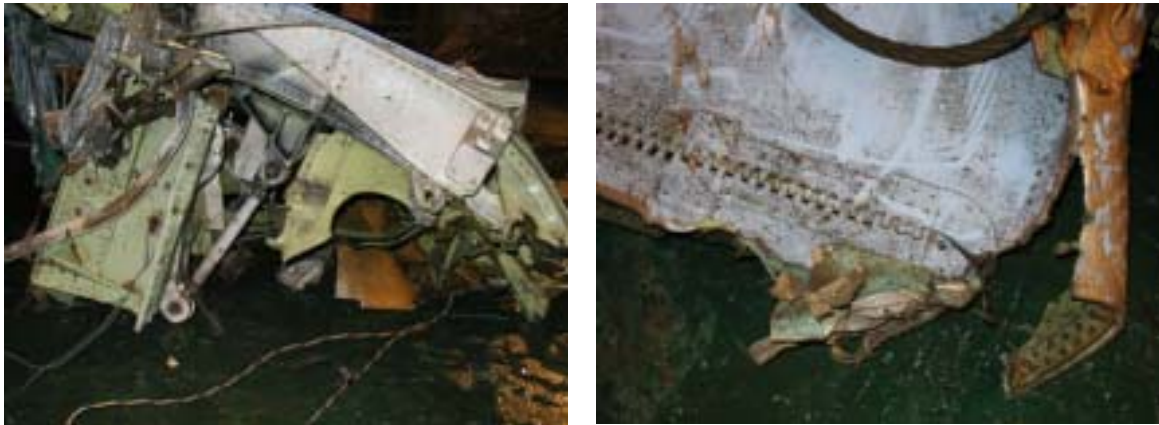
The upper portion of the forward cargo door was found still attached to the skin assembly above the door (Item 629). The hinge was intact and the door actuator mechanisms were attached. This portion retains normal body curvature. The condition and position of the hinge and door mechanisms indicates that the forward cargo door did not open prior to airplane breakup.

Figure 1.12-4 (a) Item 629 side view- left photo, (b) Item 629 hinge- right photo.

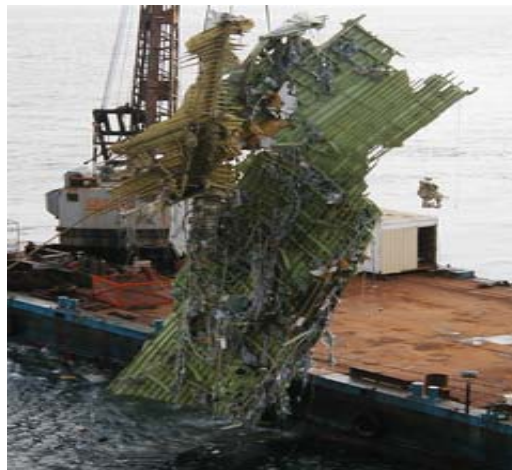
Figure 1.12-5 Items 625 and 626

The section 44 upper skin structures were found relatively intact. The largest segment (item 626 [Figure 1.12-5]) extends from STA 800 in section 42 to STA 1540 in section 46 and extends nearly to the main deck on both the RHS and LHS. Prior to recovery, this item was observed to still be attached to another large item (item 625 [Figure 1.12-5]) and was separated while lifting. These segments have nearly all stringers still attached and most frames, some of which are broken into segments. A large portion of RHS structure from the STA 1350 to approximately STA 1480 was not recovered.

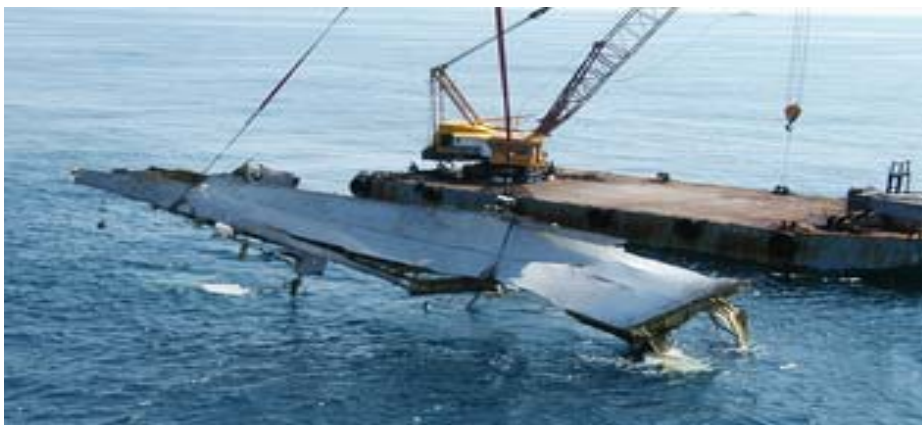
Figure 1.12-7 (a) Item 547

The lower surface of the left wing (on item 547) showed areas of distinct upward deformation of the wing skin and stringers while the upper skin and stringers remained relatively straight [Figure 1.12-7(c)]. The lower panel deformations, on the inboard portion of the wing, had general upward curvature and deformations whereas the outboard portion of the lower surface, where the panel gauges are thinner, exhibited localized deformation between the stringers. This was evident not only on the outboard wing skins on item 547, but also on item 866 which is the end of the wing-box that extends outboard from item 547 [Figure 1.12-7(c)].

No evidence of soot was observed during visual examination of the wing-box interior including the interior portions of the vent stringers on the upper wing panel.

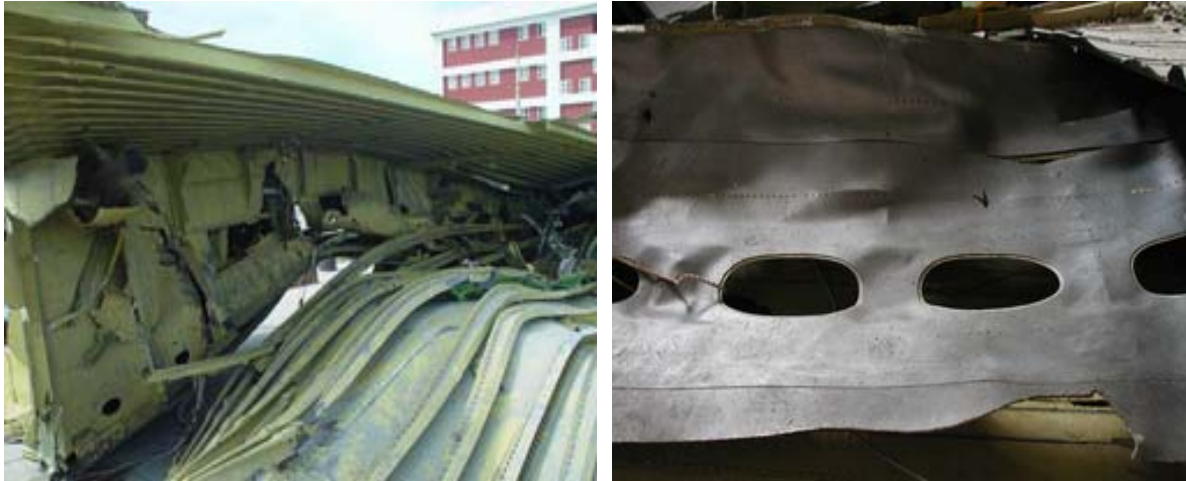
Figure 1.12-7 (b) Lower panel and midspar deformation on Item 547, (c) Localized deformation on outboard end of item 547

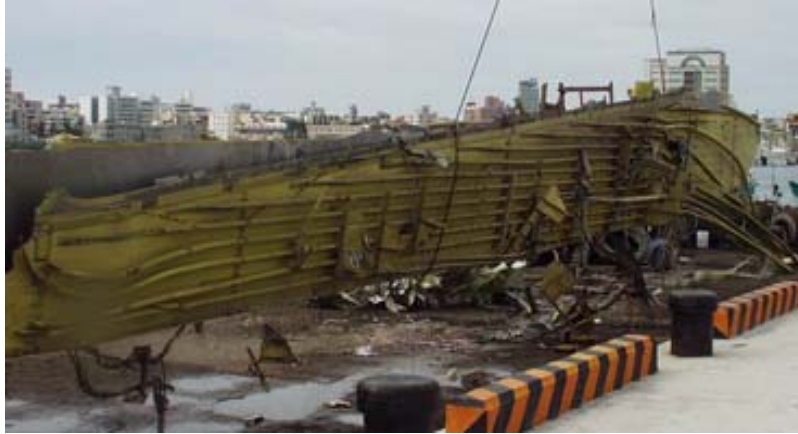
Figure 1.12-8 (a) Item 526

The majority of the right wing-box was recovered in two major sections. Most of the upper right wing skin (Item 526 [Figure 1.12-8(a)]) was recovered as one large section that was split lengthwise along the mid-spar upper chord. This 70 foot section included the upper skin from nearly the side of body to the outboard (#4) strut and the front spar to approximately 10" to 20" forward of the rear spar along its length. Most of the upper stringers remained attached to the skin panel and the entire panel remained relatively straight. No evidence of soot deposits was found during visual examination of the interior of the wing and the interior of the vent stringers.

The overall condition of the right wing was similar in nature to the condition of the left wing. The lower panel had a greater level of deformation in comparison to the upper panel. Similar to the left wing, almost all of the in-spar ribs and the mid-spar in the outboard wing were crushed in the vertical direction. In addition, the side of body rib was relatively intact from the mid-spar to the rear spar, in contrast to the recovered portions forward to the front spar. The front spar extended from just inboard of the #3 engine strut location to just outboard of the #4 engine strut location. The recovered portion of the rear spar extended from the side of body to outboard of the #4 engine strut location.

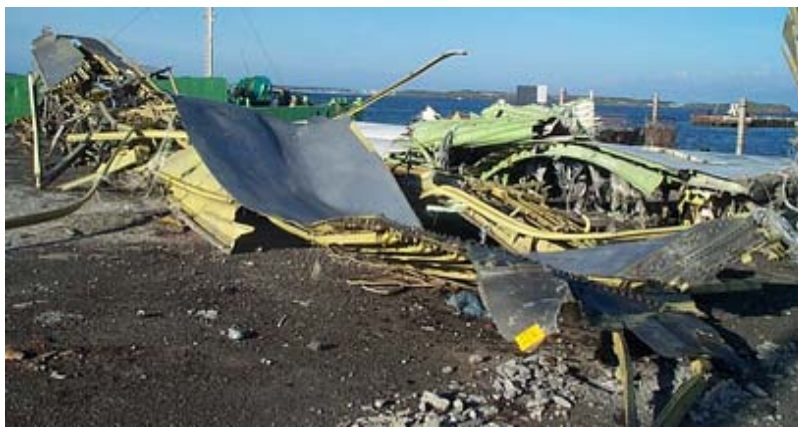
Figure 1.12-8 (b) Item 628I

The lower panel of the right wing, the upper panel outboard of the outboard engine strut (outboard of item 526), the front spar between the engine strut locations and the rear spar between the side of body and the outboard engine strut were recovered as one 95 foot section (Item 628 [Figure 1.12-8(b)]).

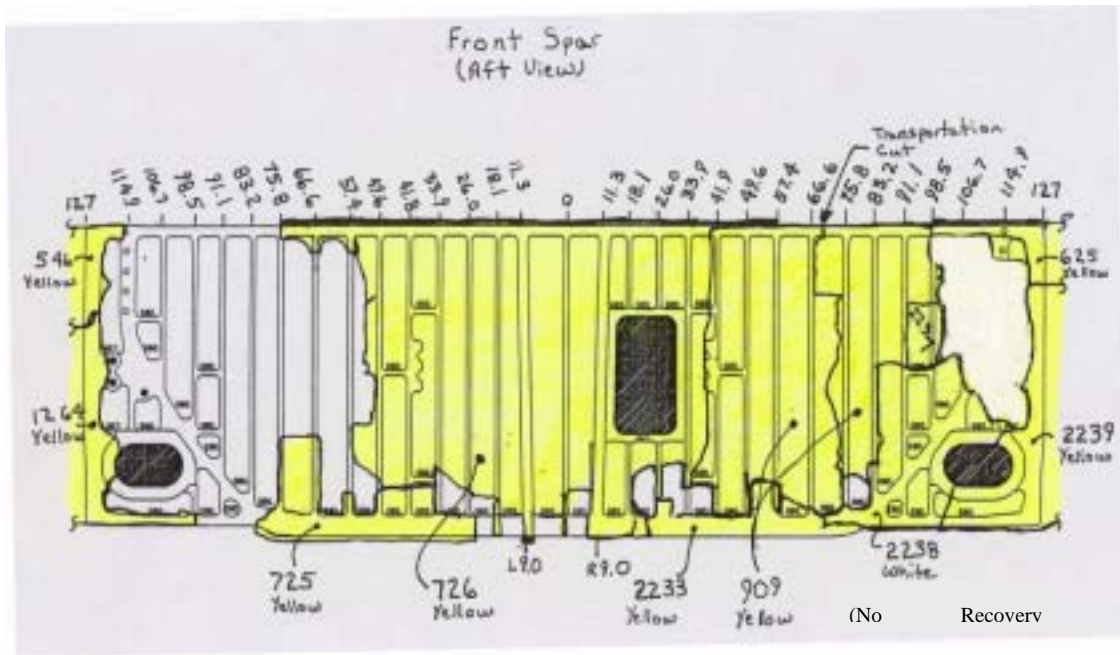
Item 726 has evidence of lateral front spar deformations indicated by the front spar web and stiffener free flange stabilization strap deformations.

There is no evidence of any fire or soot accumulations on either the forward or aft side of the front spar.

Figure 1.12-10 The recovered and identified portions of the Wing Center Section front spar

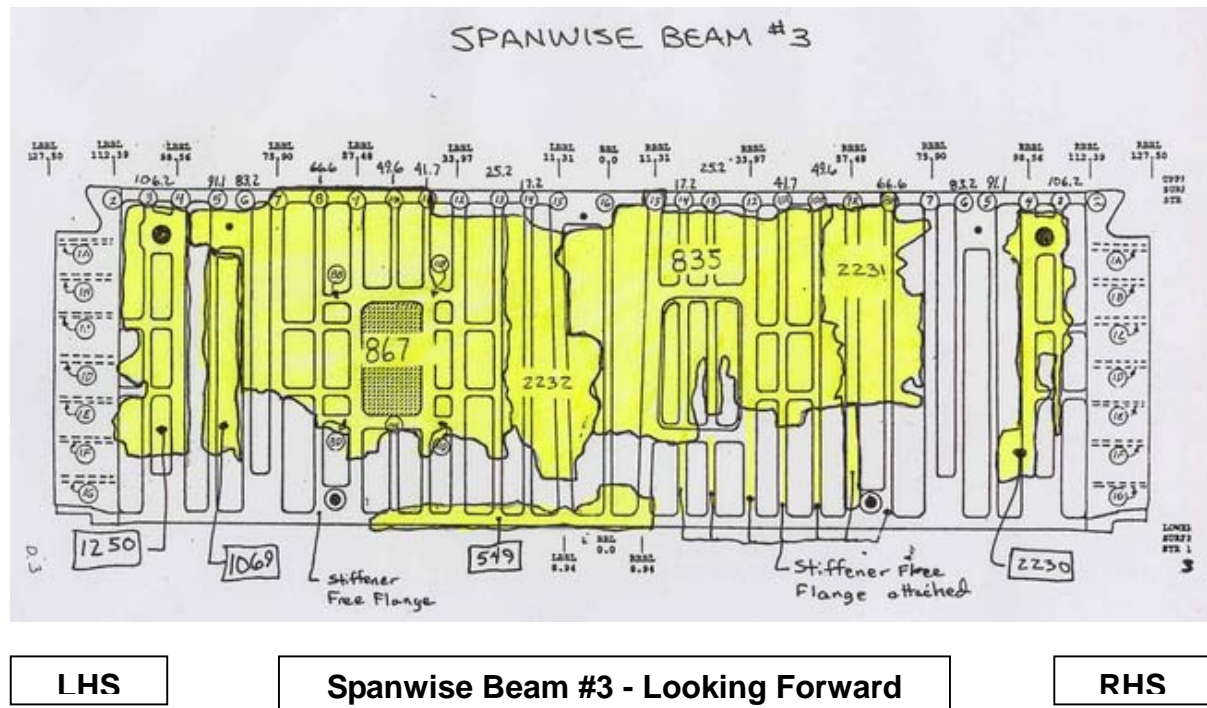
Figure 1.12-14 The recovered and identified portions of SWB #3

Nearly 75% of SWB #3 was recovered and identified. The sections that were recovered showed a consistent pattern of web and stiffener deformation and fragmentation. The upper portions of the stiffeners and web were relatively intact but the lower 25% of the web was highly fragmented and the lower end of the stiffeners free flanges were curled and bent forward (See Figure 1.12-15).

There was no evidence of soot or fire damage on the recovered portions of SWB #3.

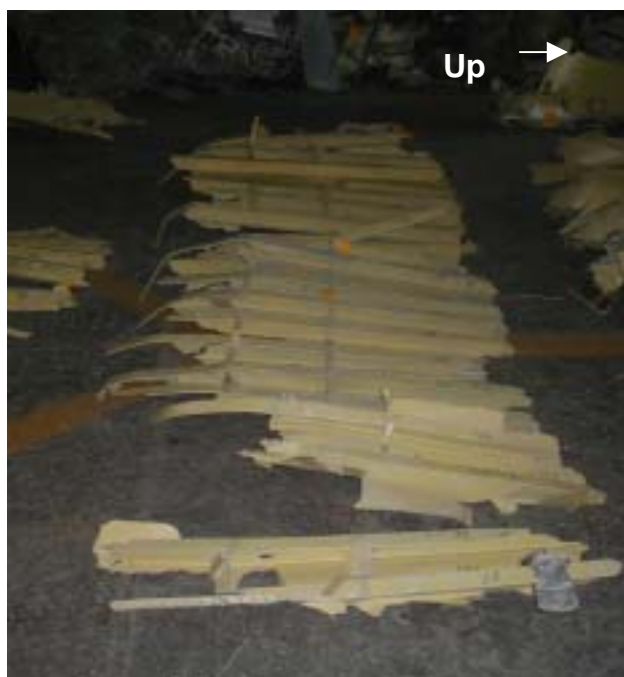
Figure 1.12-15 Aft side of SWB #3 viewed from right side

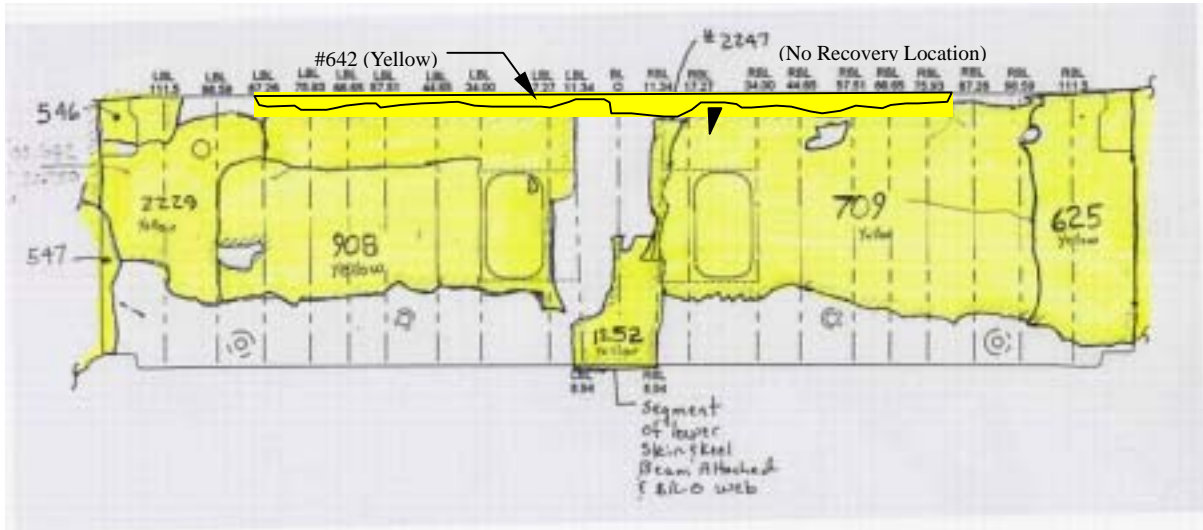
A small portion of the BL 0 rib aft of the mid-spar remained attached to item #1252.

There was no evidence of soot or fire damage on the recovered portion of the Mid-spar.

Figure 1.12-18 The recovered and identified portions of the Midspar

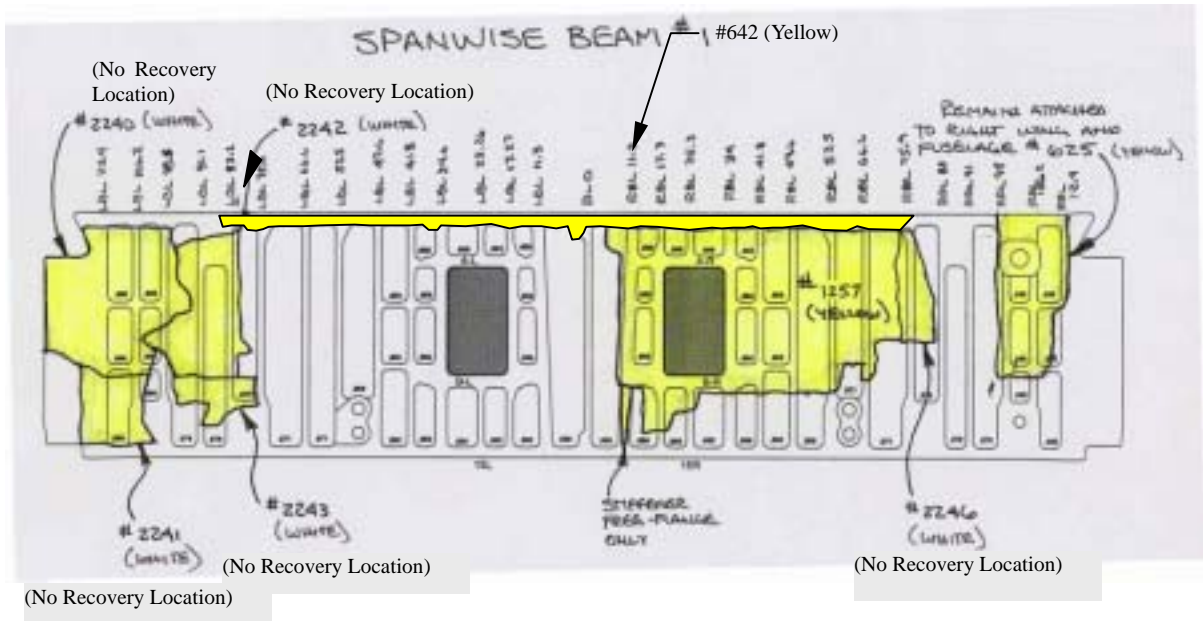
None of the lower chord remained attached to the skin but some of the stiffener shear ties remained attached to lower panel item #1256 and #836. For the shear ties on item #1256, the fastener holes that would have been common to the SWB stiffener web have been deformed on the lower edge of the hole or slightly off center from the lower edge of the hole.

There was no evidence of soot or fire damage on SWB #1.

Figure 1.12-20 The recovered and identified portions of SWB #1

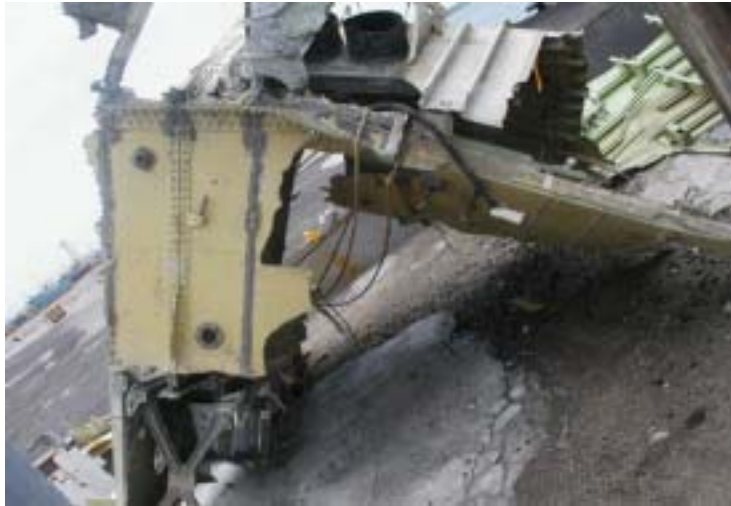
Item #910 was recovered as one section that ended up as two segments during transportation [See Figure 1.12-23(b)]. The center portion of this section remained attached to the keel structure aft of the spar. There is a chord fracture at LBL 21 where the two segments became separated. At this location on the outboard segment, the chord is twisted in an aft and upward direction. The upper chord on the outboard (LBL 95) end of this segment is twisted such that the skin flange is bent upward. The inboard end (RBL 11) of the upper chord on item #864 is also twisted in an upward and aft direction while the outboard end (RBL 86) is bent up with a slight rearward twist.

Figure 1.12-23 (b) Rear Spar Item #910 as recovered with segments connected

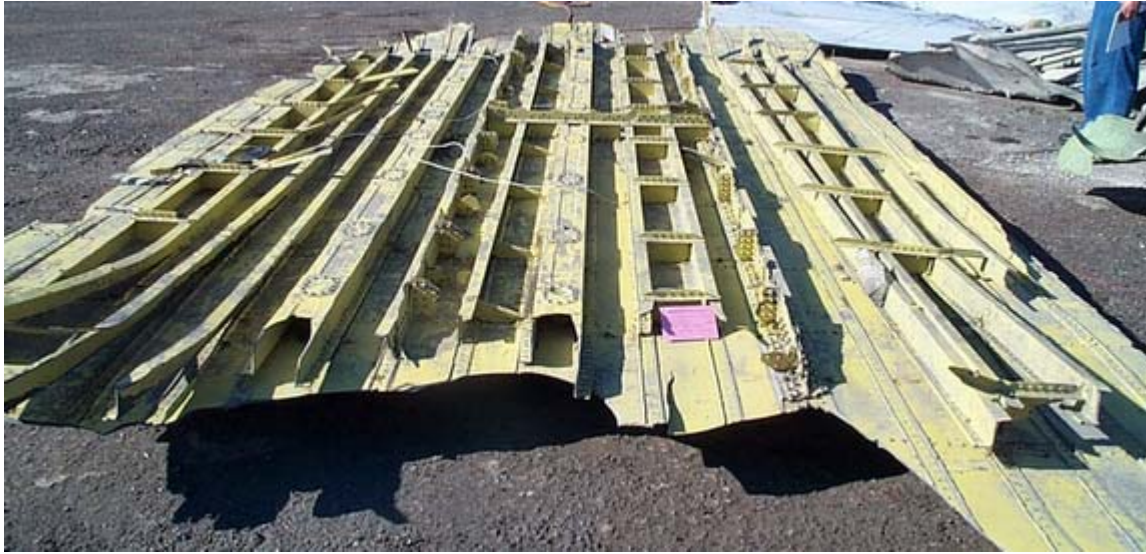
There were discolorations noted on the upper side of the panel. There were also stains that were noted on multiple segments of the upper panel. Samples were taken of the dark discolorations and the test results are contained within a separate report. There were no indications of soot or fire damage on the interior surface of the upper panel structure including vent stringers.

Figure 1.12-25 (a) Interior surface of Upper Panel Item #642-upper photo, (b) Exterior surface of Upper Panel Item #642-lower photo

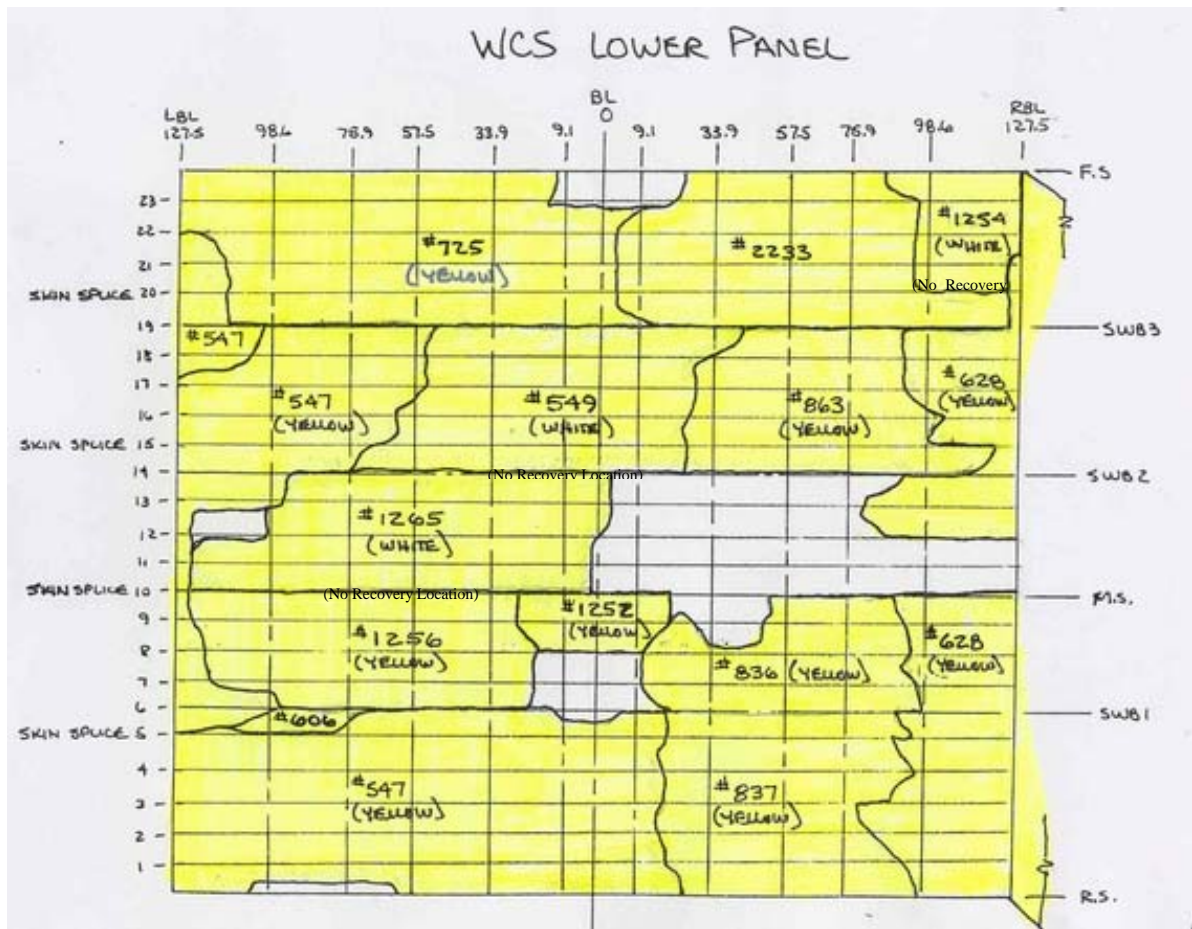
Two large segments of lower skin were recovered still attached to the left wing (Item #547) and right wing (Item #628) and the remainder of the panels were recovered separately (See Figure 1.12-26). There are two predominant characteristics for the recovered panel sections; 1) the lower panel segments fractured laterally into segments along the Span-wise Beam or Mid-spar locations and 2) the panels also generally exhibit upward curvature between the Span-wise Beams or Spars (See Figure 1.12-27 for a diagram of this characteristic). The exception to this curvature is on items #725, #1265 and #547 common to the keel beam attachment. At these locations, the panel retains curvature more typical of normal lower surface contour.

There were uniform discolorations noted on the lower surface of the panel. Samples were taken of these discolorations and the test results are contained within a separate report. There were no indications of soot or fire on the interior panel surface.

Figure 1.12-26 Documents the recovered and identified portions of the lower panel

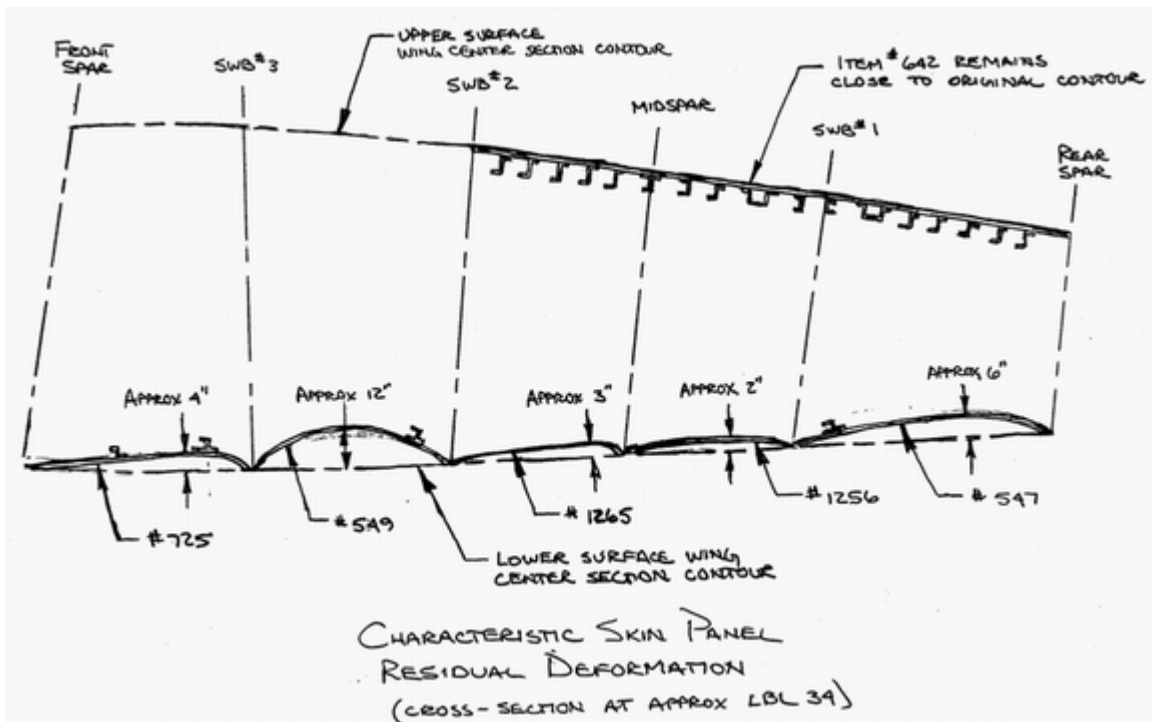
Figure 1.12-28 Characteristic Skin Panel Deformation (Cross section at approximately LBL 34)

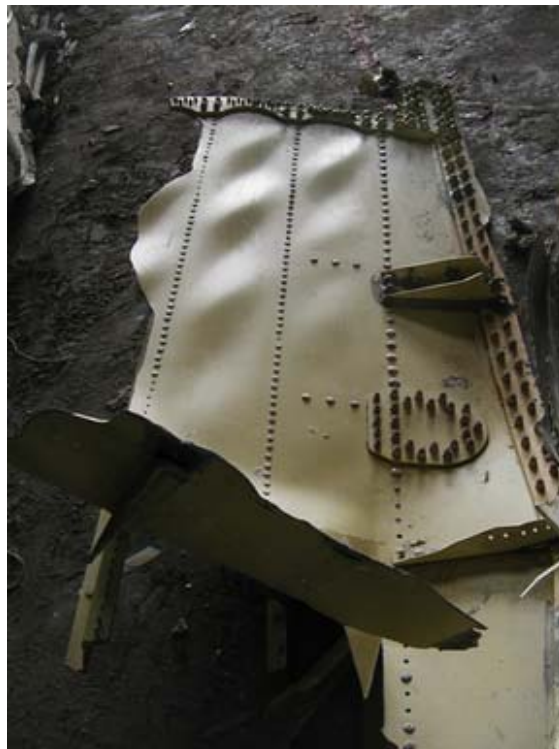
Two of the segments (item #1264 and #1019) had evidence of diagonal web buckling between the vertical stiffeners. The direction of the buckling pattern was from the lower/aft to upper/fwd direction (See Figure 1.12-31).

Figure 1.12-31 (a) Left S.O.B Rib Item #1264 showing web buckling

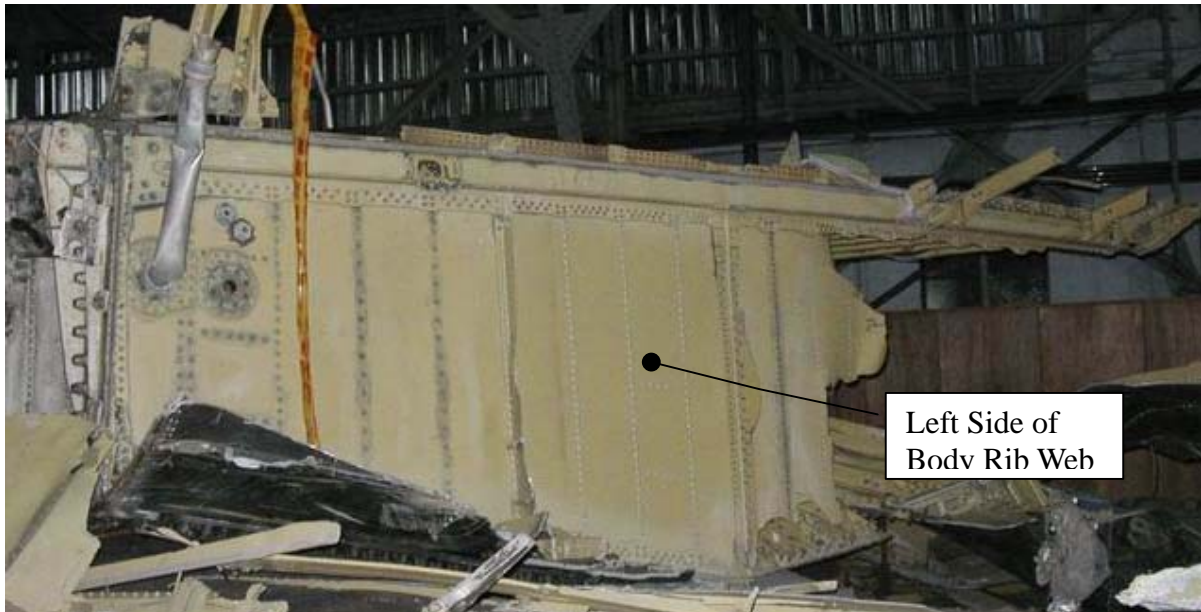
Figure 1.12-31 (b) Left Side of Body Rib Web

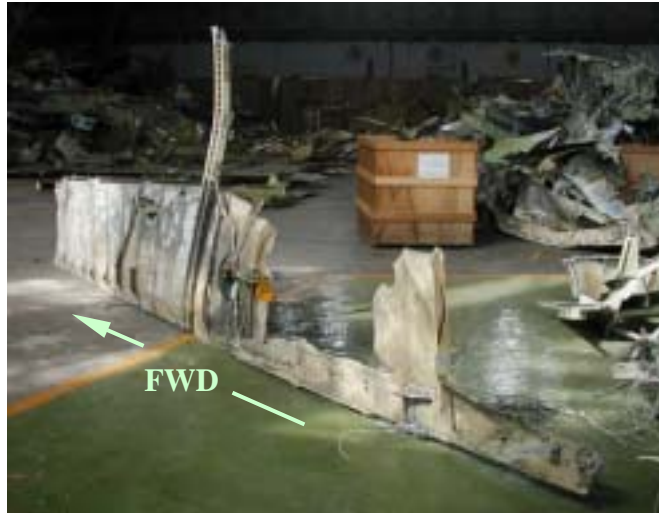
On item #840(See Figure 1.12-34), there was no obvious signs of bending or twisting of the lower chord at the fracture just fwd of the STA 1350 bulkhead or on the forward end near the mid-spar. The rear spar stiffener at LBL 9 that remained attached to the keel structure is bent such that the lower end of the stiffener and the adjacent keel structure (including web and upper chord) is bent inboard relative to the lower keel chord and the stiffener portion above the upper keel chord (common to the lower WCS skin panel) is bent outboard. In the region of the upper chord from SWB#1 to the mid-spar, the upper keel beam chord skin flange is fractured at multiple locations adjacent to the fastener holes. The fracture edges at these locations are bent upward.

Figure 1.12-34 Left Keel Beam Item #840

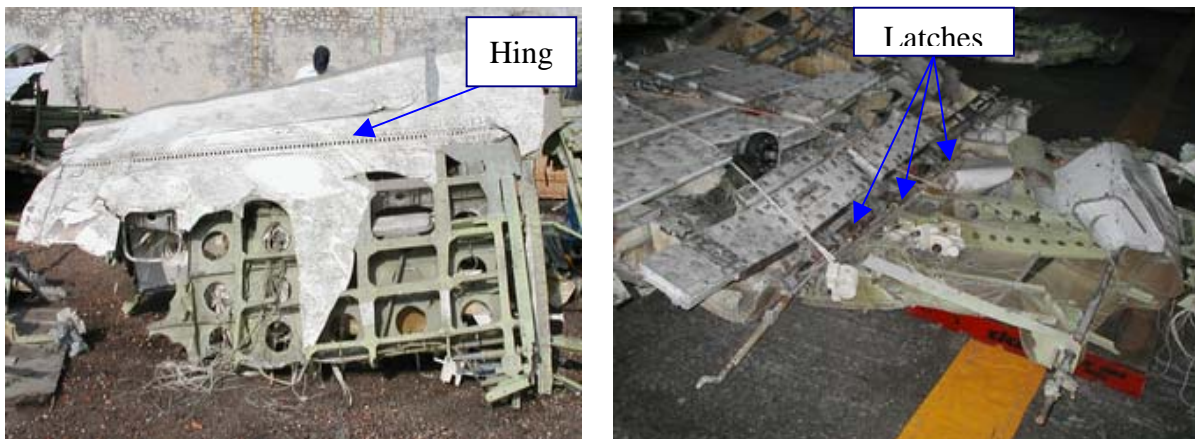
The aft cargo door was retrieved in the red zone in three major segments. The upper portion of the door (item 723 [Figure 1.12-36 (a)]) was recovered with the hinge intact and the actuators in the closed position. At the time of recovery a large section of passenger floor was structurally attached to item 723. During moving and storage the structural attachment was broken and the remaining wires holding the two assemblies together were cut at the dock in Makung. The lower portion of the door (item 741 [Figure 1.12-36 (b)]), including the three forward pairs of latches, was recovered with the latches still latched and the locks engaged. Attached as part of item 741 was a sizable portion of the cargo floor structure (frames, ballmat, etc.) extending to approximately Stringer 46L (S-46L). Very little skin and stringers remained attached to the frames. The lower aft portion of the door (item 2019 [photos below]), including the aft pair of latches, was found separated from the surrounding body structure. The lower portion of the door skin was bent outboard approximately 45 degrees. The observations of the hinge, latches, and door mechanisms indicate that the aft cargo door did not open prior to airplane breakup.

The deformation common to the lower portion of item 2019(See Figure 1.12-36) indicates that this segment of the door rotated outboard about the aft latch pair. This deformation is only evident on item 2019, indicating that this aft portion of the door was still attached at the lower aft latch pair after it was separated from the forward portion of the cargo door. The fracture along the forward edge of item 2019 shows that this separation occurred due to loads transferred through the latch pair (loads from lower edge of door segment). The remaining door segments (items 723 and 741) were still intact and separated at a later time.

Figure 1.12-36 (a) Item 723- left photo, (b) Item 741- right photo

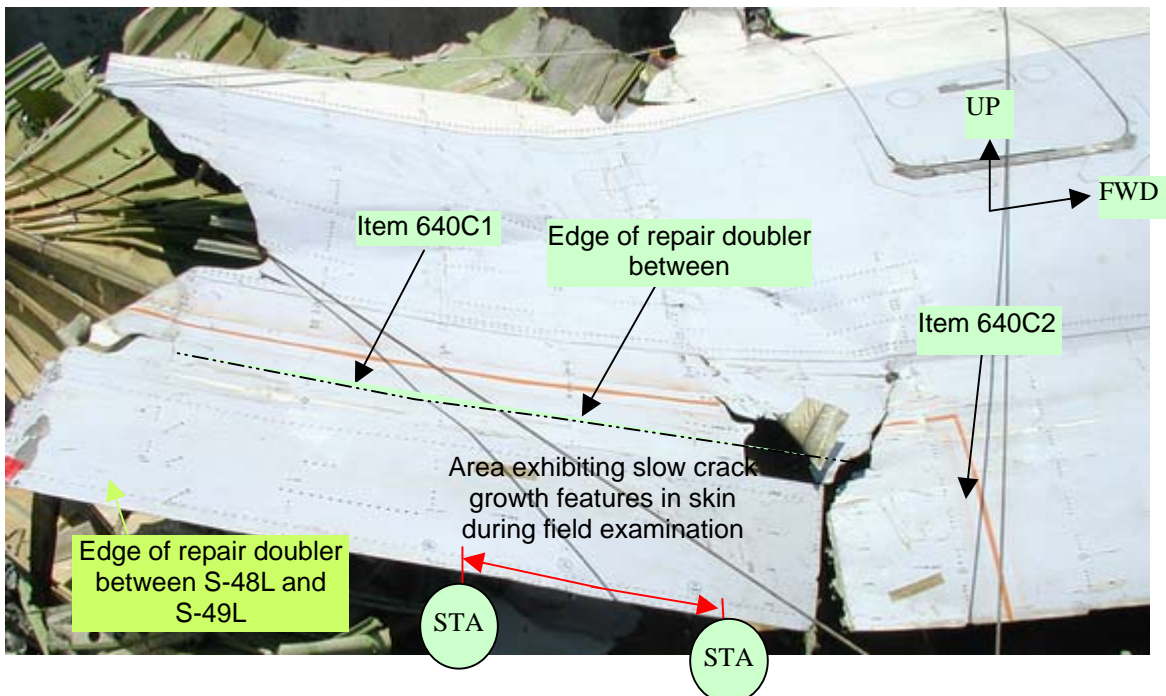
The recovered portions of the semi-monocoque structure (skins/frames/stringers) in Section 46 (see Figure 1.12-38) were arranged in a 2D reconstruction to assist in evaluating the fractures and deformations of the panels. A field examination was conducted on the fracture faces of all parts in the reconstruction. Item 640 was found to have flat-fracture surfaces (indicative of slow growth mechanisms) on the skin adjacent to an external repair doubler. The doubler measured approximately 23 inches by 125 inches. Item 640 is discussed separately below. No slow growth mechanisms were noted on the remaining skin segments in section 46.

Figure 1.12-38 The recovered portions of the semi-monocoque structure (skins/frames/stringers) in Section 46

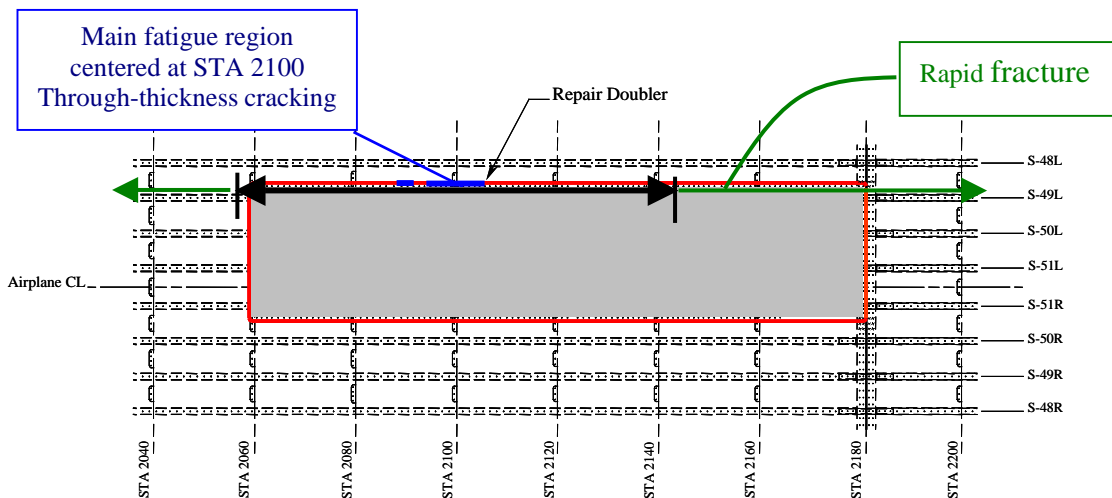
Flat fractures were observed in the skin along the edge of an external repair doubler at S-49L in the vicinity of STA 2100. The entire repair area was removed and sent for metallurgical examination. The results of this examination are the subject of reports from Chung Shan Institute of Science and Technology (CSIST) and from Boeing Materials Technology (BMT) as shown in 1.16. (See Figure 1.12-39).

Figure 1.12-39 Flat fractures were observed in the skin along the edge of an external repair doubler at S-49L in the vicinity of STA 2100.

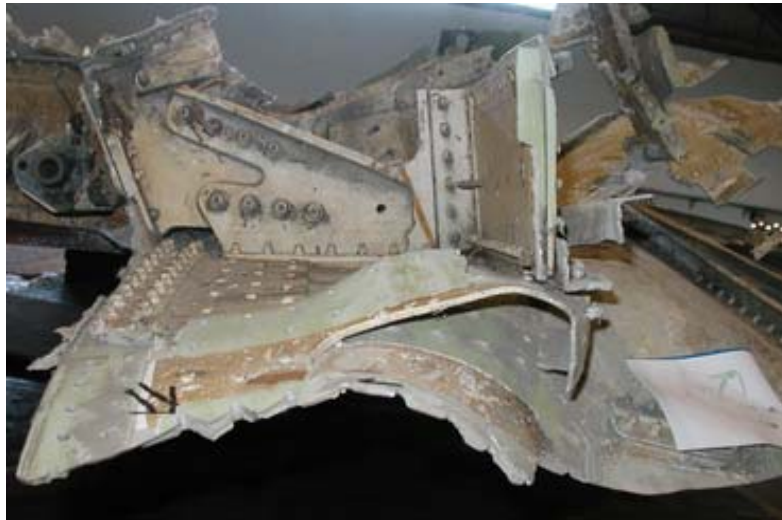
Figure 1.12-40 Item 640 at lower latch attachment

Also included in item 640 (Figure 1.12-40) is the bulk cargo door. The segment was recovered with the door closed and latched. The lower portion of the bulk cargo door seal protruded through the space between the door and the sill.

The forward portion of item 640 includes the aft portion of the aft cargo door cutout frame. There are deformations at the lower latch fitting attachment location (Figure 1.12-40).

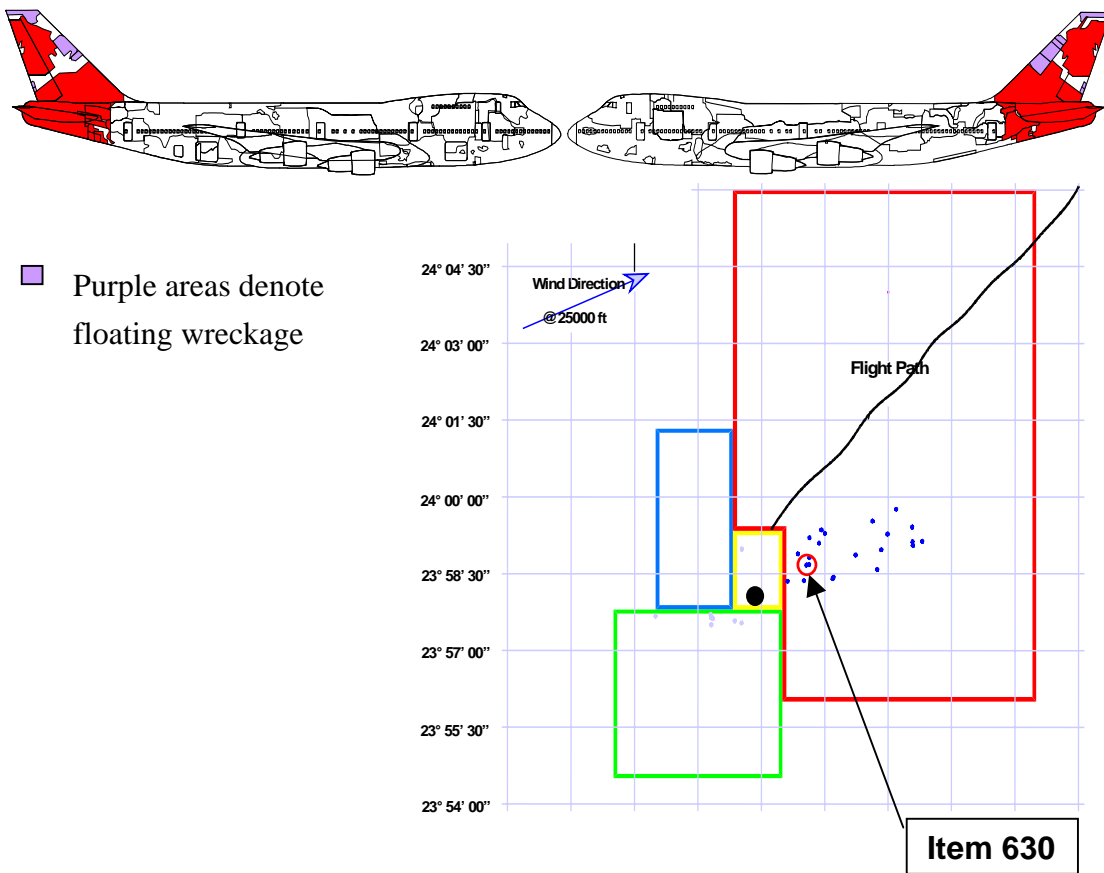
The section 48 and empennage structure (the aft pressure bulkhead and all structure aft) was found in the red zone (See Figure1.12-42) . The horizontal stabilizer, the majority of the skin/stringer/bulkhead structure, and the lower third of the vertical fin were found attached and with very little damage (item 630 [photo at right]). Some fin structure, including leading edge structure and the fin cap (items 22, 23, and 960) were recovered as floating debris. A large upper portion of the fin and rudder was found separate from item 630 (See Figure1.12-43) .

Figure 1.12-42 The section 48 and empennage structure (the aft pressure bulkhead and all structure aft) was found in the red zone.

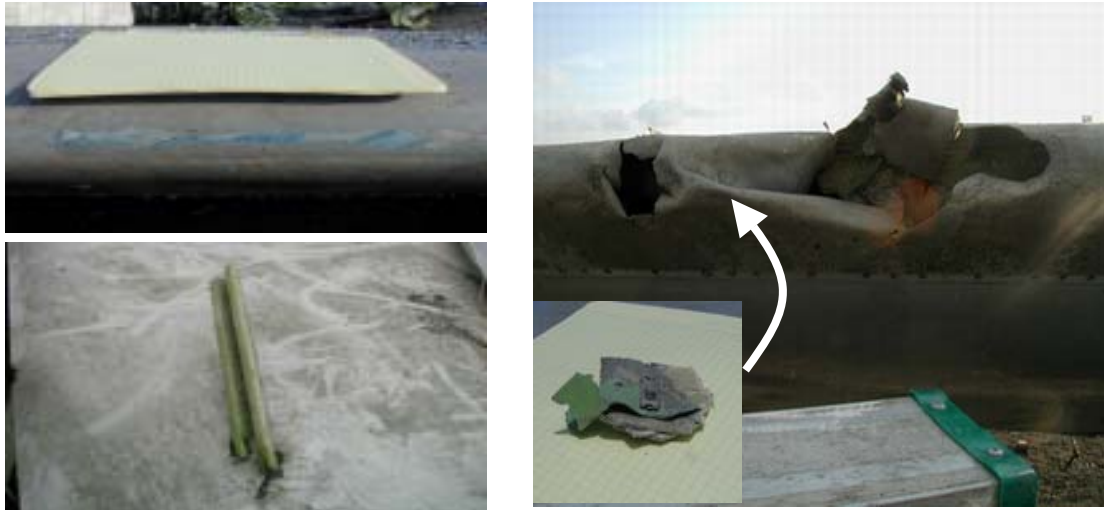
Shallow dents and varying shades of blue marks were found along the leading edge of the LHS stabilizer. Laboratory examination coupons were taken for these regions for evaluation and are the subject of a separate report. There is blue paint of similar color in the forward body. However, the transfer marks [See Figure 1.12-44(a)] were confirmed to not be from aircraft exterior finishes. Samples of some interior components were also tested and no match was found.

The RHS horizontal stabilizer is considerably more damaged than the LHS. The inboard portion of the RHS leading edge is deformed upwards. At the RHS horizontal stabilizer root, the inboard 10 feet showed considerable impact damage along with upwards deformation of the compromised structure. A portion of seat support was found inside a puncture common to the lower surface of the LHS horizontal stabilizer. A small segment of fuselage stringer was also found imbedded in the RHS elevator [See Figure 1.12-44(b)]. A small fastener and shim from a stowage bin assembly were found inside a puncture common to the RHS horizontal stabilizer leading edge [See Figure 1.12-44(c)].

Figure 1.12-44 (a) Item 630C2 – transfer marks LHS- upper-left photo, (b) Stringer imbedded in RHS Elevator- lower-left photo, (c) Item 630C3 horizontal stabilizer with stowage bin part- right photo

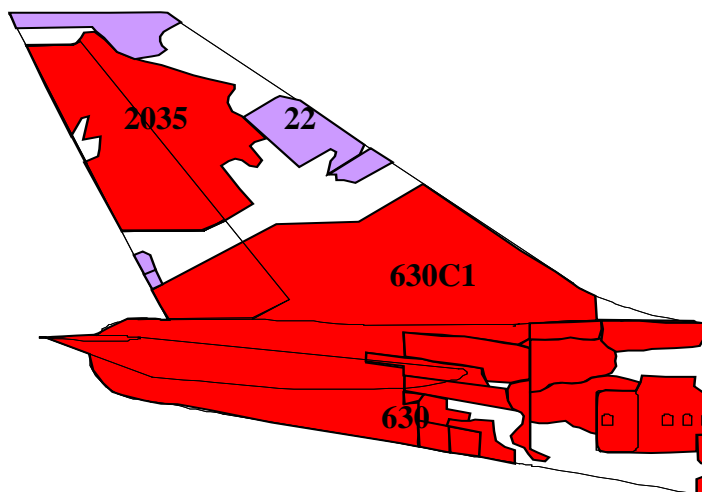
Figure 1.12-45 Vertical Fin

The majority of the upper portion of the vertical fin (item 2035) was found separate from the remaining section 48 debris, but also in the red zone. The forward edges of item 2035 were deformed to the left side indicating the leading edge portion was struck by a large object on the right side. The lower edge of this piece exhibited signs of bending and separation to the left side. At the upper forward edge of item 2035, there was significant tearing damage from fore to aft and right to left.

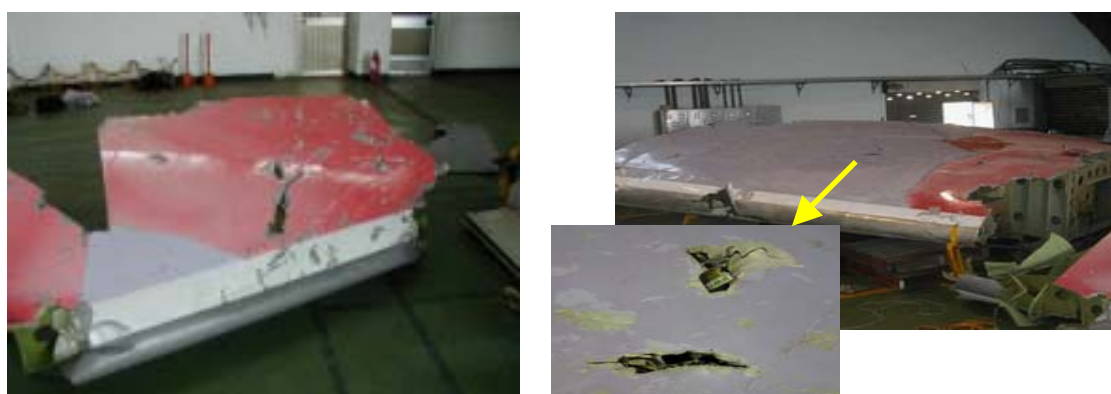
The middle portions of the vertical fin leading edge (items 22 [See Figure 1.12-46(a)], 23, 170, 350, and 392) were found floating. There were puncture marks evident on the RHS of these pieces. The vertical fin cap (item 960) was also found floating.

The lower portion of the vertical fin remained attached to the majority of section 48 and is now identified as item 630C1 [See Figure 1.12-46(a)] after being cut near the base to facilitate transportation. Two small stringer segments were found inside the leading edge portion of the fin adjacent to two punctures on the RHS. These stringer segments (items 630C4 and 630C5) originated from a section 46 fuselage belly panel. Item 630C4 is confirmed to be from STA 2170 at S-38R and the characteristics of item 630C5 indicate it is from STA 2170 at either S-42R or S-44R. Residue on the forward fracture face of these stringer segments indicates they entered the fin forward end first. The fractures and

The lower portion of the fin (item 630C1), the upper portion of the fin (item 2035), and several of the floating pieces (item 22) show similar evidence of impact damage on the right side.

Figure 1.12-46 (a) Item 22- left photo, (b) Item 630C1 penetrations with 630C4 and 630C5 stringer segments placed- right photo

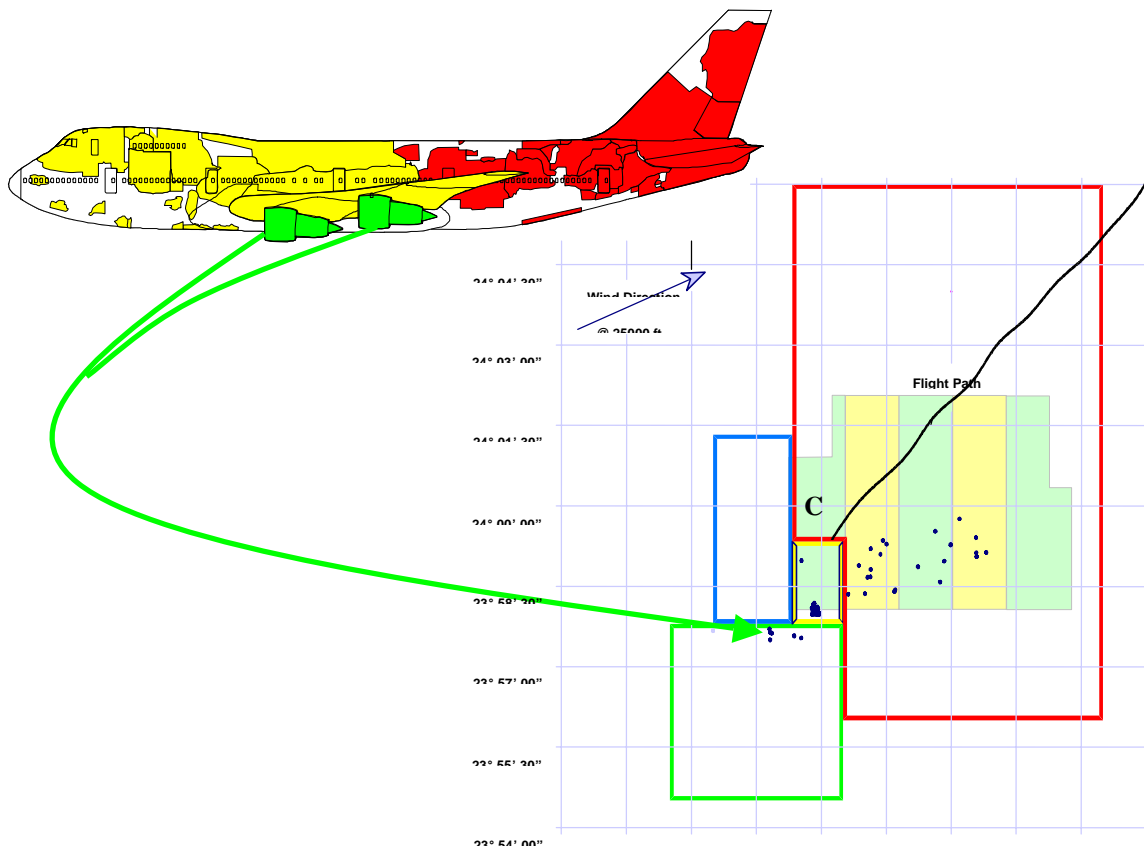
All four engines were recovered in a relatively concentrated area (as shown in Figure 1.12-47). A significant portion of the engine support structure remained attached to the left and right wing (See Figure 1.12-48). All recovered fuselage pins remained intact.

Figure 1.12-47 All four engines were recovered in a relatively concentrated area

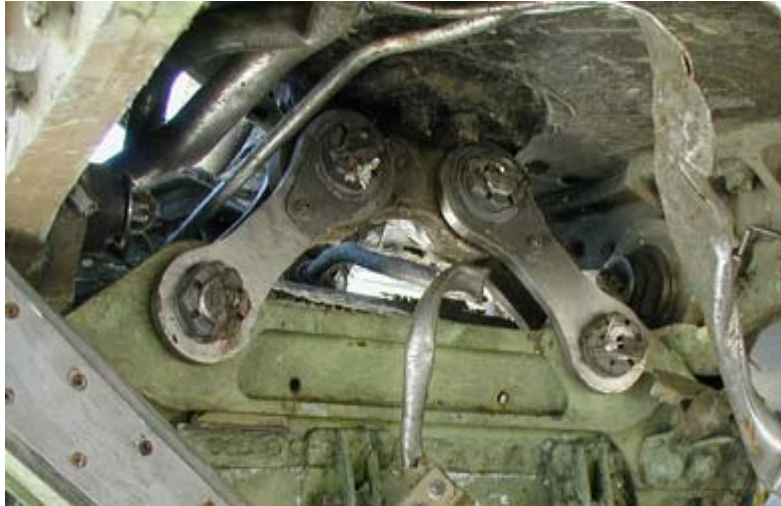
Figure 1.12-48 View of dual side links installed by strut modification

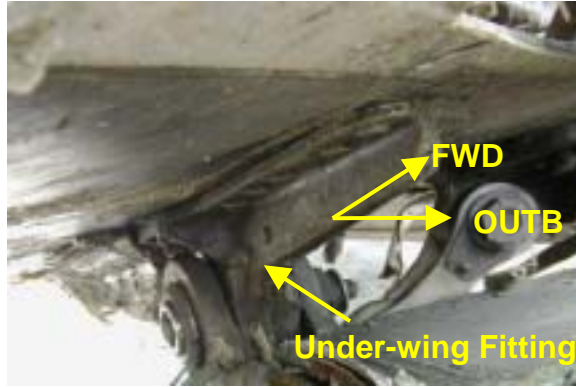
The strut upper link (R1) is intact and remains attached to the wing fittings. Pins on both ends are intact and a section of upper strut is attached to the strut end of the link. Under-wing and strut mid-spar fittings (R3 and R4) and fuse pins are all intact (Figure 1.12-49) . Dual side brace fittings (R7 and R8) are attached at both ends and appear normal. There is a 65" long section of mid-spar extending forward from the R3 and R4 fittings, as well as a 30" long piece of bulkhead extending below the R3, R4 fittings. The bulkhead extends across the width of the strut. The aft end of the diagonal brace (R2) had separated from its under-wing fitting. A portion of the under-wing fitting remained attached to the aft of the diagonal brace. The diagonal brace was bent outboard, such that the centerline had a pronounced curve (Figure 1.12-50) . At the forward end, the diagonal brace remained attached to the lower end of the strut aft bulkhead, but the attach fitting was bent outboard. The inboard mid-spar chord was bent downwards relative to the outboard mid-spar chord (Figure 1.12-51) . The observed deformations in the strut and attach structure were consistent with the lower portion of the strut translating outboard relative to the rest of the strut. n (Figure 1.12-52) .

Figure 1.12-49 Under-wing and strut mid-spar fittings (R3 and R4) and fuse pins are all intact
