**Aviation Safety Council
Taipei, Taiwan**

**CI611 Accident Investigation
Factual Data Collection
Group Report**

Structure Group

ASC-AFR-03-06-001

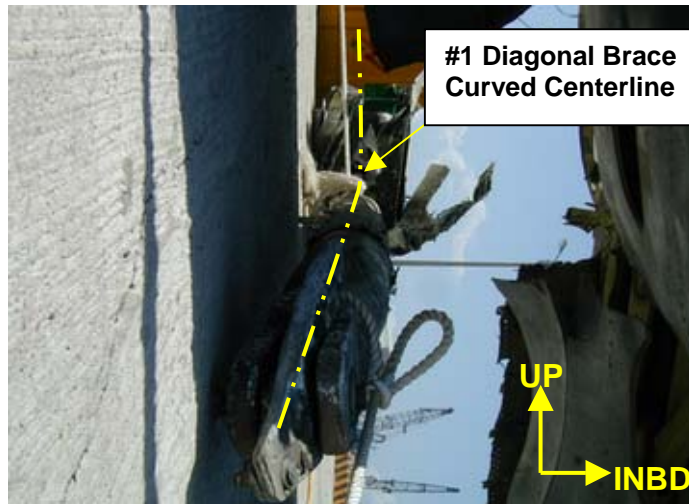
Figure 1.12-50 The diagonal brace was bent outboard, such that the centerline had a pronounced curve

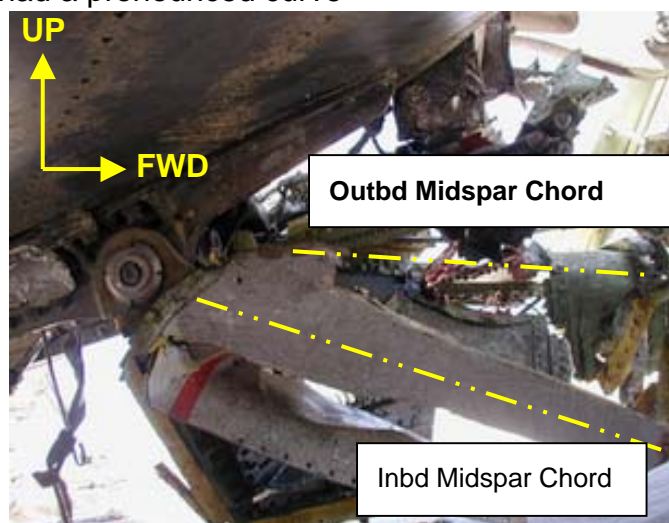
Figure 1.12-51 The inboard mid-spar chord was bent downwards relative to the outboard mid-spar chord.

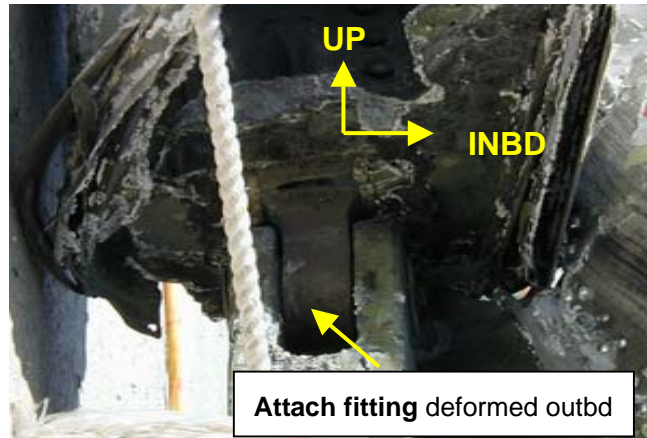
The strut upper link (R1) is intact and remains attached to the wing fittings. Pins on both ends are intact and a section of upper strut is attached to the strut end of the link. Under-wing and strut mid-spar fittings (R3 and R4) and fuse pins are all intact (Figure 1.12-49) . Dual side brace fittings (R7 and R8) are attached at both ends and appear normal. There is a 65" long section of mid-spar extending forward from the R3 and R4 fittings, as well as a 30" long piece of bulkhead extending below the R3, R4 fittings. The bulkhead extends across the width of the strut. The aft end of the diagonal brace (R2) had separated from its under-wing fitting. A portion of the under-wing fitting remained attached to the aft of the diagonal brace. The diagonal brace was bent outboard, such that the centerline had a pronounced curve (Figure 1.12-50) . At the forward end, the diagonal brace remained attached to the lower end of the strut aft bulkhead, but the attach fitting was bent outboard. The inboard mid-spar chord was bent downwards relative to the outboard mid-spar chord (Figure 1.12-51) . The observed deformations in the strut and attach structure were consistent with the lower portion of the strut translating outboard relative to the rest of the strut. n (Figure 1.12-52) .

Figure 1.12-52 Deformations departing the airplane in an outboard direction.

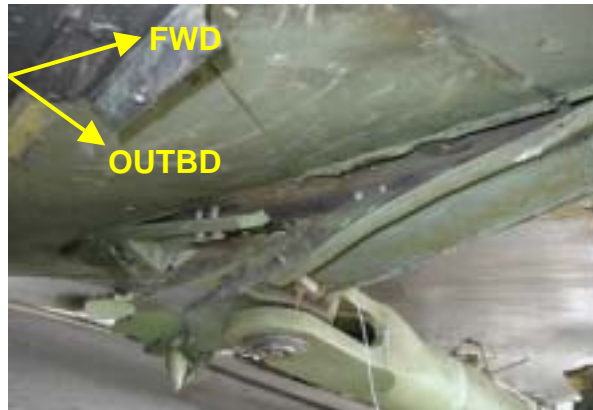
Figure 1.12-53 The diagonal brace itself was displaced outboard nearly 90 degrees

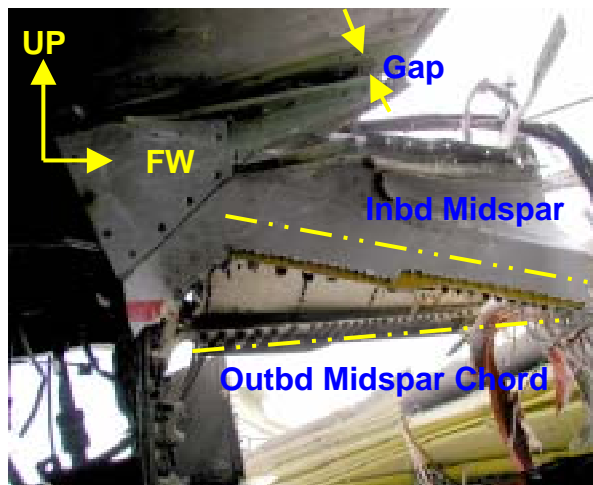
Figure 1.12-54 The inboard strut mid-spar chord was bent down relative to the outboard mid-spar chord

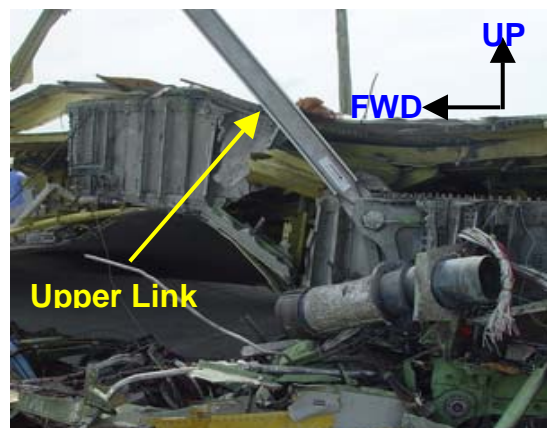
The rotation of the upper link is consistent with upward motion of the strut (Figure 1.12-55) . However, the deformation of the diagonal brace, mid-spar chords, and gap between the lower wing skin and inboard under-wing mid-spar

fitting are consistent with outward motion of the strut. The two motions could not have happened simultaneously. The separation direction for the #2 engine was not conclusively determined.

Figure 1.12-55 The rotation of the upper link is consistent with upward motion of the strut

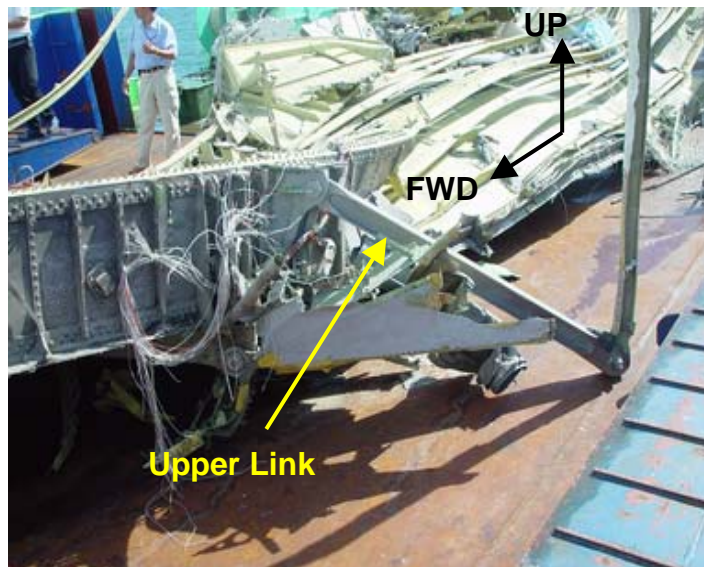
The strut upper link (R1) is intact and remains attached to the wing fittings (Figure 1.12-56) . Pins on both ends are intact and a 72" piece of strut beam is attached to the forward end of the link. Under-wing and strut mid-spar fittings (R3 and R4) and fuse pins are intact. Dual side brace links (R7 and R8) are attached at the top but the outboard aft link is bent aft. There is a 55" long piece of mid-spar structure extending forward from the R3 and R4 fittings, as well as a 20" long piece of bulkhead extending below R3 and R4 fittings. The bulkhead extends across the width of the strut, but has been twisted with the outboard portion pulled free from the vertical leg of the strut mid-spar fitting (Figure 1.12-57). The diagonal brace was not recovered. The diagonal brace under-wing fitting was found fractured and the remaining portion was bent outboard (Figure 1.12-58) . The deformation of the outboard aft side link is consistent with the twisting of the aft bulkhead. The twisting of the aft bulkhead is consistent with clockwise rotation of the #3 engine (when viewed from above). The deformation of the diagonal brace under-wing fitting and the strut aft bulkhead are consistent with clockwise twisting and outward rotation of the #3 engine.

Figure 1.12-56 The strut upper link (R1) is intact and remains attached to the wing fittings

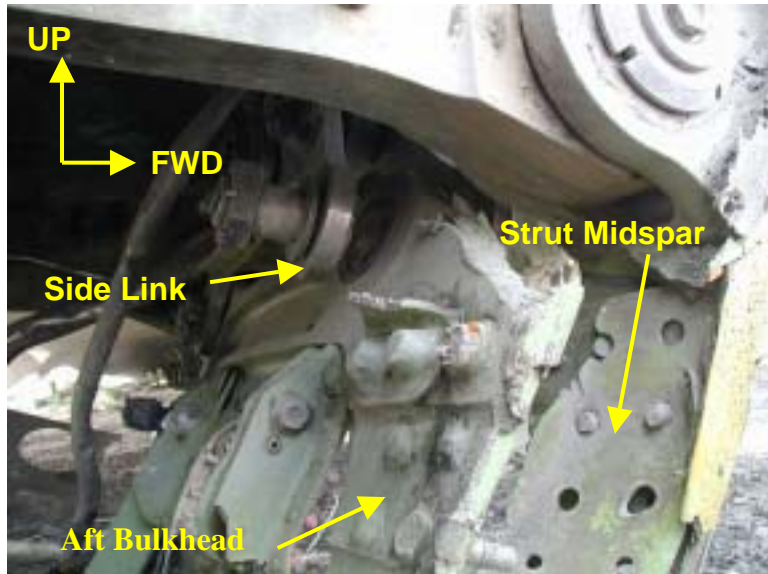
Figure 1.12-57 The bulkhead extends across the width of the strut, but has been twisted with the outboard portion pulled free from the vertical leg of the strut mid-spar fitting

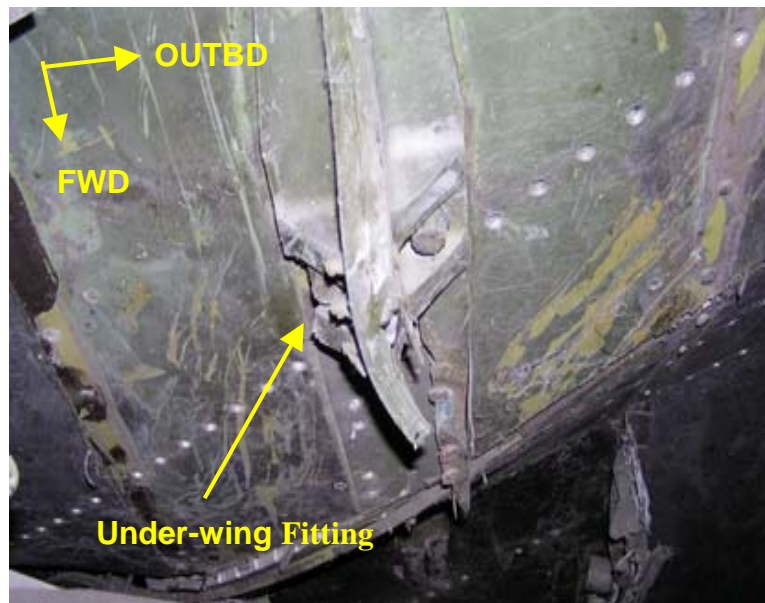
Figure 1.12-58 The diagonal brace under-wing fitting was found fractured

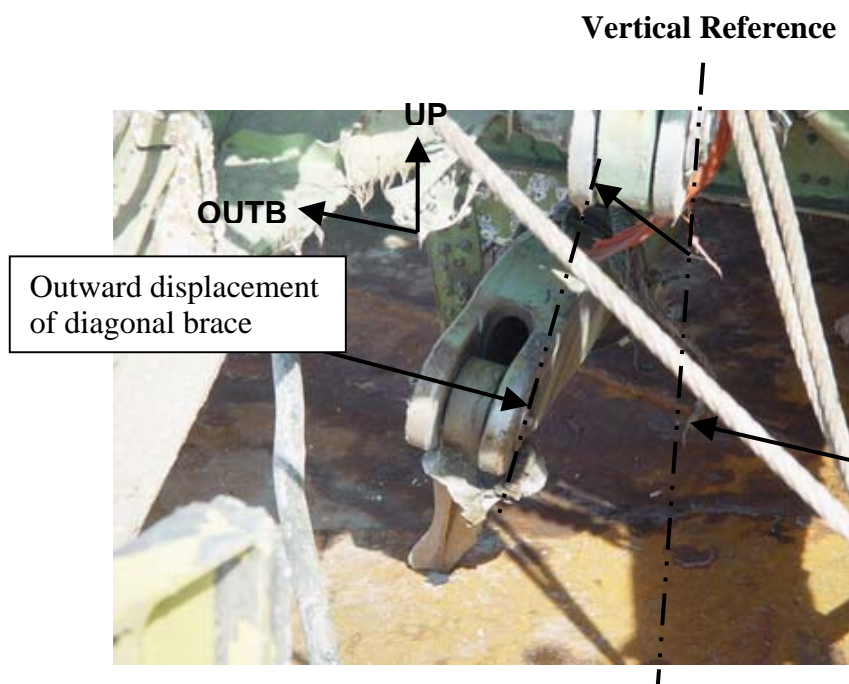
The strut upper link (R1) is intact and remains attached to the wing fittings. Pins on both ends are intact and a 15" by 20" wide section of strut is attached to the forward end of the link. Under-wing and strut mid-spar fittings (R3 and R4) and fuse pins are intact. Dual side links (R7 and R8) and fittings are attached at both ends and appear normal. There is a 51" long section of strut structure extending forward from the R3, R4 fittings, as well as a 24" long piece of bulkhead extending below R3 and R4 fittings. The bulkhead extends across the width of the strut. The diagonal brace is attached to the R2 wing fitting and both appear in good condition. A small piece of strut fitting is attached to the diagonal brace forward end. The forward end of the diagonal brace is bent outboard of its normal position (Figure 1.12-59). The outboard mid-spar chord is bent up relative to the inboard mid-spar chord (Figure 1.12-60). The observed deformations are consistent with the #4 engine departing the airplane in an outboard direction.

Figure 1.12-59 The forward end of the diagonal brace is bent outboard of its normal position

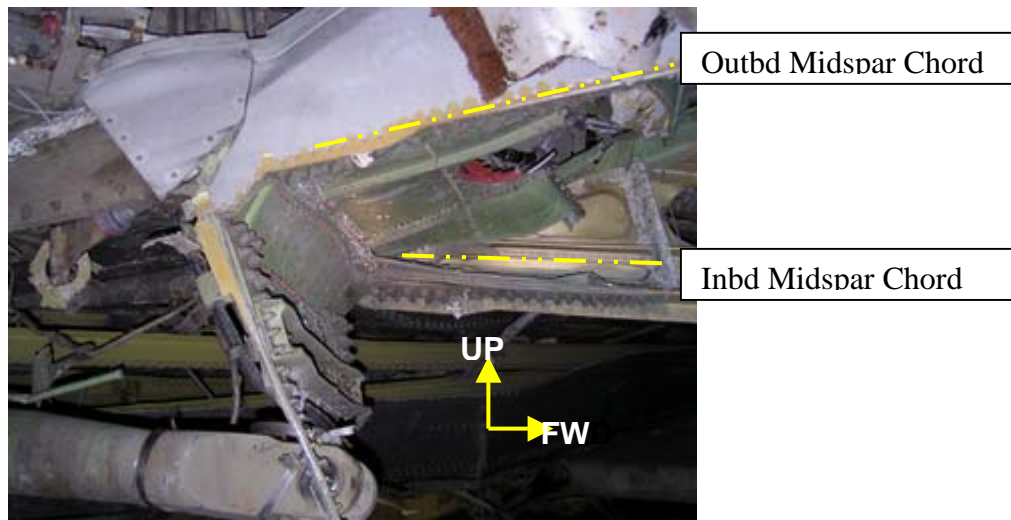
Figure 1.12-60 The outboard mid-spar chord is bent up relative to the inboard mid-spar chord

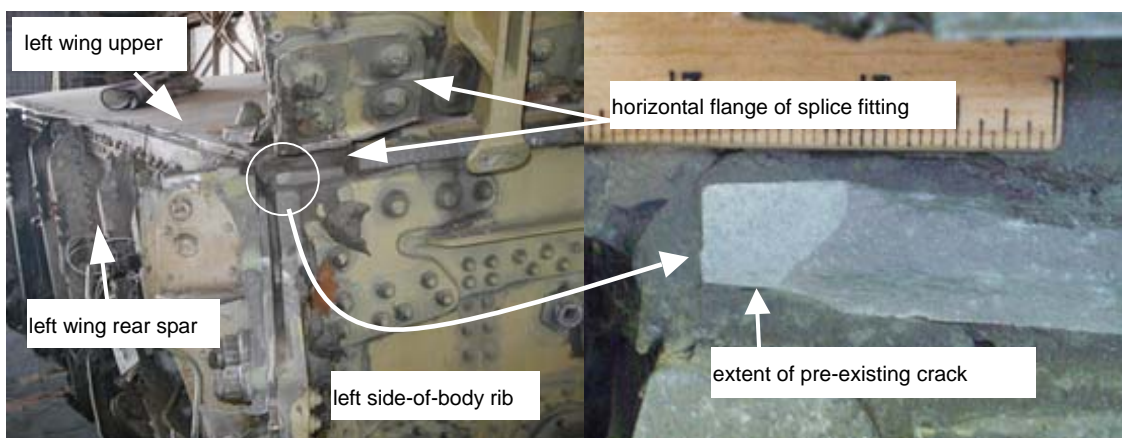
Figure 1.12-61 Left Wing Upper Internal Splice Fitting - Left SOB, Rear Spar on item #547C2

Visual examination revealed what appears to be a pre-existing crack on the outboard flange of the Left Wing Upper Internal Splice Fitting common to the left SOB and Rear Spar on item #547C2. The feature appears to be a fatigue crack that initiated on the upper surface of the flange near the aft edge and propagated through the flange thickness and forward to a length of approximately 0.75 inch, where the fracture displayed an abrupt transition from light color associated with a flat profile to a dark colored, slanted profile. The total forward and aft length of the fracture at this location was measured to be approximately 4.0 inches.

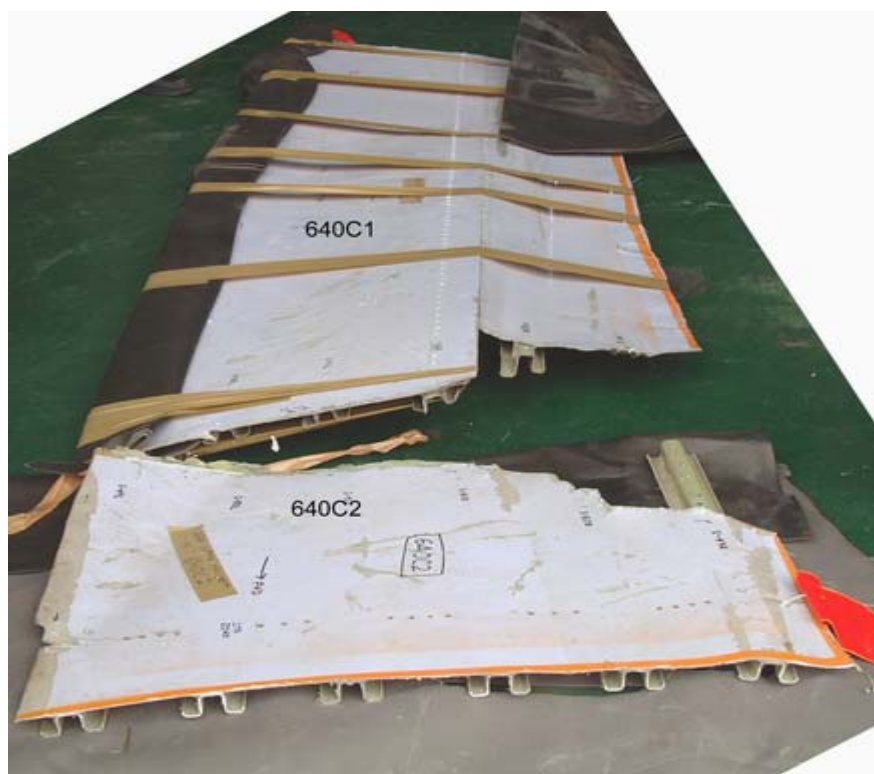
Figure 1.16-12 Item 640

An overall appearance of ITEM 640 wreckage, submitted to Aero Material Department (AMD) for failure analysis is shown in Figure 1.16-12, which consists of ITEM 640C1 and 640C2. At first, the ITEM 640 wreckage was visually examined and its features were recorded in detail. Further, failure analyses were done as well to identify extent of fatigue area, initiation sites and direction of crack propagation in order to provide valuable information for determining root cause of Cl611 plane crash.

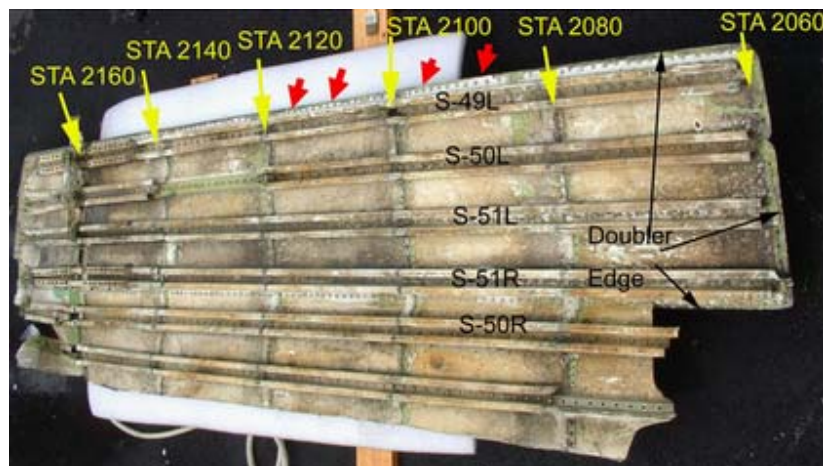
Figures 1.16-13 (a) and 1.16-13 (b), shows both sides of 640C1 and indicates where a repair doubler was attached to the outboard fuselage skin. The range of doubler was approximately within the area between frames STA 2060 and 2180 and stringers S-49L and S-51R, respectively. Figure 1.16-13 (a) indicates that all the frames came off of the skin and were missing except at STA 2160 where a partial frame was attached. However, aside from the section between STA 2120 and STA 2140 of stringer S-50L, almost all stringers were still attached to the fuselage skin. By way of visual examination, the fuselage skin was found to have suspected evidence of fatigue cracking (fracture surface normal to the surface of skin) that was close to, and parallel with, stringer S-49L. This portion of the skin fracture is marked with red arrows in Figure 1.16-13 (a).

Figure 1.16-13 (a) Inboard side of item 640 indicates that all the frames came off of the skin and were missing except at STA 2160 where a partial frame was attached

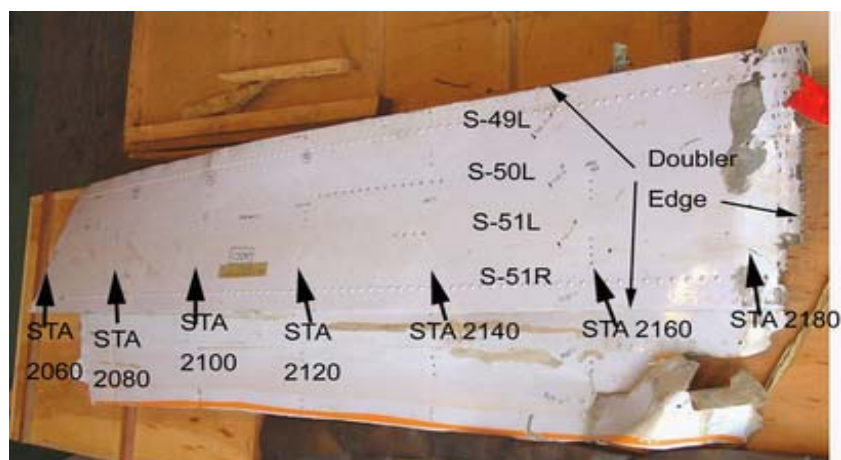
Figures 1.16-13 (b) Out board side of item 640 repair doubler was attached to the outboard fuselage skin

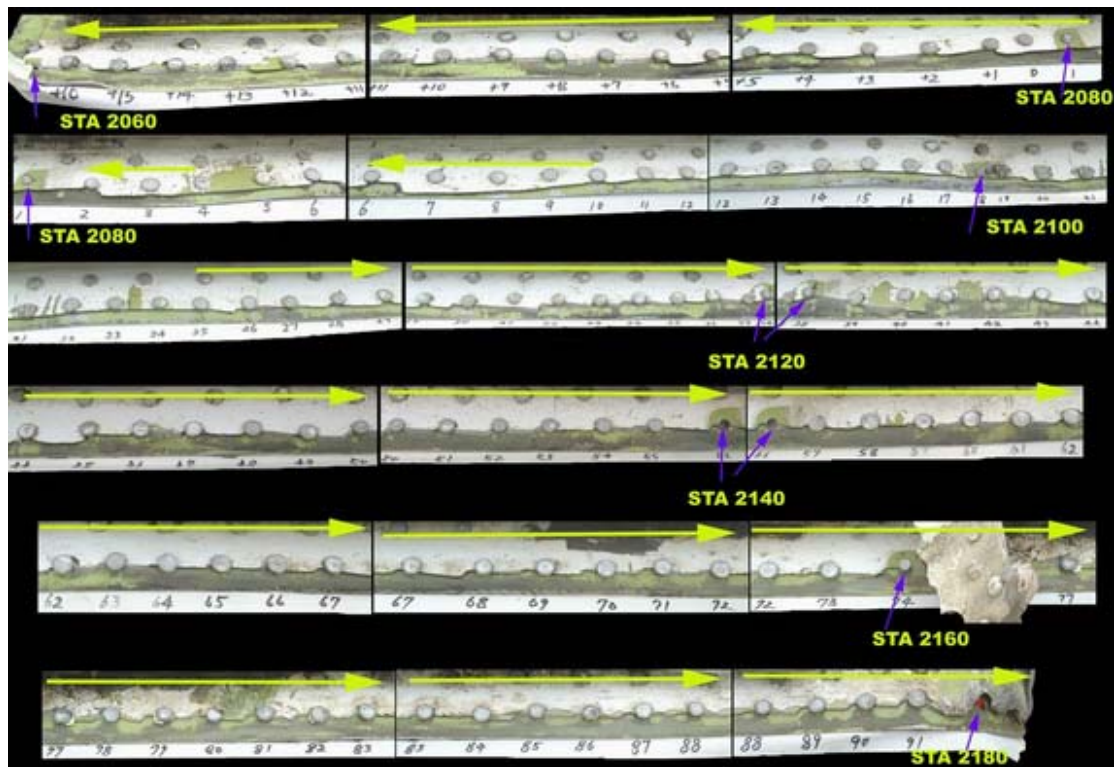
Figure 1.16-14 is composed of 18 photos and shows an overall view of the skin fracture surface along the direction of stringer S-49L. For referencing purposes rivets were identified by the numbers +17 to 91 along the fracture as shown in Figure 1.16-14. The same identification for these rivets was used throughout the report.

Figure 1.16-14 Shows an overall view of the skin fracture surface along the direction of stringer S-49L

- (6) In general, there were two types of propagation on the fracture surface shown in Figure 1.16-14. One is fatigue which proceeded through the skin thickness, as mentioned above. The other is overstress fracture. Even though the overstress fracture probably propagated along the direction of thickness in some areas, for example, the shear lip in the vicinity of fatigue area, in most areas it propagated along the directions as indicated by the yellow arrows in Figure 1.16-14 about parallel to stringer of S-49L. The overstress cracking generally emanated from the region bounded between rivet 10 through rivet 25. In addition, except for very few areas there is a distinctive feature for the overstress cracking which propagated from hole to hole, as shown in Figure 1.16-14. In the fracture region between rivets 6 and 10, corresponding to rivets 7 through 9, the fracture surface was on a 45° slant plane that was typical of an overstress fracture in tension stress but the fracture did not propagate from hole to hole.

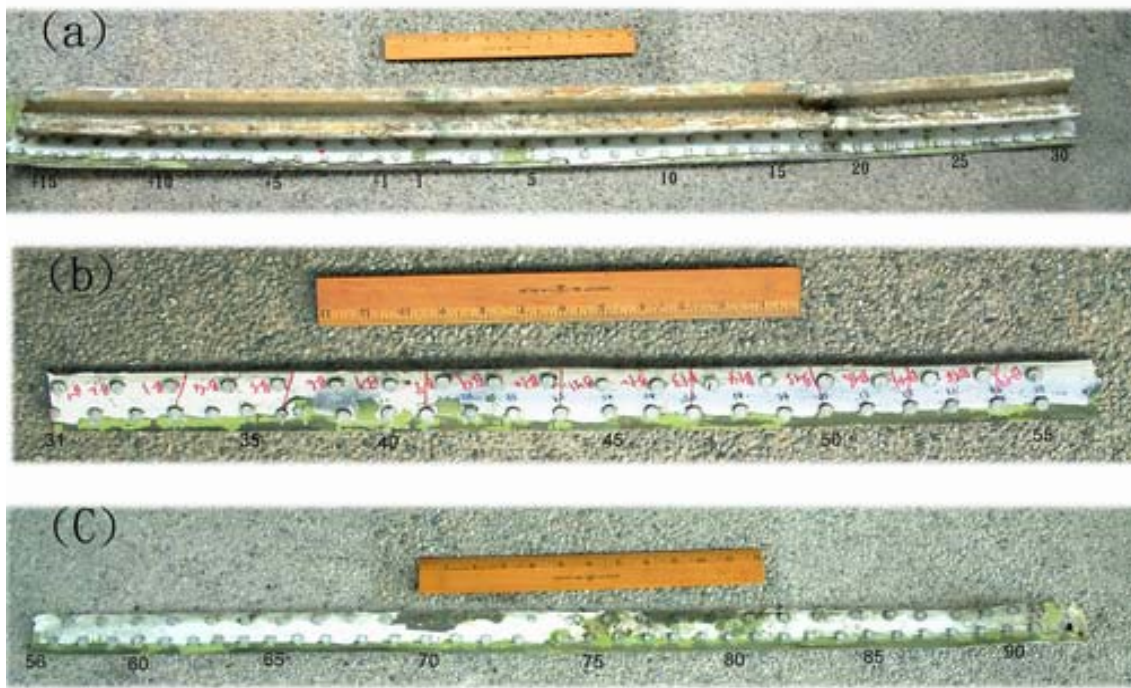
The fracture surfaces near the rivets from +17 to 91 in Figure 1.16-14 were examined by low-magnification optical (light) microscopy for suspected evidence of fatigue cracking. Three sections of the skin fracture incorporating rivets and doubler sections were removed by saw cutting for macroscopic examination and are shown in Figure 1.16-15. Macro examination using low power optical method was performed at the AMD laboratory while the fracture surfaces were cleaned with a soft bristle brush and acetone during examination. The NTSB Boeing China Airlines (In part from +17 to 38) AMD and ASC representatives participated in macroscopic examination of fracture surface.

Figure 1.16-15 Three sections of the skin fracture incorporating rivets and doubler sections were removed by saw cutting

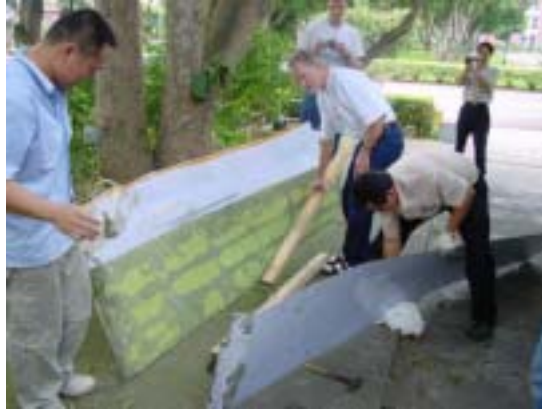
Before SEM examination, the skin was disassembled (See Figure 1.16-16) and sectioned into many segments that were of an appropriate size so as to fit in the SEM chamber. Moreover, in order not to destroy the skin fracture surface saw cuts, if possible, were made through fastener hole. One exception was the saw cut at a location near rivet number 4.

Figure 1.16-16 The investigator was disassembling the skin before SEM examination

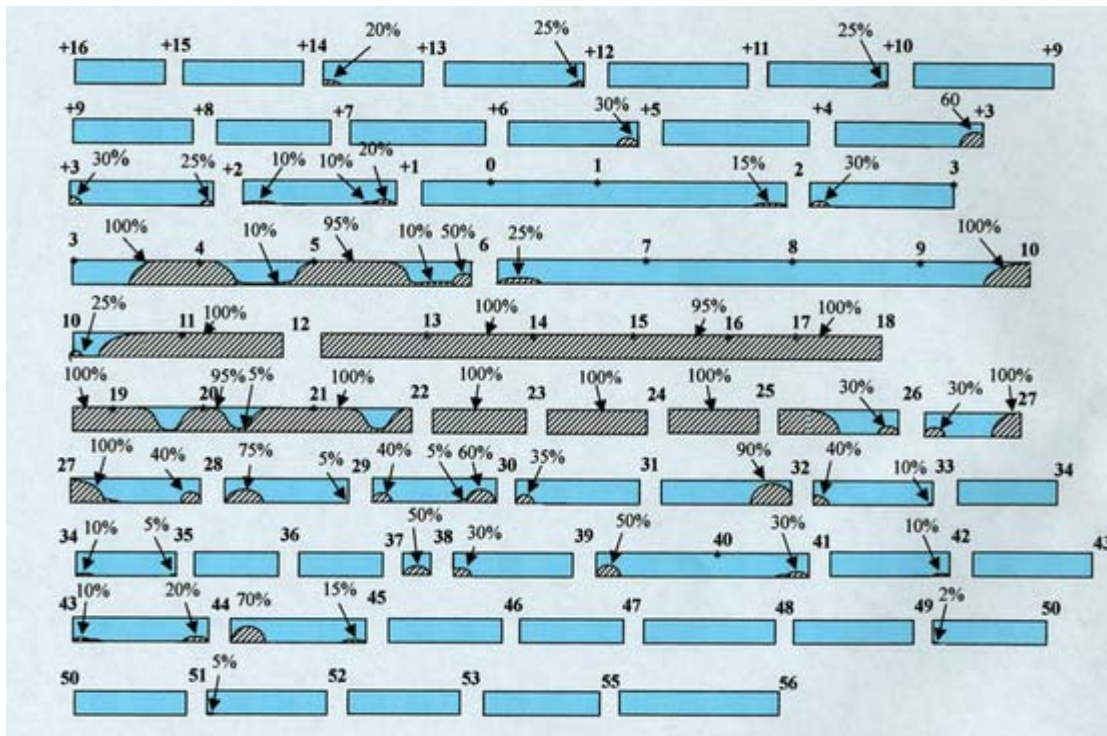
The majority of the fatigue cracking was associated with frame STA 2100, in the area corresponding to the region of rivets from 10 to 25. Figure 1.16-23 is a drawing (not to scale) indicating the fatigue cracking on the skin fracture surface from rivets +16 through 56.

Figure 1.16-23 A drawing (not to scale) indicating the fatigue cracking on the skin fracture surface from rivets +16 through 56.

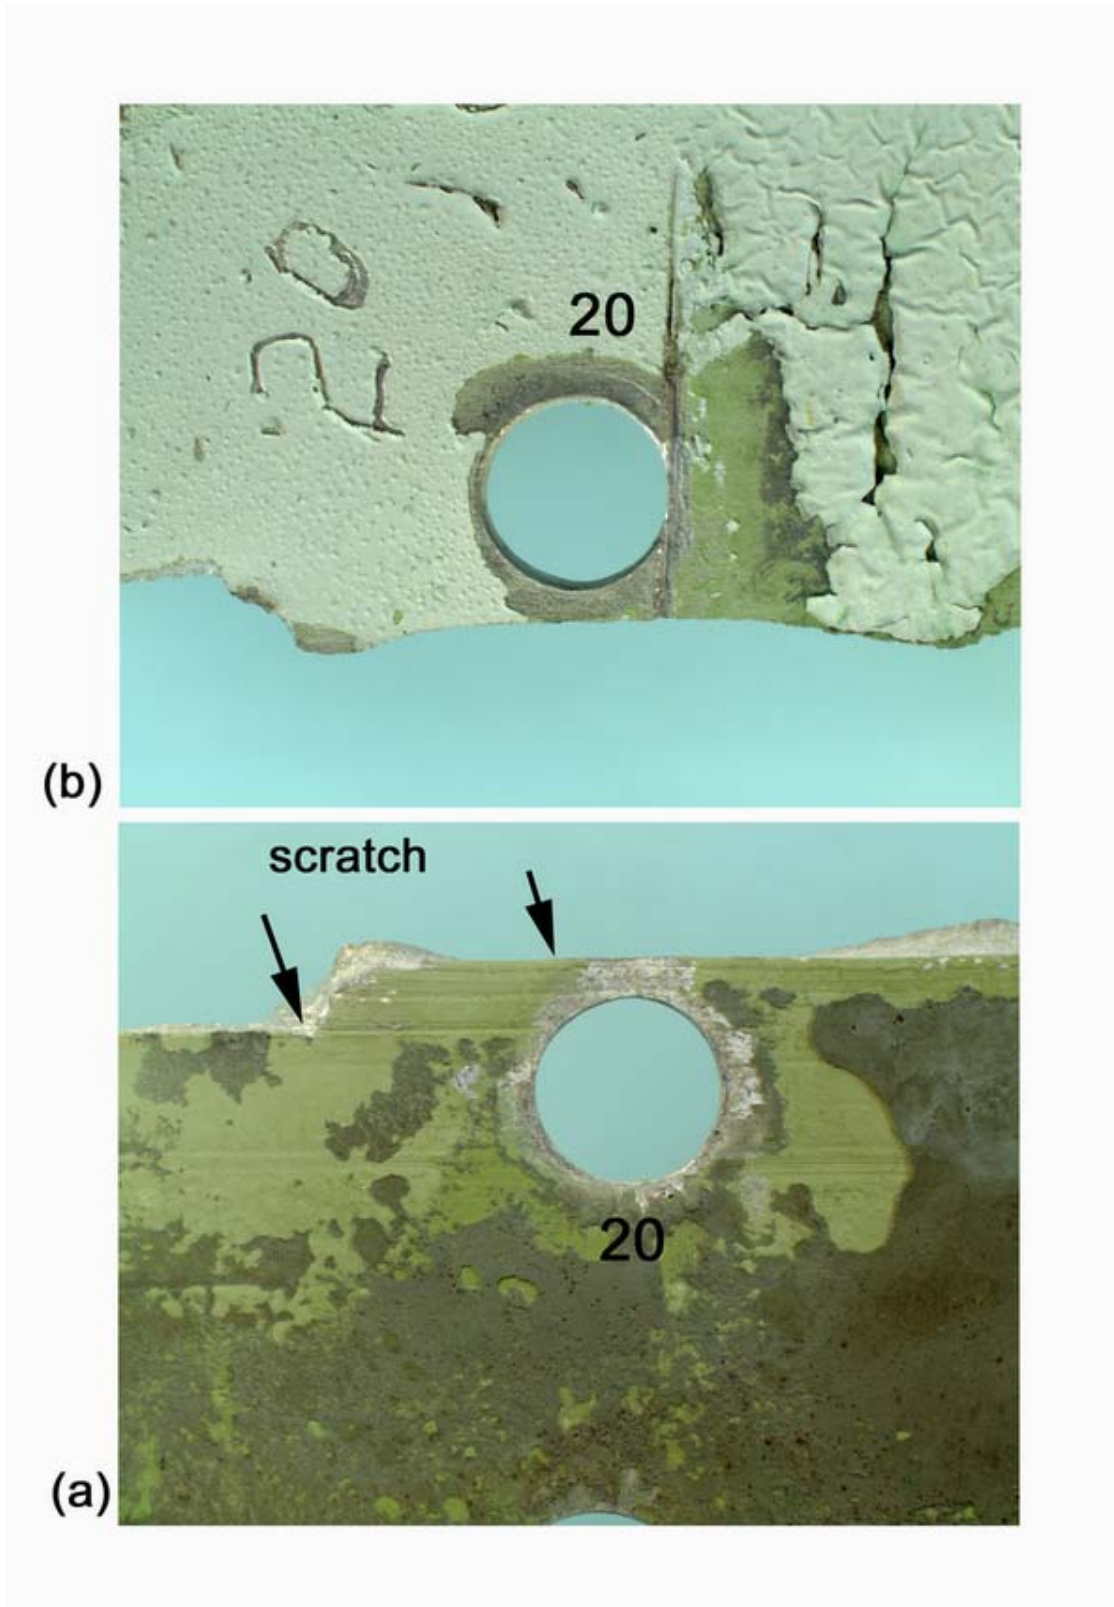
Figure 1.16-29 The skin surface around the rivets 20

- (8) Although almost all the fracture surfaces near the rivets from 10 through 28 were dominated by the same through the thickness fatigue fracture, it was found that there were some different features among them. The fatigue cracks associated with rivets 13 through 20 were more close to the edge of doubler and the shanks of these rivets, with the exception of the blind rivet at 18, were not exposed. In comparison, the shank of the rivets on 10, 12 and 22 through 28 were readily visible. In the areas between rivet numbers 22~28, there was a trend for the higher numbered rivets to be associated with a larger portion of exposed rivet shank.

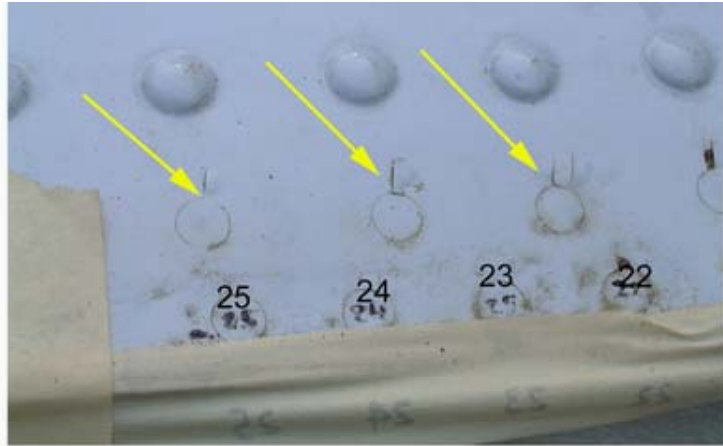
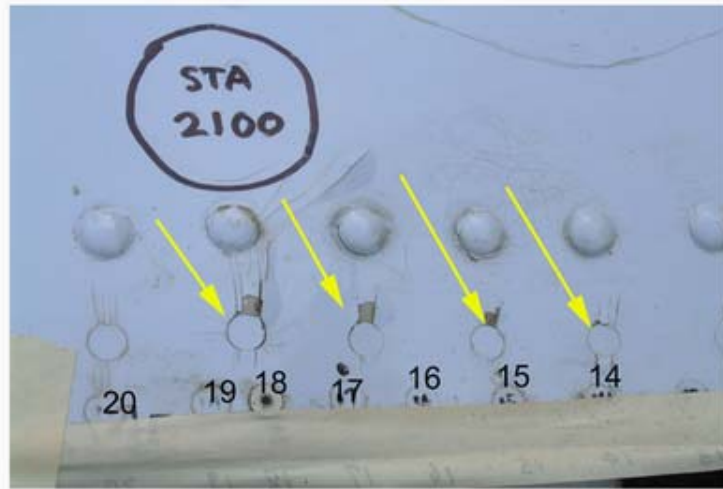
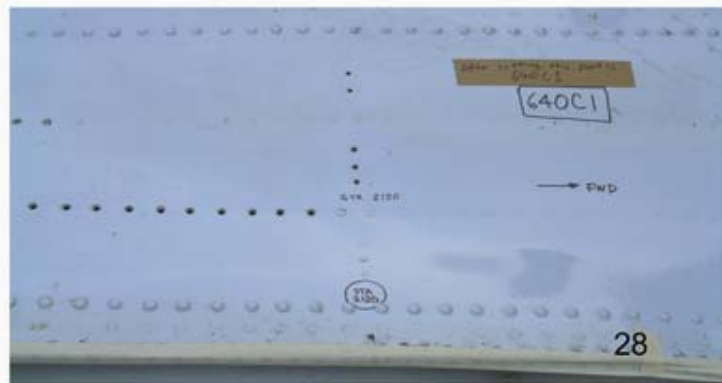
Figure 1.16-32 Show the exterior appearance of the doubler

(10) Figure 1.16-32 shows the exterior appearance of the doubler in the area of the local deformation illustrating that the paint around the rivet heads was cracked in some areas. The cracked paint occurred at the location from rivet 14 to 25, which corresponded to the fracture area with the intensive fatigue crack. In the areas with little evidence of fatigue cracking, the exterior paint surface of the doubler was intact around the rivets, such as the locations of rivets beyond number 28.

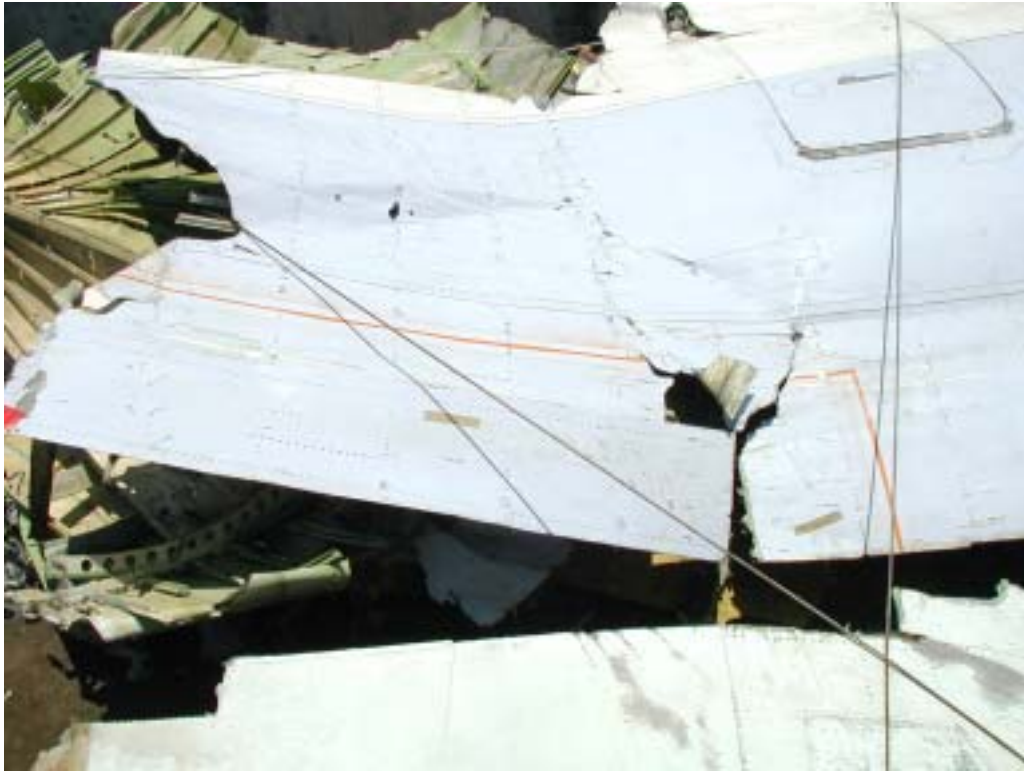
Field notes were taken in Makung, Taiwan on item 640C1 and C2 fuselage skin panel sections to document the condition of the items prior to shipment to the CSIST. Figure 1.16-36 provides a view of item 640 with the locations of 640C1 and C2 prior to removal in Makung. Figure 1.16-37 provides a view of the interior surface of item 640C1 prior to disassembly at the CSIST laboratory. Item 640C1 contained a 23 inch wide external repair doubler (referred to as the doubler) from approximately STA 2060 to STA 2180 which was installed after a tail strike event was experienced upon landing. The doubler terminated between S-48L and S-49L on one side and between S-50R and S-51R on the other side. The doubler was attached to the skin by two rows of countersunk rivets around its periphery as well as by fasteners common to the stringer and shear tie locations. Universal head rivets were used at S-51R and S-49L while countersunk rivets were used at S-50L and S-51L. Stringer splice repairs were present forward and aft of STA 2160 at S-51R and S-49L. Each of the four splice repairs measured approximately 11 inches in length. At STA 2160 a partial portion of the frame containing three shear ties, the failsafe chord, a fragment of the web, and two stringer clips remained attached to the item 640C1 skin panel. No other frames were attached to either item 640C1 or C2 when the parts arrived in Taichung. However, photographs taken aboard the recovery vessel show that a portion of the STA 2100 frame (item 2015) was attached to item 640C1 when it was recovered. A portion of S-50L between STA 2120 and STA 2140 was missing from item 640C1. Detailed notes were taken prior to disassembly noting the condition of the shear tie and stringer clip attachment to the items 640C1 and C2 skin panels. Table 1.16-2 contains the results of this examination.

Figure 1.16-36 Item 640C1 and C2 Skin panel segments prior to removal from the parent item 640 wreckage in Makung, Taiwan.

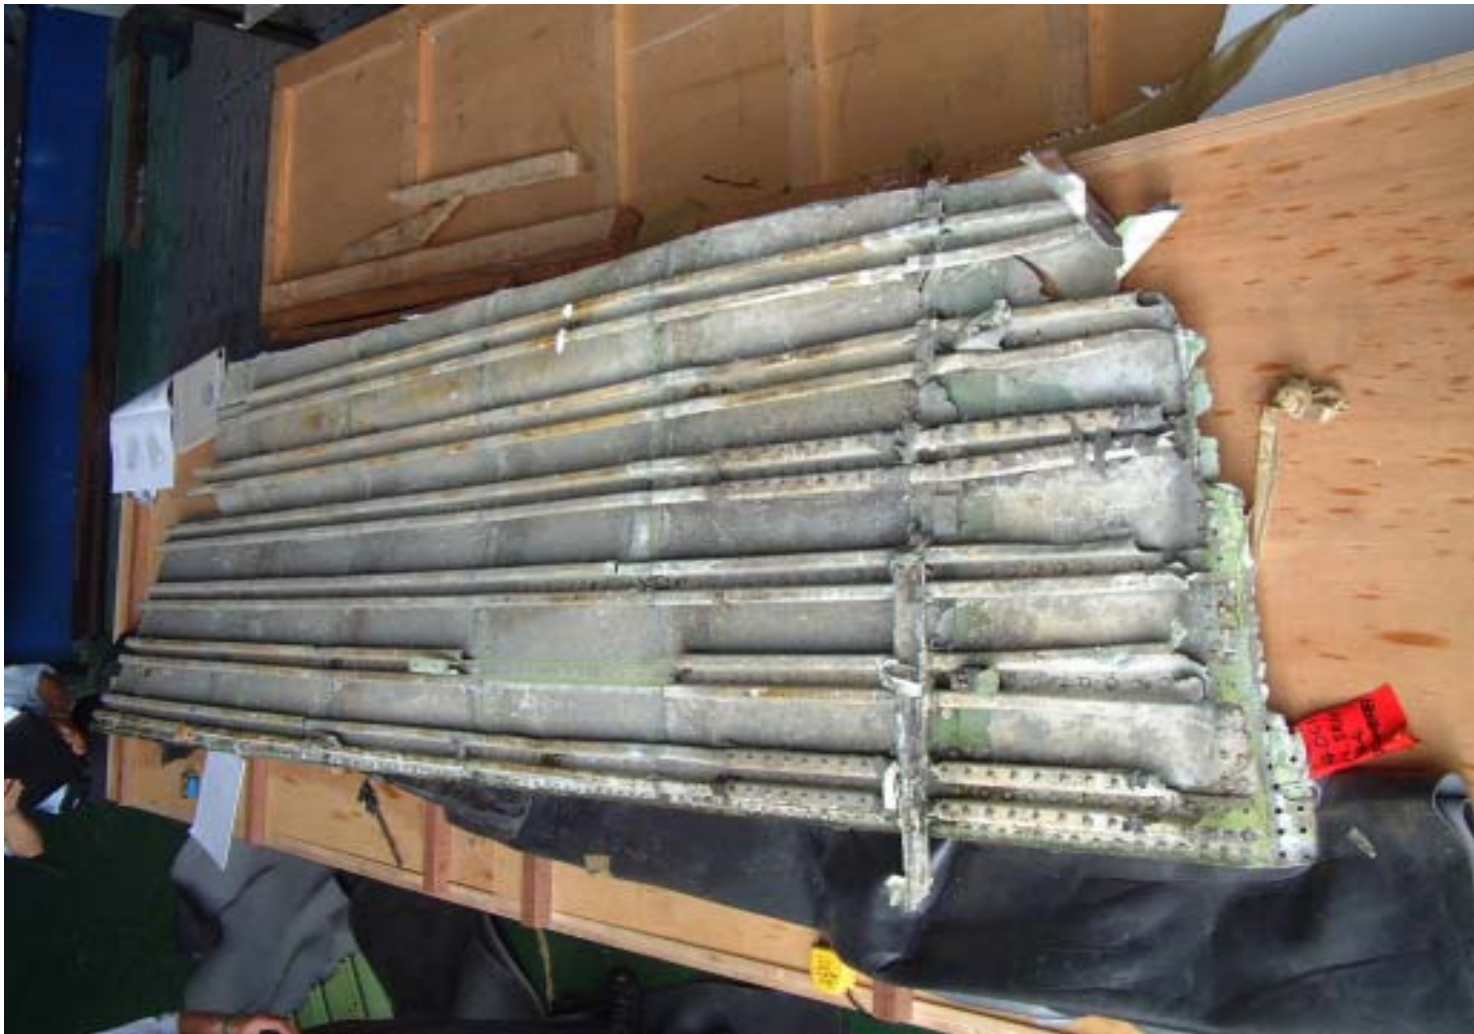
Figure 1.16-37 Interior surface of Item 640C1 as received at CSIST laboratory in Taichung, Taiwan.

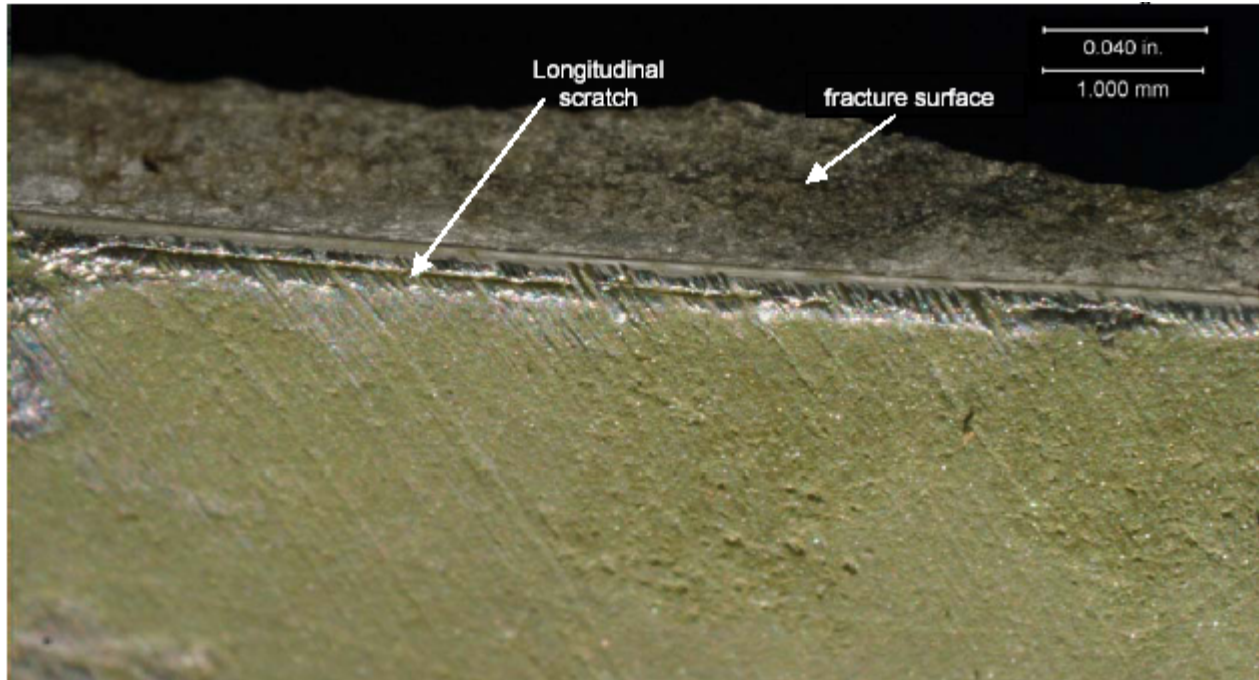
* The crack depth at a local area forward of hole 20 was 5%.

Figure 1.16-41 Surface of skin faying with repair doubler near hole 20 showing the longitudinal scratch where fatigue crack initiation occurred from multiple origins. Also note the sanding marks induced during rework of the skin.

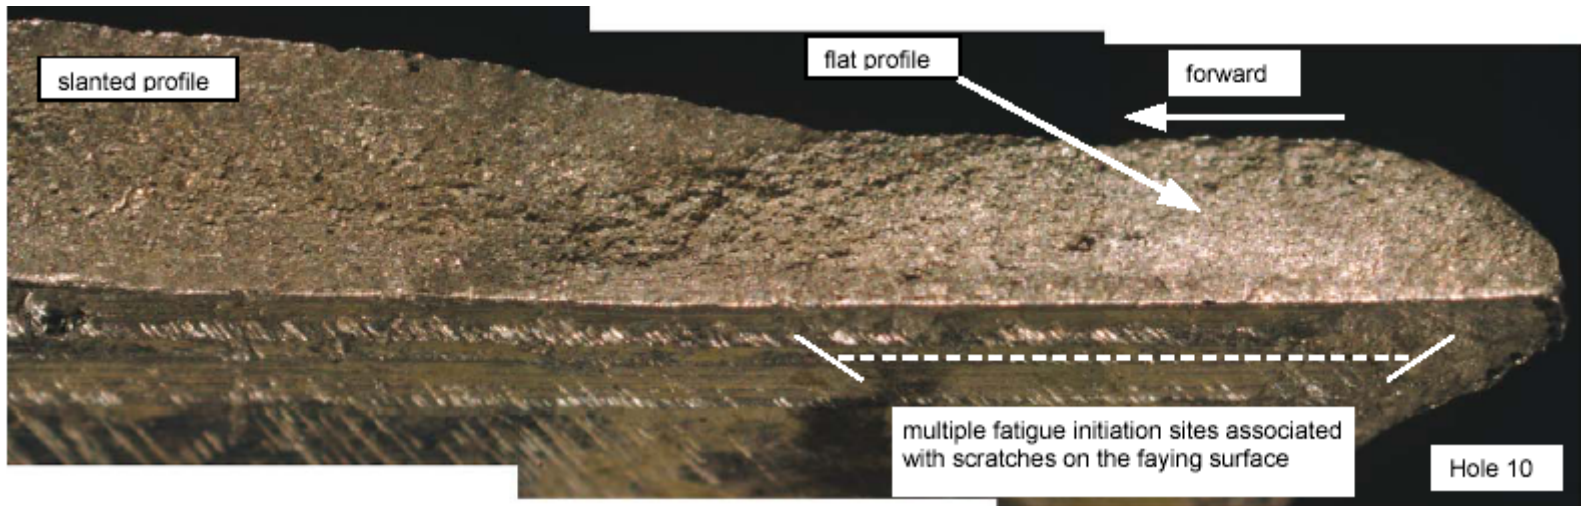
Figure 1.16-45 Photograph showing the transition region from a flat fracture profile to a slanted profile at fastener Hole 10 in the forward direction.

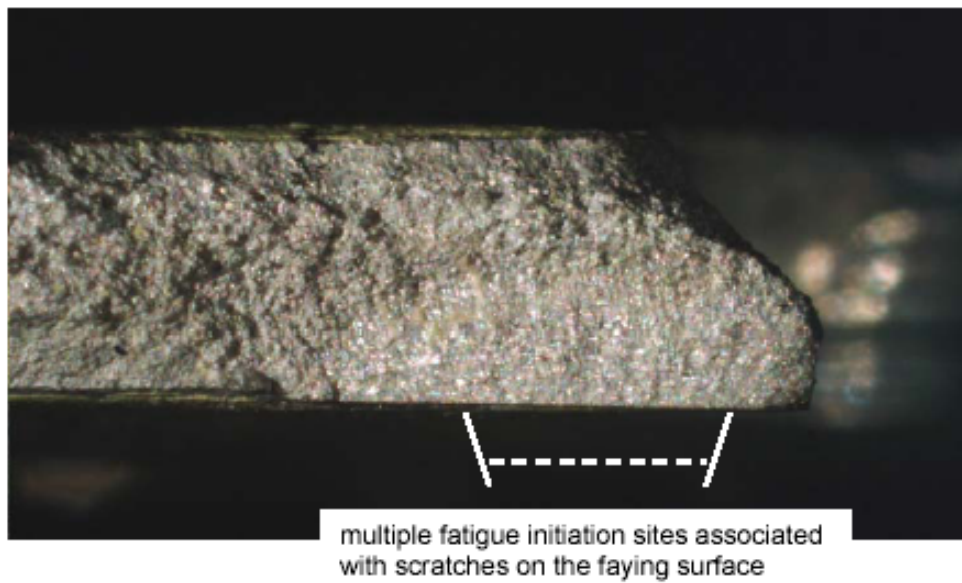
From Hole 4 to Hole 26 the fracture surface generally maintained a flat profile through the skin thickness, with the exception of an intermediate segment between Holes 6 and 10 where the fracture assumed a slanted profile. The forward and aft end of the flat profile fatigue fracture surfaces displayed transition zones where the cracking mechanism changed from plane strain to plane stress conditions. Large transition zones were associated with the forward and aft extension of the main fatigue cracking between holes 10 and 25, as well as the forward extension of the fatigue cracking between holes 4 and 6 (see Figures 1.16-43 through 45). Generally, the smaller flat profile fatigue regions forward of hole 3 and aft of hole 32 displayed relatively brief transition zones. Figures 1.16-46 through 48 demonstrate the very small transition zones at holes +3 and 39.

Figure 1.16-46 Photographs of the fracture segment extending from Hole +3 to +4 (top), and closer view of the flat profile fatigue region on the forward side of Hole +3 (bottom).

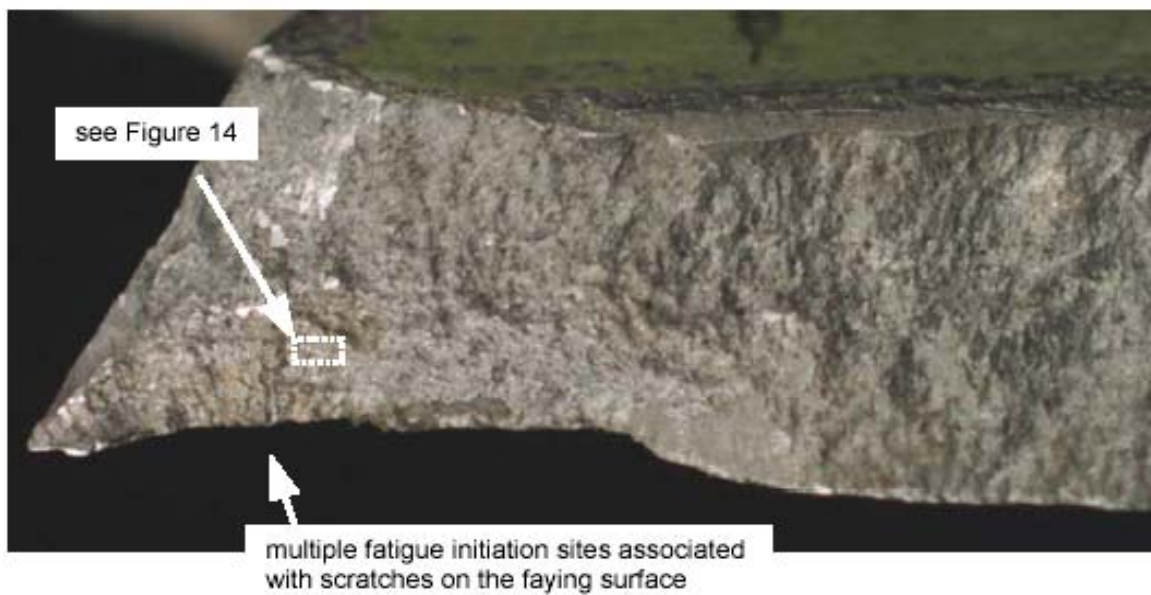
Figure 1.16-47 Photographs of the fracture segment extending from Hole 39 to 40 (top), and closer view of the flat profile fatigue region and short transition zone on the aft side of Hole 39 (bottom). SEM photographs showing an increase in striation spacing near the extent of the flat fracture thumbnail (indicated area) are shown below in Figure 1.16-48.

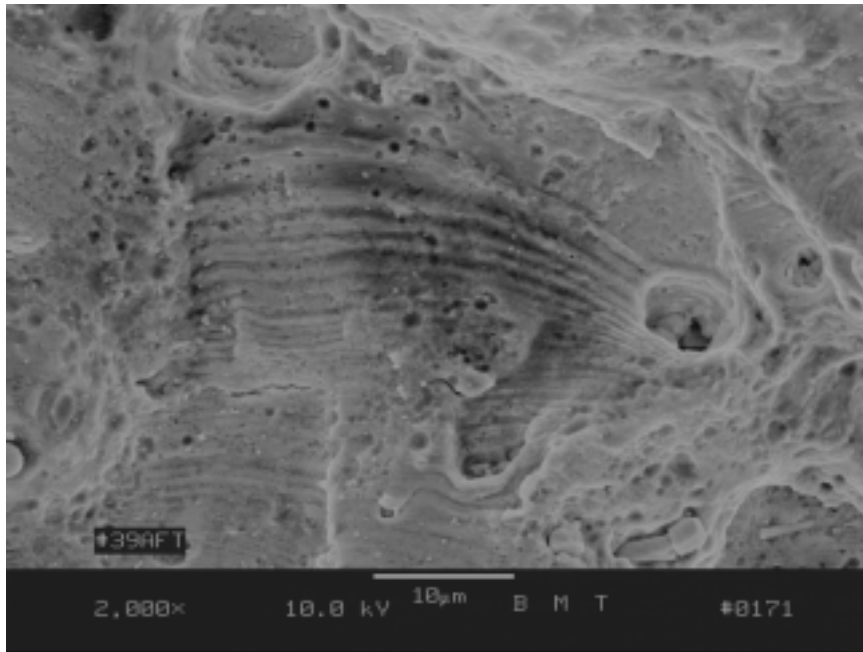
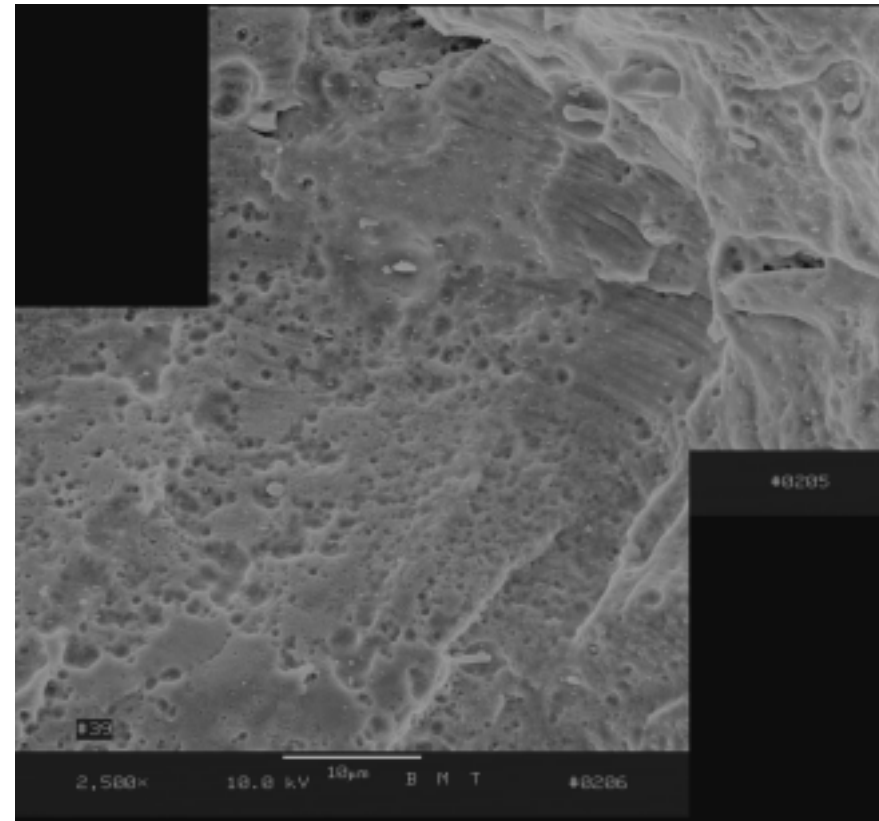
Figure 1.16-48 Scanning electron microscope photographs showing fatigue striations near the end of the flat profile fracture surface aft of Hole 39. Just beyond these regions, the fracture surface was dominated by a dimpled morphology, indicative of the fracture mechanism of micro-void coalescence, or ductile separation. Severe pitting due to corrosion can also be seen.
