**Aviation Safety Council
Taipei, Taiwan**

**CI611 Accident Investigation
Factual Data Collection
Group Report**

Structure Group

ASC-AFR-03-06-001

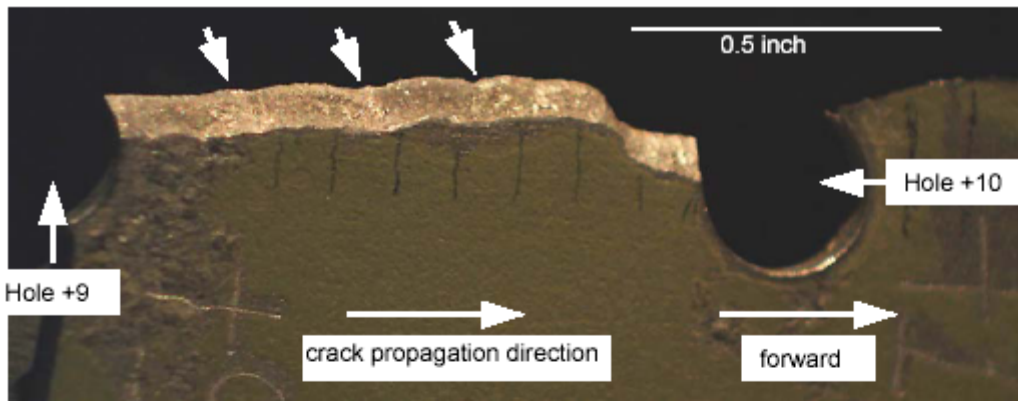
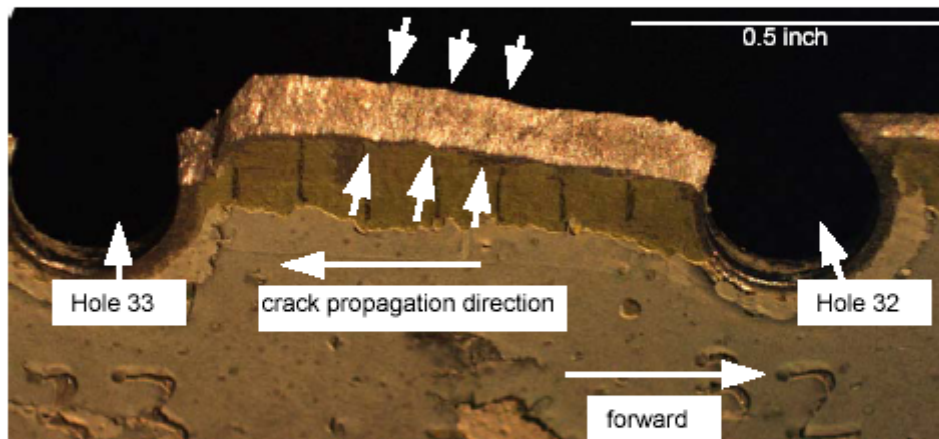
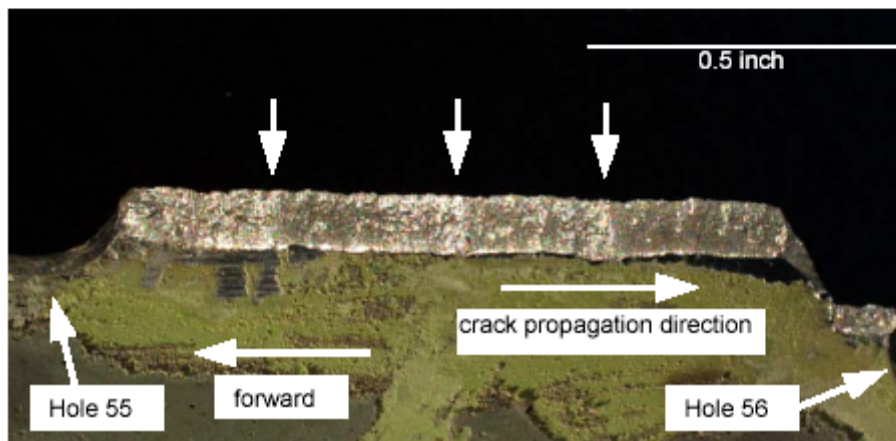
Beyond the flat profile and transition zones of the main fatigue areas, the fracture surface contained numerous segments that displayed indications of incremental crack growth that could be observed visually or with the aid of low power optical instrumentation (Figures 1.16-49 and 1.16-50). In general, these indications were observed to increase in spacing as the distance from the flat profile fatigue regions increased in both the forward and aft directions. Such features were also observed on the fracture face between holes 6 and 10 with

Figure 1.16-50 Photographs showing the incremental crack growth indications on the fracture segments between Holes +9 and +10 (top), Holes 32 and 33 (center), and Holes 55 and 56 (bottom).

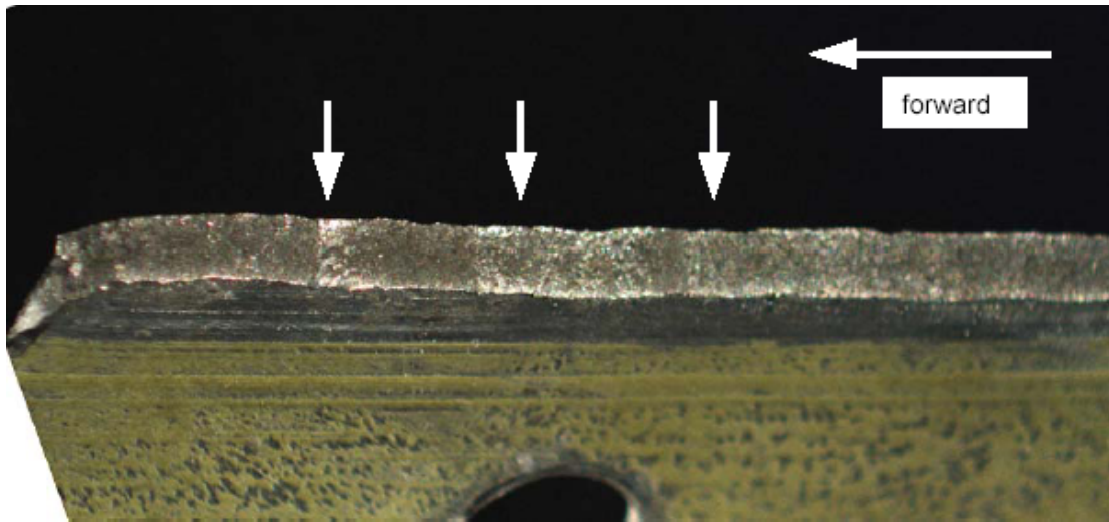
increasing spacing in the forward direction (Figure 1.16-51). Incremental crack growth indications were observed as far forward as approximately STA 2055 and as far aft as hole 56 (STA 2140).

Figure 1.16-51 Photograph showing the incremental crack growth indications (arrows) on the fracture segment near Hole 7, which is between the two main fatigue cracking systems at Holes 4 and 5 and Holes 10 through 25.

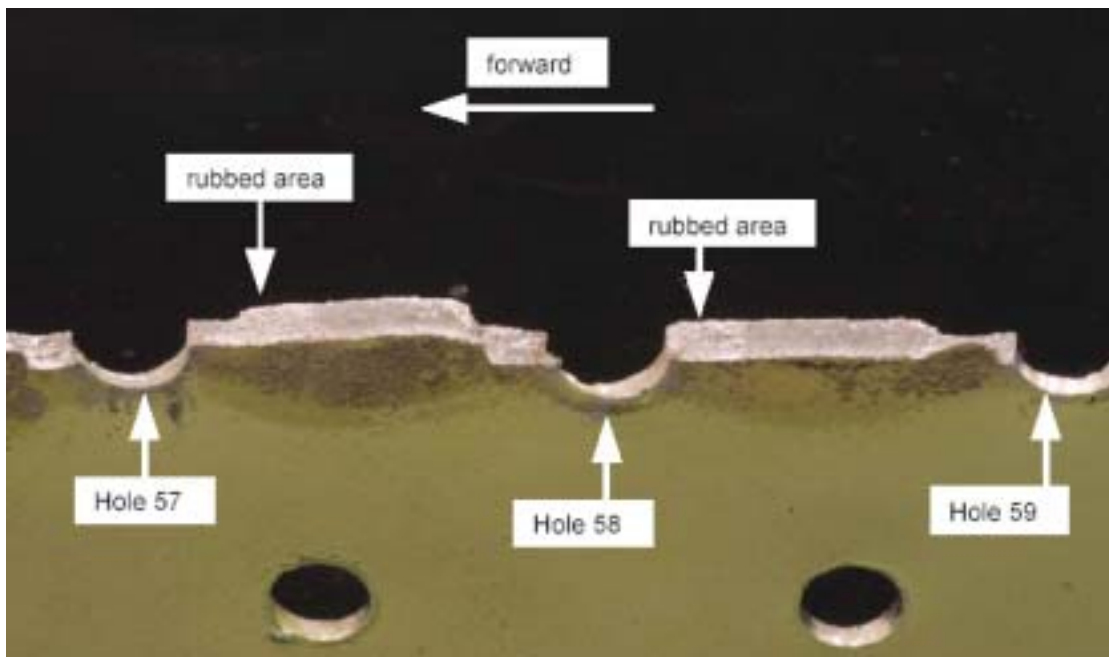
Rubbing of the fracture surface and associated compression deformation of the cladding was observed along the faying surface. Figure 1.16-52 shows the visible appearance of the fracture surface near holes 57, 58, and 59. The significant amounts of cladding were missing in the area of the panel coincident with the scratches. However, all areas where cladding remained forward and aft of the main fatigue cracking displayed compressive deformation consistent with crack closure as far forward as hole +17 and as far aft as hole 62. Figures 1.16-53 through 55 are SEM photographs showing the appearance of such aluminum cladding deformation. The remaining fracture aft of hole 62 displayed “necking”, which is typical of continuous tensile loading to ultimate tensile separation (Figure 1.16-56). The distance from the forward most incremental crack growth indication (STA 2055) to hole 62 is approximately 93.75 inches.

Figure 1.16-52 Photograph of the fracture surface at Holes 57, 58, and 59. The shiny areas are indicative of rubbing with the mating fracture surface and appeared consistently forward of this area, but were not present aftward beyond Hole 62.

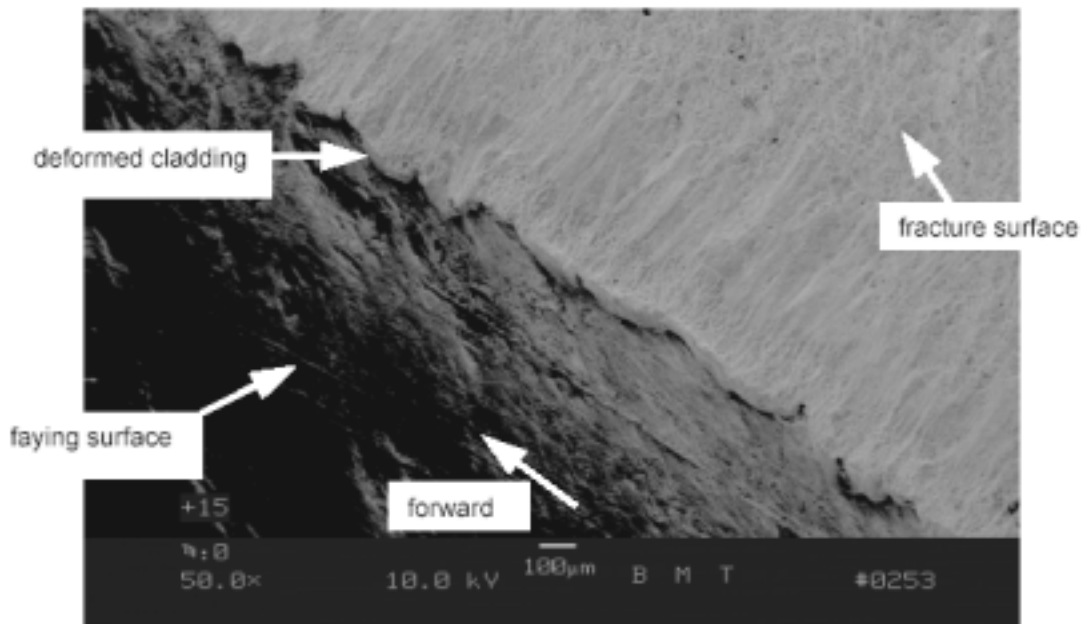
Figure 1.16-54 SEM photograph showing the compressive deformation of the cladding just forward of Hole +15.

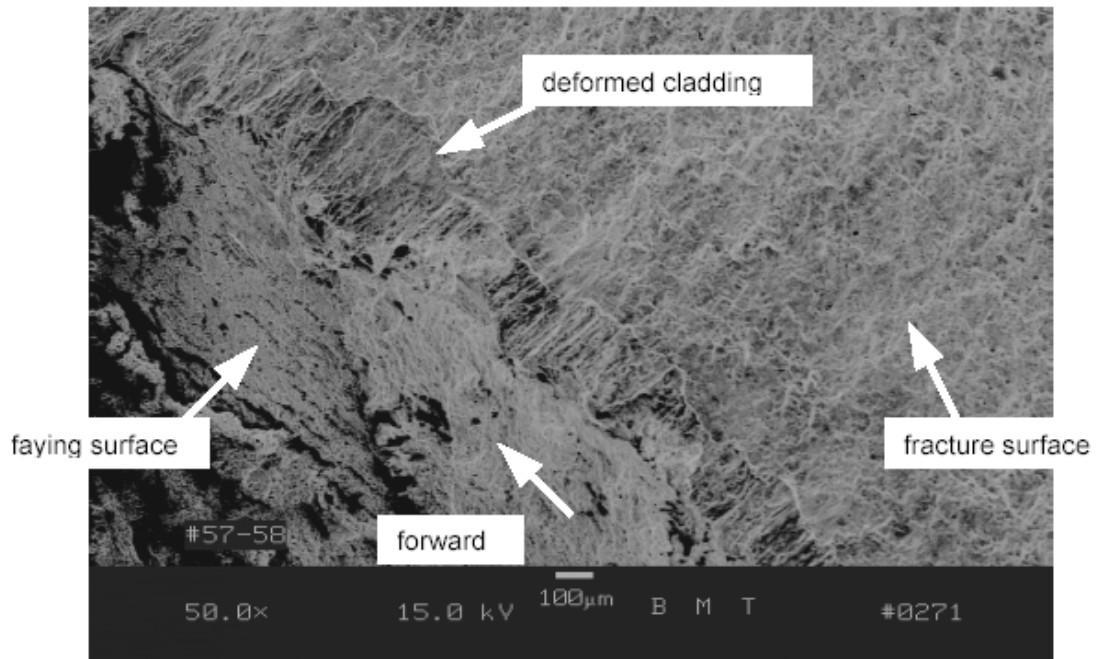
Figure 1.16-55 SEM photograph showing the compressive deformation of the cladding between Holes 57 and 58. Note that the degree of compressive damage is less severe than that observed closer to the main cracking system, Figure 1.16-53 for example.

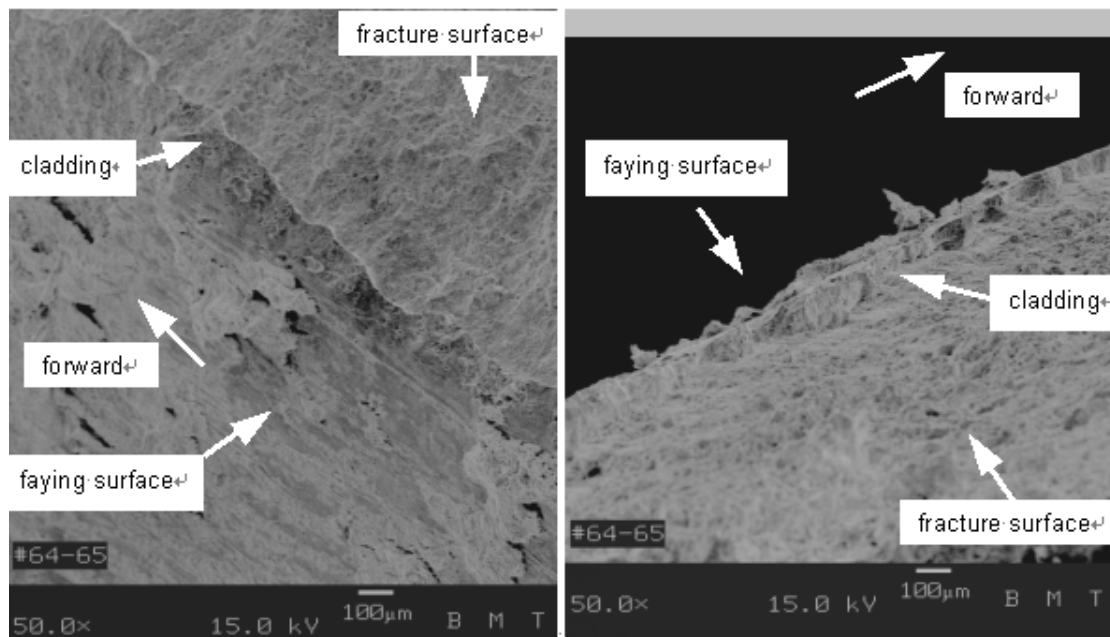
Figure 1.16-56 Opposing angle SEM photographs of the fracture segment between Holes 64 and 65 showing the cladding on the faying surface retaining its upward profile from the necking process during ultimate tensile separation without subsequent crack closure.

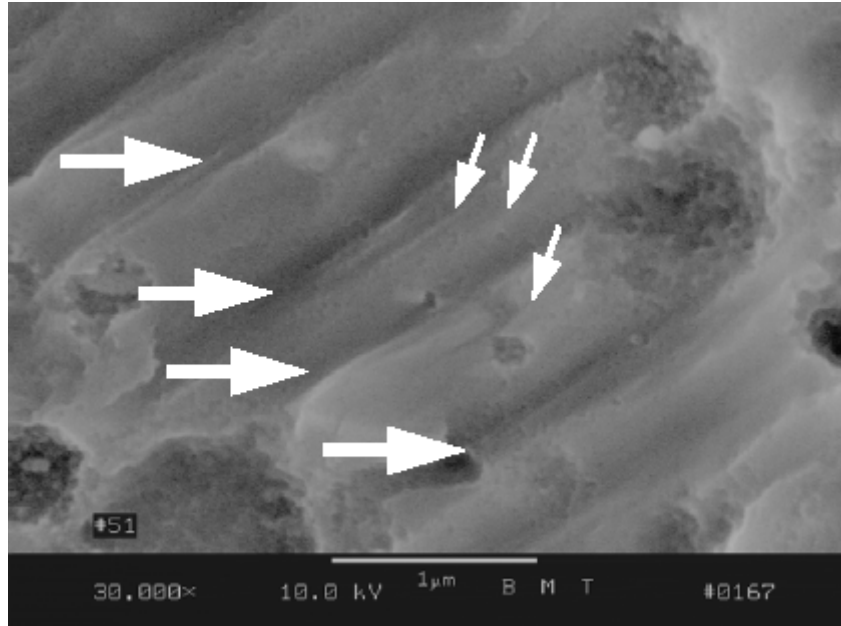
Although much of the fracture suffered from heavy corrosion, fatigue striations were resolved by SEM in many local areas of the fatigue cracking regions as described in Figures 1.16-39 and 1.16-40. Striation counting was performed at a number of locations along the flat profile fatigue regions of the fracture. Since the fracture surface was not continuous from a single fatigue initiation origin to the ultimate extent of stage II (striation producing) cracking, it was not possible to estimate a time of initiation. Instead, the nature of cracking on this detail provided numerous initiation sites along scratches on the faying surface, with subsequent propagation in the through-thickness direction. Because cyclic cabin pressure is the prevailing driving force for cracking at this detail, each striation is considered to represent the microscopic crack advancement during one flight cycle of the airplane. Thus, striation counting was performed in order to obtain an estimate of the number of flight cycles that contributed to the fatigue crack propagation through the material thickness. CSIST reported the observation of “major” and “minor” striations. These minor striation-like features are shown in Figure 1.16-57 and were ignored for striation counting purposes.

Figure 1.16-57 SEM photograph showing minor striation-like features (indicated with smaller arrows).

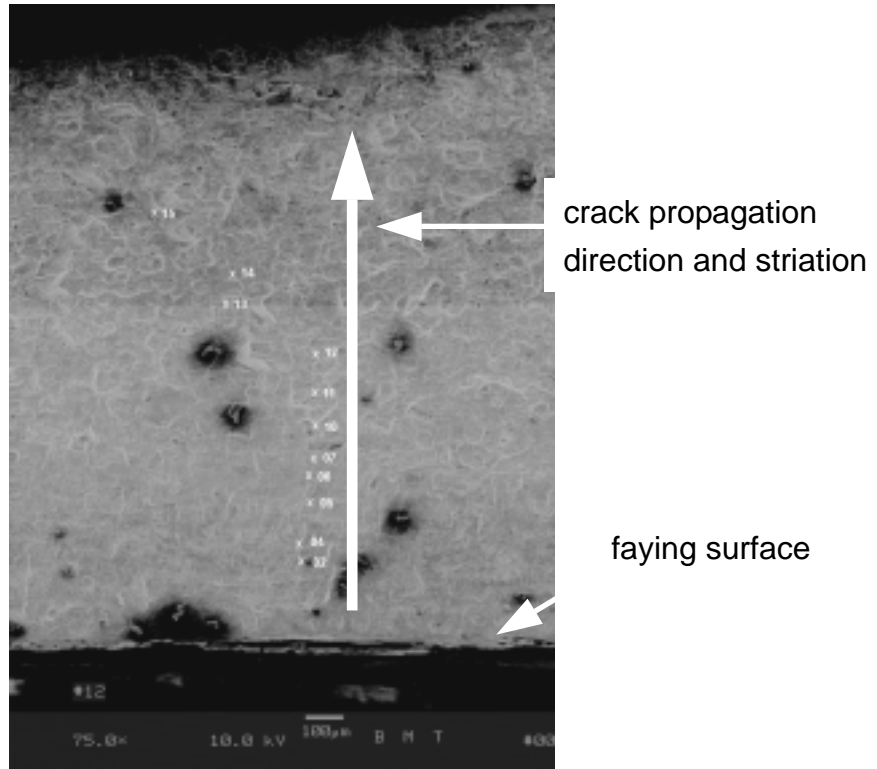
across the fracture at several points between the skin surfaces was made by sampling striation spacing with SEM photographs (Figure 1.16-58). For determining the crack length at each sample point, x and y Cartesian coordinates generated by the SEM stage were recorded and compared with a reference slope using an analytical geometrical approach. Striation spacing was determined by direct measurement from a photograph at each sampling location. The data was reduced and calculated by employing a trapezoidal integration method, whereby the number of cycles between two successive data points is equal to the distance divided by the average striation spacing (half of the sum of the growth rates at the two points). Although this approach may not precisely represent actual cracking behavior, it removes some of the subjectivity of assigning best-fit curves to widely scattered data points and can provide useful information, given an understanding of its limitations.

Figure 1.16-58 SEM photograph showing the locations through the skin thickness that were sampled for crack growth rate at Hole 12. The approach was repeated for other through-thickness areas

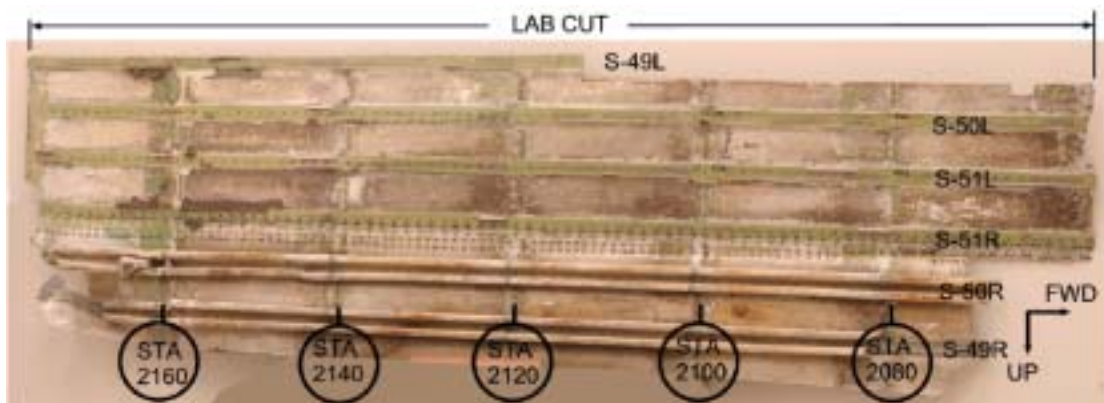
Photographs showing features of the as-received item 640 C1 skin inboard and outboard (repair faying surface) surfaces are shown in Figures 1.16-59 and 60 respectively. Protective finishes had previously been removed from much of the repair faying surface at the CSIST to enable examination of skin damage consistent with a tail strike event. Close-up photographs displaying the extent of damage consistent with a tail strike are shown in Figures 1.16-61

Figure 1.16-59 As received item 640 CI skin inboard surface- the S-49L fracture segment was removed at the CSIST during the initial examination.

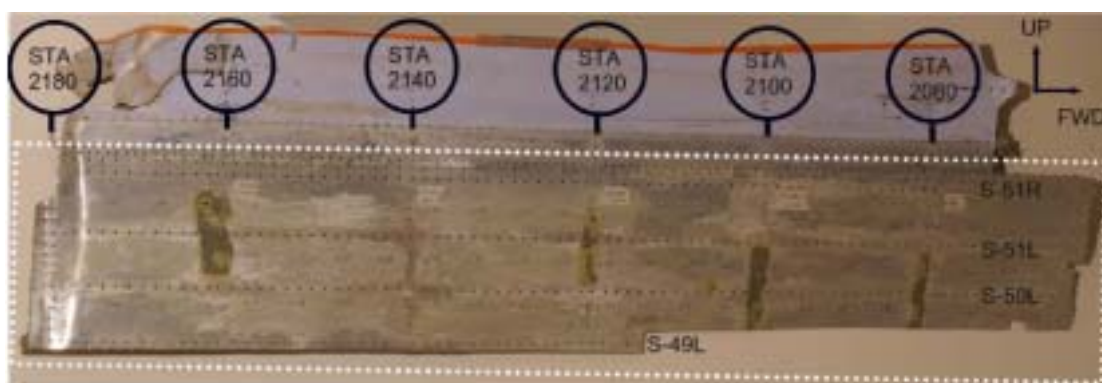
Figure 1.16-60 As received item 640 CI skin outboard surface – the approximate location of the repair doubler is shown with dotted lines. Protective finishes were removed from the repair faying surface at the CSIST.

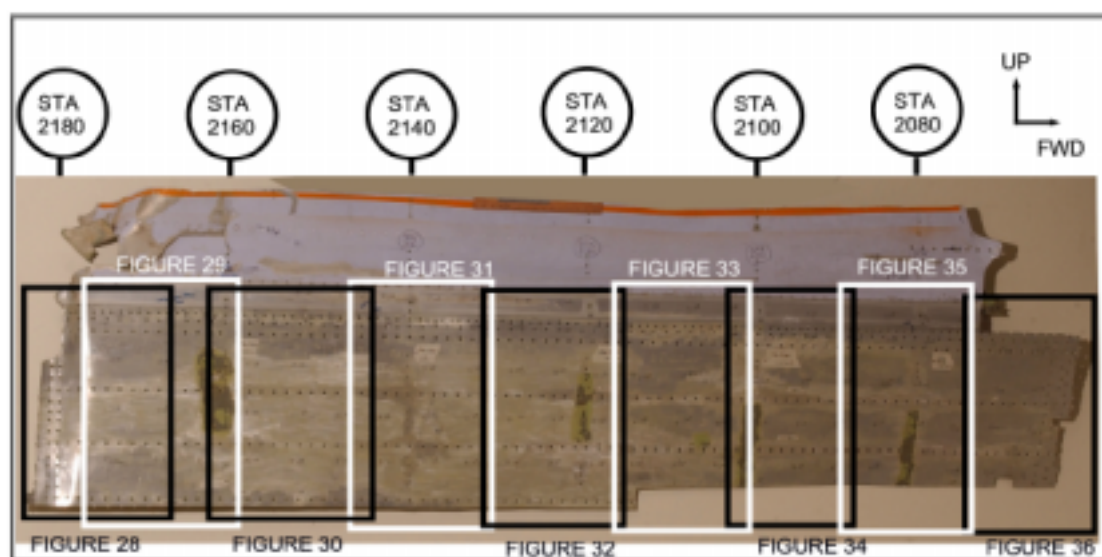
through 70. This damage consists primarily of fore to aft (longitudinal) scratching with the most severe scratching typically occurring at the location of skin stiffening members such as skin stringers and body frame shear ties. Figure 1.16-71 displays the location of the most severe skin damage. As noted in this photograph, the most severe damage consistent with a tail strike occurred on the left hand side of the airplane in the area covered by the repair doubler. Evidence of rework sanding marks was noted over much of the repair surface.

Figure 1.16-61 Scratch photograph legend– This illustration identifies the location of following photographs that document scratch features observed on the skin repair faying surface. Scratches are fore/aft in orientation and characteristic of a tail strike event.

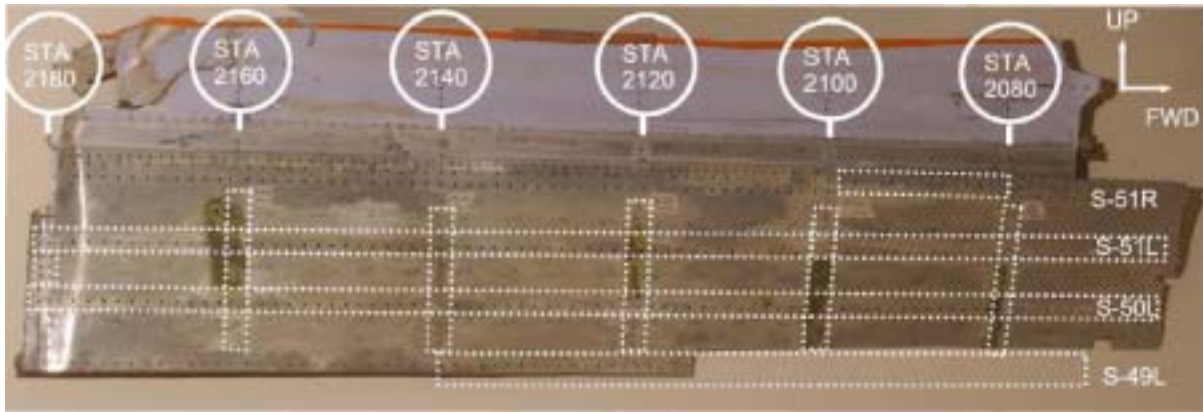
Figure 1.16-71 Areas of most severe skin damage- Scratch severity was greatest in the left hand/forward area of the skin.

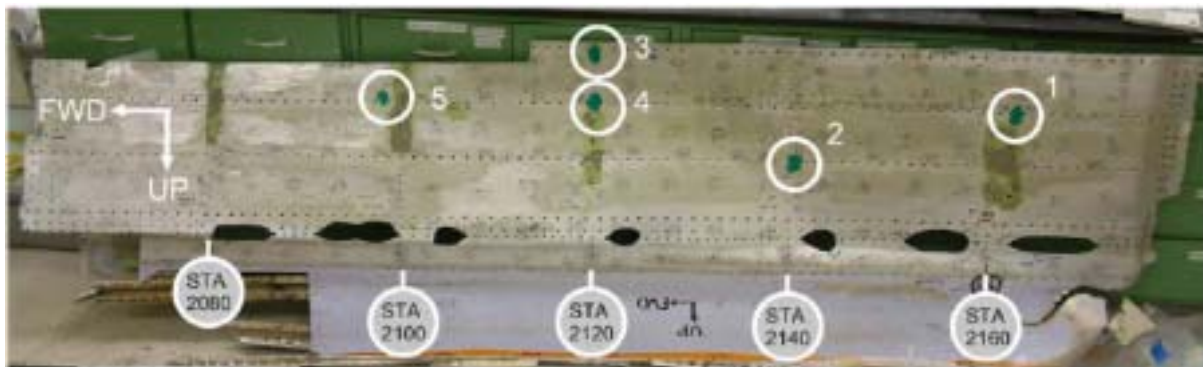
Figure 1.16-72 Location of scratch replication areas

A surface replication medium was applied at five locations on the skin repair faying surface as shown in Figure 1.16-72 to examine scratch geometry and depth. The locations were chosen to display surface features typical to areas exhibiting major scratching. This medium creates a "positive" of the surface it is applied to, enabling direct feature measurement from the replica. The maximum scratch depth measured with this technique was 0.0096 inch. Composite photographs exhibiting scratch profiles at locations noted above are shown in Figures 1.16-73 and 74.

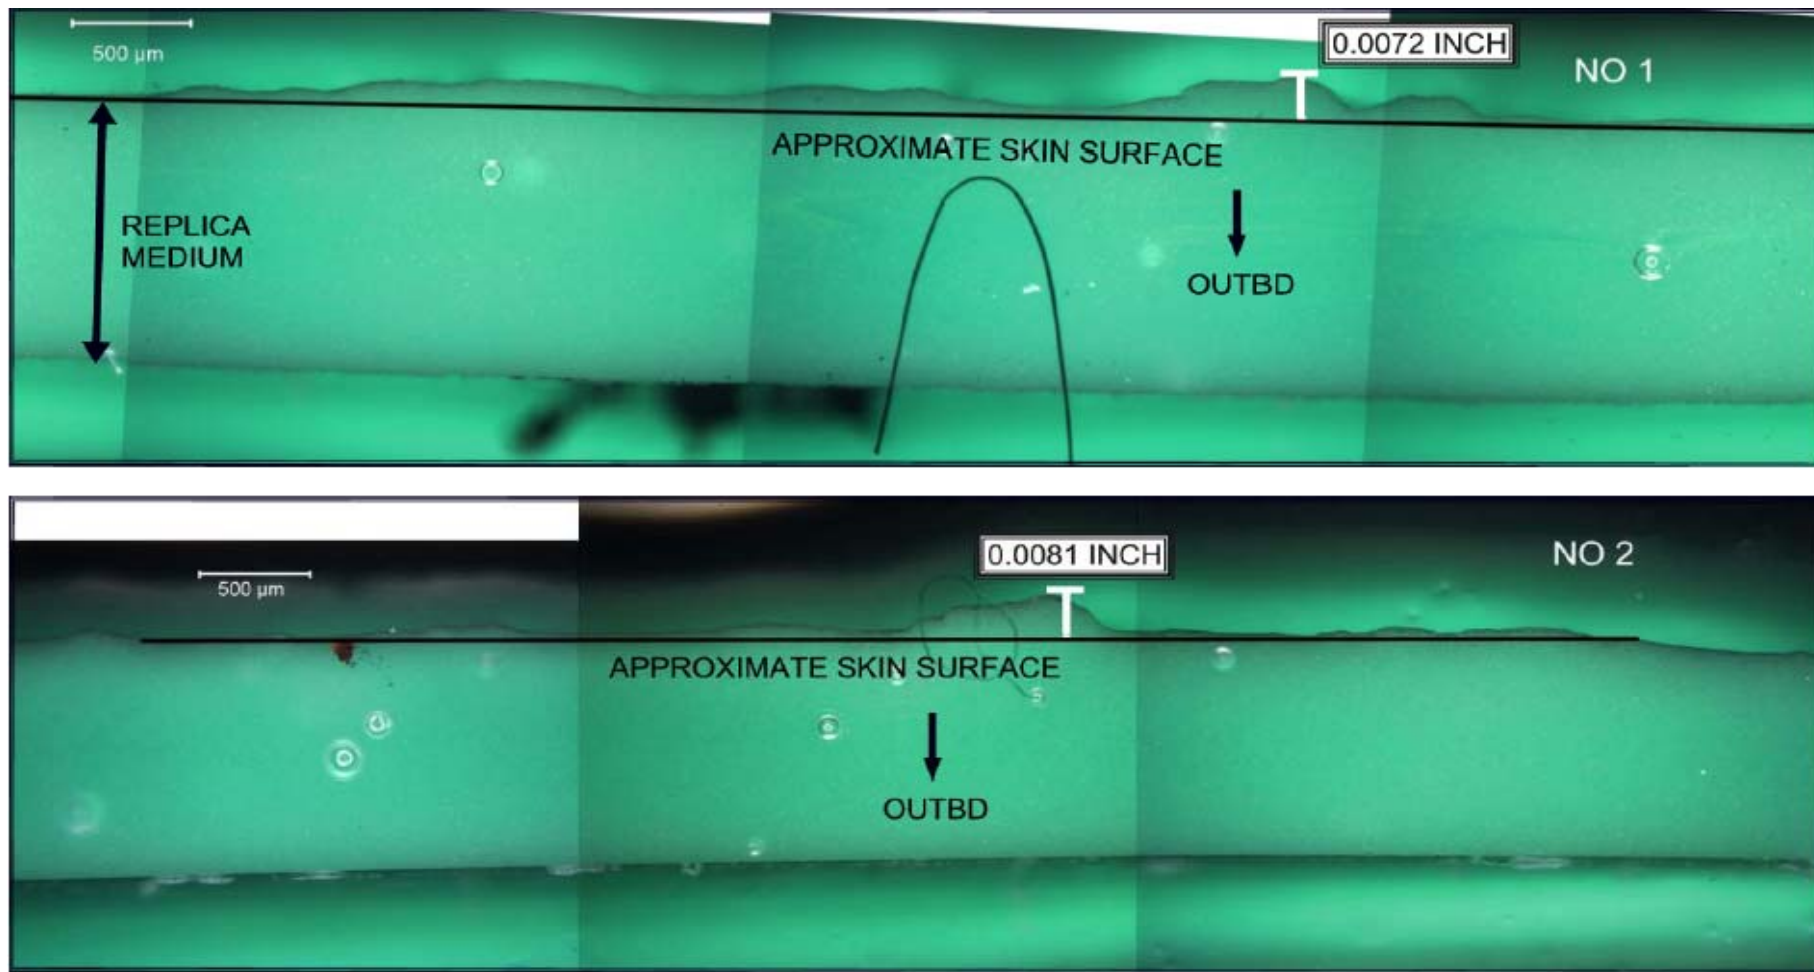
Figure 1.16-73 Scratch profile composite photographs- the replication medium creates a “positive” of the skin scratches. Scratch features of replica locations 1 and 2 are shown above.

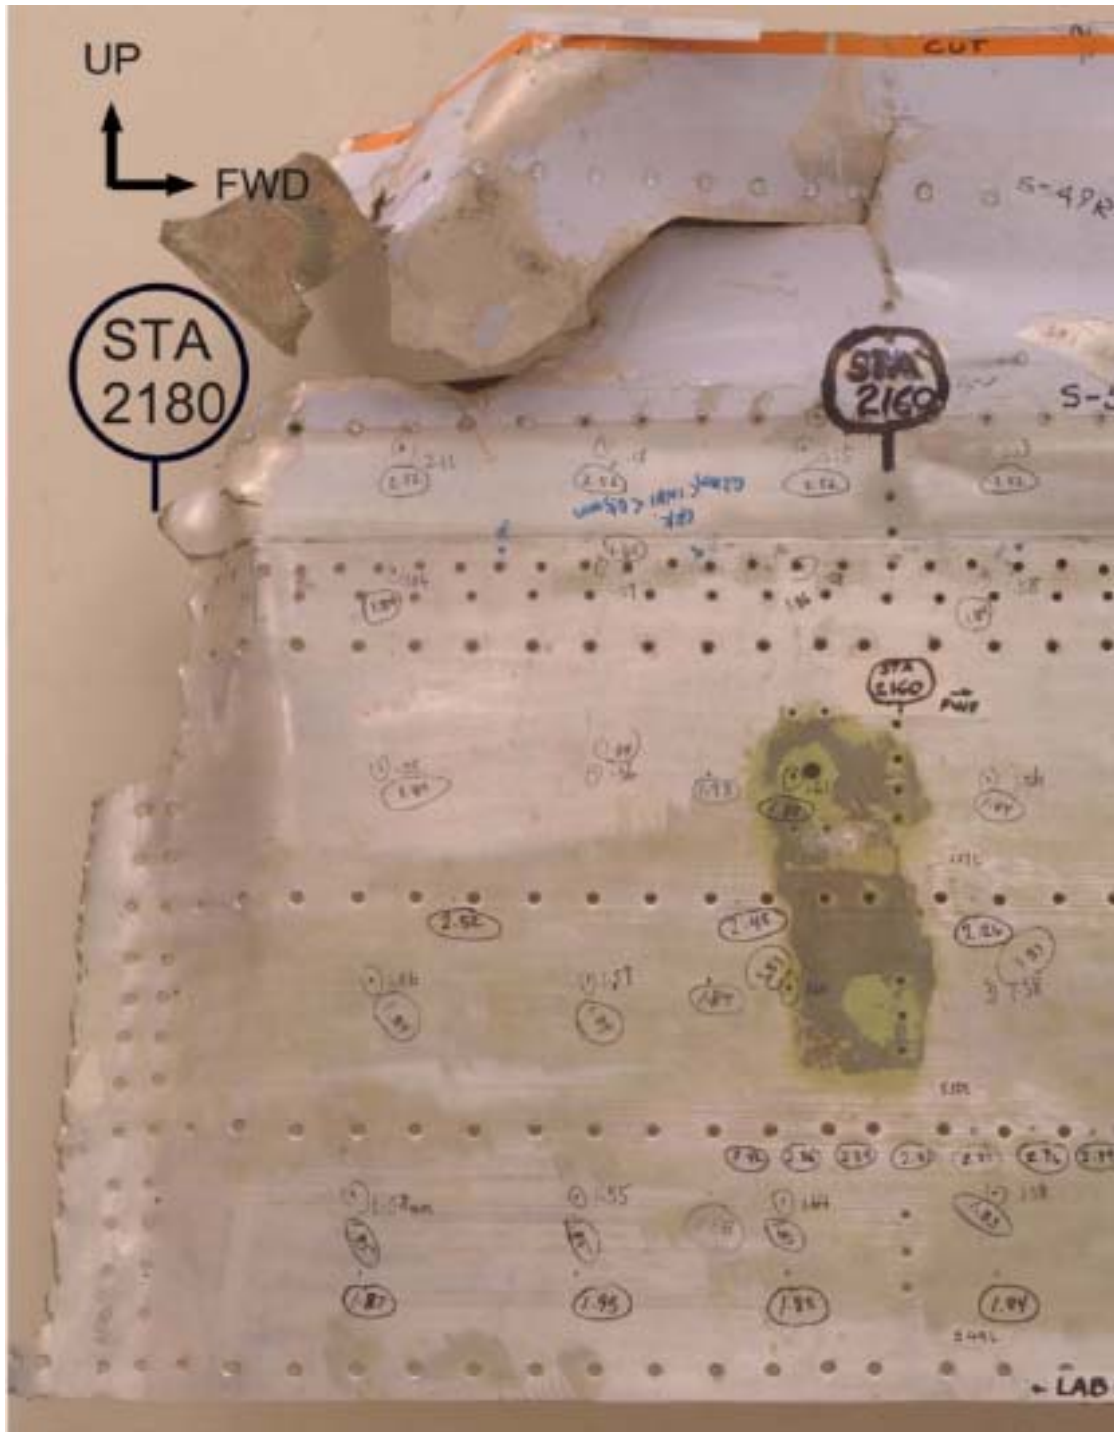
Figure 1.16-75 Skin thickness measurements- All measurements are in millimeters. Circled values were performed at Boeing

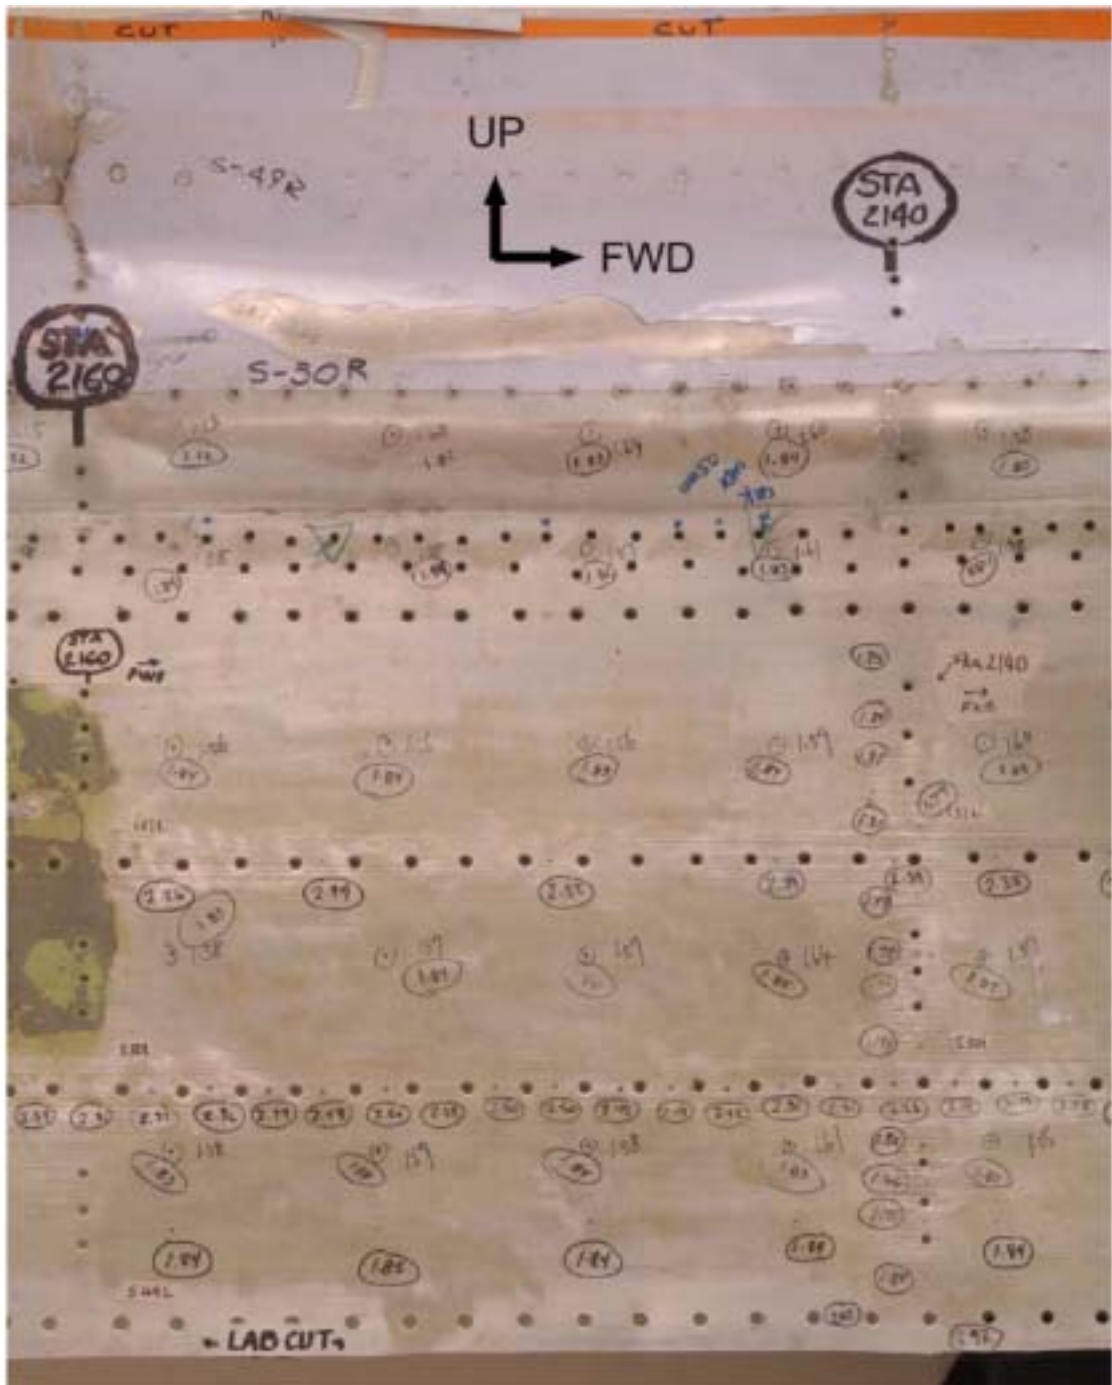
Figure 1.16-76 Skin thickness measurements- All measurements are in millimeters. Circled values were performed at Boeing.

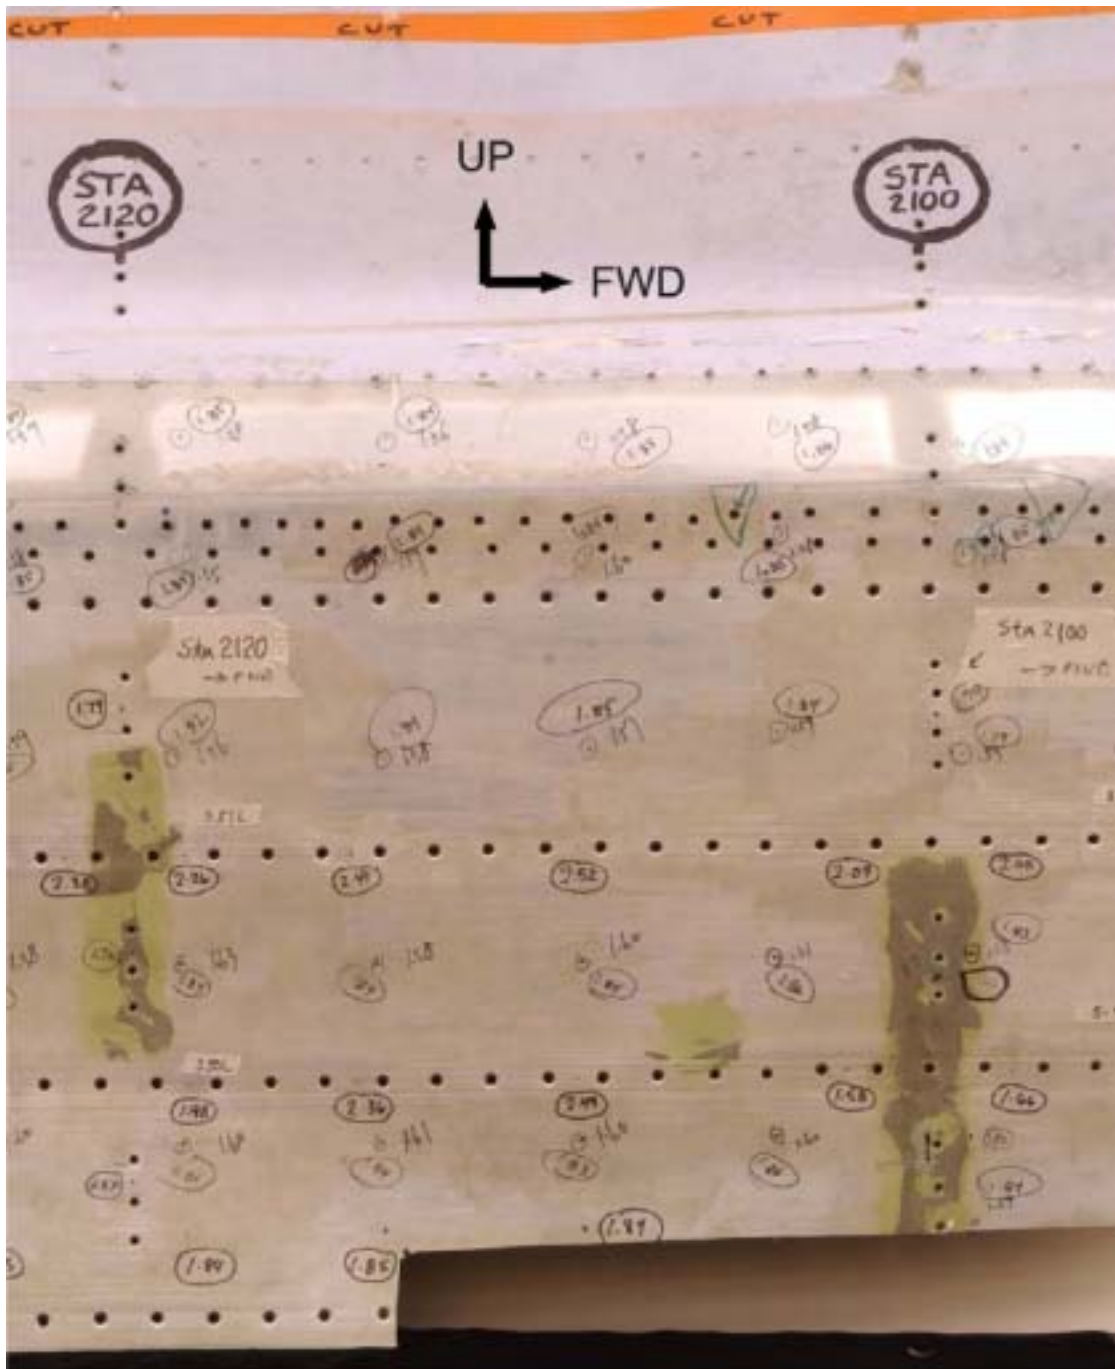
Figure 1.16-78 Skin thickness measurements- All measurements are in millimeters. Circled values were performed at Boeing.

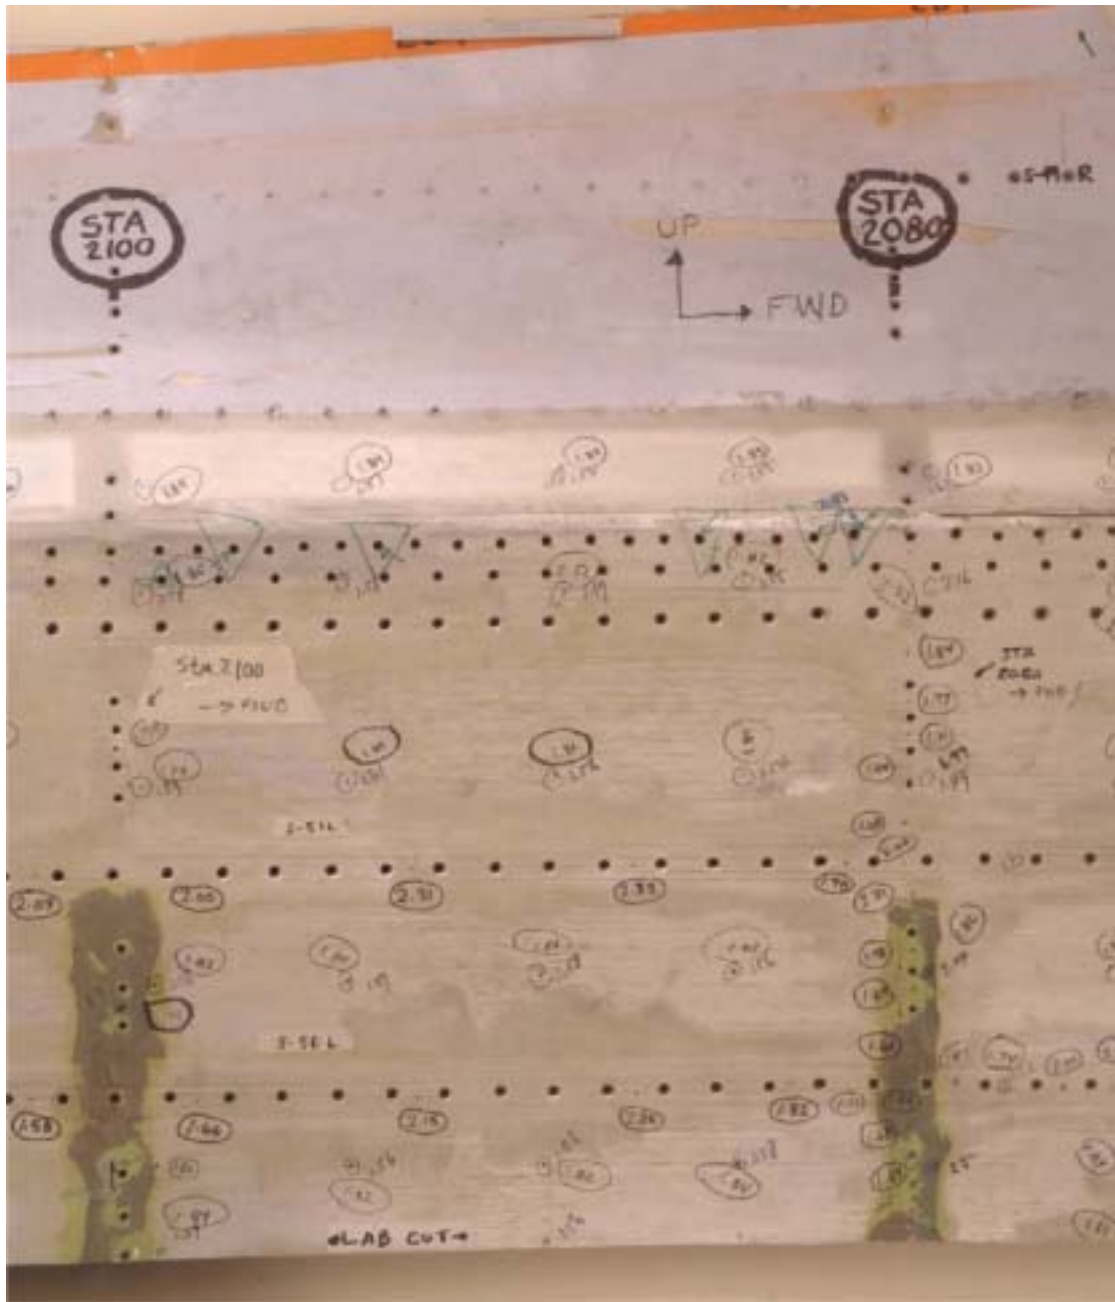
Figure 1.16-79 Skin thickness measurements- All measurements are in millimeters. Circled values were performed at Boeing.

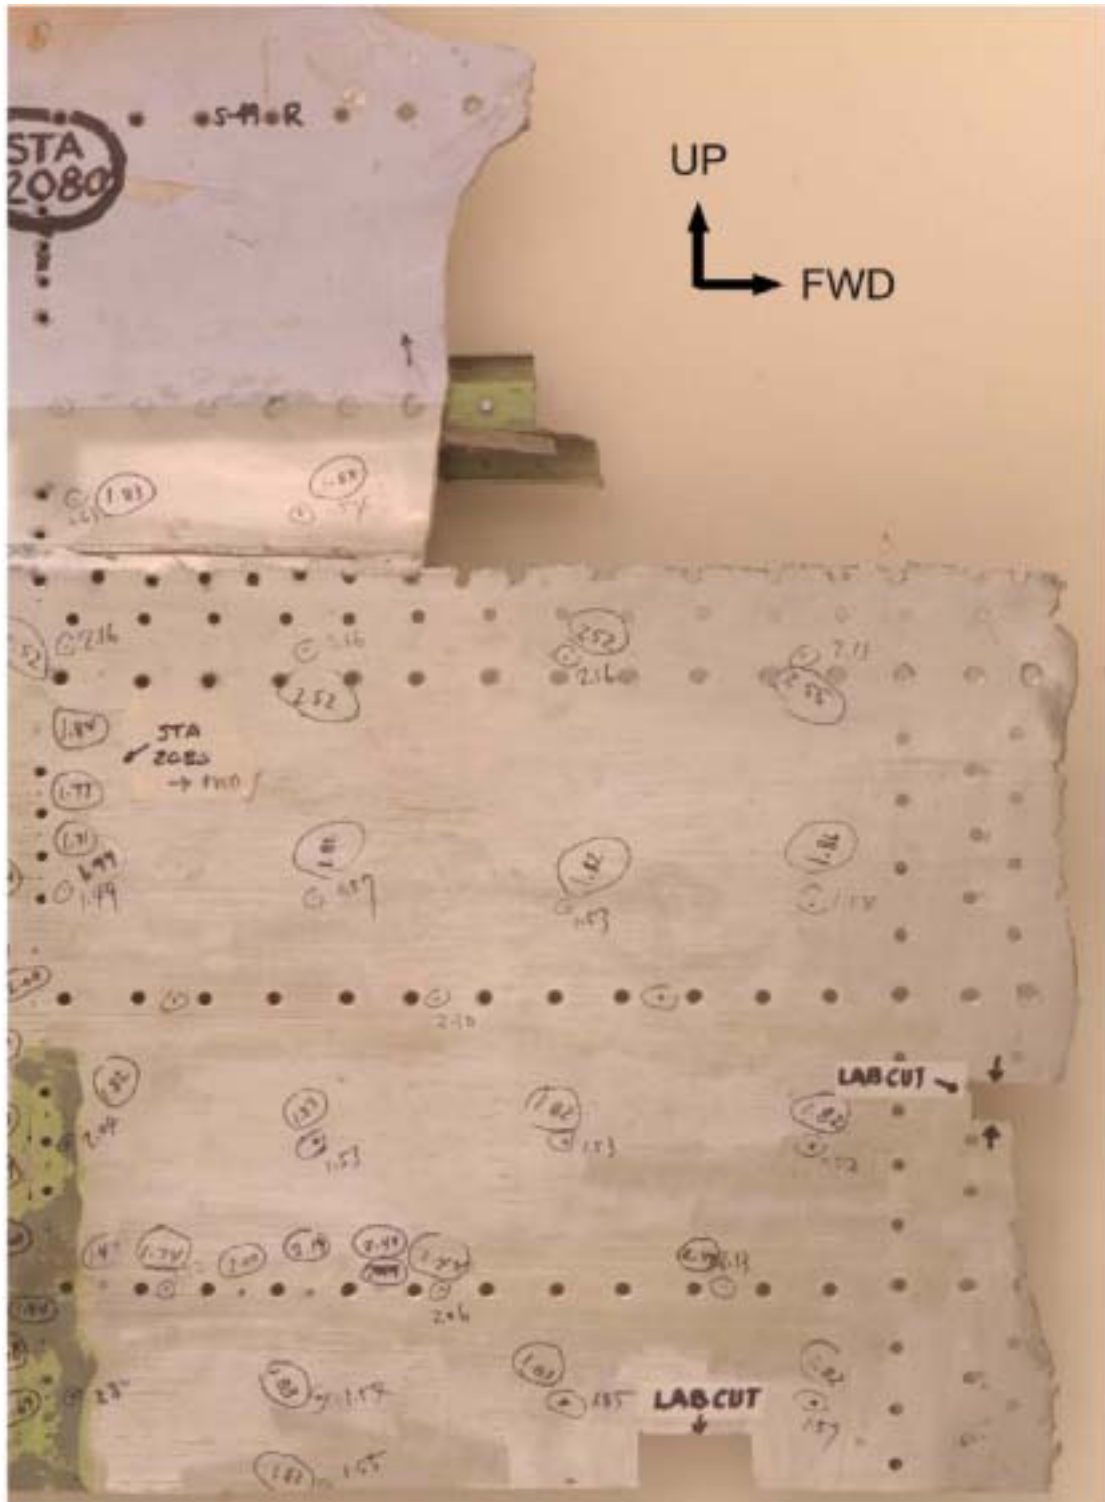
Figure 1.16-80 Skin thickness measurements- All measurements are in millimeters. Circled values were performed at Boeing.

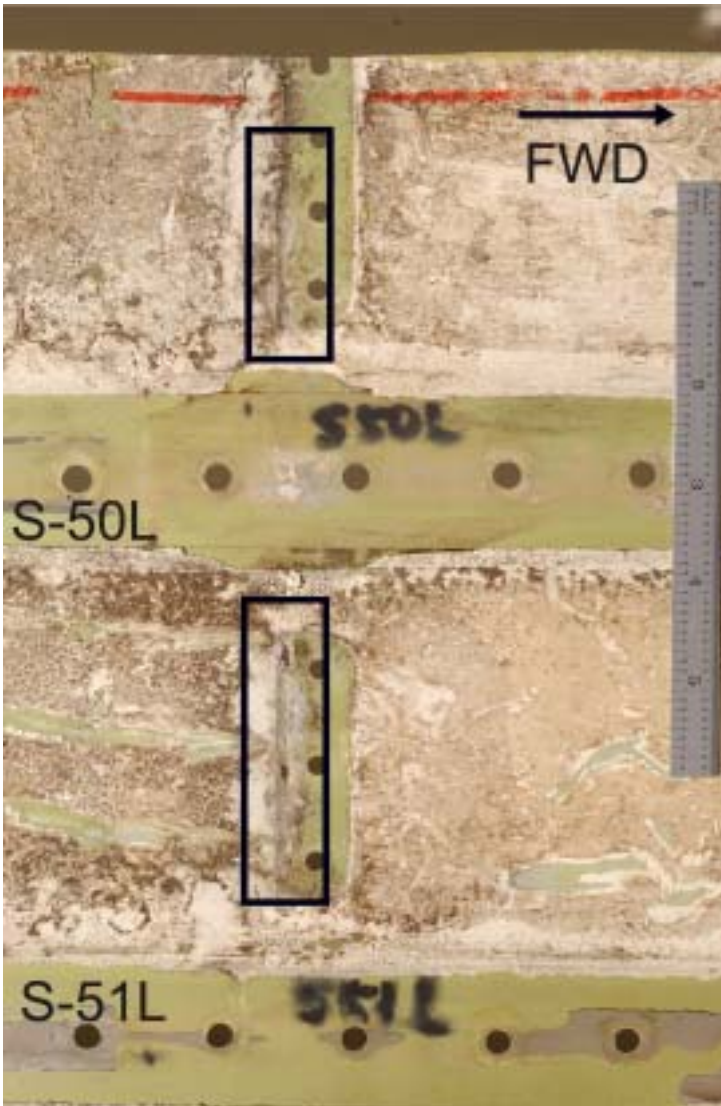
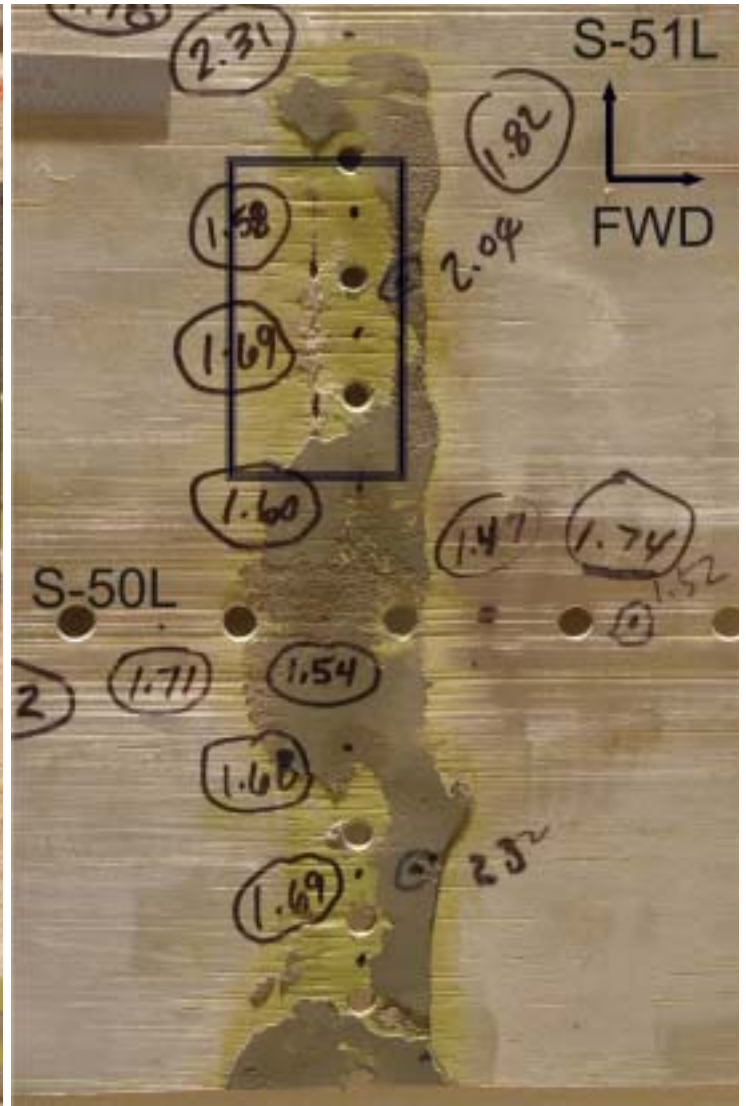
Corrosion was noted at several shear tie locations on the skin inboard surface sometimes penetrating completely through the skin thickness. Photographs displaying these corrosion features are shown in Figures 1.16-81 through 1.16-83. Table 1.16-8 records visual observations of these features.

Figure 1.16-81 Skin corrosion features at STA 2080 - Areas of corrosion are identified with rectangles above. Corrosion penetrated completely through the skin thickness at the shear tie located between S-50L and S-51L.
