**Aviation Safety Council
Taipei, Taiwan**

**CI611 Accident Investigation
Factual Data Collection
Group Report**

Structure Group

ASC-AFR-03-06-001

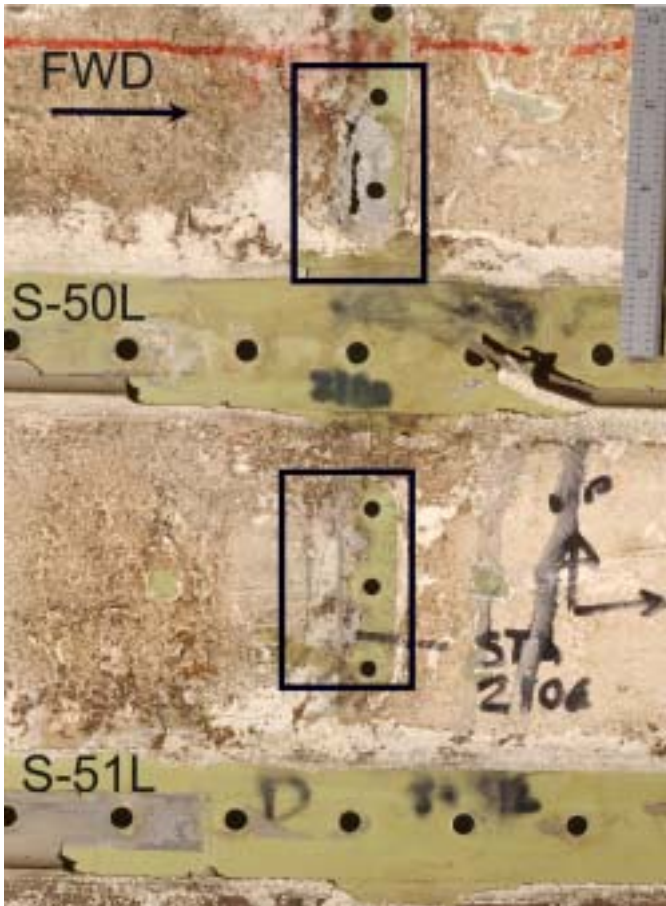
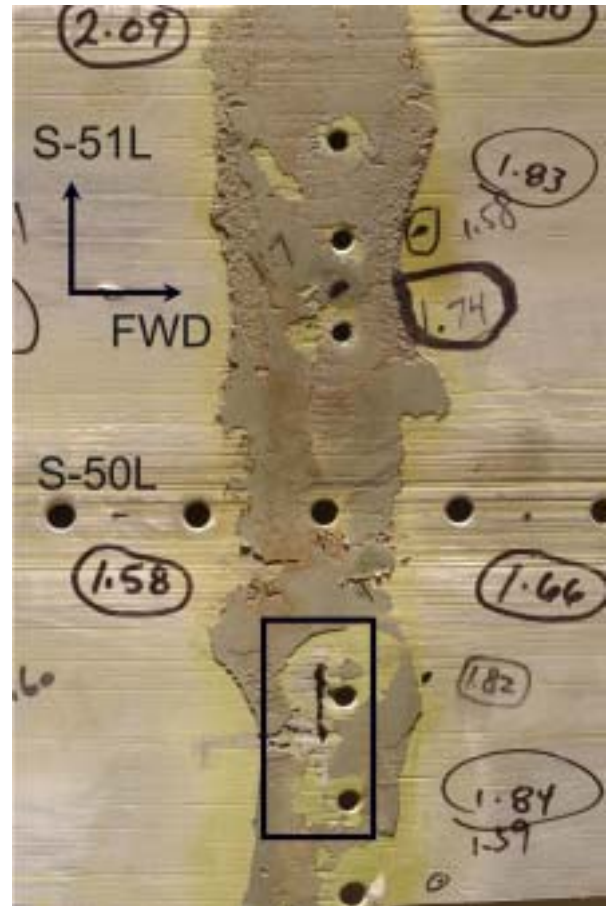
Corrosion was noted at several shear tie locations on the skin inboard surface sometimes penetrating completely through the skin thickness. Photographs displaying these corrosion features are shown in Figures 1.16-81 through 1.16-83. Table 1.16-8 records visual observations of these features.

Figure 1.16-82 Skin corrosion features at STA 2100 - Areas of corrosion are highlighted with rectangles. Corrosion penetrated completely through the skin thickness between S-49L and S-50L.

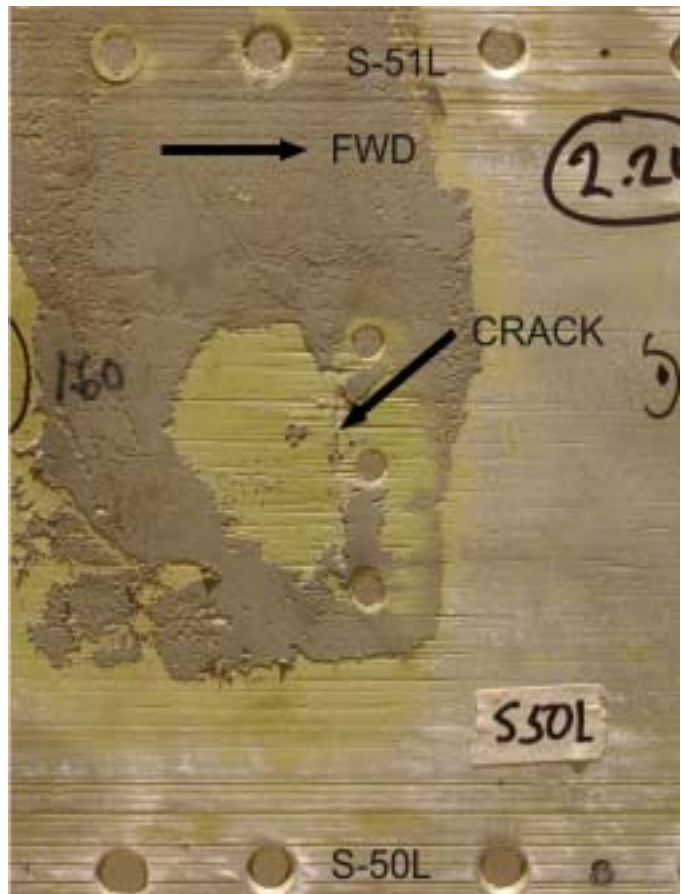
Figure 1.16-83 Corrosion features at STA 2160, inboard surface - The area of corrosion is identified with a rectangle above. A crack noted on the skin faying surface may have been the result of exfoliation corrosion penetrating from the skin inboard surface.

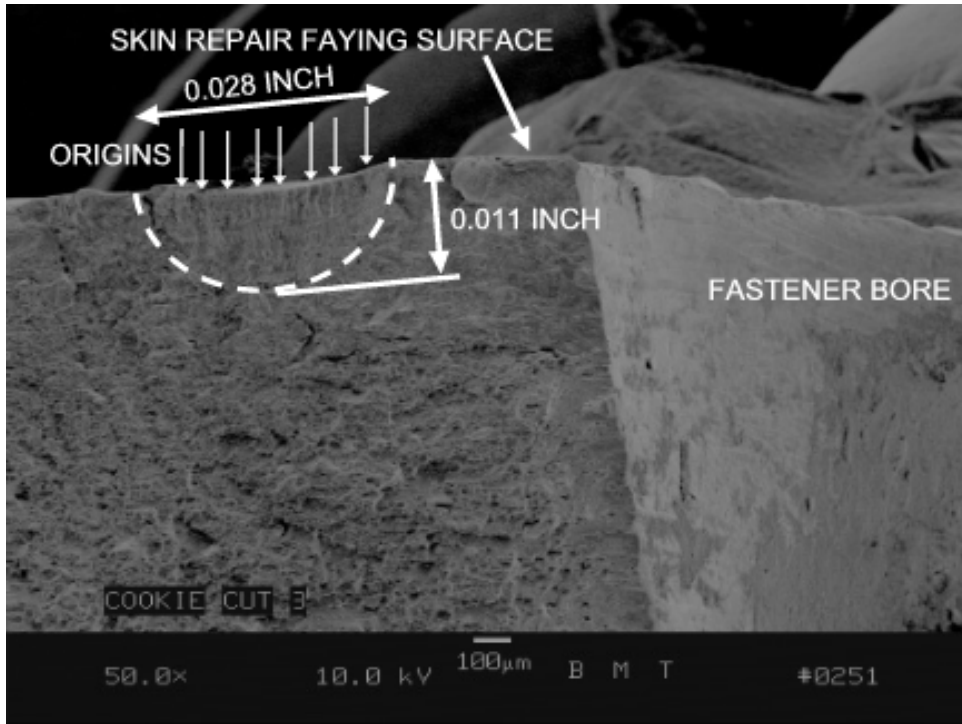
Figure 1.16-88 Cookie cut # 3 fatigue crack features – The extent of fatigue cracking is identified with a dashed line. Multiple fatigue origins are denoted with arrows.

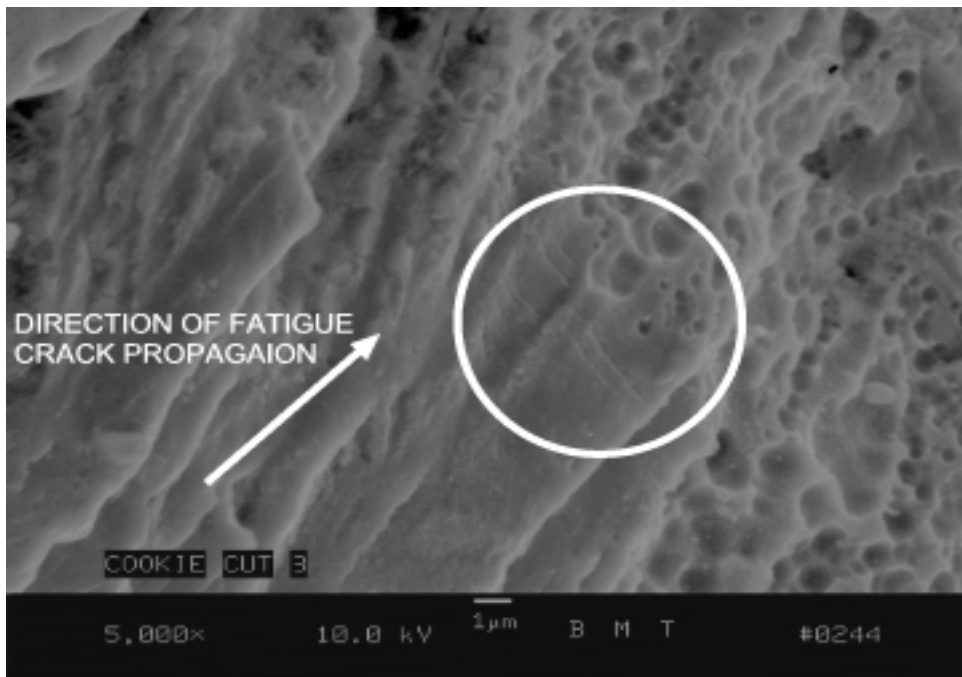
Figure 1.16-89 FATIGUE FEATUES FOUND IN CRACK AT COOKIE CUT #3 - Circled area identifies typical fatigue striations characteristic of fuselage pressure cycles observed at the maximum depth of cracking in Cookie Cut #3

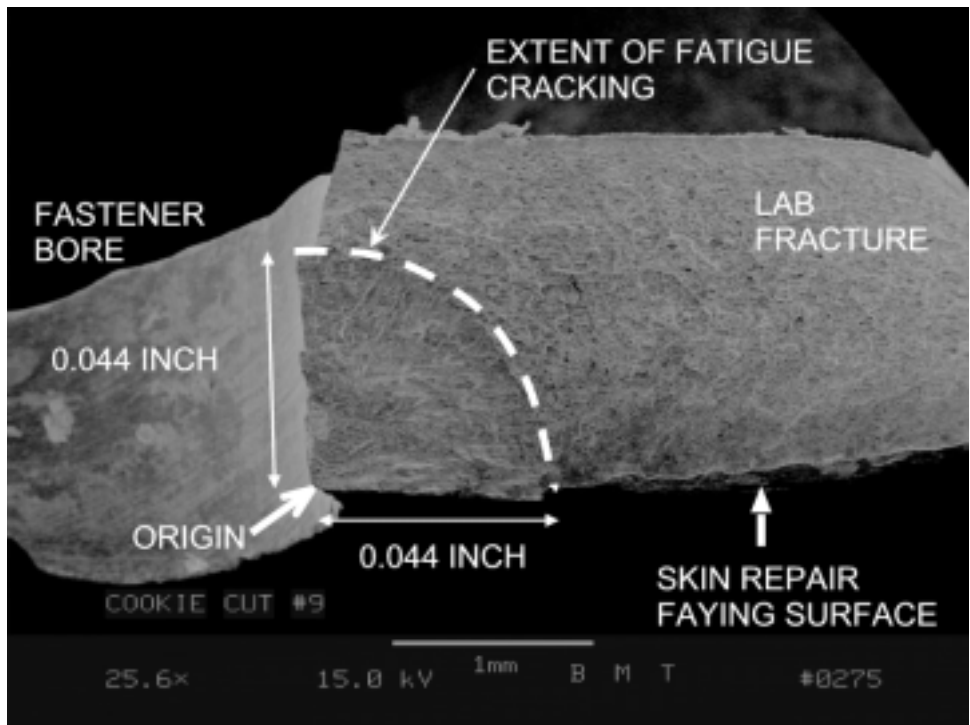
Figure 1.16-90 COOKIE CUT #9 FATIGUE CRACK FEATURES - Cracking initiated from the single origin noted above.

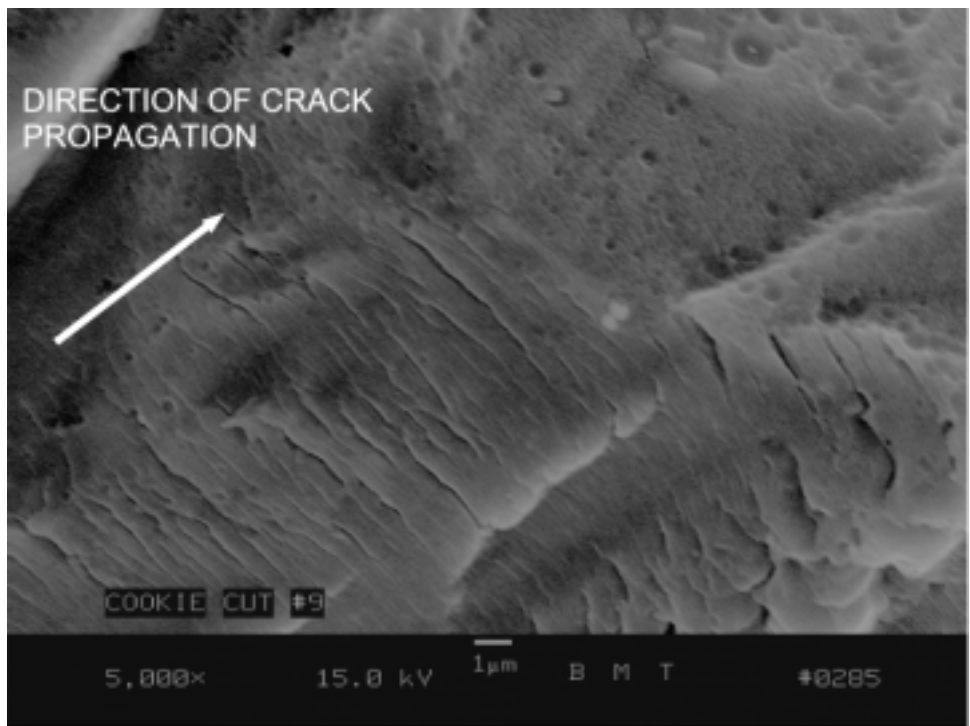
Figure 1.16-91 COOKIE CUT #9 FATIGUE STRIATIONS – The above features were located at the maximum extension of the fatigue crack.

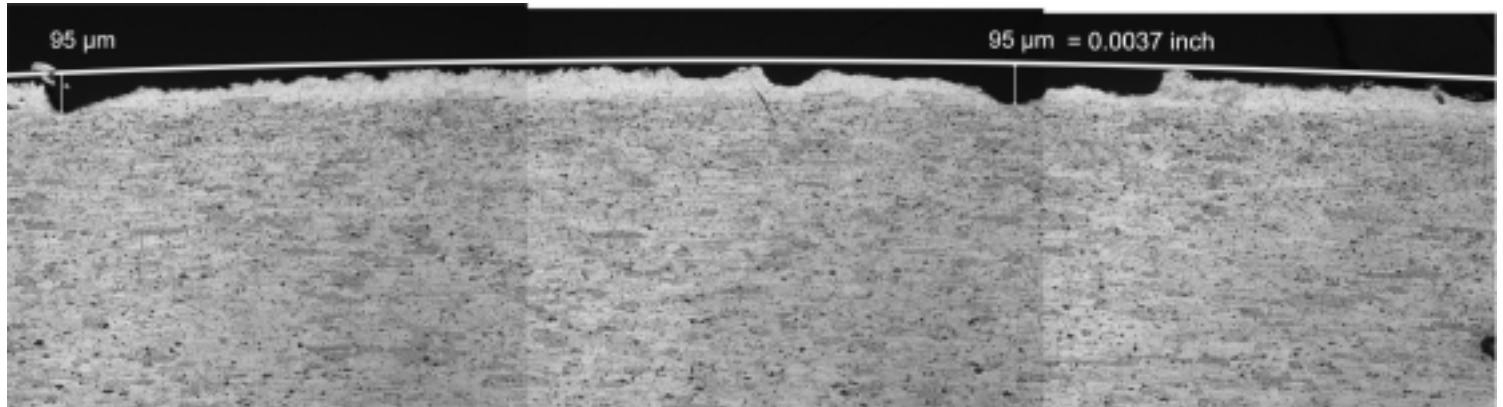
Figure 1.16-92 FILLET SEAL SCRATCH FEATURES - These skin surface features were observed at Plane A-A Figure. The clad layer of the skin appears to be penetrated at both measurement locations.

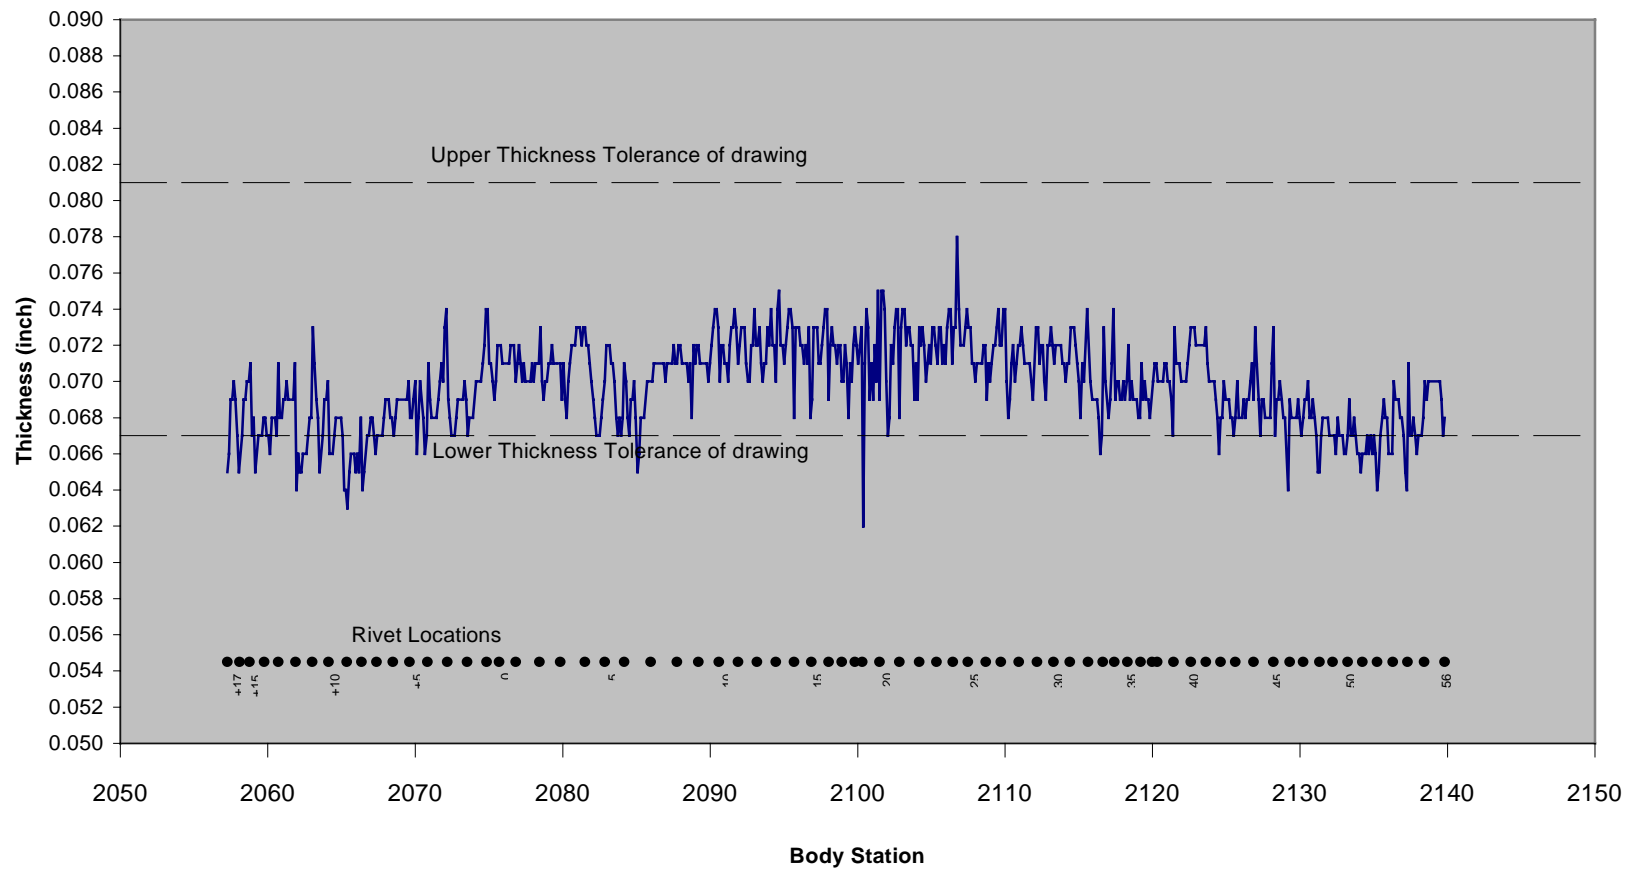
Figure 1.16-94 Thickness measurements taken along the fracture surface above S-49L.

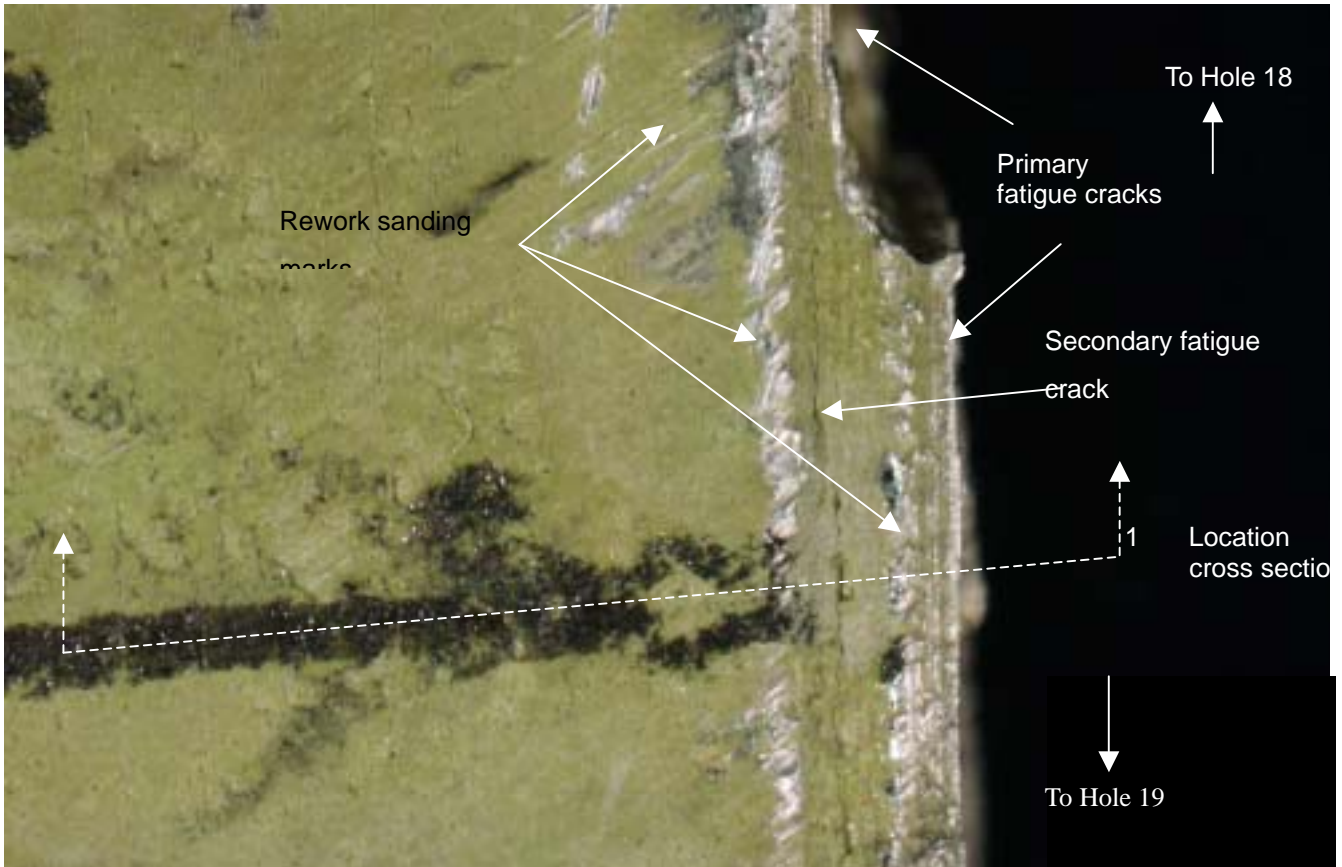
Figure 1.16-95 Location of cross section taken to characterize the scratch depth and geometry in the main fatigue region between holes 18 and 19.

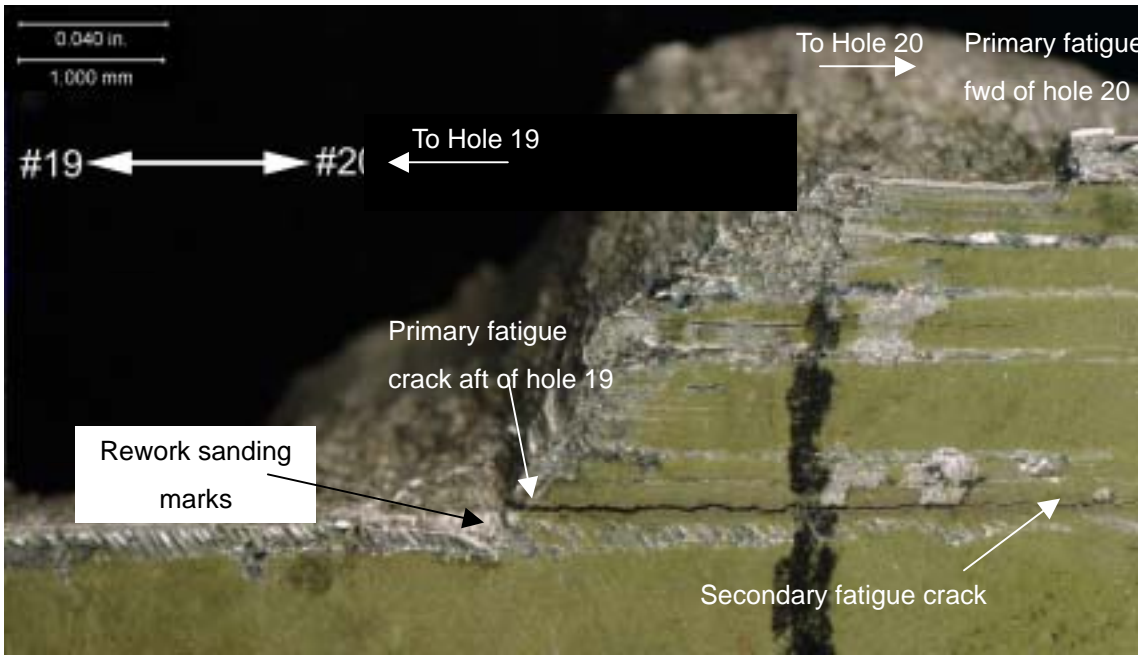
Figure 1.16-97 Location of cross section taken to characterize the scratch depth and in the main fatigue region between holes 19 and 20.

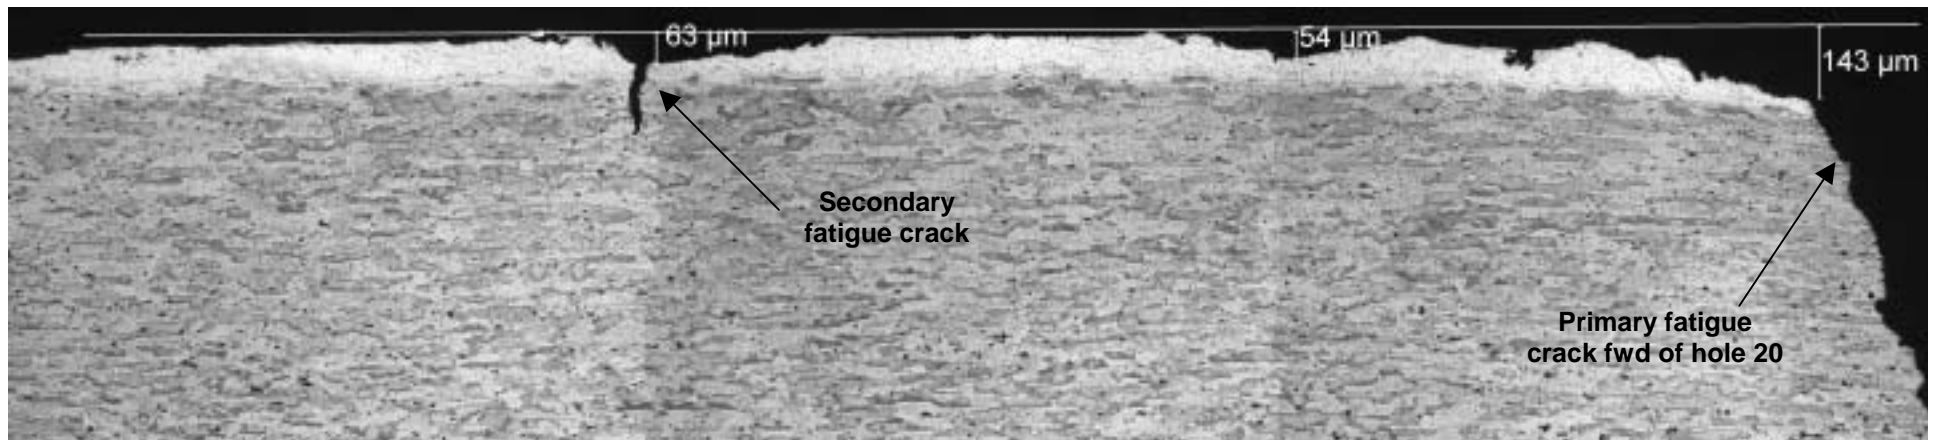
Figure 1.16-98 Metallographic montage through the area indicated in Figure 1.16-75 above. The line shown was projected back to an area of undisturbed clad material to determine the depth of the scratches at the primary and secondary fatigue cracks present in this area.

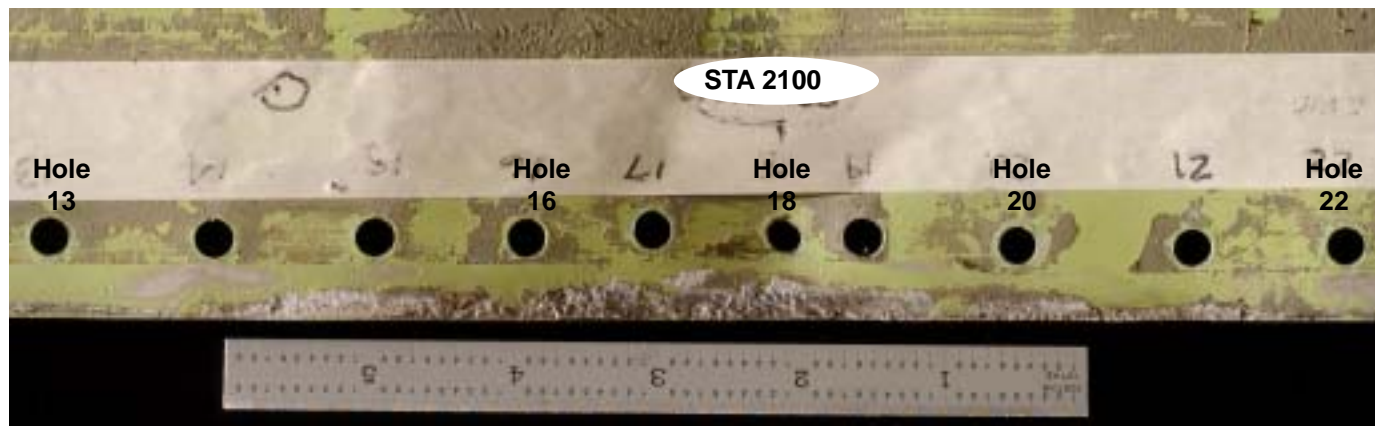
Figure 1.16-99 Faying surface of doubler with skin showing the light colored deposit present from hole 14 to 22

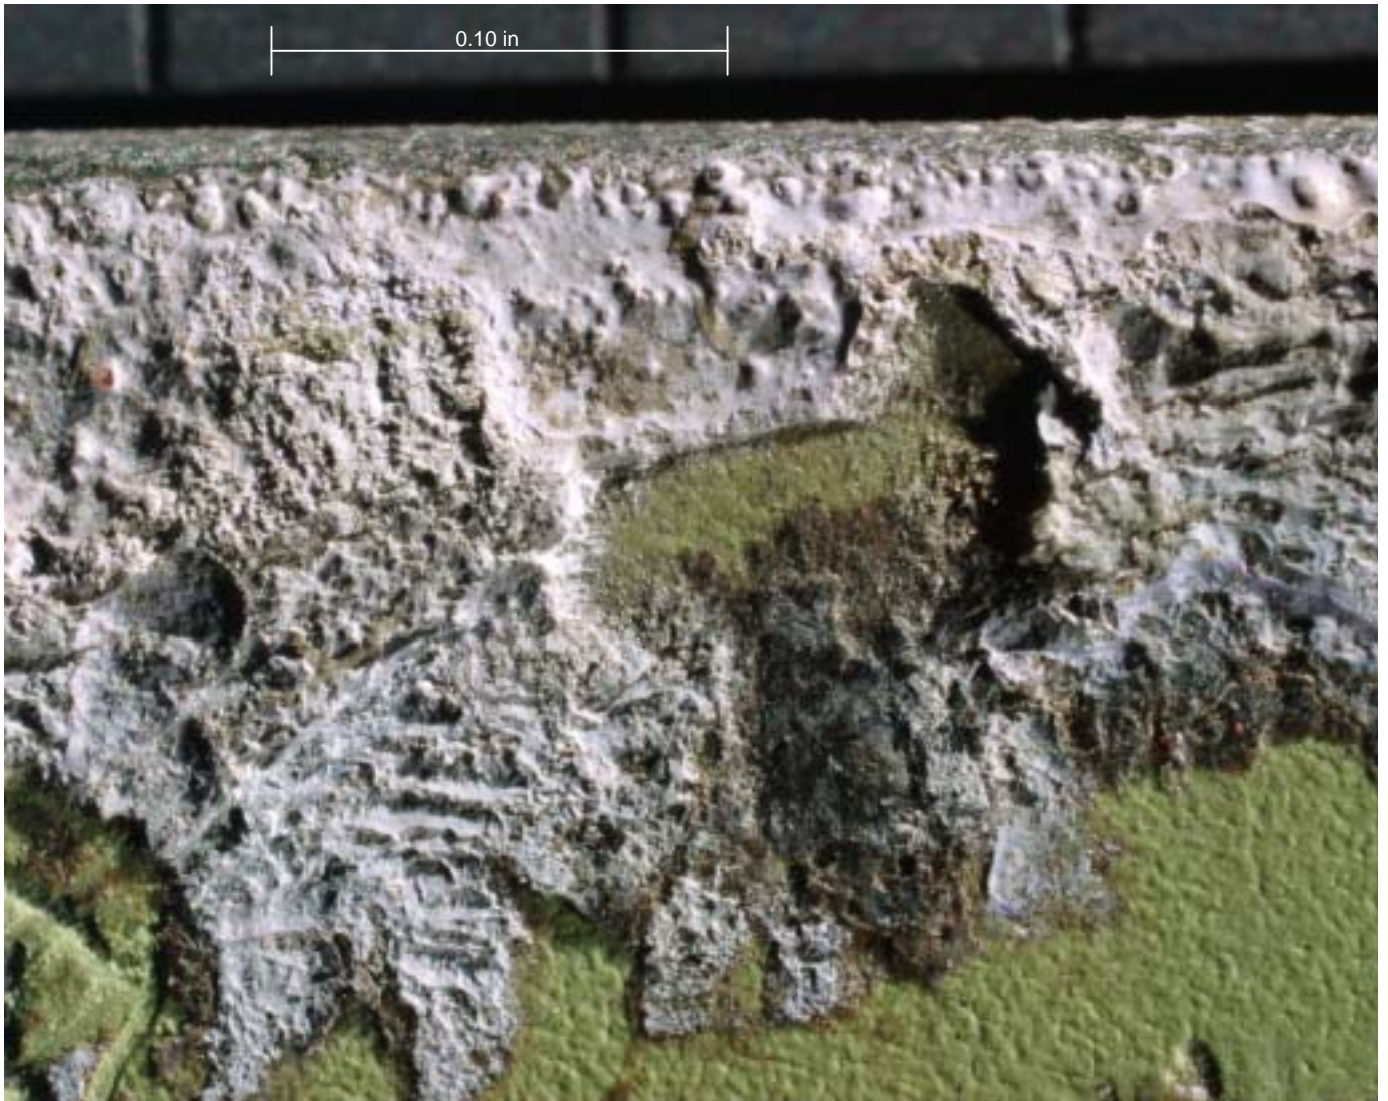
Figure 1.16-100 Higher magnification image of light colored deposit on faying surface of doubler in the vicinity of hole 15. Note the smooth bubbled appearance of the deposit adjacent to the edge of the doubler.

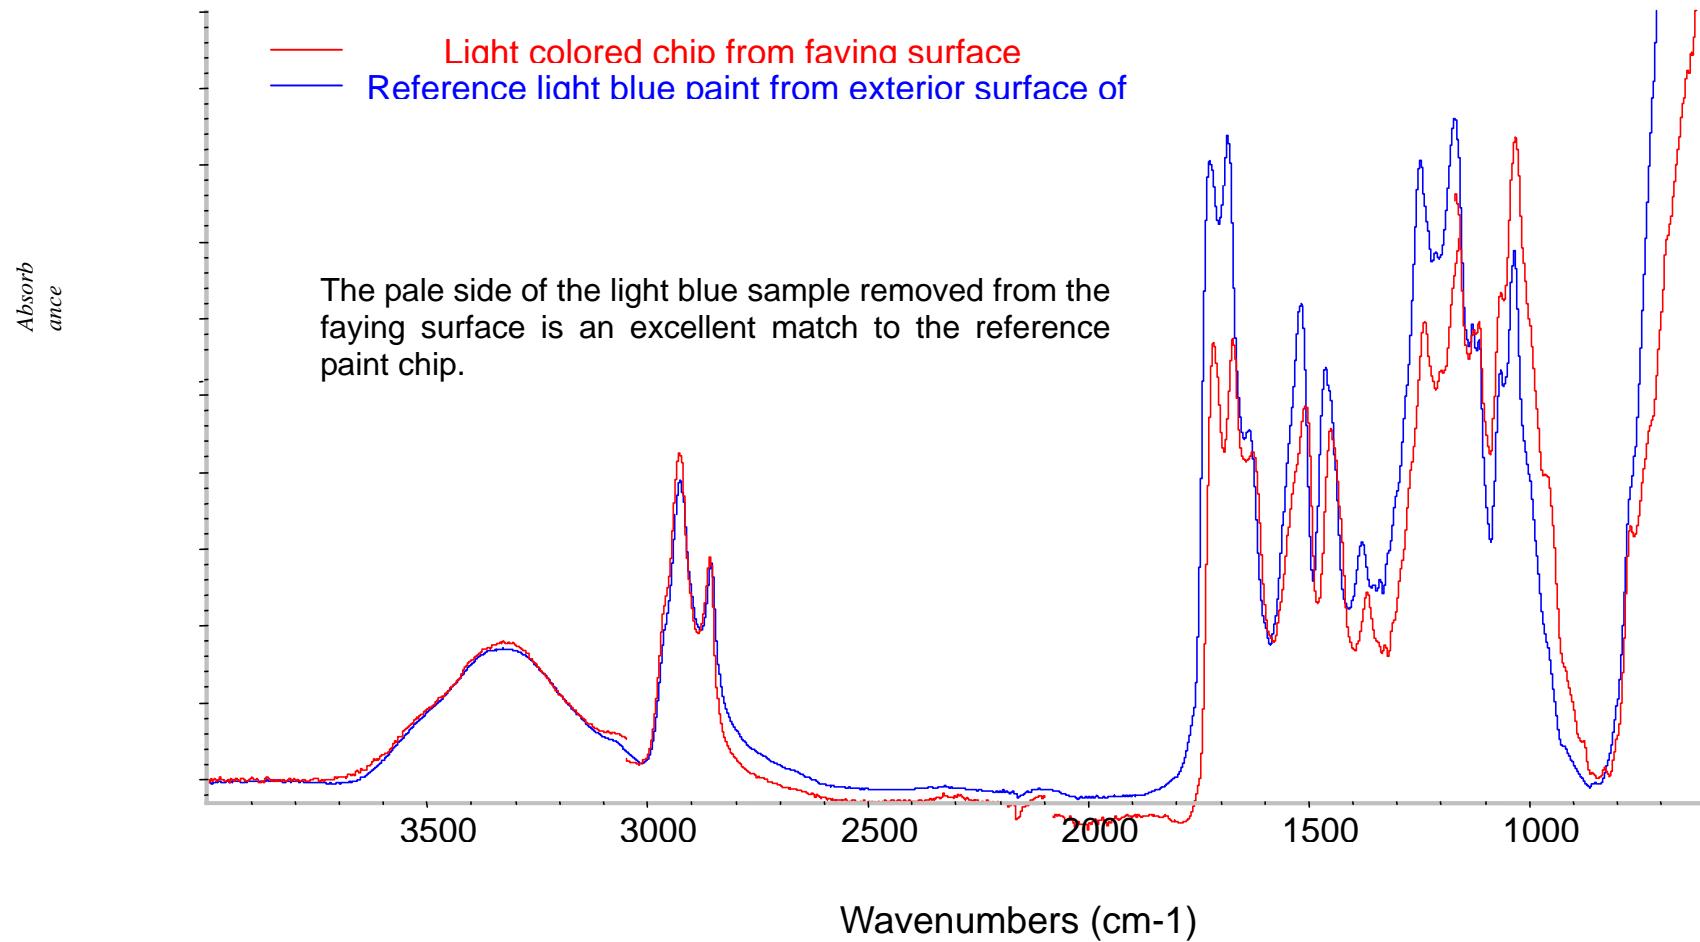
Figure 1.16-101 FT-IR analysis spectra of light colored material removed from overhanging portion of doubler faying surface adjacent to hole 18 and spectra from light blue exterior paint on the doubler. These spectra are baseline corrected and scaled to make an easier comparison.

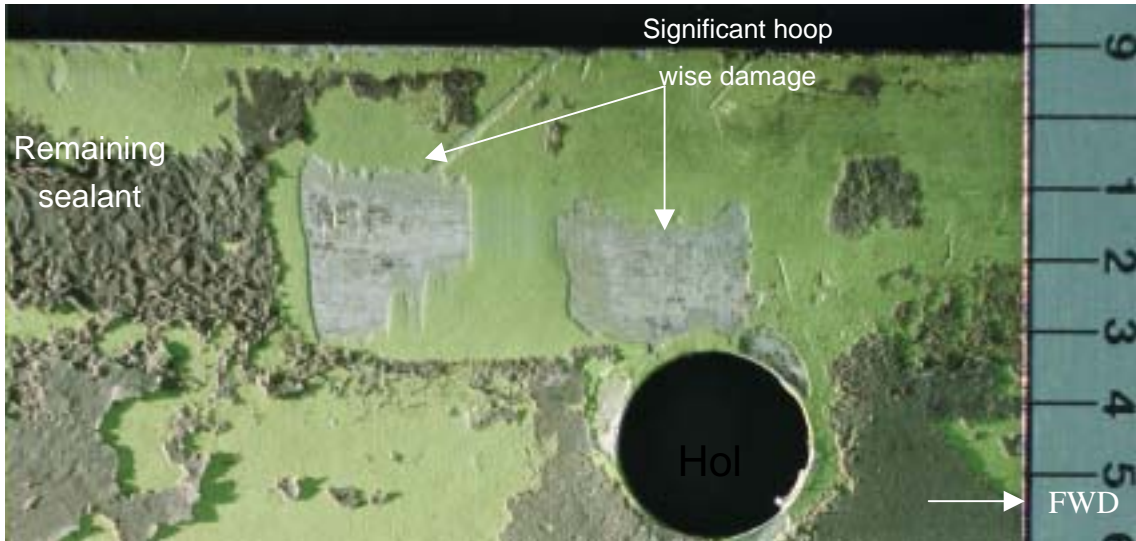
Figure 1.16-102 Faying surface of doubler in the vicinity of hole 6 showing an example of significant hoop wise damage at the 10:00 to 11:00 and 1:00 to 2:00 clock positions.

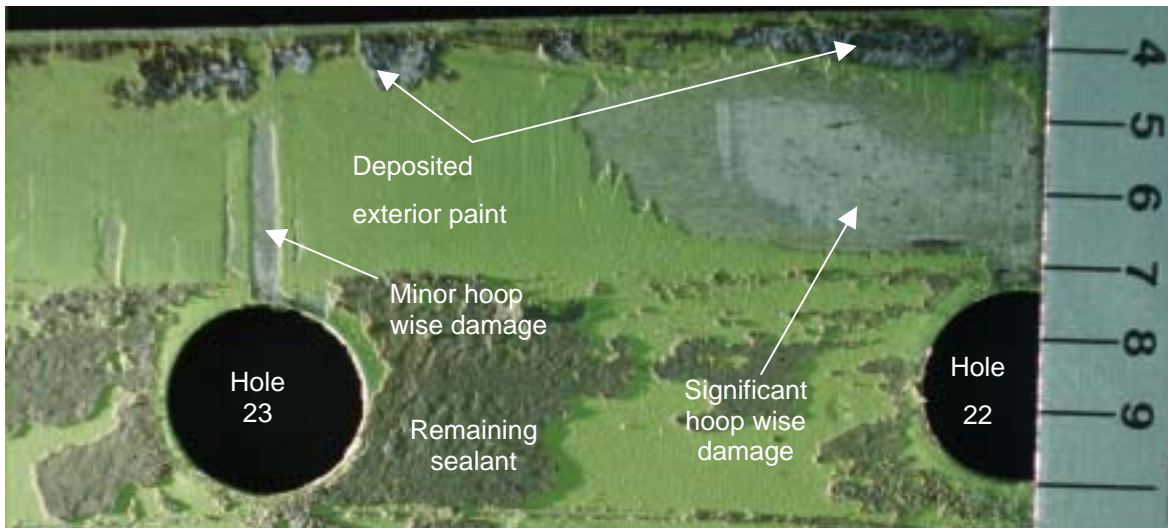
Figure 1.16-103 Faying surface of the doubler showing an example of minor hoop wise damage at the 12:00 clock position of hole 23 and significant hoop wise damage at the 10:00 to 12:00 clock position of hole 22. Note the presence of deposited paint near the edge of the doubler.

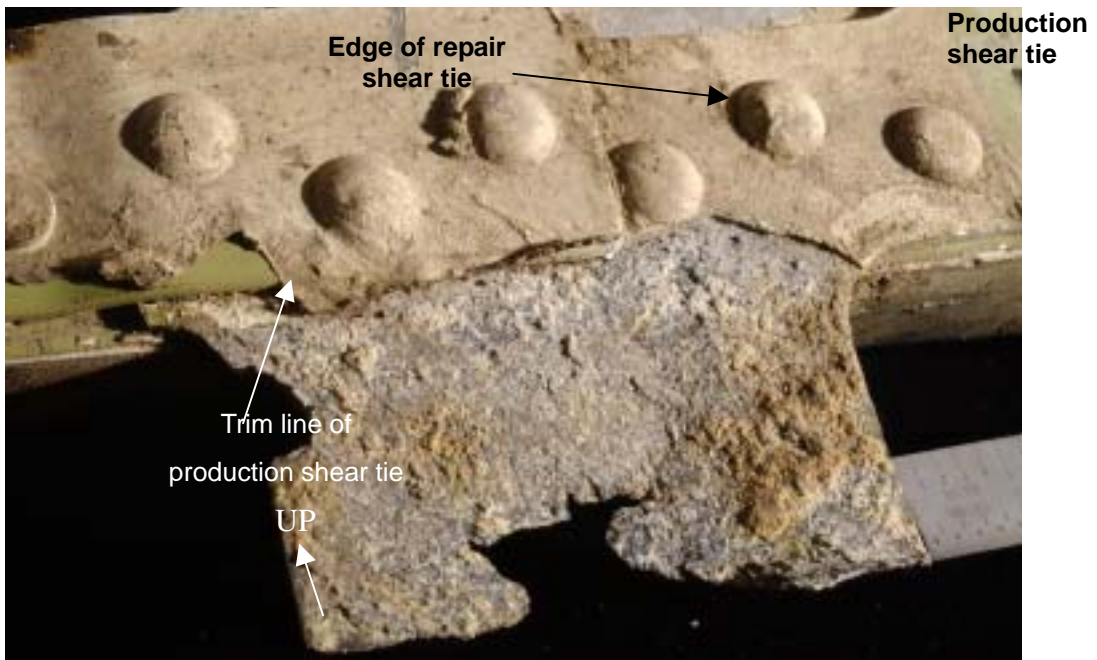
Figure 1.16-107 Exfoliation corrosion present at shear tie between S-50L and S-49L of STA 2160 frame segment.

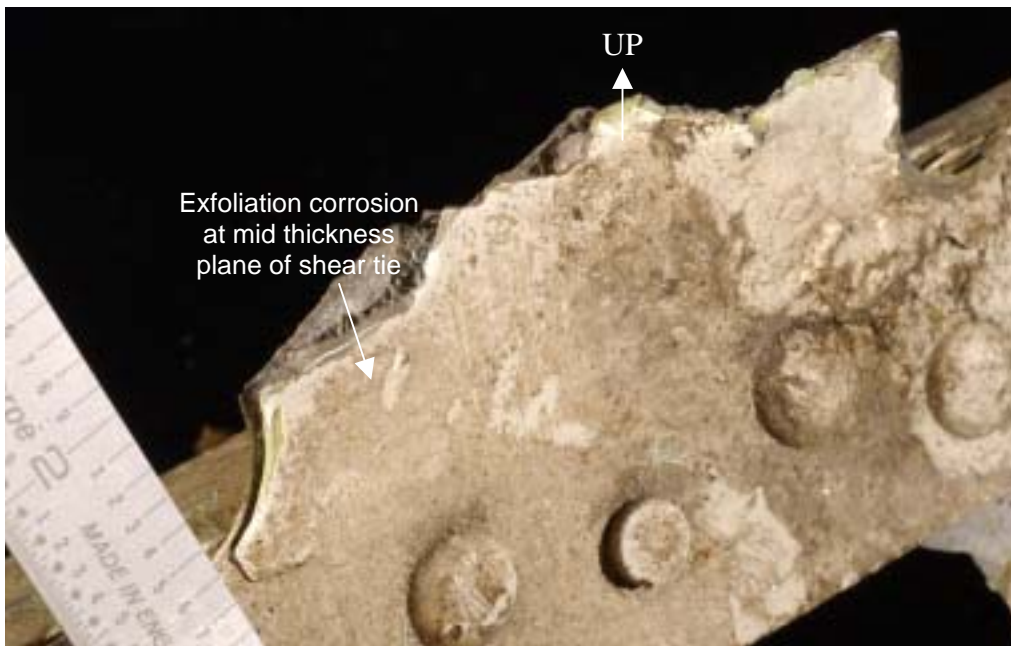
Figure 1.16-108 Exfoliation corrosion present at shear tie between S-49L and S-48L of STA 2160 frame segment.

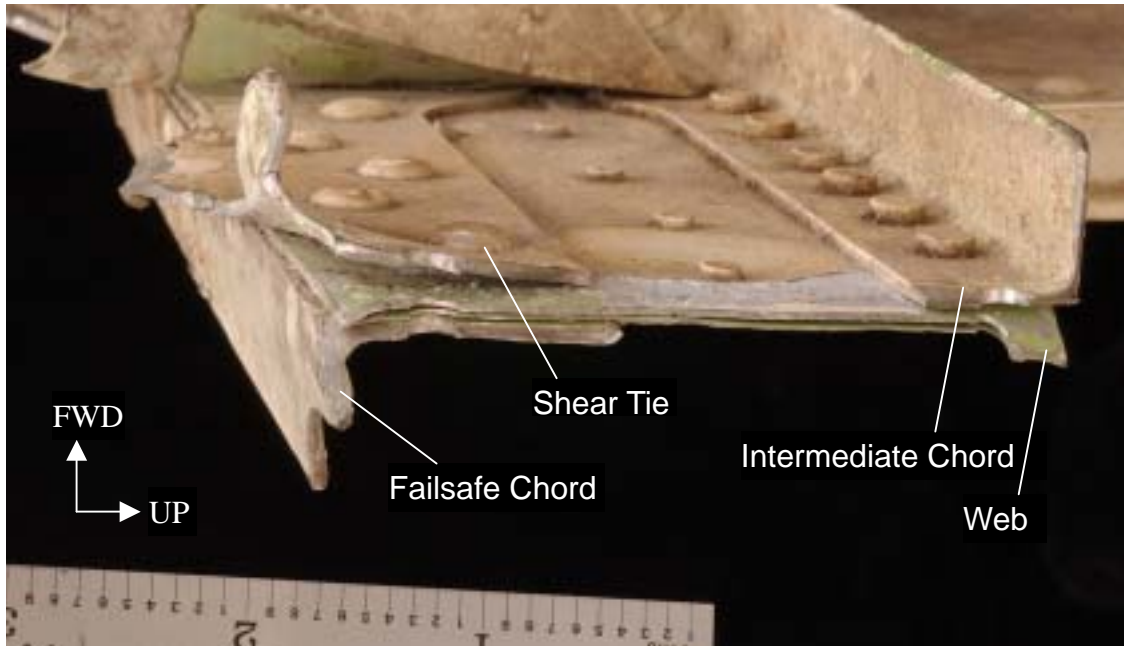
Figure 1.16-111 Fracture at S-49L of the STA 2100 frame segment showing deformation in shear tie and web.

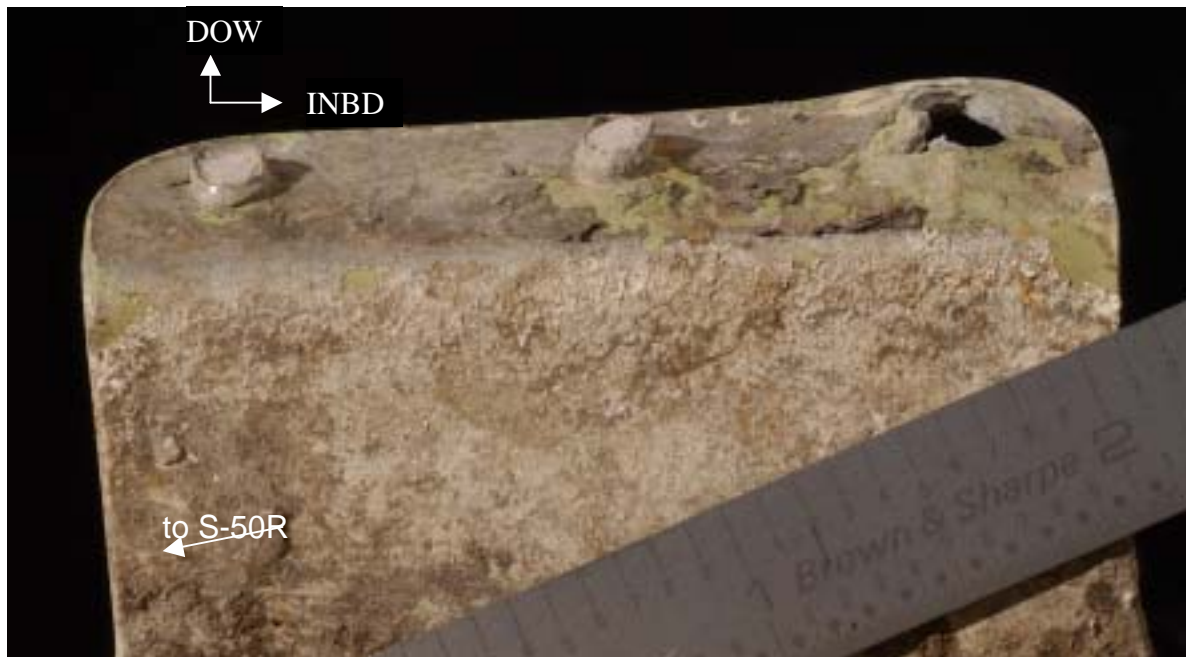
Figure 1.16-112 Shear tie between S-51R and S-50R of the STA 2100 frame segment showing downward deformation in skin flange and pull through of the fastener hole at the inboard most fastener hole.

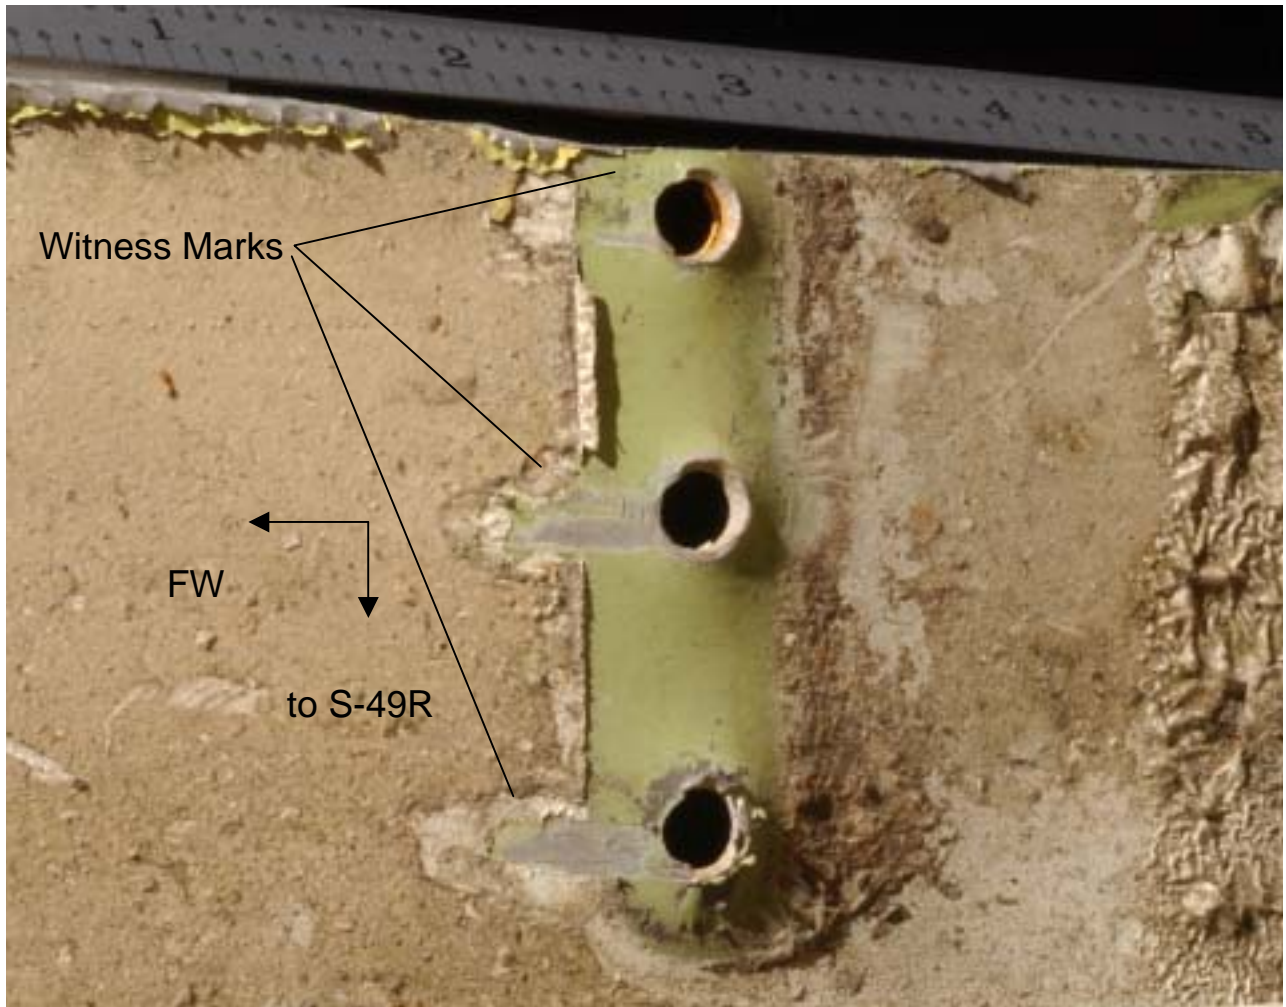
Figure 1.16-113 Witness marks and deformation in skin at shear tie fastener holes common to S-49R /S-48R at STA 2100

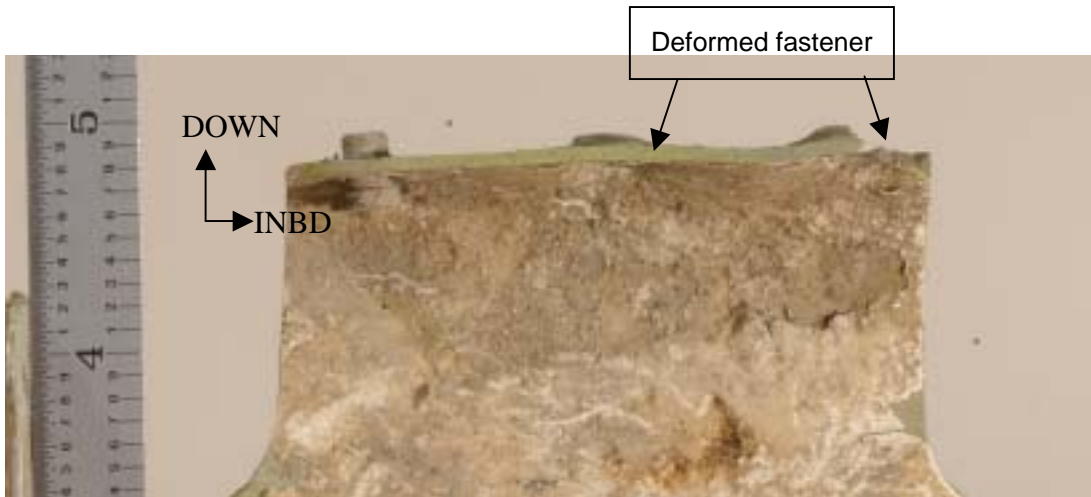
Figure 1.16-117 Shear tie between S-51L and S-50L of the STA 2060 frame segment showing deformation of skin flange fastener holes in the downward direction.

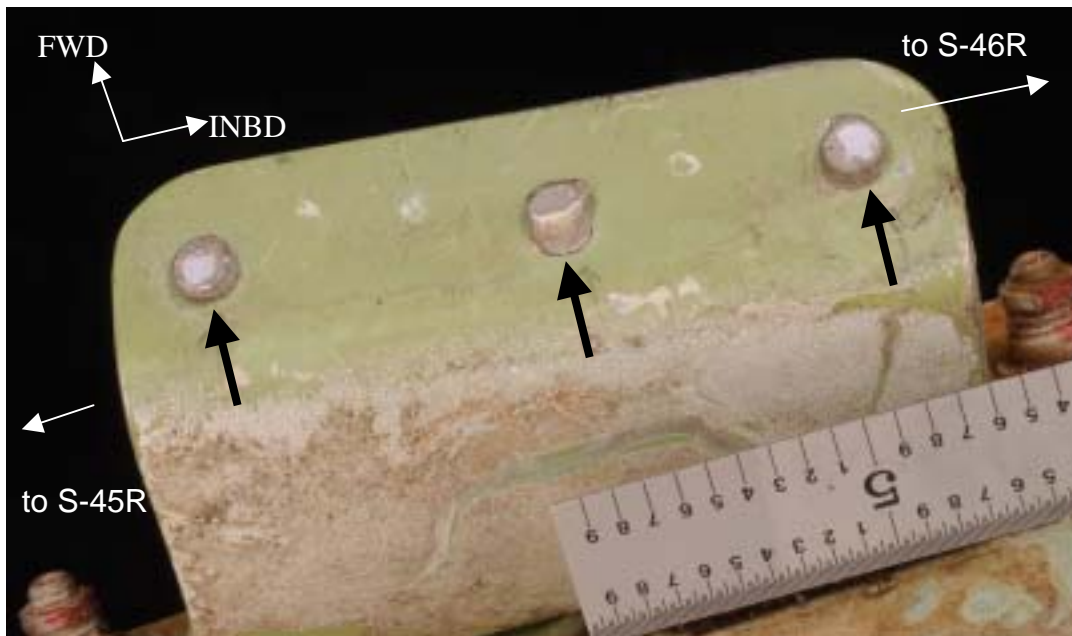
Figure 1.16-121. Skin flange rivet fractures at shear tie between S-45R and S-46R of the STA 2040 frame. Black arrows indicate the direction of loading.

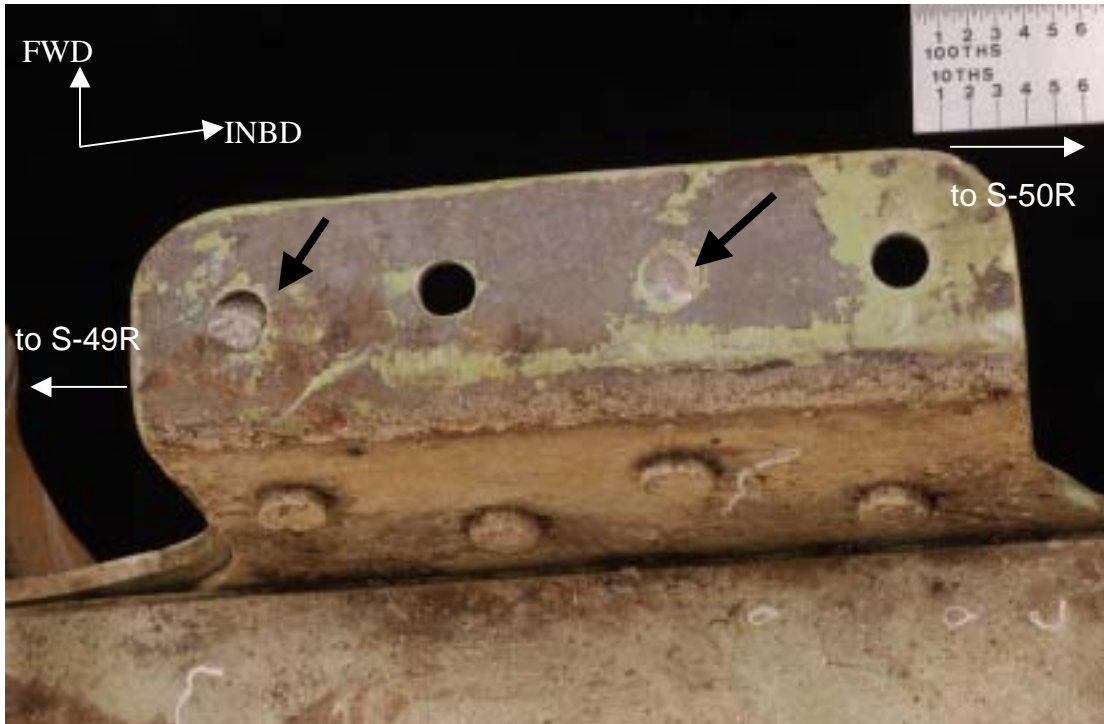
Figure 1.16-122 Skin flange rivet fractures at shear tie between S-49R and S-50R of the STA 2040 frame segment. Black arrows indicate the direction of loading.

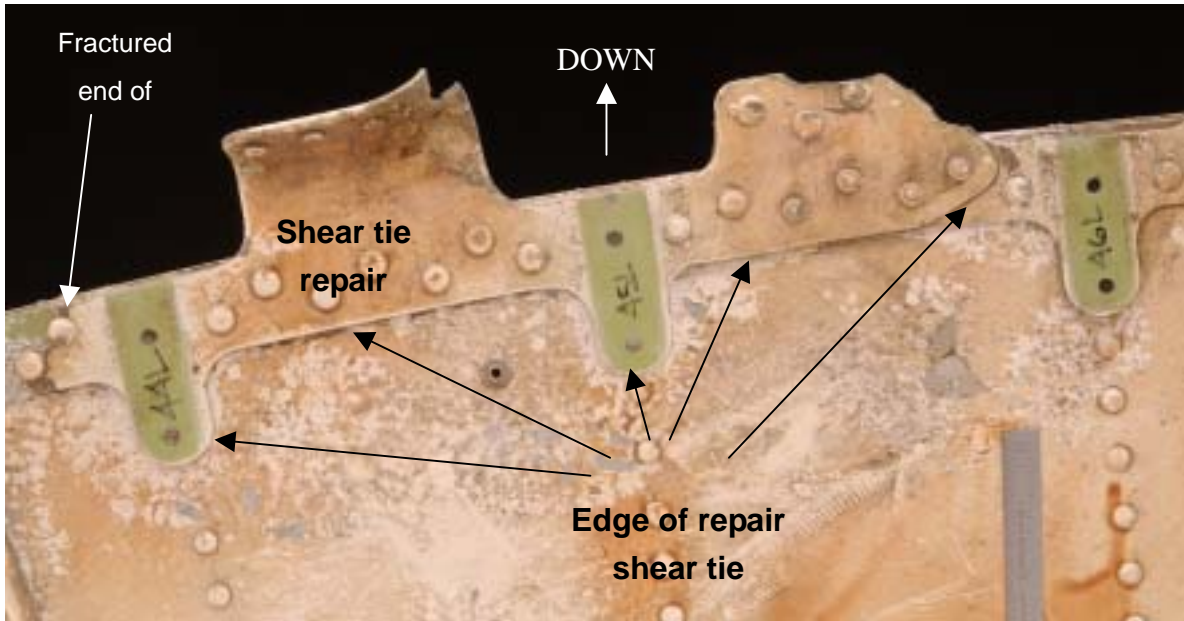
Figure 1.16-126 STA 1940 frame segment showing the shear tie repair between S-46L and S-44L.

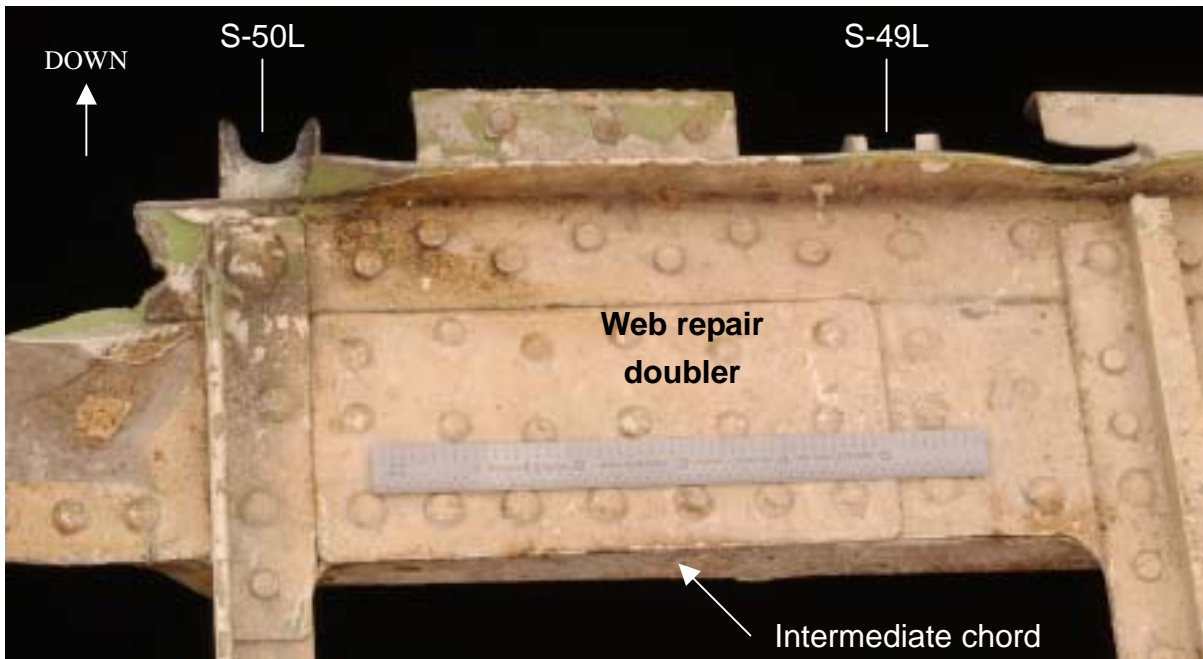
Figure 1.16-127 STA 1940 frame segment showing the web repair doubler on the aft side between S-50L and S-49L.
