**Aviation Safety Council
Taipei, Taiwan**

**CI611 Accident Investigation
Factual Data Collection
Group Report**

Structure Group

ASC-AFR-03-06-001

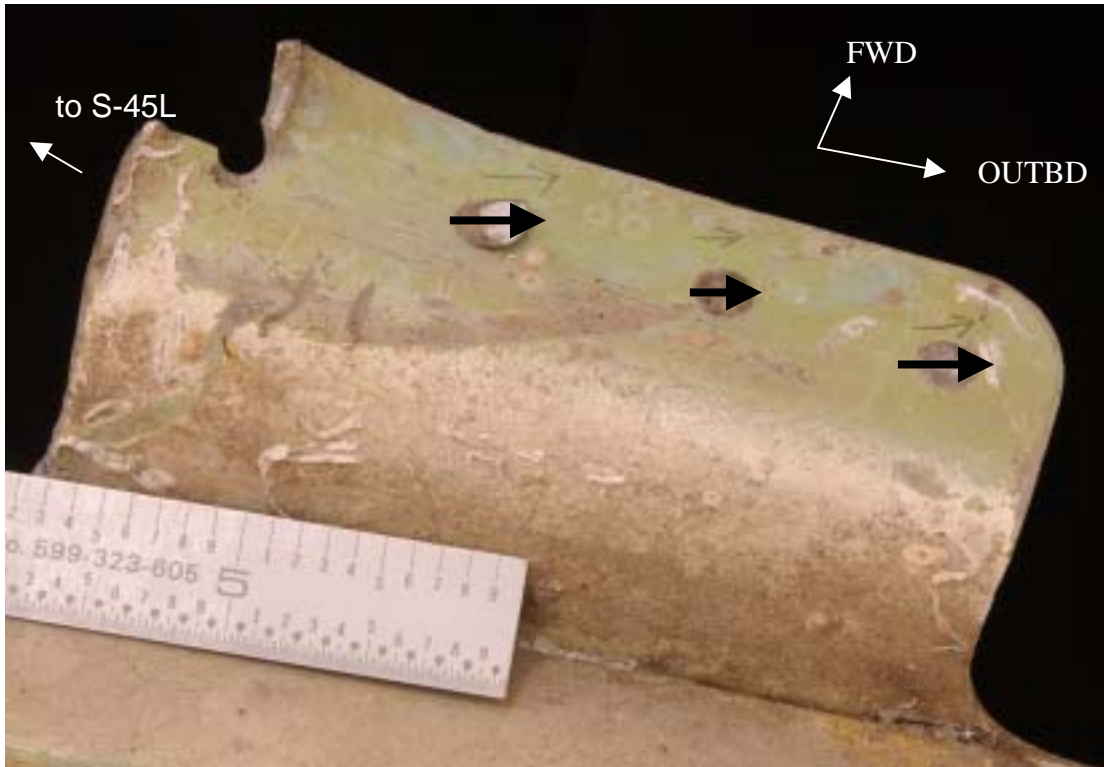
Figure 1.16-128 Shear tie between S-45L and S-44L of STA 1940 frame segment. Black arrows indicate the direction of loading.

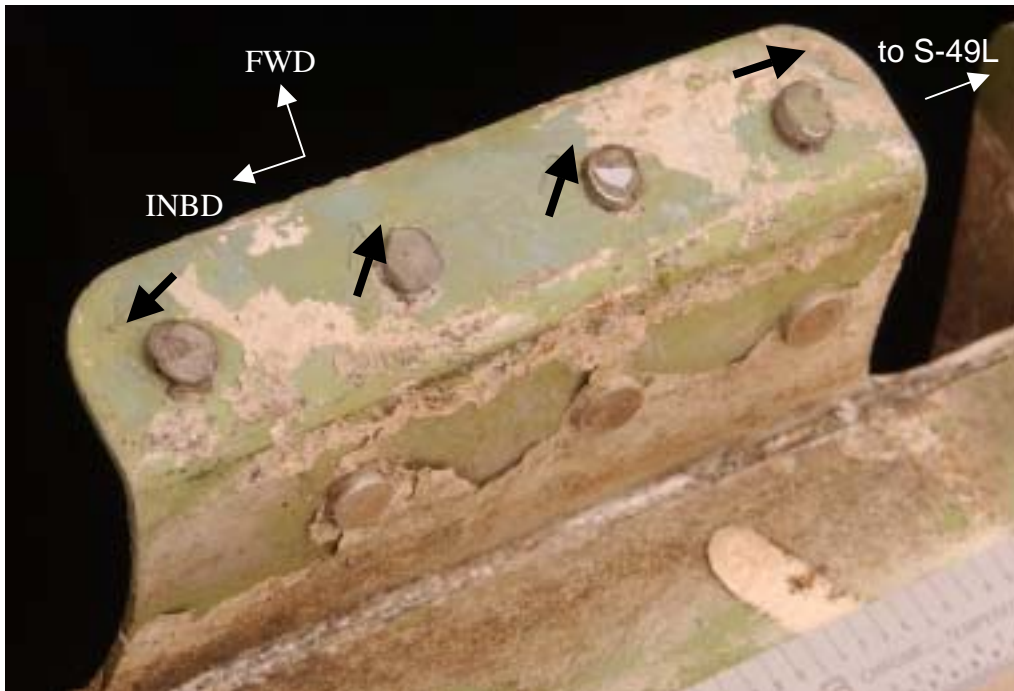
Figure 1.16-129 Shear tie between S-50L and S-49L of STA 1940 frame segment. Black arrows indicate the direction of loading.

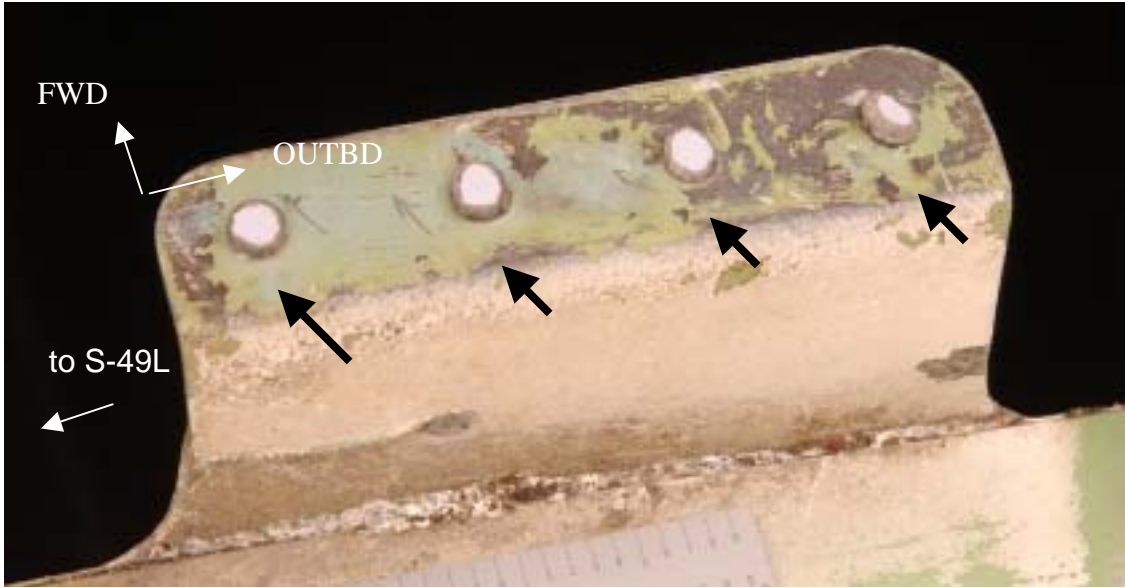
Figure 1.16-130 Shear tie between S-49L and S-48L of STA 1940 frame segment. Black arrows indicate the direction of loading.

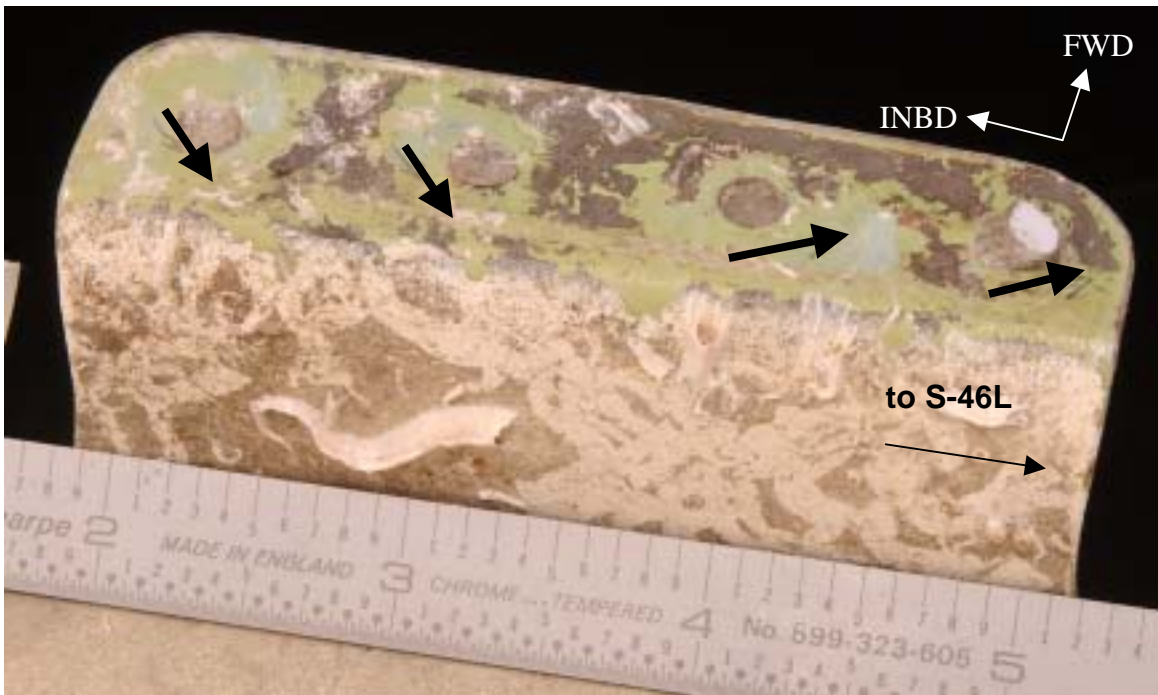
Figure 1.16-131 Shear tie between S-47L and S-46L of STA 1940 frame segment. Black arrows indicate the direction of loading.

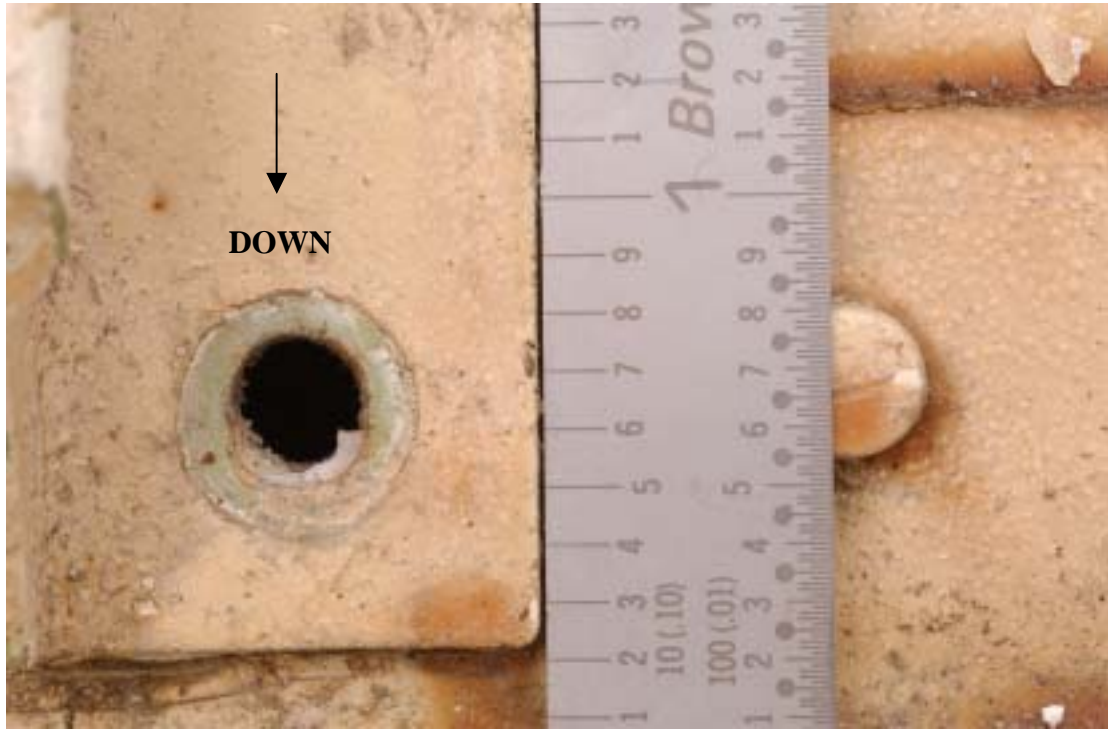
Figure 1.16-132 FWD view of STA 1940 frame segment showing downward deformation of the lower attachment hole of shear tie at S-47L clip.

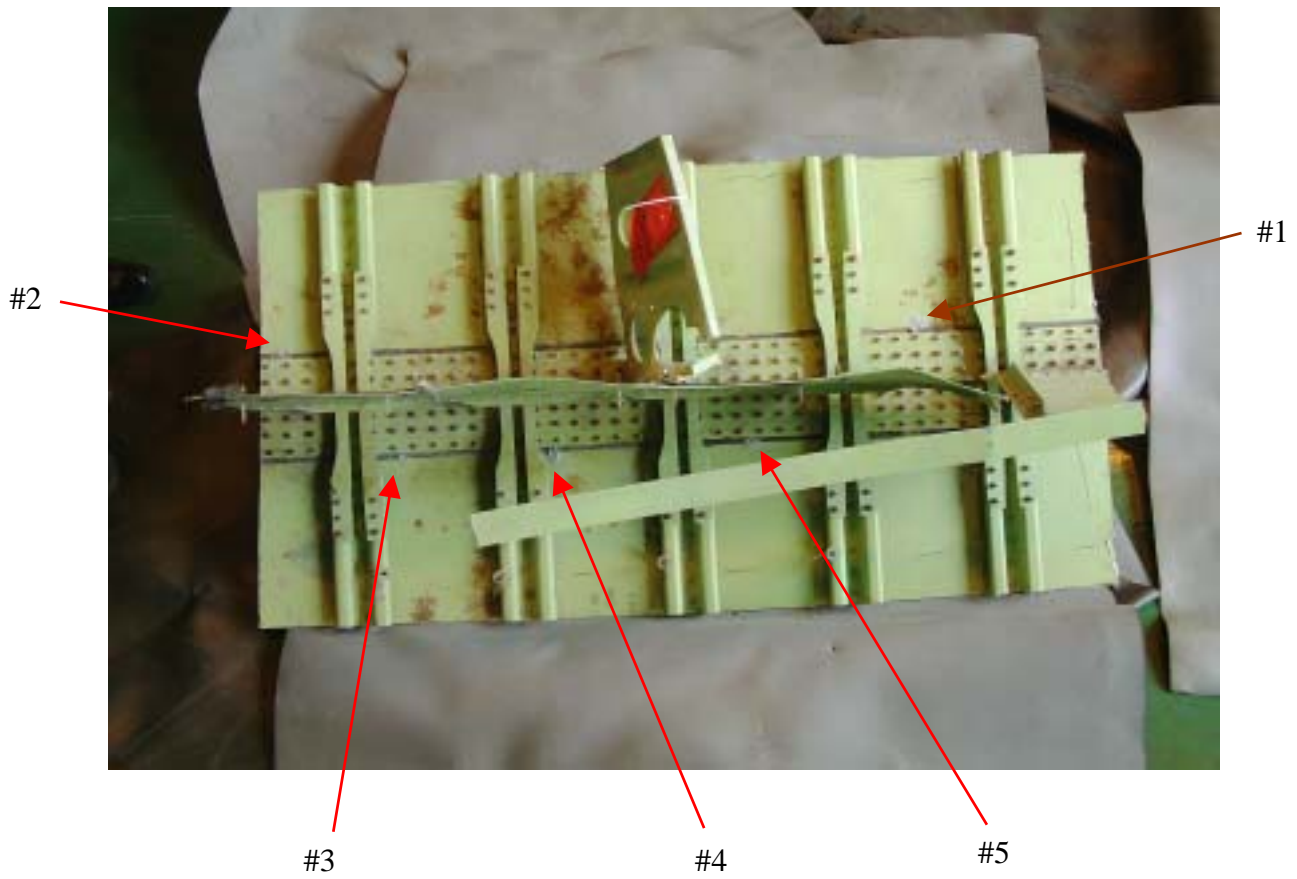
- (1) Macro Observation and photograph Figure 1.16-133 showed that the overall appearance of item 626 C1, there are 6 corrosion pits as arrows indicate. Those initial site of corrosion evidences were occurred at the interface of sealant and splice plate as in Figure 1.16-134 through Figure 1.16-138. It is believed that this is typical of morphology of crevice corrosion as in Figure 1.16-134 through Figure 1.16-138.

Figure 1.16-133 Overall appearance of ITEM 626 C1.(0.09X)

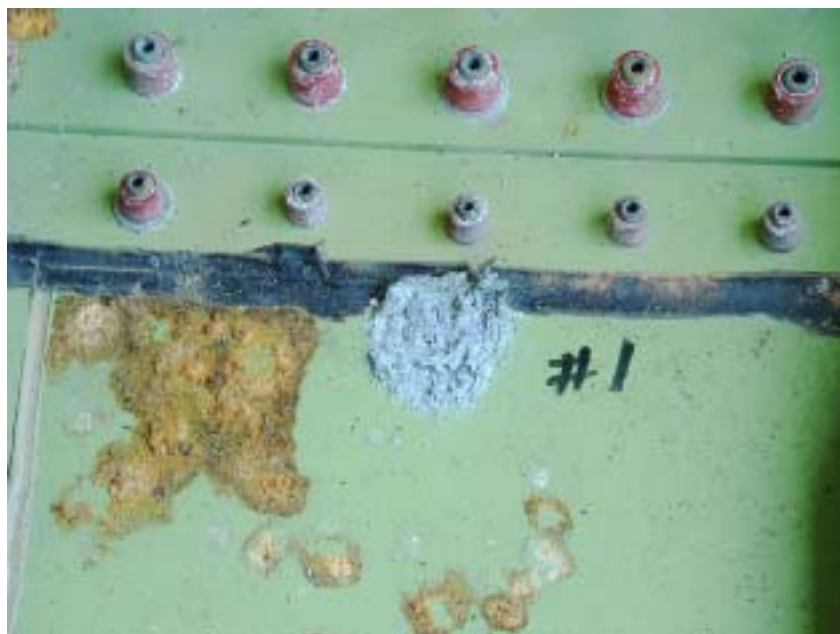
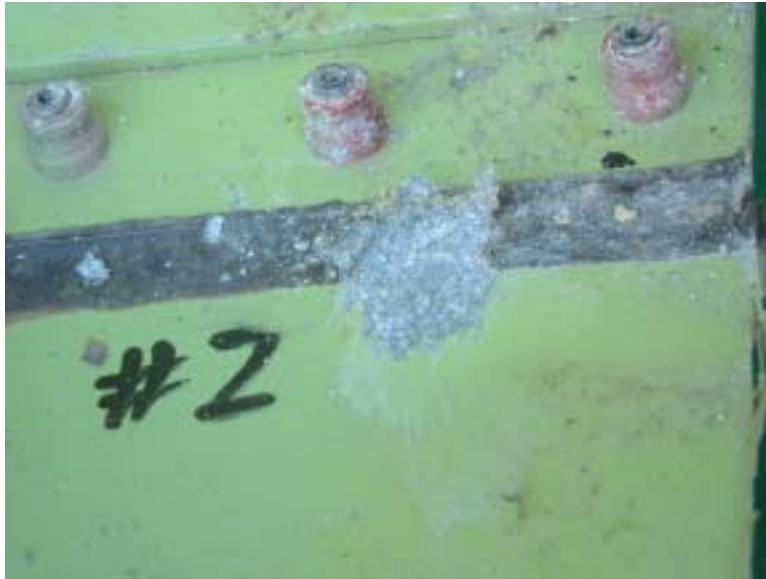
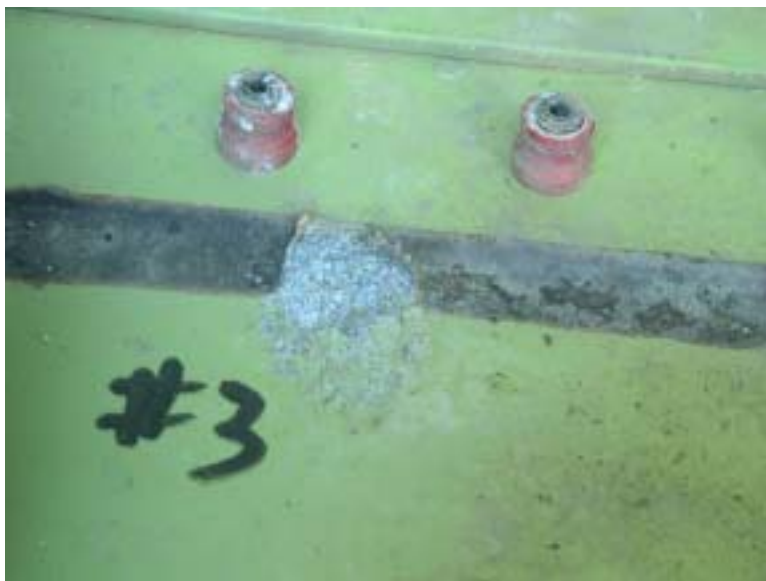
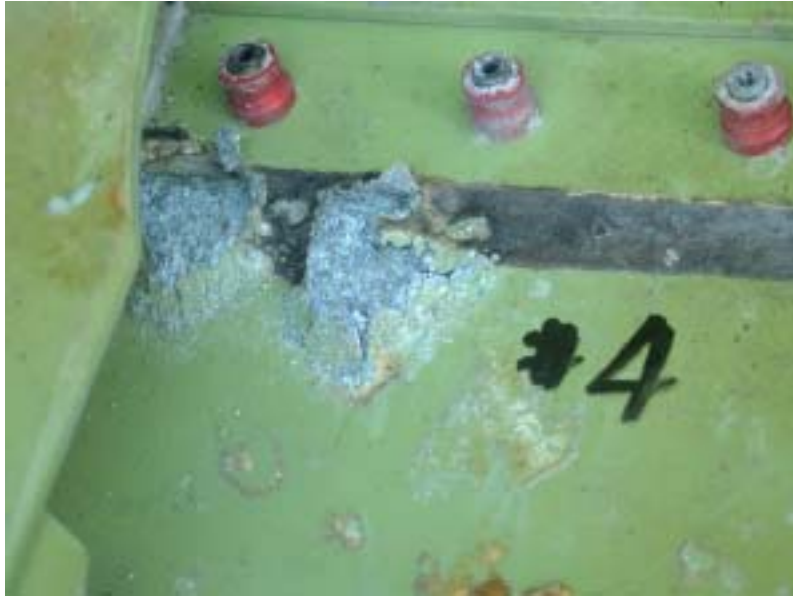
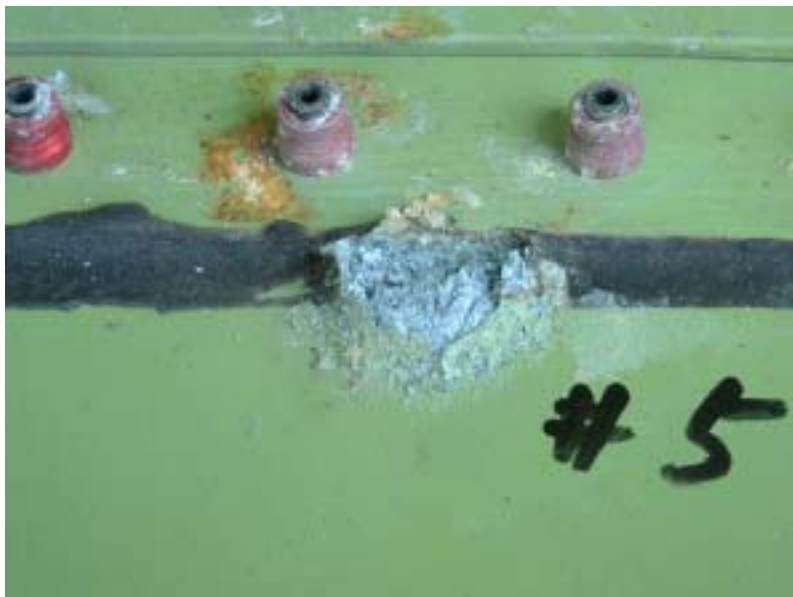
Figure 1.16-134 Higher magnification of #1 corrosion pit, before cleaning (0.71X)

Figure 1.16-135 Higher magnification of #2 corrosion pit, before cleaning (1.52X)

Figure 1.16-136 Higher magnification of #3 corrosion pit, before cleaning (1.56X)

Figure 1.16-137 Higher magnification of #4 corrosion pit, before cleaning (1.27X)

Figure 1.16-138 Higher magnification of #5 corrosion pit, before cleaning (1.46X)

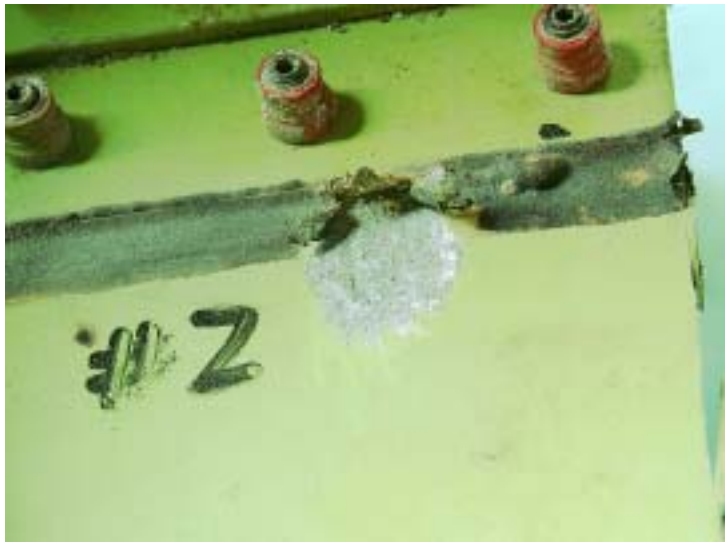
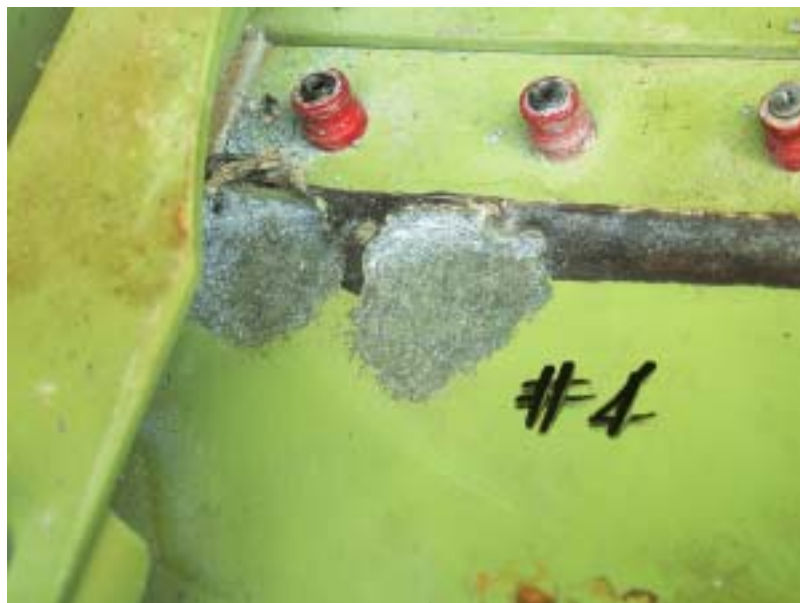
- (2) Dimensional measurement and examination of corrosion pit Figure 1.16-139 through Figure 1.16-143 showed that the higher magnification of corrosion pit after cleaning by acetone and steel ruler, which were taken from area #1 through #5 as in Figure 1.16-133, respectively. The corrosion was not observed by 6X magnifier to extend under the splice plate, therefore no further inspection was required. Figure 1.16-144 through Figure 1.16-148 showed that the dimensional measurement of corrosion, which were taken from area #1 through #5 as in Figure 1.16-139 through Figure 1.16-143, respectively.

Figure 1.16-139 Higher magnification of #1 corrosion pit, after cleaning (0.99X)

Figure 1.16-140 Higher magnification of #2 corrosion pit, after cleaning (1.40X)

Figure 1.16-141 Higher magnification of #3 corrosion pit, after cleaning (1.73X)

Figure 1.16-142 Higher magnification of #4 corrosion pit, after cleaning (1.22X)

Figure 1.16-143 Higher magnification of #5 corrosion pit, after cleaning (1.44X)

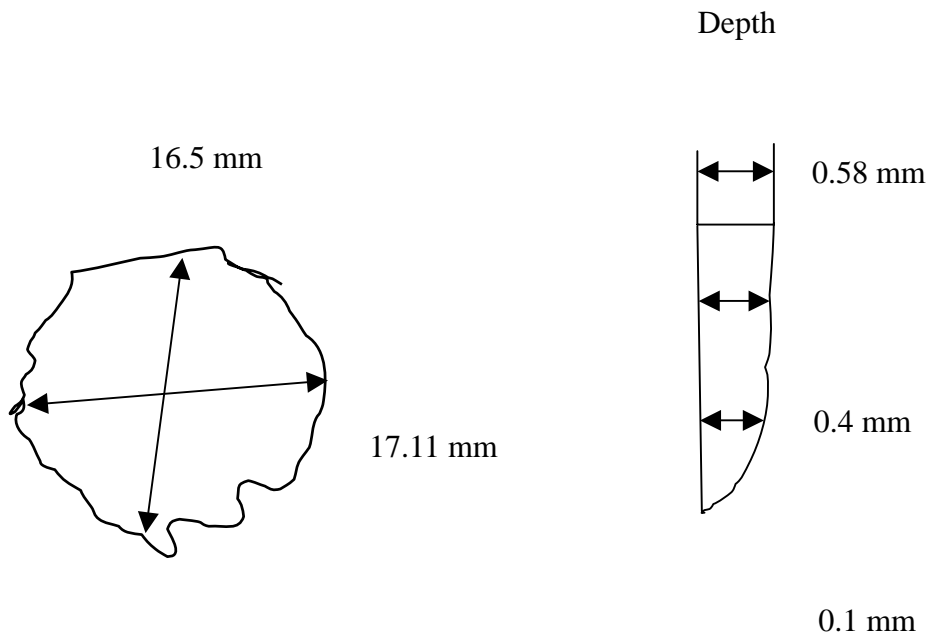
Figure 1.16-145 Sketch of #2 corrosion pit dimensional measurement.

The depth of corrosion pit on left hand site can't measure.

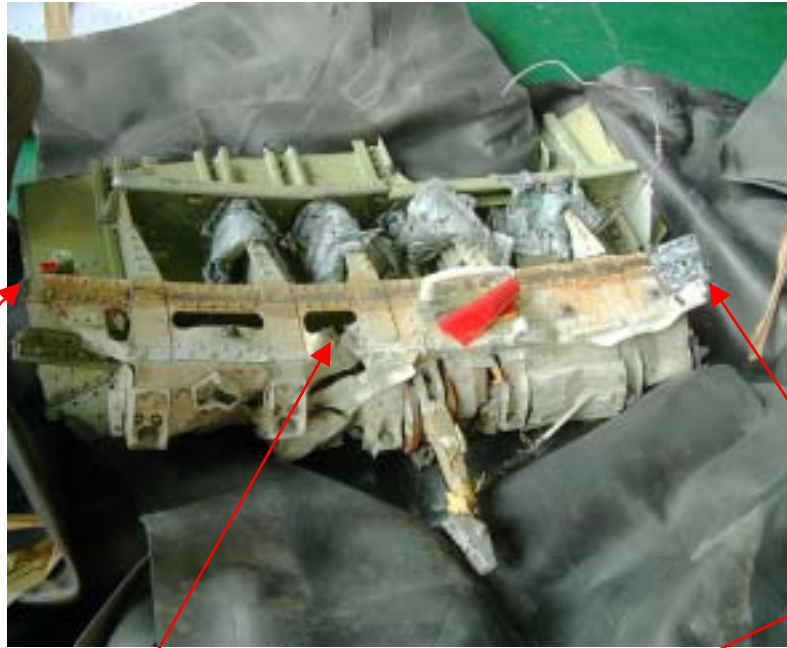
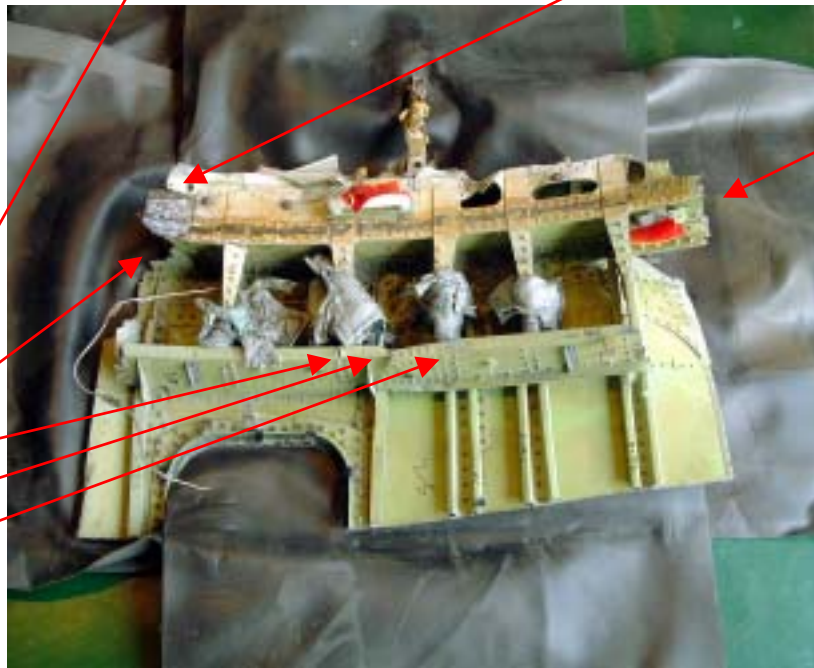
Figure 1.16-149 showed that the overall appearance of #5 LH entry door and basically the fractography can be divided into three examination focuses, No. A revealed the examination of the fractured door reveal, No. B revealed the examination of patch, and No. C revealed 5 different crack evidences caused by impact stress (torn) as arrows indicate in Figure 1.16-149. The fractured door reveal has two fractographys, one is upper fractography (Figure 1.16-150) and the other is lower fractography (Figure 1.16-151). Some suspicious fatigue evidences were found in macro examination on left hand side of the upper fractography and it need to do the further inspection and analysis in next paragraph. Fractography of lower door reveal as in Figure 1.16-151 showed

【A】Fracture surface of door reveal has a suspicious fatigue evidence

【B】Patch

【C】Typical overload fractography which was caused by impact.

Figure 1.16-149 Overall appearance, ITEM 751, of #5 LH door reveal.

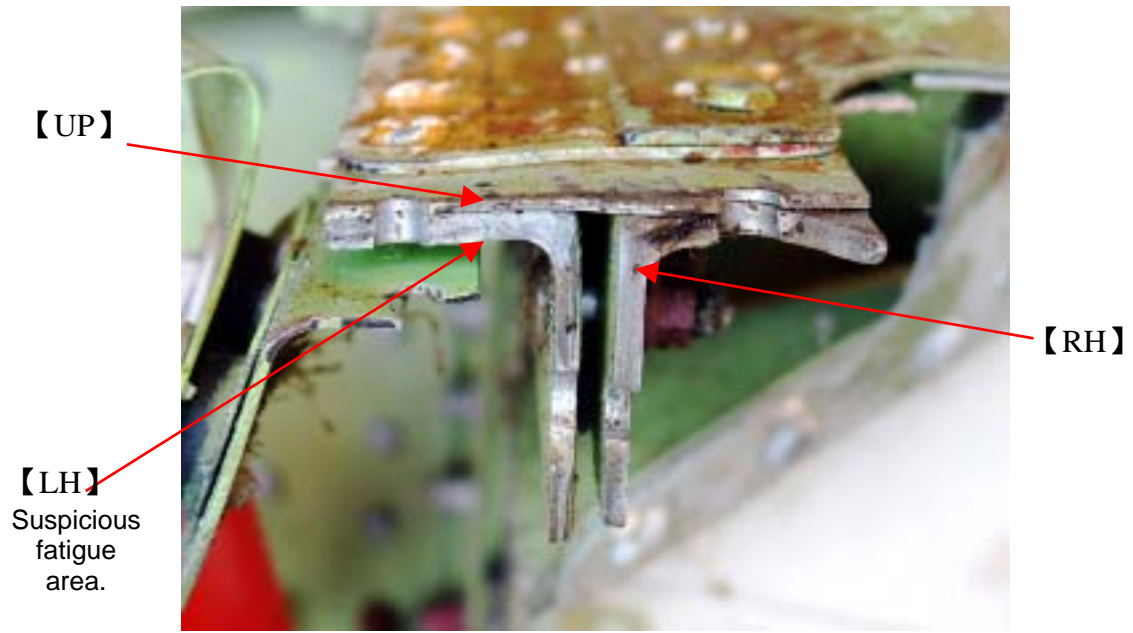
The fractography of upper door reveal was composed of 3 parts which were upper (UP), left (LH), and right (RH) as shown in figure 2, respectively. The fractography of upper (UP) and right (RH) of the upper fractography as in figure 2 showed that the fracture plane was at about 45 ° slant to the maximum tensile stress. It means the typical overload fractography of soft metal and no further inspection was required. Fractographic examination (fracture surface was covered with severe corrosion) of LH of upper door reveal (Figure 1.16-150) was performed by 6X magnifier and the results were shown in Figure 1.16-153. Fracture surface can be divided into two zones, one is more flatness and the other is more roughness. Fracture surface exhibiting beach marks (more flat plane, light color, and covers about 48% of the fracture surface) indicate that cracking was initiated and propagated by fatigue until an overload stage was reached. The critical crack length was about 0.95 inches as measured from free edge of left hand side of the extrusion part to the extend of fatigue crack and which was described more detailed in Figure 1.16-154, and also it was about 0.62 inches as measured from the center of the fastener hole of the extrusion part to the extent of fatigue crack. The color of final-fracture region, more rough plane, looked more dark and the final-fracture region covered about 52% of the fracture surface and it was at about 45 ° slant to the maximum tensile stress. That's the characteristic of typical overload fractography of soft metal.

Figure 1.16-150 Macro fractographic examination of upper door reveal.(1.5X)

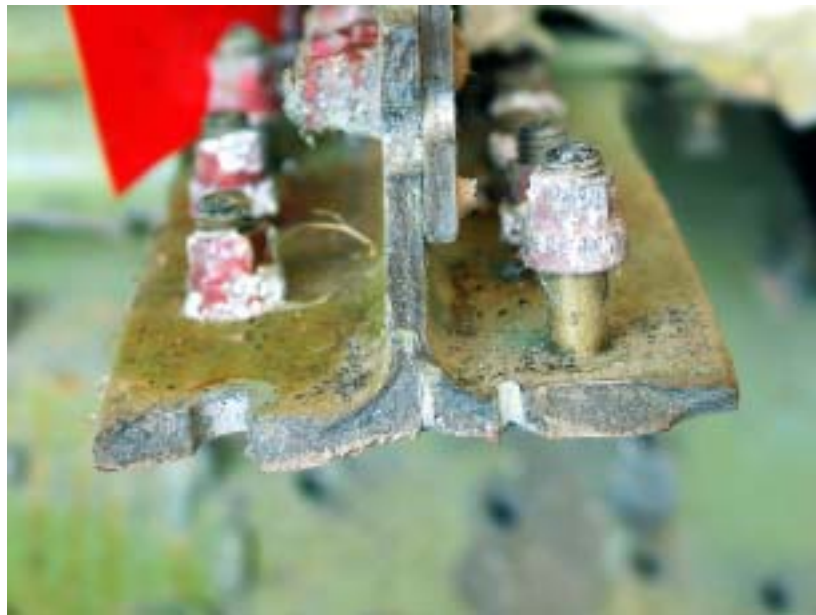
that the fractured surface was at about 45 ° slant to the maximum tensile stress and it means the typical overload fractography of soft metal and no further inspection was required. Only 4 rivets left and patch was deformed as shown in figure 4. Figure 1.16-152 revealed that the bonding rivet was disappeared and both of the aluminum alloy sheet and rivet were torn apart as arrow indicates.

Figure 1.16-151 Macro fractographic examination of lower door reveal (1.53X)

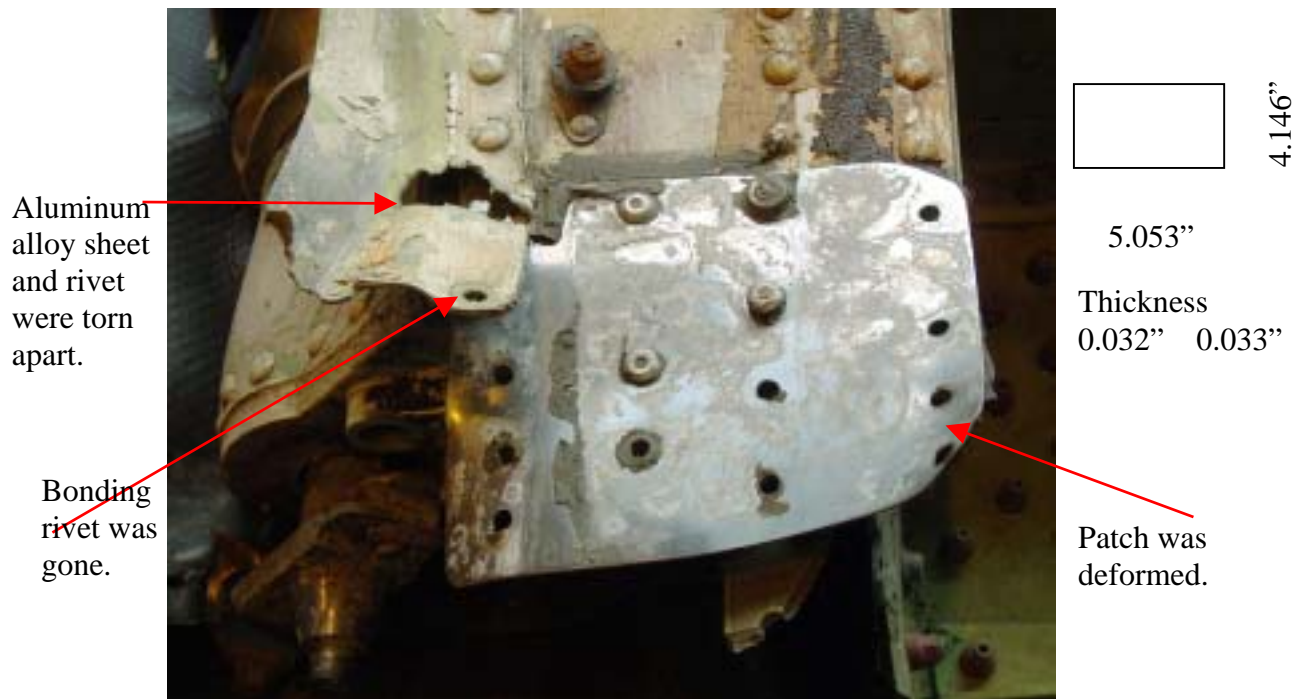
Four rivets were removed out by using handy grinder to disassemble the patch and then measured its dimension. The patch's dimension of length, width, thickness were 5.053 " X 4.146 " X 0.032 " 0.033 ", respectively. Fractography of door reveal where under the patch as in Figure 1.16-155 showed that the fracture surface was at about 45 ° slant to the maximum tensile stress and it means the characteristic of typical overload fractography of soft metal and no further inspection was required.

Figure 1.16-152 Higher magnification of patch which was located at the opposite side of the door reveal.(0.46X)

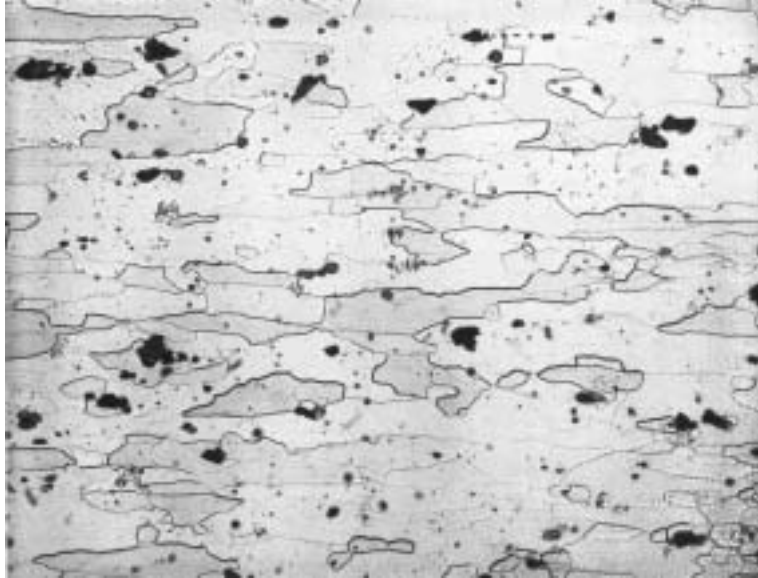
Metallographic examination of door reveal as in Figure 1.16-156 and compare to ASM handbook volume 9, it is believed that this is typical of microstructure of 7075-T6 Aluminum alloy. The actual average hardness reading was 82.8 HRB and it conforms to AMS-H-6088 specification requirements.(7075-T6 78 HRB) The conductivity testing results of door reveal were described as follows, 【UP】 are 32.8 IACS, 32.4 IACS ;【LH】are 31.6 IACS, 31.4 IACS, and 【RH】 are 32.1 IACS, 32.2 IACS, respectively. Those conductivity results conform to AMS-H-6088 specification requirements.(conductivity of 7075-T6 at 30.5 36.0 IACS) The Boeing company's engineer said that the material and heat treatment condition was 7075-T6511.

Figure 1.16-156 Metallographic examination of Left fractography as in figure 2.(400X)

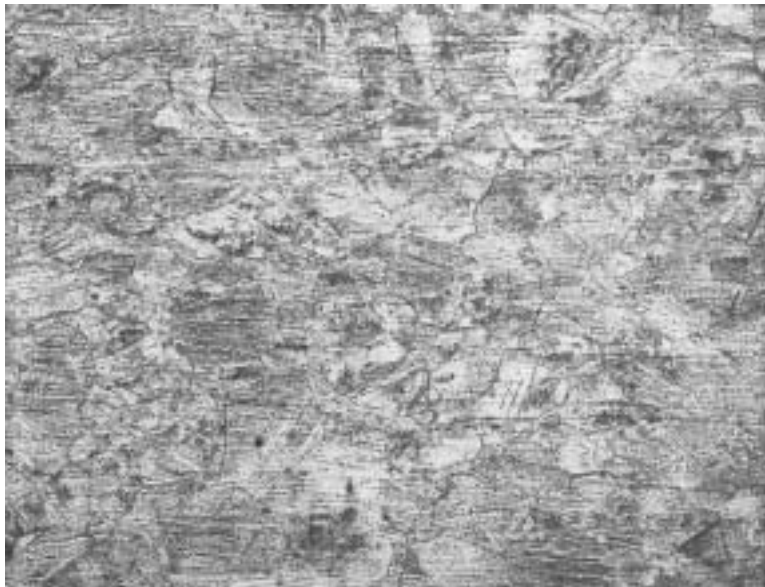
Metallographic examination of patch as in Figure 1.16-157 and compare to ASM handbook volume 9, it is believed that this is typical of microstructure of 17-7 Stainless steel with solution treated and precipitation hardened to 177ksi (39HRC). The actual average hardness reading was 39 HRC (converted from 391 H_k) and it conforms to AMS 5528 specification requirements.(hardness of 17-7 with ST+PH at 38 46HRC, approximately tensile strength shall be 150ksi minimum)

Figure 1.16-157 Metallographic examination of patch.(400X)

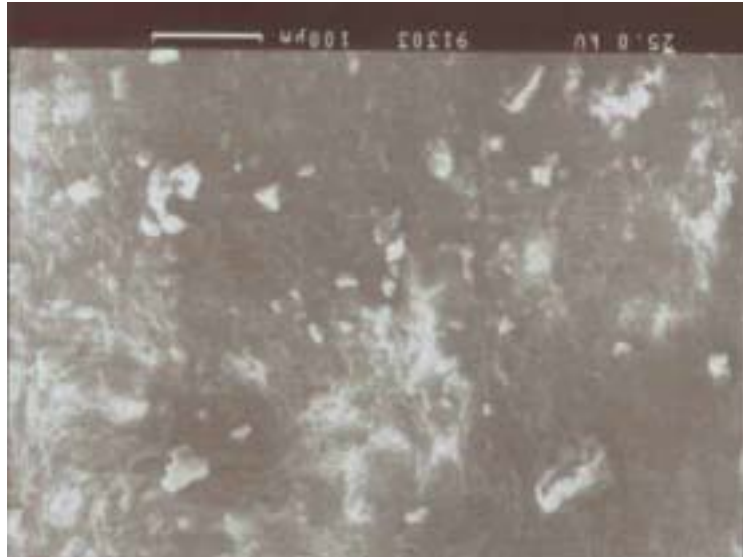
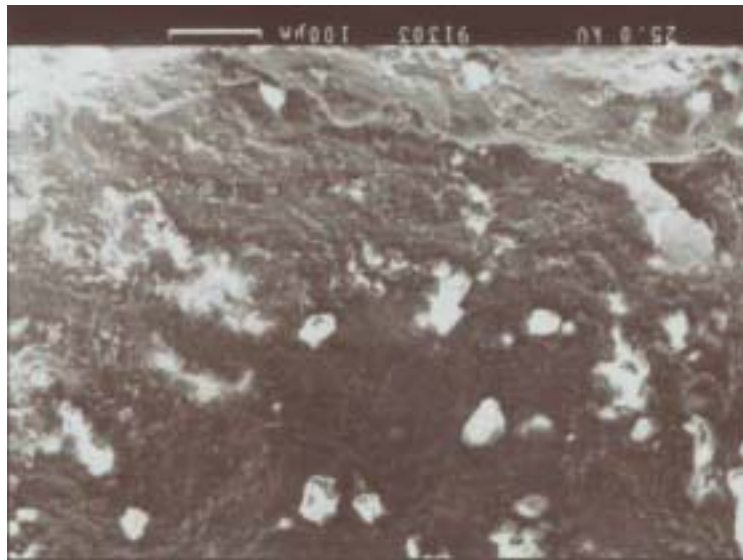
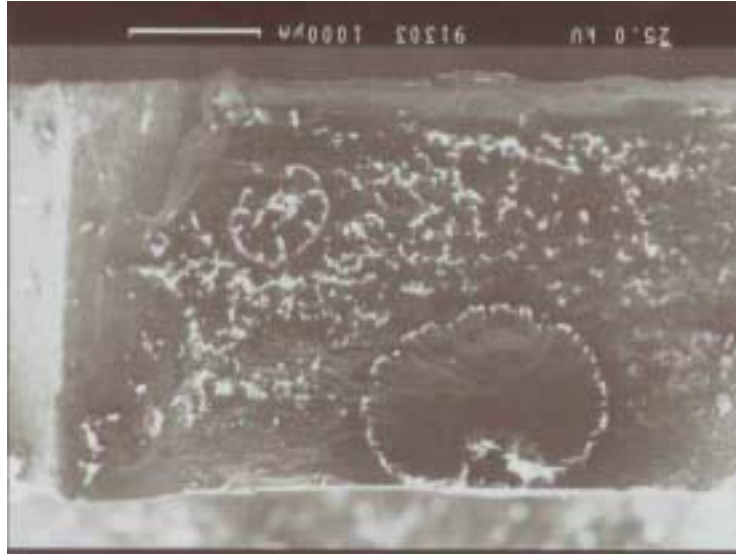
Figure 1.16-158 and 159 showed that SEM photographs of upper door reveal(LH), which were taken from area A and B as in figure 6, respectively. Fracture surface as described above was covered with severe corrosion so that we can't perform any further inspection by SEM. Figure 1.16-160 showed that the lower magnification of SEM photograph of upper door reveal (LH), which was taken from suspicious fatigue fracture area as in Figure 1.16-154. Corroded residues, light-colored spot, were also occurred on the fracture surface as in Figure 1.16-160 and the features cannot be observed clearly. Figure 1.16-161 and 1.16-162 showed that the typical fatigue fractography of

Figure 1.16-158 SEM photograph of upper door reveal (LH), which was taken from area A as in figure 6.(170X)

Figure 1.16-159 SEM photograph of upper door reveal(LH) , which was taken from area B as in figure 6. (140X)

Figure 1.16-160 SEM photograph of upper door reveal (LH), which was taken from suspicious fatigue fracture area as in figure 6.(21X)

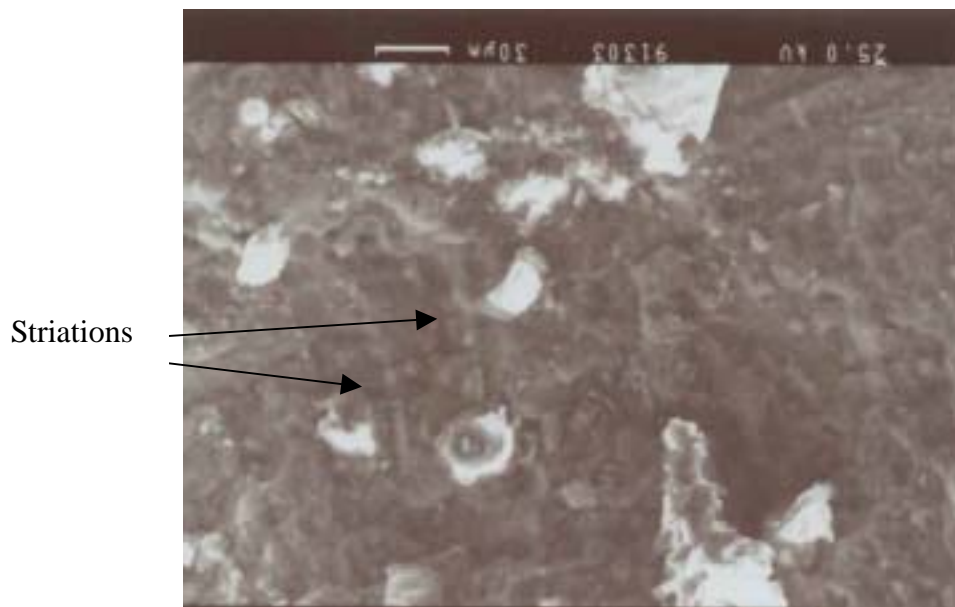
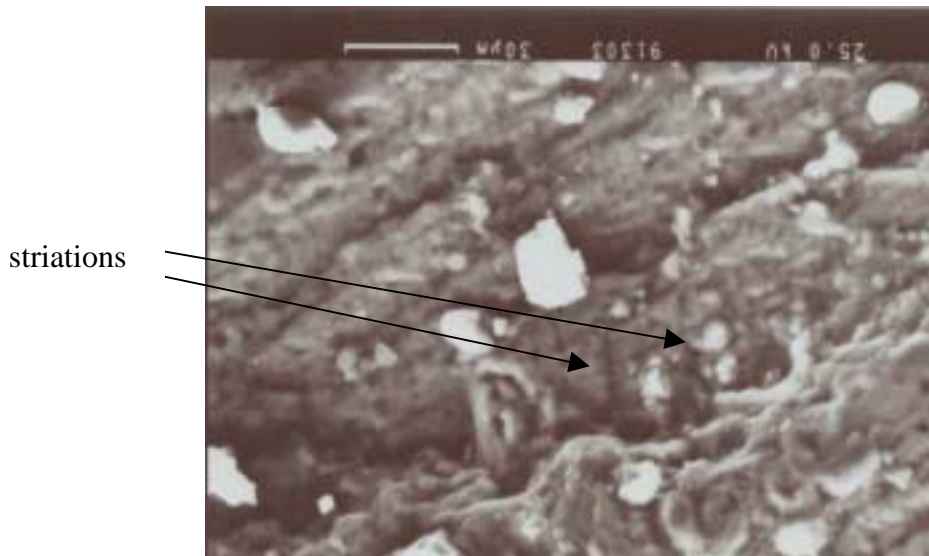
upper door reveal (LH), striations as arrows indicate, which were taken from area D and E as in Figure 1.16-154, respectively. The typical overload fractography of upper door reveal(LH), dimple structure, cannot be observed due to severe corrosion.

Figure 1.16-161 SEM photograph of upper door reveal (LH), which was taken from area D as in figure 6.(360X)

Figure 1.16-162 SEM photograph of upper door reveal(LH) , which was taken from area E as in figure 6. (610X)

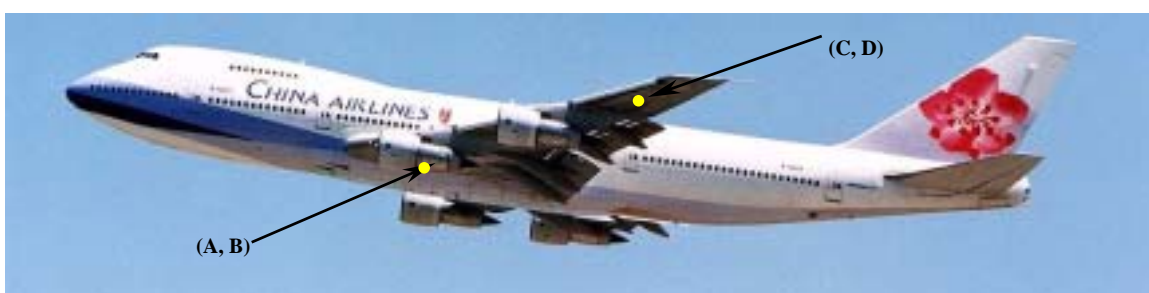
The discolored areas found on the wing center section of C1611 match the discolored areas from the retired 747 and are consistent with environmental contamination. No evidence of unburned fuel was found in the submitted samples. Sample 547C3 had an elevated level of sulfur. The origin of the sulfur was not determined.

Figure 1.16-163 Photo of CI611 showing general locations from which discoloration samples were taken. Samples 642C3 and 547C3 were from wing center section as indicated by A and B. Samples 628C3 and 628C6 were from the right wing corresponding to the location indicated by C and D.

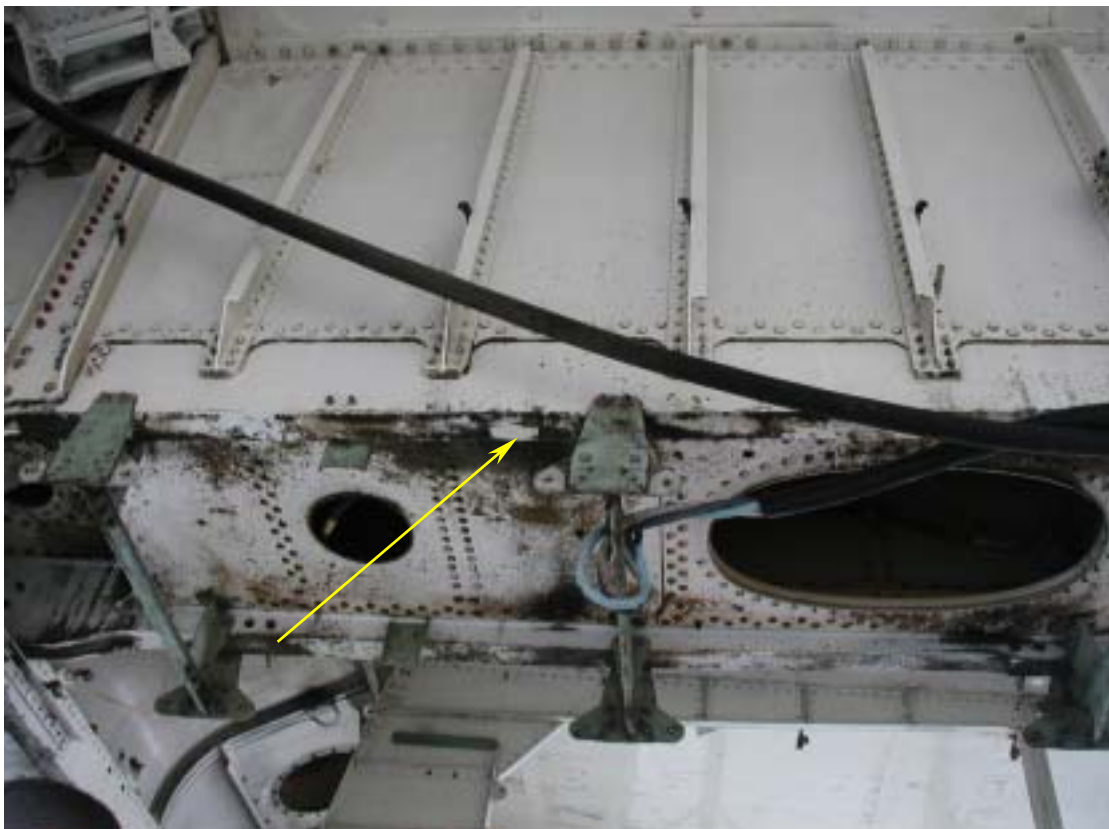
The wing center section of a retired 747 was examined for similar discolored areas. The retired 747 (line number 229) is located at Boeing's Everett facility and differs from CI611 in that the final surface coating on the wing center section lower skin is an enamel rather than BMS 10-100. Discolored areas were found in crevices and around joints in the wing center section and the wheel wells. Samples were taken from the bottom of the keel beam below the wing center section (see Figure 1.16-174 for approximate location of sample) and from the wing-to-body fairing chord (see Figure 1.16-175) for comparison to the discolored areas found on the wing center section of CI611.

Figure 1.16-174 Photo showing location of reference discoloration sample from keel beam of retired 747.

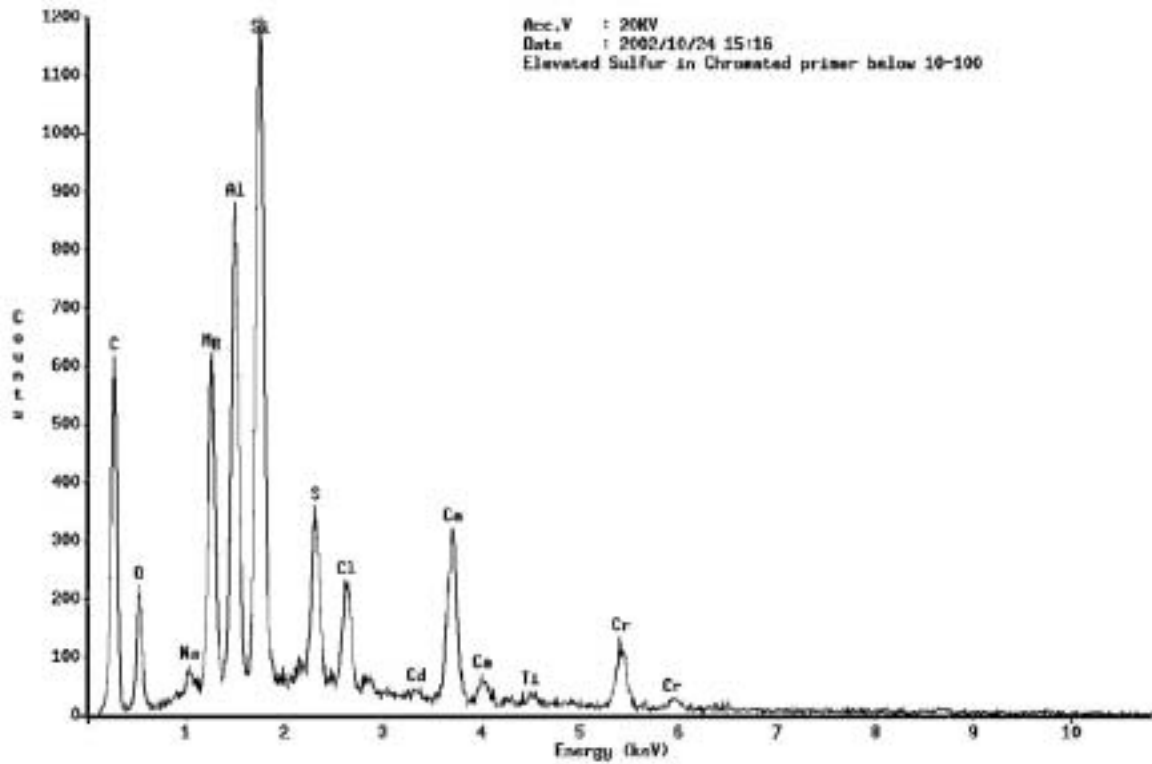
Figure 1.16-180 EDX spectrum of discolorations from sample 547C3. This sample is typical of 10-100 but has elevated sulfur.

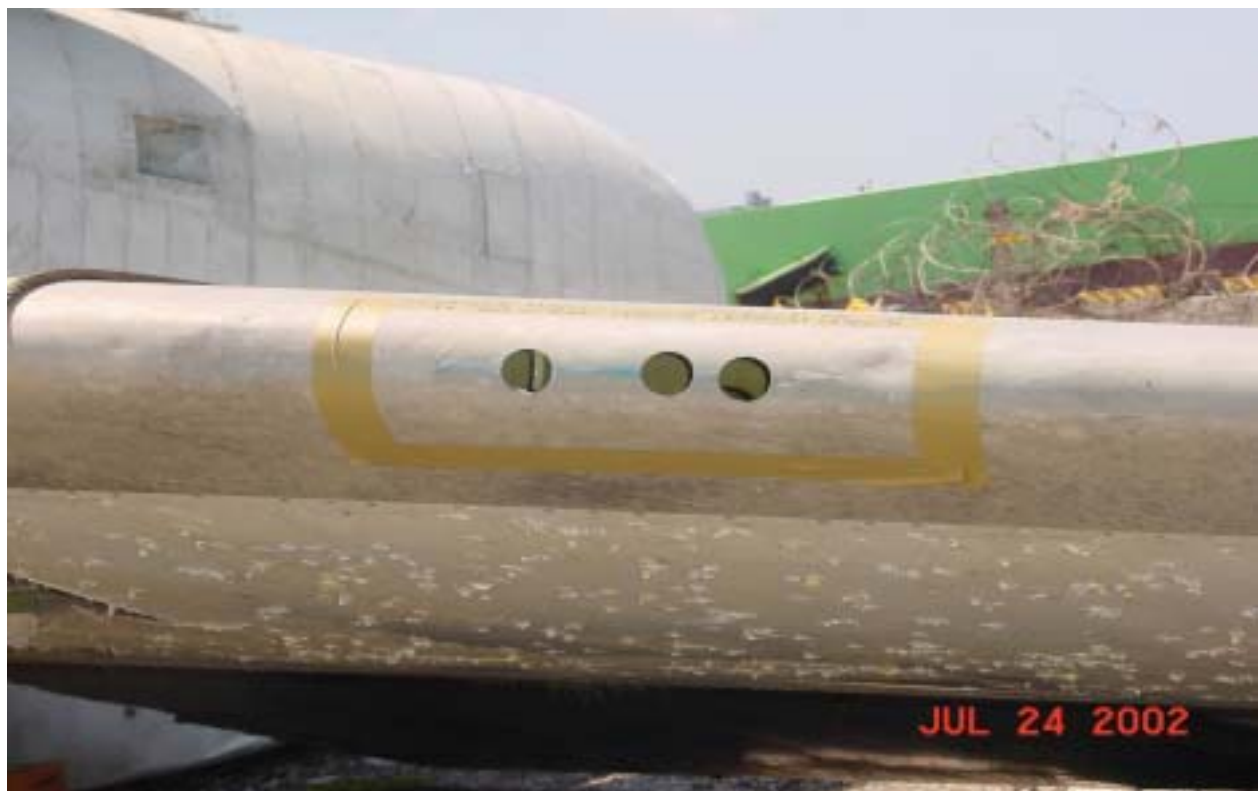
Two colors of transfer marks were found on a coating applied to the leading edge of the horizontal stabilizer. Samples of these transfer marks were taken (see Figures 1.16-187, 188 and 189) for analysis to identify their possible origins. Reference samples were taken of exterior decorative paint from the forward fuselage (see Figure 1.16-187 for approximate locations of these samples), and from various materials used in the aircraft interior. The samples were designated 656C3 (Dark Blue Paint, see Figure 1.16-190), 650C3 (Light Blue Paint, see Figure 1.16-191), 640C5 (Very Light Blue Paint, see Figure 1.16-192), 284C3 (Light Blue Plastic Seat Surround, see Figure 1.16-193), 526C3 (Dark Blue Plastic Trim, see Figure 1.16-194) and 284C6 (Dark Blue Seat Arm Rest, see Figure 1.16-195).

Figure 1.16-188 Photograph of the left horizontal stabilizer leading edge showing transfer marks on the applied coating.

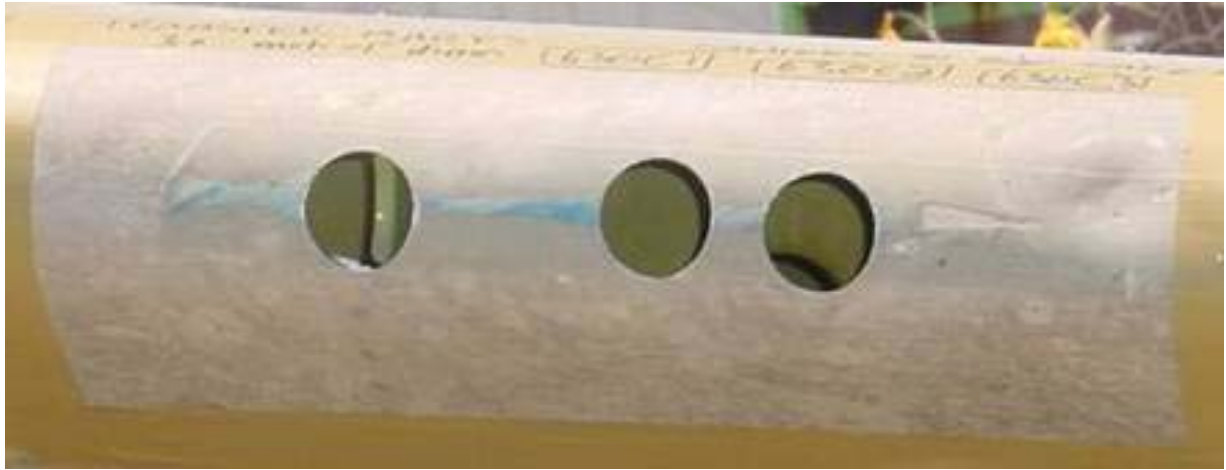
Figure 1.16-189 Enlarged image of the transfer marks showing that they end at the edge of the coating.
