**Aviation Safety Council
Taipei, Taiwan**

**CI611 Accident Investigation
Factual Data Collection
Group Report**

Structure Group

ASC-AFR-03-06-001

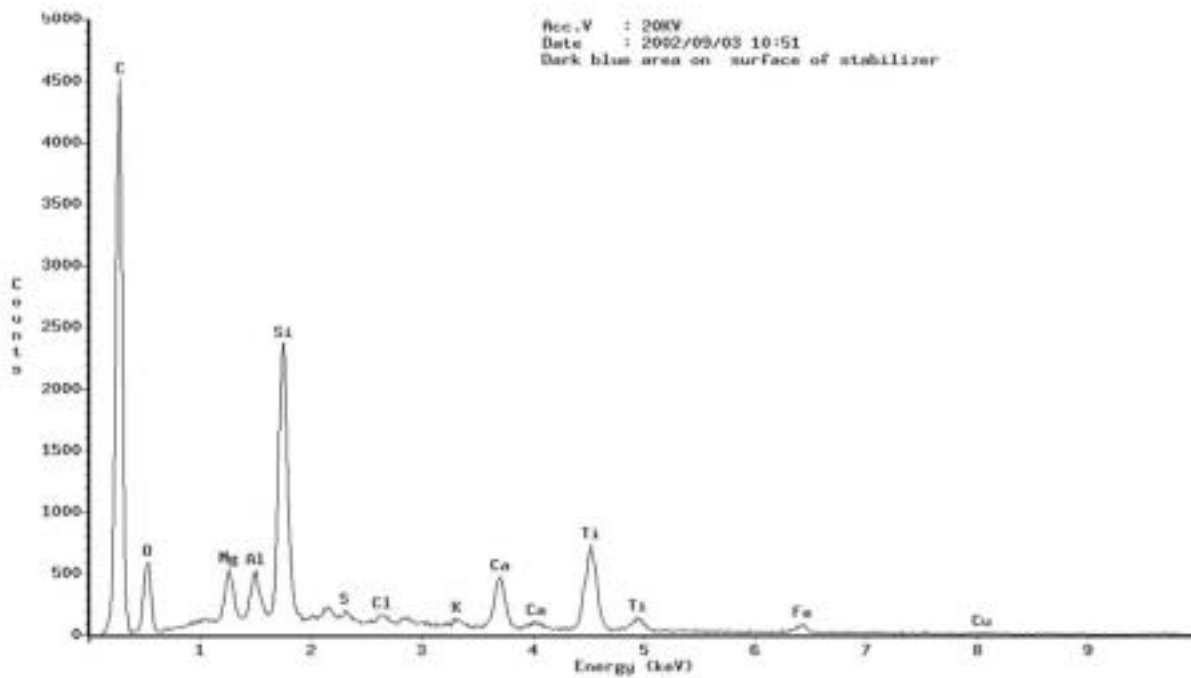
Elemental data was obtained from the transfer marks, the paint samples and the interior samples. These are shown in Figures 1.16-203 through 212. The dark blue transfer mark was found to contain barium and sulfur rich particles that were on the order of 1 micron in diameter (see EDX in Figure 1.16-204). These particles were not found in any of the other samples. Due to the limited amount of material that could be separated, it is possible that these particles could have been missed in the light blue transfer sample. The elemental data is summarized in Table 1.16-15, which indicates the presence or absence of particular elements in the various samples.

Figure 1.16-203 EDX spectrum of dark blue transfer mark.

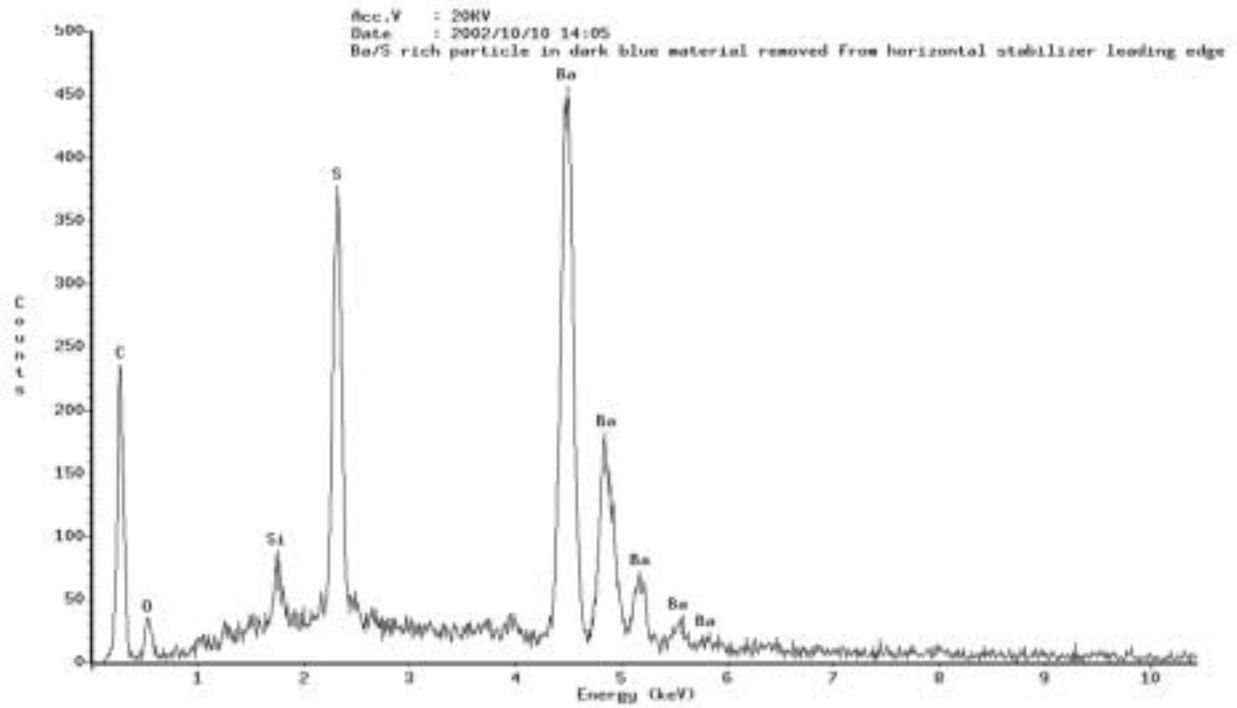
Figure 1.16-204 EDX spectrum of barium and sulfur rich particle found in dark blue transfer mark.

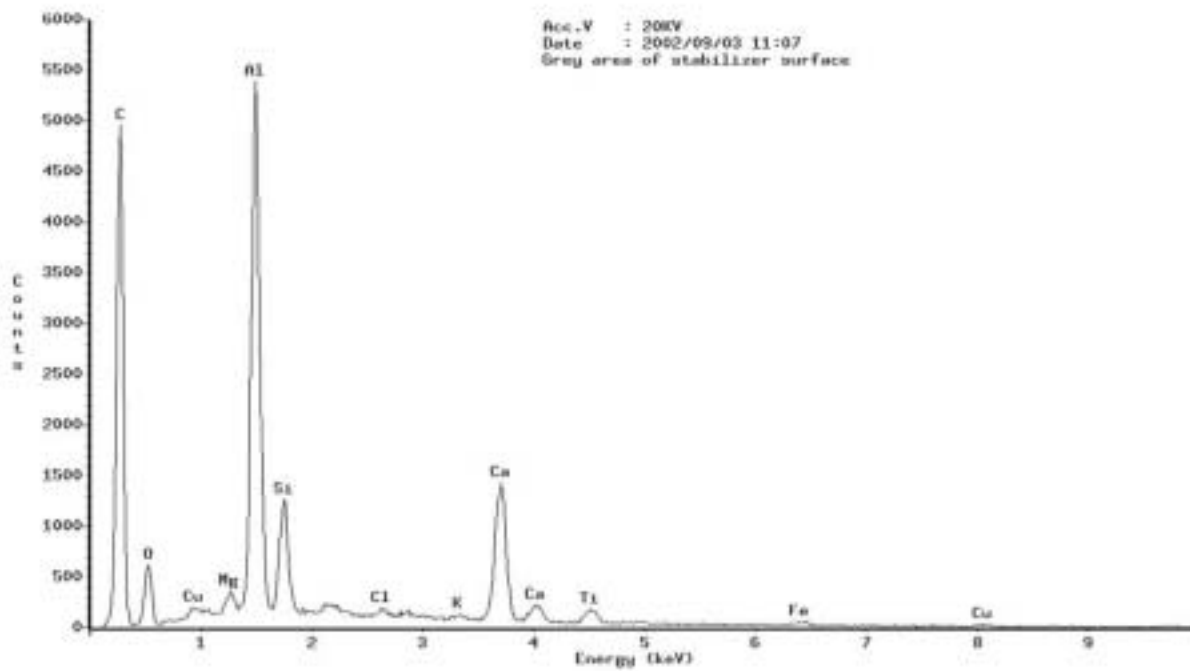
Figure 1.16-205 EDX spectrum of light blue transfer mark.

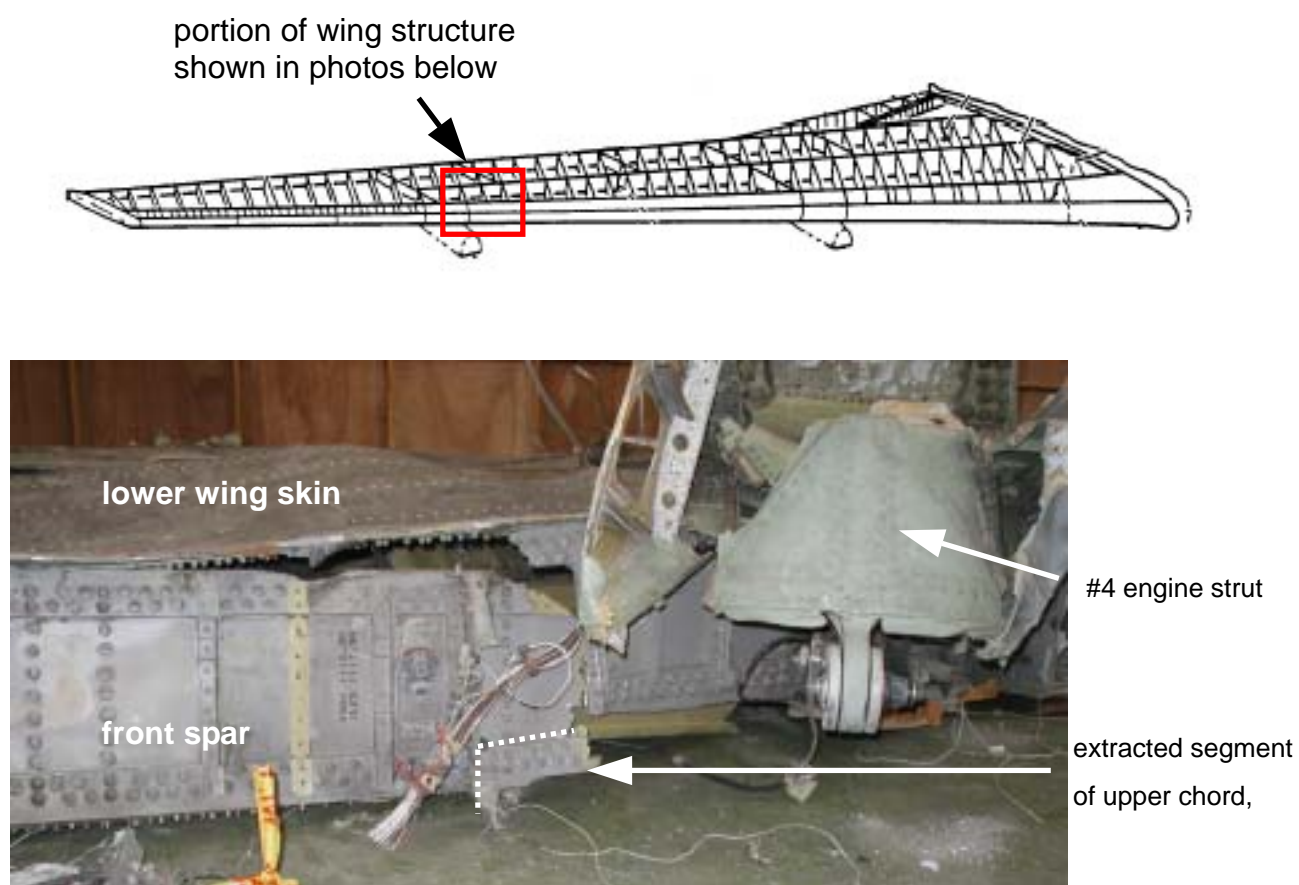
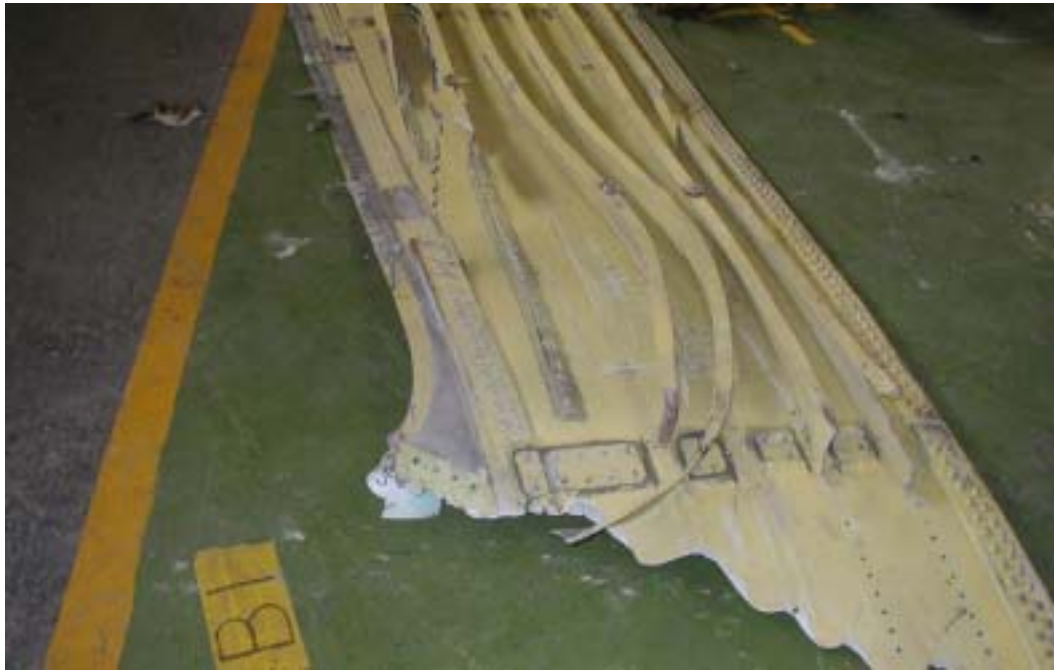
During a supplemental examination of the wreckage of China Airlines flight CI611, a 747-200 airplane, two structural details were identified to contain areas of cracking that may have existed prior to the accident. As noted in the referenced Sequencing Document Supplement, the two areas identified were the upper chord of the right wing front spar at approximately WS 1116 (Figure 1.16-213) which was thought to possibly contain an area of stress corrosion cracking, and the left side of body, rear spar internal splice upper tee fitting, believed to contain a region of fatigue cracking (Figure 1.16-214). Portions of both details were extracted and submitted for metallurgical analysis (Figure 1.16-215).

Figure 1.16-213 Diagram of the right wing and photographs showing where the specimens of the upper chord with mating fracture portions were extracted.

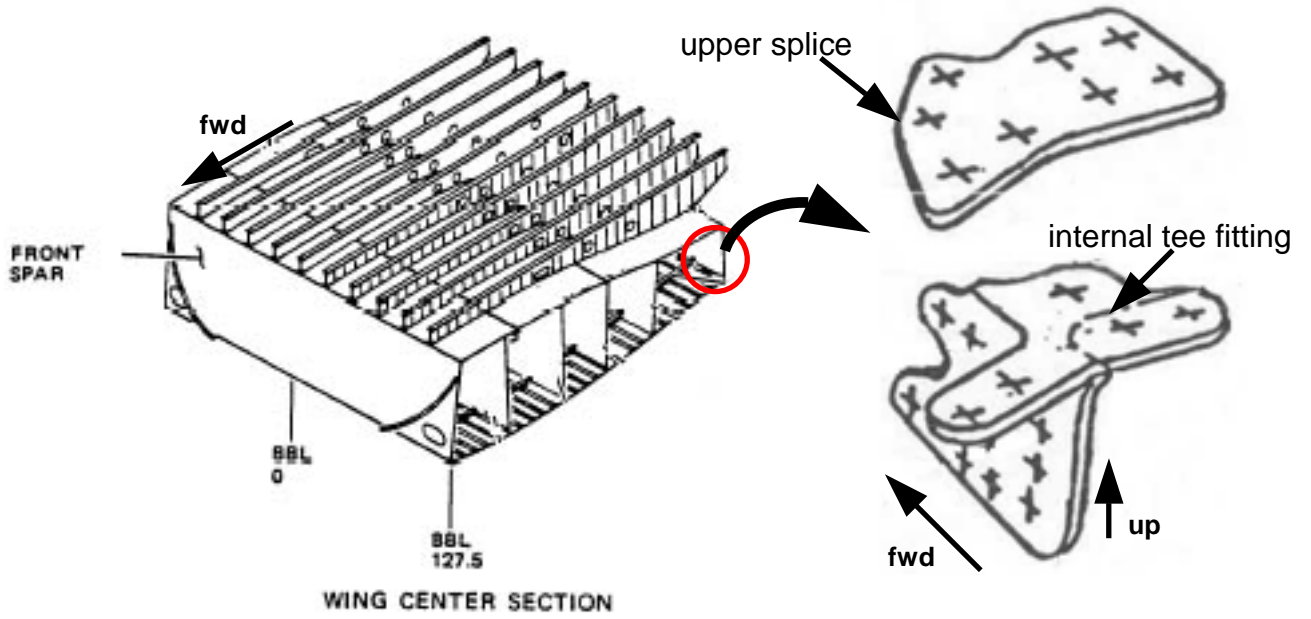
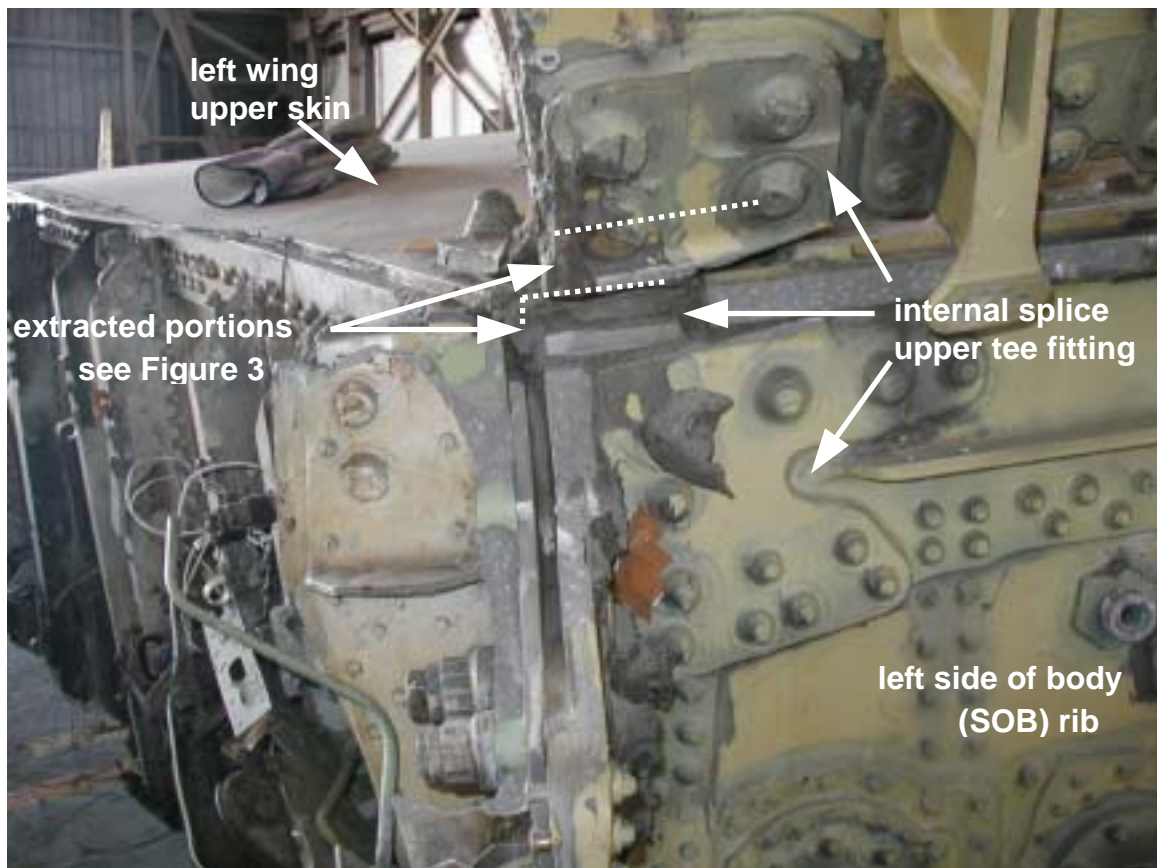
Figure 1.16-214 Diagram and photograph showing the location of the internal splice upper tee fitting and the portions extracted.

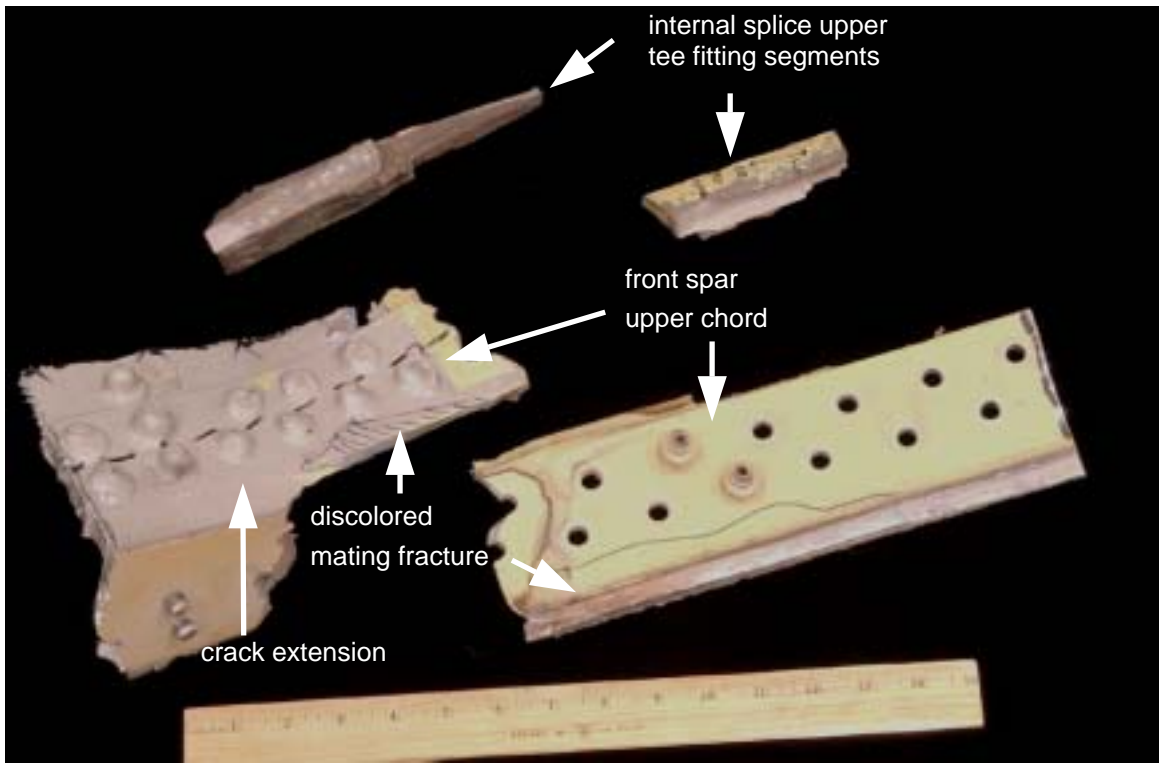
Figure 1.16-215 Photograph of the extracted specimens in the as-received condition.

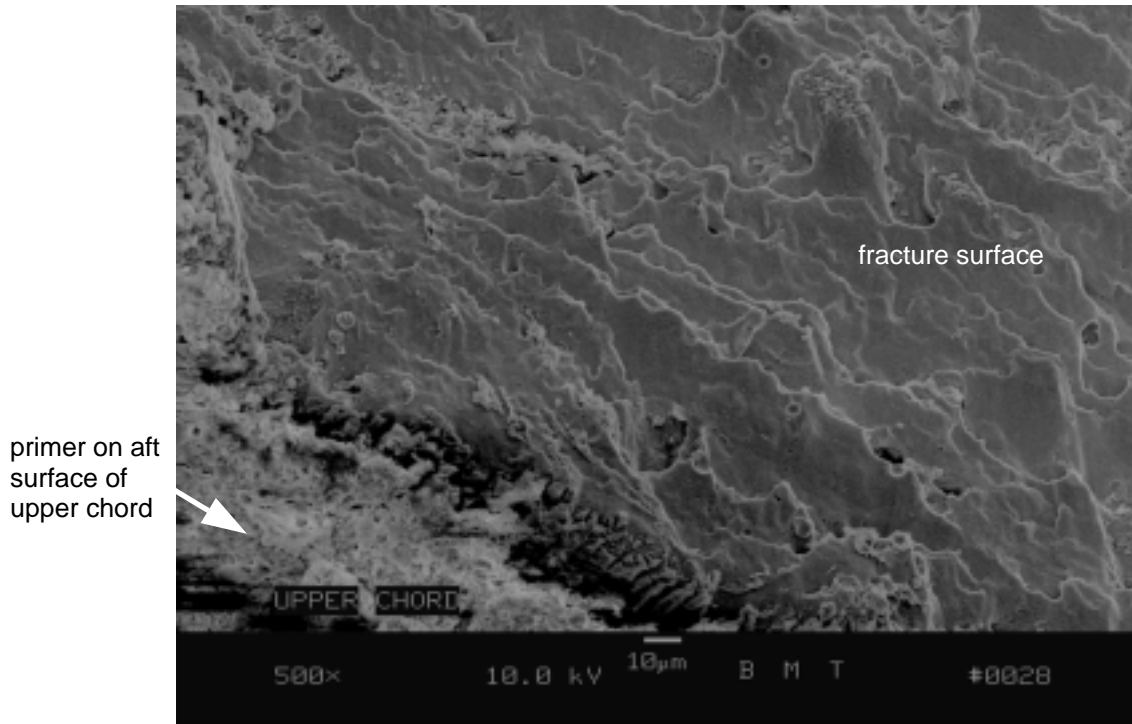
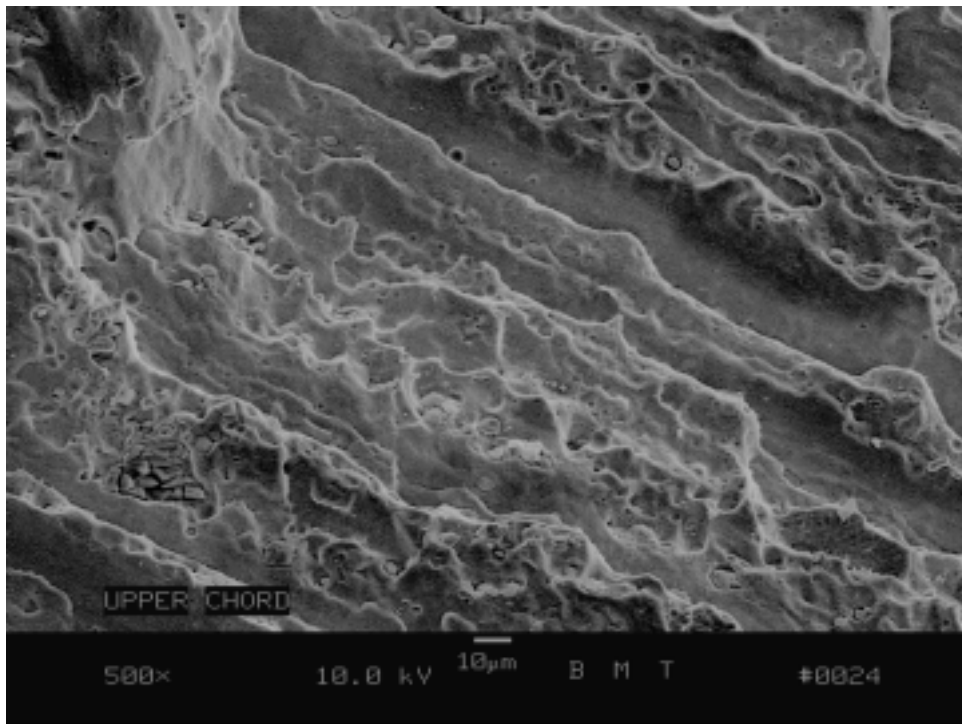
Several areas along the aft edge of the upper chord fracture surface where this local portion of the fracture initiated, as well as at locations in the interior, had a dimpled morphology, indicative of ultimate tensile or shear separation (Figures 1.16-216 and 217), not stress corrosion cracking (SCC). In addition, further evidence of plastic deformation from tensile separation (necking) along this edge was observed on metallographic cross sections (Figures 1.16-216 and 218).

Figure 1.16-217 SEM photographs of portions of the mating fracture to that shown in Figure 4 at the corresponding location indicated. The entire fracture surface suffered from heavy corrosion. However, evidence of ductile separation represented by the remnant dimpled morphology was observed at locations along the aft edge (top photo) as well as through the interior (bottom photo).

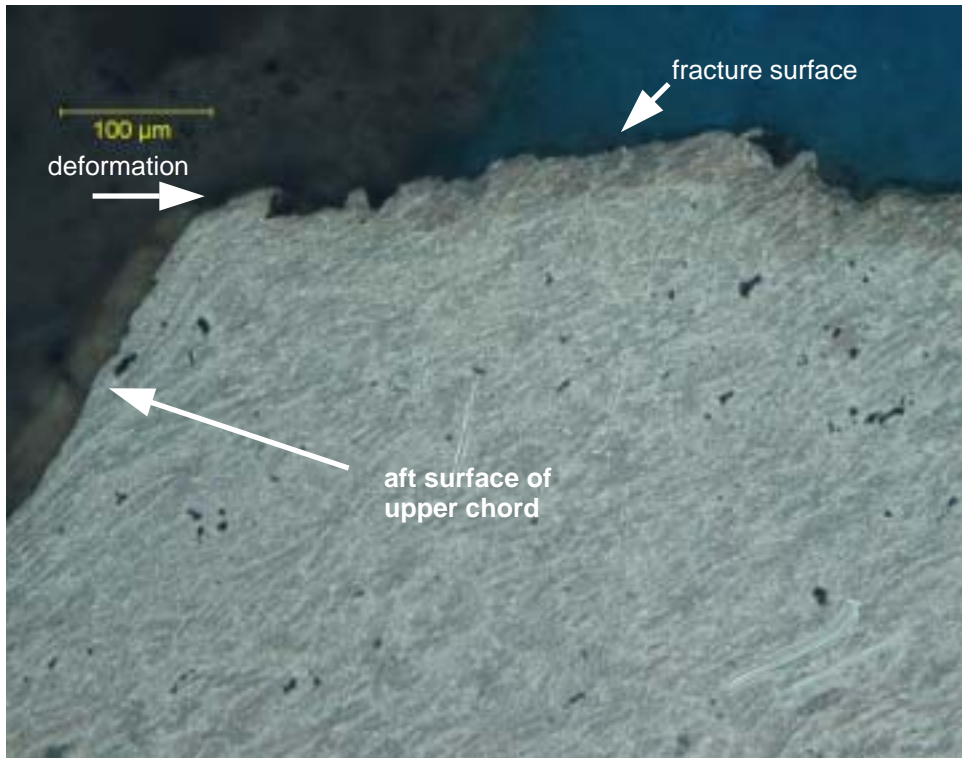
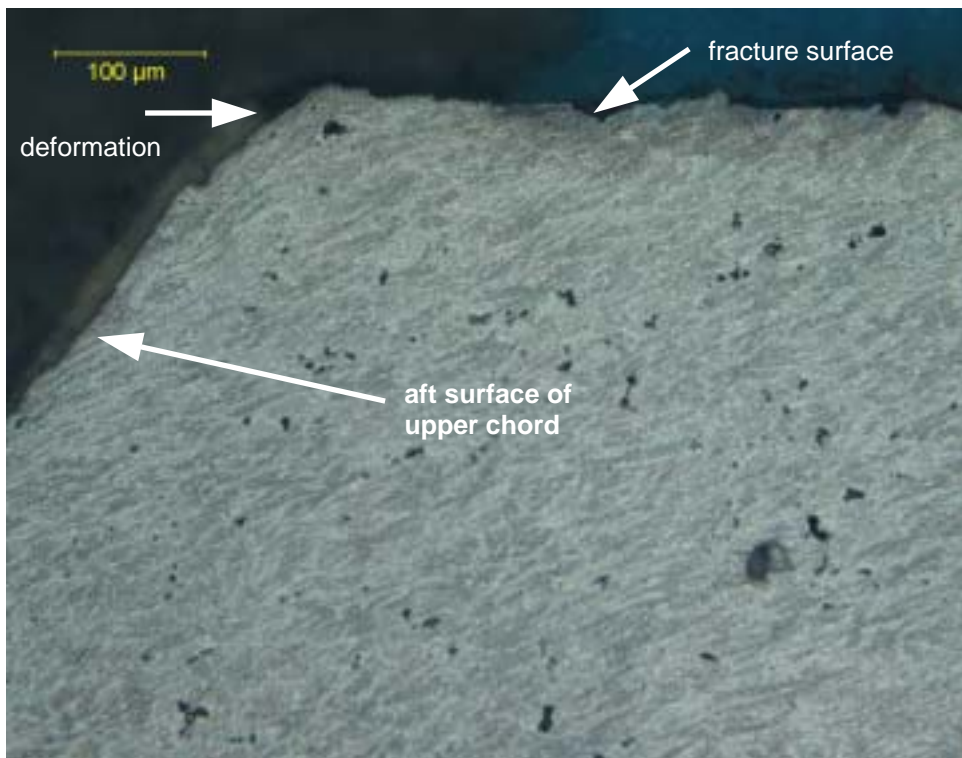
Figure 1.16-218 Metallographic cross sections showing the residual inward deformation, commonly known as “necking”, adjacent to the fracture surface consistent with an ultimate tensile/shear separation mechanism.

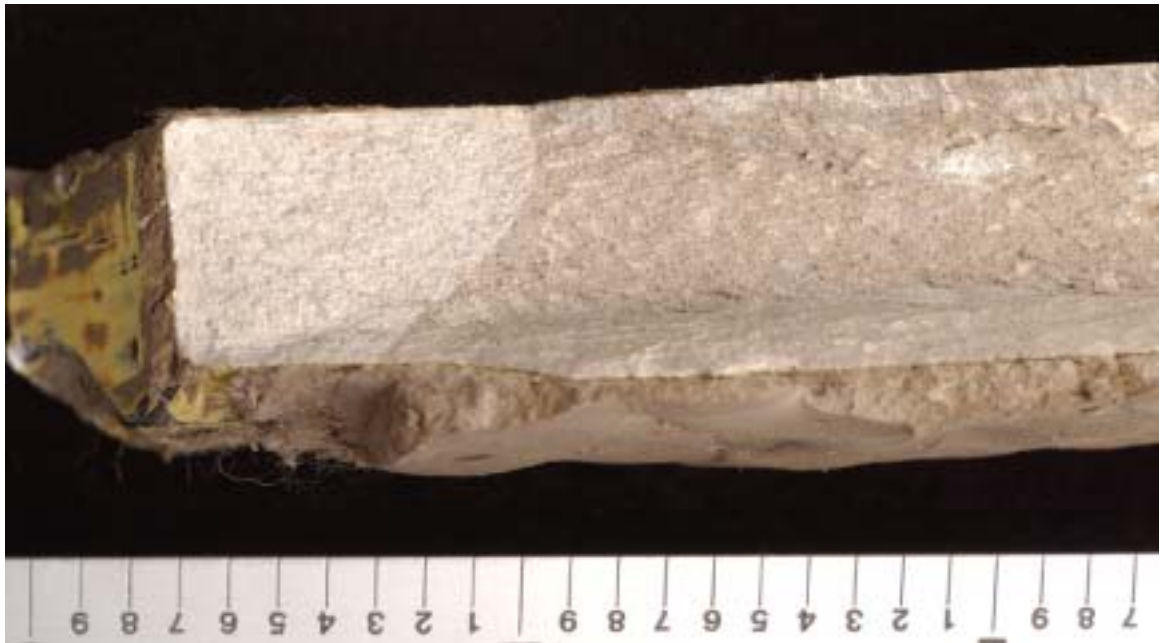
The fracture surface of the tee fitting contained a flat profile “thumbnail” region that generally extended forward to approximately 0.75 inches from the aft edge of the part (Figure 1.16-219). Fatigue striations could be resolved in several areas (Figure 1.16-220). The striation spacing, which is an indicator of crack growth rate for a fatigue cracking mechanism, was observed to remain constant at the extent of the fatigue region, which transitioned abruptly to a dimpled morphology due to ultimate tensile separation (Figure 1.16-221). The initiation location was observed to be on the upper surface of the flange near

Figure 1.16-219 Photograph of the outboard half of the fracture of the upper tee fitting showing the distinct "thumbnail" region, associated with a flat profile.

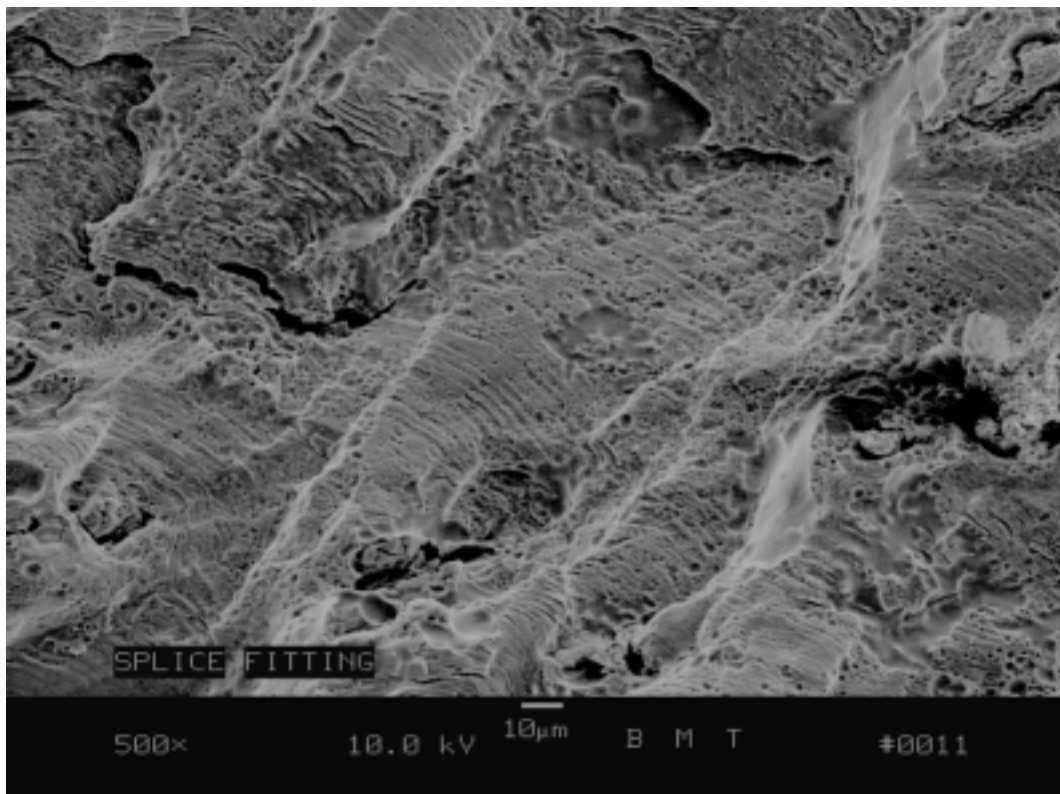
Figure 1.16-220 SEM photograph of the inboard fracture of the tee fitting within the flat profile (thumbnail) region showing fatigue striations.

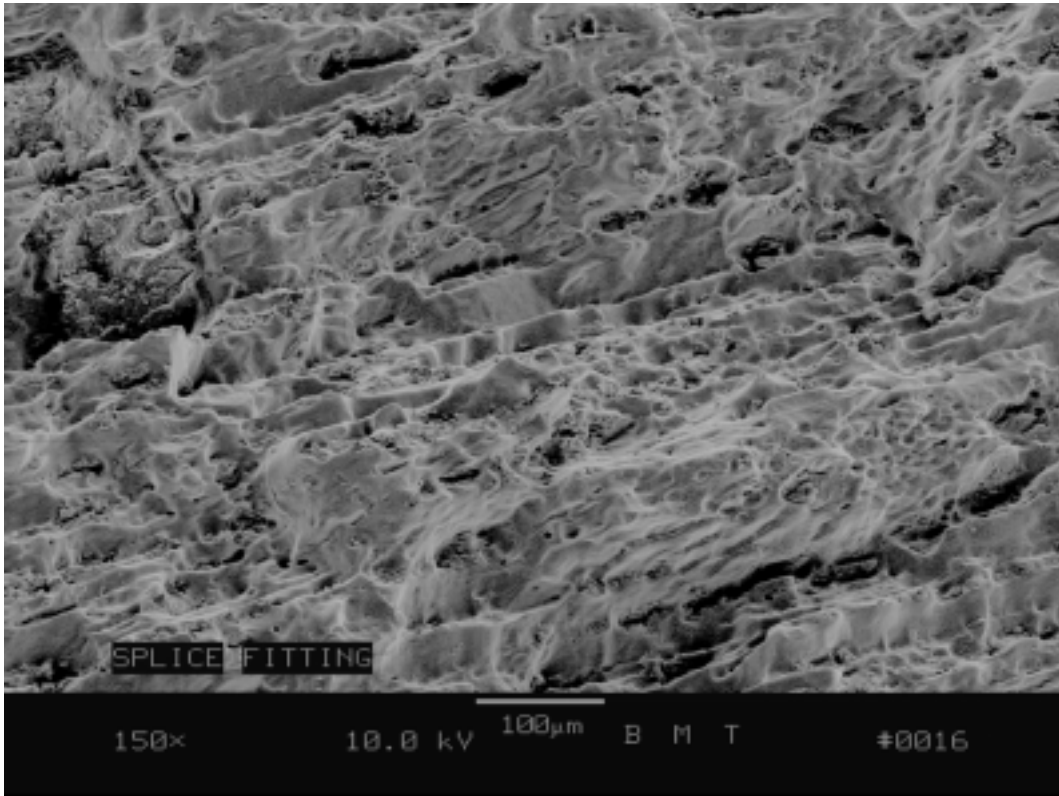
Figure 1.16-221 SEM photograph of the upper tee fitting fracture surface showing the typical dimpled morphology beyond the “thumbnail” region.

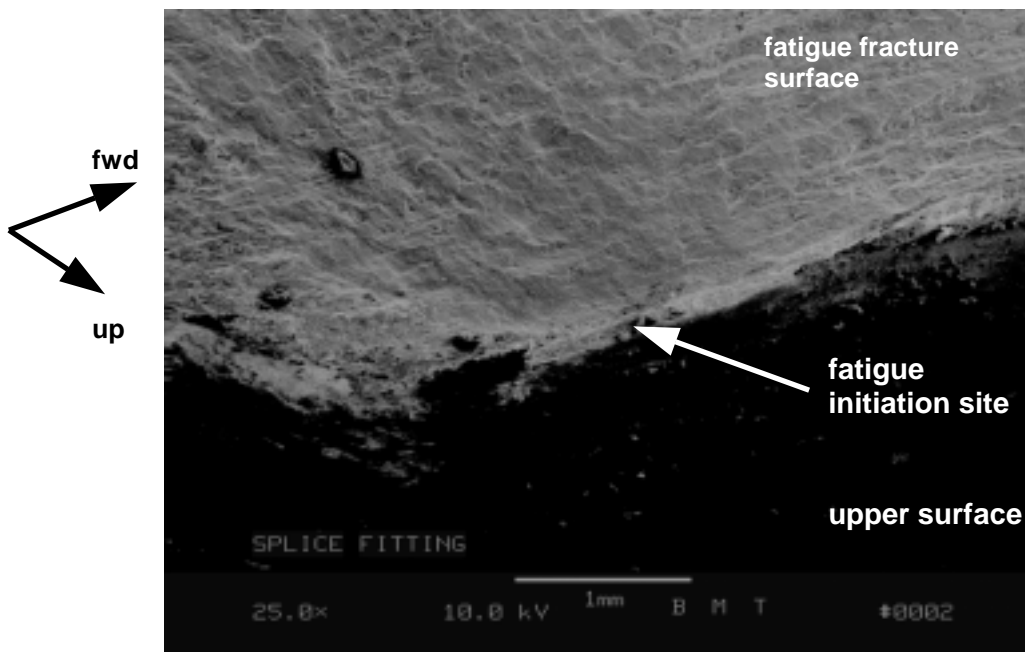
the aft edge transition radius (Figure 1.16-212). No geometrical anomalies that may have contributed to the initiation were observed.

Figure 1.16-222 SEM photograph of the fatigue initiation location adjacent to the radius of the aft edge of the fitting.
