**Aviation Safety Council
Taipei, Taiwan**

**GE791 Accident Investigation
Factual Data Collection
Group Report**

Recorders Group

ASC-GRP-03-10-001

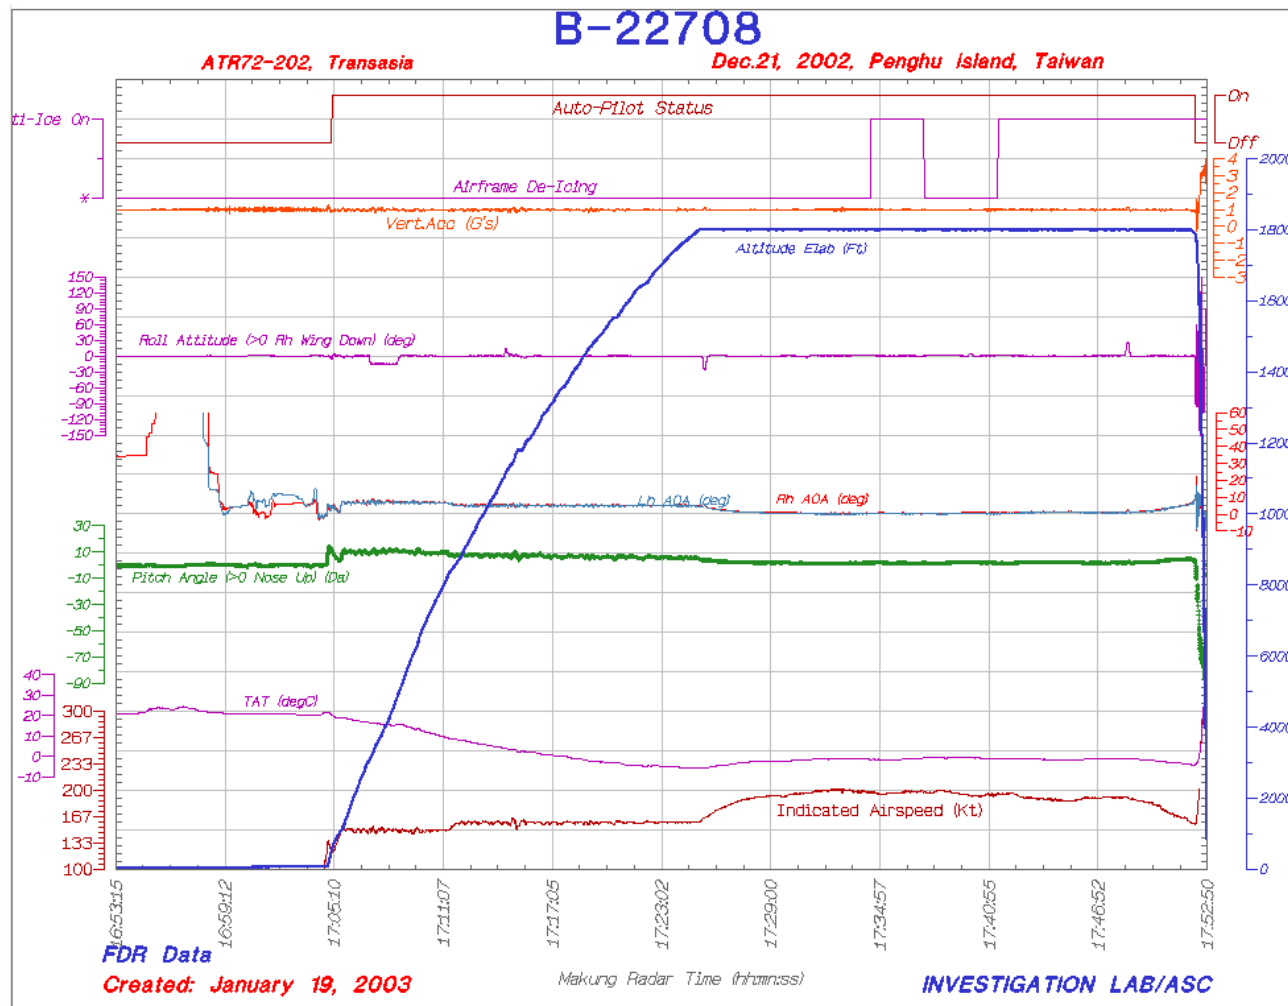
Figure 1.11-5 The flight data of GE791 from 1653:15 to 17:52:50

(pressure altitude, IAS, pitch, roll, AOA, icing condition, AP, Acceleration, total temperature)

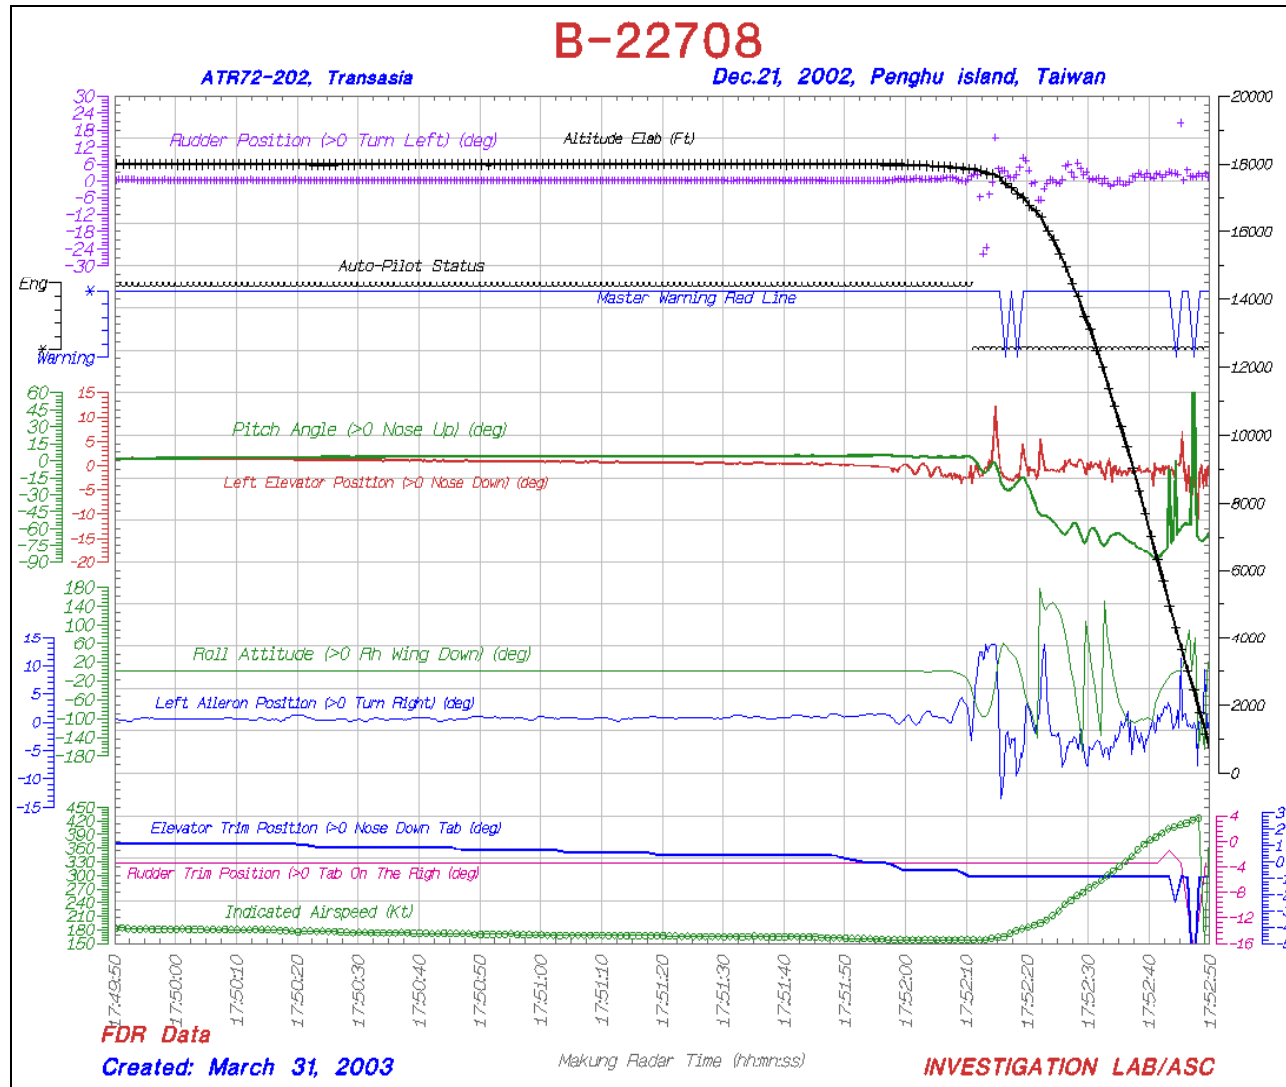
Figure1.11-6 The flight data of Last 3 minutes of GE791 (1749:15~17:52:50)

(pressure altitude, IAS, pitch, roll, AOA, AP, master warning, elevator, aileron, rudder)

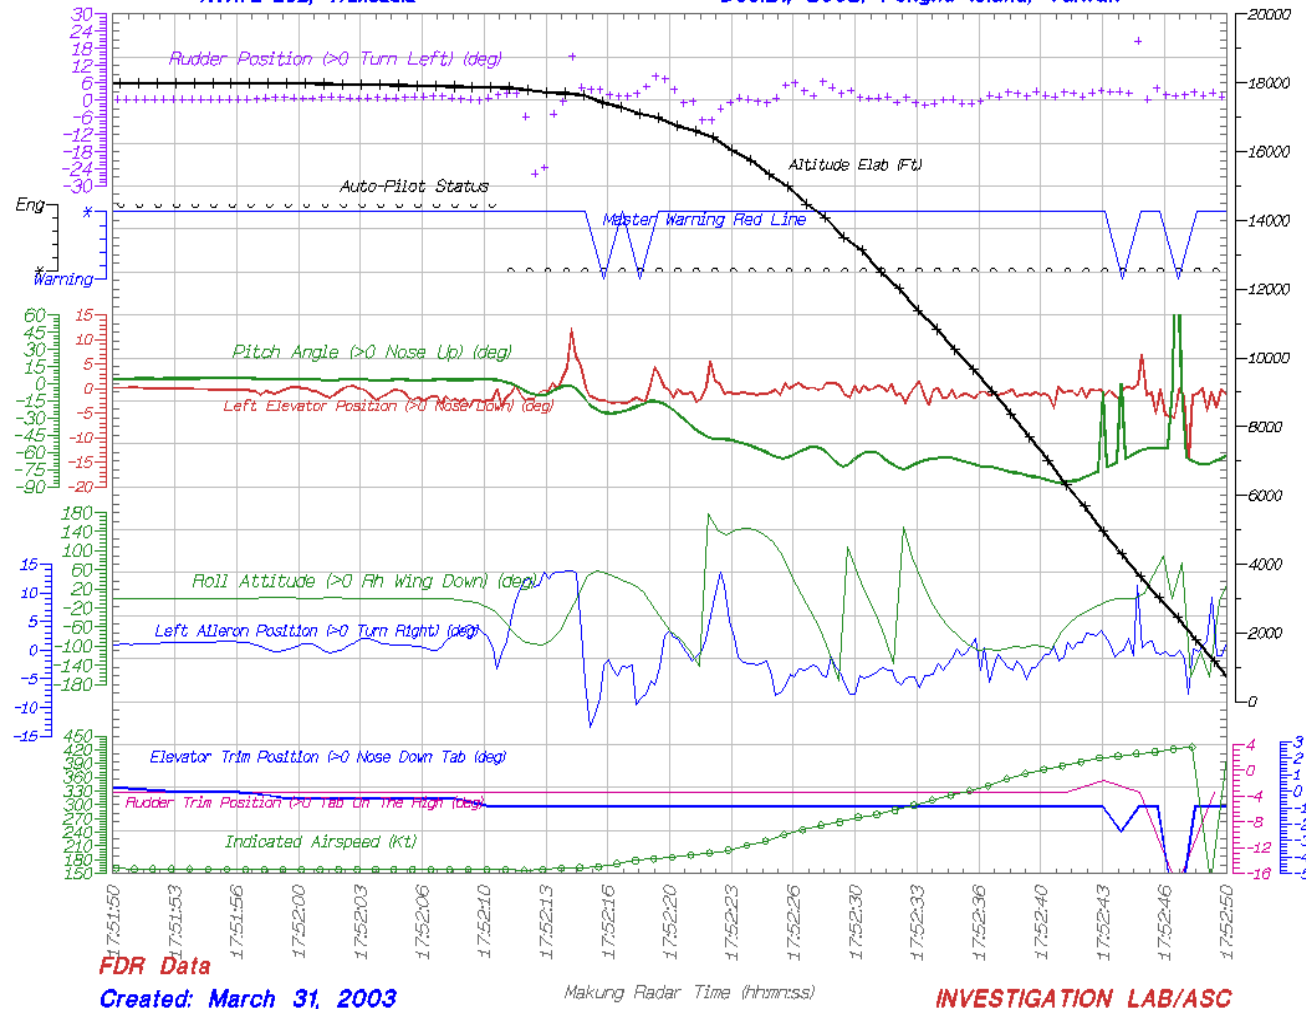
Figure1.11-7 The flight data of the last one minute of GE791 (17:51:50~17:52:50)

(pressure altitude, IAS, pitch, roll, AOA, AP, master warning, elevator, eileron, rudder)

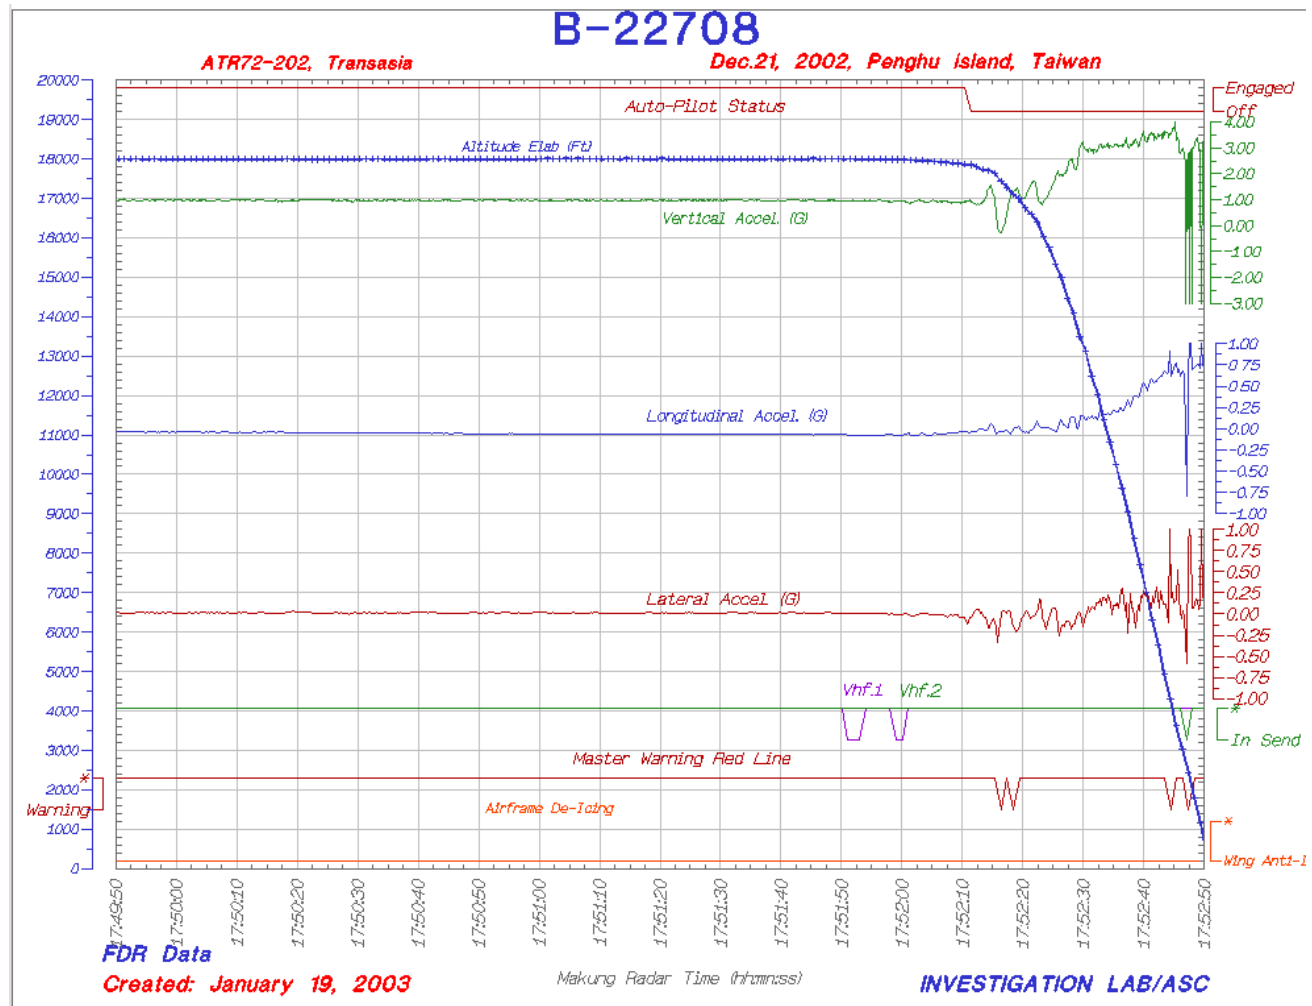
Figure 1.11-8 The flight data of last three minutes of GE791 (17:49:50~17:52:50)

(pressure altitude, AP, master warning, three-dimensional accelerations)

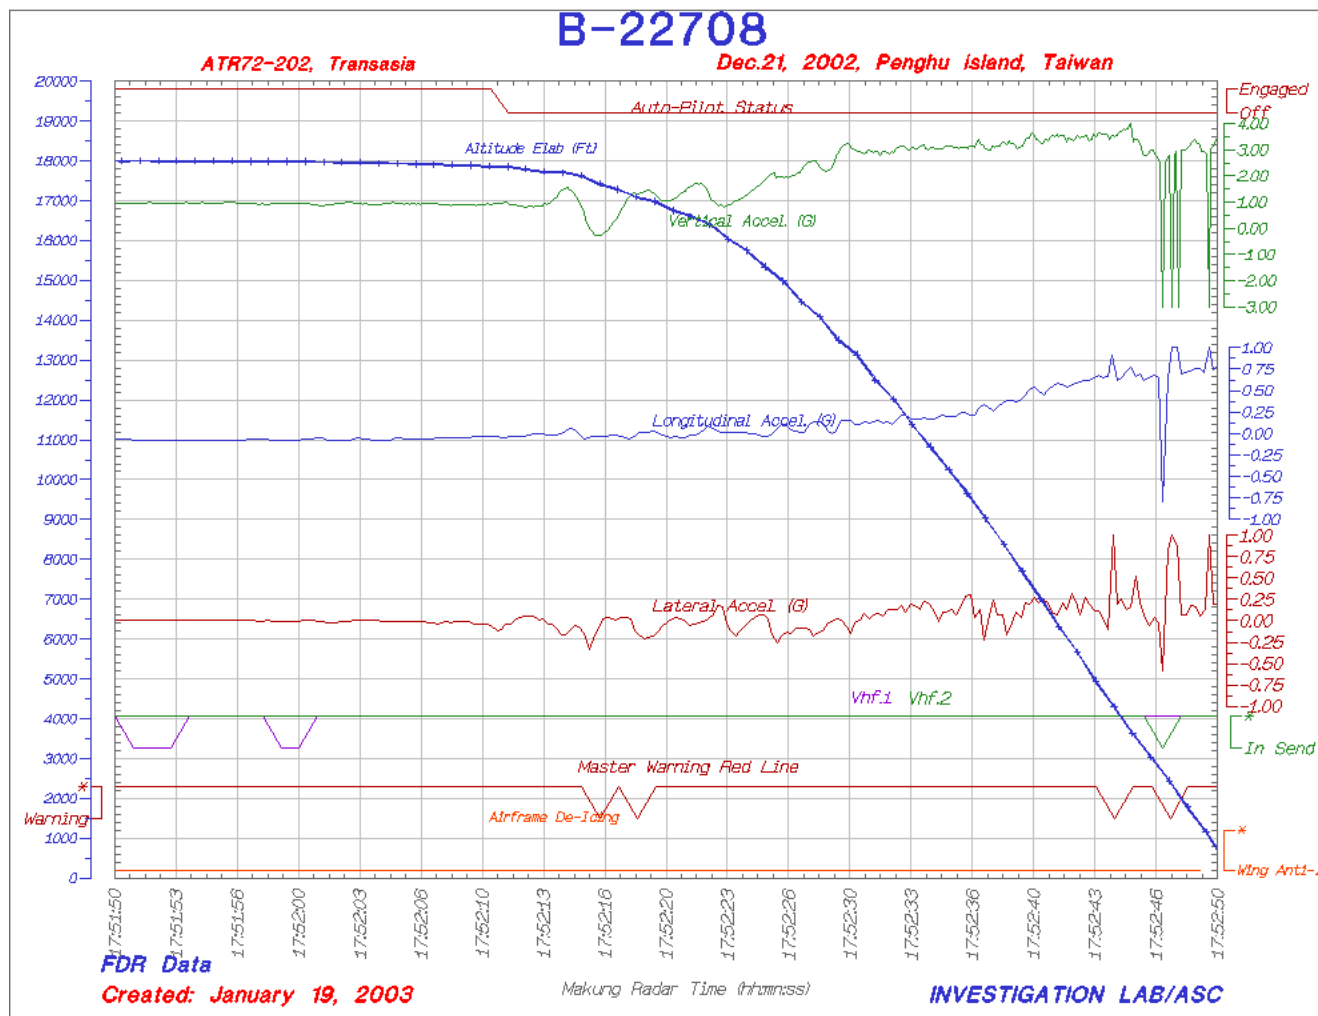
Figure 1.11-9 The flight data of the last one minute of GE791 (17:51:50~17:52:50)
 (pressure altitude, AP, master warning, three-dimensional accelerations)

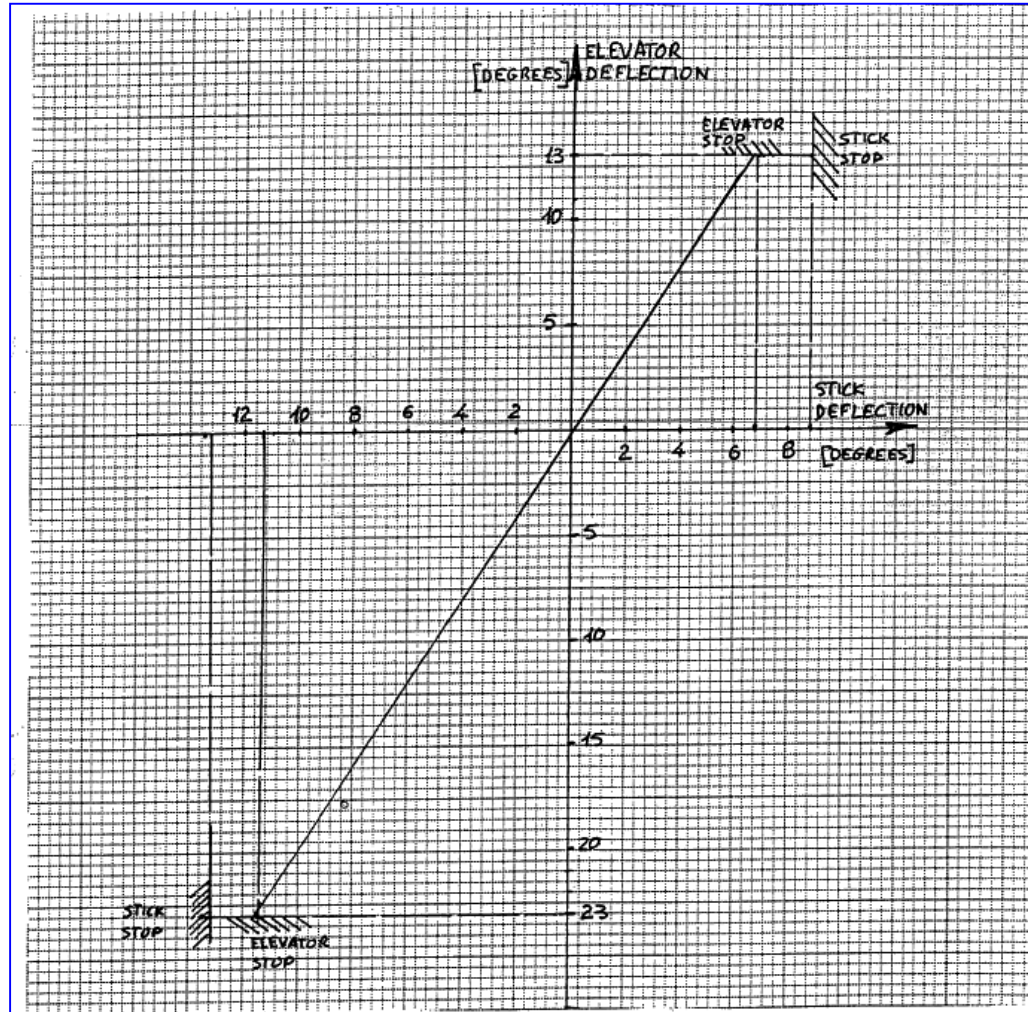
Figure 1.11-11 The correlation between CWD and elevator
 (with CWD from -11.2 to +6.8 degrees and elevator from -23 to +13 degrees)

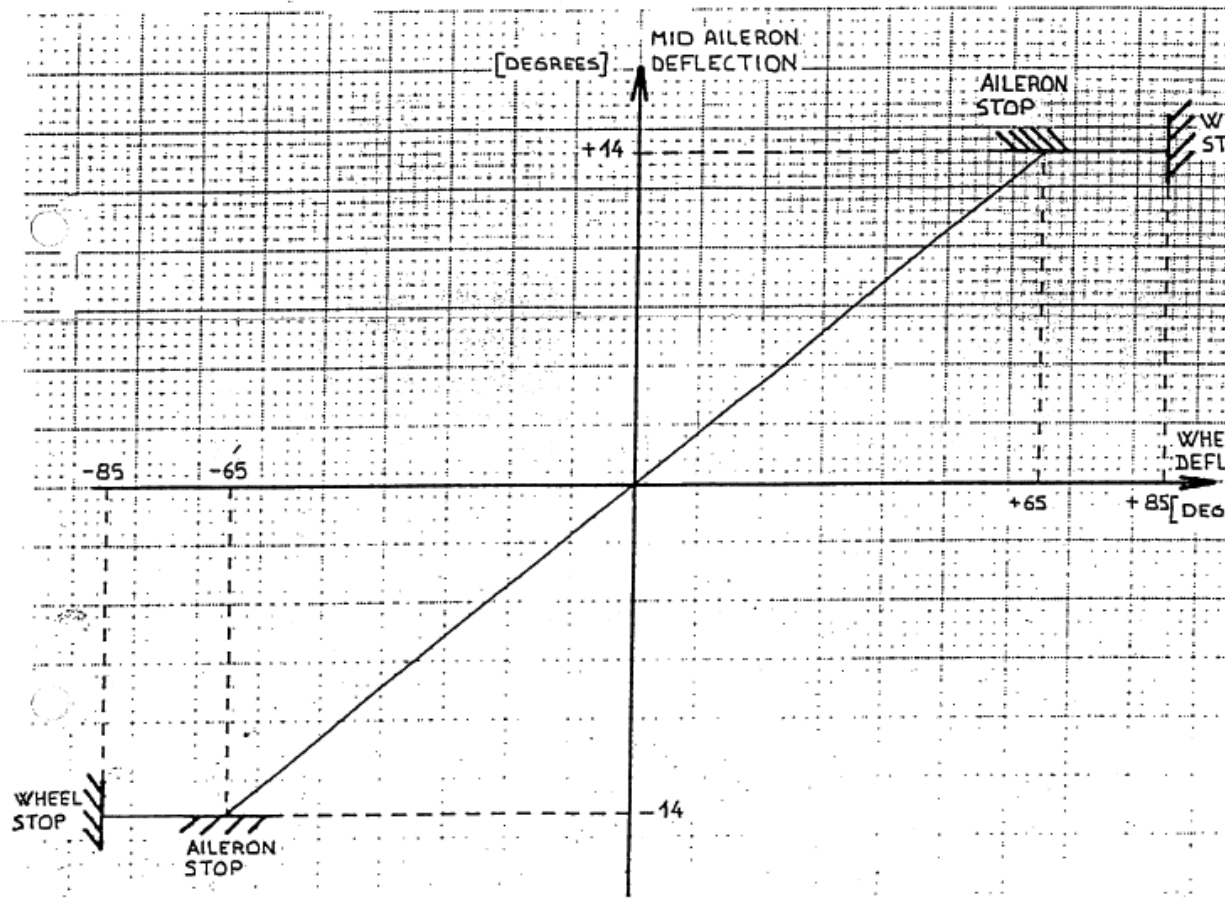
Figure 1.11-12 The correlation between CCD and aileron

(with CCD from -65 to +65 degrees and aileron from -14 to +14 degrees)

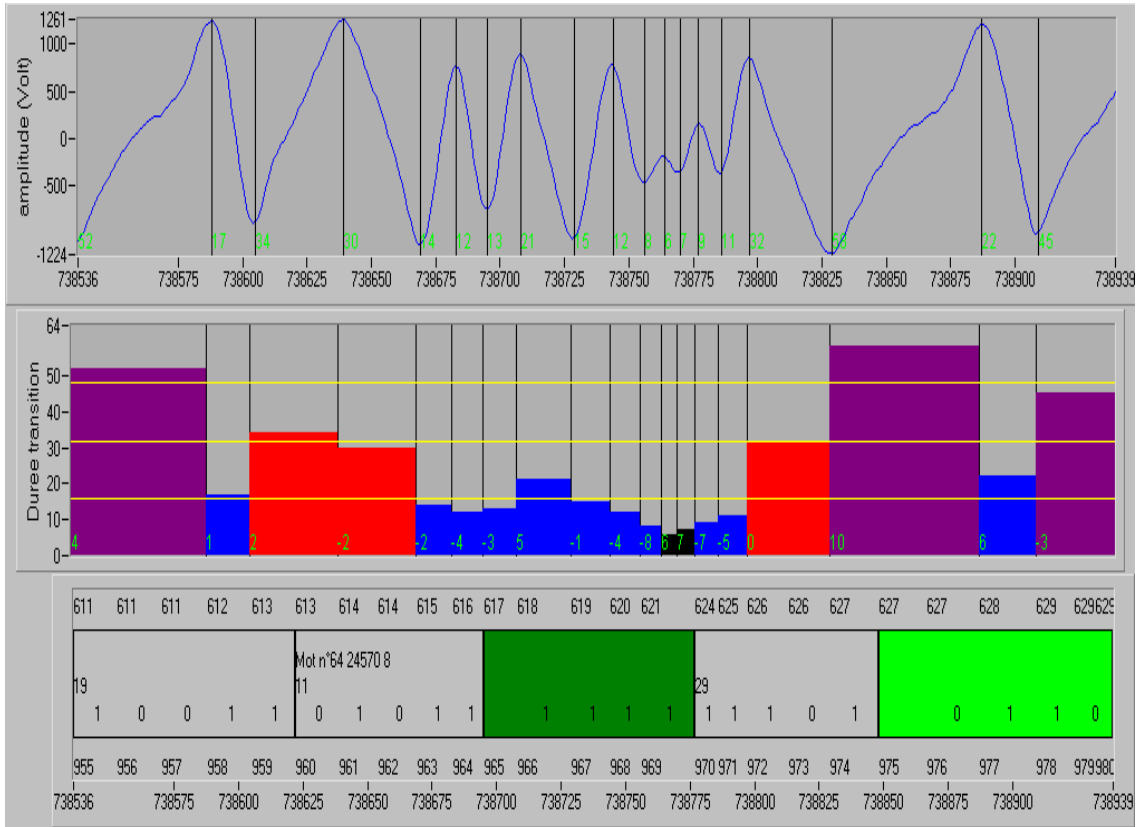
Figure1.11-15 The readout process of GCR readout system (original)

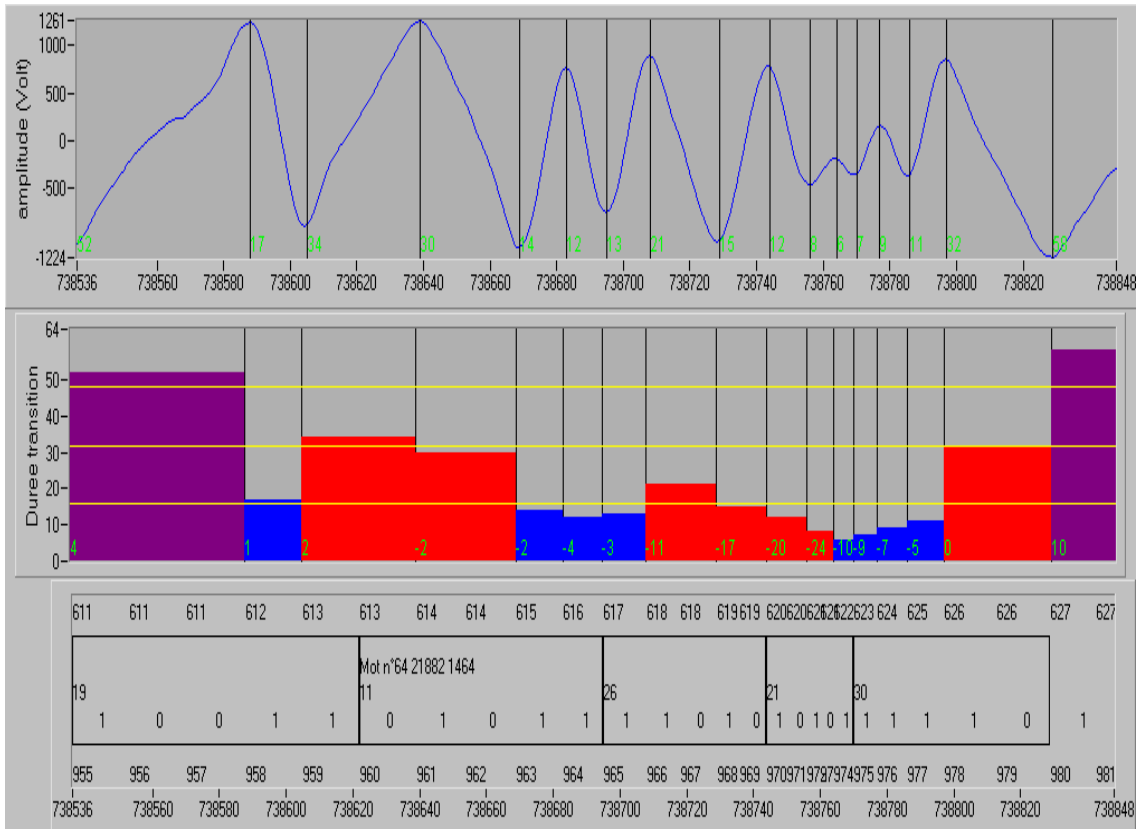
Figure1.11-16 The readout process of GCR readout system (error fixed)

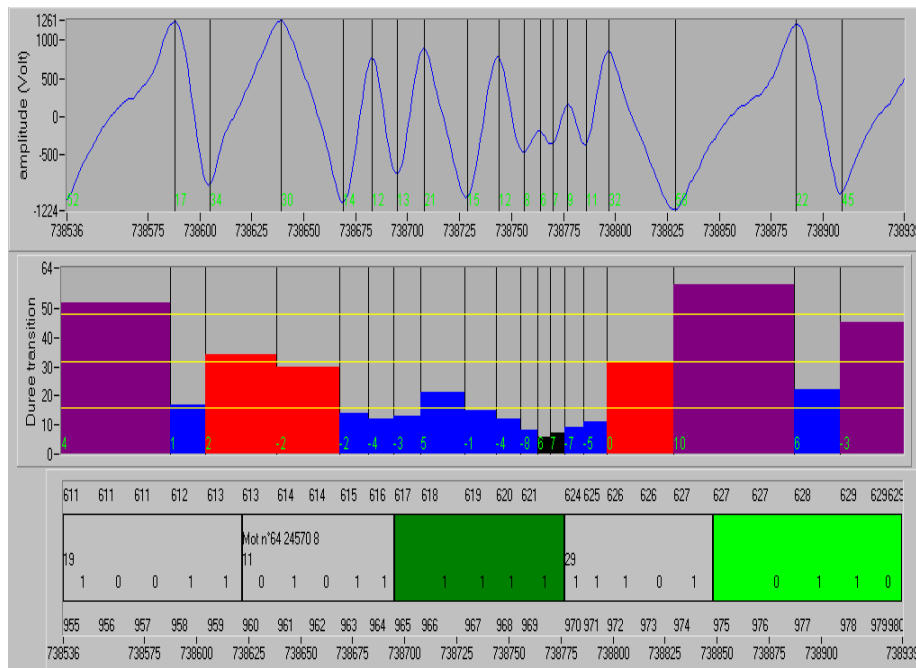
Figure 1: Before Correction

In the following example of error, the bit length was significantly reduced by a very sharp increase in the tape speed.
