**Aviation Safety Council  
Taipei, Taiwan**

# **GE 791 Occurrence Investigation Report**

**IN-FLIGHT ICING ENCOUNTER AND CRASH INTO THE SEA  
TRANSASIA AIRWAYS FLIGHT 791  
ATR72-200, B-22708  
17 KILOMETERS SOUTHWEST OF MAKUNG CITY,  
PENGHU ISLANDS, TAIWAN  
DECEMBER 21, 2002**

**ASC-AOR-05-04-001**

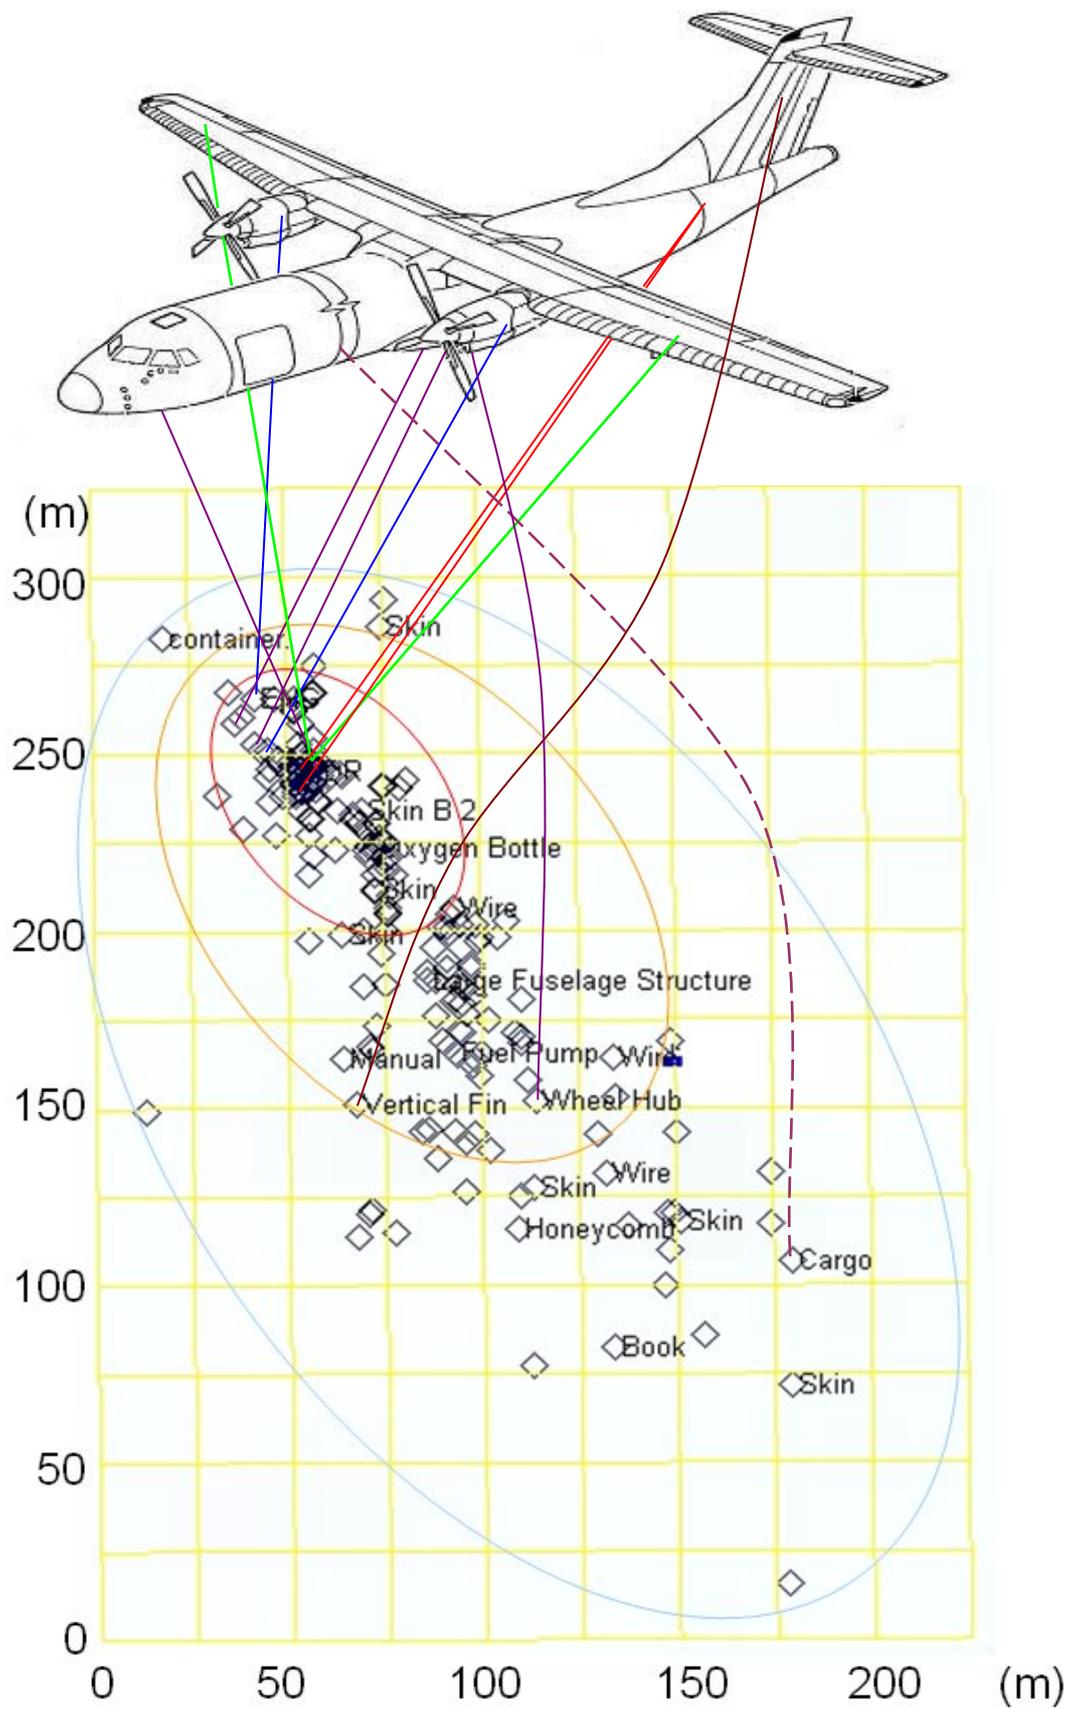
Figure 2.6-1 Wreckage scattering observed from ROV

Observation made by remote operating vehicle indicates that the wreckage including structure and components of accident aircraft are distributed within an area of 200 by 300 meter ( Figure 2.6-1 ) .

The pilot seat strut, wheel and tire of the landing gear, all above strong structures were burst apart, exhibit that the diving speed of the aircraft was very high during the water impact.

Total 199 pieces of wreckage were examined. There were no evidence of slow growth damage, i.e., no structure fatigue damage was found. All the structure failure was cause by over load damage and occurred during water impact.
