# 國家運輸安全調查委員會

### 調查報告

遠東航空股份有限公司 FE8026 班機

於進場階段距松山機場約 10 哩處左發動機失效

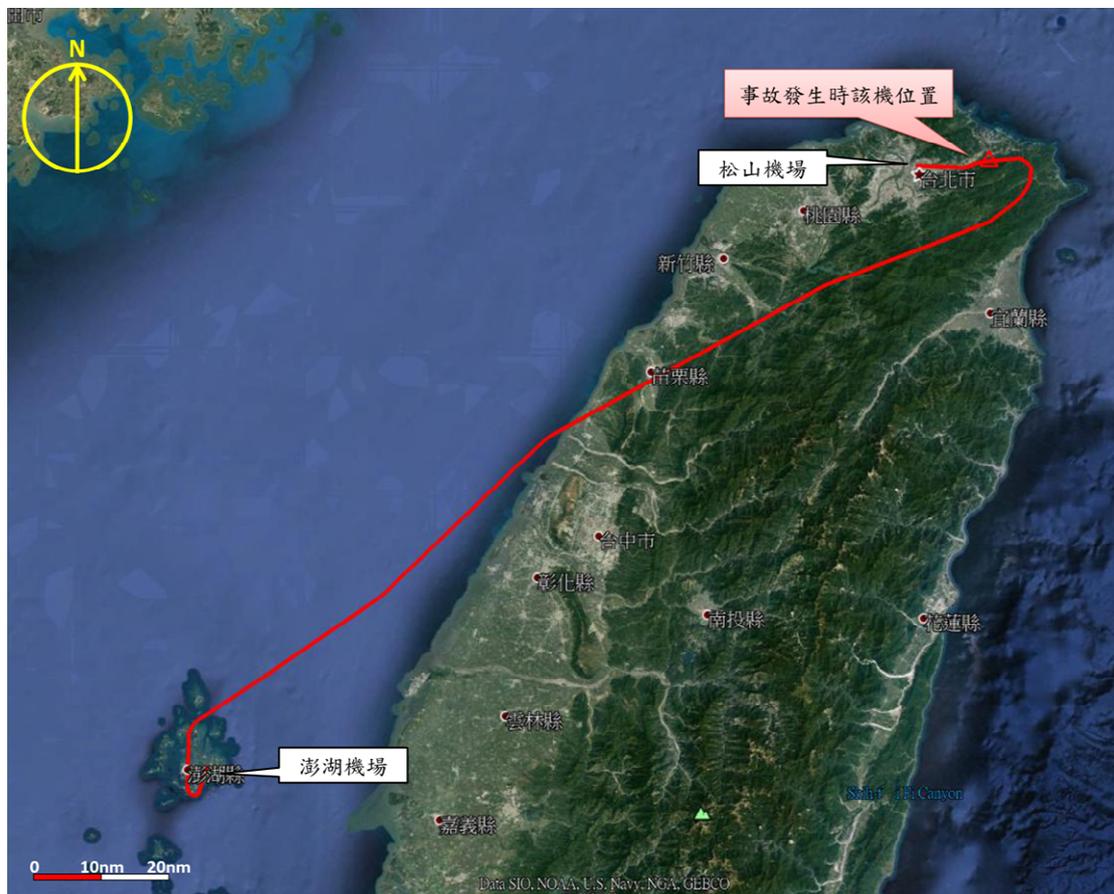
圖 1.1-1 事故機起飛至落地之飛航軌跡

1905:19 時飛航組員將襟翼收起至 28 度，1906:03 時松山塔臺告  
知該機風向 280 度，風速 10 浬/時，並許可由 28 跑道落地。1908:04  
時該機於 28 跑道降落。航機落地後，機務維修人員檢查發現左發動  
機內部零件損壞並刺穿發動機外罩，該機起飛至落地之飛航軌跡如圖  
1.1-1。

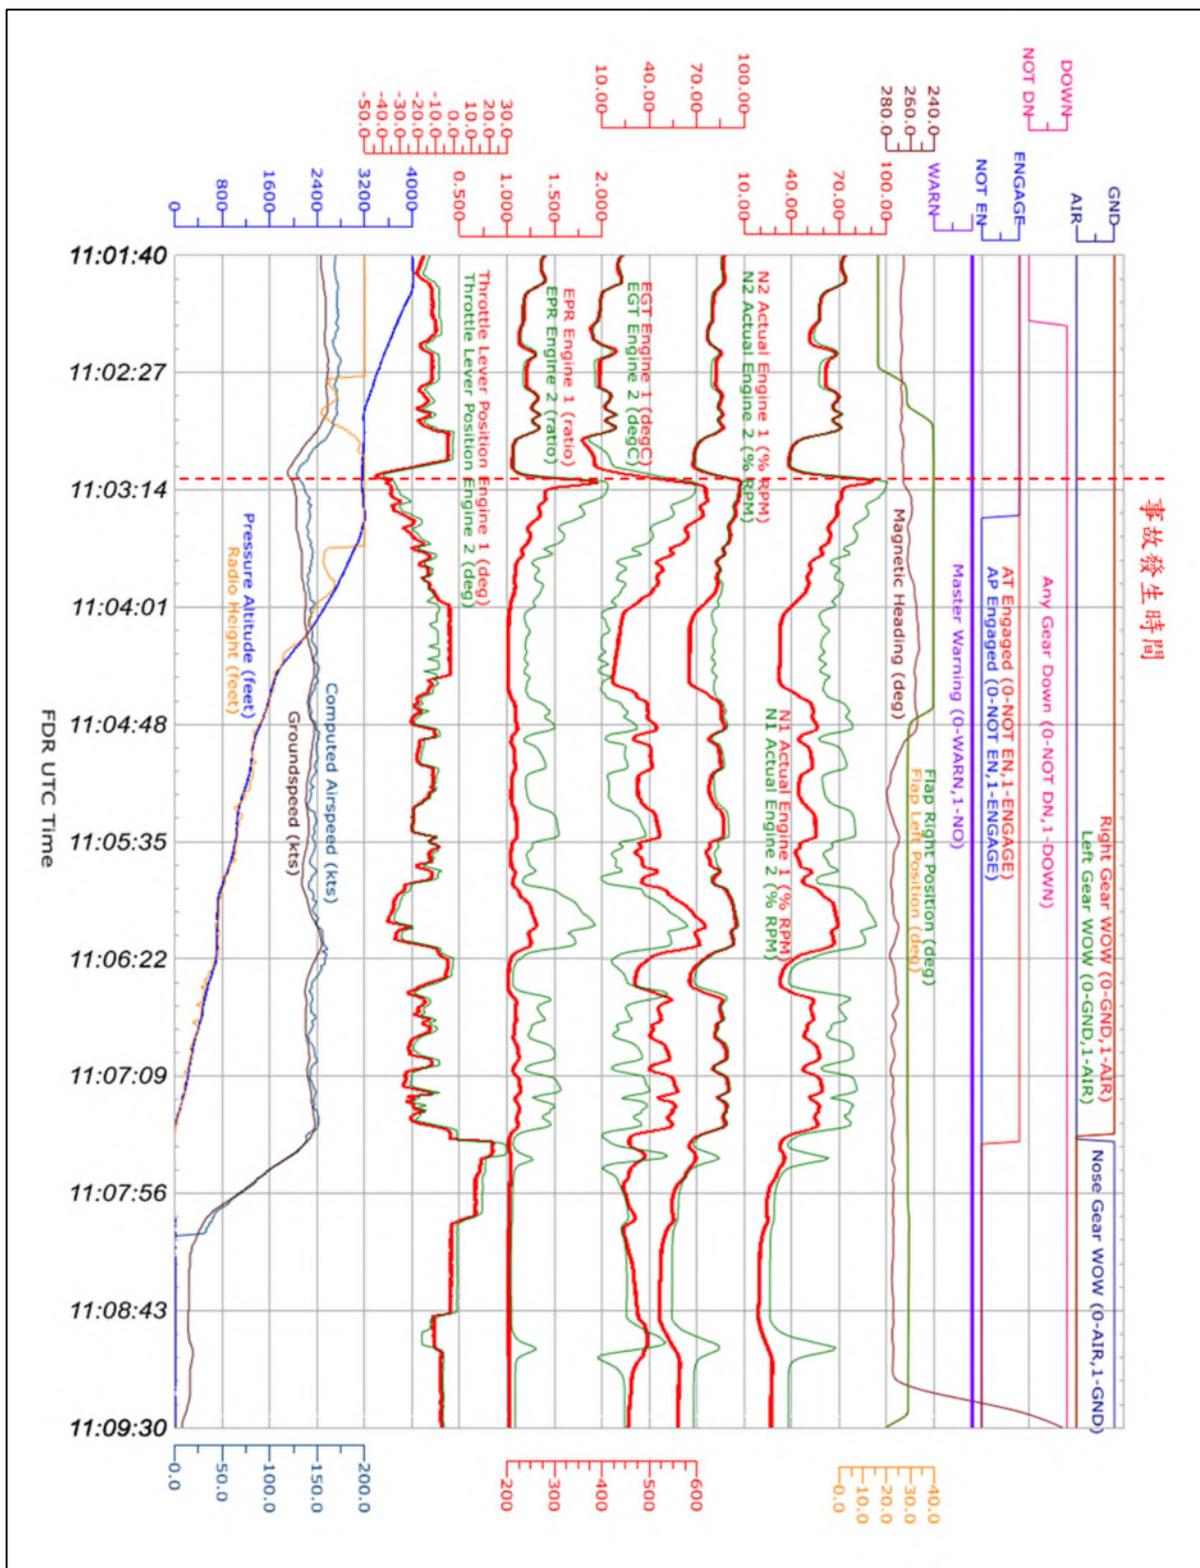
圖 1.11-2 事故發生期間至降落 FDR 參數

10. 1904:50 時空速 150 浬/時，無線電高度 1,895 呎，左發動機 N1 32.5% RPM、N2 65.5% RPM、EGT 攝氏 432 度、EPR 1.02，右發動機 N1 61.0% RPM、N2 81.5% RPM、EGT 攝氏 408 度、EPR 1.21。同時間組員向松山塔臺宣告故障並表示單發動機失效，CVR 記錄“RDO-2：songshan tower pan-pan pan-pan pan-pan far eastern eight zero two six we have left single engine”。
