飛航事故調查報告 第二冊

ASC-AOR-05-02-001

中華航空公司 CI611 班機

行政院飛航安全委員會
AVIATION SAFETY COUNCIL
中華民國九十四年六月

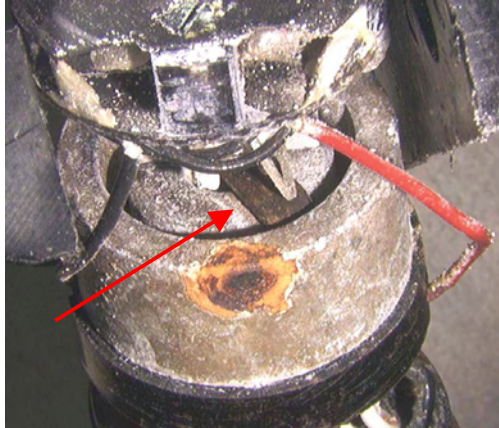
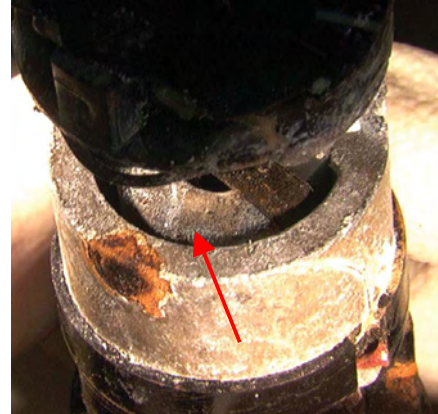
Figure 17: LEFT, OUTFLOW VALVES
Position Indicator witness mark

Figure 18: LEFT, OUTFLOW VALVES
Position Indicator showing witness mark after moving armature.

- Moving armature/needle, mounting tab corresponds to a witness mark on underlying base. This position corresponds to needle positioned at approximately 25% open. The armature was moved from its location in Figure 17 to display the “witness” pattern underneath the movable armature, shown in Figure 18.

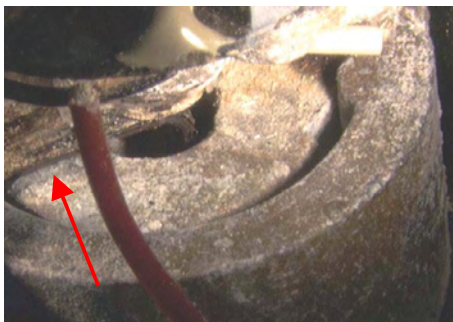
Figure 19: RIGHT, OUTFLOW VALVES
Indicator; armature is over witness mark.

Figure 20: RIGHT, OUTFLOW VALVES
Indicator; armature moved to show witness mark.

- Armature/wiper member corresponds to witness marks on base at two places (at both extreme ends of possible needle movement). It was inconclusive as to the exact corresponding location of needle position.
- Both **LEFT** and **RIGHT, OUTFLOW VALVES** Indicators’ needles were detached from armature/needle mounting tabs and loose within the housings.

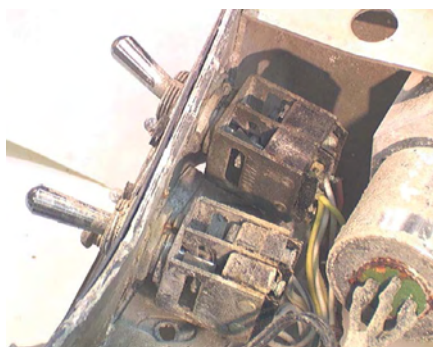
Figure 22: Outflow Valves, **MANUAL CONTROL, OPEN & CLOSE** toggle switches as viewed from underneath.

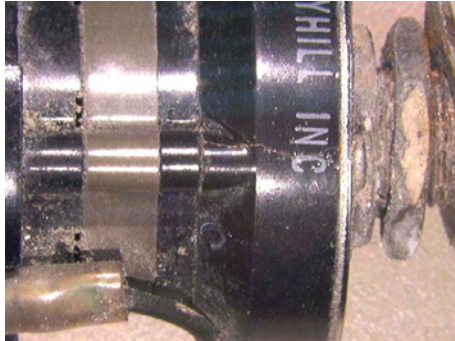
Figure 28: Detail view of switch #2, cracks in the body.

- Corrosion on all metallic parts
- Minor cracking of the switch body.
- No continuity could be attained.
- All external wiring appears intact.
- X-ray confirms that the valve-closed electrical contacts are aligned with each other.

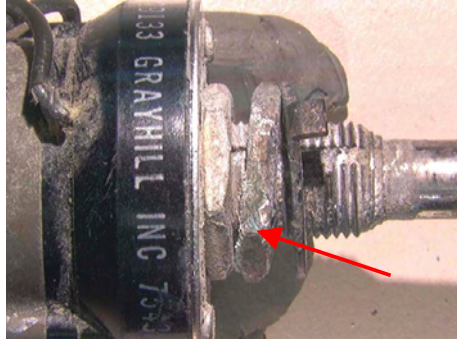
Figure 33: Bleed Air Switch #1

- Displaced nut
- Knob in OFF position
- Rear mounting nut has been displaced.
- Corrosion on all metallic parts

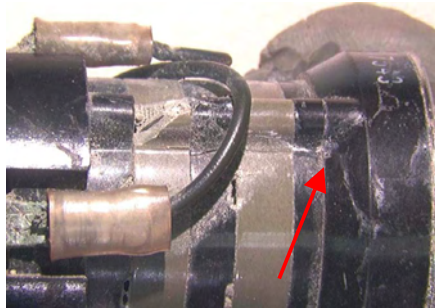
Figure 34: Bleed Air Switch #1.

- Minor cracking of housing is apparent.
- Crack detail.
- No continuity could be attained.
- All external wiring appears intact.

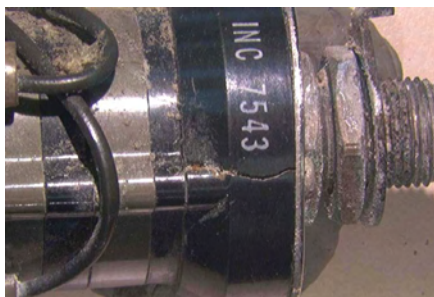
Figure 36: **BLEED AIR** switch 2.

- Minor cracking of housing apparent.
- Detail of cracks.
- No continuity could be attained.
- All external wiring appears intact.
- Knob in OFF position
- Corrosion on all metallic parts

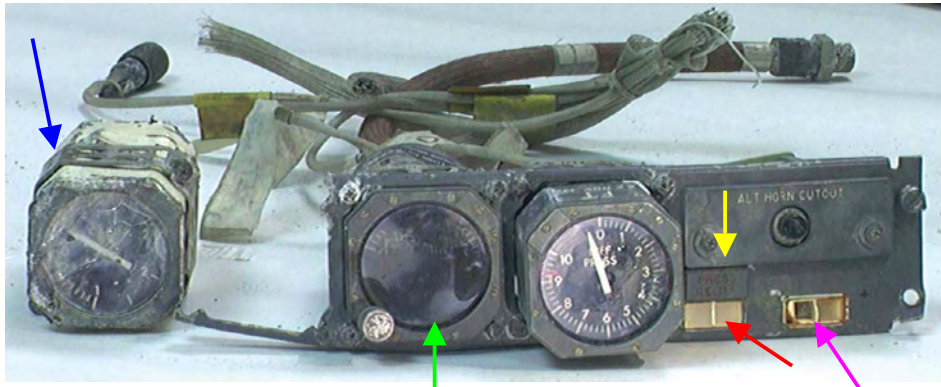
Figure 37: M188 panel. Note that the vertical speed indicator was detached from the module.

- Vertical Speed Indicator not attached to panel (blue arrow).
- Corrosion present on various surfaces with salt residue and sediment.
- **AUTO FAIL** legend plate is missing (purple arrow).
- **PRESS RELIEF** lower Indicator light cover is missing (red arrow).
- Panel frame is bent inward on left and broken at Vertical Speed Indicator frame.

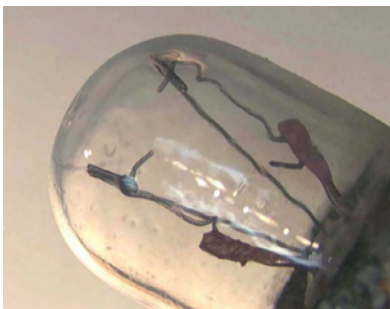
Figure 40: PRESS RELIEF light, lower left lamp.
 • Filament is broken - (Ref. Figure 37, red arrow for lamp location).

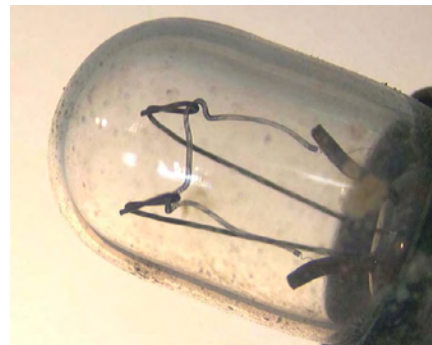
Figure 41: PRESS RELIEF light, lower right lamp.
 • Filament appears to be intact.
 • Legend plate missing. (Ref. Figure 37, red arrow for lamp location).

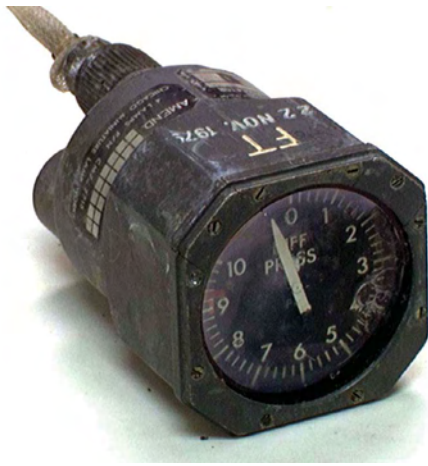
Figure 50: Cabin **DIFF PRESS** Indicator

- Water stains inside glass face.
- Needle is indicating below zero.

- Removal of the bezel did not reveal any abnormal markings on inside of glass.
- Dial indicated less than zero (at approximately 0.6 - 0.8 psi).
- Casing was removed. Cabin pressure line was cut to remove indicator from case. When pressure line was cut, the indicator dial returned to zero.
- No apparent damage was visible to internal parts.
- Minimal corrosion was present on internal surfaces.
- Red scale mark on face at approximately 9.25 – 9.3 (mechanism is physically limited at that point).

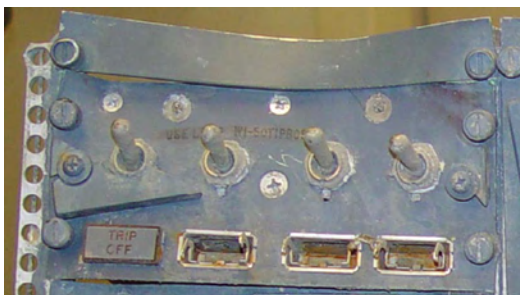
Figure 52: Galley Power control panel M179

- Light plate is missing.
- All switch toggles are in up position.
- **TRIP OFF** indicator lights, numbers 2, 3 & 4 legend plates, bulbs and retaining assemblies are missing.

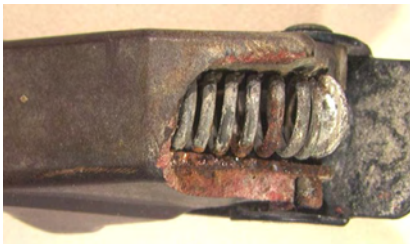
Figure 61: Top view of switch guard damage.

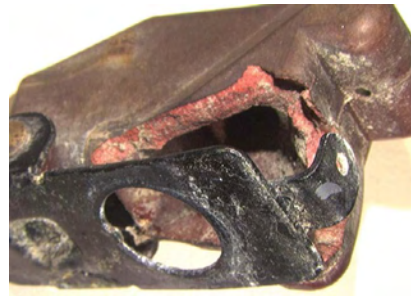
Figure 62: Bottom view of switch guard damage.

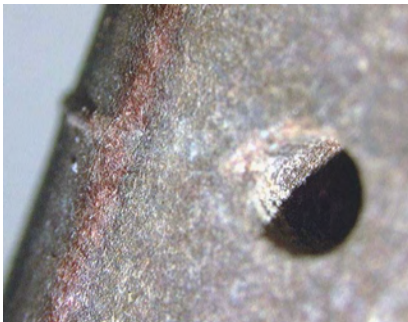
Figure 63: Switch guard safety wire (breakaway wire) hole (top view).

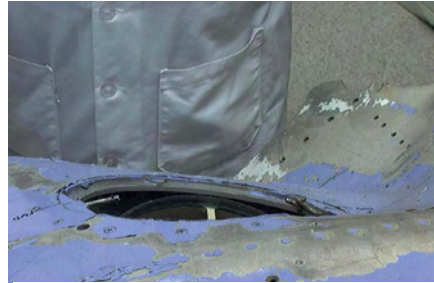
Figure 77: Upper pressure relief valve, (center of picture) distorted exterior skin.

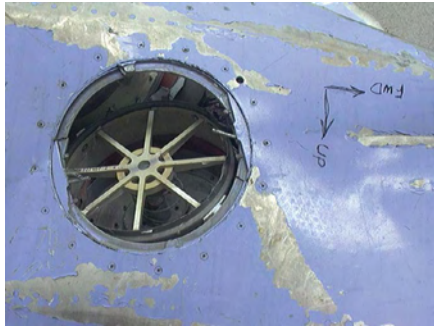
Figure 81: Upper Pressure Relief Valve, showing orientation, note that blowout doors are missing.

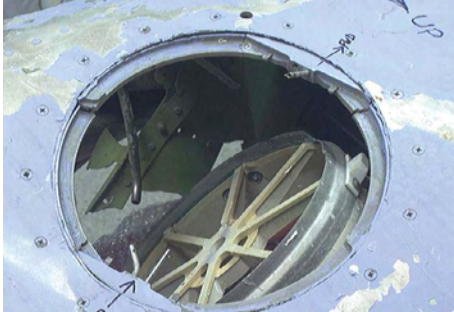
Figure 90: Exterior view of opening with valve not yet removed.

- Hinge pins are movable (free to rotate); aft/upper hinge pin is only one difficult to rotate and is bent outboard.

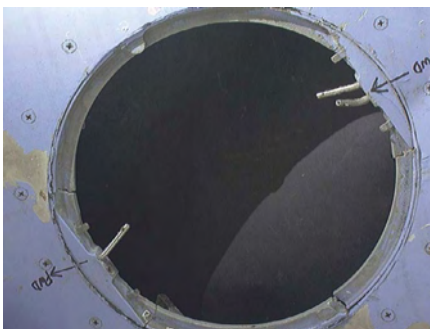
Figure 94: Upper Pressure Relief Valve, pins in approximately "door fully open" position.

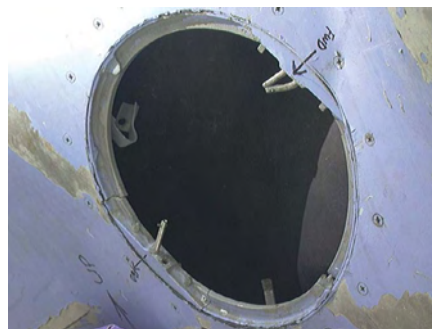
Figure 95: Upper Pressure Relief Valve, same as # 94, another view.

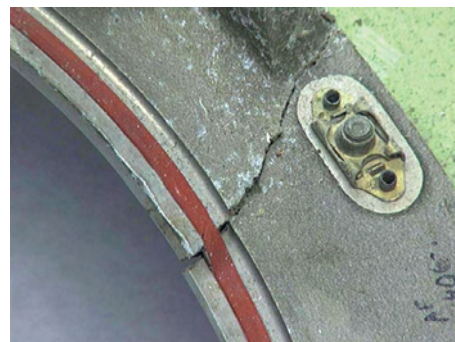
Figure 98: One slight cut adjacent to housing fracture.

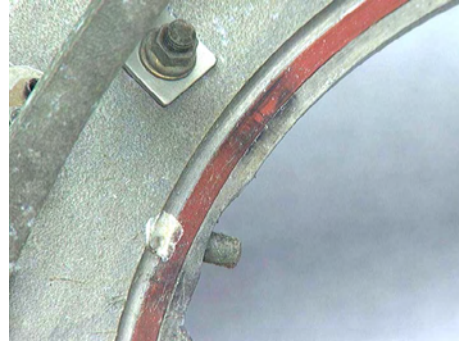
Figure 100: Discolored region of gate seal.
 • Unknown white colored contaminant on seal.

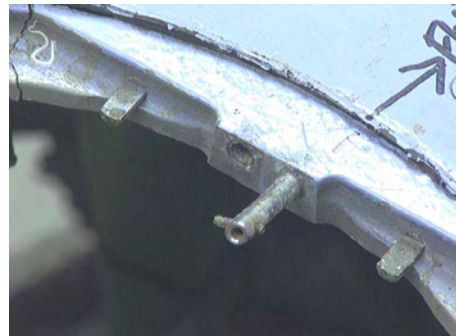
Figure 102: Forward stops and hinge pins, (looking from outside to inside).
 • Forward/upper hinge pin can rotate freely.
 • Stop pins look normal and unbent.

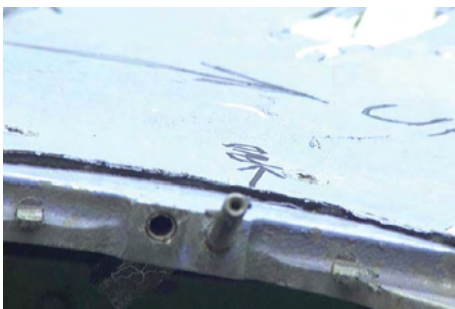
Figure 103: Forward/upper hinge pin, physically rotated by hand so that bent portion was oriented outboard.

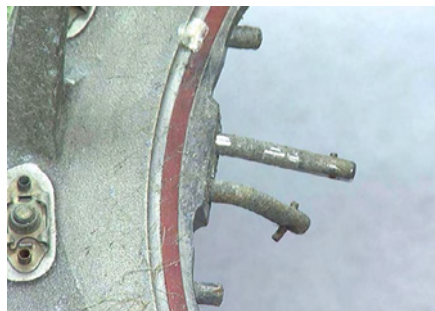
Figure 106: Aft hinge & stop pins (looking from inside to outside).

- Aft/lower stop pin appears to have a rust mark and can rotate.

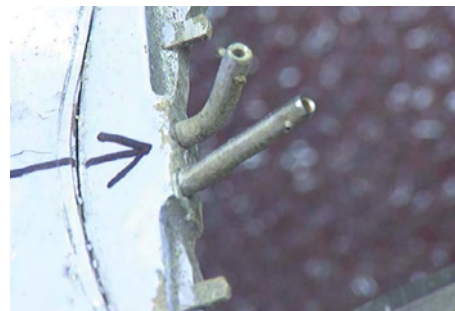
Figure 107: Aft hinge & stop pins, (looking from outside to inside)

- Aft/upper hinge pin (lower pin in photo) is difficult to rotate.
- Aft/lower hinge pin (upper pin in photo) rotates.

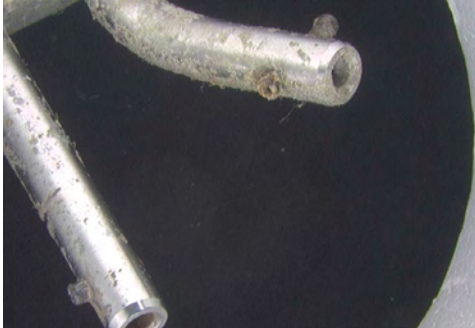
Figure 110: Aft hinge pins, upper & lower. Aft/lower pin is rotated to non-closed door position.

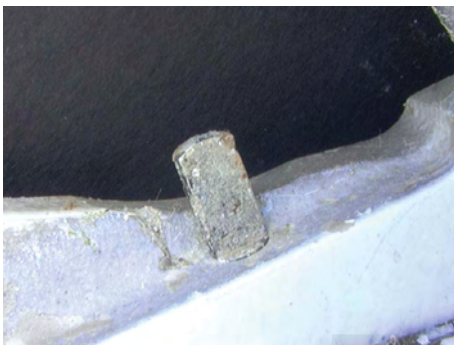
[Figure 119](#): Overview of forward/upper stop pin, as viewed from outside.

- Pin is relatively straight, paint missing.

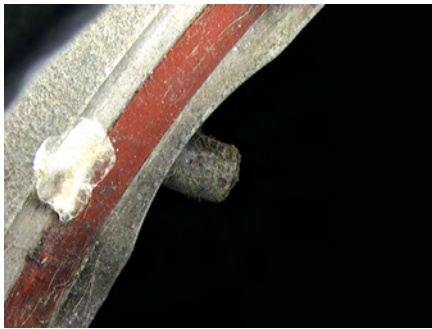
[Figure 122](#): Overview of aft/upper stop pin, as viewed from inside.

- Pin is relatively straight.

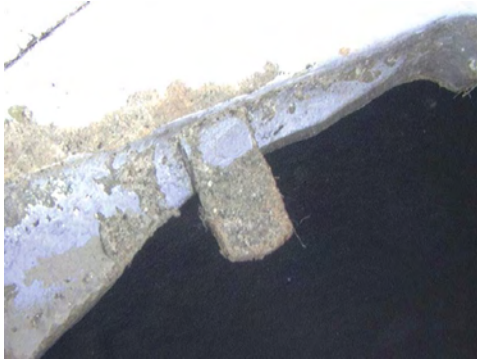
Figure 125: Overview of aft/upper stop pin as viewed from outside.

- Pin is relatively straight.

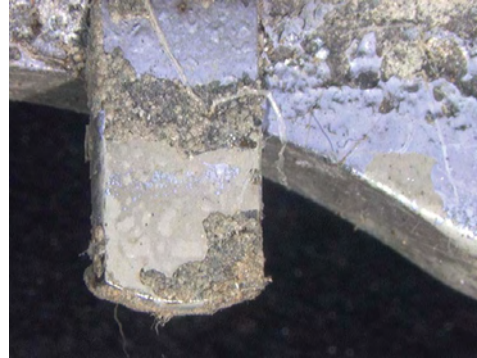
Figure 137: Aft/lower stop pin, close-up of figure #136.
 • Paint is chipped.

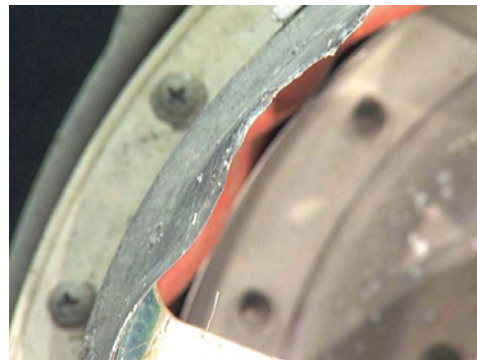
Figure 139: Close-up of knife-edge damage.

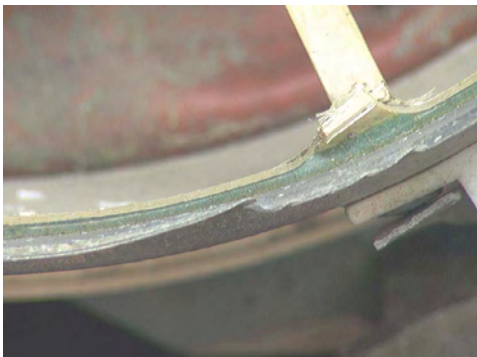
Figure 140: Close-up of knife-edge damage.

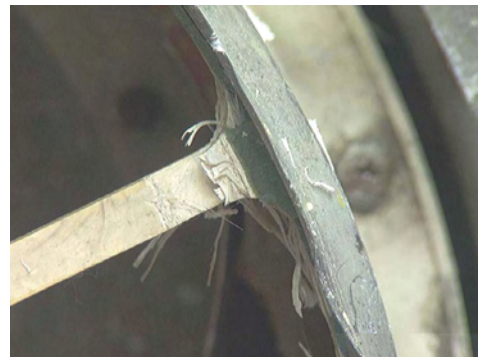
Figure 141: Close-up of knife-edge damage.

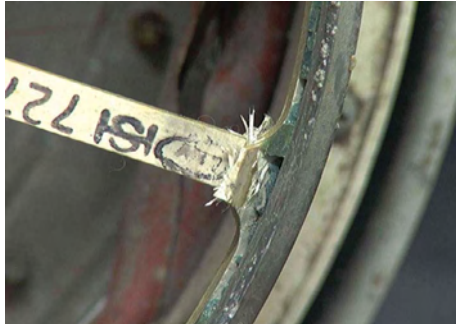
Figure 142: Overview, close-up of typical web fracture.

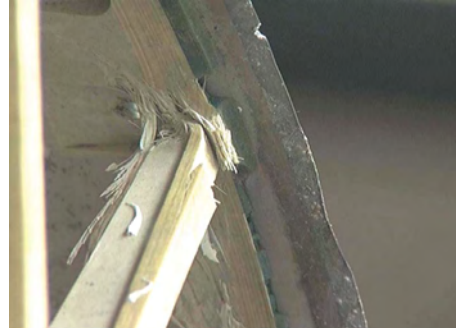
Figure 143: Close-up of web, representative of web fractures at gate ID.

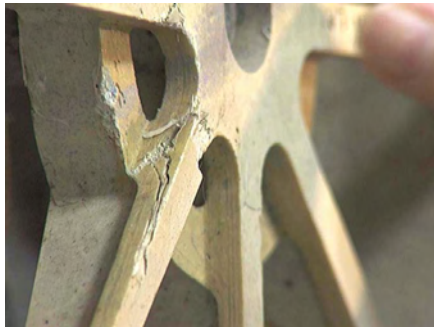
Figure 144: Worst of the center web cracks. 2 of 8 appear to be intact, remaining exhibit various degrees of cracking.

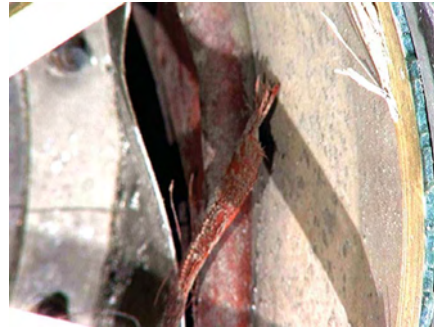
Figure 145: Diaphragm, 75 % of outer circumference is torn/split.

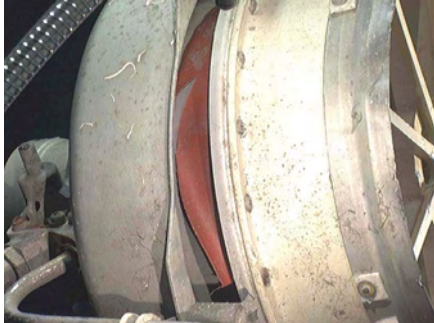
Figure 148: Diaphragm, circumferential tear.

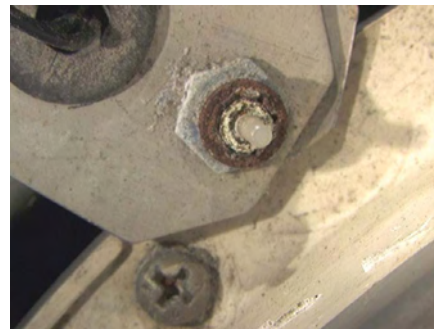
Figure 152: Upper Pressure Relief Valve; valve gate & switch bracket.

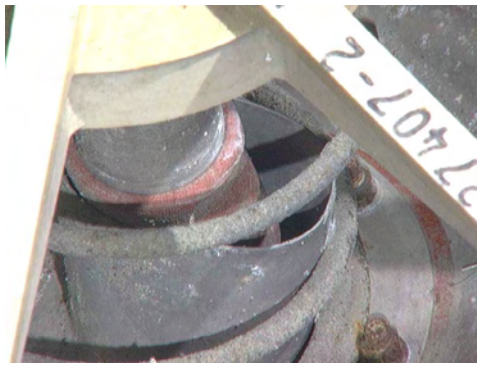
Figure 154: Center diaphragm guide, HS P/N 727411-1, showing distortion of guide itself.

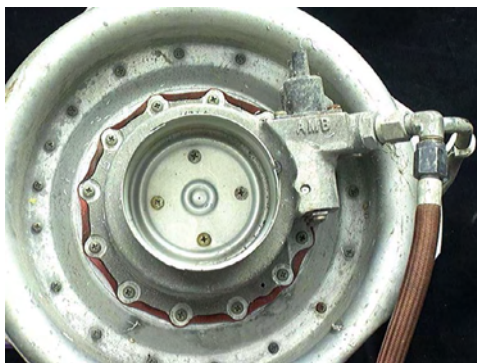
Figure 156: Overview of control and filter assemblies.

- The filter (HS P/N 715942-1), cover (HS P/N 727423-1) and spring (HS P/N 727430-1) – are all missing.
- Control orifice shown in bottom of filter housing looks clean.
- Exterior of sensors exhibit light deposits of contamination.

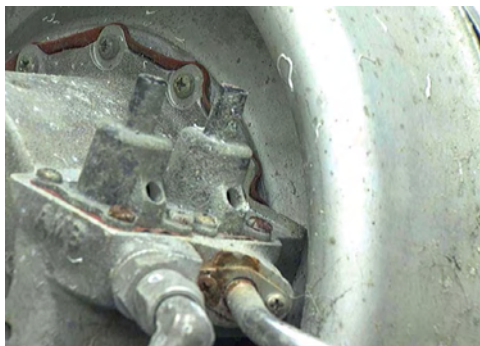
Figure 157: Exterior view of sensors, showing some apparent corrosion on the integral ambient sense tube.

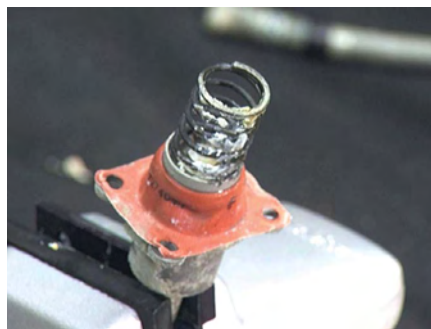
Figure 166: Diaphragm appears to be intact.

- Salt deposits on spring.
- Heavy corrosion on spring seat (one-third).

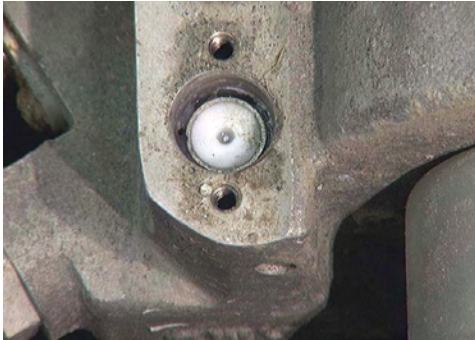
Figure 167: Remote ambient sensor poppet and guide, opposite side - relatively clean.

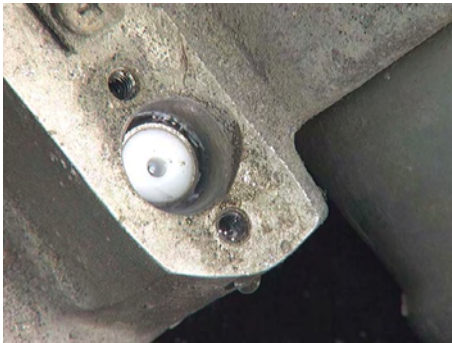
Figure 169: Shows water in plug area.

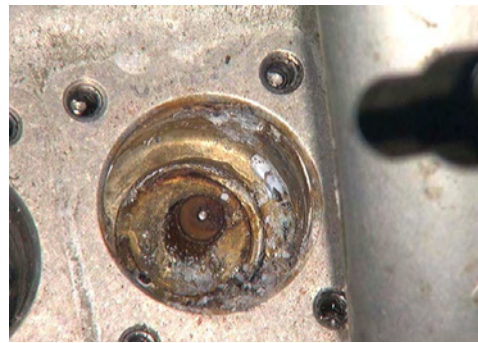
Figure 170: Integral ambient sensor poppet housing bore.

- Poppet was free.

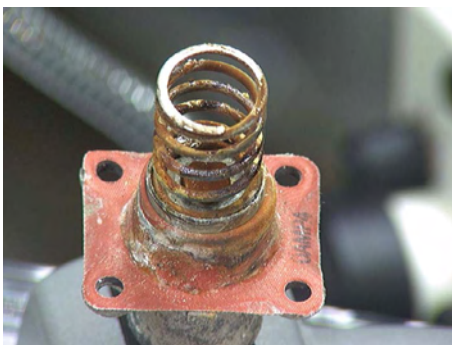
Figure 171: Integral ambient sensor spring & diaphragm.

- Heavy hardened corrosion on spring and diaphragm in localized areas.
- Corrosion on spring seat almost all the way around.

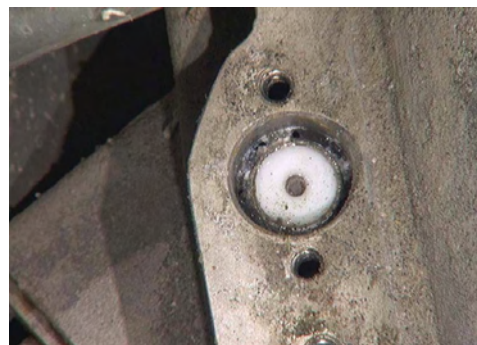
Figure 172: Opposite end of integral ambient sensor poppet and guide.

- A little moisture is present.

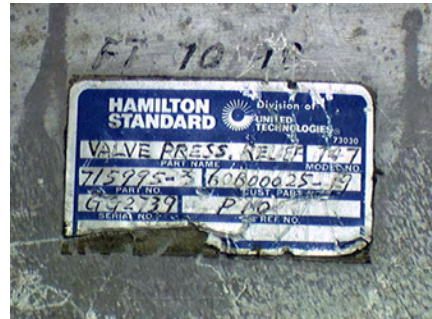
Figure 175: Lower Pressure Relief Valve, data plate identification.

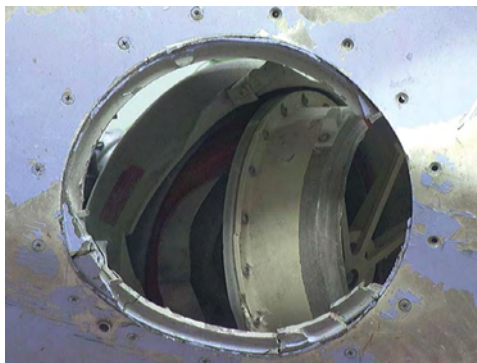
Figure 176: Lower Pressure Relief Valve as viewed from outside, still installed but not attached to structure. (Ref. For following section on pins and stops)

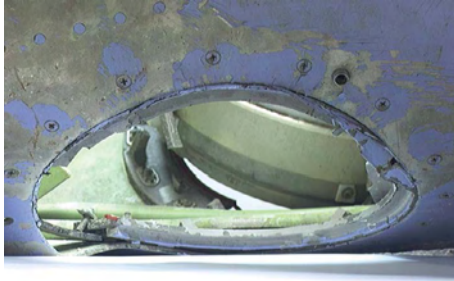
Figure 178: External view of opening for Lower Pressure Relief Valve, looking inside.

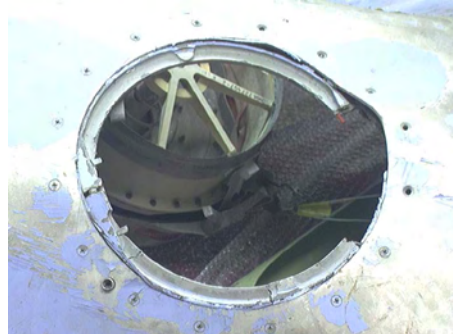
Figure 179: Exterior opening for Lower Pressure Relief Valve (valve still inside).

- External view shows the heads of 5 attachments screws to the skin, are missing and about 25% of mounting flange is missing.

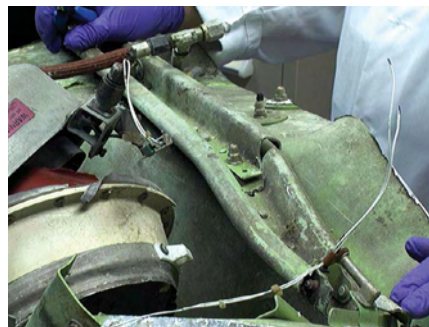
Figure 181: Lower Pressure Relief Valve. Cut switch lead wire B, step 2 in removal of lower valve (after cut).

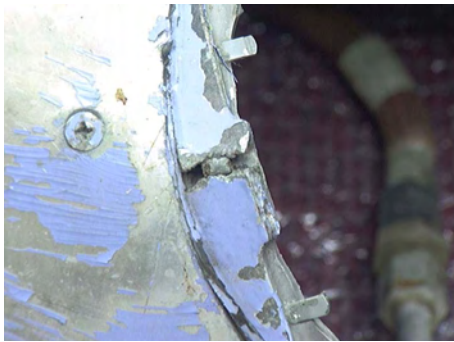
Figure 184: Exterior opening, close-up of fracture of valve housing at forward/upper hinge pin.

Figure 185: Exterior opening, close-up, another view of figure #184

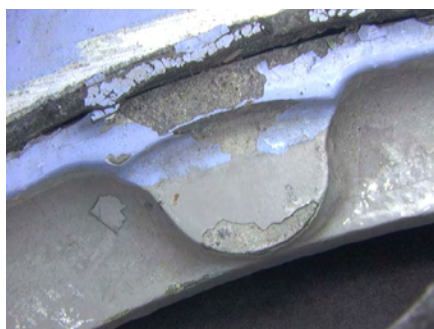
Figure 191: Upper stop pad; paint chipped.

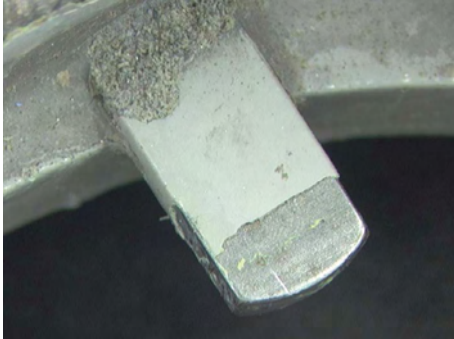
Figure 198: Forward/upper stop pin as viewed from outside looking inside..

- Pin is relatively straight.

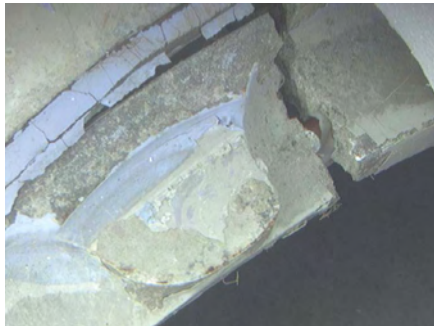
Figure 200: Lower stop pad, with adjacent crack on housing.

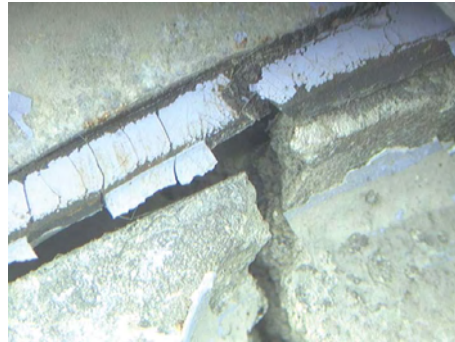
Figure 201: Detail of lower stop pad.

- It is broken away from housing (housing cracked).

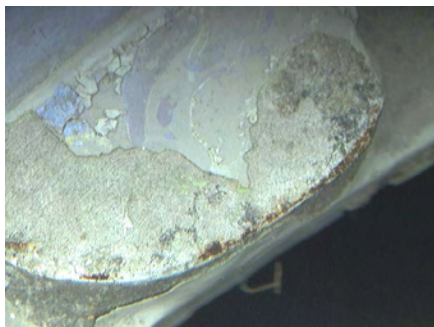
Figure 202: Close-up of figure #200, paint chipped.

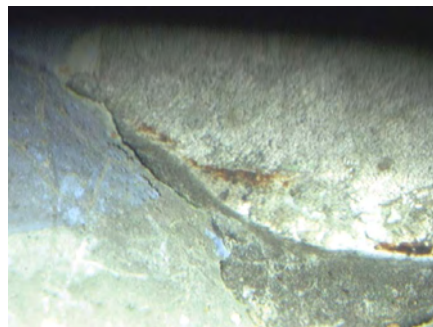
Figure 203: Close-up of figures #200 and #202, slight dent on pad, paint chipped.

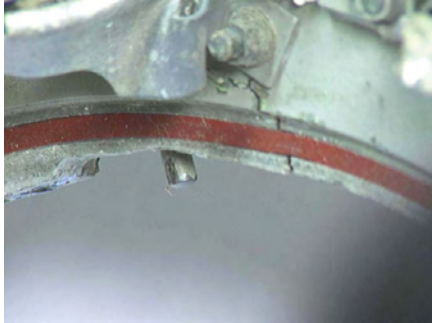
Figure 204: Exterior door open, forward/lower stop pin, HS P/N 730539-1, as viewed from inside.

- Appears to be normal and not bent relative to valve housing.
- Note: aft upper & lower pins are missing along with a portion of valve housing that they are normally installed in.

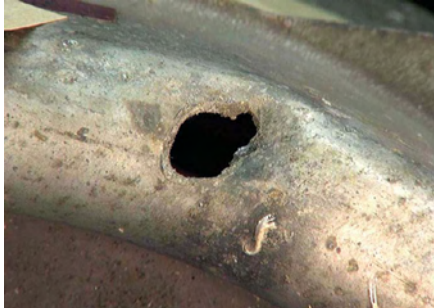
Figure 209: Hole penetrating support housing, HS P/N 727405-1.

- Hole is approximately 0.365 inch x 0.560 inch.

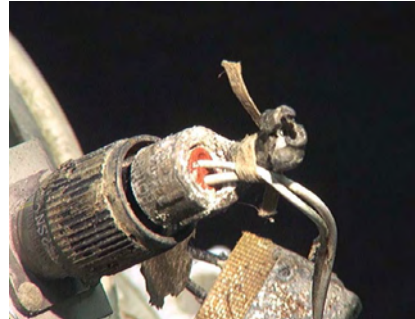
Figure 210: Electrical switch connector interface appears to be intact.

- Wires are intact exiting plug.
- Strain relief on backshell is broken.

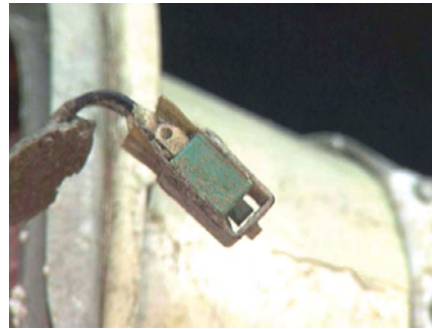
Figure 212: Switch (side view): actuator is missing from switch housing.

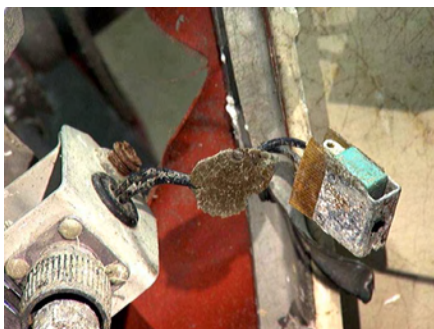
Figure 213: Switch lead wires showing bond detached from housing.

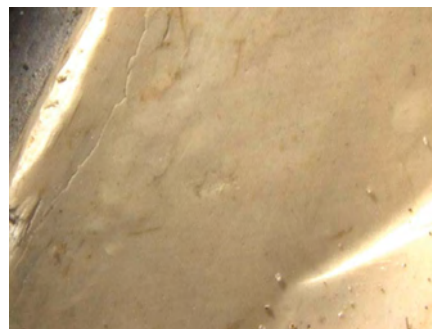
Figure 214: Lower Pressure Relief Valve; detail of valve gate, switch contact area.

- Checked continuity of switch:

Ends of lead wires stripped to perform continuity check.
Continuity verified in the normally relaxed condition, per normal installation.
When plunger was depressed, switch changed state (of circuit).

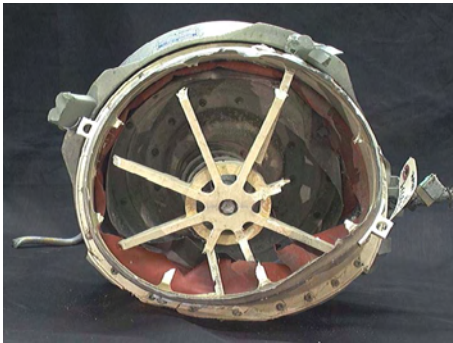
Figure 215: Overview of removed valve.

- Gate adapter is out of round.
- Web members have rotated approximately 45° in relation to case.
- Approximately 50% of edges were curled & torn.
- Light salt deposits.
- At attachment to gate HS P/N 727407-11, 50% of sealant is cracked.
- All 8 rivets (attaching gate to gate adapter) are intact.
- 2 of 4 spacers HS P/N 727407-30, are broken off at flanges.
- HS P/N 727407-11, gate – all 8 of center body webs are broken (7 of 8 at the inside diameter [ID] of the gate).

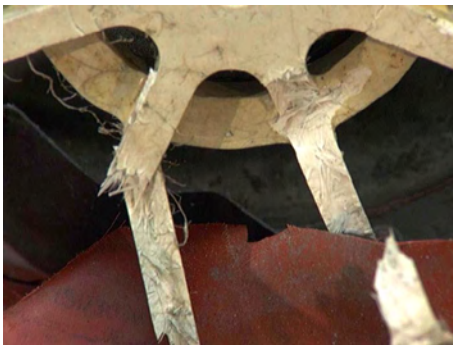
Figure 216: Gate webs, detailed view of broken web members.

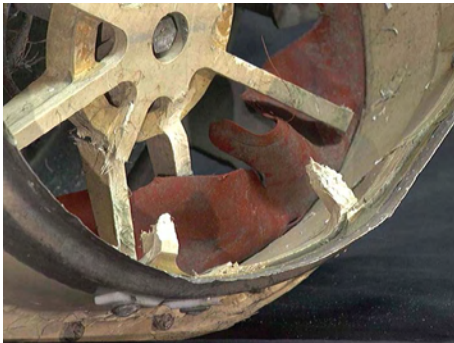
[Figure 220](#): Detail of more broken webs.

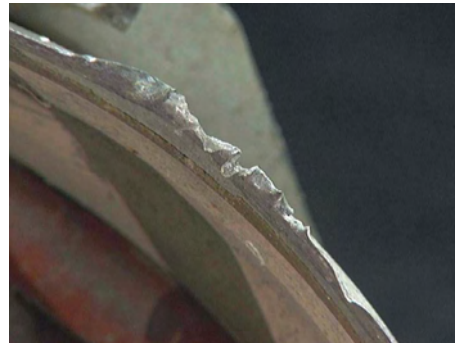
[Figure 221](#): Knife-edge close-up of damage.

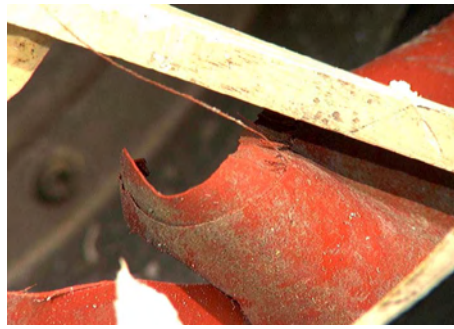
[Figure 227](#): Outer diaphragm HS P/N 727403-1, torn location.

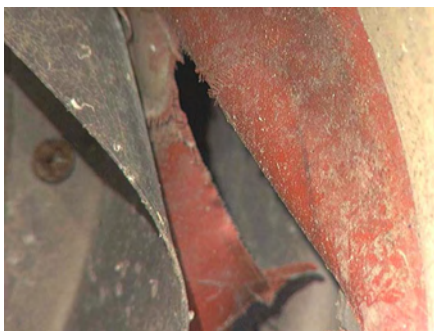
[Figure 228](#): Outer diaphragm, approximately 60% of circumference is torn.

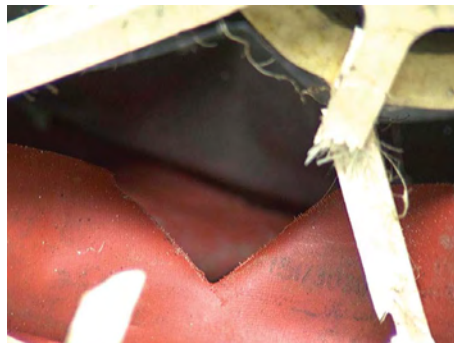
[Figure 229](#): Outer diaphragm, torn location.

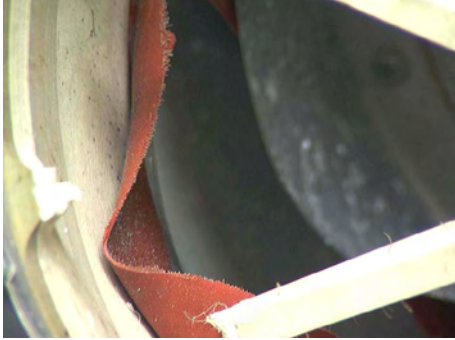
Figure 230: Outer diaphragm damage.

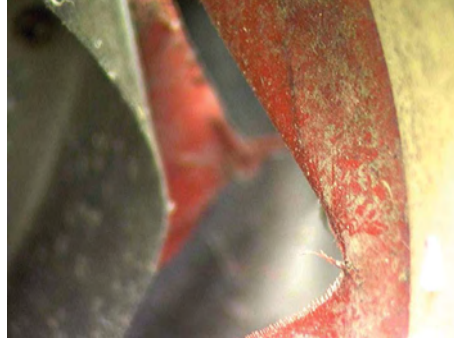
Figure 231: Outer diaphragm damage.

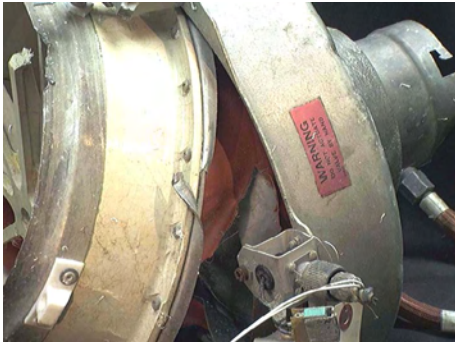
Figure 232: Side view of gate assembly & valve cover, showing the approximate 30° angle between gate assembly & valve cover.

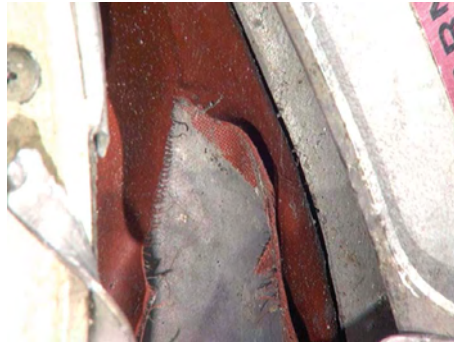
Figure 233: Outer diaphragm, close-up of tear origin.

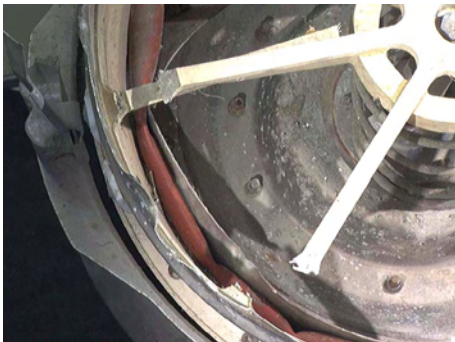
Figure 234: Outer diaphragm, intact (not torn) portion.

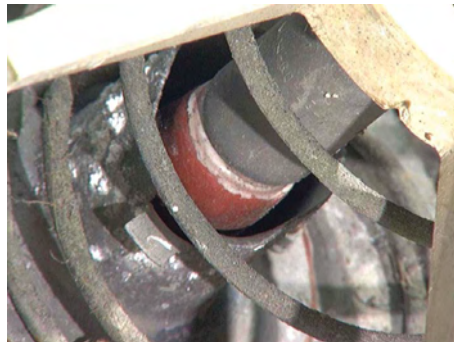
Figure 235: Center diaphragm, HS P/N 727401-1 appears to be intact and the bond portion can be seen; looks normal.

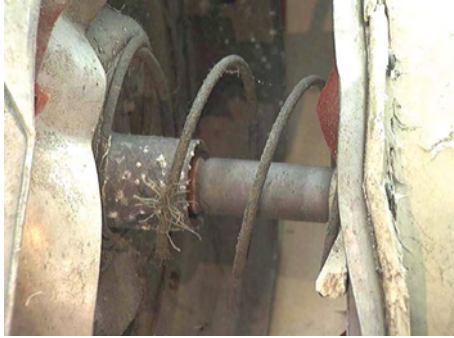
Figure 236: Gate return spring, HS P/N 727414-2 appears to be intact.

- Some unknown surface accumulation is present.

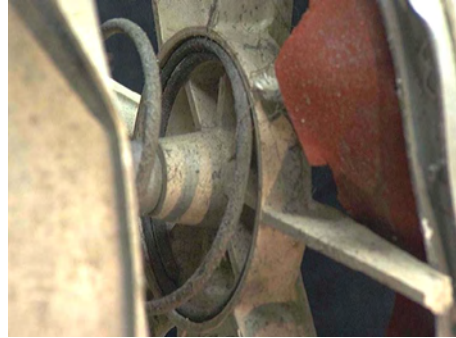
Figure 237: Gate return spring is seated in the gate. The end coil appears to be inside the last active coil.

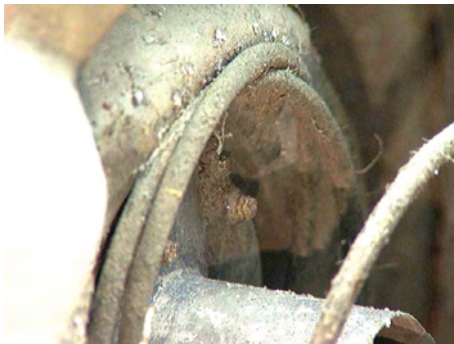
Figure 238: Gate return spring is over end showing intertwining of end coil and the active coil.

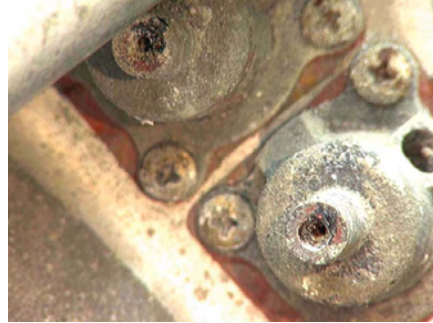
Figure 242: Control adjustment screws, both appear to be intact.

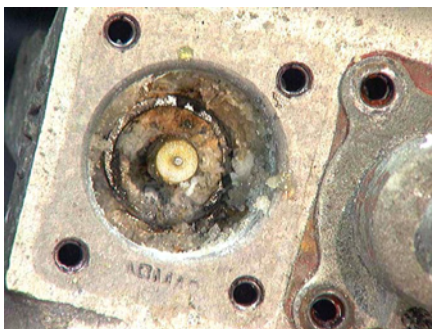
Figure 251: Close-up of salt deposits inside housing bore.

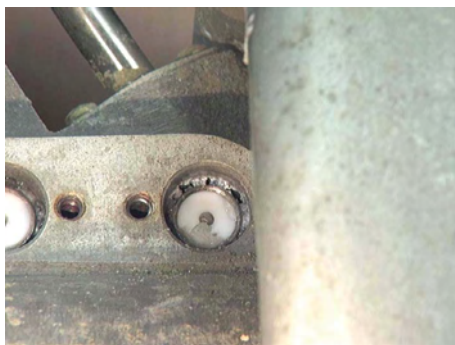
Figure 256: Opposite end of integral sensor poppet and guide; heavy salt deposits.

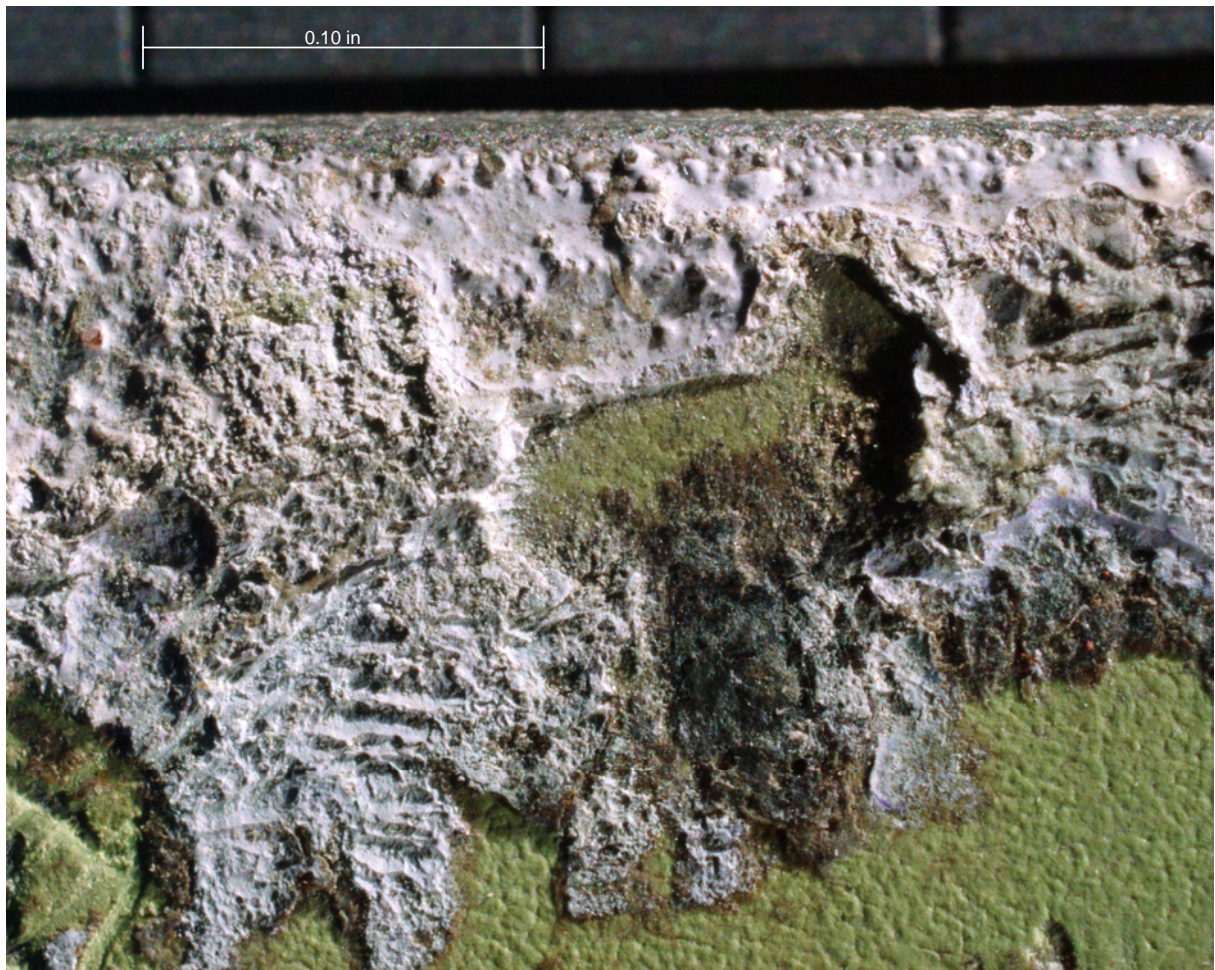
Figure 66.
Higher magnification image of light colored deposit on faying surface of doubler in the vicinity of hole 15. Note the smooth bubbled appearance of the deposit adjacent to the edge of the doubler indicative of paint flow into the joint.

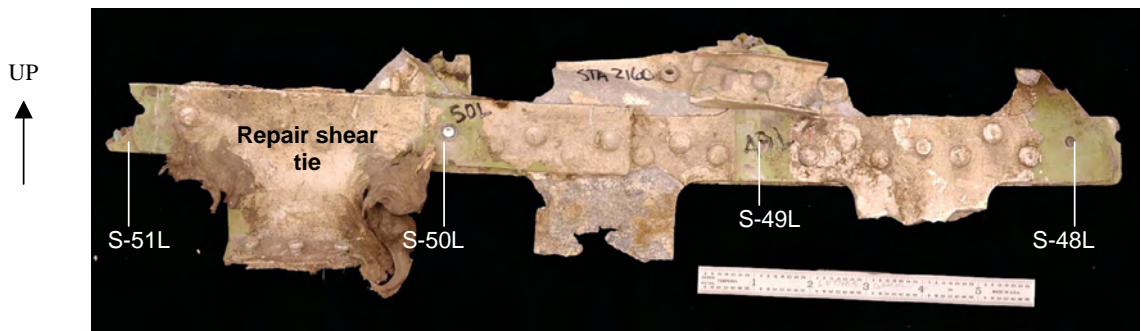
Figure 71.
As received condition of the STA 2160 frame segment submitted for examination. The aft surface is shown in this view.

Figure 72. As received condition of the STA 2160 frame segment submitted for examination. The forward surface is shown in this view.

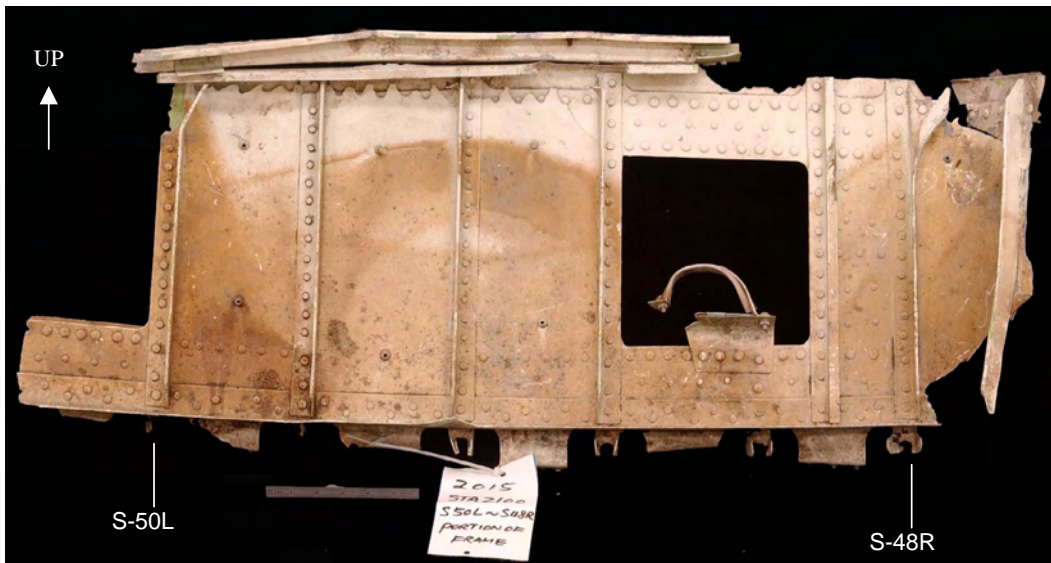
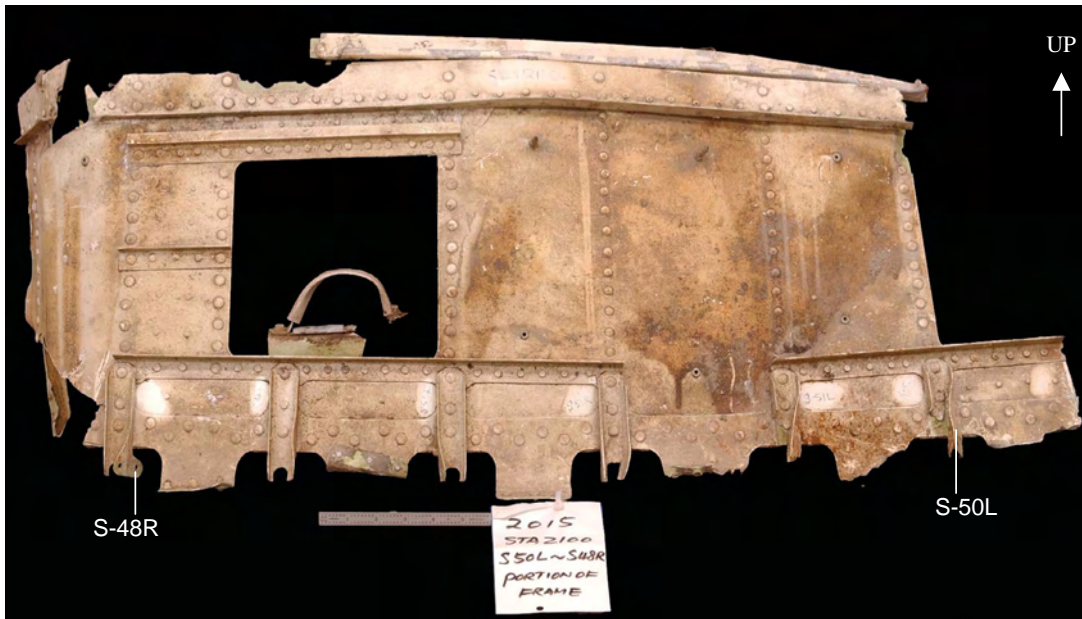
The overall condition of this frame segment as received by BMT is presented in Figures 75 and 76.

Figure 75. As received condition of the STA 2100 frame segment submitted for examination. The aft surface is shown in this view.

Figure 76. As received condition of the STA 2100 frame segment submitted for examination. The forward surface is shown in this view.

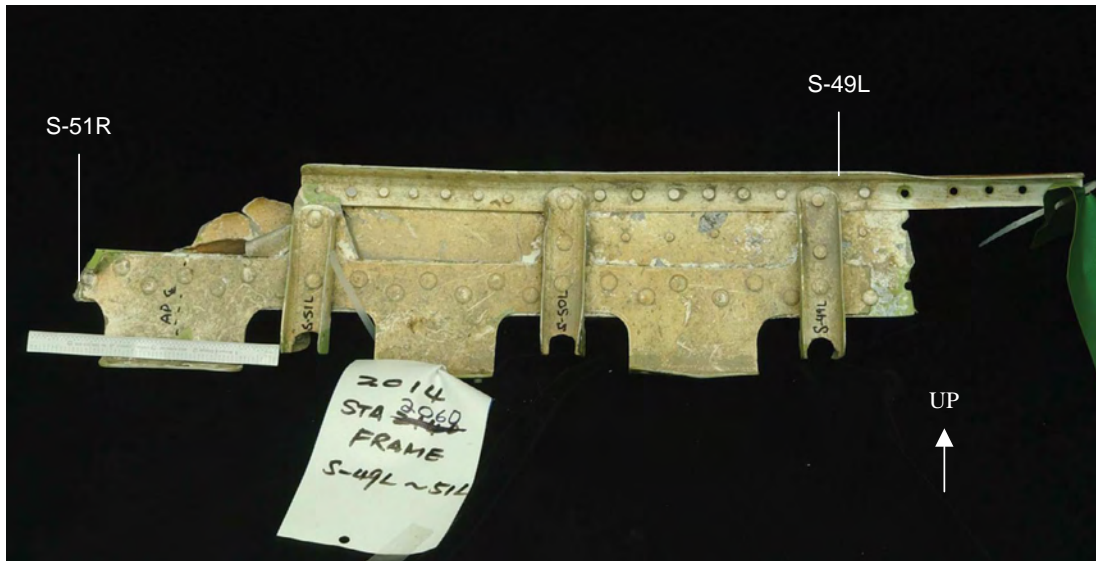
The as-received condition of this frame segment is shown in Figures 80 and 81. This frame segment contained three stringer clips, two shear ties, the failsafe chord, the intermediate chord and a portion of the web.

Figure 80. As received condition of the STA 2060 frame segment. The aft surface is shown in this view.

Figure 81.
As received condition of the STA 2060 frame segment. The forward surface is shown in this view.

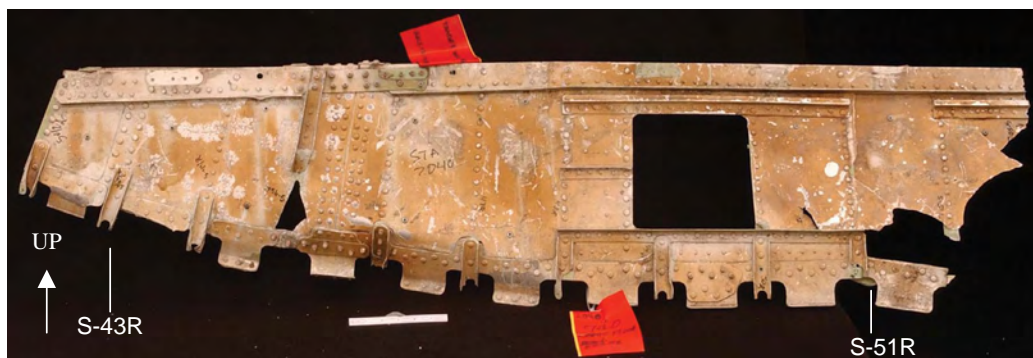
Figure 84 and 85 provide overall views of the aft and forward faces of this frame segment submitted for examination.

Figure 84. As received condition of the STA 2040 frame segment submitted for examination. The aft surface is shown.

Figure 85. As received condition of the STA 2040 frame segment submitted for examination. The forward surface is shown in this view.

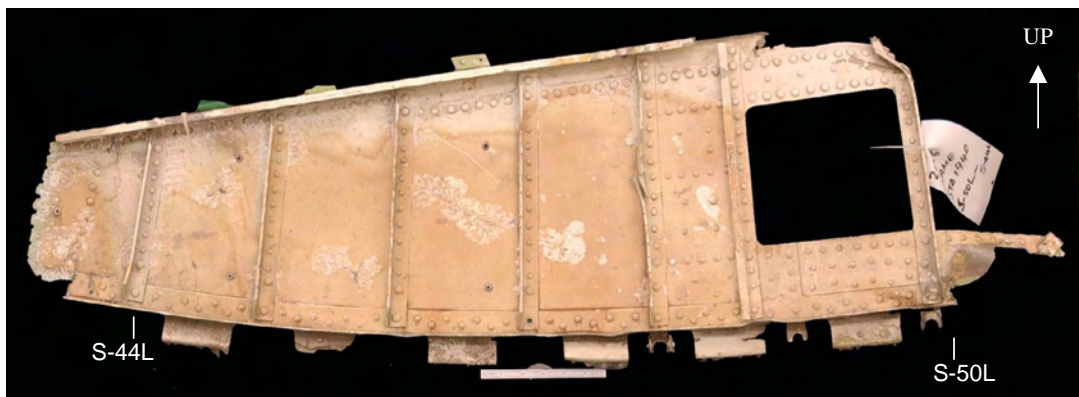
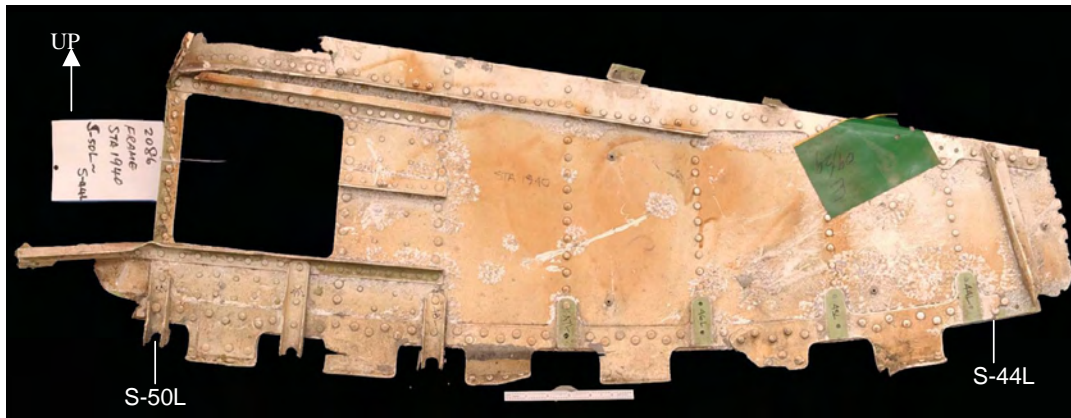
The as-received condition of this frame segment is shown in Figures 89 and 90. This frame segment contained two repairs of shear tie locations and one repair to the web. The shear ties were repaired between S-50L and S-49L with the use of a doubler (see Figure 91) and between S-46L and S-44L with the use of a replacement shear tie/doubler combination (see Figure 92). The web was repaired with the use of a doubler placed on the aft side under the cut-out between S-50L and S-49L (see Figure 93).

Figure 89. As received condition of the STA 1940 frame segment submitted for examination. The aft surface is shown in this view.

Figure 90.
As received condition of STA 1940 frame segment submitted for examination.
The forward surface is shown in this view.
