# 行政院飛航安全委員會

## GE791 事故調查事實資料分組報告

### 飛航性能分組

報告編號：ASC-GRP-03-10-001

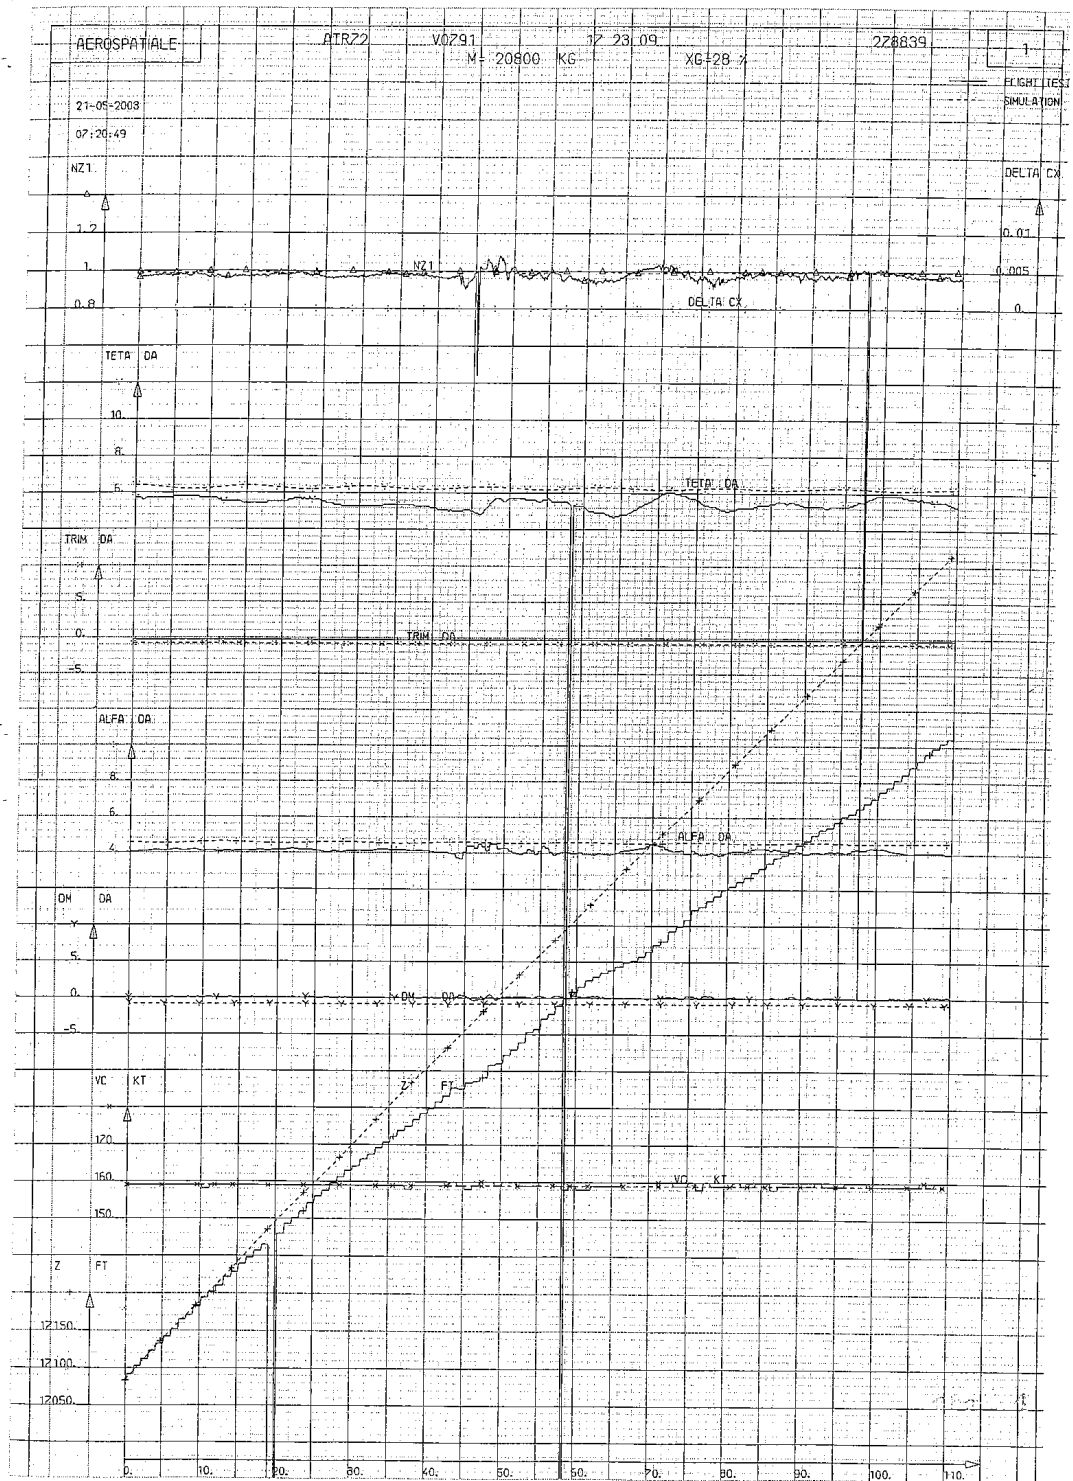
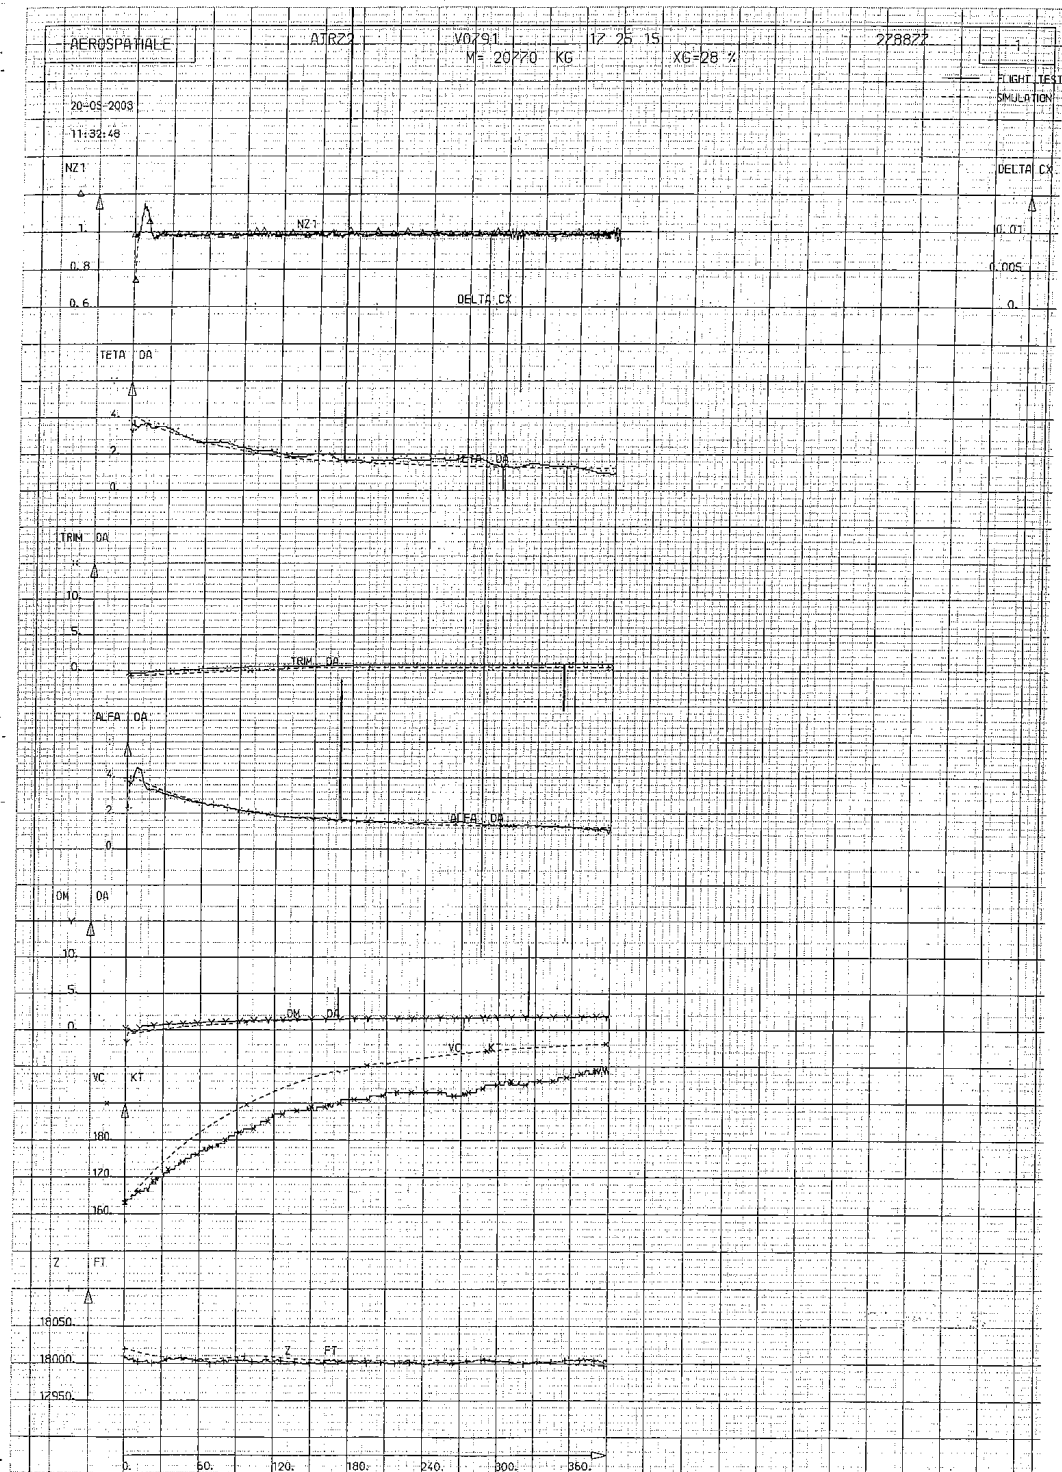
### **Figure 1 and 2**

➤ 17h 24mn 57s (see Figure 1)

➤ 17h 24mn 57s to 17h 32mn 38s(see Figure 1)

- Flight level 180: Speed decay (see figure 1)
